Remediation Action Plan

Proposed Mixed Use Development

**79-81 Queens Road & 2-8 Spencer Street,
Five Dock NSW**

Project 224583.03

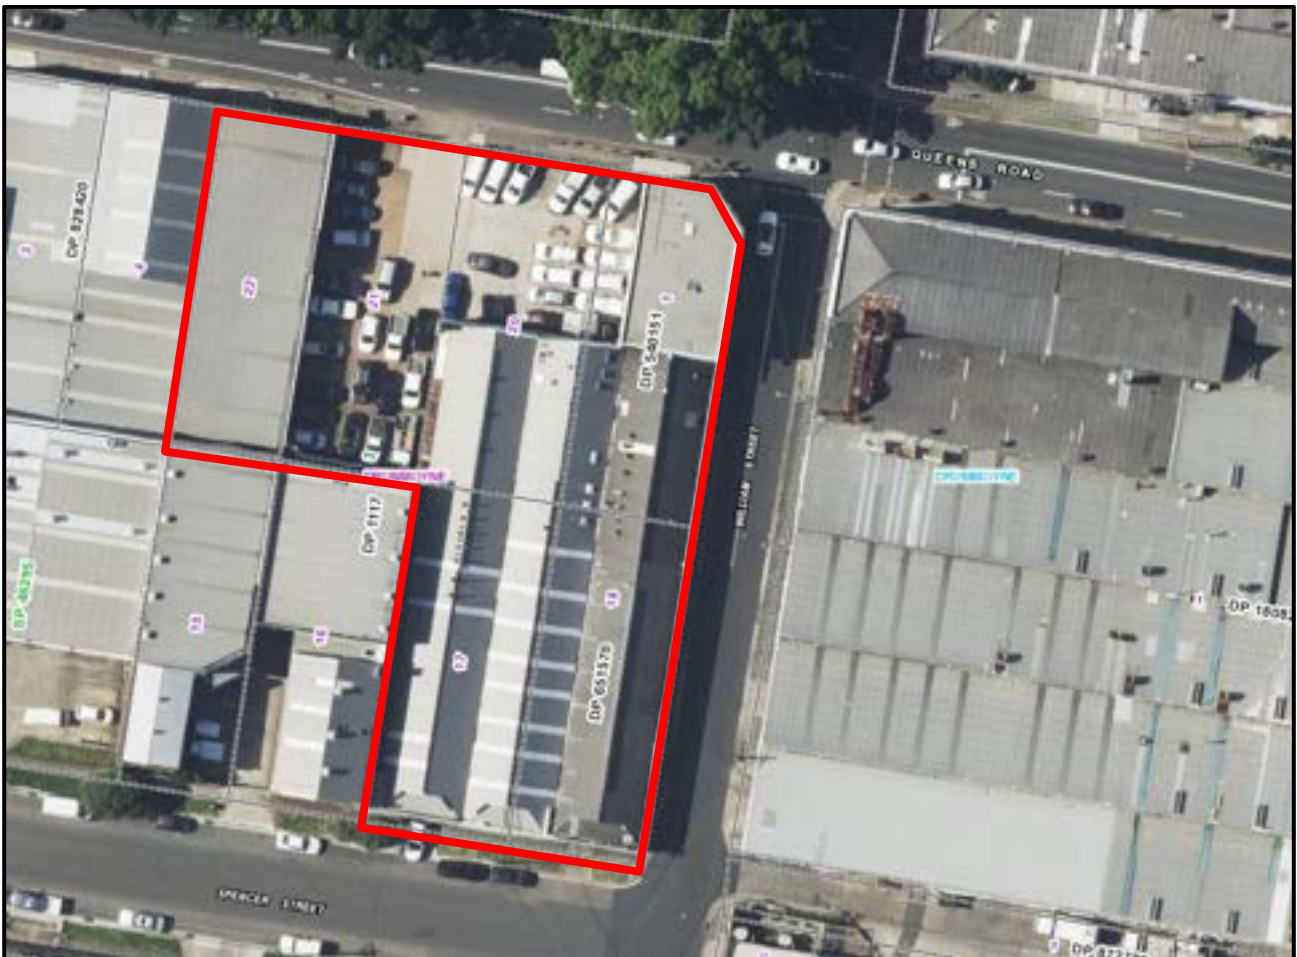
Figure 1. Site boundary (red outline, refer to Drawing 1 for full legend)

The site boundary is shown on Figure 1.

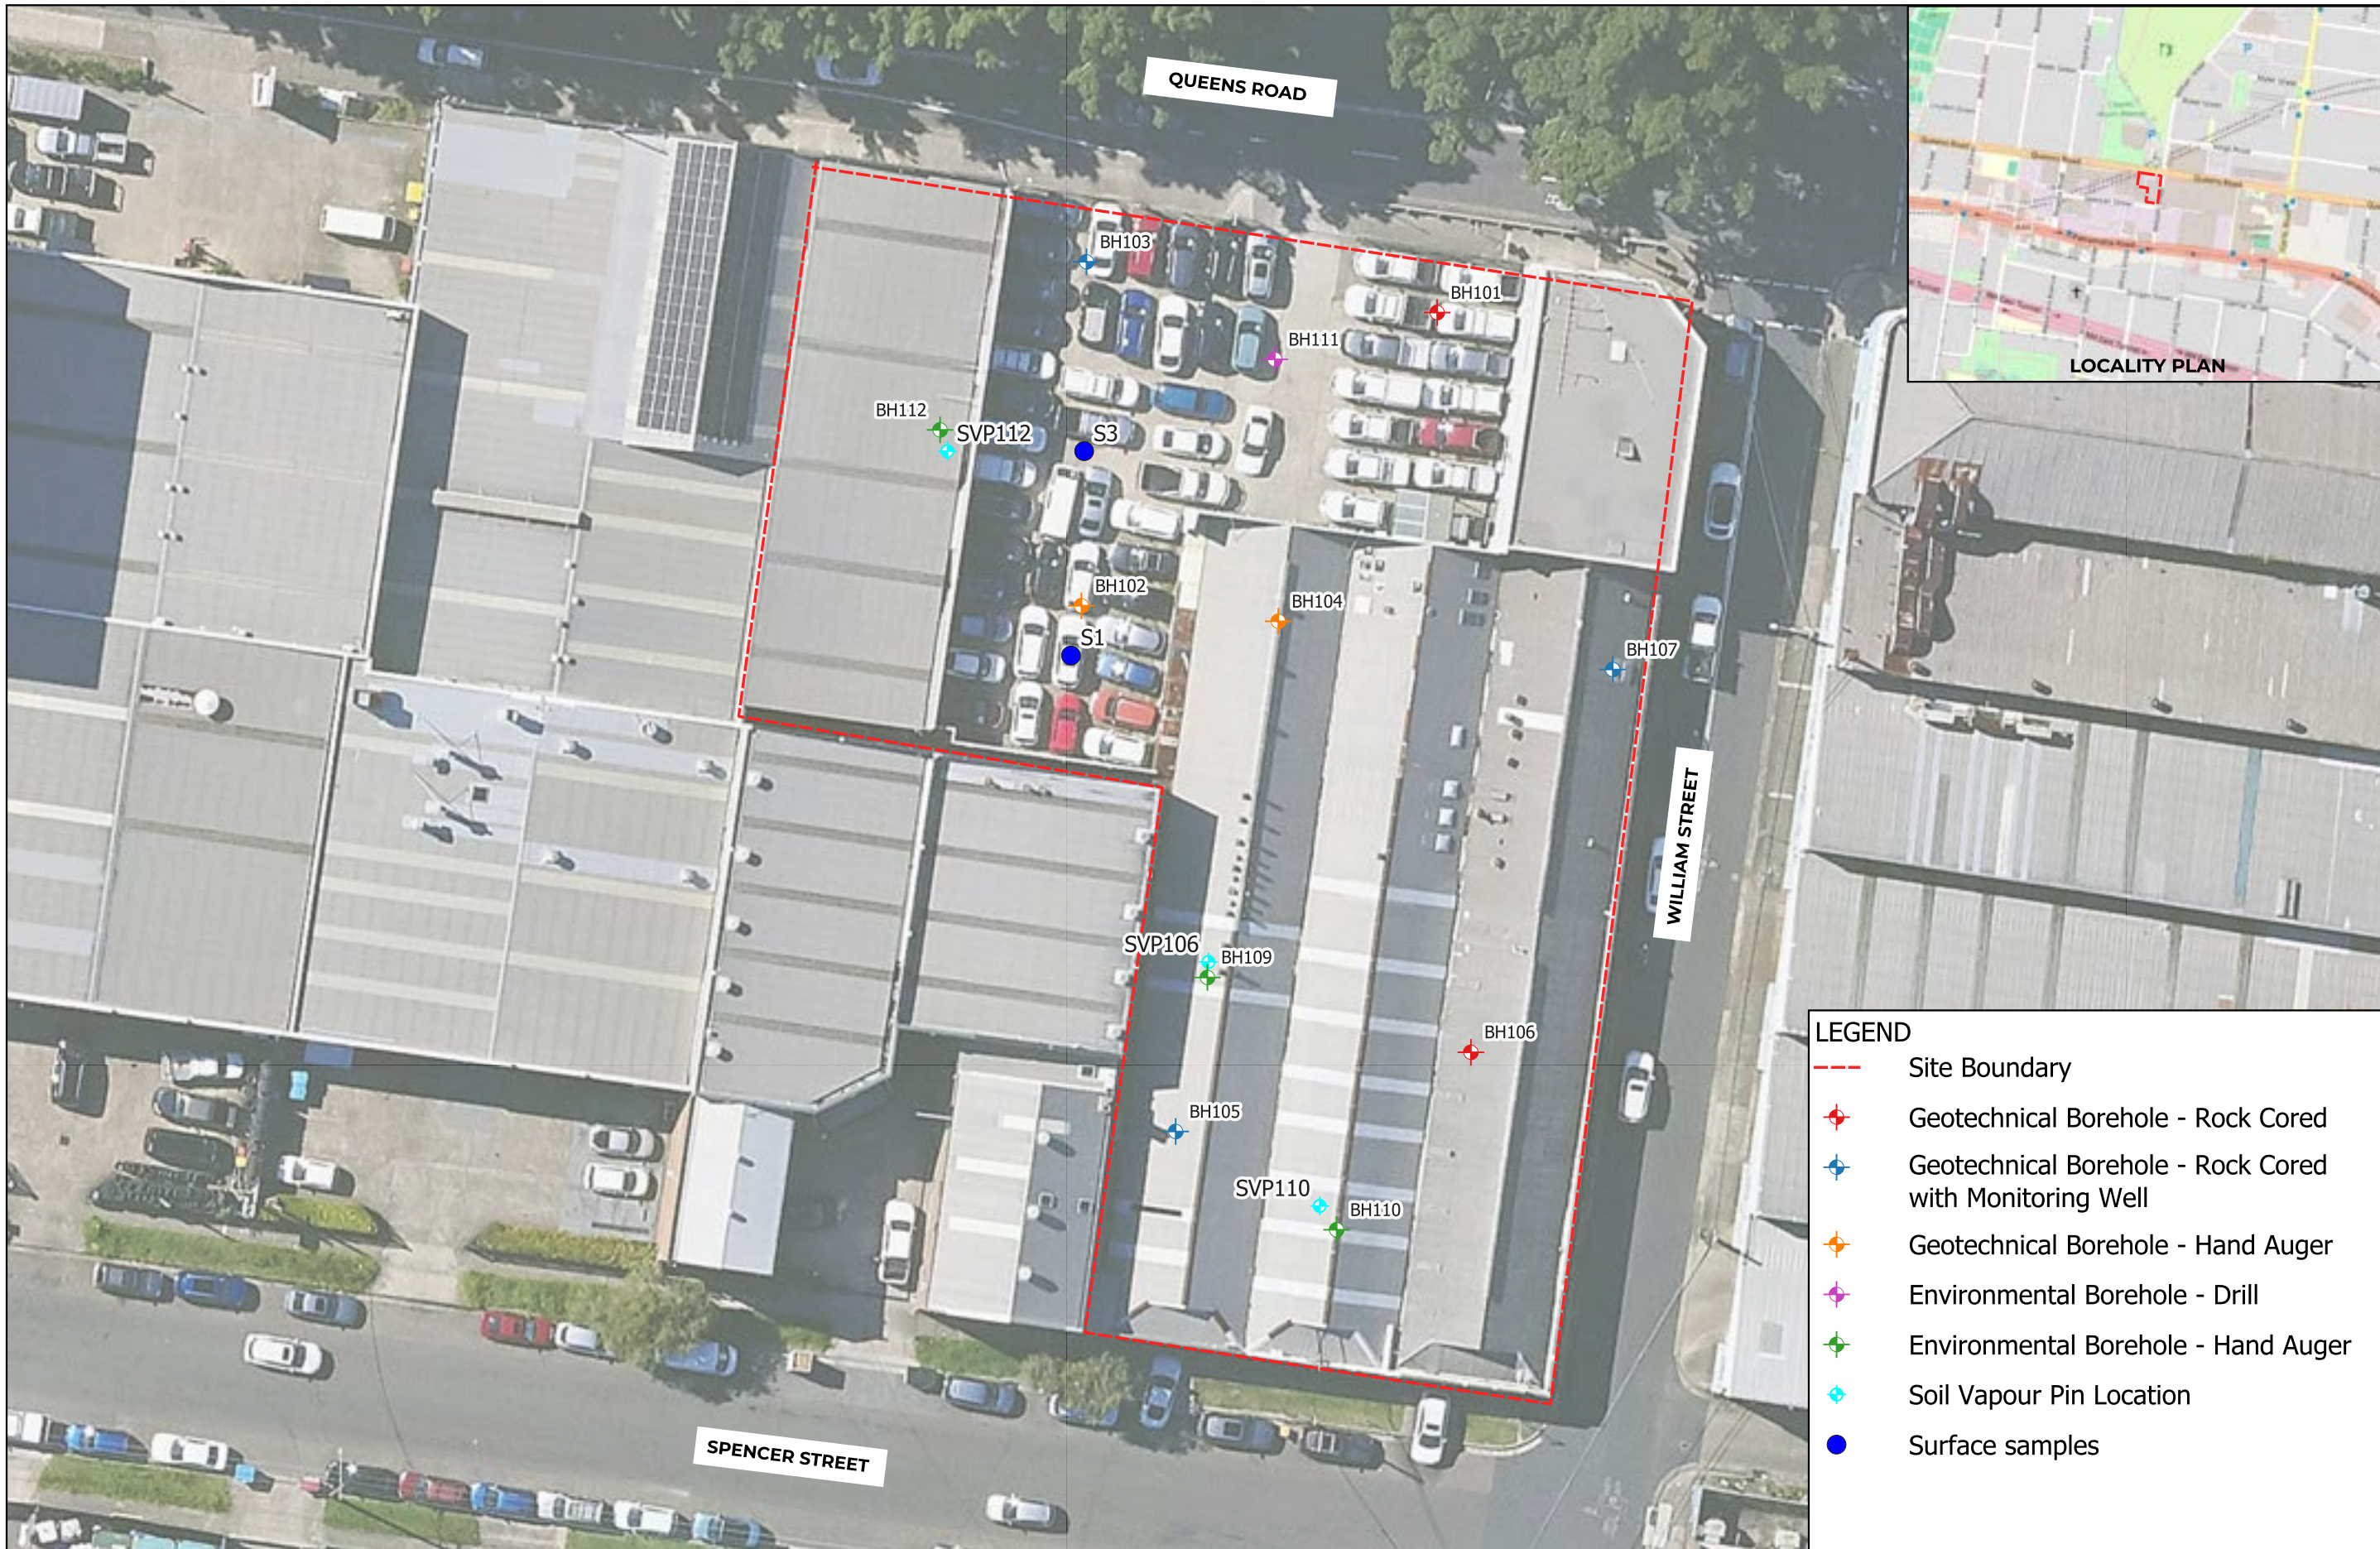
DRAWING NO:
1

LEGEND	
	Site Boundary
	Geotechnical Borehole - Rock Cored
	Geotechnical Borehole - Rock Cored with Monitoring Well
	Geotechnical Borehole - Hand Auger
	Environmental Borehole - Drill
	Environmental Borehole - Hand Auger
	Soil Vapour Pin Location
	Surface samples

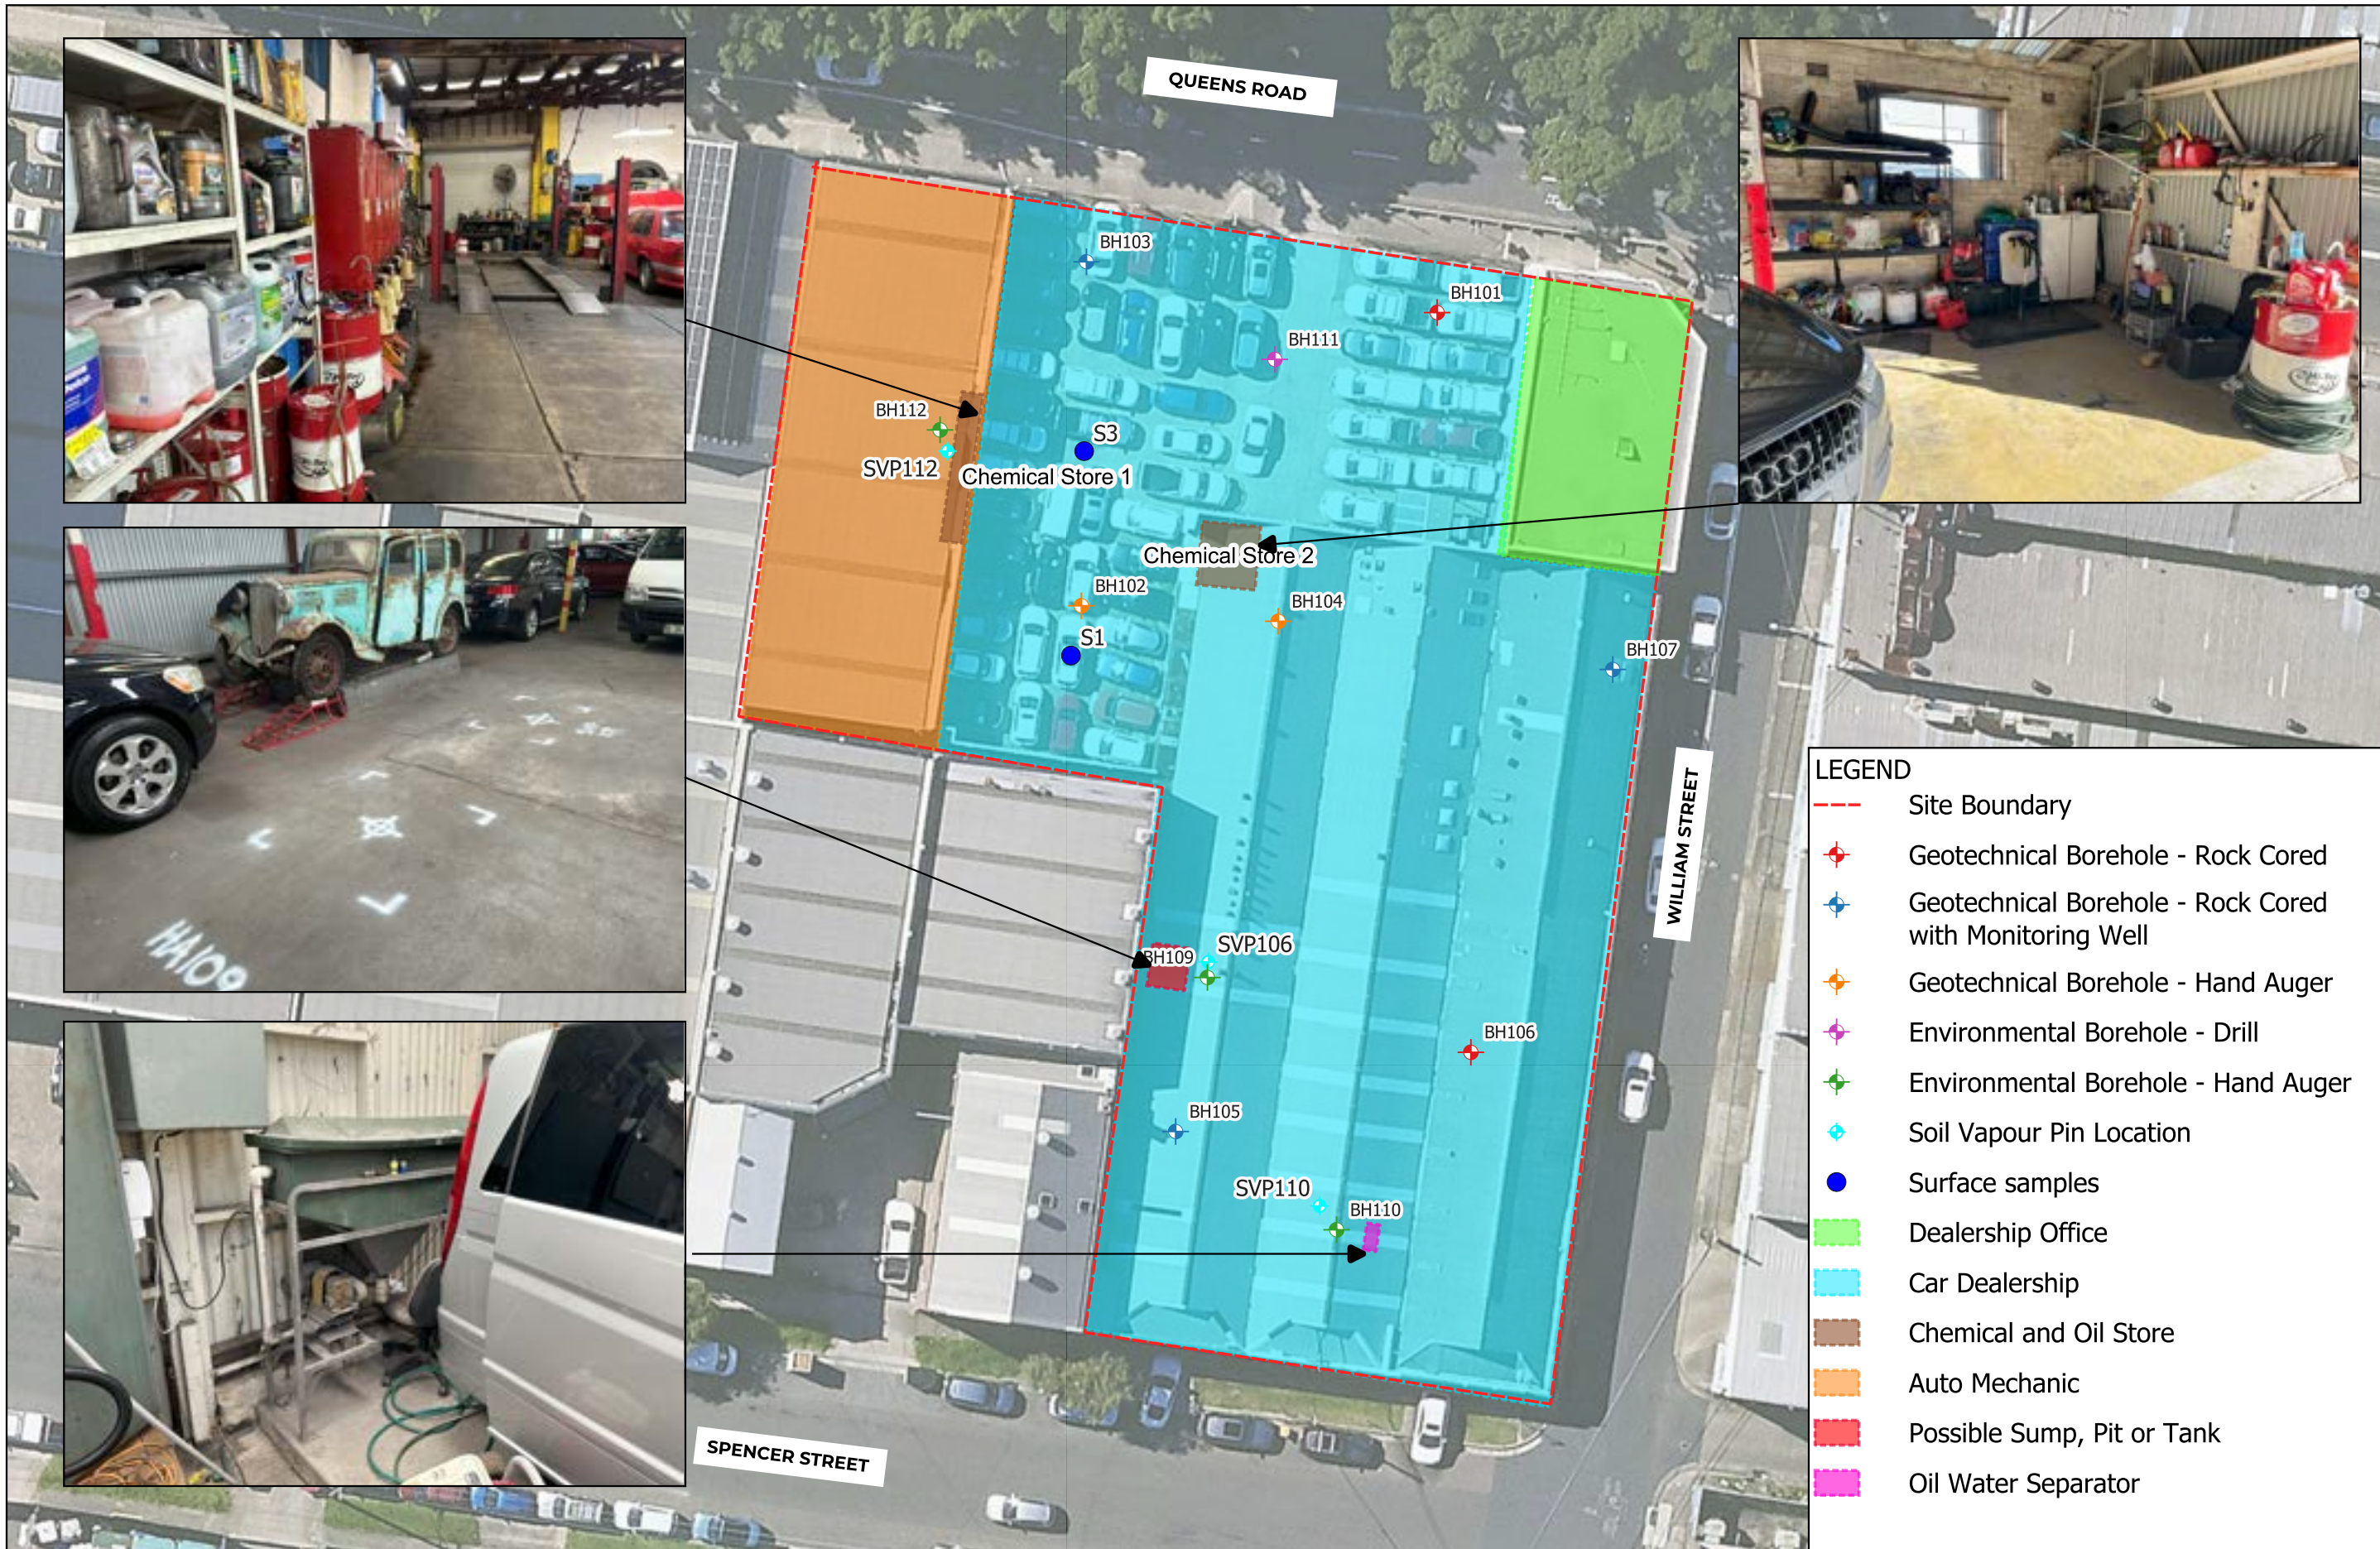
DRAWING NO:
3

- Site Boundary
- ◆ Geotechnical Borehole - Rock Cored
- ◆ Geotechnical Borehole - Rock Cored with Monitoring Well
- ◆ Geotechnical Borehole - Hand Auger
- ◆ Environmental Borehole - Drill
- ◆ Environmental Borehole - Hand Auger
- ◆ Soil Vapour Pin Location
- Surface samples
- Dealership Office
- Car Dealership
- Chemical and Oil Store
- Auto Mechanic
- Possible Sump, Pit or Tank
- Oil Water Separator

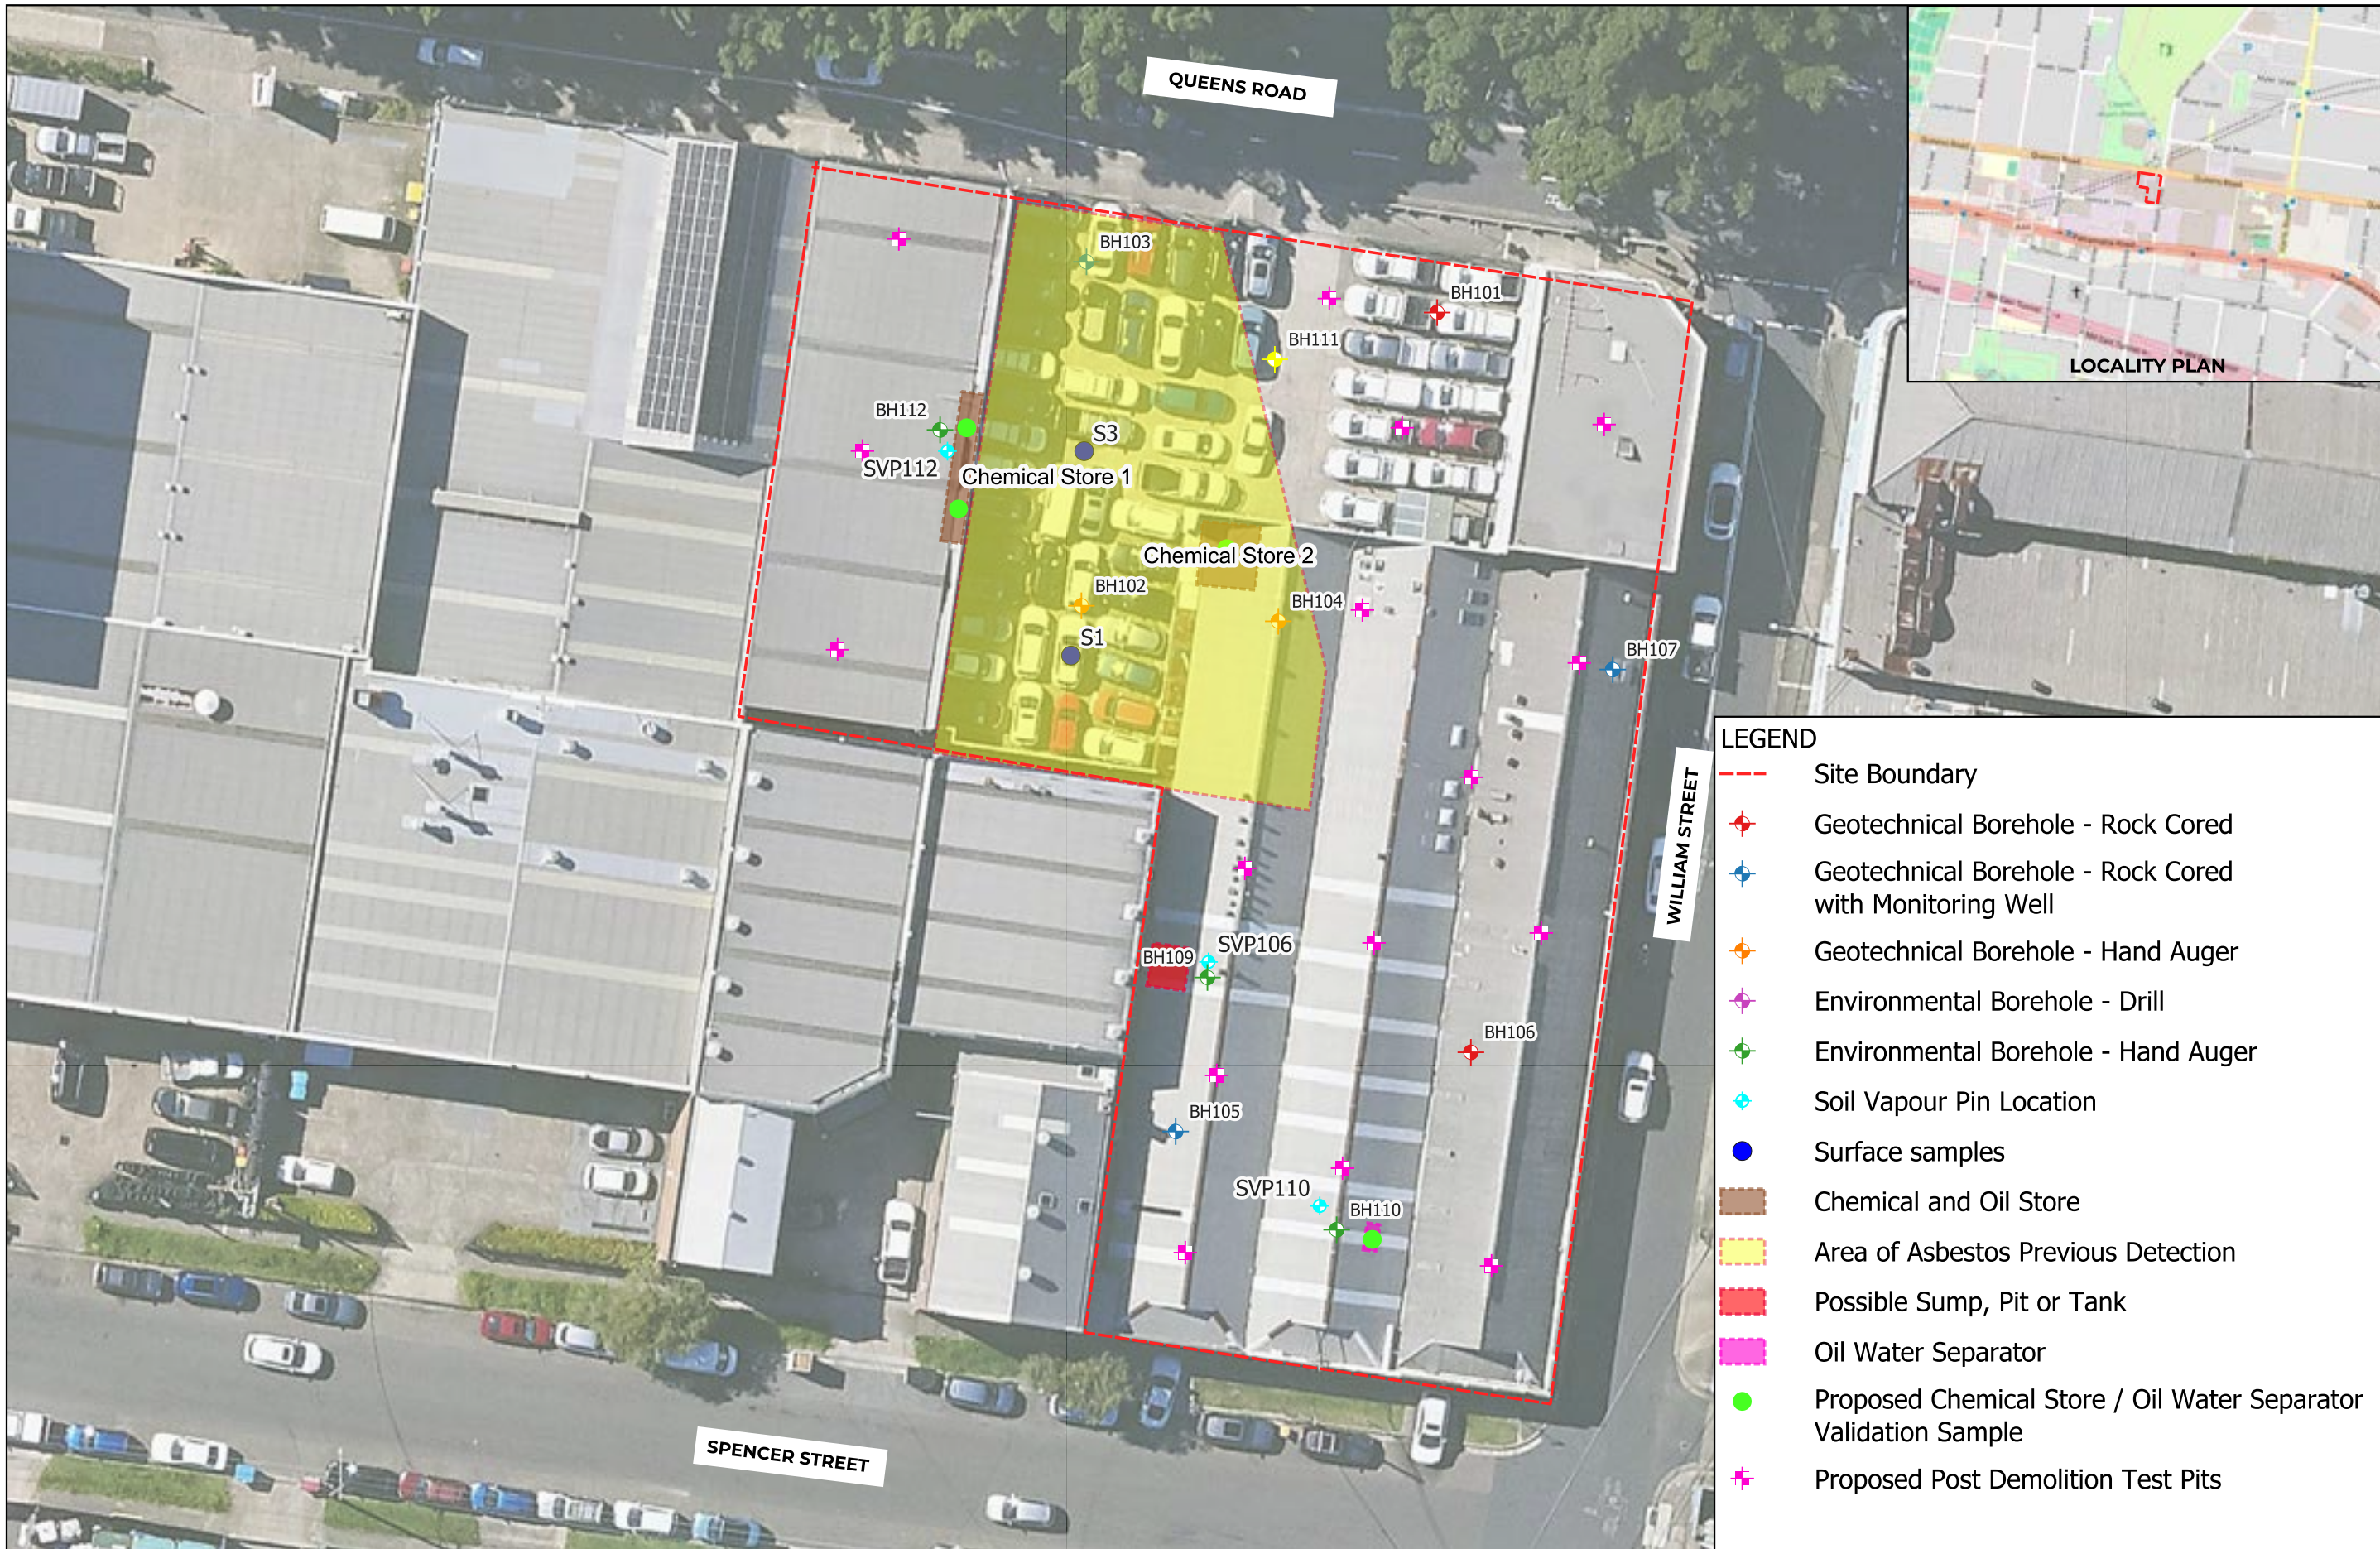
LEGEND	
	Site Boundary
	Geotechnical Borehole - Rock Cored
	Geotechnical Borehole - Rock Cored with Monitoring Well
	Geotechnical Borehole - Hand Auger
	Environmental Borehole - Drill
	Environmental Borehole - Hand Auger
	Soil Vapour Pin Location
	Surface samples
	Chemical and Oil Store
	Area of Asbestos Previous Detection
	Possible Sump, Pit or Tank
	Oil Water Separator
	Proposed Chemical Store / Oil Water Separator Validation Sample
	Proposed Post Demolition Test Pits

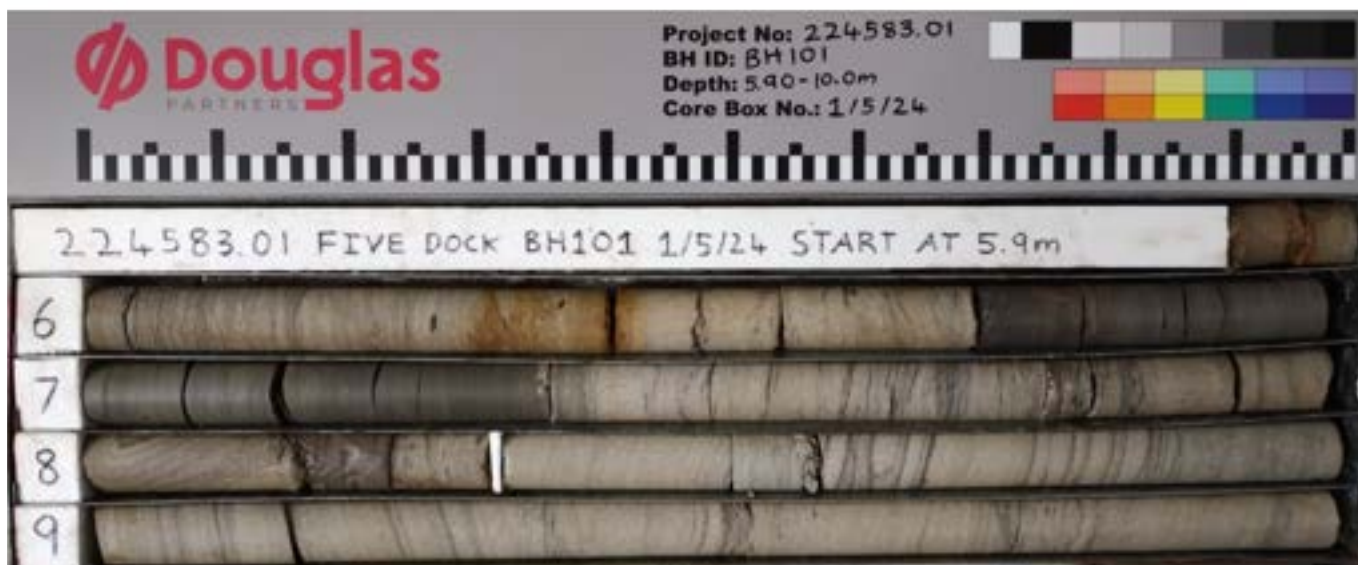
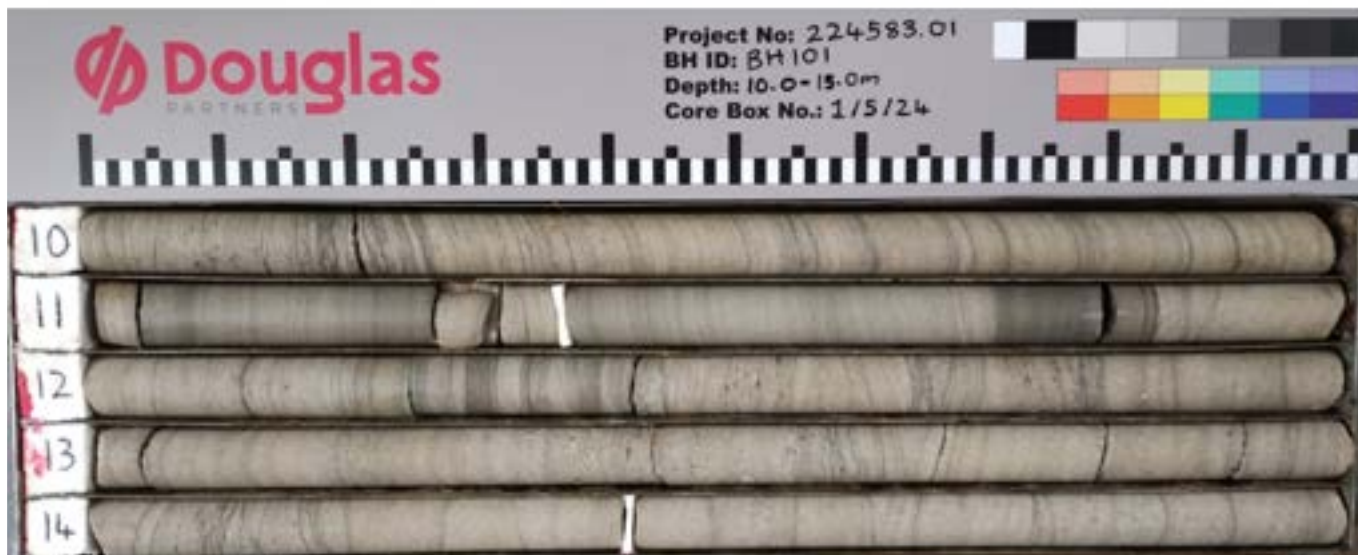
LOCATION ID: BH101
PROJECT No: 224583.01
DATE: 01/05/24 - 02/05/24
SHEET: 1 of 2

5.90-10.00 m depth

10.00-15.00 m depth

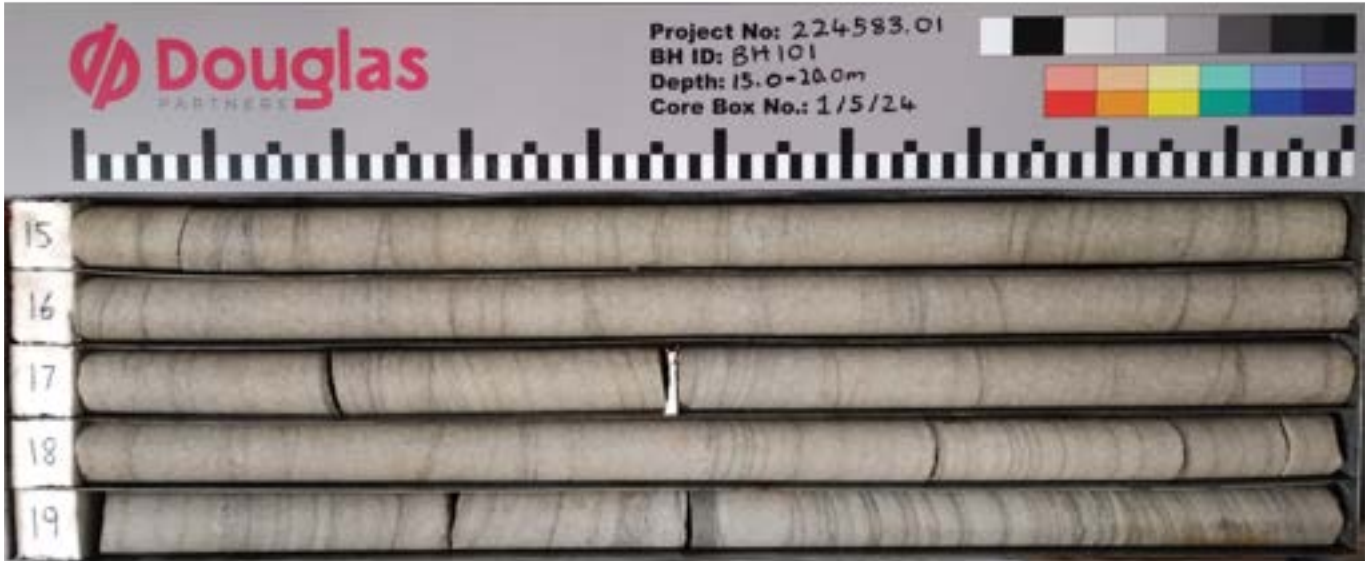
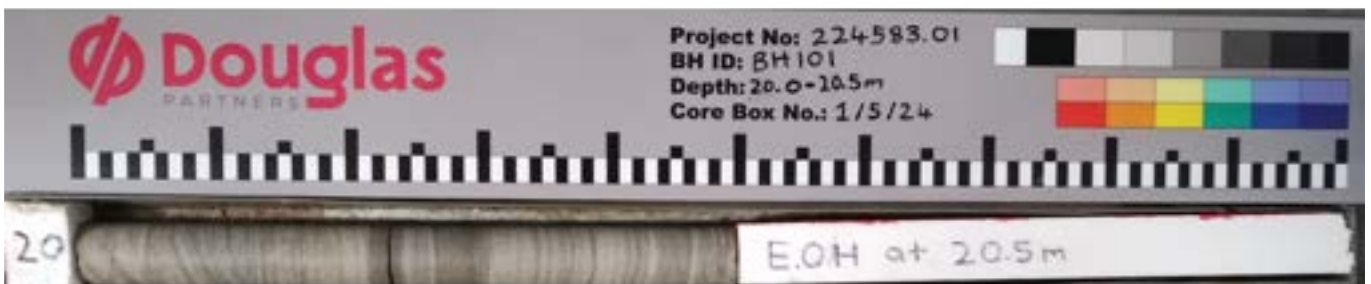
LOCATION ID: BH101
PROJECT No: 224583.01
DATE: 01/05/24 - 02/05/24
SHEET: 2 of 2

15.00-20.00 m depth

20.00-20.50 m depth

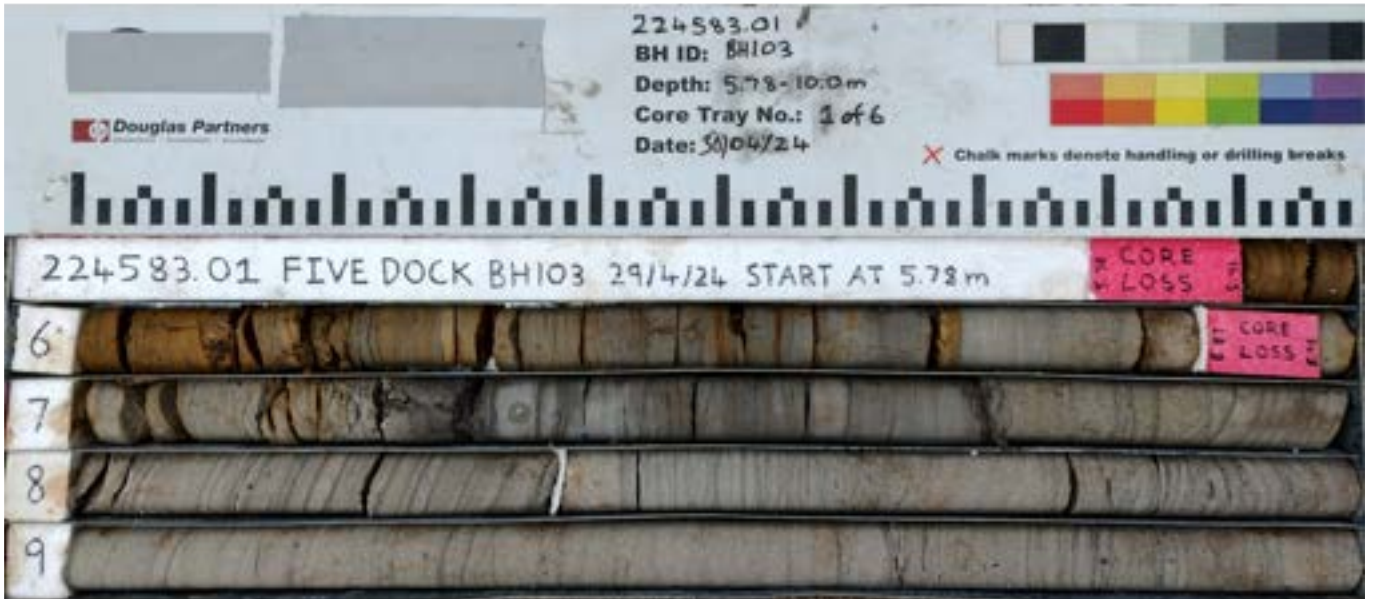
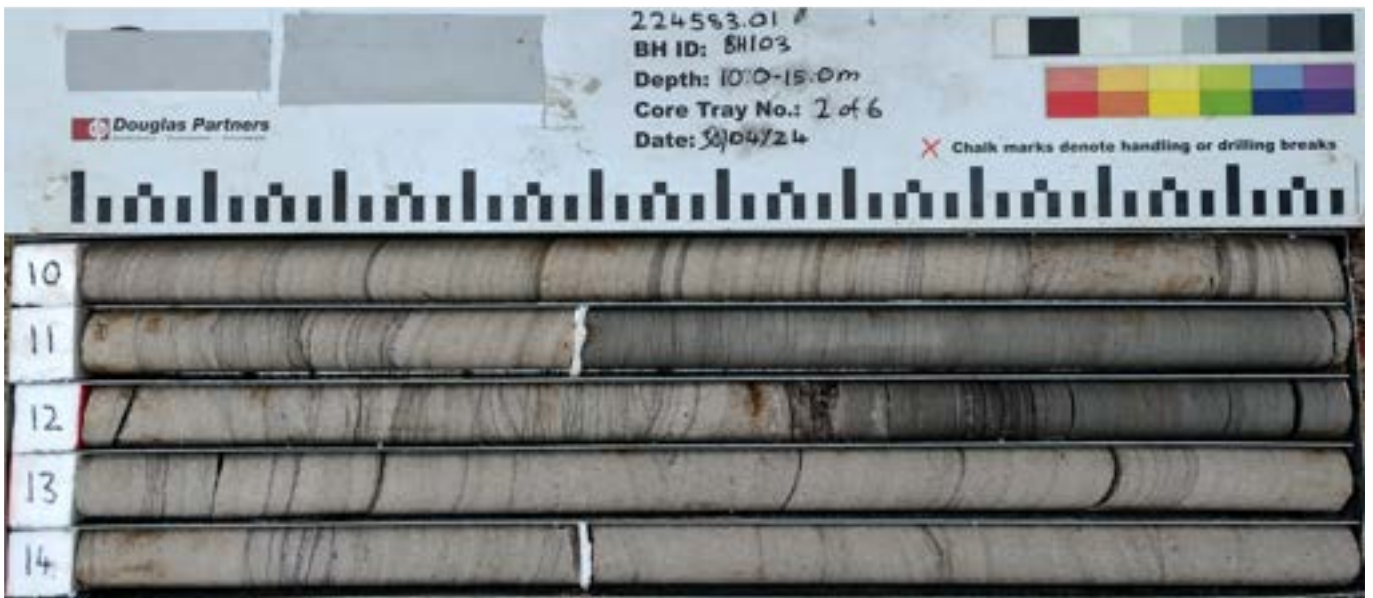
LOCATION ID: BH103
PROJECT No: 224583.01
DATE: 29/04/24 - 30/04/24
SHEET: 1 of 3

5.78-10.00 m depth

10.00-15.00 m depth

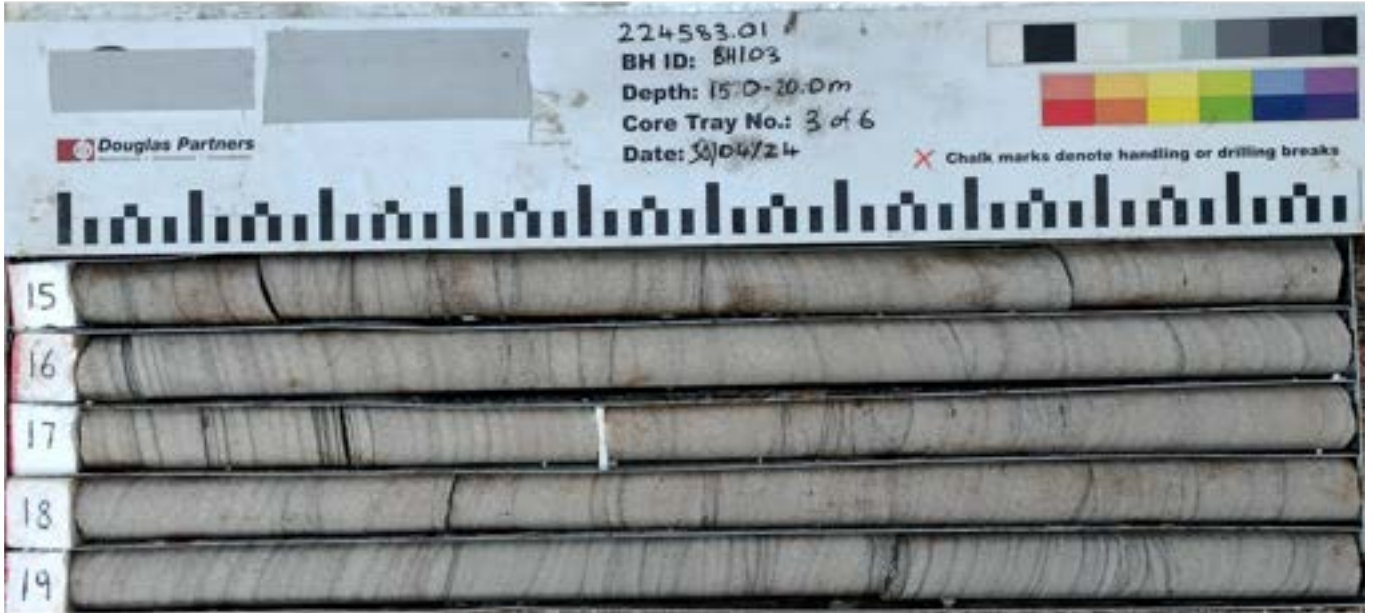
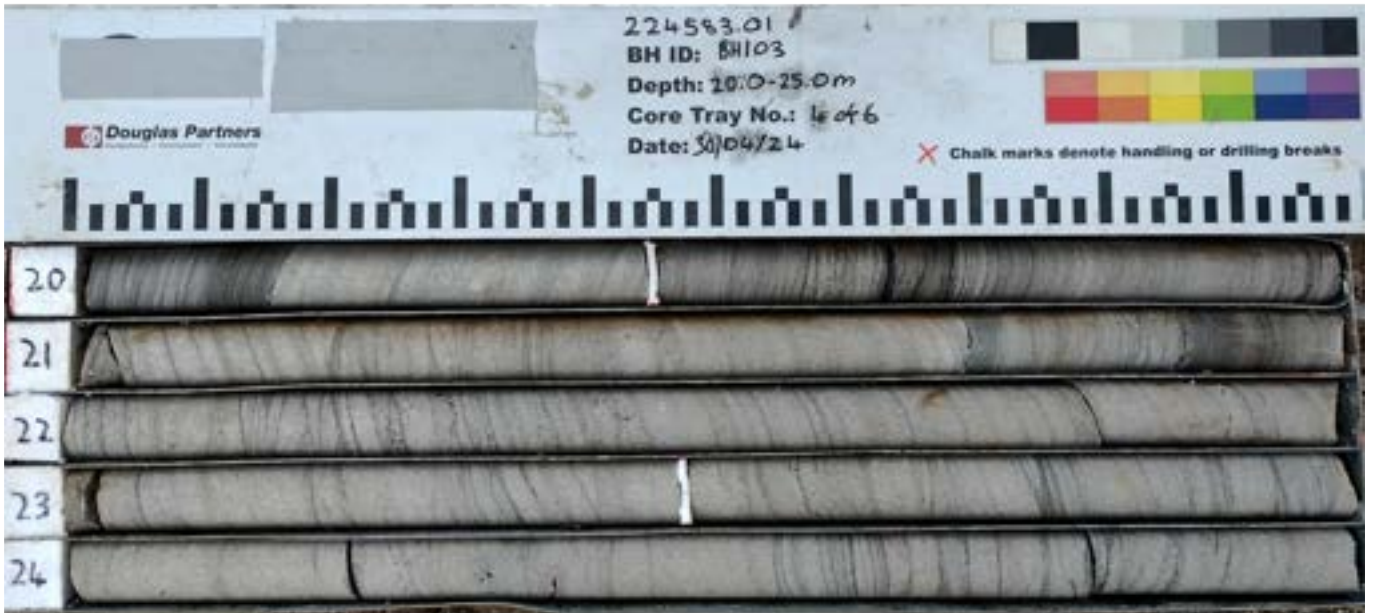
LOCATION ID: BH103
PROJECT No: 224583.01
DATE: 29/04/24 - 30/04/24
SHEET: 2 of 3

15.00-20.00 m depth

20.00-25.00 m depth

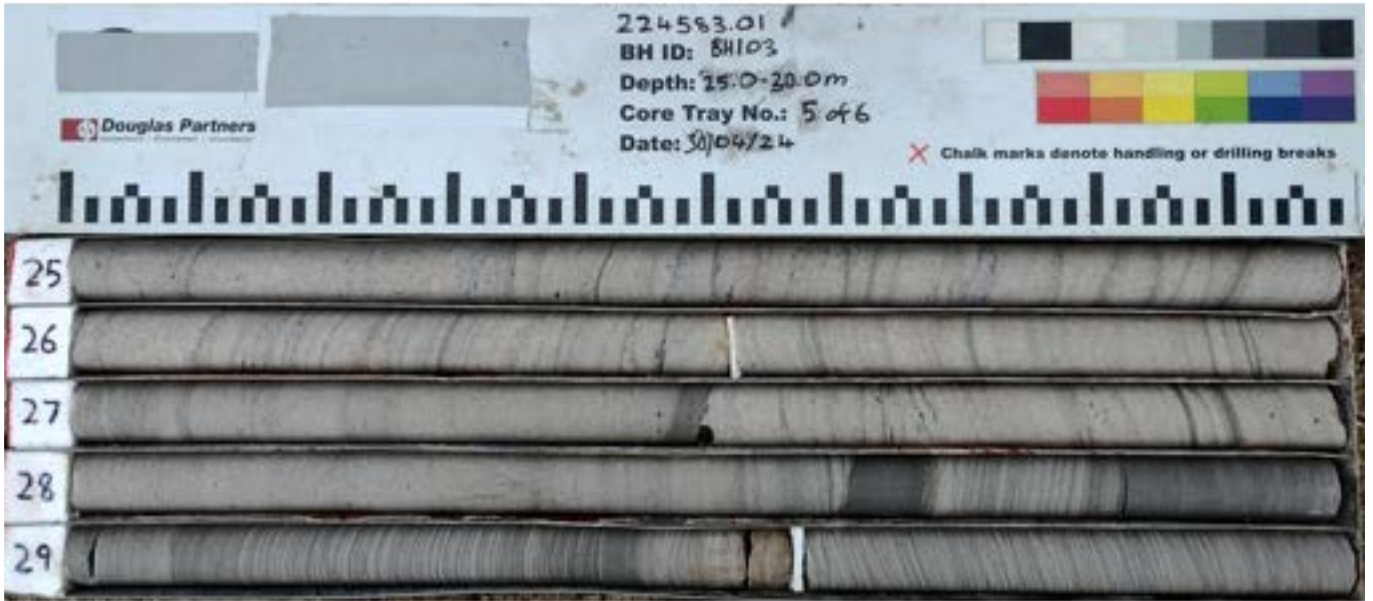
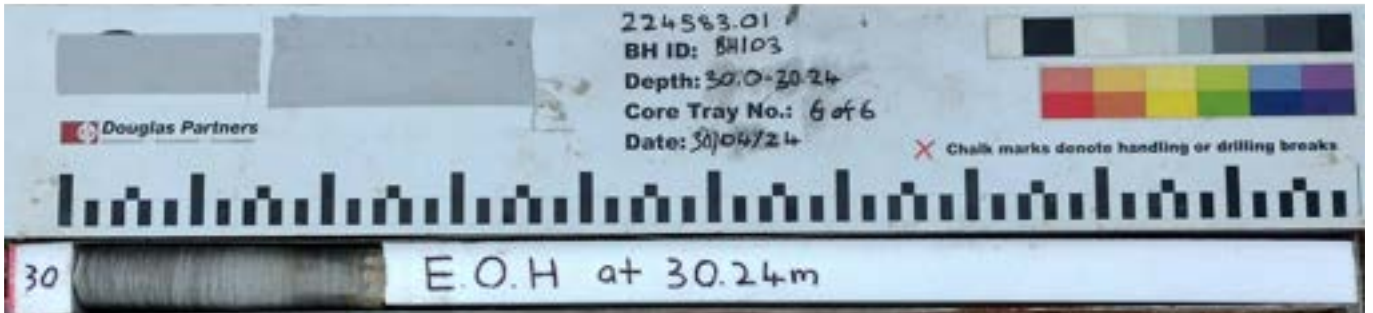
LOCATION ID: BH103
PROJECT No: 224583.01
DATE: 29/04/24 - 30/04/24
SHEET: 3 of 3

25.00-30.00 m depth

30.00-30.24 m depth

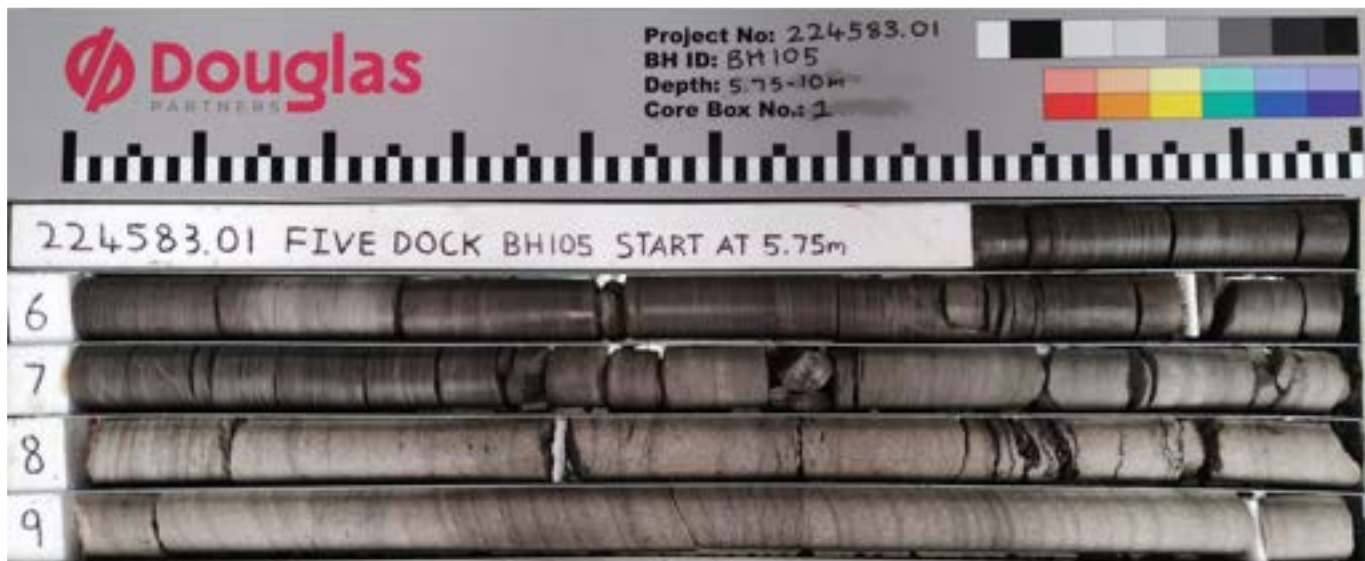
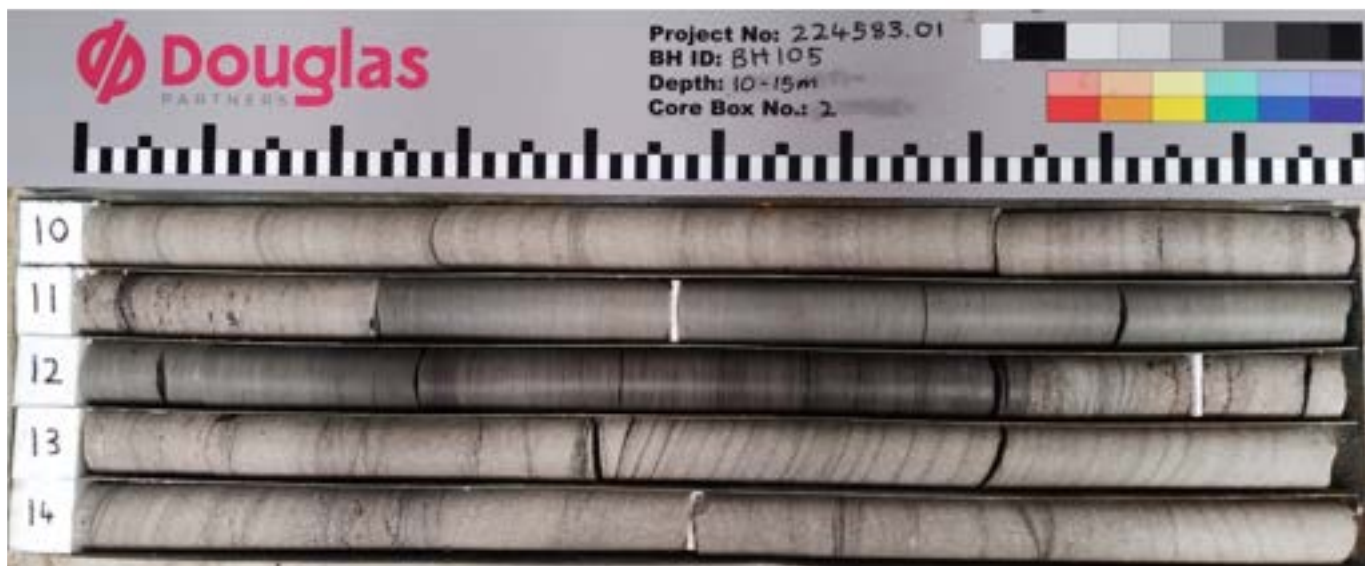
LOCATION ID: BH105
PROJECT No: 224583.01
DATE: 14/05/24
SHEET: 1 of 2

5.75-10.00 m depth

10.00-15.00 m depth

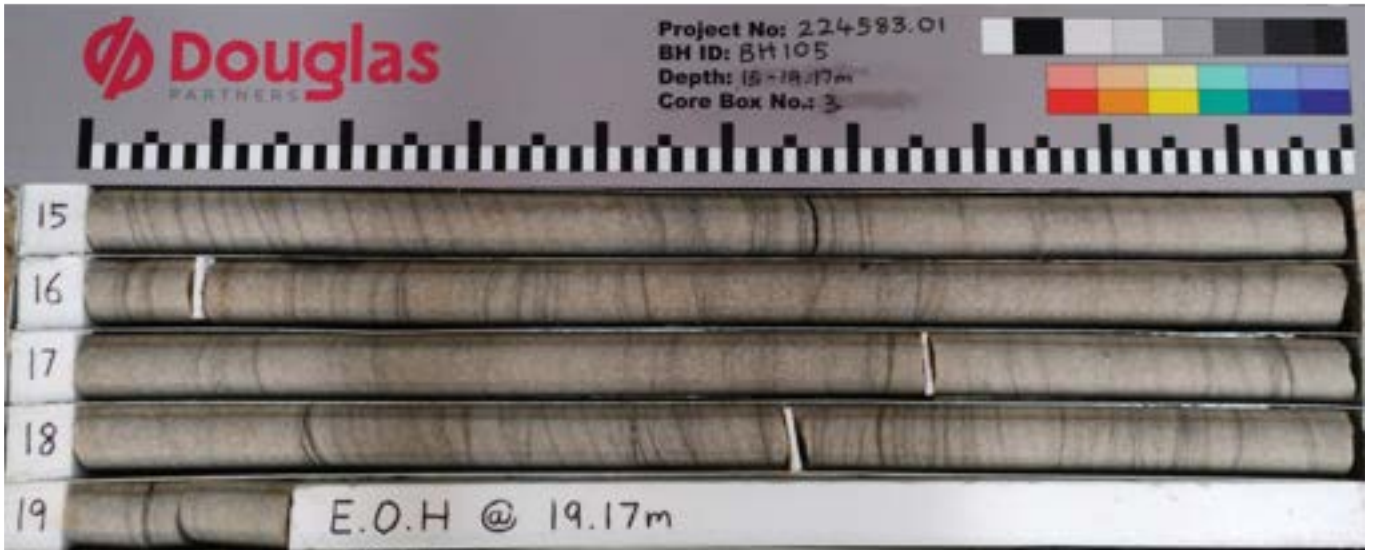
LOCATION ID: BH105
PROJECT No: 224583.01
DATE: 14/05/24
SHEET: 2 of 2

15.00-19.17 m depth
