Remediation Action Plan

Proposed Mixed Use Development

**79-81 Queens Road & 2-8 Spencer Street,
Five Dock NSW**

Project 224583.03

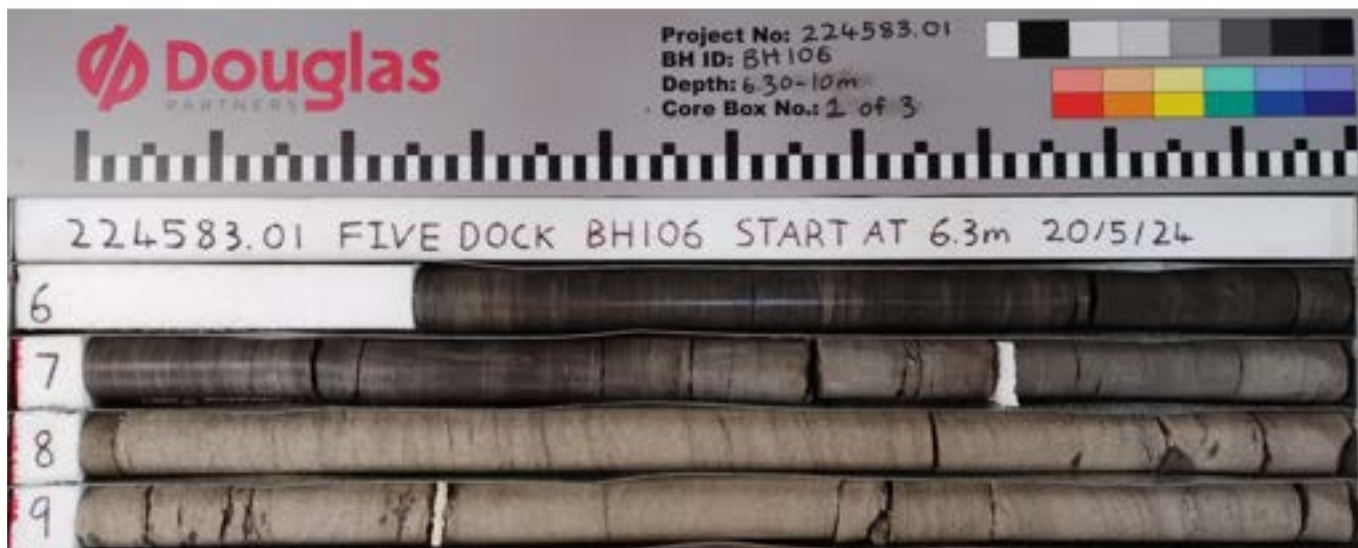
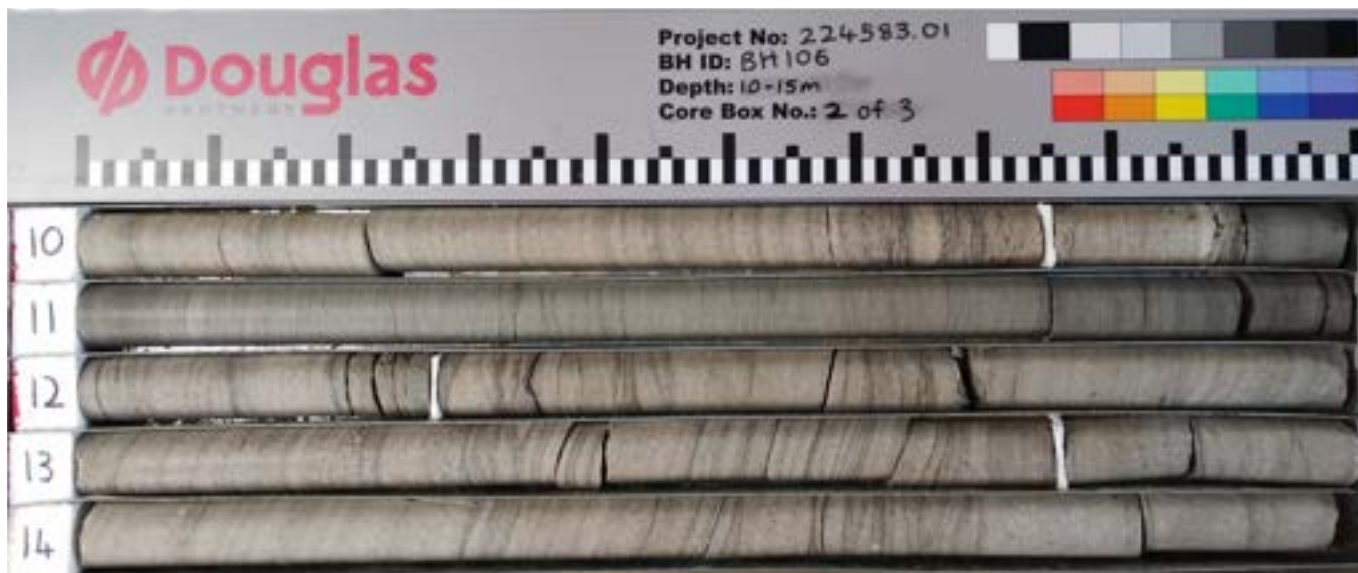
LOCATION ID: BH106
PROJECT No: 224583.01
DATE: 16/05/24
SHEET: 1 of 2

6.30-10.00 m depth

10.00-15.00 m depth

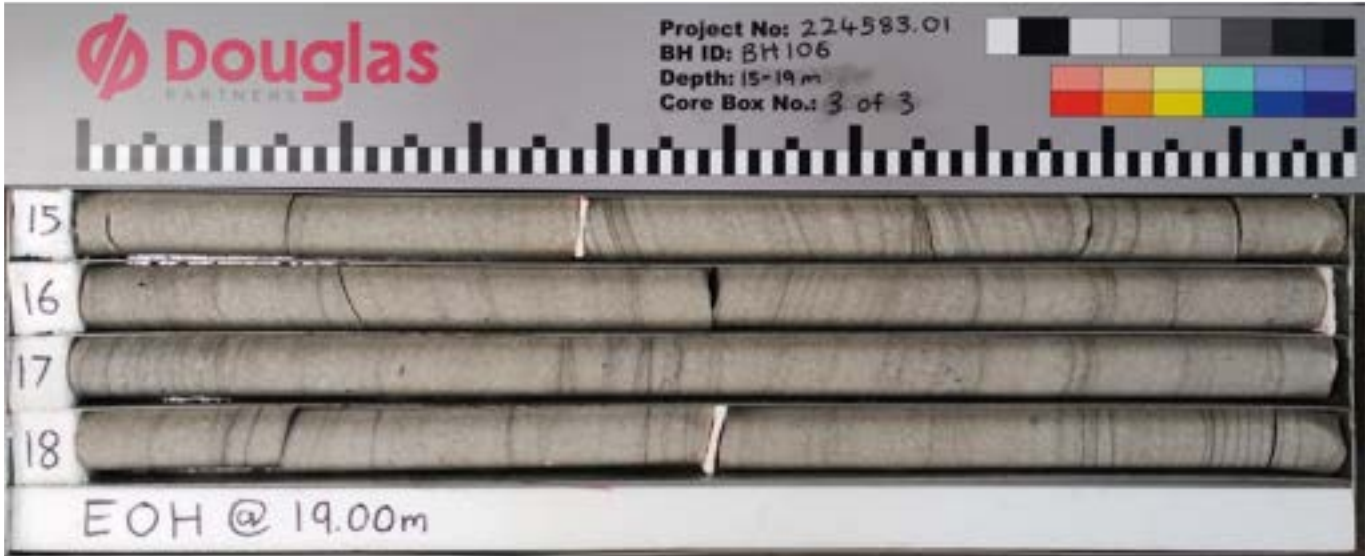
LOCATION ID: BH106
PROJECT No: 224583.01
DATE: 16/05/24
SHEET: 2 of 2

15.00-19.00 m depth

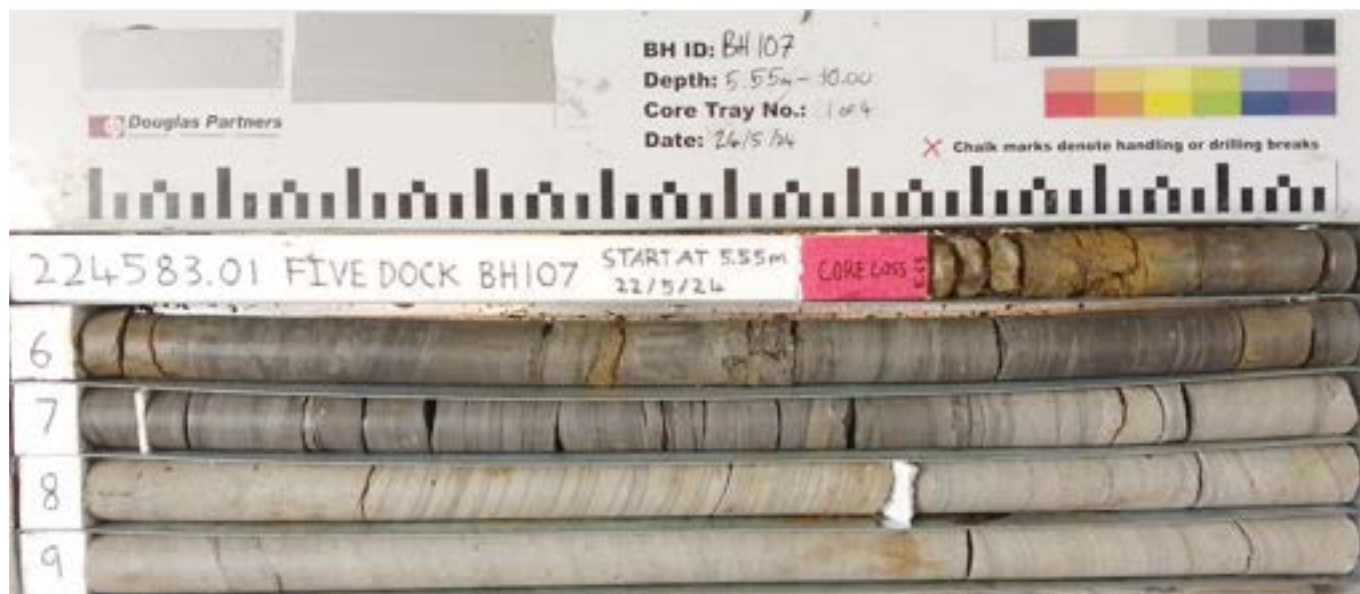
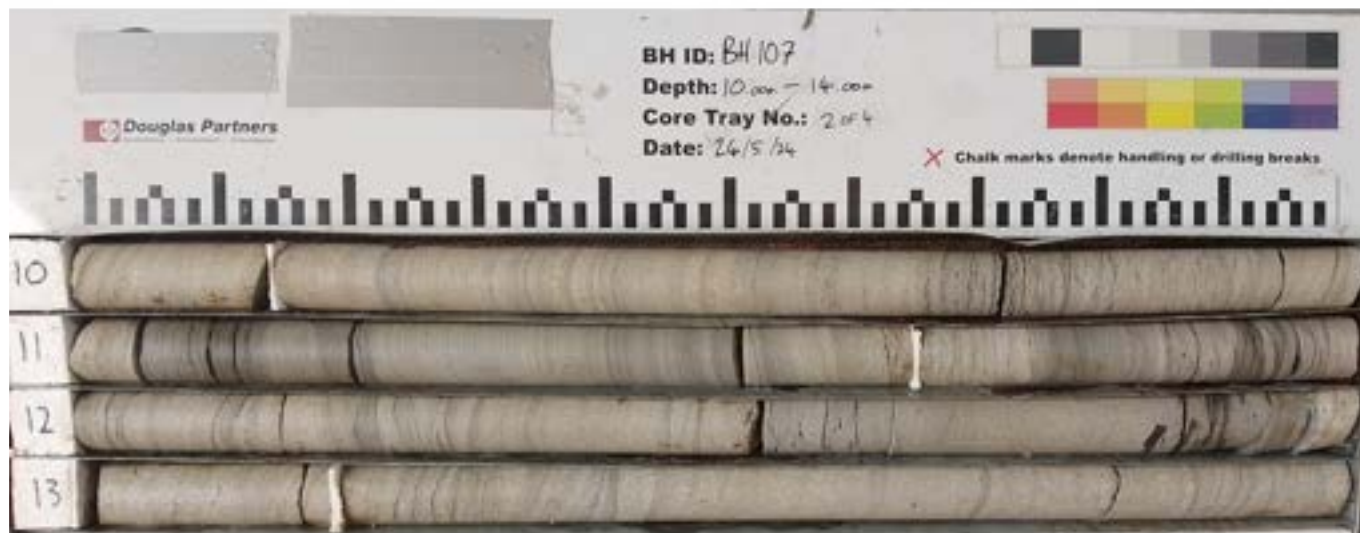
LOCATION ID: BH107
PROJECT No: 224583.01
DATE: 22/05/24 - 23/05/24
SHEET: 1 of 2

5.55-10.00 m depth

10.00-14.00 m depth

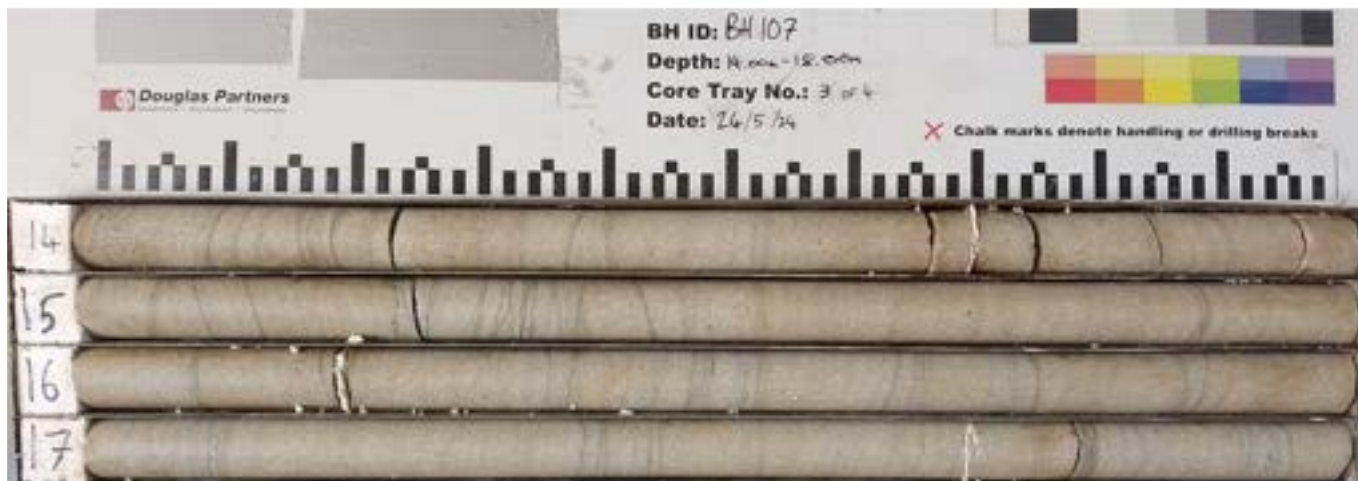
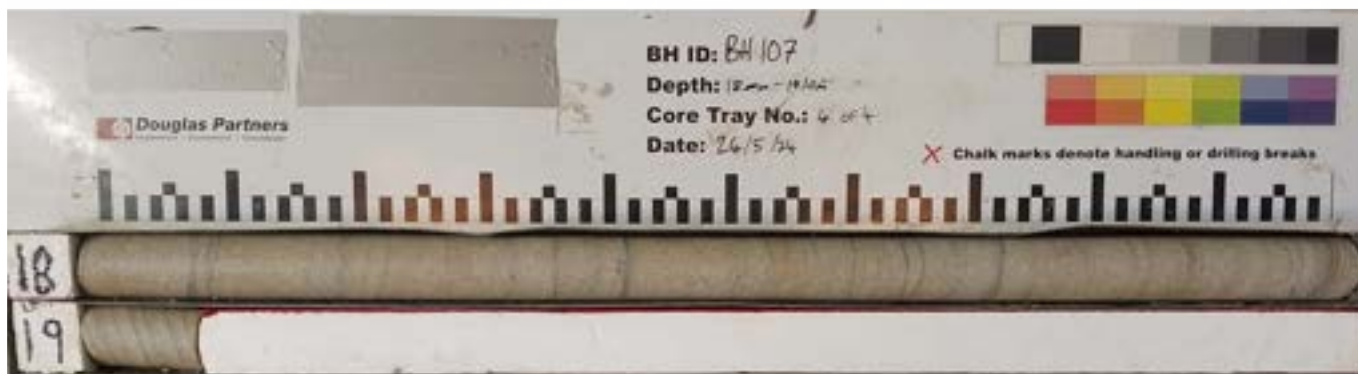
LOCATION ID: BH107
PROJECT No: 224583.01
DATE: 22/05/24 - 23/05/24
SHEET: 2 of 2

14.00-18.00 m depth

18.00-19.10 m depth

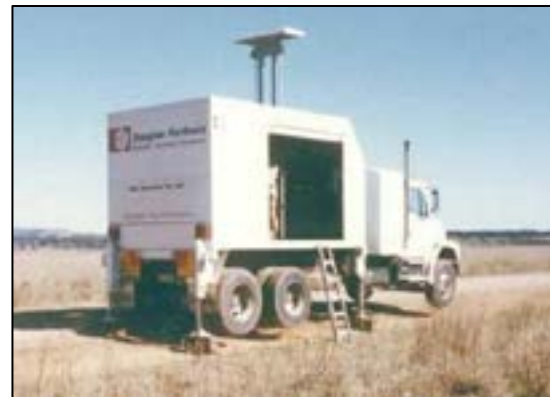
The cone is thrust into the ground at a steady rate of about 20 mm/sec, usually using the hydraulic rams of a purpose built CPT rig, or a drilling rig. The testing is carried out in accordance with the Australian Standard AS1289 Test 6.5.1.

Figure 2: Purpose built CPT rig
