# PRELIMINARY SITE INVESTIGATION REPORT

**PROJECT:** 2-8 Highgate Rd, Lindfield NSW 2070  
**CLIENT:** CPDM  
**DATE:** 11 April 2025  
**REPORT NO:** NE1980 Rpt1V4

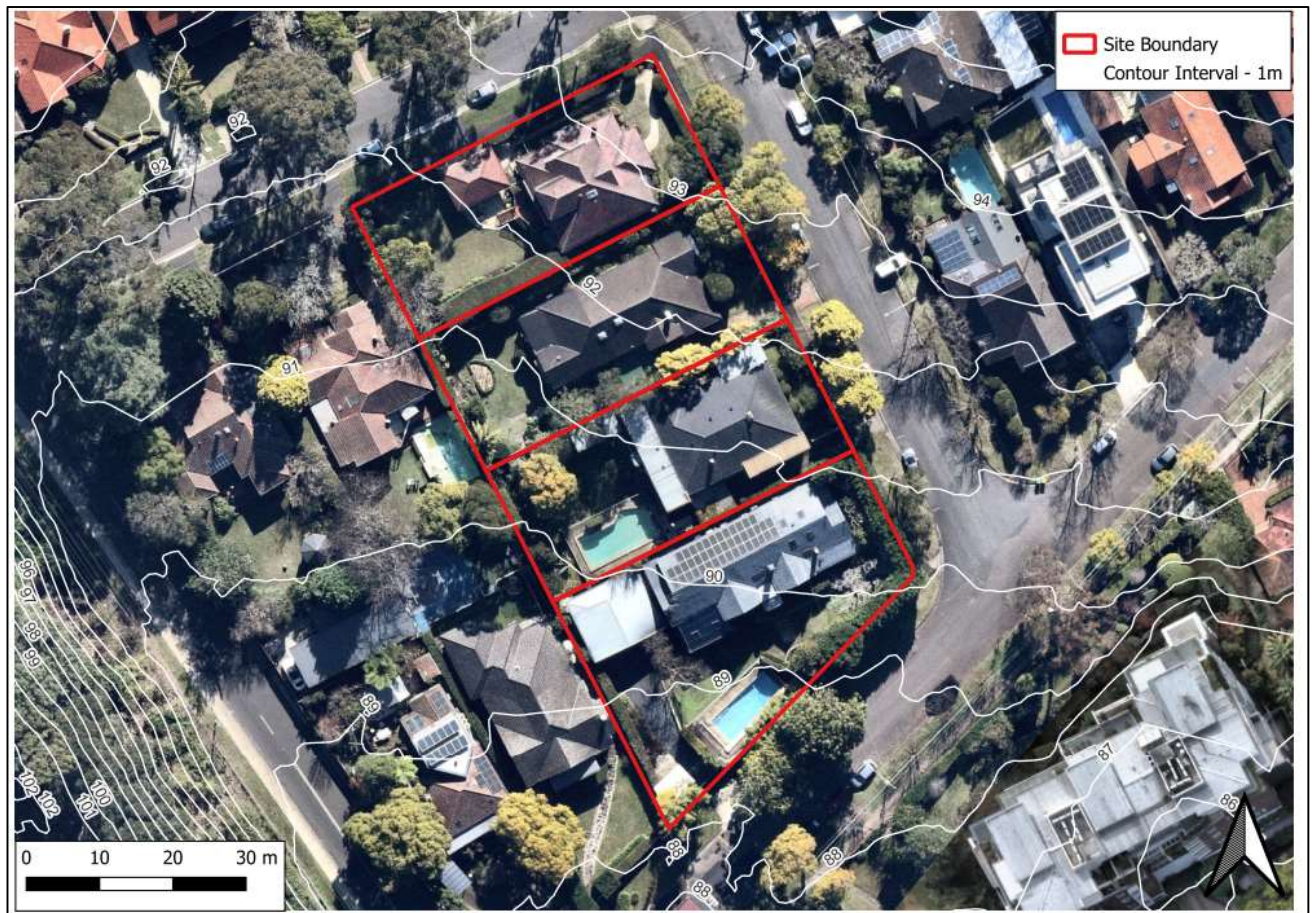
**Figure 1.** Site overview (Nearmap, imagery dated 22 July 2024)

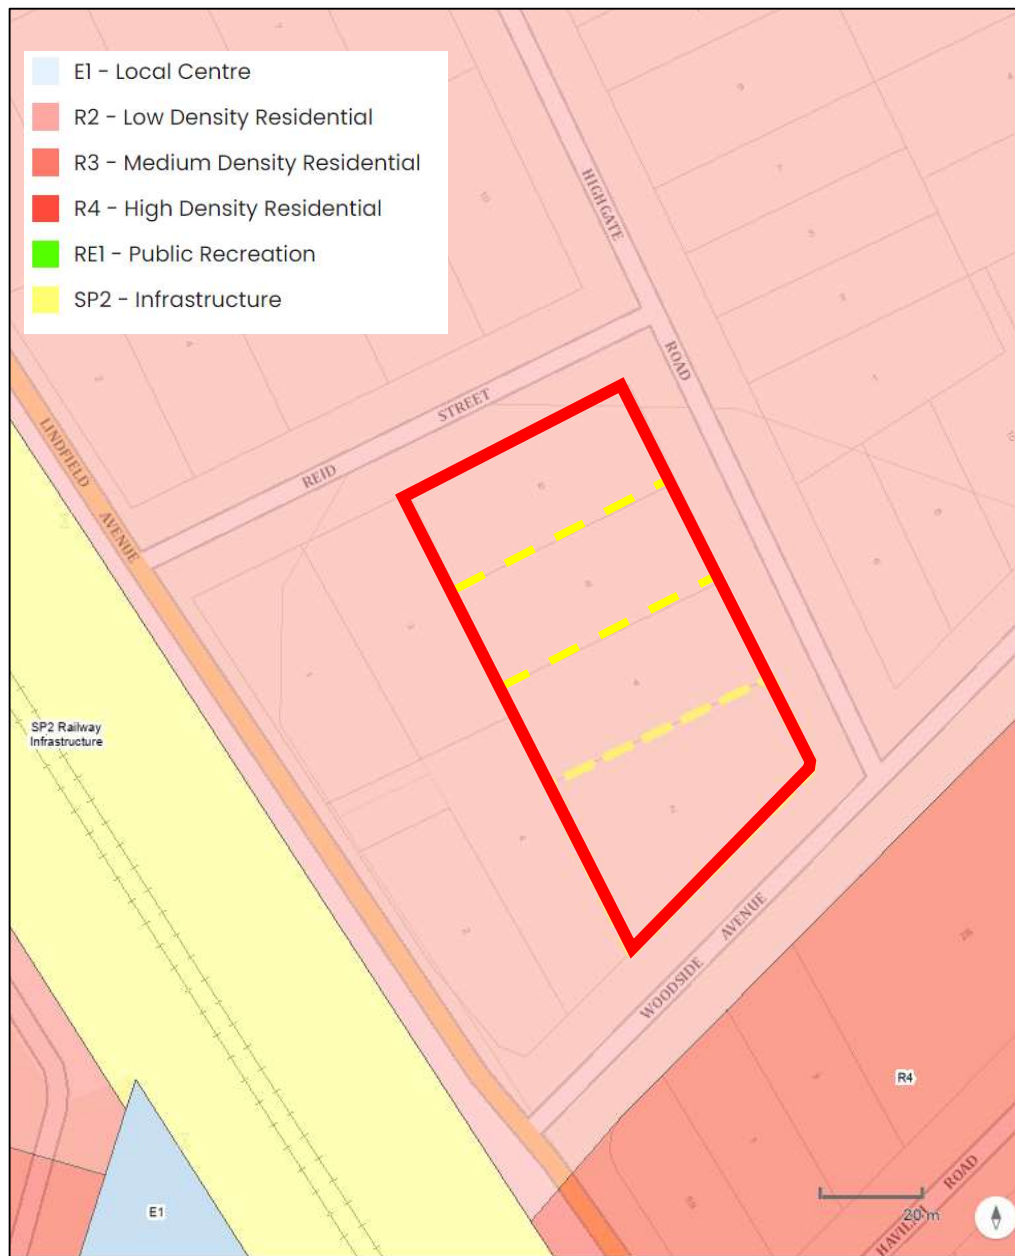
It is understood that the proposed future site use is for a standard residential development. The site lies within a Low-Density Residential zone (R2). The site and surrounding areas (Figure 2) include a mix of planning zones: Local Centre (E1), Low Density Residential (R2), Medium Density Residential (R3), High Density Residential (R4), Infrastructure (SP2) and Public Recreation (RE1).

**Figure 2. Site Planning Zone**

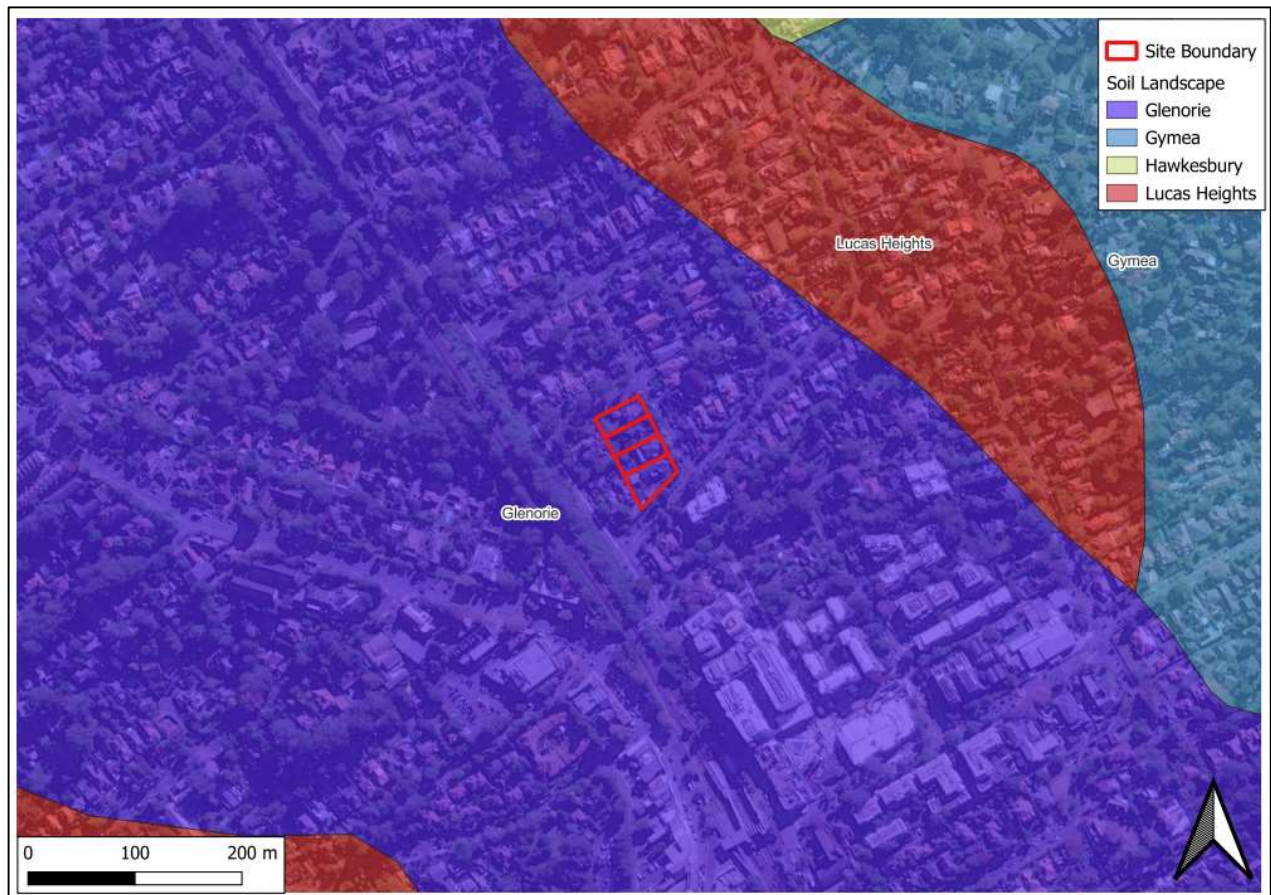
**Geology** — This soil landscape is underlain by Wianamatta Group, Ashfield Shale and Bringelly Shale formations.

**Topography** — Low rolling and steep hills. Local relief 50–120 m, slopes 5–20%. Convex narrow (20–300 m) ridges and hillcrests grade into moderately inclined side slopes with narrow concave drainage lines. Moderately inclined slopes of 10–15% are the dominant landform elements.

**Figure 3.** Local Landscape Map (Soil Landscapes of Central and Eastern NSW)

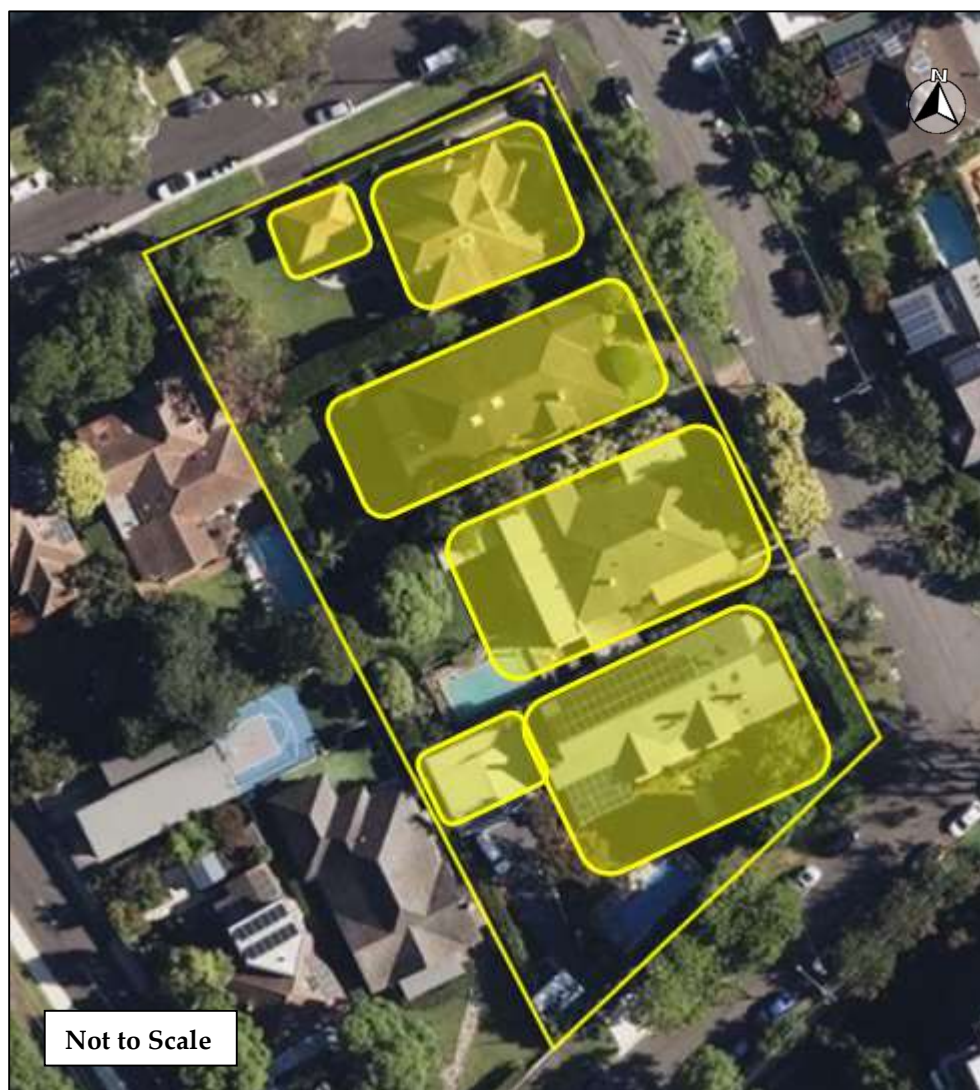
To address identified AECs, intrusive soil sampling regime was conducted to determine what, if any, remediation is required to render the site fit for the proposed use as for the proposed residential development. A soil sampling plan has been developed based on a judgemental sampling pattern and risk-based assessment.

**Figure 6:** Areas of Environmental Concerns (AEC)

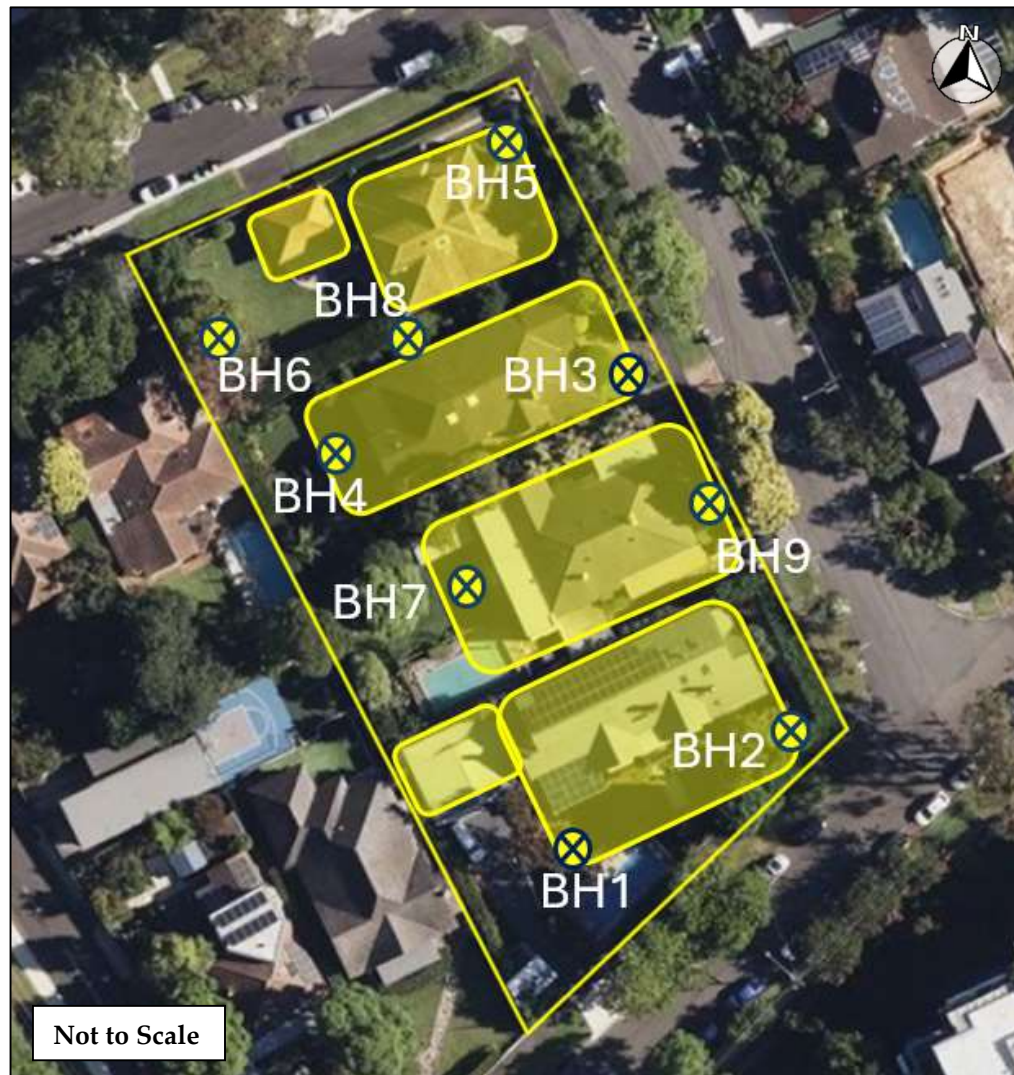
Boreholes were advanced via a hand auger and ute-mounted rig to a maximum depth of up to 2.2 m below ground level (bgl). All samples were collected directly from the recovered soils from the auger. A total of nine (9) samples were collected. The sampling borehole locations are shown in Figure 7 and Table 5.

**Figure 7.** Sampling borehole locations

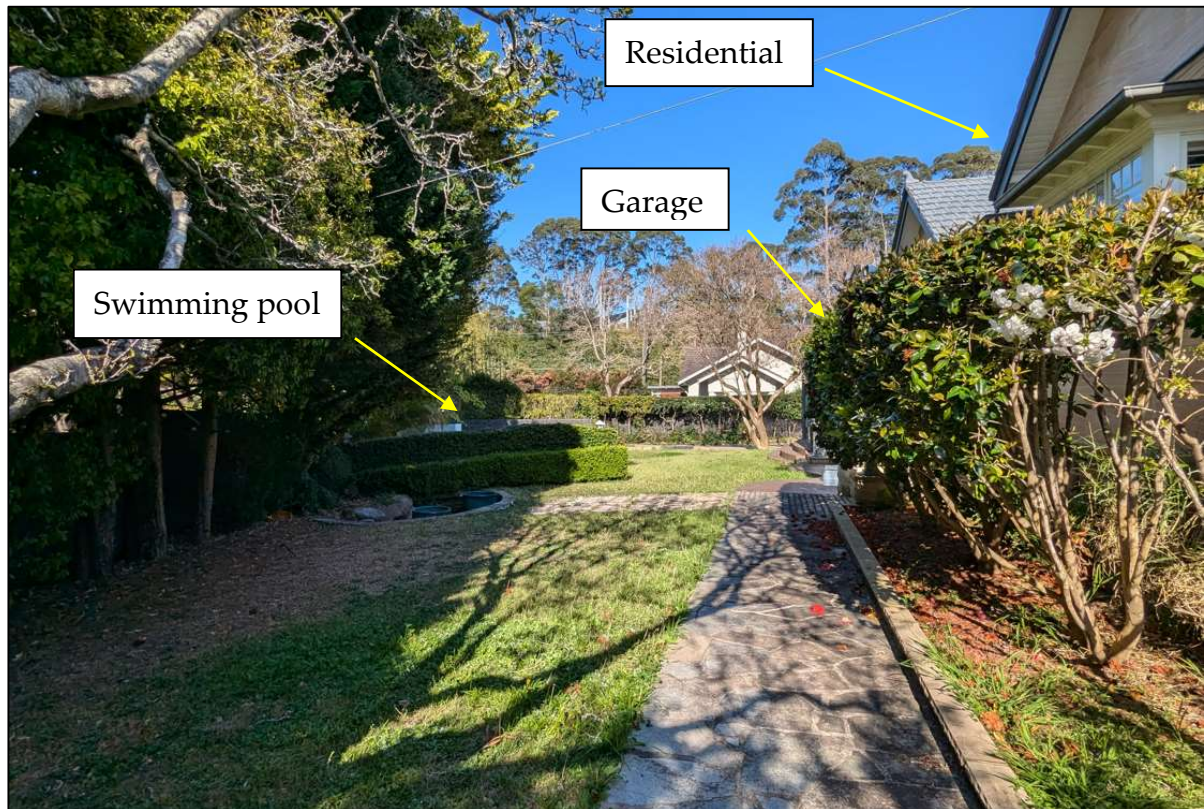
**Photograph C1:** 2 Highgate Road , Lindfield, NSW 2070 – View of the front yard

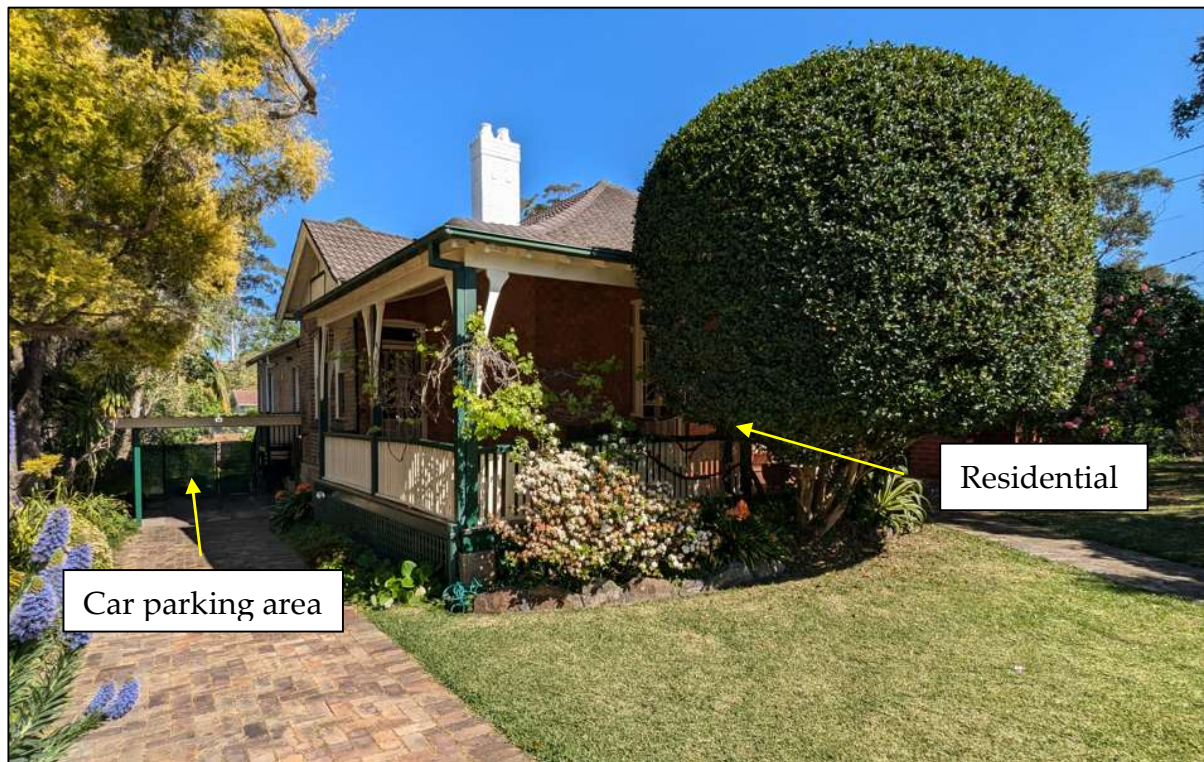
**Photograph C3:** 6 Highgate Road , Lindfield, NSW 2070 – View of the front yard

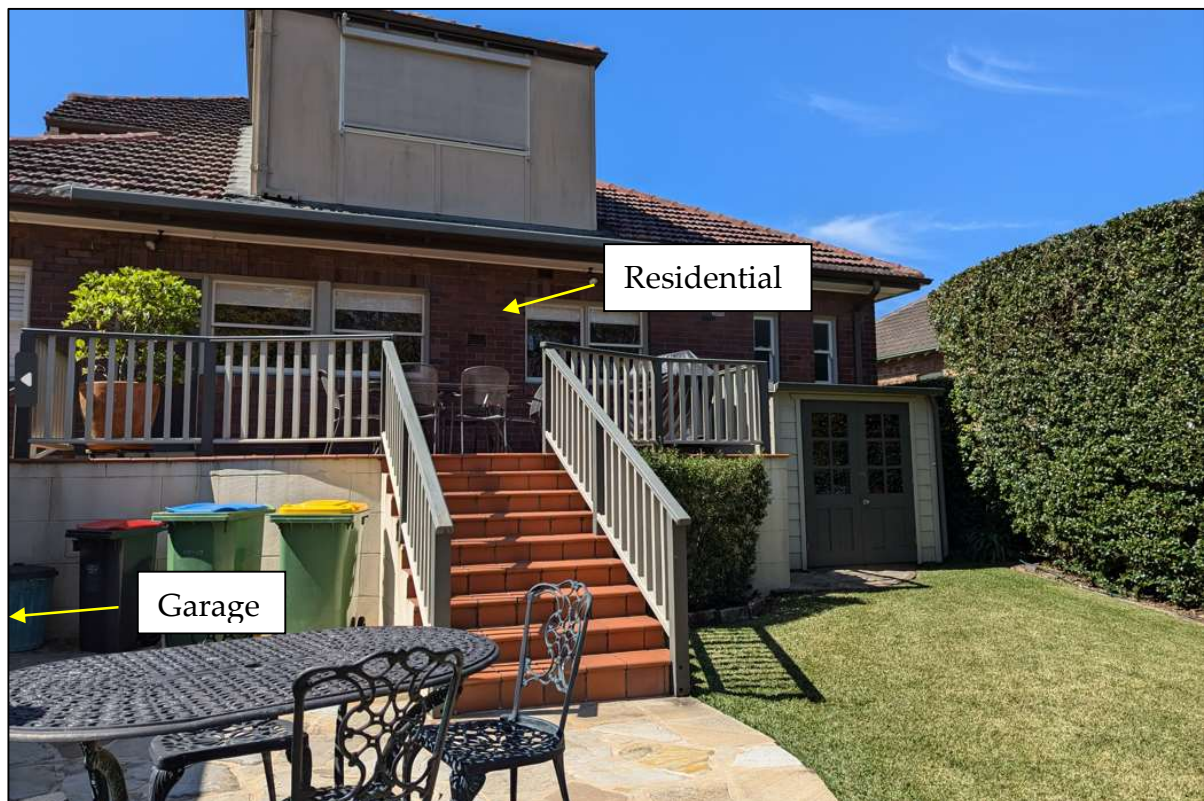
**Photograph C4:** 8 Highgate Road , Lindfield, NSW 2070 – View of the back yard

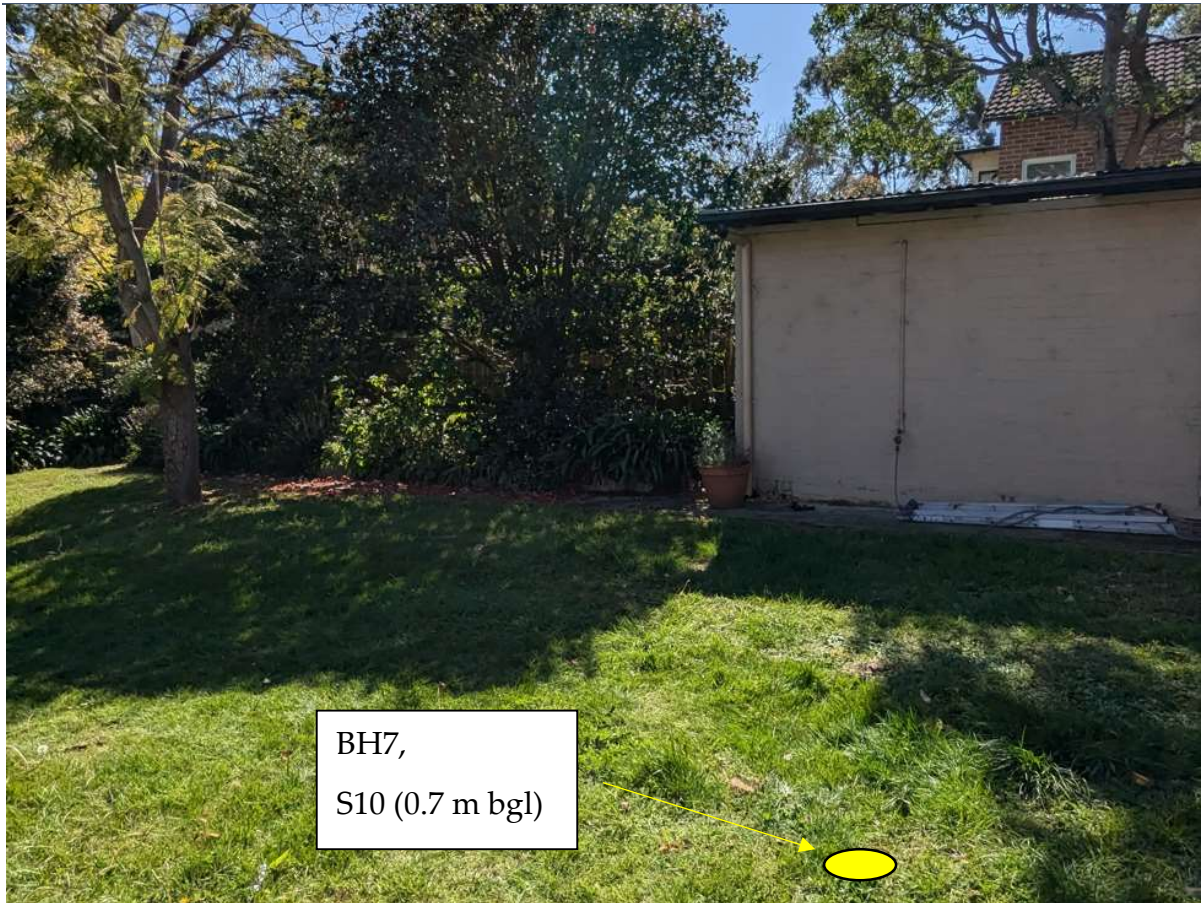
**Photograph C5:** 8 Highgate Road , Lindfield, NSW 2070 – View of the back yard

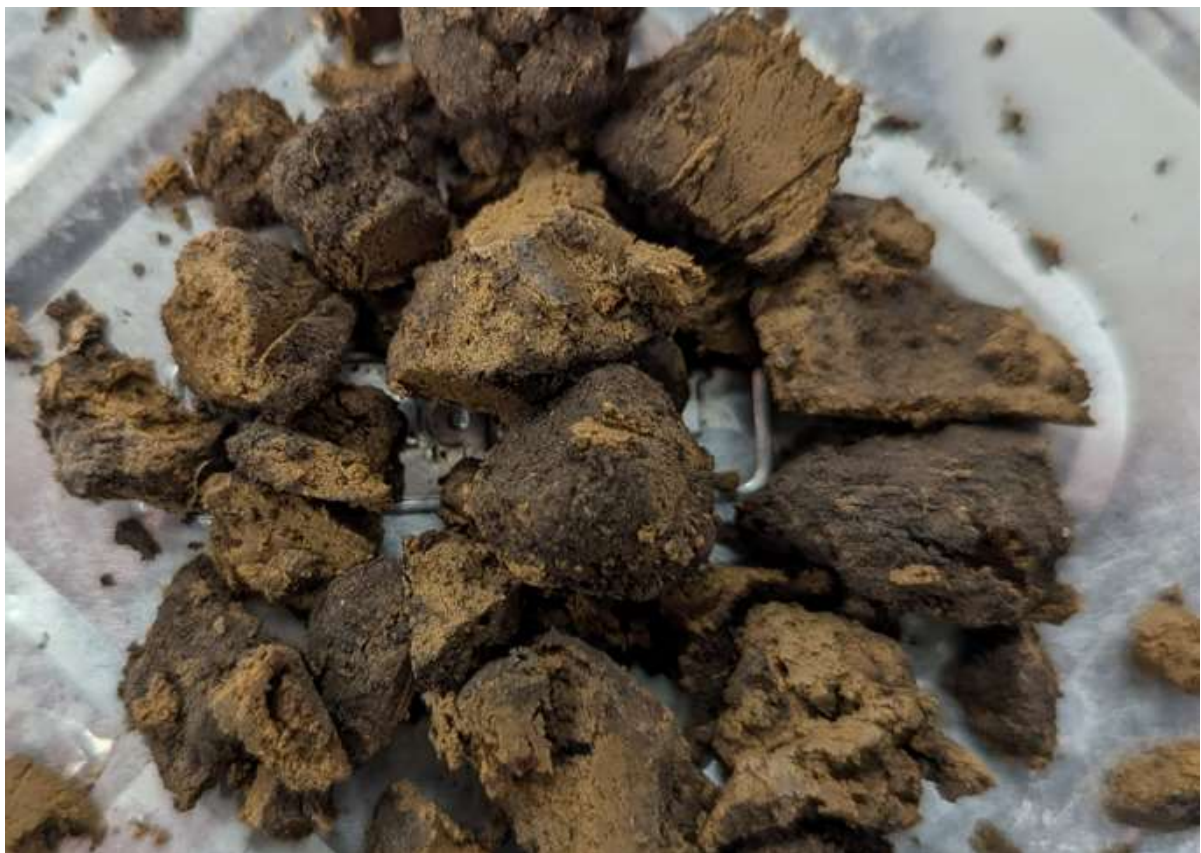
- The preliminary assessment of site soils for waste disposal near the arsenic hotspot (Sample S10 in borehole BH7) is "Hazardous Waste", and General Solid Waste (non-putrescible) in the remaining areas. Further sampling and analysis post demolition of the structures near the arsenic hotspot would be required prior to off-site disposal.

**Photograph C6:** Image of the S10 from 0.7 mbgl of BH7.  
Yellow-Brown Sandy Clayey Soil with trace rootlets observed inside.

- Further investigation of the presence of arsenic treated wood at a depth of 0.7m near borehole BH7 may be warranted;
- Further data gap sampling is recommended in the footprints of the demolished structures and sheds and the area around borehole BH7.

- The site can be made suitable for the proposed residential use upon the completion of remediation work around BH7 or any other contamination found during the data gap assessment in the footprints of the sheds and dwellings, if any.
