# Additional Geotechnical Investigation

47-97 Marlborough Street, Surry Hills, NSW

Report Title: Additional Geotechnical Investigation, 47-97 Marlborough Street, Surry Hills, NSW

Report No: E26534.G04\_Rev3

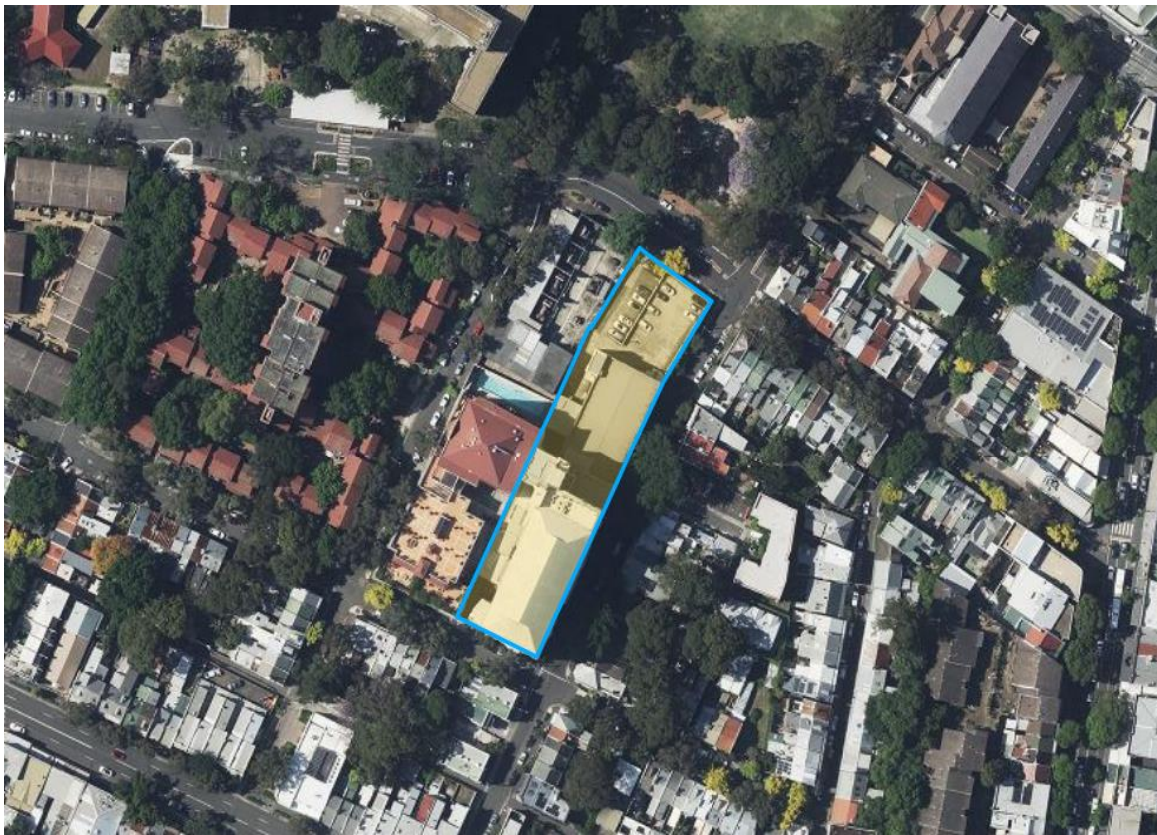
**Plate 1**      Aerial photograph of the site (source: SDT Explorer, accessed on 12 September 2025)

| Information | Detail |
|---|---|
| Brief Site Description | At the time of our investigation, the site was occupied by an existing eight-storey building in the southern third of the site, connected to an existing three-storey building in the middle third of the site. The northern third of the site is an existing single-storey building with roof top open car parking. A driveway off Lansdowne Street runs along the western perimeter of the northern third of the site together with a car park. A driveway off Goodlet Street at the south-western corner of the site leads to a carport and loading dock with a raised ceiling space. The remaining areas of the site were occupied by concrete pavement. |

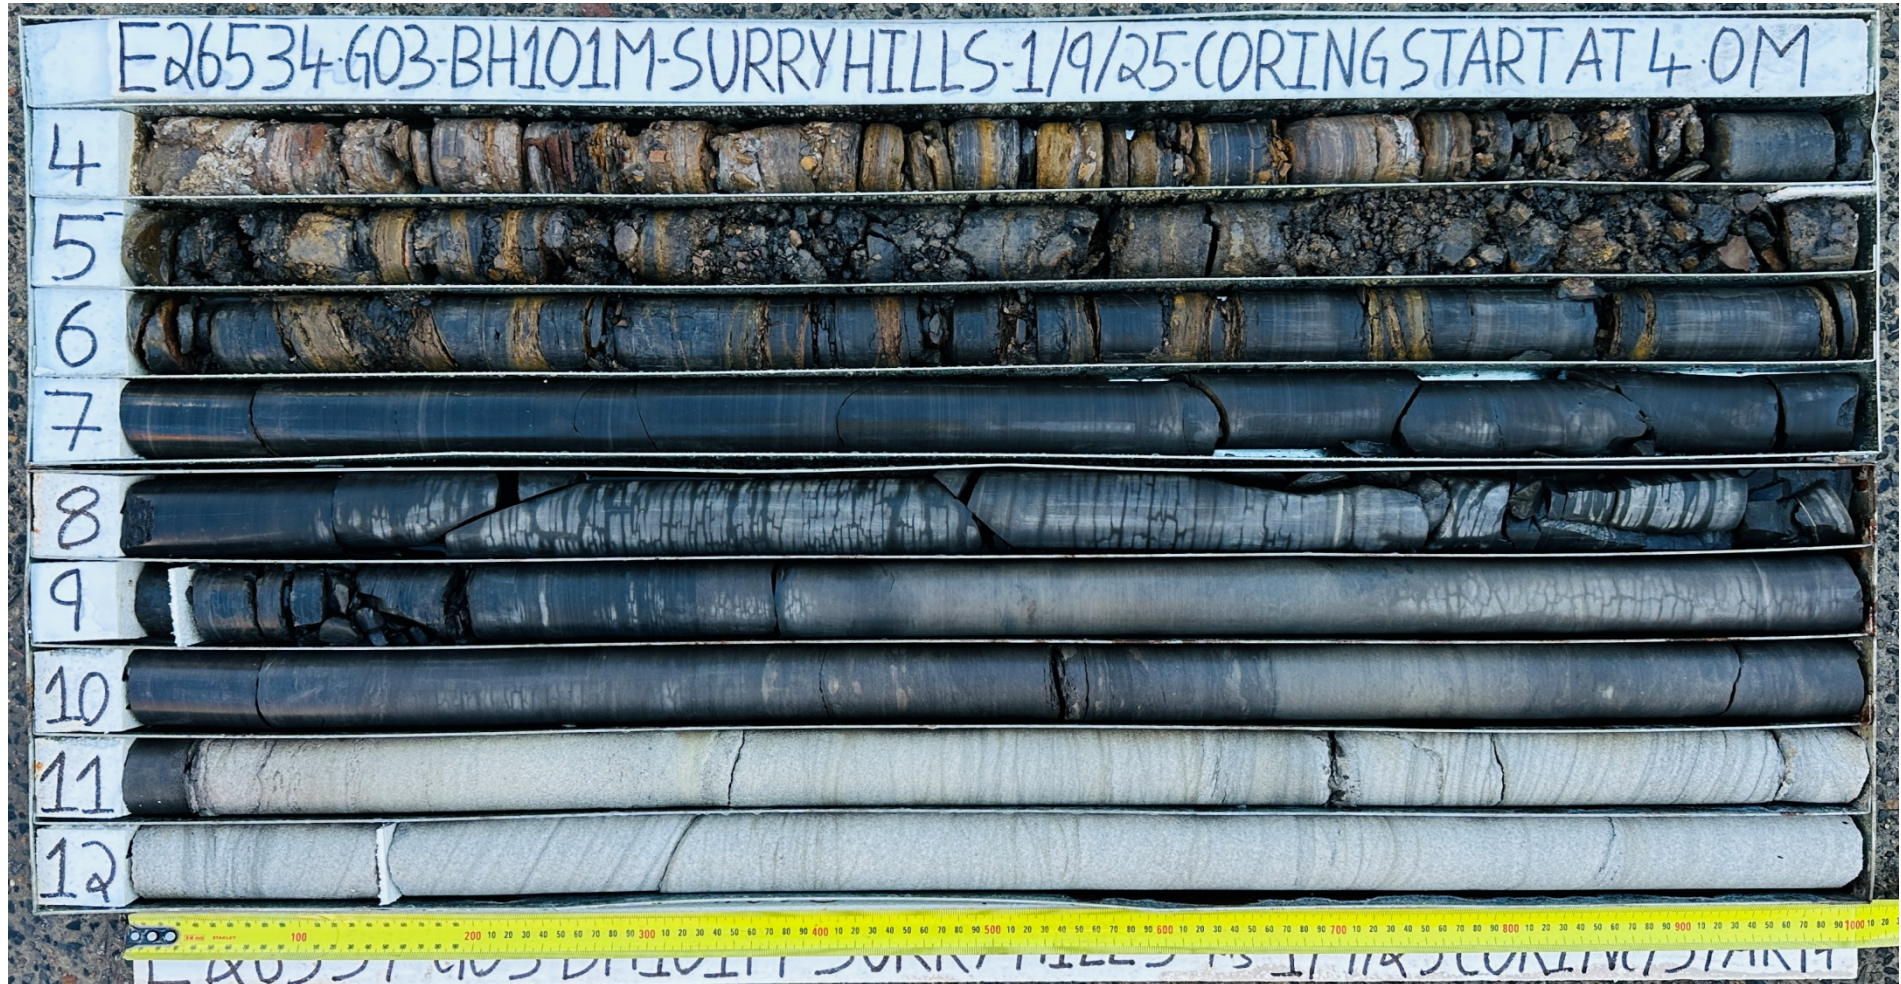
## CORE PHOTOGRAPH OF BOREHOLE: BH101M

| <b>Project</b> | Proposed Development | <b>Depth Range</b> | 4.0m to 45.14m | |

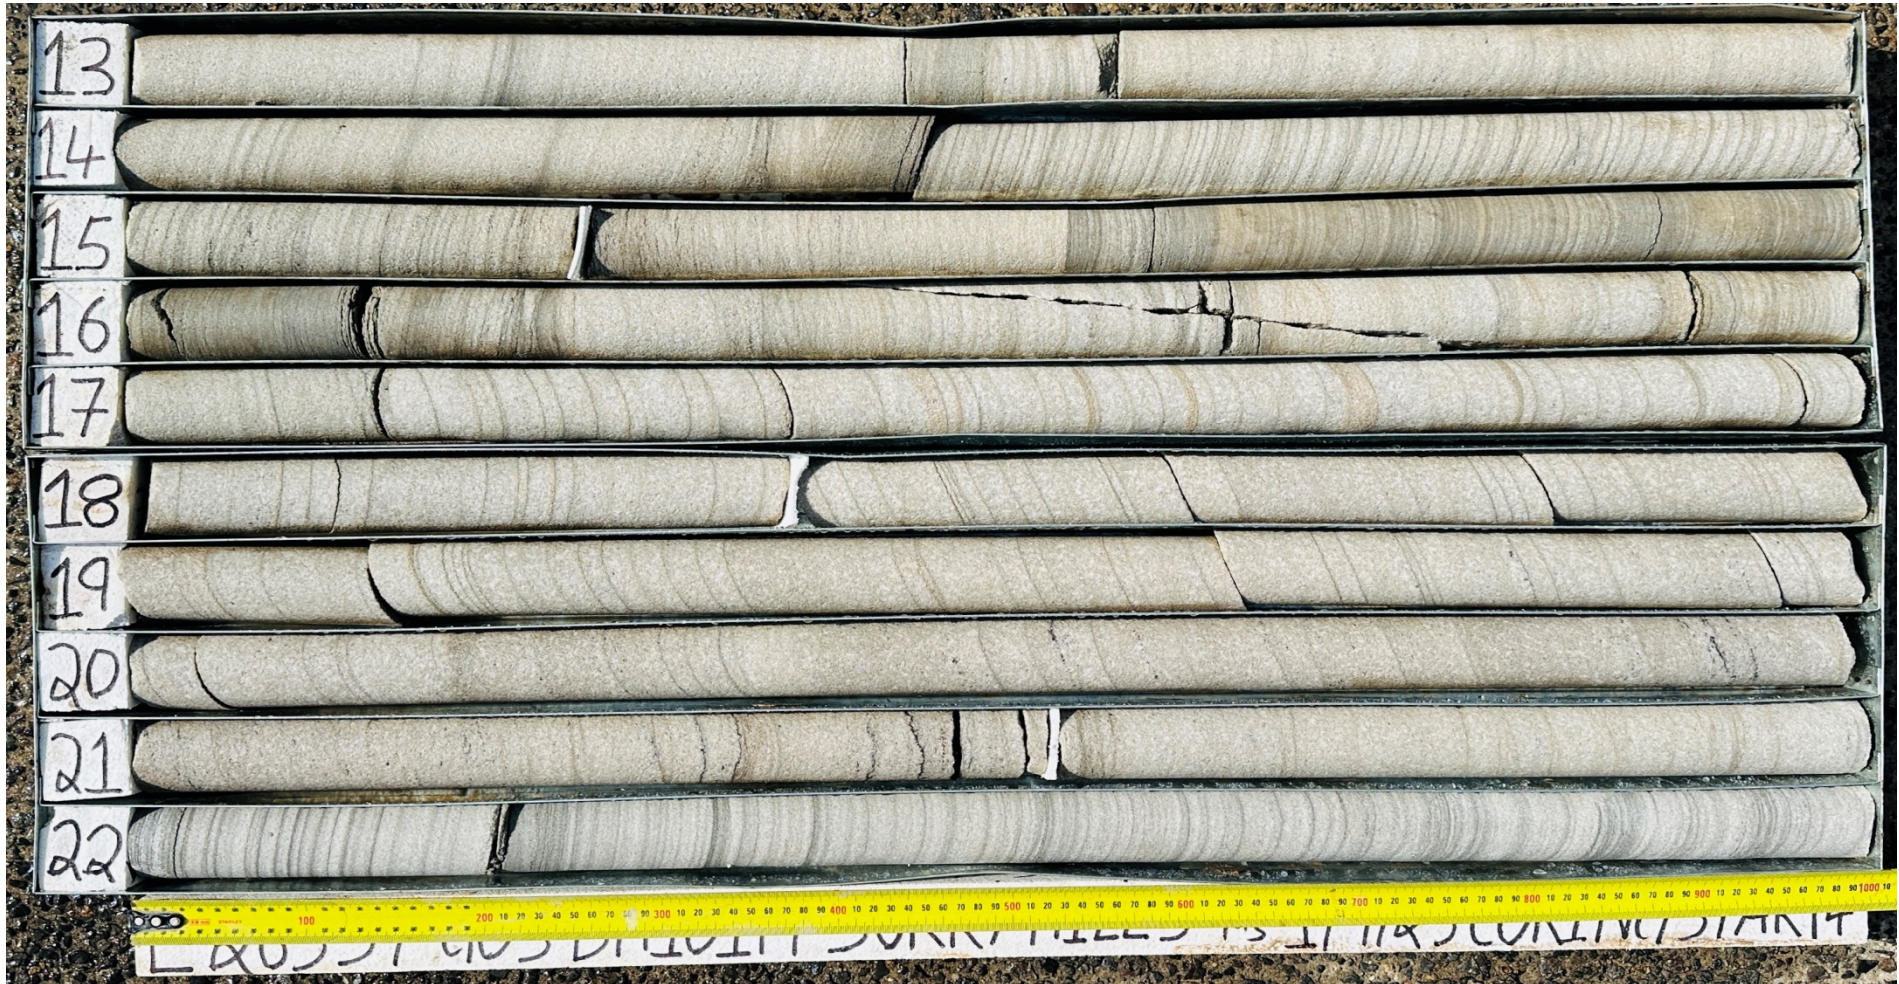
## CORE PHOTOGRAPH OF BOREHOLE: BH101M

| <b>Project</b> | Proposed Development | <b>Depth Range</b> | 4.0m to 45.14m | |

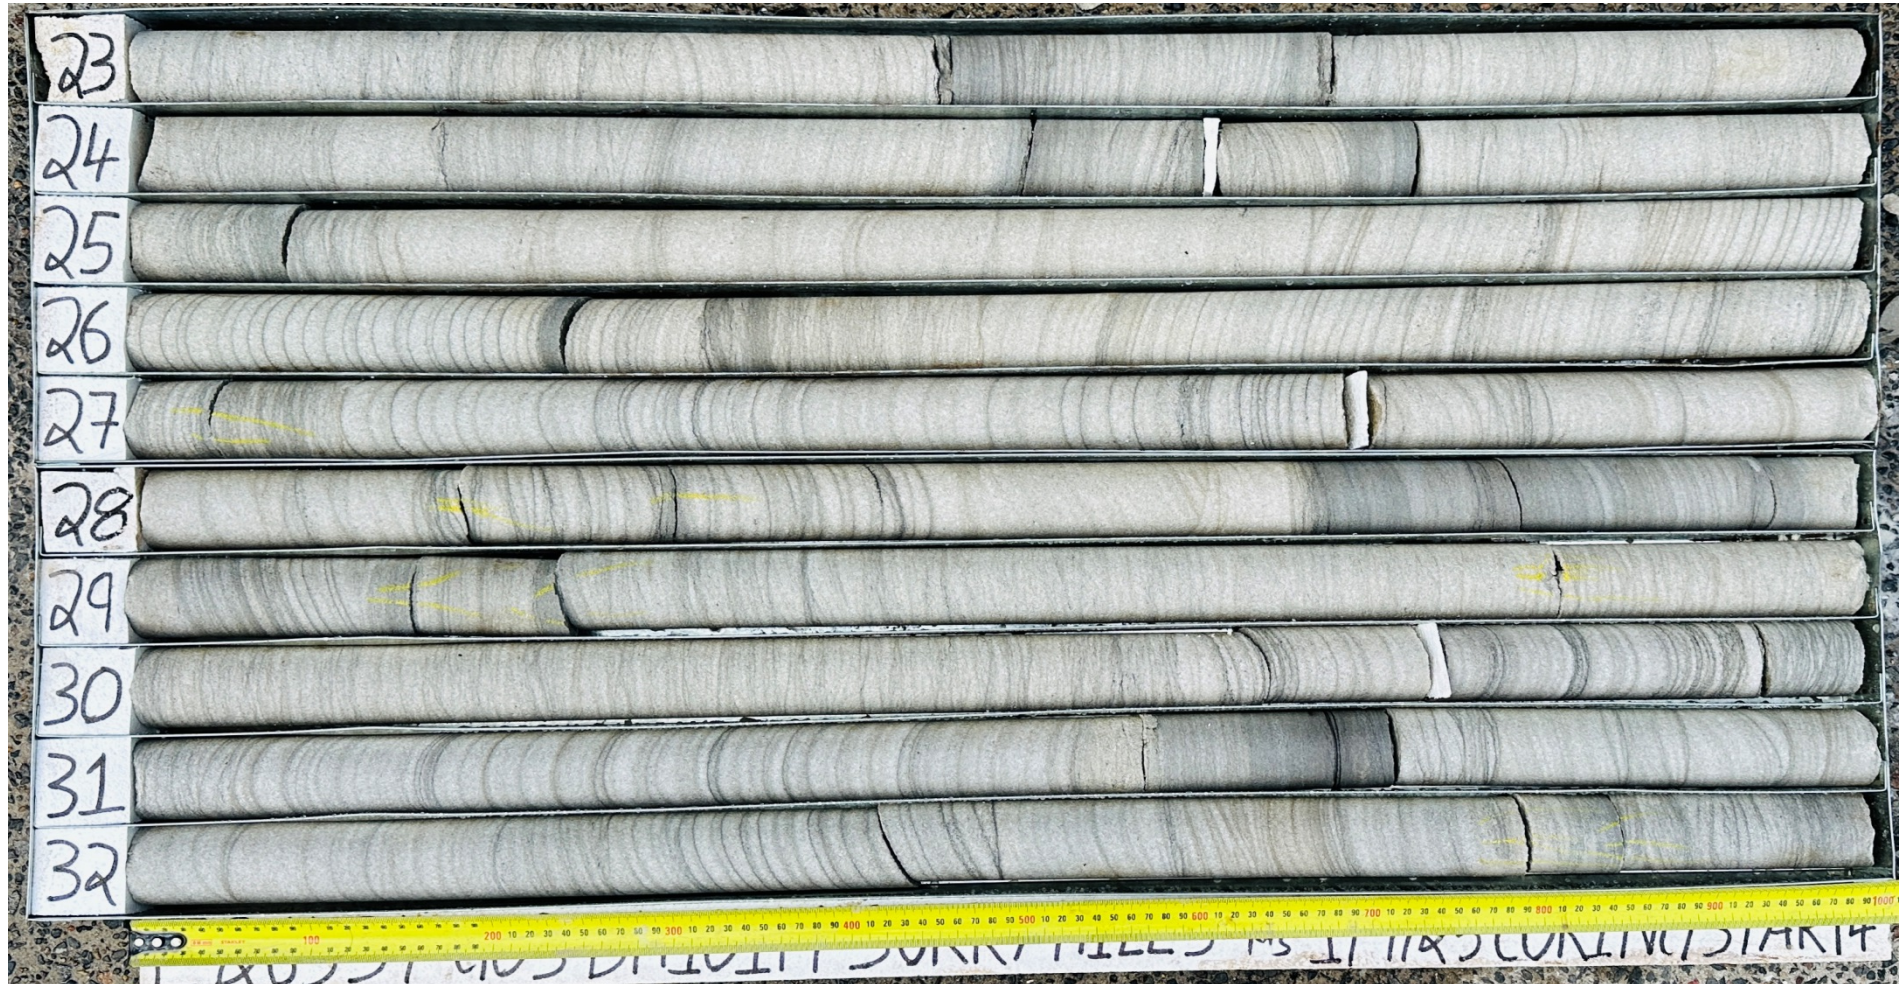
## CORE PHOTOGRAPH OF BOREHOLE: BH101M

| <b>Project</b> | Proposed Development | <b>Depth Range</b> | 4.0m to 45.14m | |

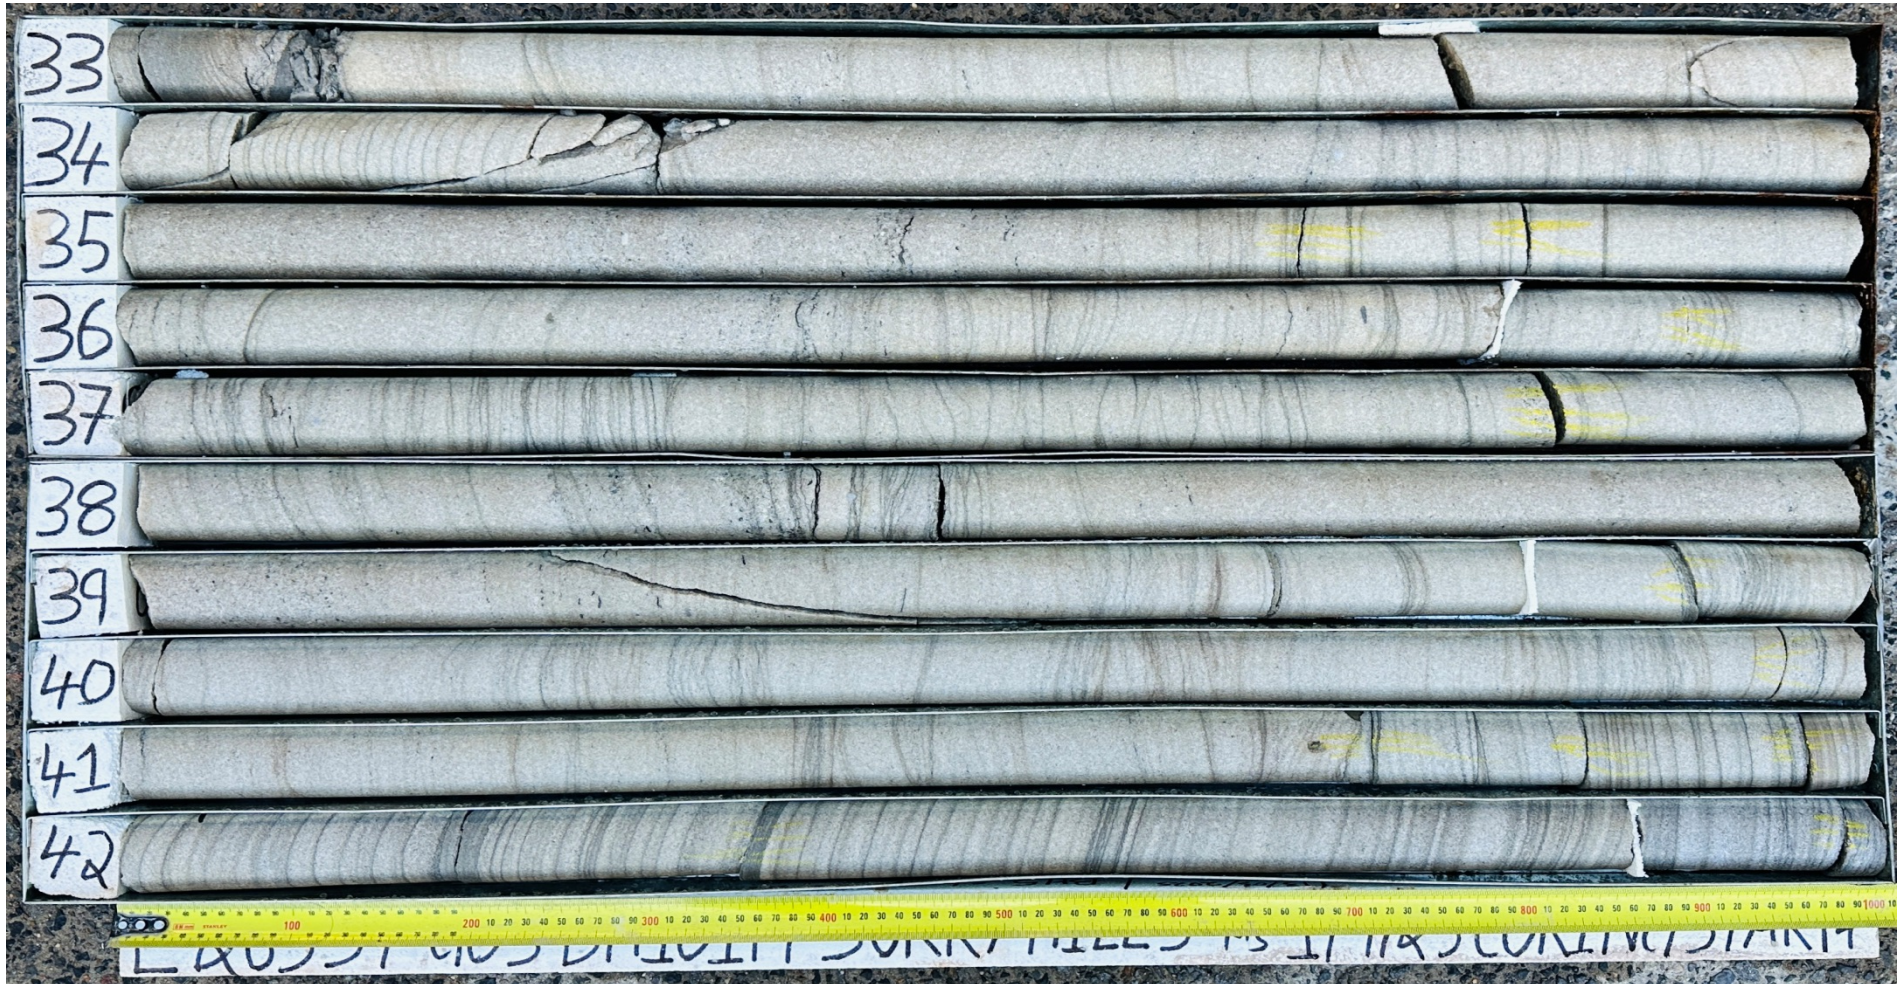
## CORE PHOTOGRAPH OF BOREHOLE: BH101M

| <b>Project</b> | Proposed Development | <b>Depth Range</b> | 4.0m to 45.14m |

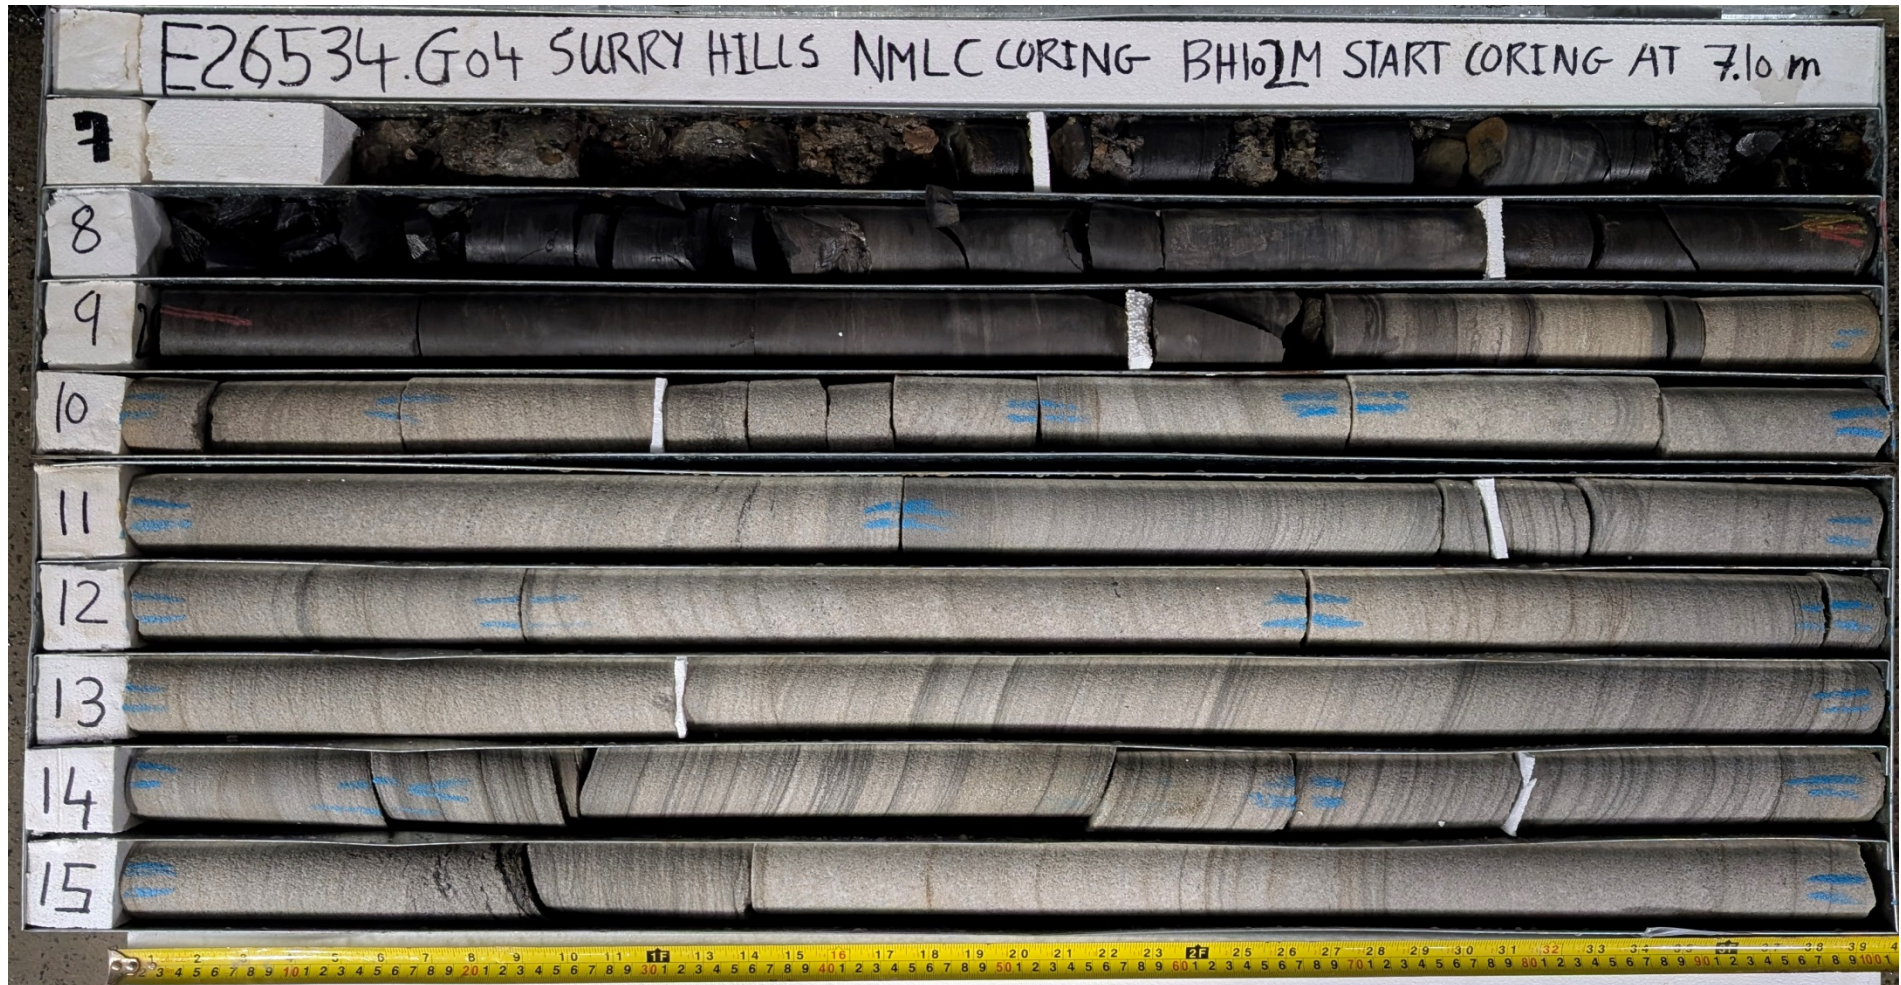
# CORE PHOTOGRAPH OF BOREHOLE: BH102M

| <b>Project</b> | Proposed Development | <b>Depth Range</b> | 7.10m to 24.82m | |

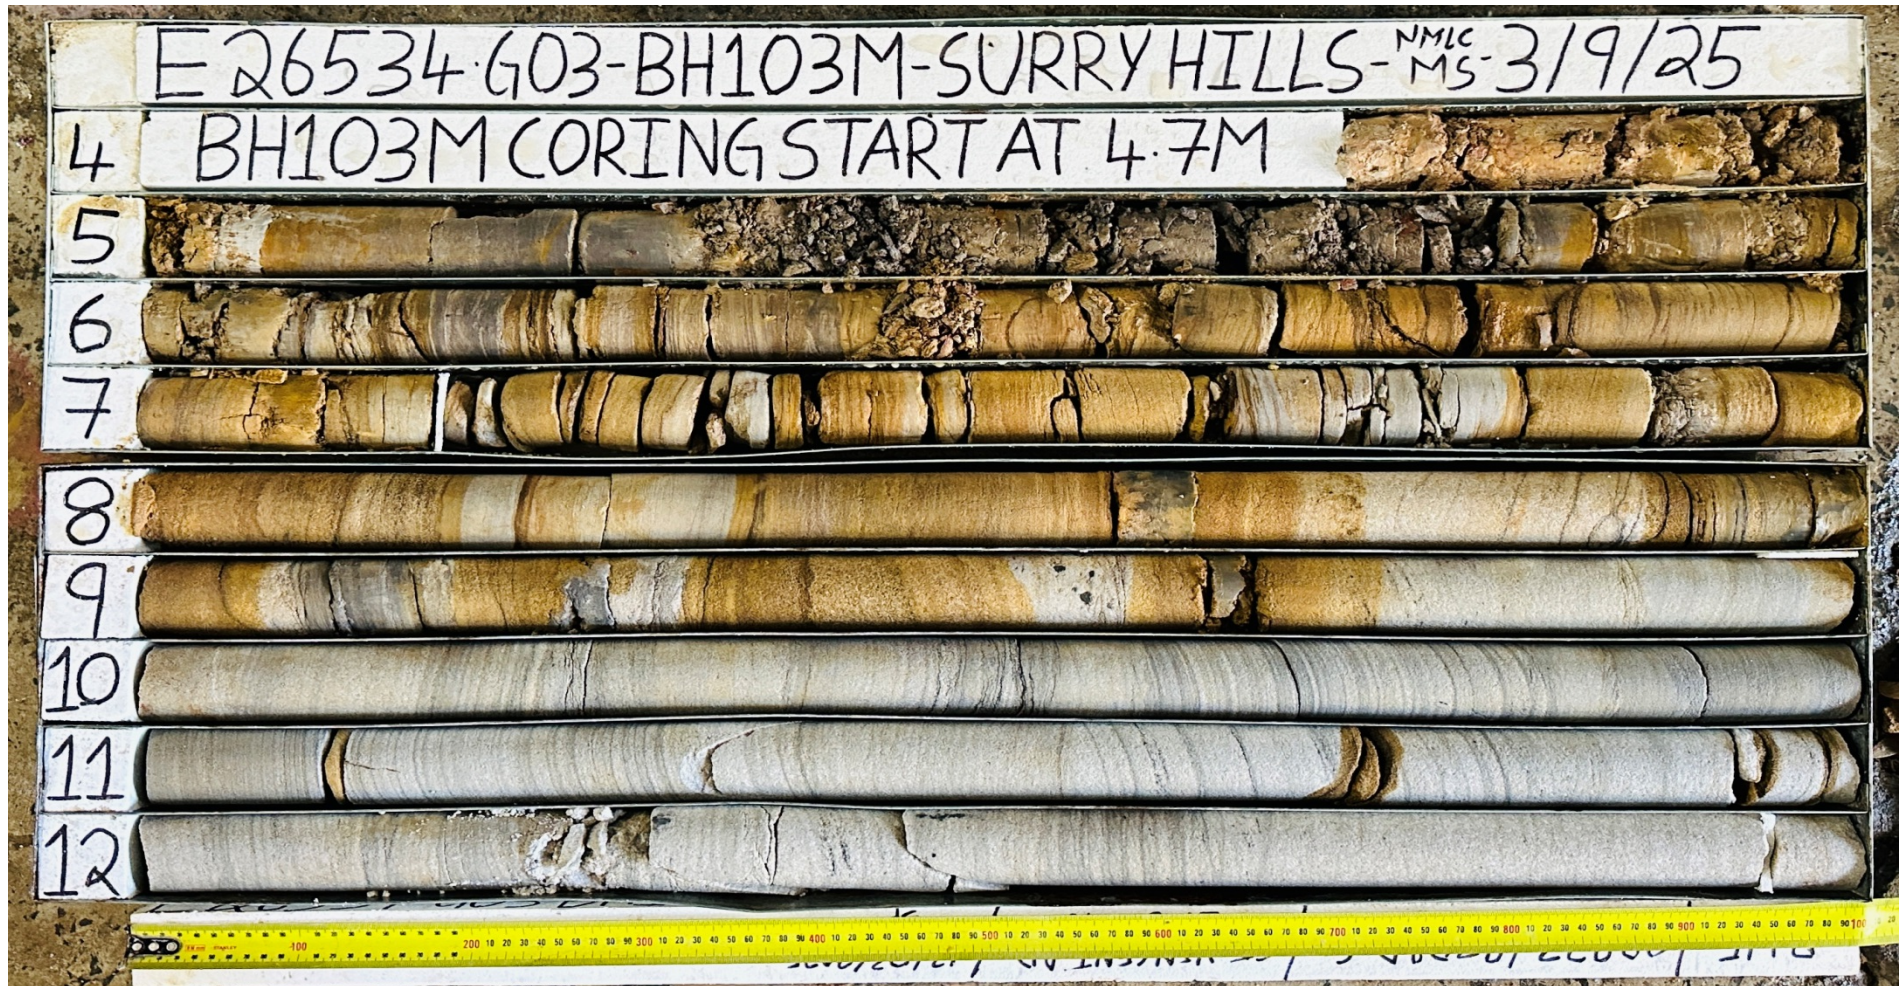
# CORE PHOTOGRAPH OF BOREHOLE: BH103M

| <b>Project</b> | Proposed Development | <b>Depth Range</b> | 4.7m to 30.16m |

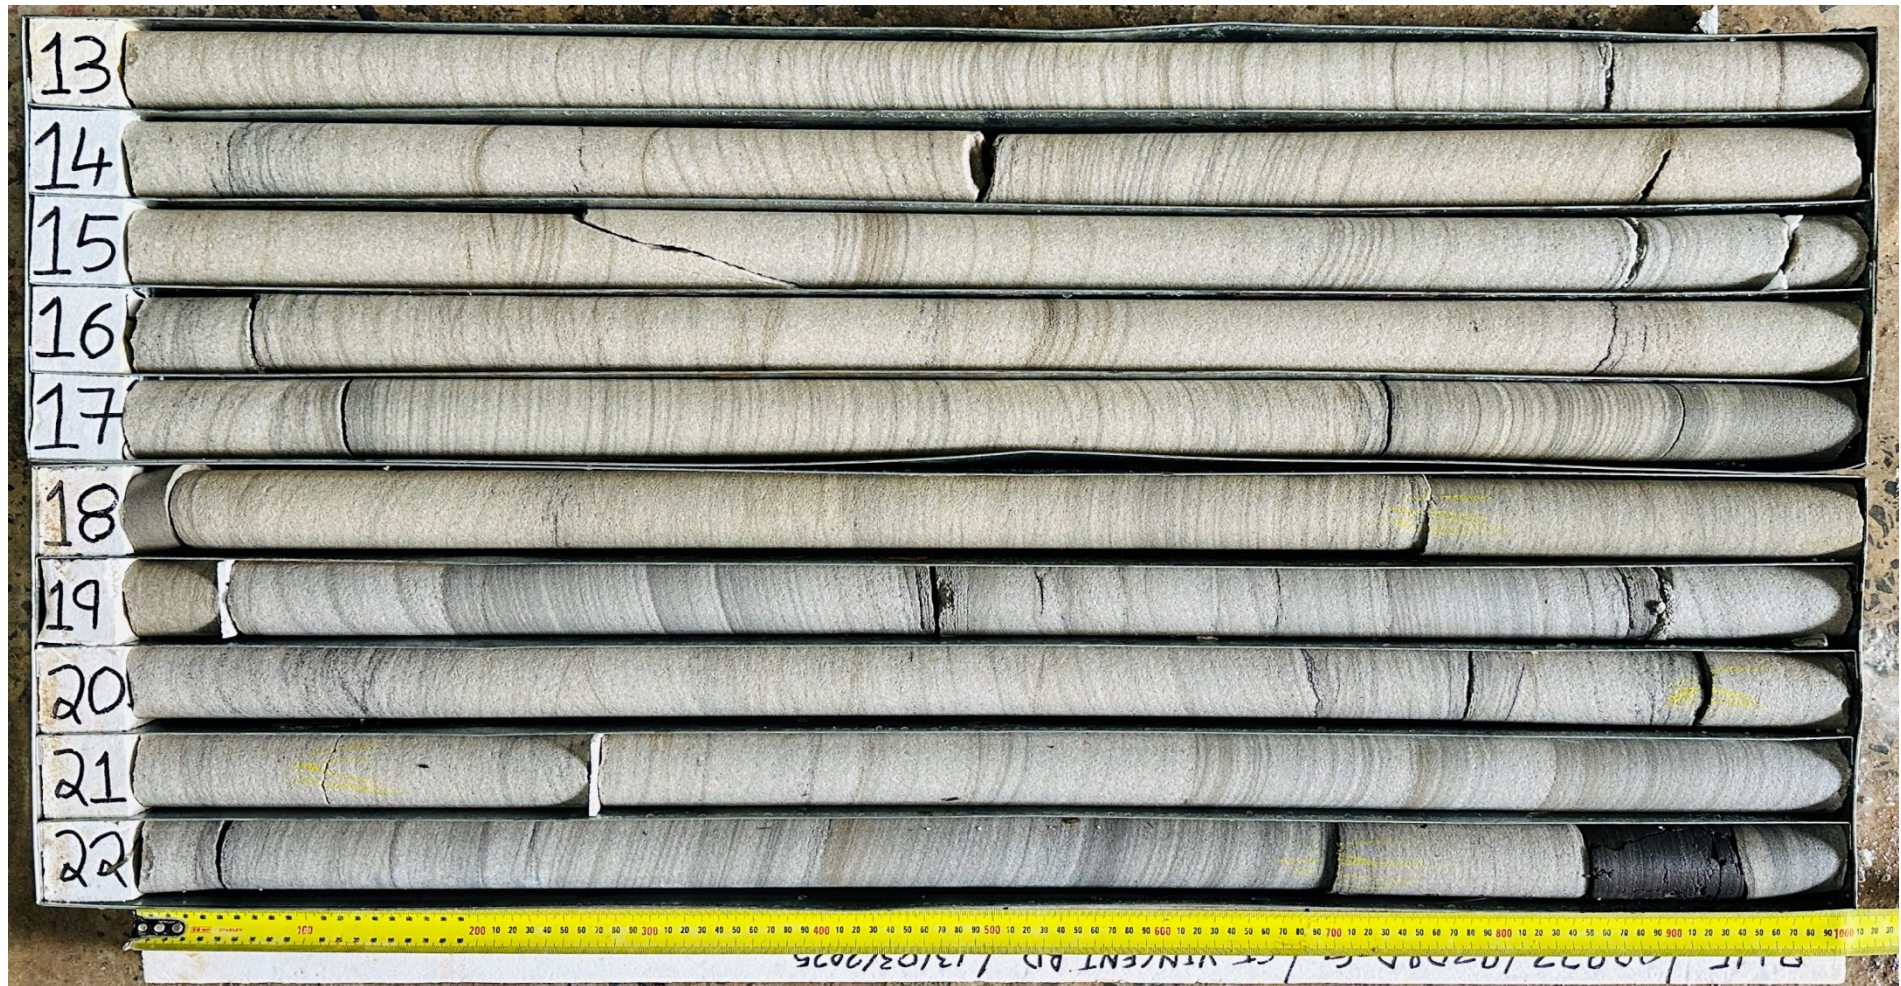
## CORE PHOTOGRAPH OF BOREHOLE: BH103M

| <b>Project</b> | Proposed Development | <b>Depth Range</b> | 4.7m to 30.16m | |
