**PROPOSED RESIDENTIAL  
REDEVELOPMENT (SSD-78669234)**

**GEOTECHNICAL INVESTIGATION REPORT  
27-29 TRYON ROAD LINDFIELD**

4 February 2025

Project Number:  
2025002

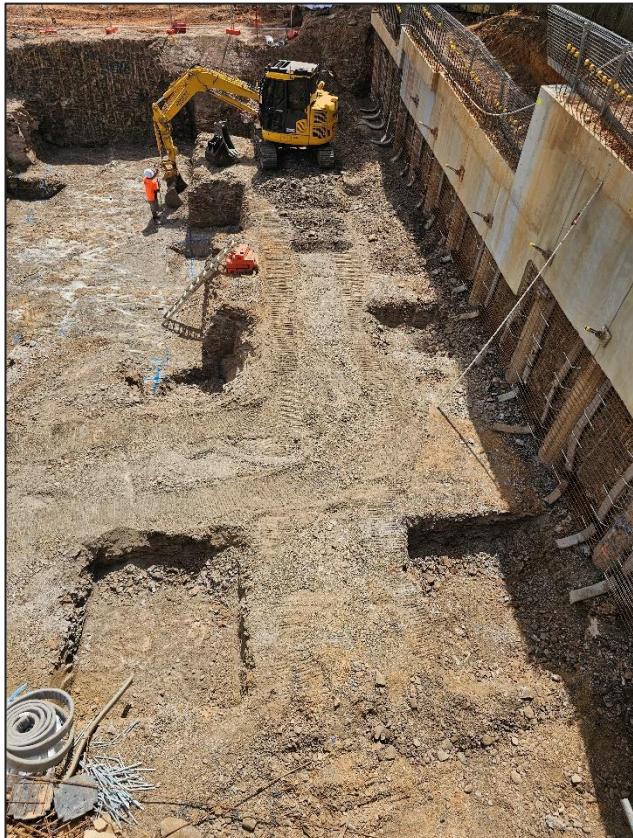
Photo 1- Basement in shale at up to 8m depth

Feature basement excavation photos from closeby Lindfield project of up to 9m of excavation are

shown below. No seepage was observed.

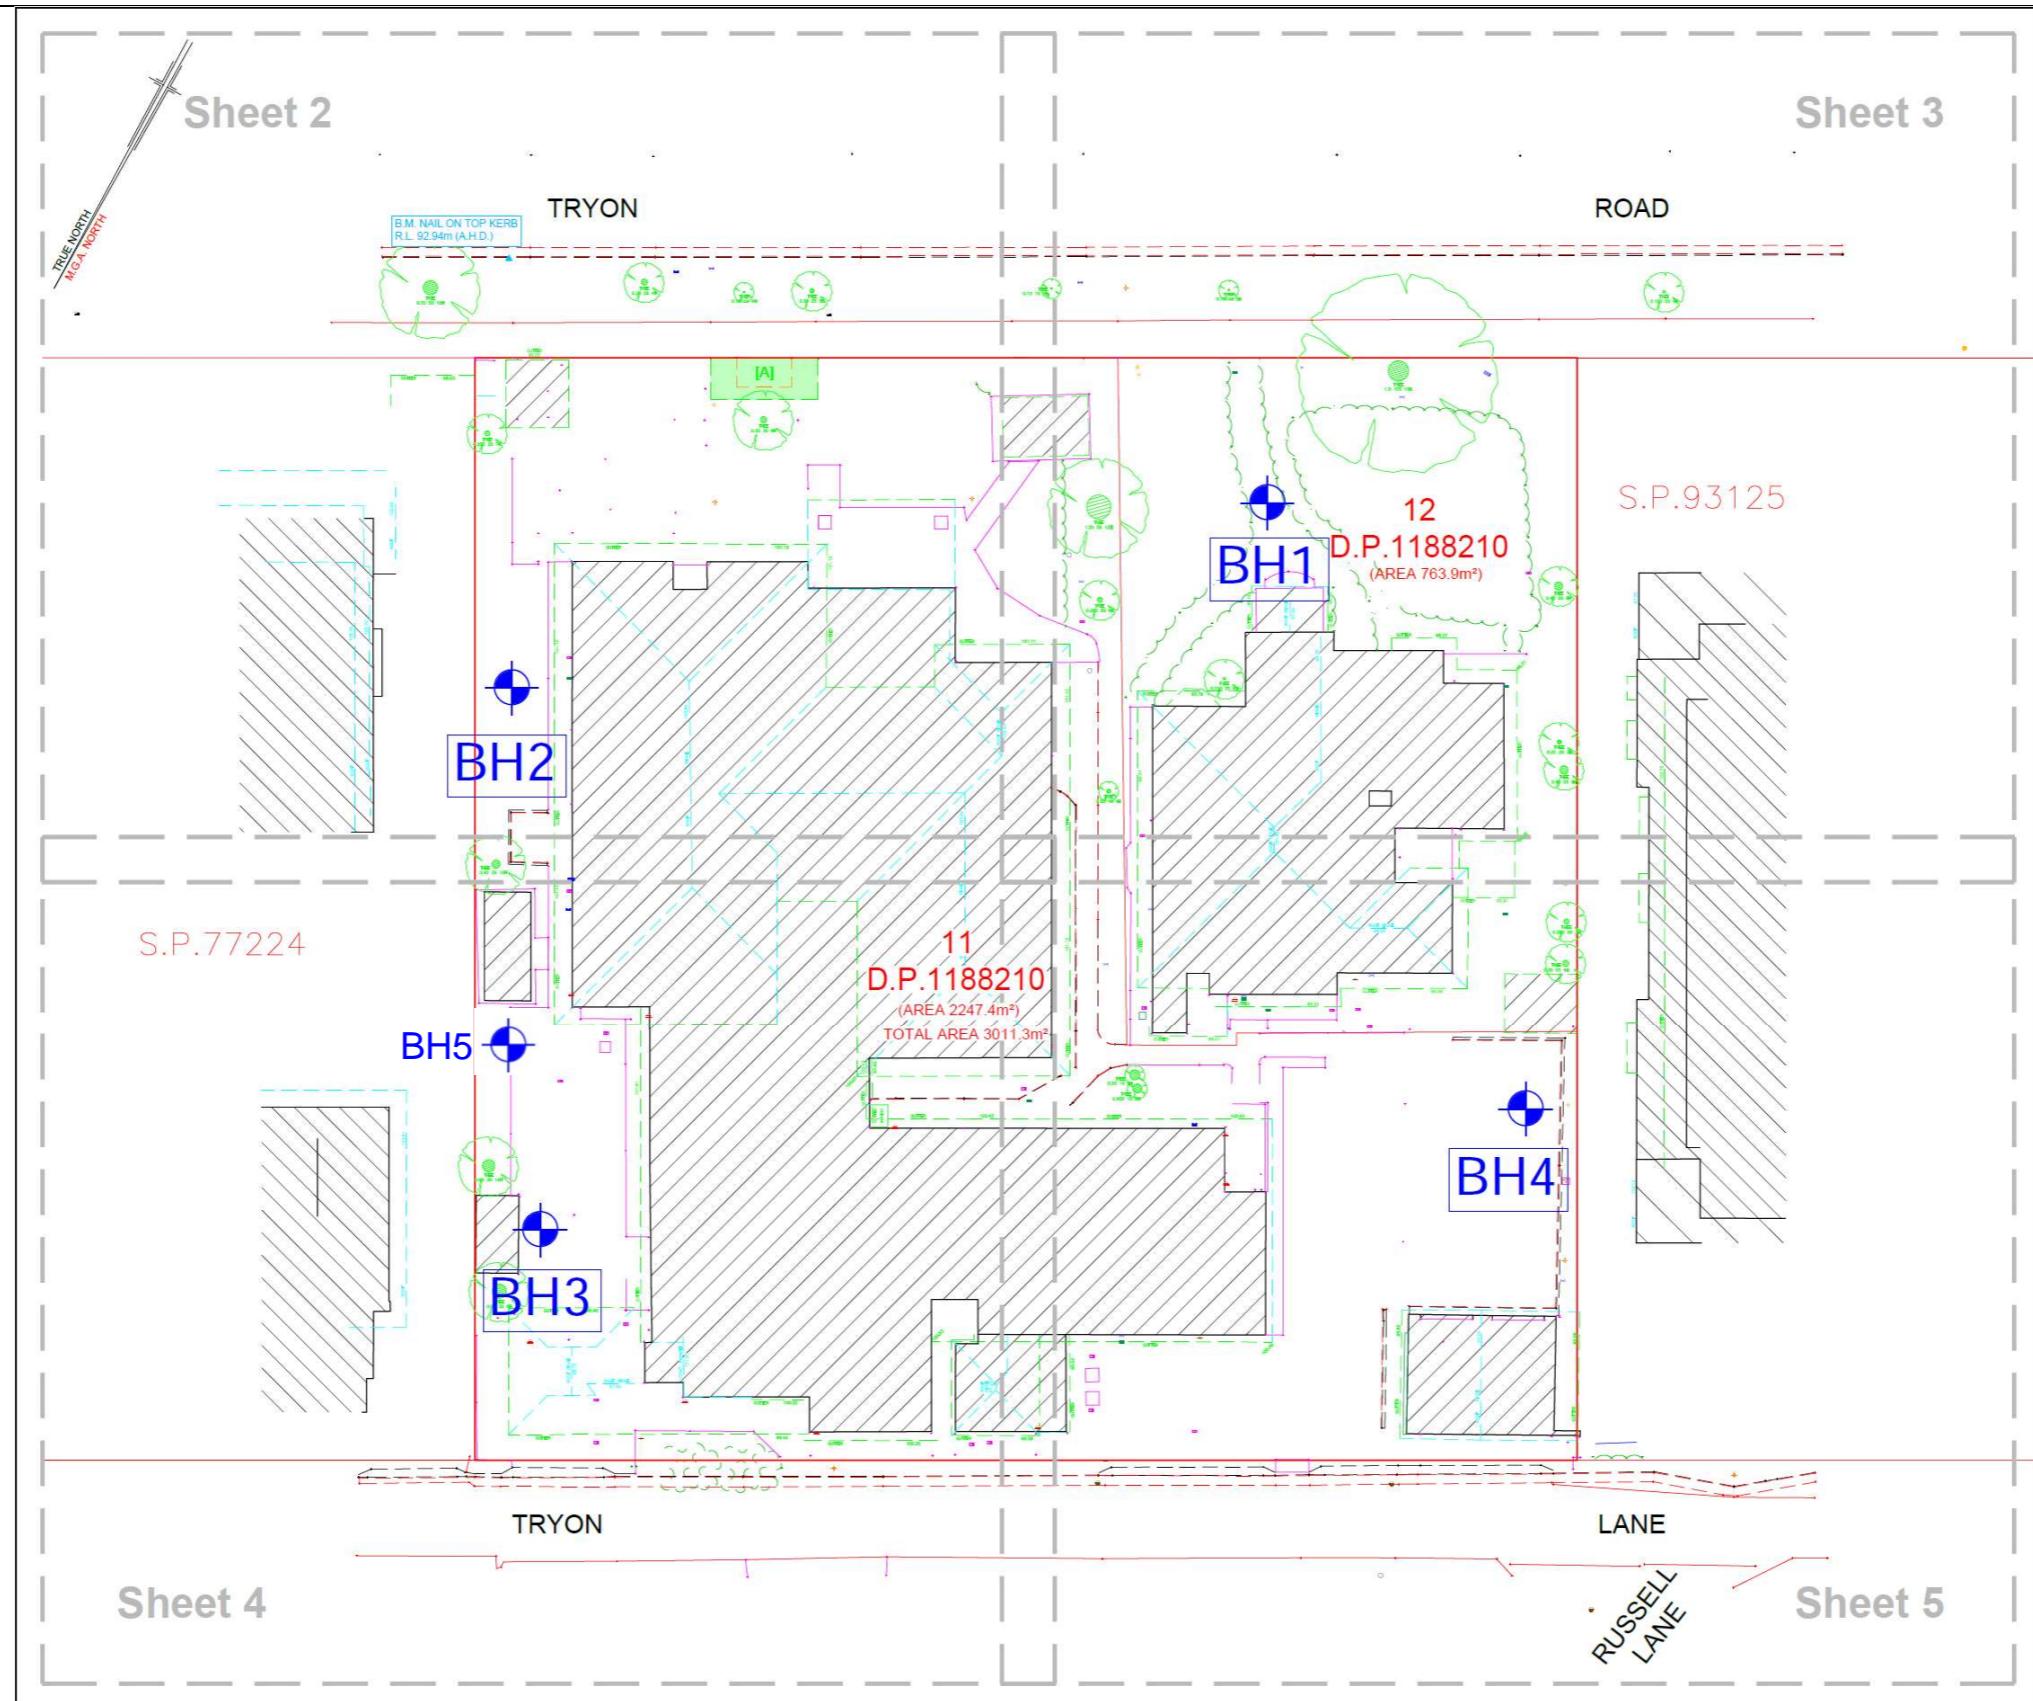
**Site Plan**  
27-29 Tryon Road, Lindfield NSW 2070

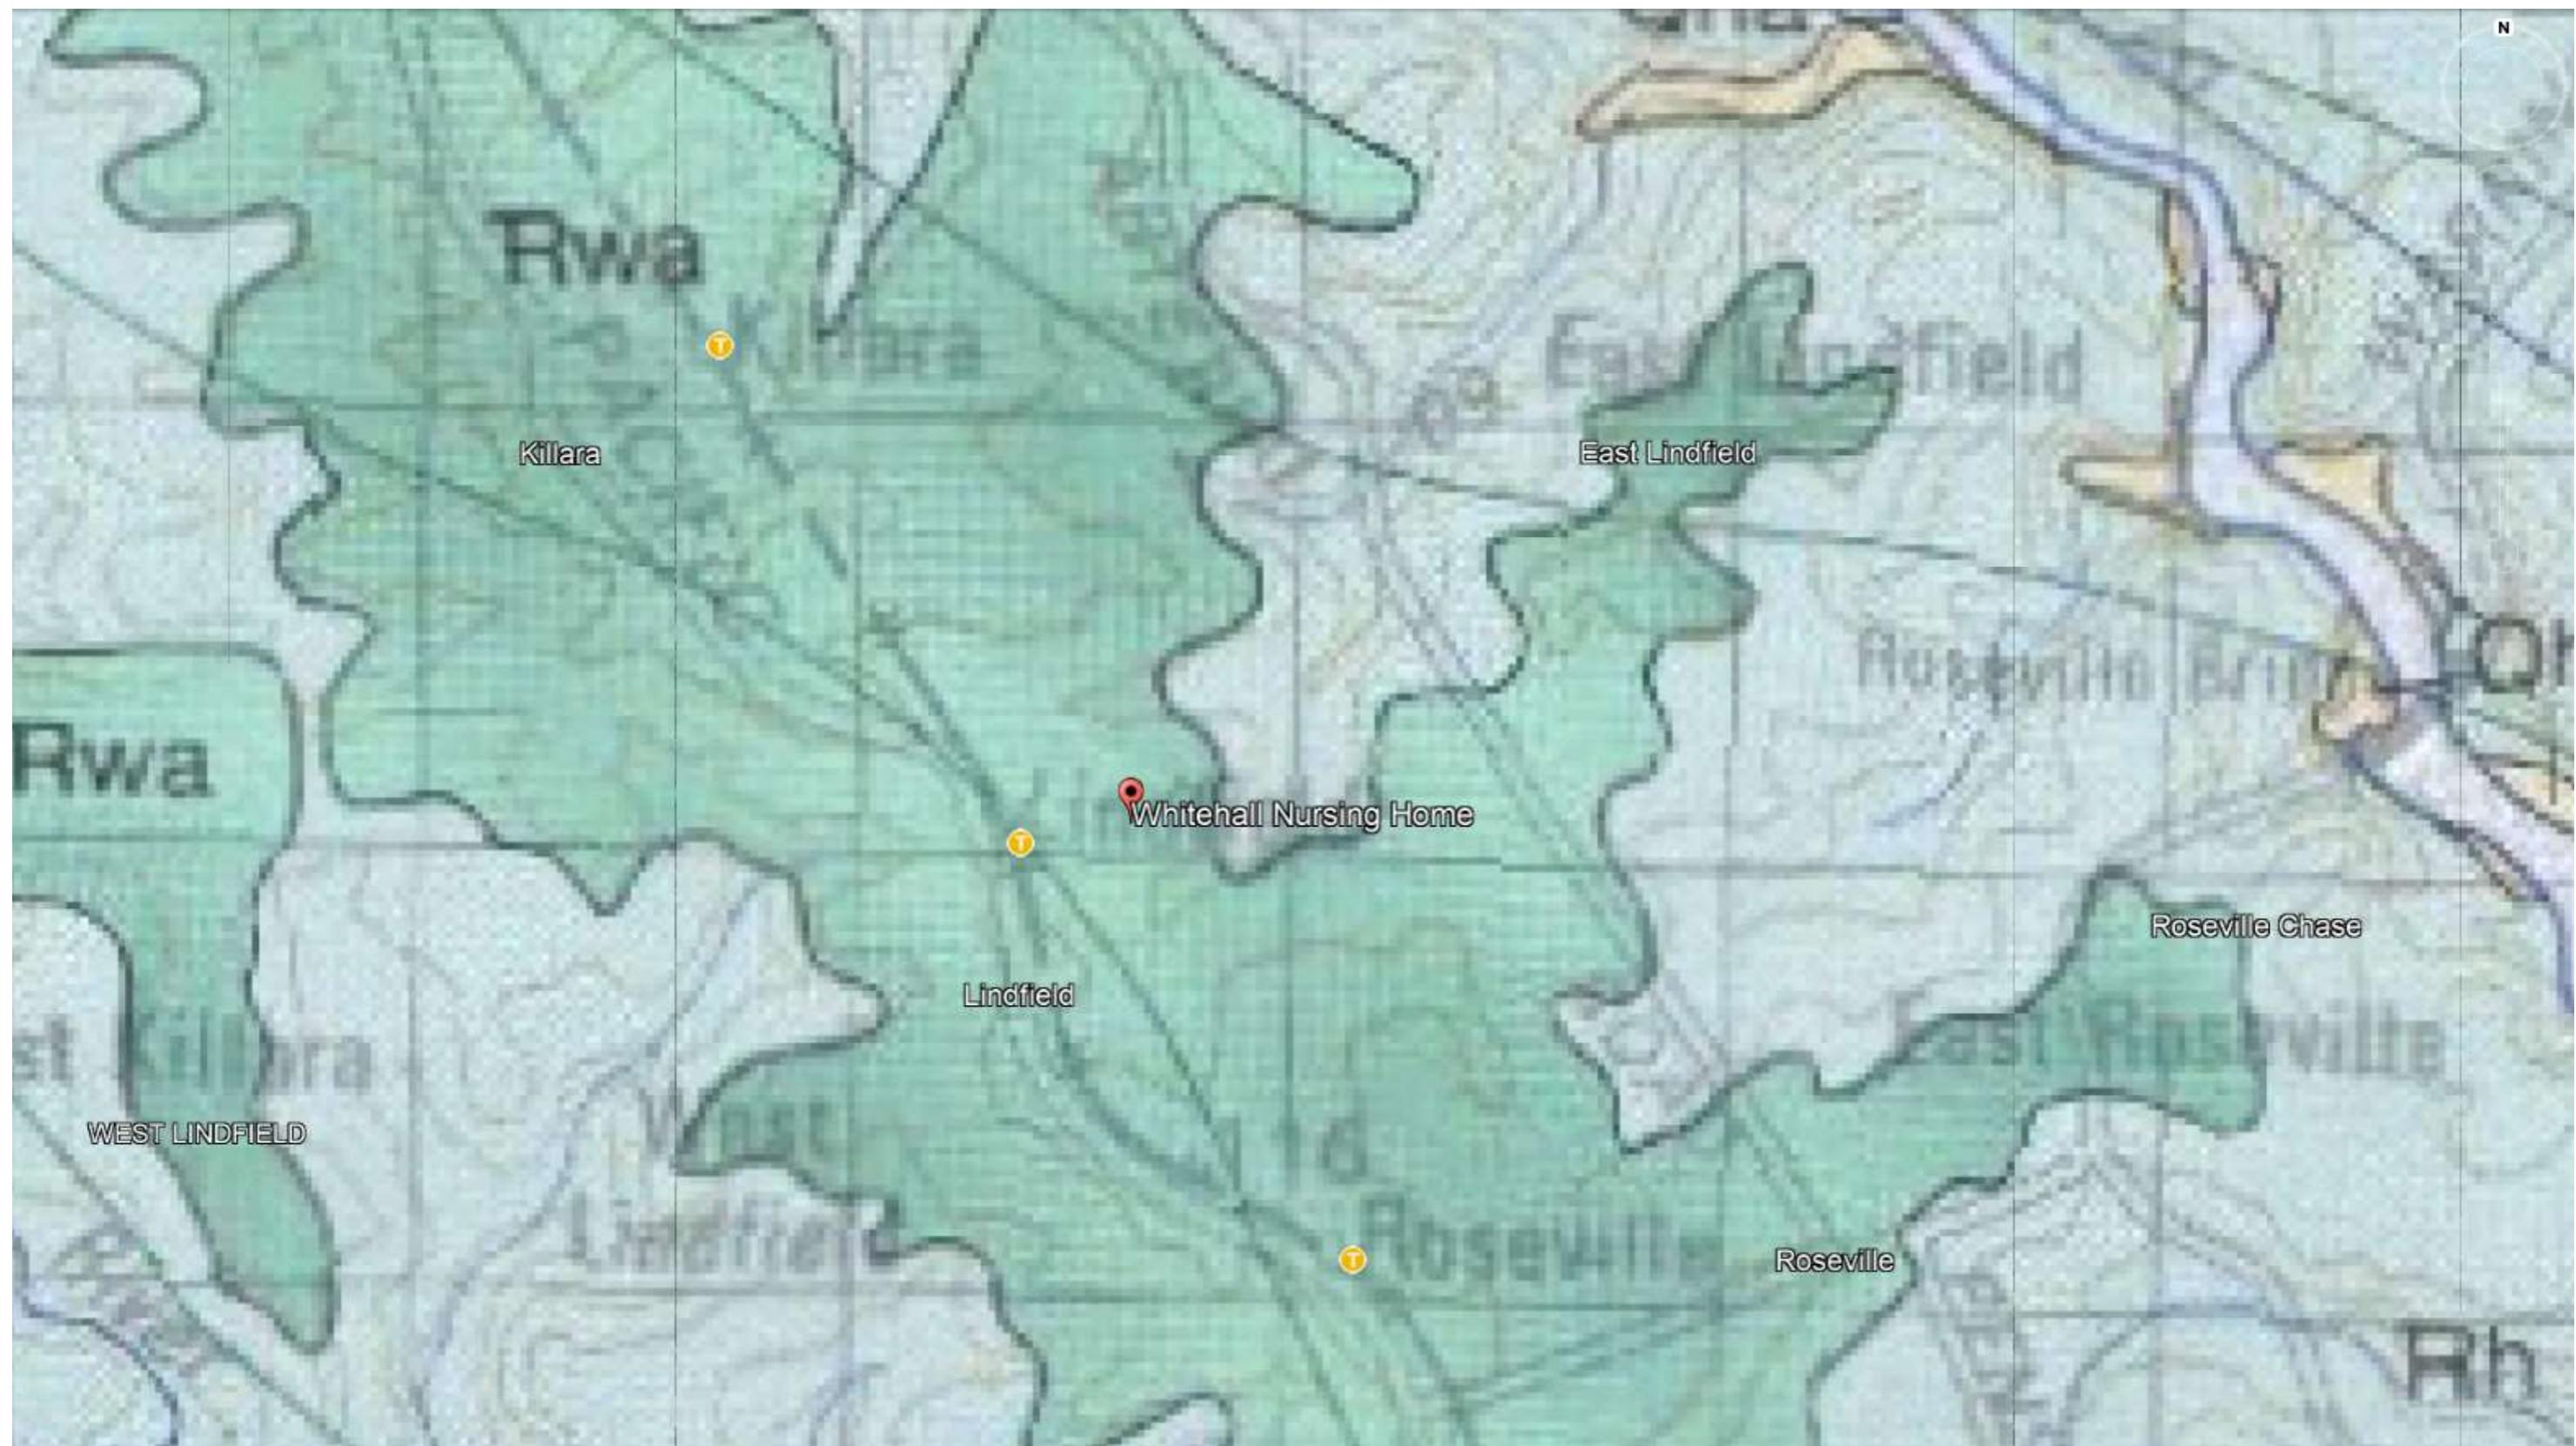
**Geology Plan**  
27-29 Tryon Road, Lindfield NSW 2070

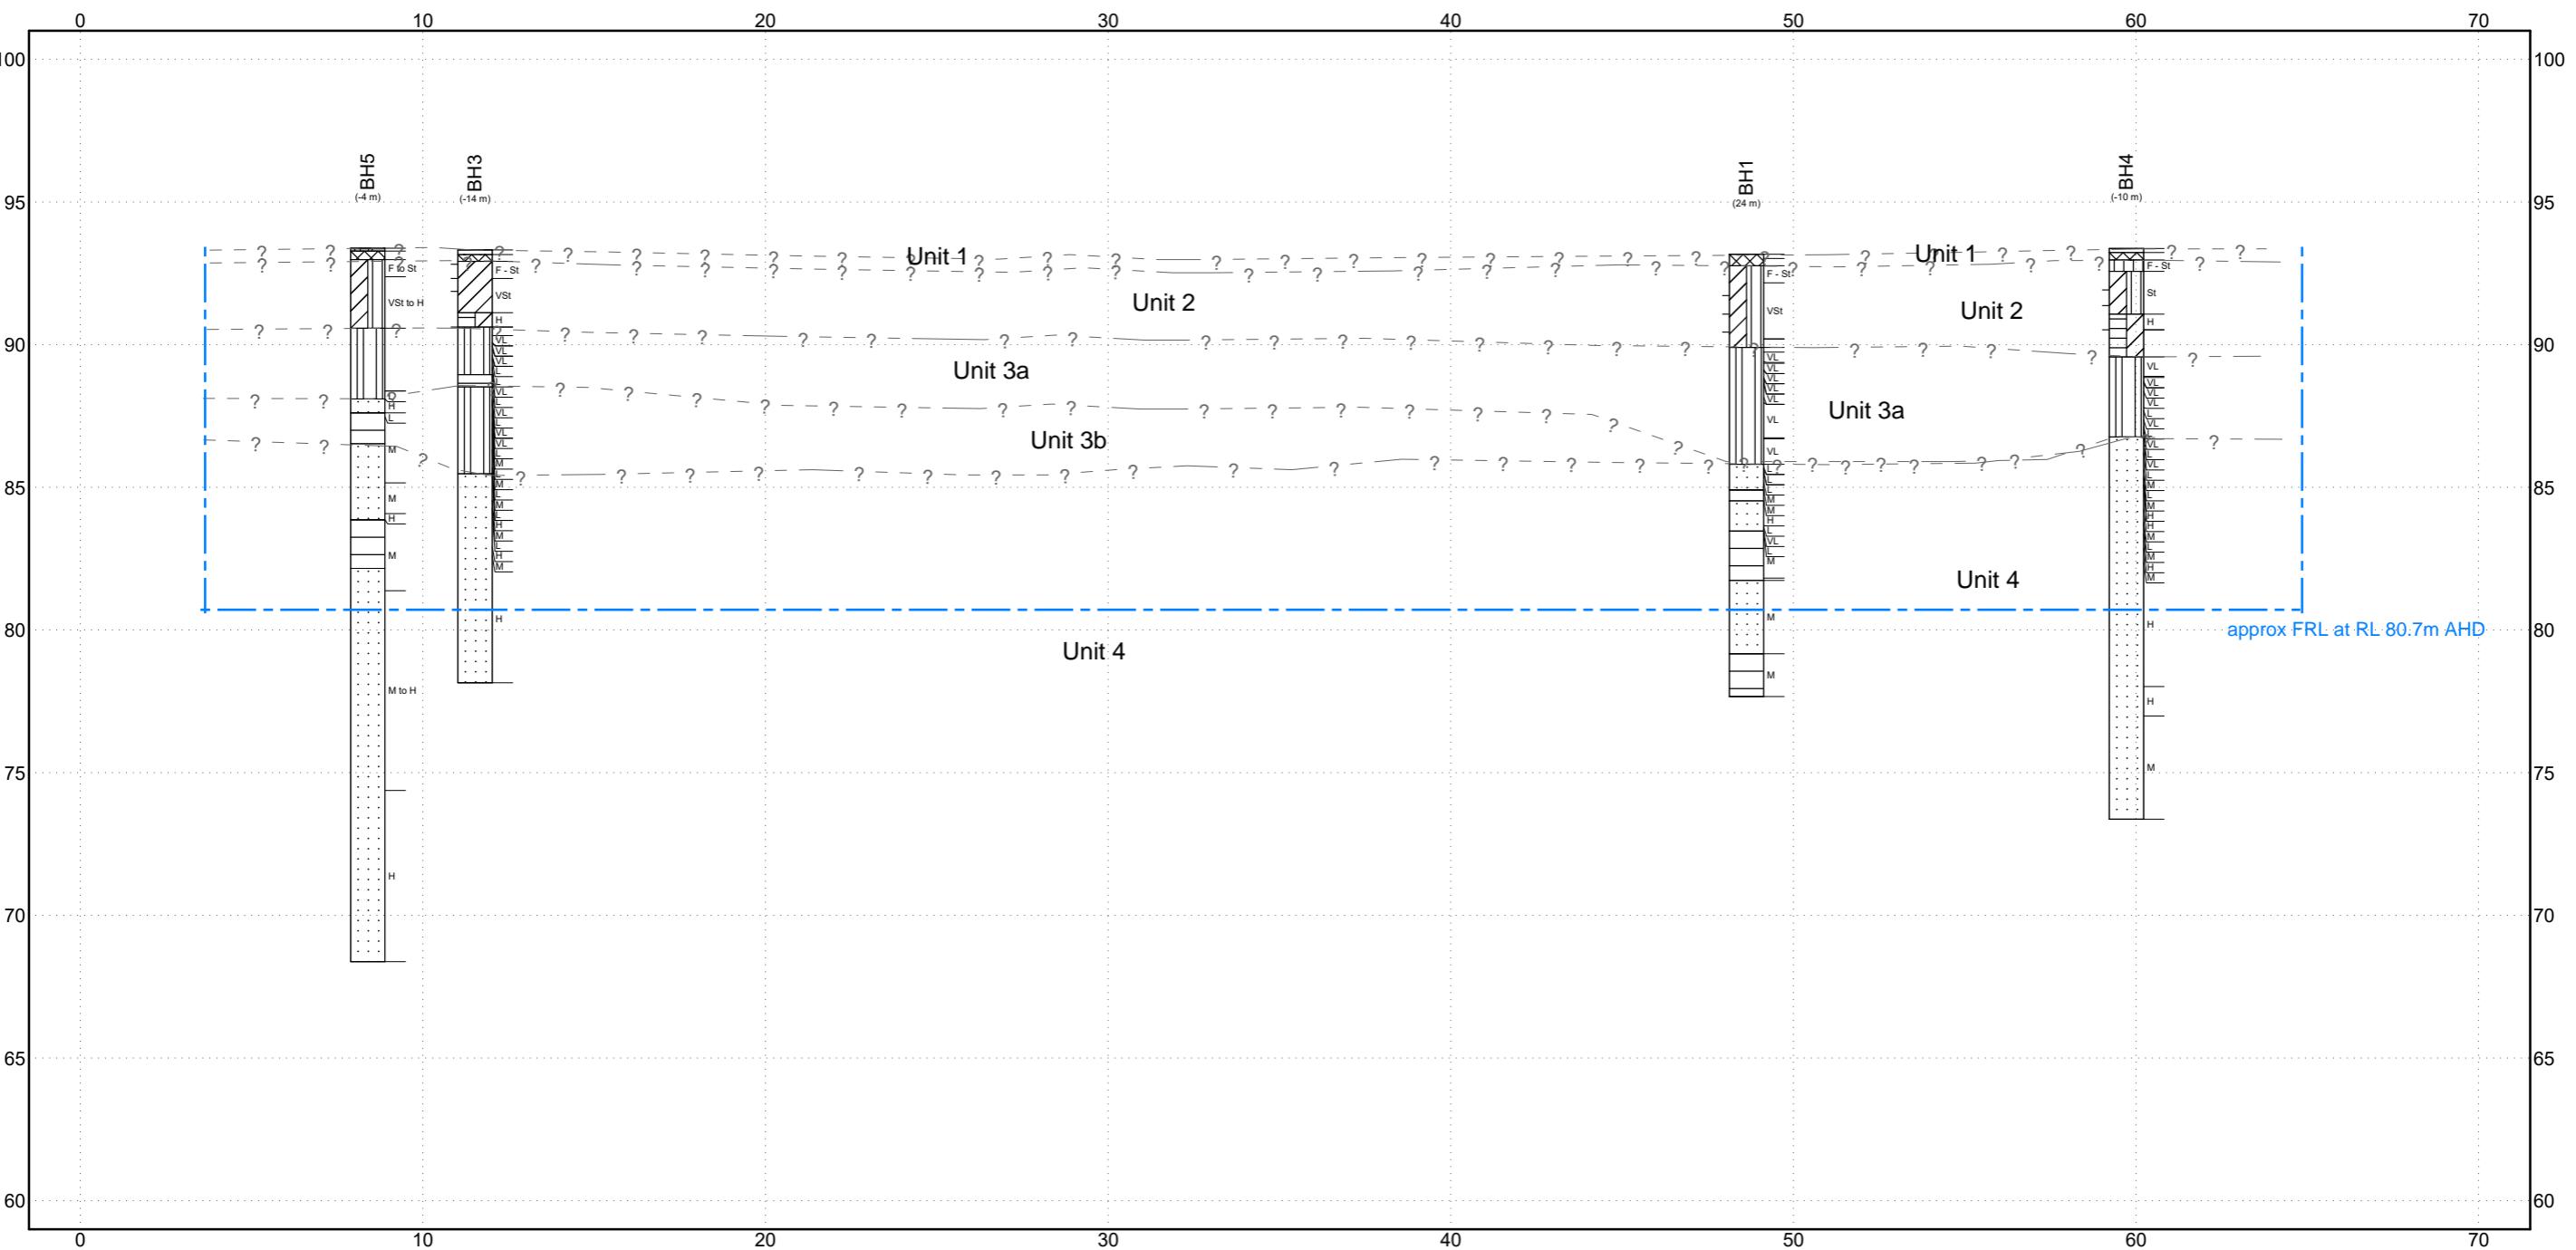
CLIENT	Bridgestone Projects		PROJECT	Geotechnical Investigation 27-29 Tryon Road, Lindfield	
DRAWN	RC	DATE	05/02/2025		
CHECKED	TH	DATE	05/02/2025	TITLE	Geotechnical Cross Section A-A'
SCALE	H 1:200 V 1:240		A3	PROJECT No	2025002
				FIGURE No	Figure 1

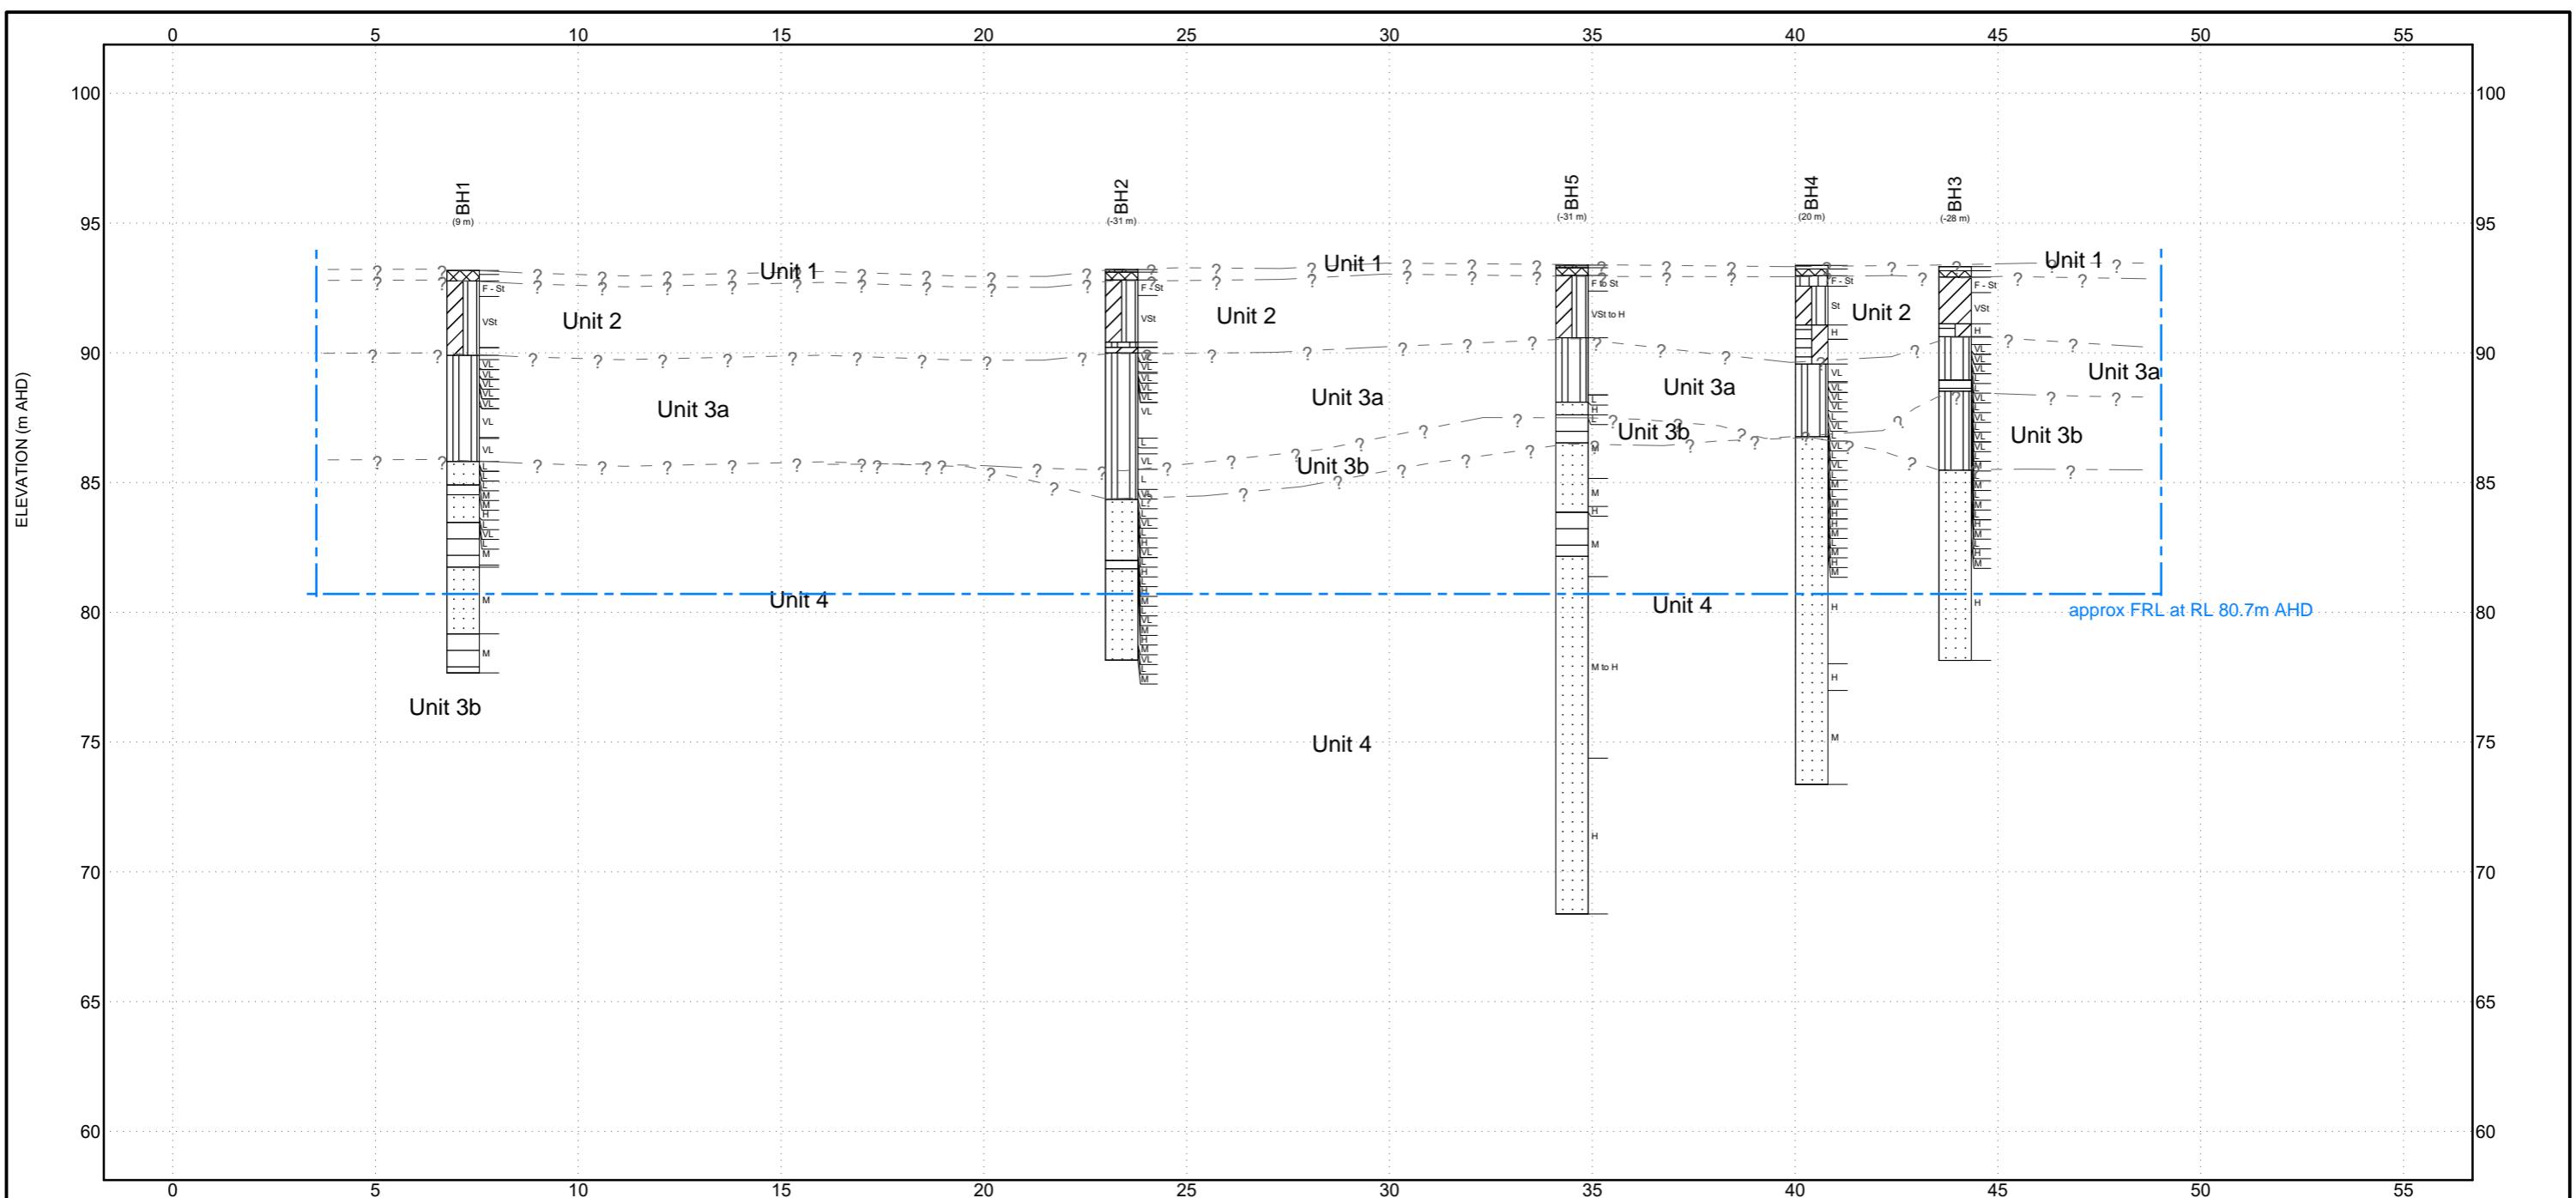
CLIENT		Bridgestone Projects		PROJECT	Geotechnical Investigation	
	DRAWN	RC	DATE	05/02/2025		27-29 Tryon Road, Lindfield	
	CHECKED	TH	DATE	05/02/2025	TITLE	Geotechnical Cross Section B-B'	
SCALE	H 1:160 V 1:250		A3	PROJECT No	2025002	FIGURE No	Figure 1

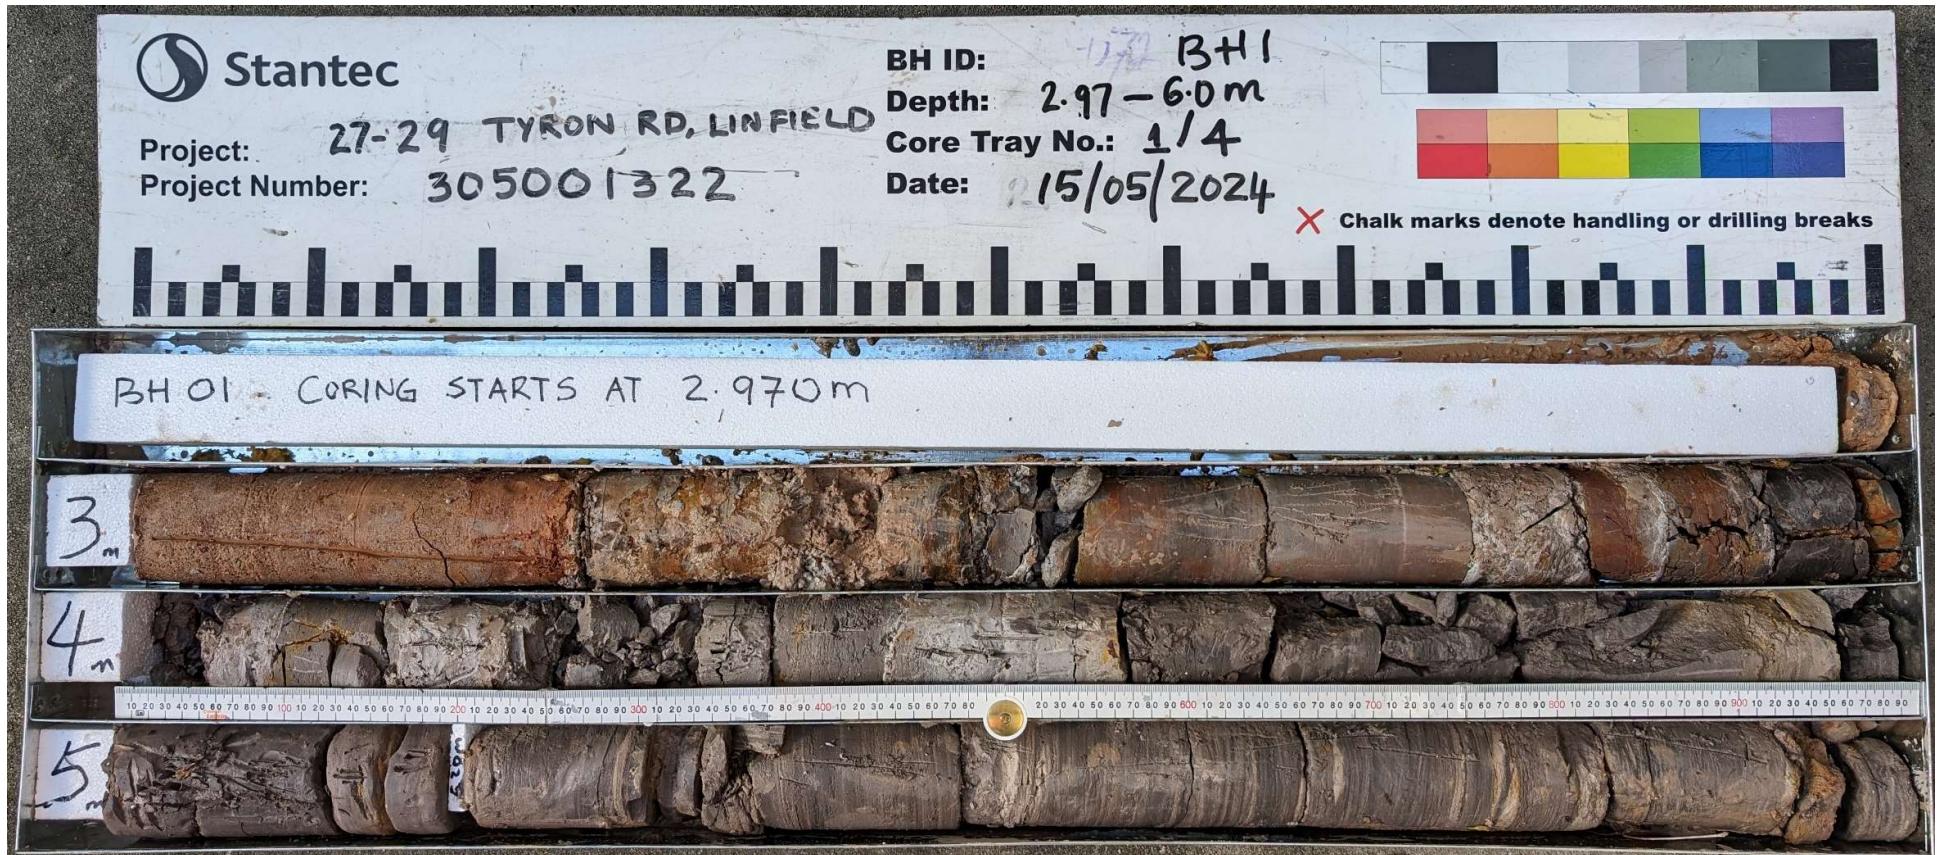
<p><b>Borehole Core Photographs – BH1</b>  <b>27-29 Tryon Road, Lindfield</b></p>			
	PROJECT NO: <b>305001322</b>	TEST DATE: <b>14/05/2024</b>	INCLINATION: <b>-90 degree</b>	CORED LENGTH: <b>BOX 1 OF 4</b> <b>2.97 – 6.00m (3.03m Length)</b>
	DRILL RIG: <b>MI2</b>	CONTRACTOR: <b>Stratacore</b>	LOGGED BY: <b>RN</b>	CHECKED BY: <b>TH</b>

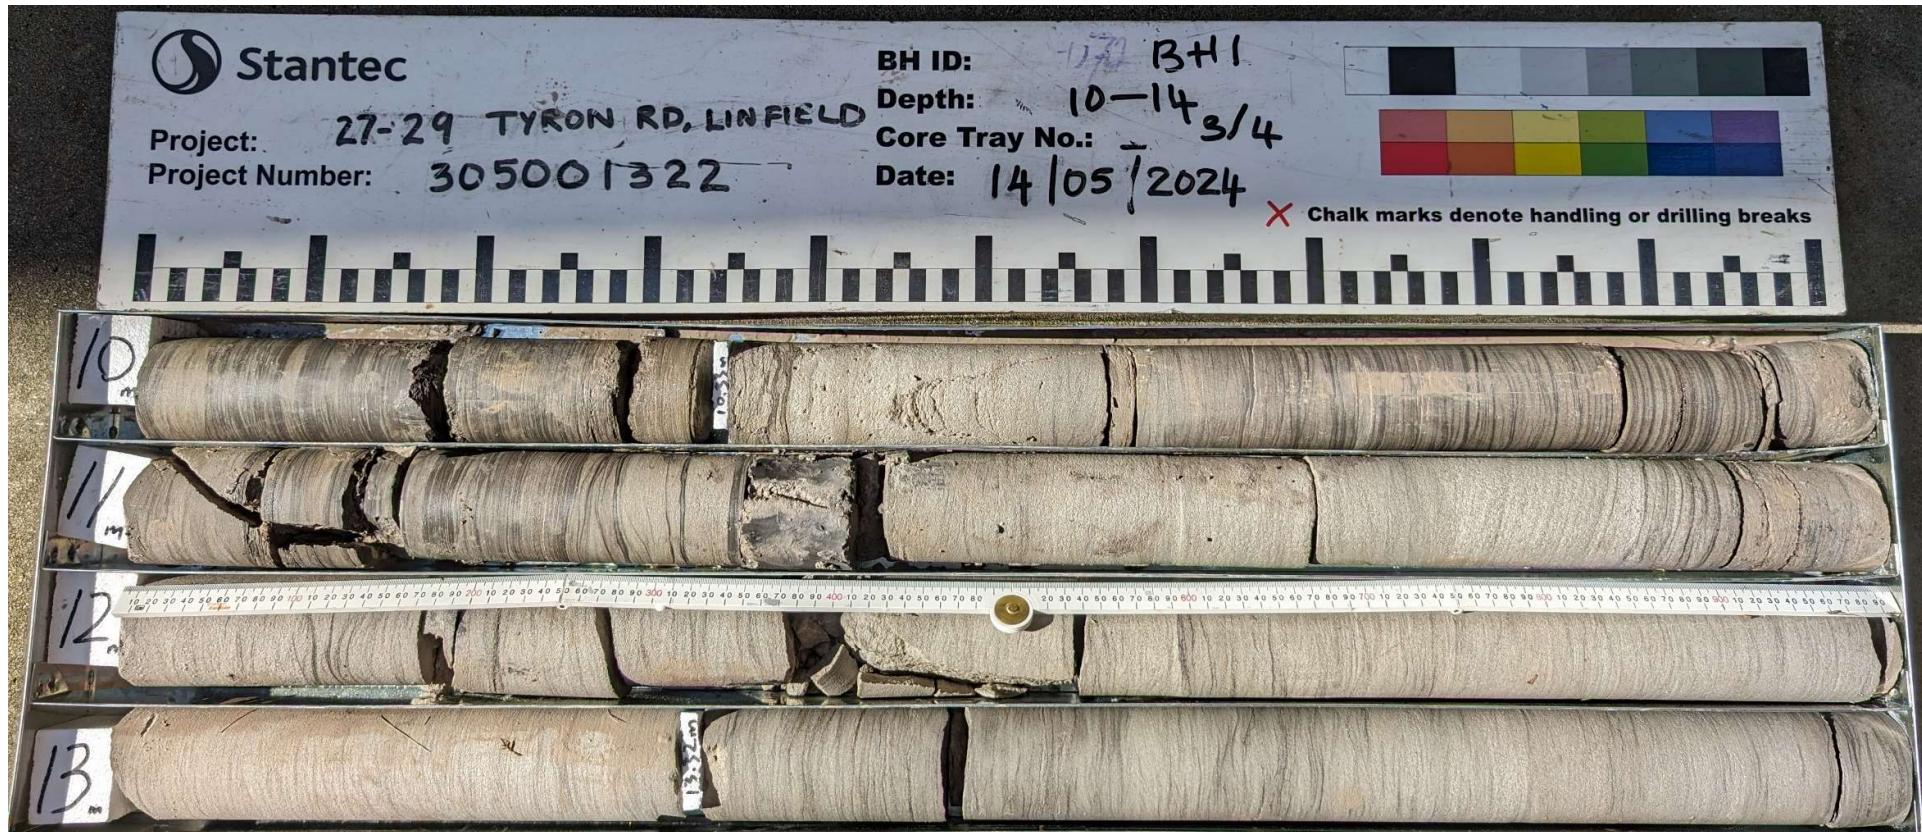
<p><b>TITLE:</b> <b>Borehole Core Photographs – BH1</b>  <b>27-29 Tryon Road, Lindfield</b></p>			
	PROJECT NO: <b>305001322</b>	TEST DATE: <b>14/05/2024</b>	INCLINATION: <b>-90 degree</b>	CORED LENGTH: <b>BOX 3 OF 4</b> <b>10.0 – 14.0m (4.0m Length)</b>
	DRILL RIG: <b>MI2</b>	CONTRACTOR: <b>Stratacore</b>	LOGGED BY: <b>RN</b>	CHECKED BY: <b>TH</b>

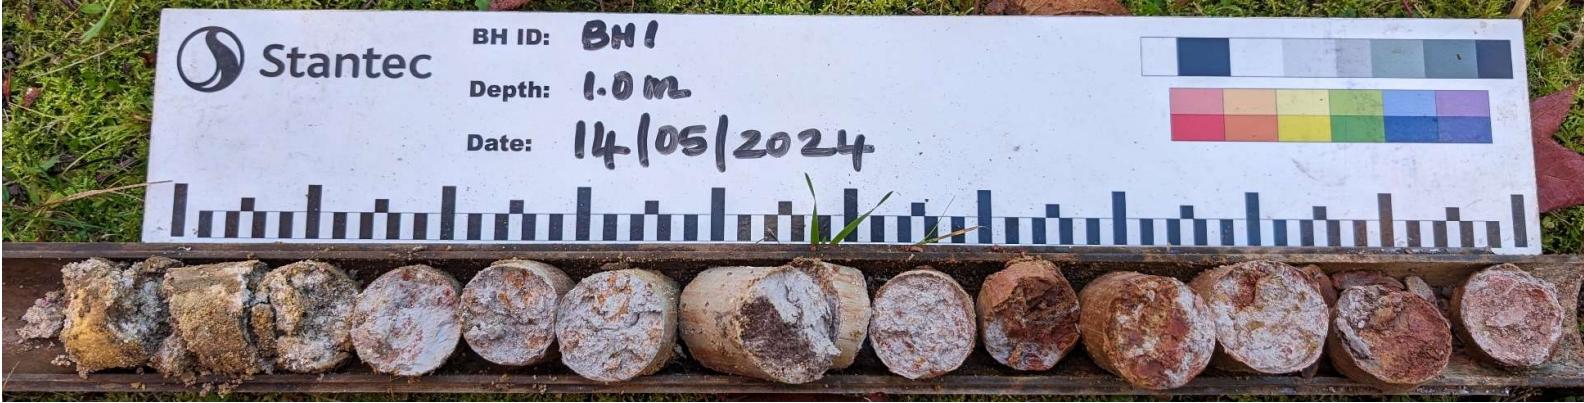
<p>A photograph of a borehole sample at 1.0m depth. The sample consists of 12 cylindrical rock cores arranged in a row. Above the cores is a white Stantec label with black text and markings. The label includes the Stantec logo, 'BH ID: BH1', 'Depth: 1.0 m', and 'Date: 14/05/2024'. To the right of the label is a color calibration chart with a black and white ruler below it. The sample is set against a background of green grass.</p>

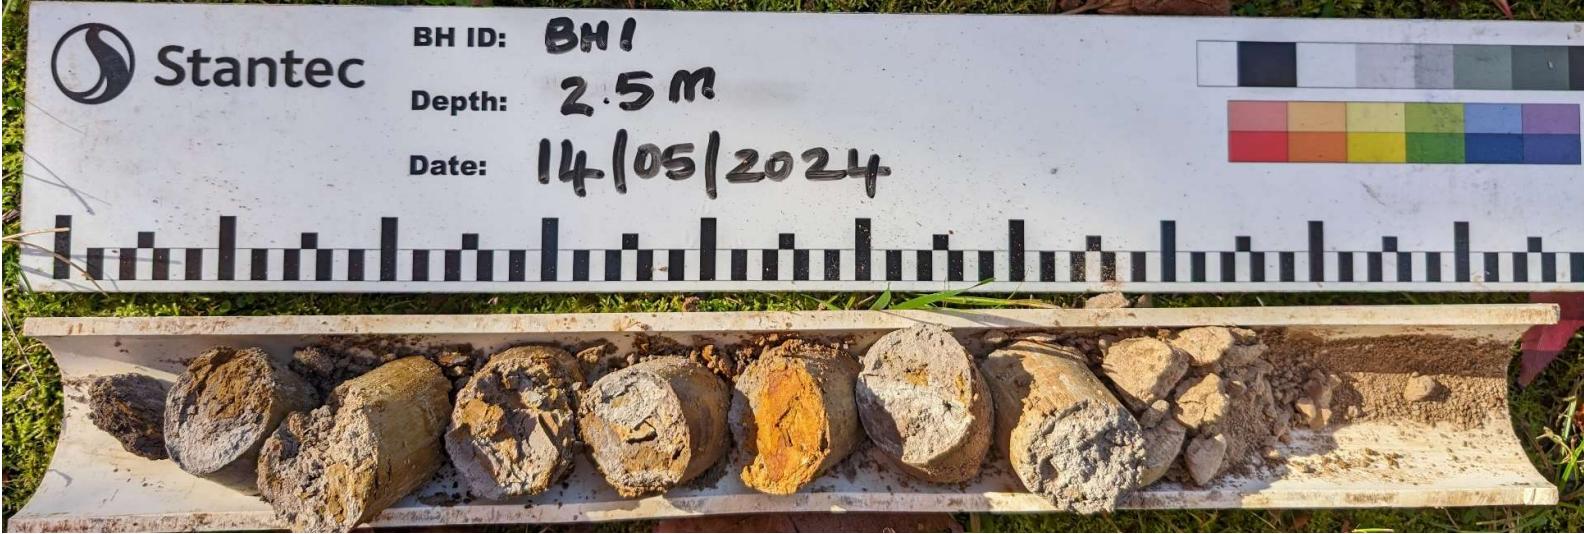
<p>A photograph of a borehole sample at 2.5m depth. The sample consists of 7 large, irregular rock blocks arranged in a row. Above the blocks is a white Stantec label with black text and markings. The label includes the Stantec logo, 'BH ID: BH1', 'Depth: 2.5 m', and 'Date: 14/05/2024'. To the right of the label is a color calibration chart with a black and white ruler below it. The sample is set against a background of green grass.</p>

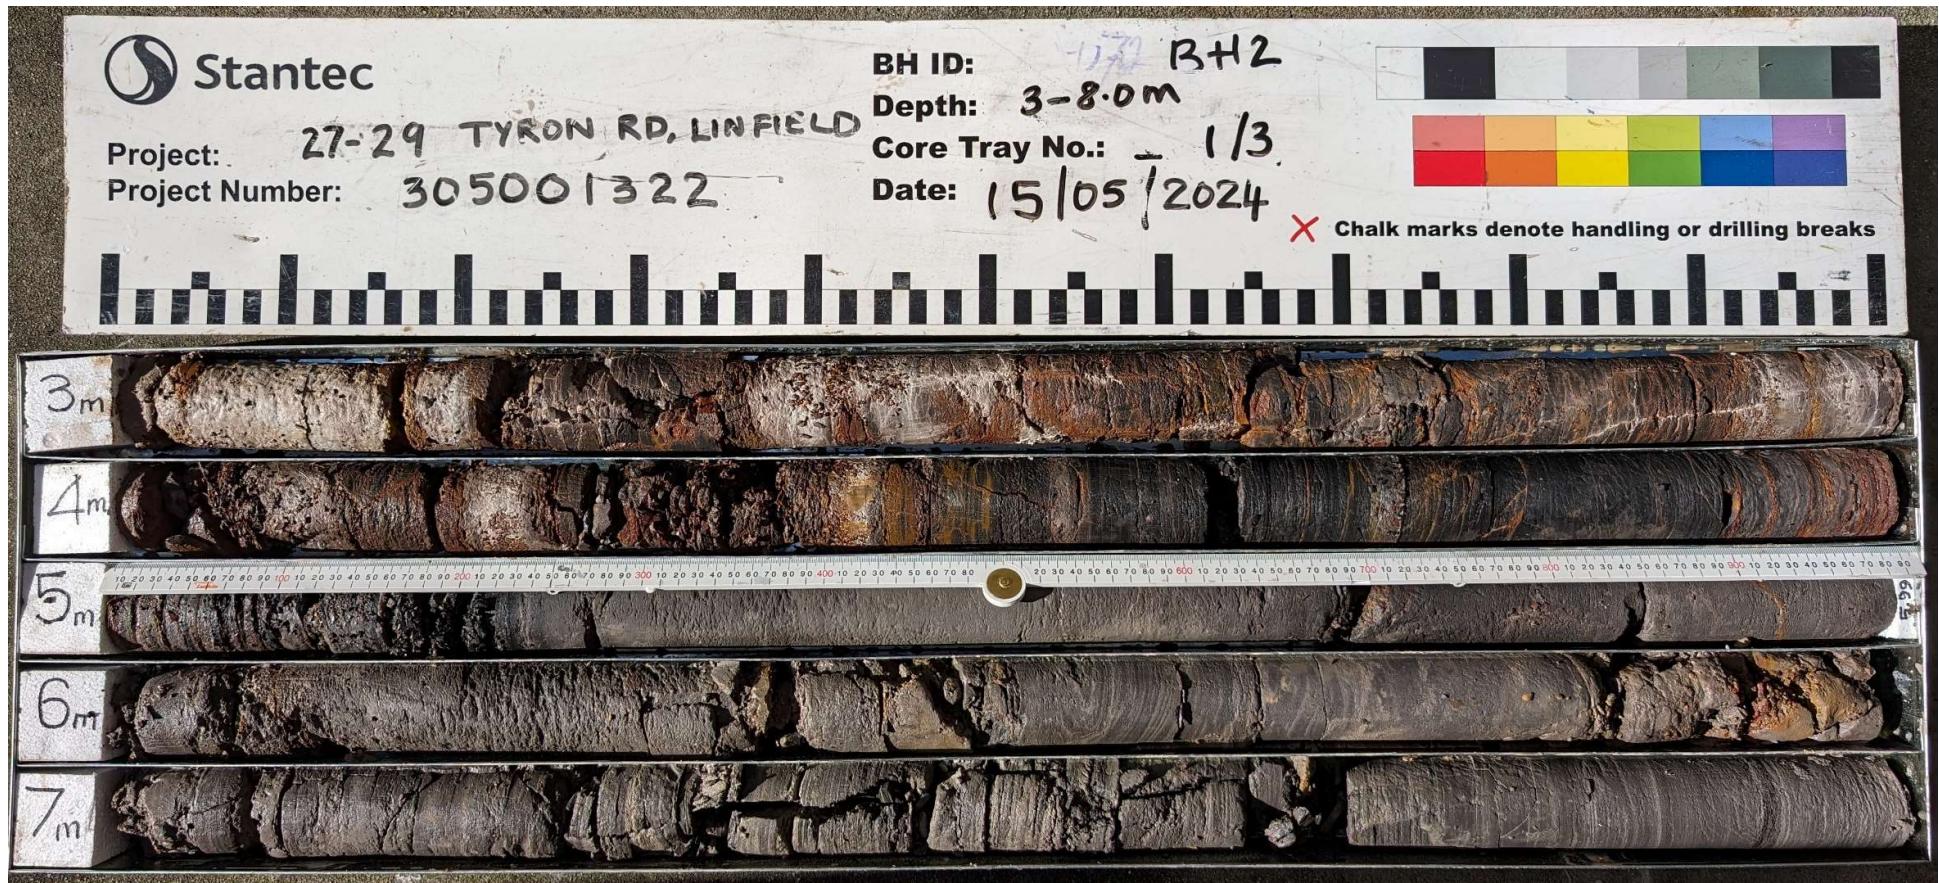
<p><b>TITLE:</b> <b>Borehole Core Photographs – BH2</b>  <b>27-29 Tryon Road, Lindfield</b></p>			
	PROJECT NO: <b>305001322</b>	TEST DATE: <b>15/05/2024</b>	INCLINATION: <b>-90 degree</b>	CORED LENGTH: <b>BOX 1 OF 3</b> <b>3.0 – 8.0m (5.0m Length)</b>
	DRILL RIG: <b>MI2</b>	CONTRACTOR: <b>Stratacore</b>	LOGGED BY: <b>RN</b>	CHECKED BY: <b>TH</b>

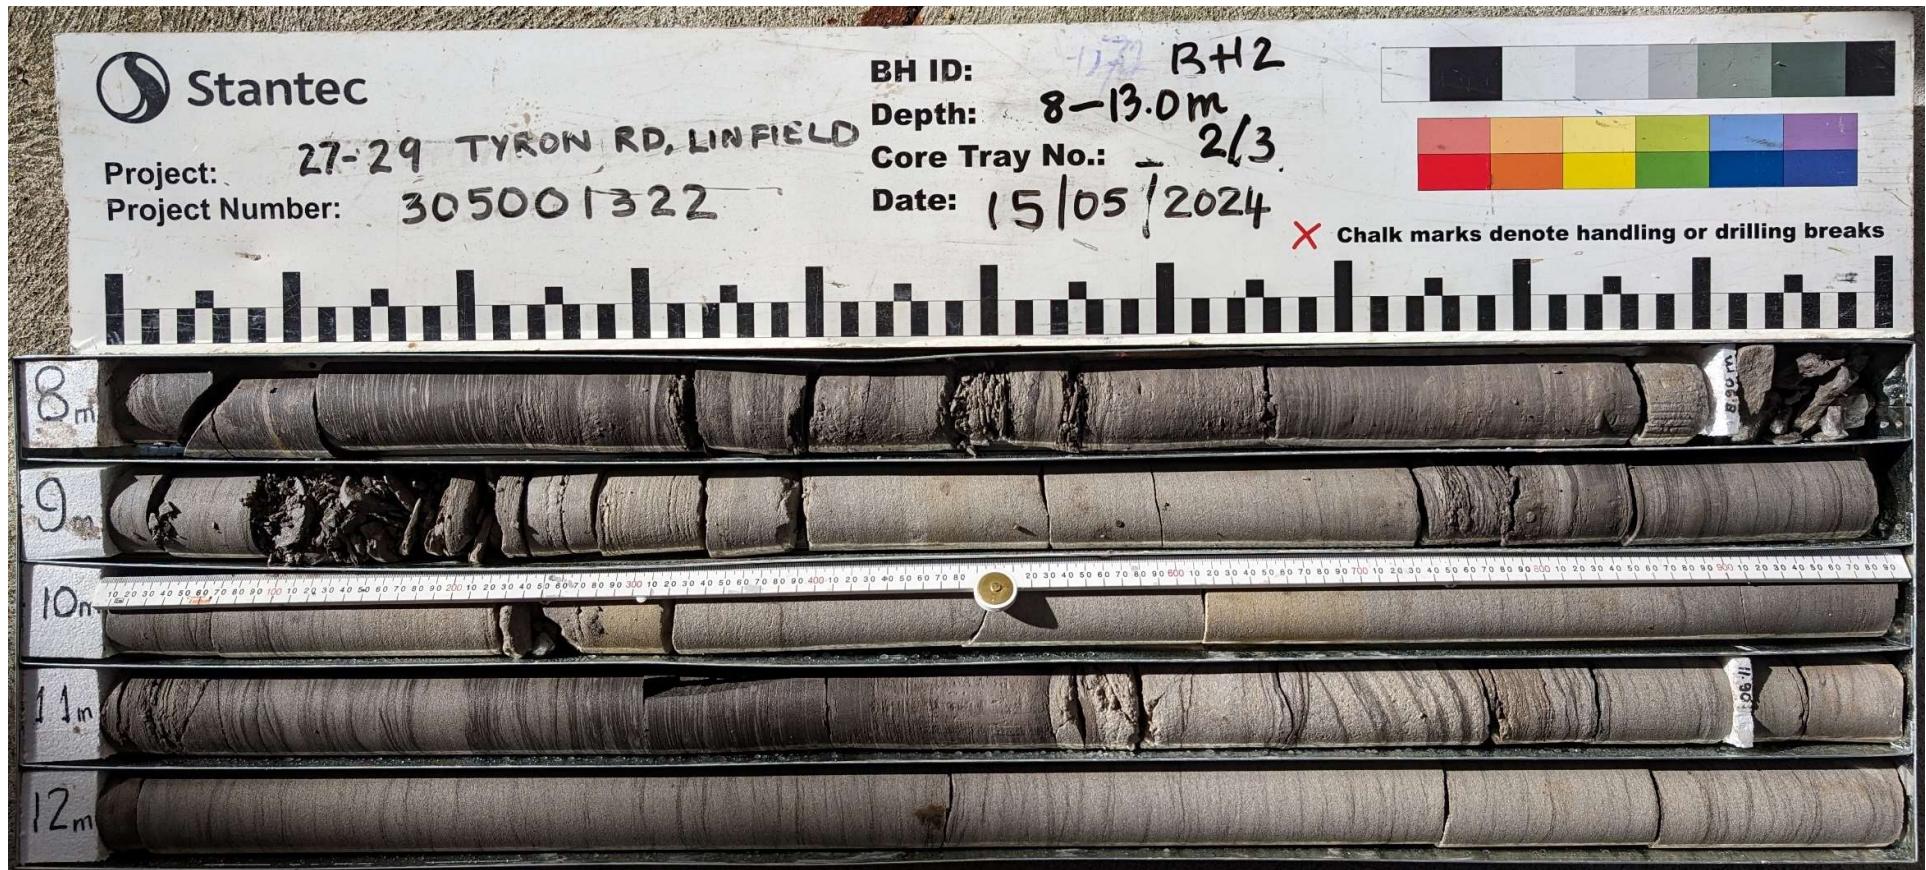
<p><b>Borehole Core Photographs – BH2</b></p> <p><b>27-29 Tryon Road, Lindfield</b></p>			
	<b>PROJECT NO:</b> <b>305001322</b>	<b>TEST DATE:</b> <b>15/05/2024</b>	<b>INCLINATION:</b> <b>-90 degree</b>	<b>CORED LENGTH: BOX 2 OF 3</b> <b>8.0 – 13.0m (5.0m Length)</b>
	<b>DRILL RIG:</b> <b>MI2</b>	<b>CONTRACTOR:</b> <b>Stratacore</b>	<b>LOGGED BY:</b> <b>RN</b>	<b>CHECKED BY:</b> <b>TH</b>
