**PROPOSED RESIDENTIAL  
REDEVELOPMENT (SSD-78669234)**

**GEOTECHNICAL INVESTIGATION REPORT  
27-29 TRYON ROAD LINDFIELD**

4 February 2025

Project Number:  
2025002

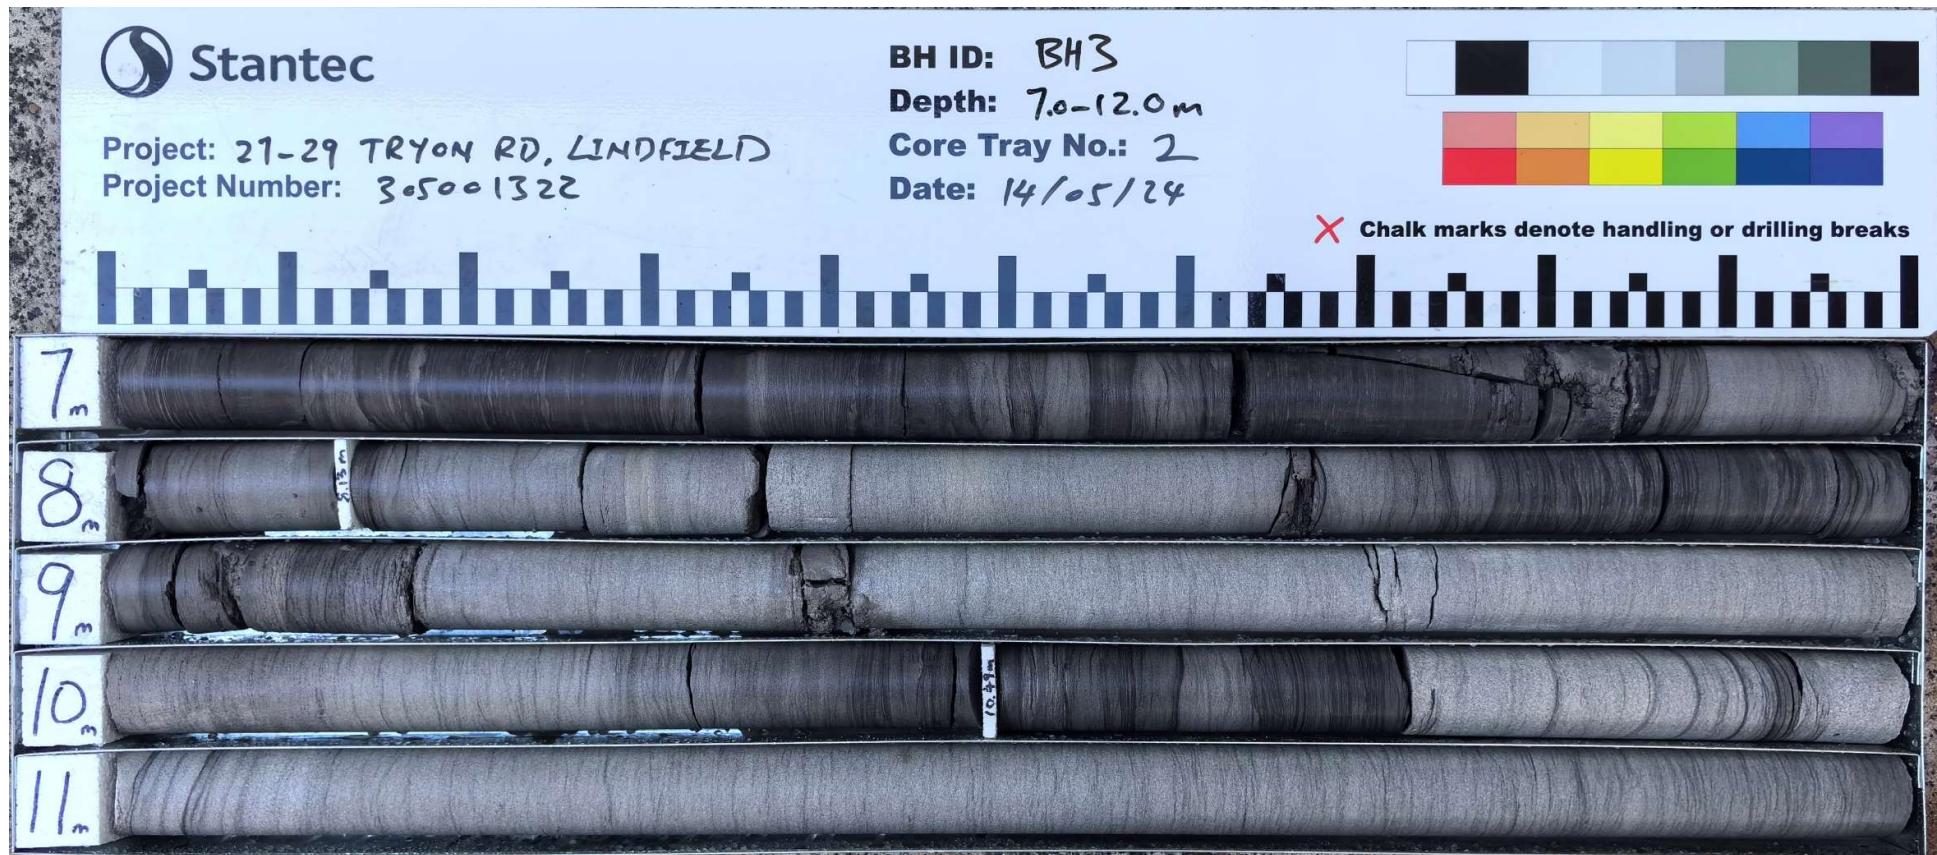
<p><b>Borehole Core Photographs – BH3</b>  <b>27-29 Tryon Road, Lindfield</b></p>			
	PROJECT NO: 305001322	TEST DATE: 14/05/2024	INCLINATION: -90 degree	CORED LENGTH: <b>BOX 2 OF 3</b> <b>7.0 – 12.0m (5.0m Length)</b>
	DRILL RIG: MD300	CONTRACTOR: Traccess	LOGGED BY: SL	CHECKED BY: TH

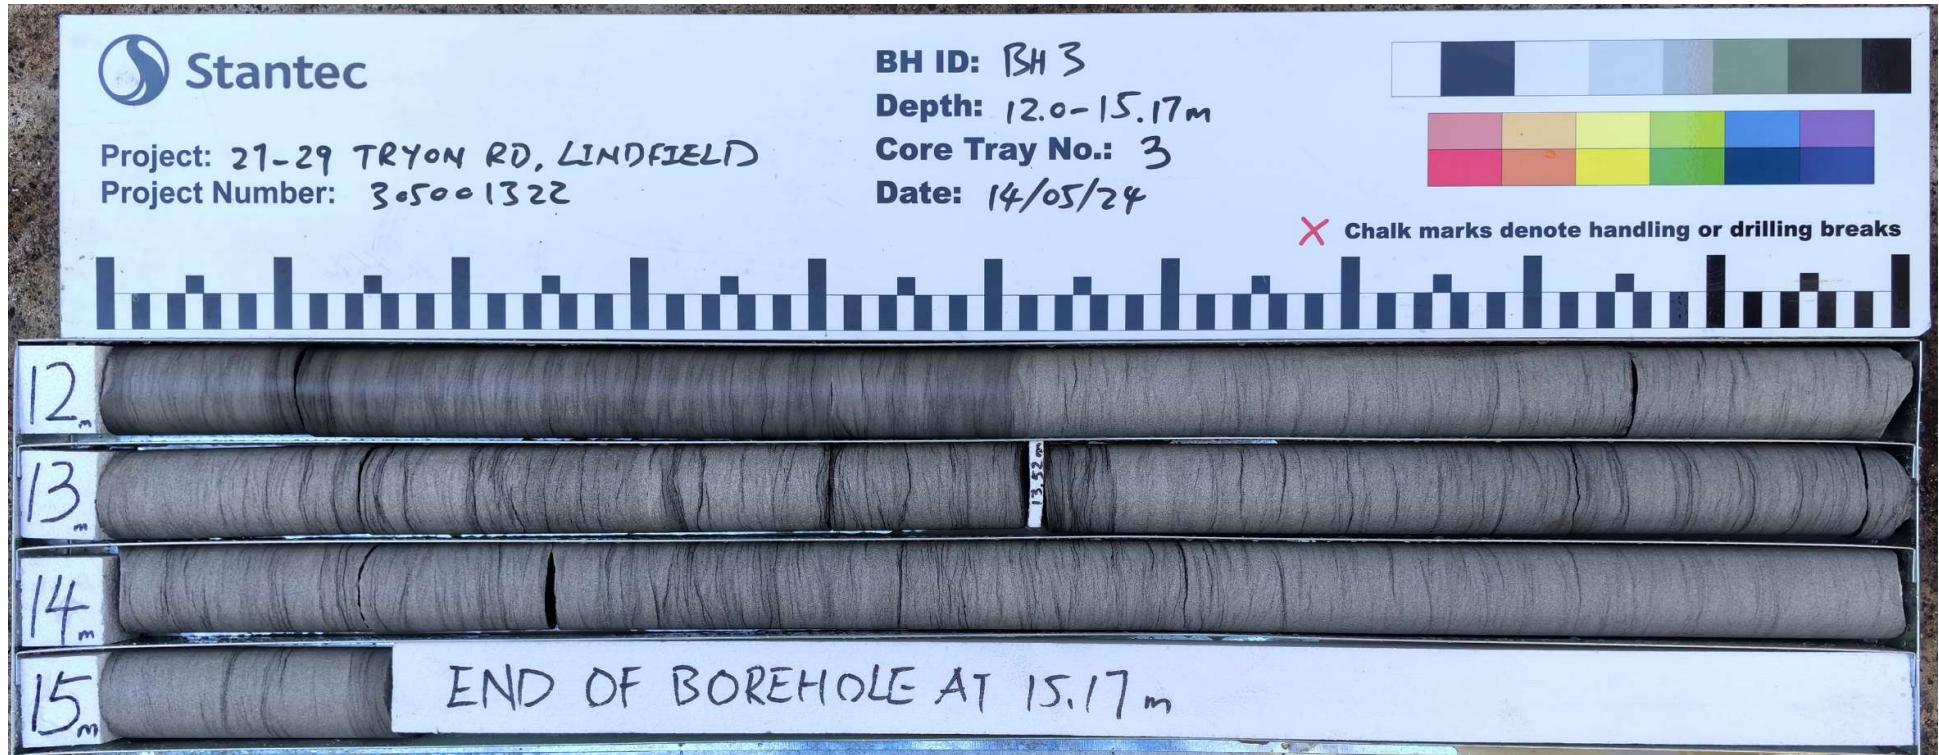
TITLE: <b>Borehole Core Photographs – BH3</b> <b>27-29 Tryon Road, Lindfield</b>			
	PROJECT NO: <b>305001322</b>	TEST DATE: <b>14/05/2024</b>	INCLINATION: <b>-90 degree</b>	CORED LENGTH: <b>BOX 3 OF 3</b> <b>12.00 – 15.17m (3.17m Length)</b>
	DRILL RIG: <b>MD300</b>	CONTRACTOR: <b>Traccess</b>	LOGGED BY: <b>SL</b>	CHECKED BY: <b>TH</b>

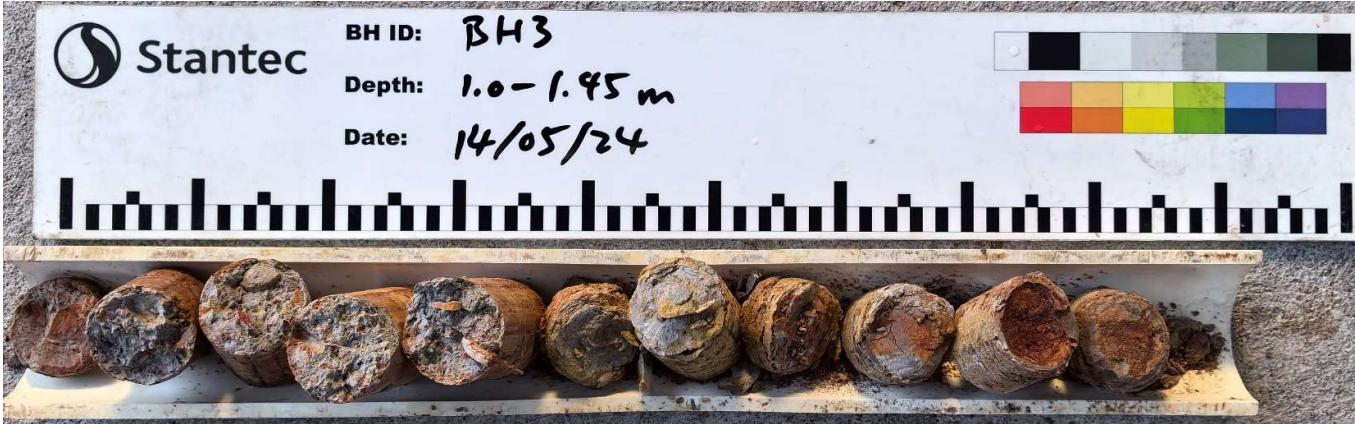
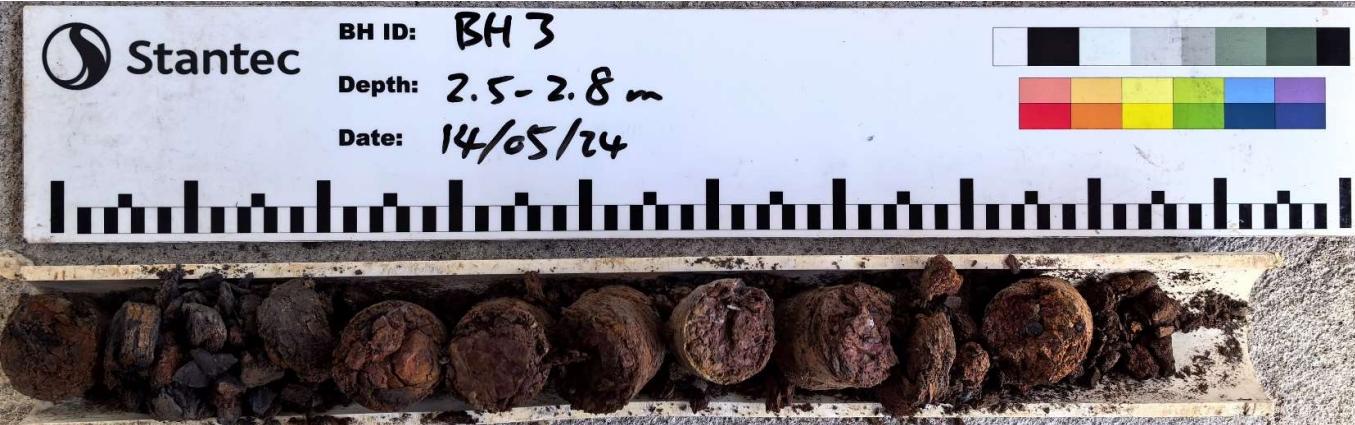
<p><b>Borehole SPT Photographs – BH3</b>  <b>27-29 Tryon Road, Lindfield</b></p>			
	PROJECT NO: <b>305001322</b>	TEST DATE: <b>14/05/2024</b>	INCLINATION: <b>-90 degree</b>	SPT PHOTOS
	DRILL RIG: <b>MD300</b>	CONTRACTOR: <b>Traccess</b>	LOGGED BY: <b>SL</b>	CHECKED BY: <b>TH</b>

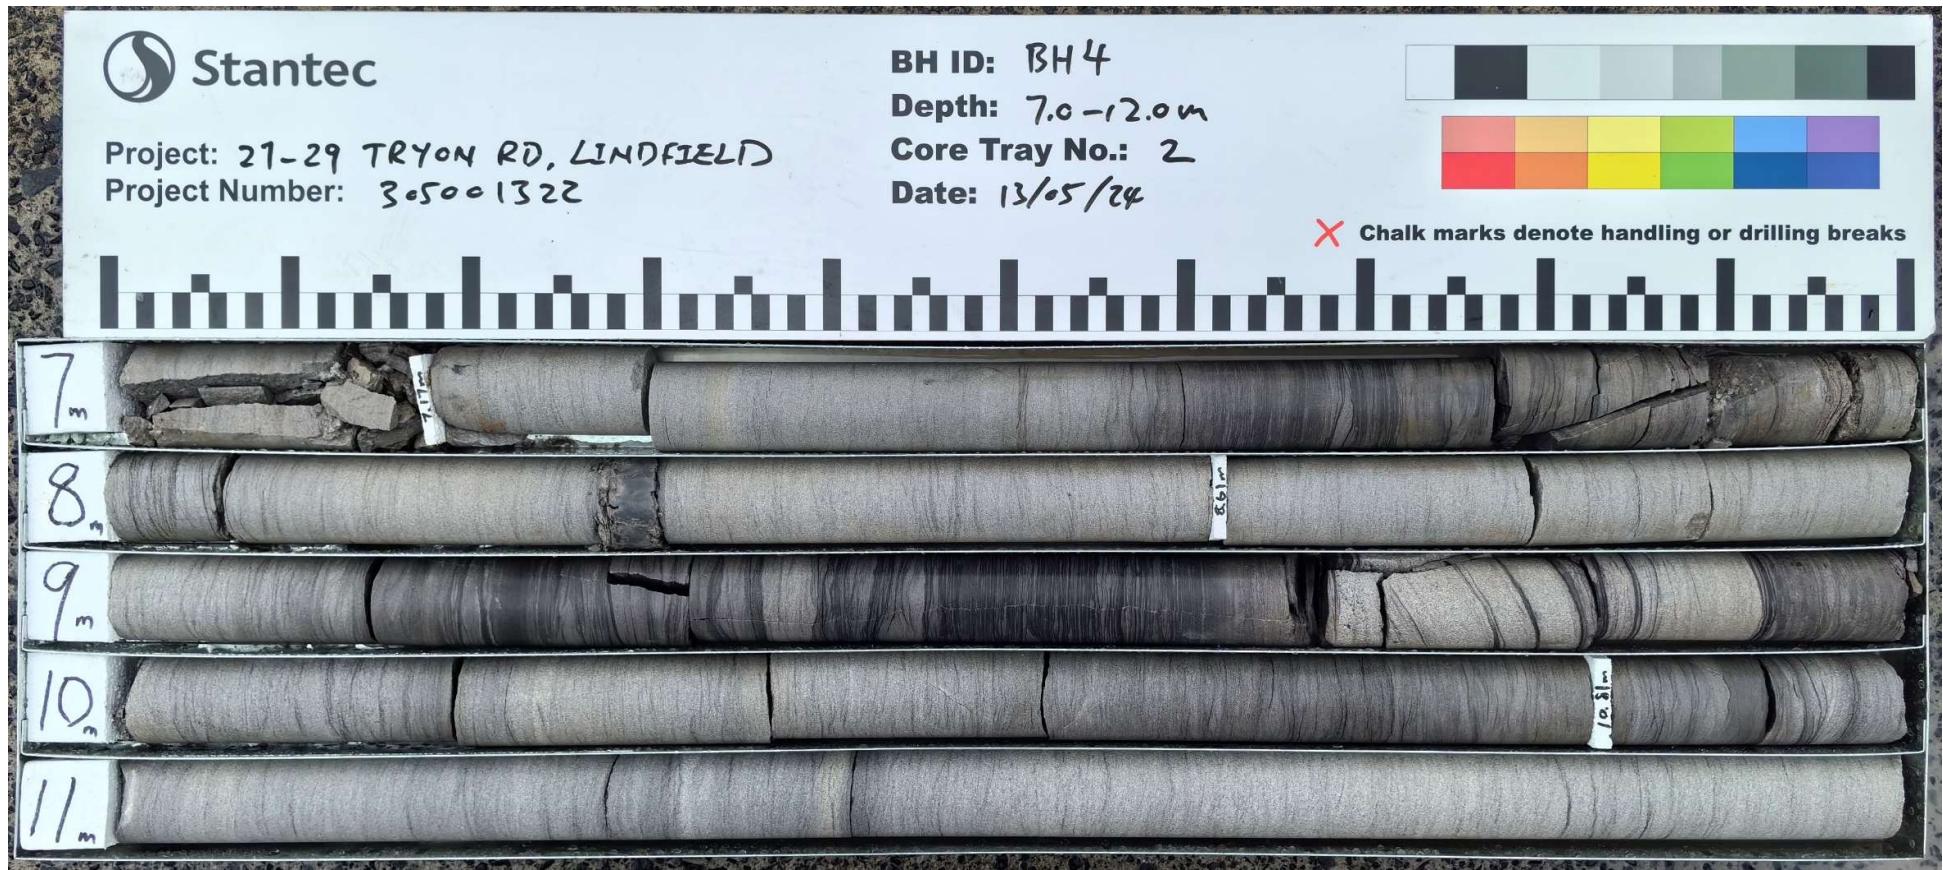
<p><b>Borehole Core Photographs – BH4</b>  <b>27-29 Tryon Road, Lindfield</b></p>			
	PROJECT NO: 305001322	TEST DATE: 13/05/2024	INCLINATION: -90 degree	CORED LENGTH: <b>BOX 2 OF 4</b> <b>7.0 – 12.0m (5.0m Length)</b>
	DRILL RIG: MD300	CONTRACTOR: Traccess	LOGGED BY: SL	CHECKED BY: TH

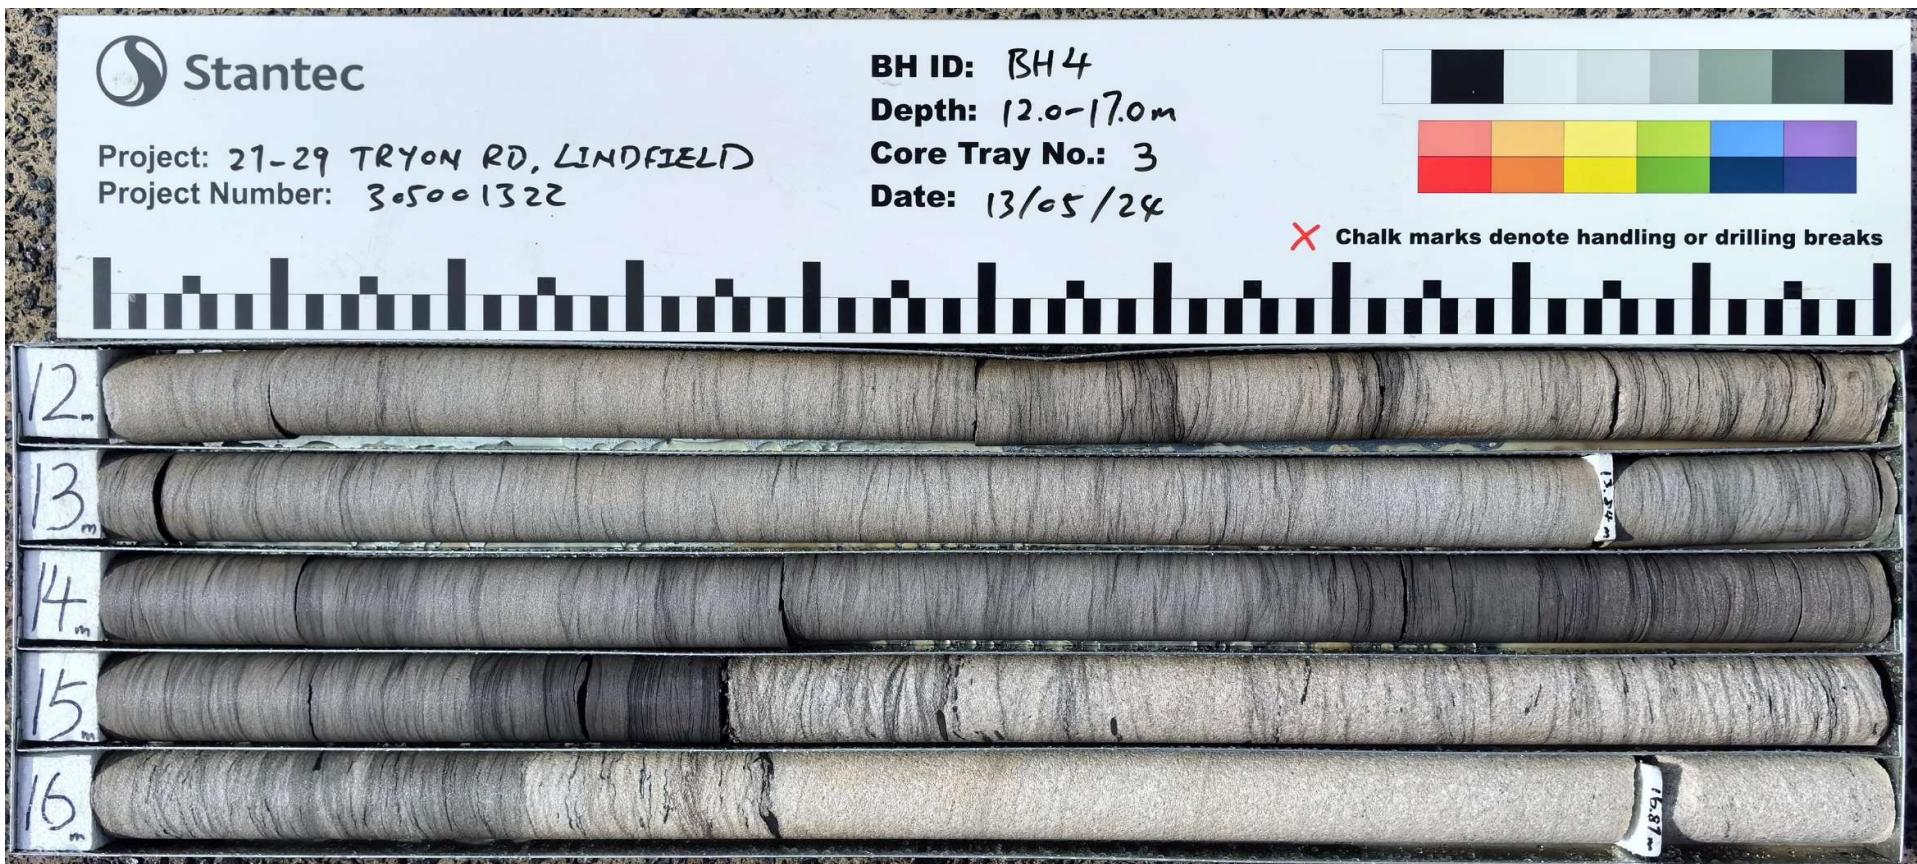
<p><b>TITLE:</b> <b>Borehole Core Photographs – BH4</b>  <b>27-29 Tryon Road, Lindfield</b></p>			
	PROJECT NO: <b>305001322</b>	TEST DATE: <b>13/05/2024</b>	INCLINATION: <b>-90 degree</b>	CORED LENGTH: <b>BOX 3 OF 4</b> <b>12.0 – 17.0m (5.0m Length)</b>
	DRILL RIG: <b>MD300</b>	CONTRACTOR: <b>Traccess</b>	LOGGED BY: <b>SL</b>	CHECKED BY: <b>TH</b>

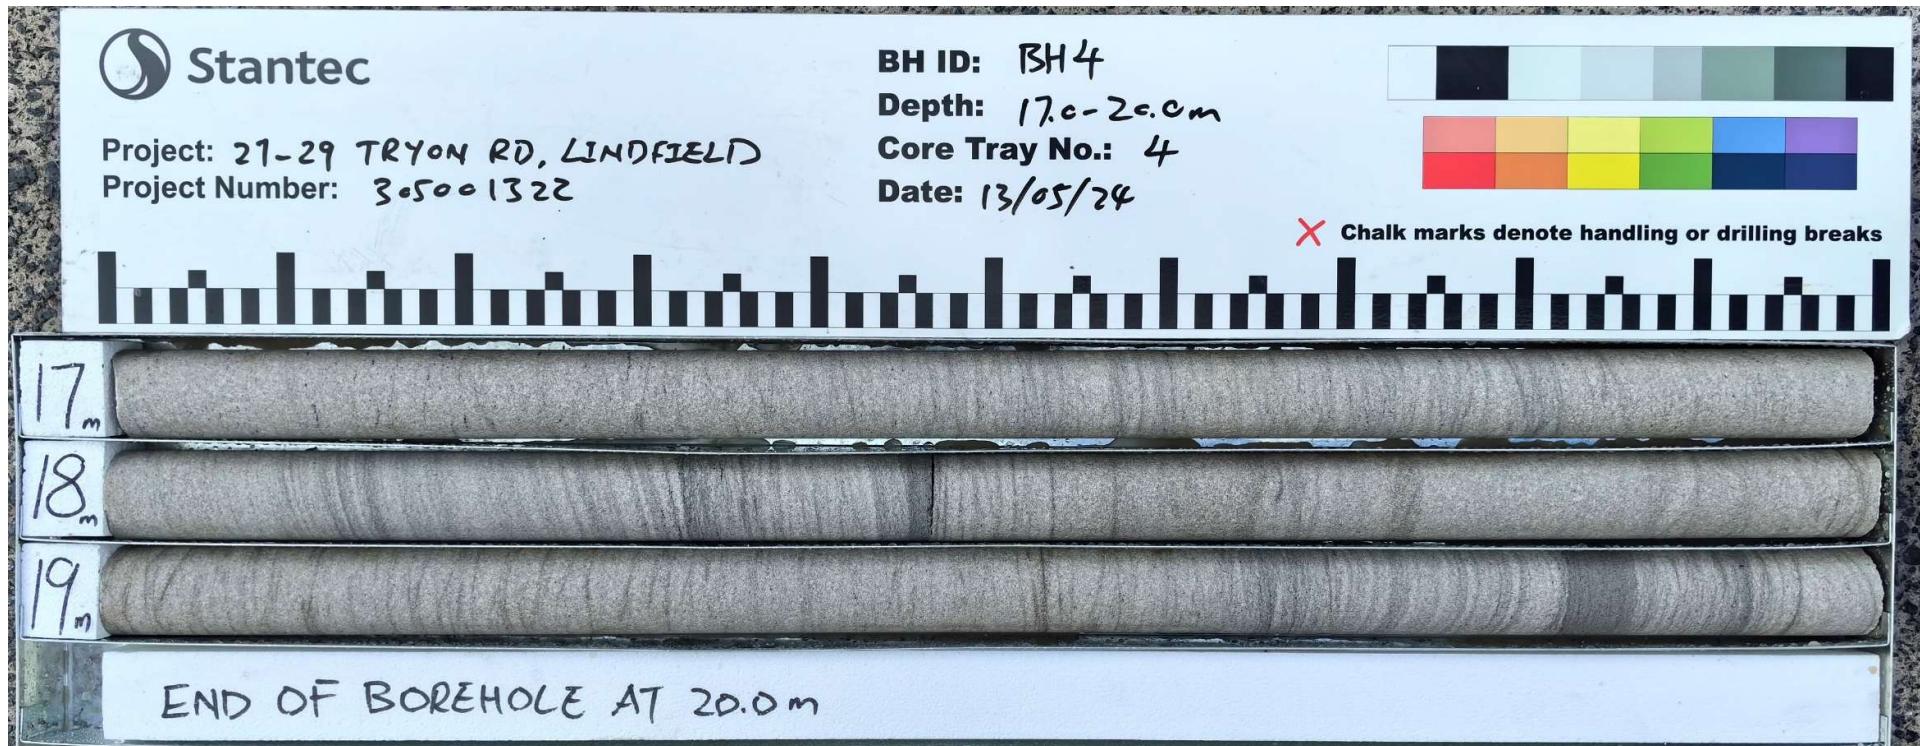
<p><b>Borehole Core Photographs – BH4</b>  <b>27-29 Tryon Road, Lindfield</b></p>			
	PROJECT NO: 305001322	TEST DATE: 13/05/2024	INCLINATION: -90 degree	CORED LENGTH: <b>BOX 3 OF 4</b> <b>17.0 – 20.0m (3.0m Length)</b>
	DRILL RIG: MD300	CONTRACTOR: Traccess	LOGGED BY: SL	CHECKED BY: TH

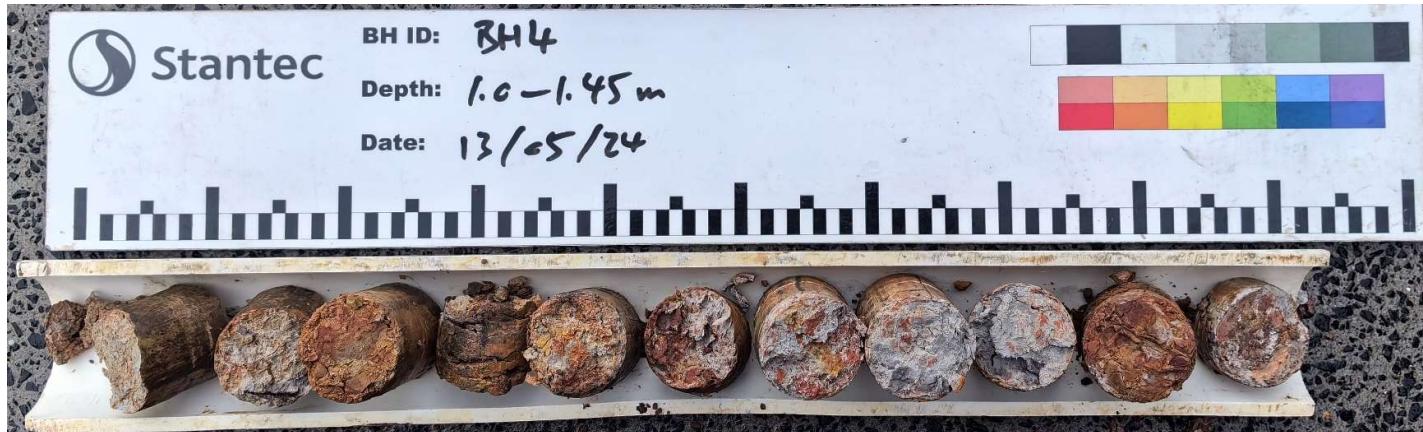
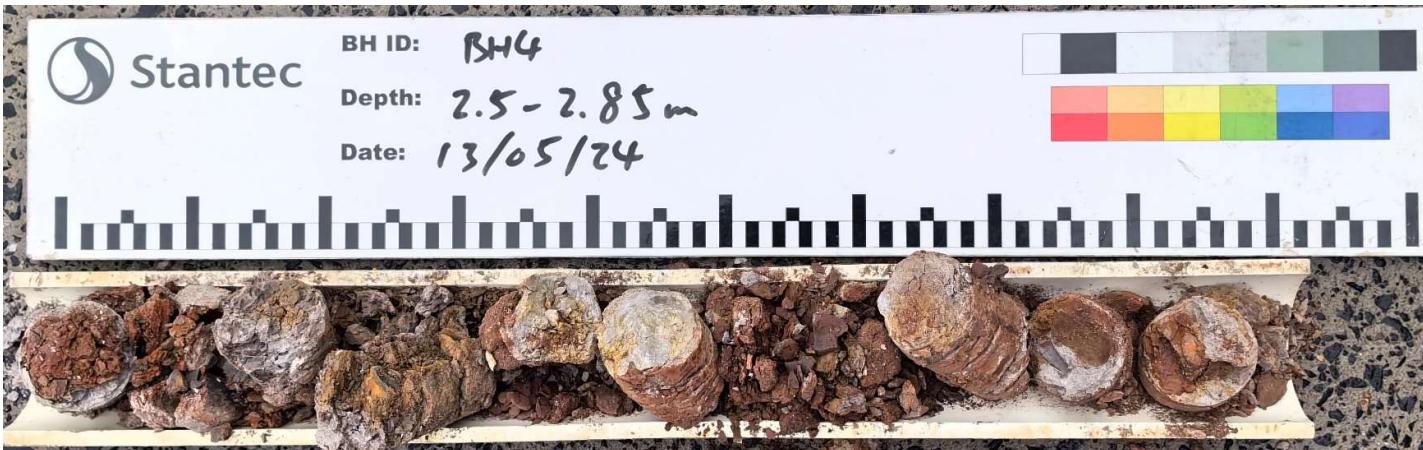
<p><b>Borehole SPT Photographs – BH4</b>  <b>27-29 Tryon Road, Lindfield</b></p>			
	PROJECT NO: <b>305001322</b>	TEST DATE: <b>13/05/2024</b>	INCLINATION: <b>-90 degree</b>	SPT PHOTOS
	DRILL RIG: <b>MD300</b>	CONTRACTOR: <b>Traccess</b>	LOGGED BY: <b>SL</b>	CHECKED BY: <b>TH</b>

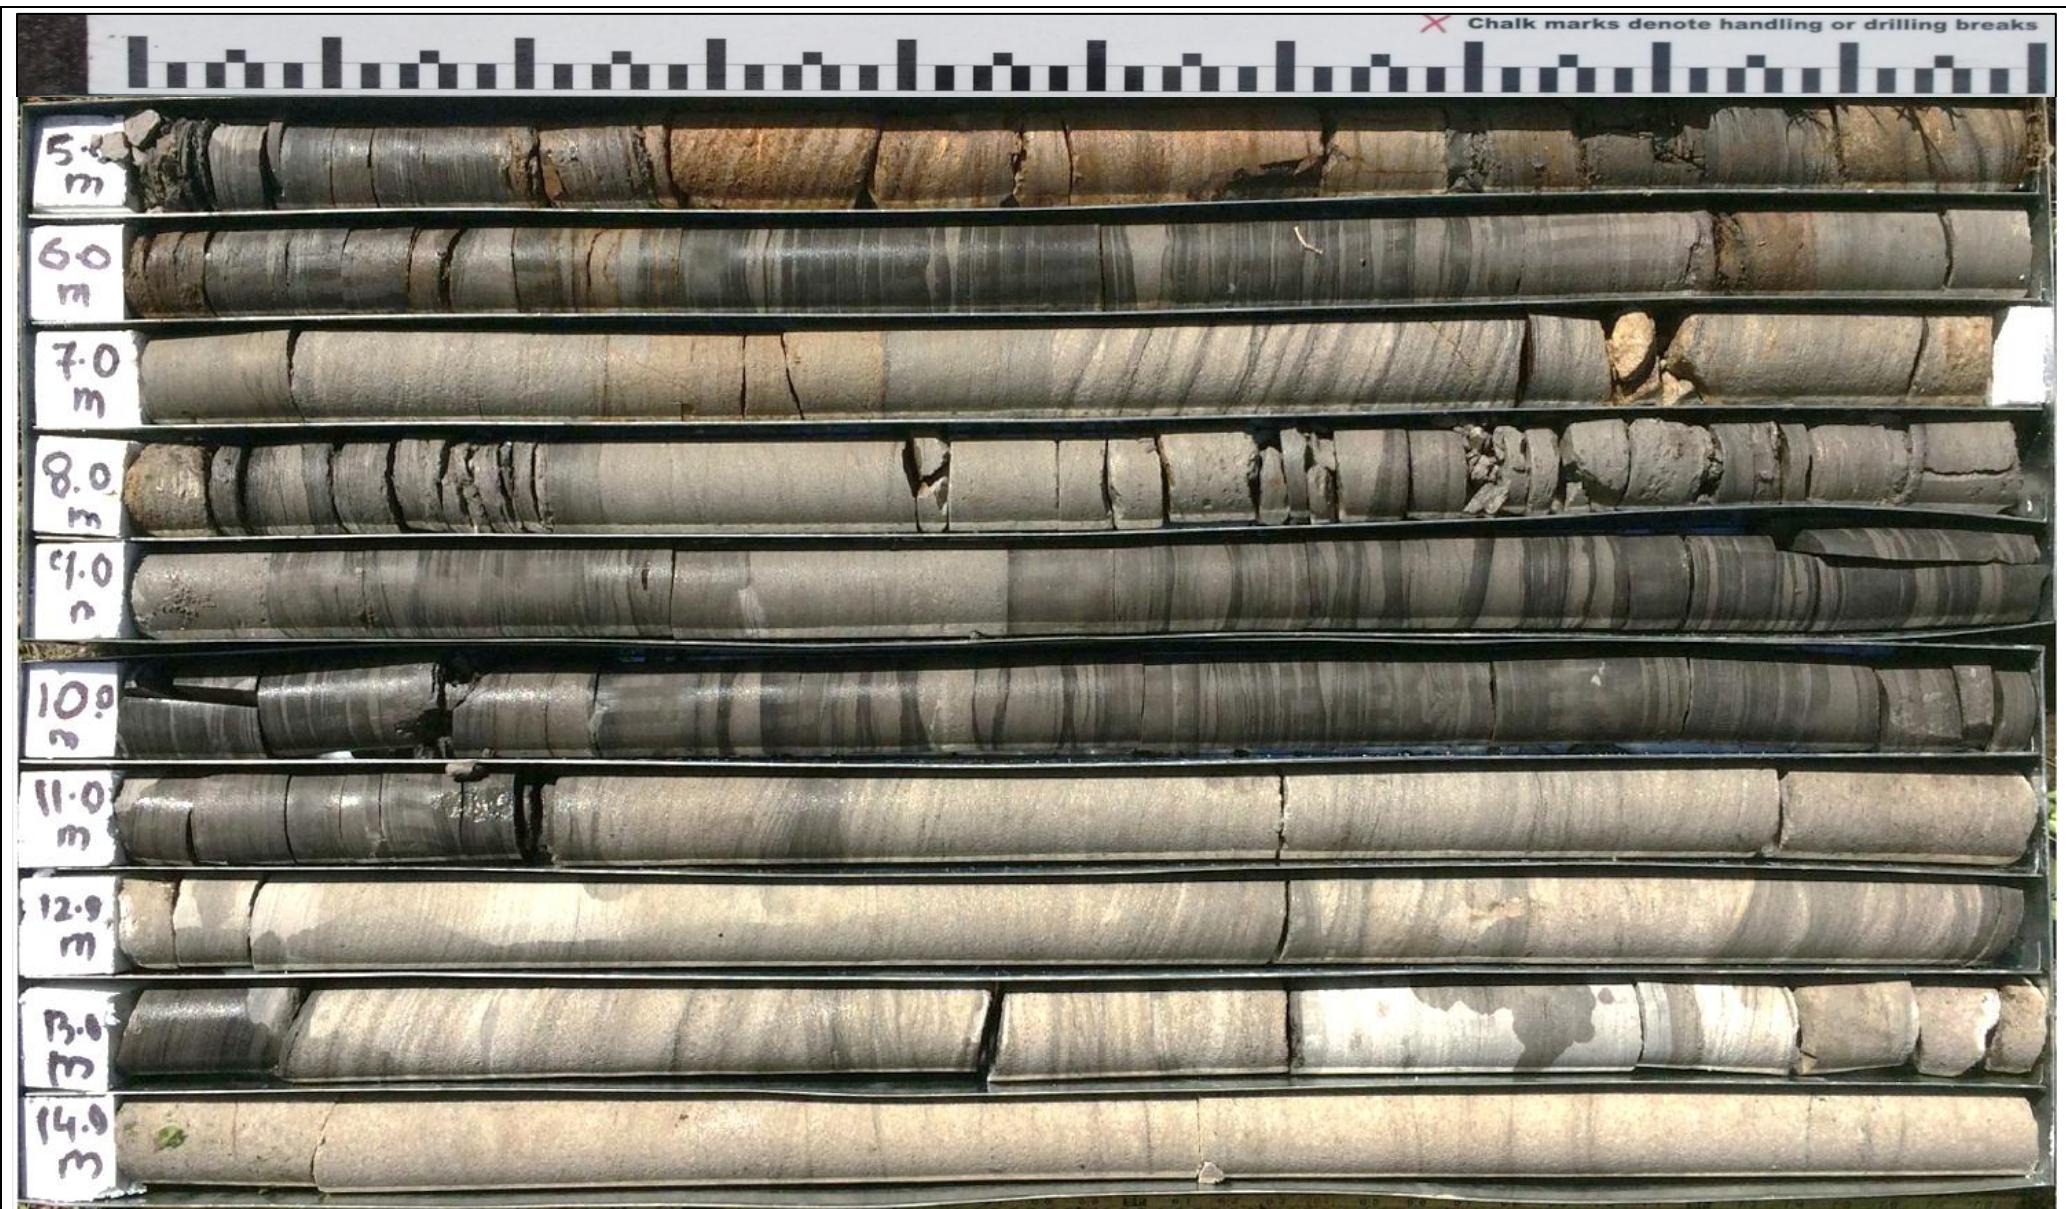
<b>ELITE GEOSCIENCES</b>	TITLE: <b>Borehole Core Photographs – 27-29 Tryon Road, Lindfield</b>			
	PROJECT NO: <b>2025002</b>	TEST DATE: <b>23-24 Jan 2025</b>	INCLINATION: <b>-90 degree</b>	CORE LENGTH: <b>5m to 15m</b>
	DRILL RIG: <b>MD300</b>	CONTRACTOR: <b>Traccess</b>	LOGGED BY: <b>AS/TH</b>	CHECKED BY: <b>TH</b>

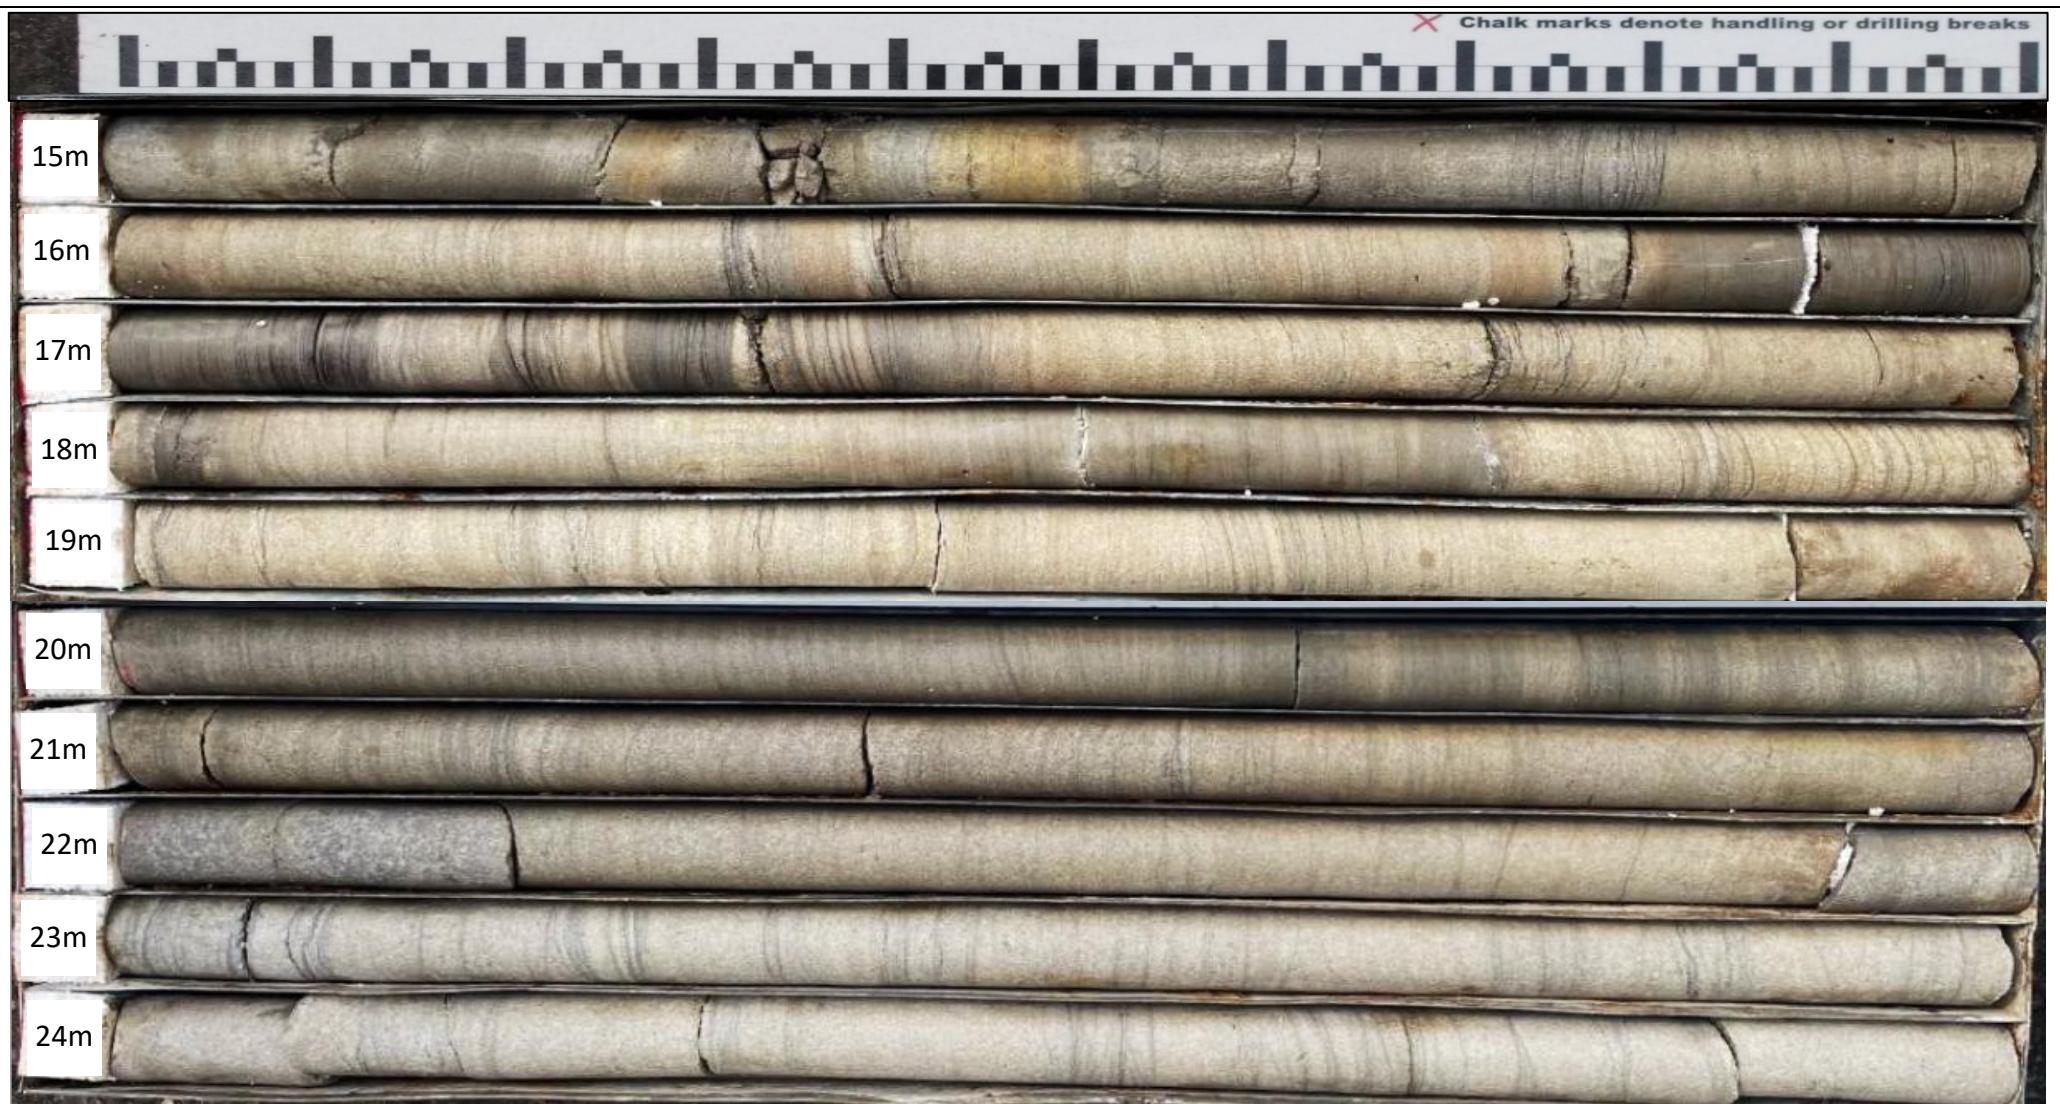
<b>ELITE GEOSCIENCES</b>	TITLE: <b>Borehole Core Photographs – 27-29 Tryon Road, Lindfield</b>			
	PROJECT NO: <b>2025002</b>	TEST DATE: <b>23-24 Jan 2025</b>	INCLINATION: <b>-90 degree</b>	CORE LENGTH: <b>15m to 25m</b>
	DRILL RIG: <b>MD300</b>	CONTRACTOR: <b>Traccess</b>	LOGGED BY: <b>AS/TH</b>	CHECKED BY: <b>TH</b>

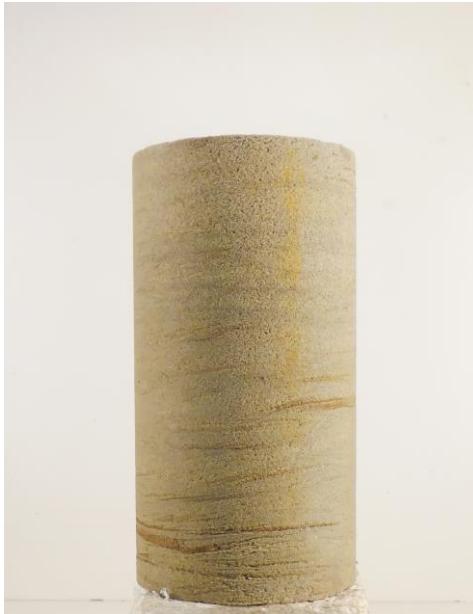
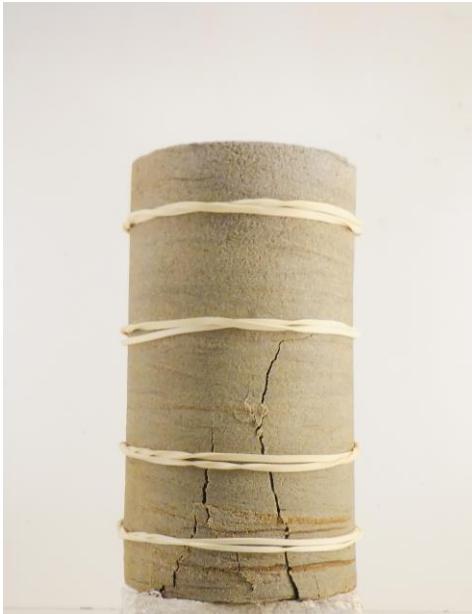
Uniaxial Compressive Strength			
Client	Stantec	Sample Source	BH1 8.80-8.94m
Address	Level 9 - The Forum, 203 Pacific Highway, St Leonards, New South Wales 2065	Sample Description	Sandstone
Project	27-29 Tryon Road Lindfield (305001322)	Report #	S96932-UCS
Job #	S24260-1	Sample #	S96932
Test Procedure	AS 4133.4.2.2 Determination of uniaxial compressive strength-Rock strength less than 50 MPa		
Sampling	Sampled by Client - results apply to the sample as received	Date Sampled	14/05/2024
Storage History	Sealed	Storage Environment	Sealed at as received moisture condition
Sample Curing	-	Testing Machine	Matest 2000 kN Compression Machine

<b>Uniaxial Compressive Strength</b>		<b>7.3</b>	<b>MPa</b>
Date Tested:	7/06/2024	Moisture Content:	9.5 %
Specimen Height:	141.4 mm	Duration of Test:	680 seconds
Average Specimen Diameter:	63.2 mm	Rate of Displacement:	< 0.1 mm/min
Failure Type:	Mixed mode		
Other Pertinent Observations:

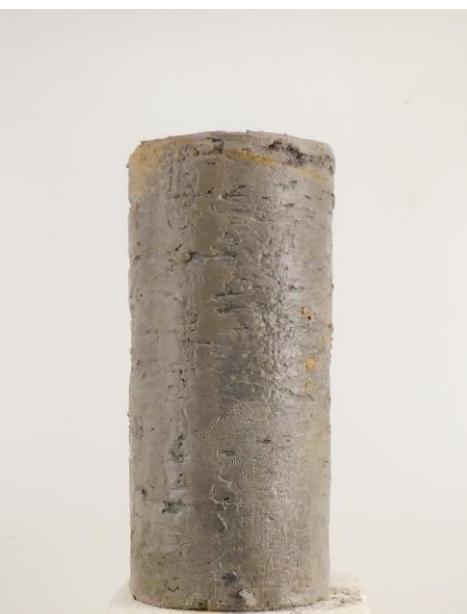
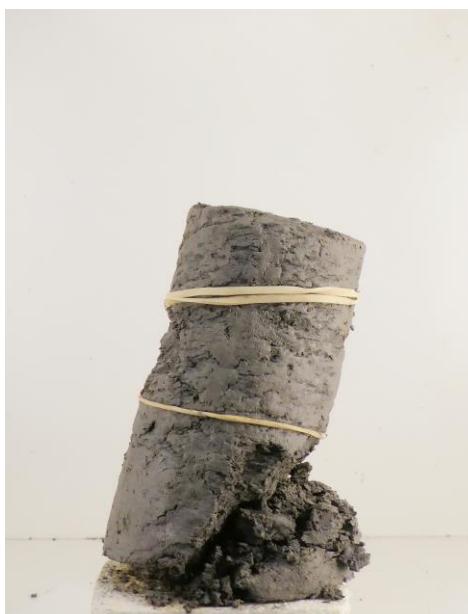
Uniaxial Compressive Strength			
Client	Stantec	Sample Source	BH2 6.10-6.30m
Address	Level 9 - The Forum, 203 Pacific Highway, St Leonards, New South Wales 2065	Sample Description	Claystone
Project	27-29 Tryon Road Lindfield (305001322)	Report #	S96933-UCS
Job #	S24260-1	Sample #	S96933
Test Procedure	AS 4133.4.2.2 Determination of uniaxial compressive strength-Rock strength less than 50 MPa		
Sampling	Sampled by Client - results apply to the sample as received	Date Sampled	15/05/2024
Storage History	Sealed	Storage Environment	Sealed at as received moisture condition
Sample Curing	-	Testing Machine	Matest 2000 kN Compression Machine

<b>Uniaxial Compressive Strength    0.22    MPa</b>			
Date Tested:	8/06/2024	Moisture Content:	11.2 %
Specimen Height:	137.6 mm	Duration of Test:	843 seconds
Average Specimen Diameter:	52.0 mm	Rate of Displacement:	< 0.1 mm/min
Failure Type:	Mixed mode		
Other Pertinent Observations:

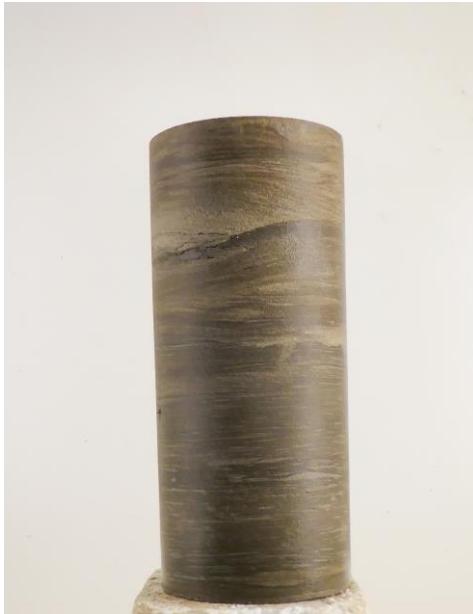
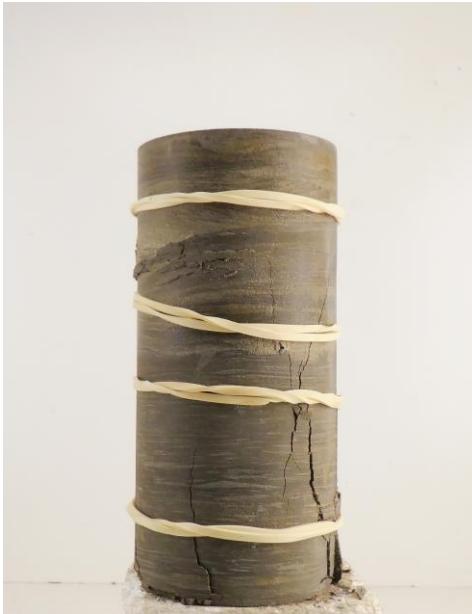
Uniaxial Compressive Strength			
Client	Stantec	Sample Source	BH3 7.11-7.36m
Address	Level 9 - The Forum, 203 Pacific Highway, St Leonards, New South Wales 2065	Sample Description	Shale
Project	27-29 Tryon Road Lindfield (305001322)	Report #	S96934-UCS
Job #	S24260-1	Sample #	S96934
Test Procedure	AS 4133.4.2.2 Determination of uniaxial compressive strength-Rock strength less than 50 MPa		
Sampling	Sampled by Client - results apply to the sample as received	Date Sampled	14/05/2024
Storage History	Sealed	Storage Environment	Sealed at as received moisture condition
Sample Curing	-	Testing Machine	Matest 2000 kN Compression Machine

<b>Uniaxial Compressive Strength</b> <b>16</b> <b>MPa</b>			
Date Tested:	11/06/2024	Moisture Content:	3.8 %
Specimen Height:	139.3 mm	Duration of Test:	685 seconds
Average Specimen Diameter:	51.8 mm	Rate of Displacement:	< 0.1 mm/min
Failure Type:	Mixed mode		
Other Pertinent Observations:

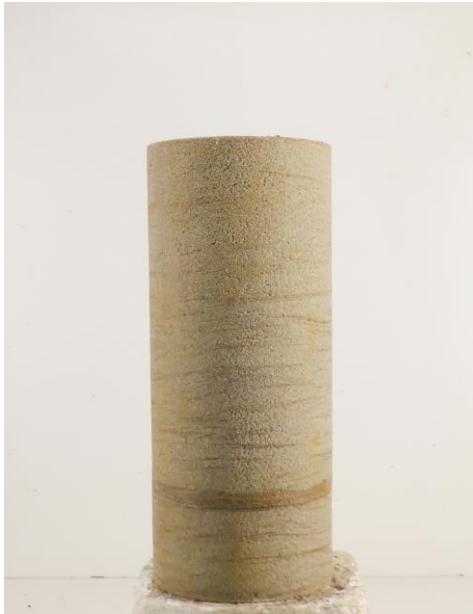
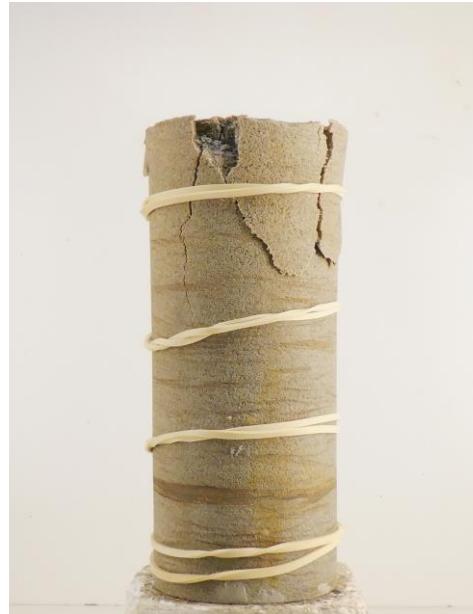
Uniaxial Compressive Strength			
Client	Stantec	Sample Source	BH4 7.36-7.59m
Address	Level 9 - The Forum, 203 Pacific Highway, St Leonards, New South Wales 2065	Sample Description	Sandstone
Project	27-29 Tryon Road Lindfield (305001322)	Report #	S96935-UCS
Job #	S24260-1	Sample #	S96935
Test Procedure	AS 4133.4.2.2 Determination of uniaxial compressive strength-Rock strength less than 50 MPa		
Sampling	Sampled by Client - results apply to the sample as received	Date Sampled	13/05/2024
Storage History	Sealed	Storage Environment	Sealed at as received moisture condition
Sample Curing	-	Testing Machine	Matest 2000 kN Compression Machine

<b>Uniaxial Compressive Strength</b>		<b>13</b>	<b>MPa</b>
Date Tested:	7/06/2024	Moisture Content:	8.8 %
Specimen Height:	144.2 mm	Duration of Test:	680 seconds
Average Specimen Diameter:	51.6 mm	Rate of Displacement:	< 0.1 mm/min
Failure Type:	Mixed mode		
Other Pertinent Observations:

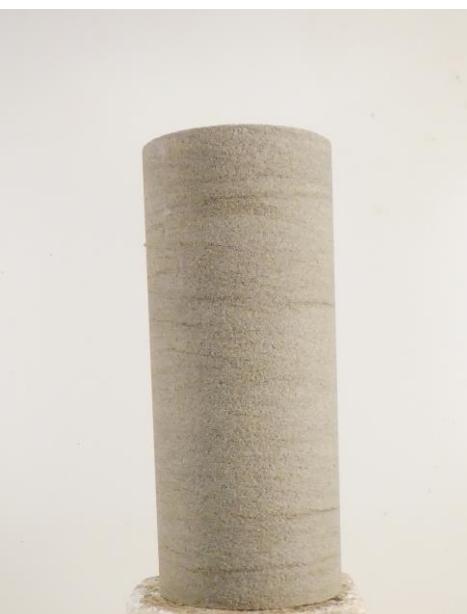
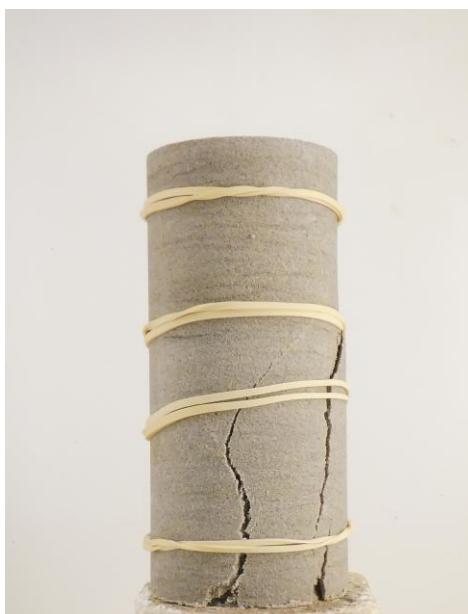
Uniaxial Compressive Strength			
Client	Stantec	Sample Source	BH4 11.00-11.27m
Address	Level 9 - The Forum, 203 Pacific Highway, St Leonards, New South Wales 2065	Sample Description	Sandstone
Project	27-29 Tryon Road Lindfield (305001322)	Report #	S96936-UCS
Job #	S24260-1	Sample #	S96936
Test Procedure	AS 4133.4.2.2 Determination of uniaxial compressive strength-Rock strength less than 50 MPa		
Sampling	Sampled by Client - results apply to the sample as received	Date Sampled	13/05/2024
Storage History	Sealed	Storage Environment	Sealed at as received moisture condition
Sample Curing	-	Testing Machine	Matest 2000 kN Compression Machine

<b>Uniaxial Compressive Strength</b>		<b>24</b>	<b>MPa</b>
Date Tested:	7/06/2024	Moisture Content:	5.2 %
Specimen Height:	142.8 mm	Duration of Test:	688 seconds
Average Specimen Diameter:	51.7 mm	Rate of Displacement:	< 0.1 mm/min
Failure Type:	Mixed mode		
Other Pertinent Observations:
