# Geotechnical Investigation

2-4 Giffnock Avenue, Macquarie Park NSW

Report No: E26706.G03\_Rev2

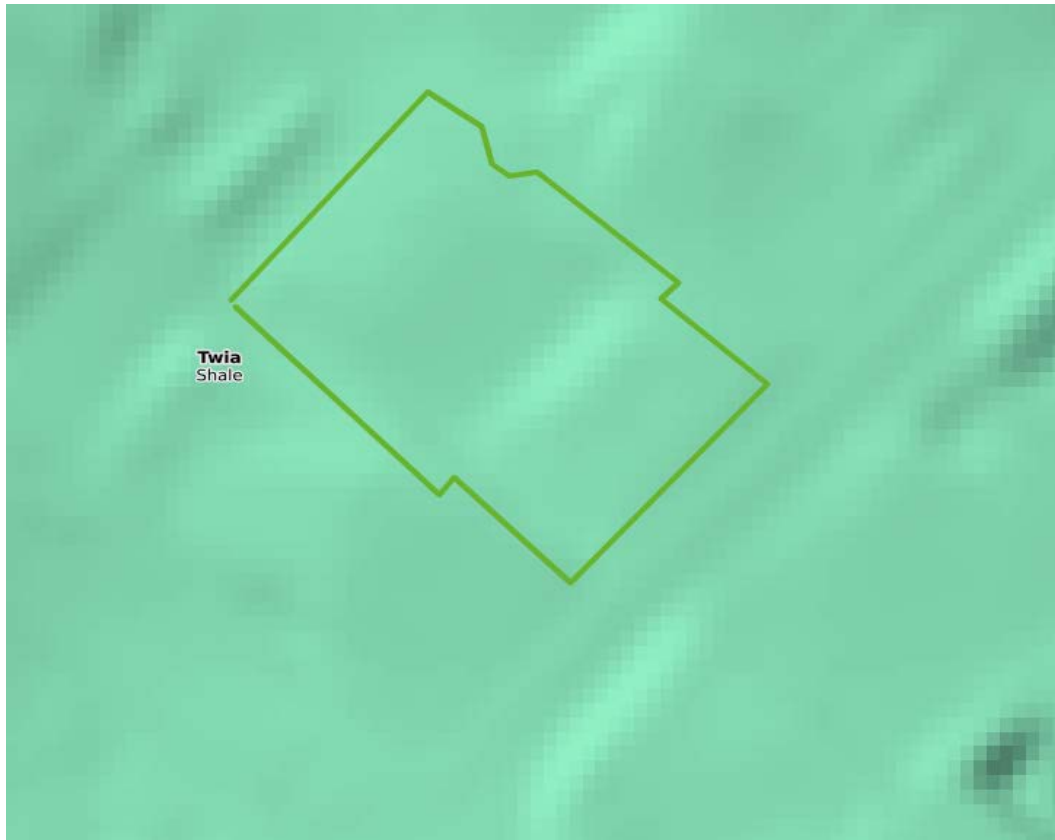
**Plate 2** Excerpt of geological map showing location of site.

| Attribute | Description |
|---|---|
| <b>Regional Geology</b> | Information on regional sub – surface conditions , referenced from the NSW Seamless Geology dataset (Colquhoun et al., 2024, corresponding to the Sydney 1:100, 000 Geological Series Sheet) indicates the site to be underlain by Ashfield Shale (Twia) Which typically comprises dark-grey to black claystone-siltstone and fine sandstone – siltstone laminate. |

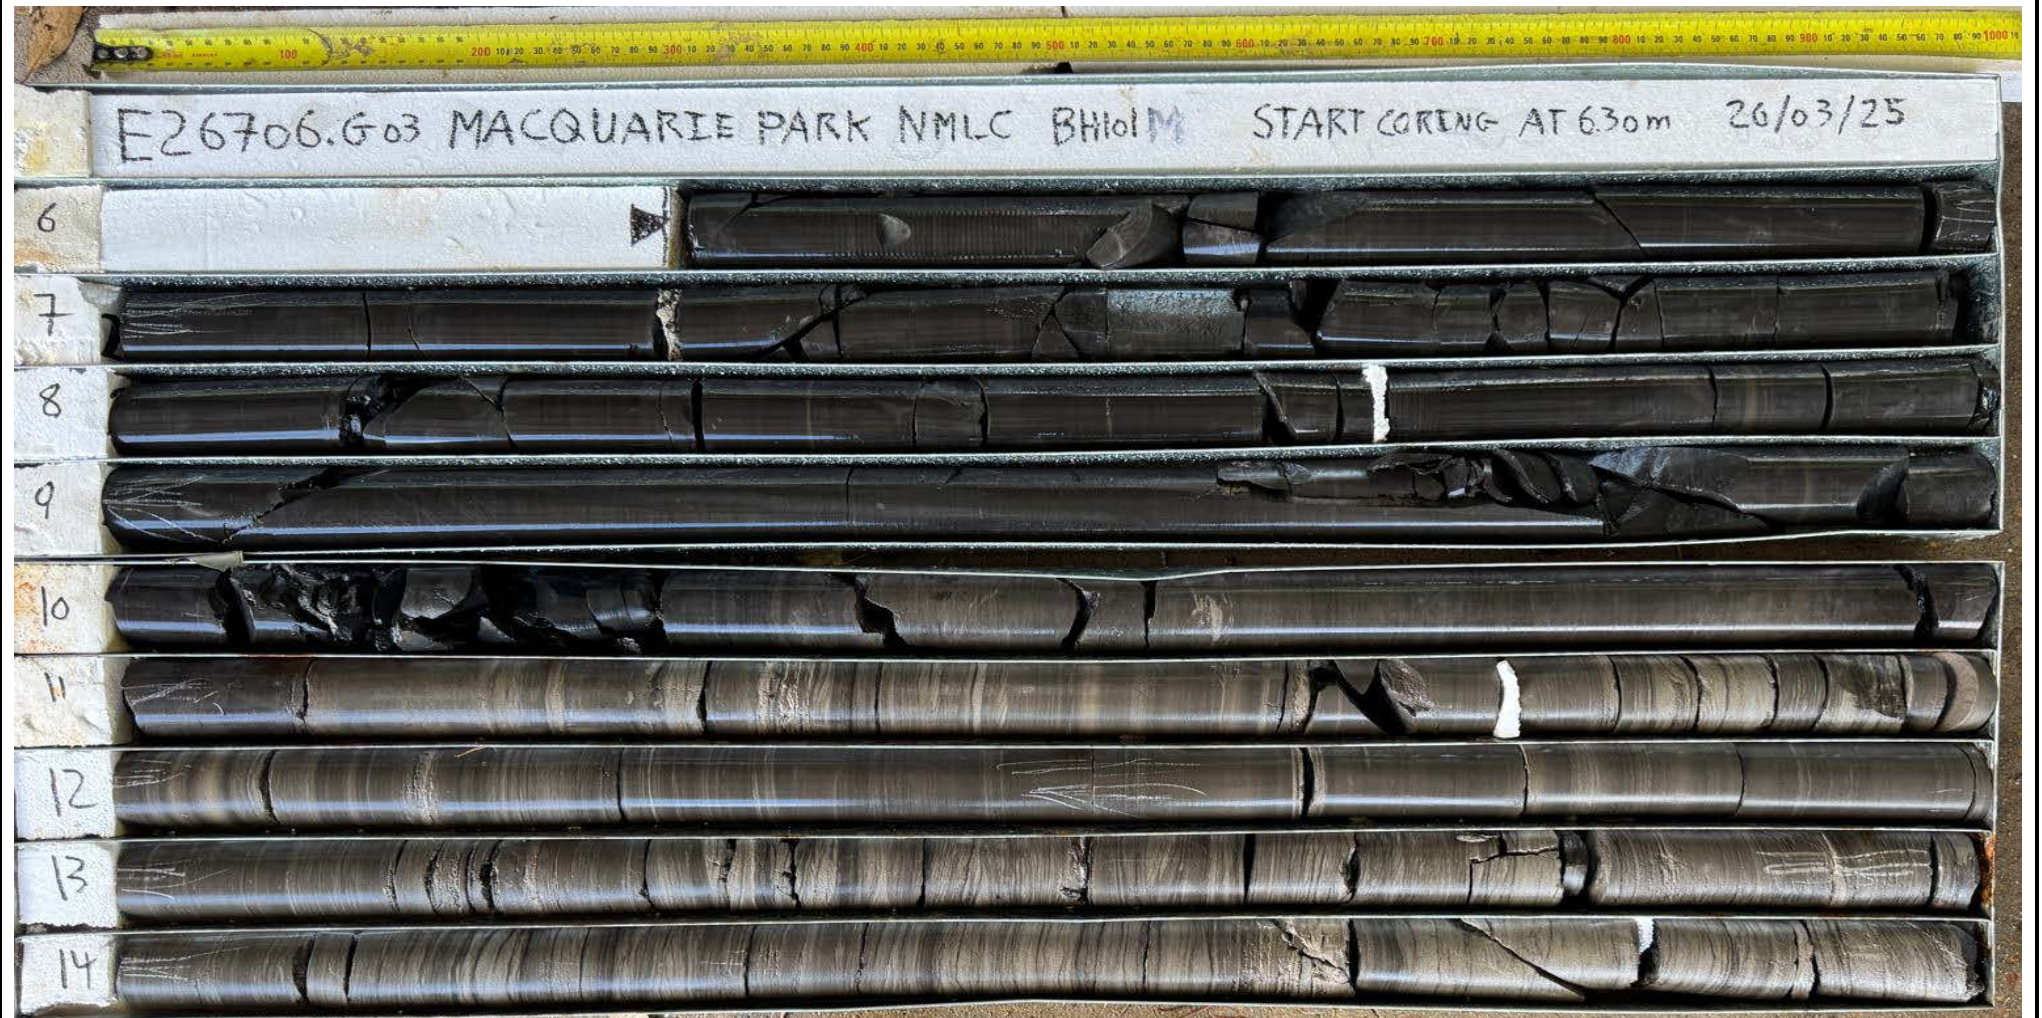
## CORE PHOTOGRAPH OF BOREHOLE: BH101M

| <b>Project</b> | Proposed Development | <b>East</b> | - | <b>Depth Range</b> | 15.0m to 25.0m | |

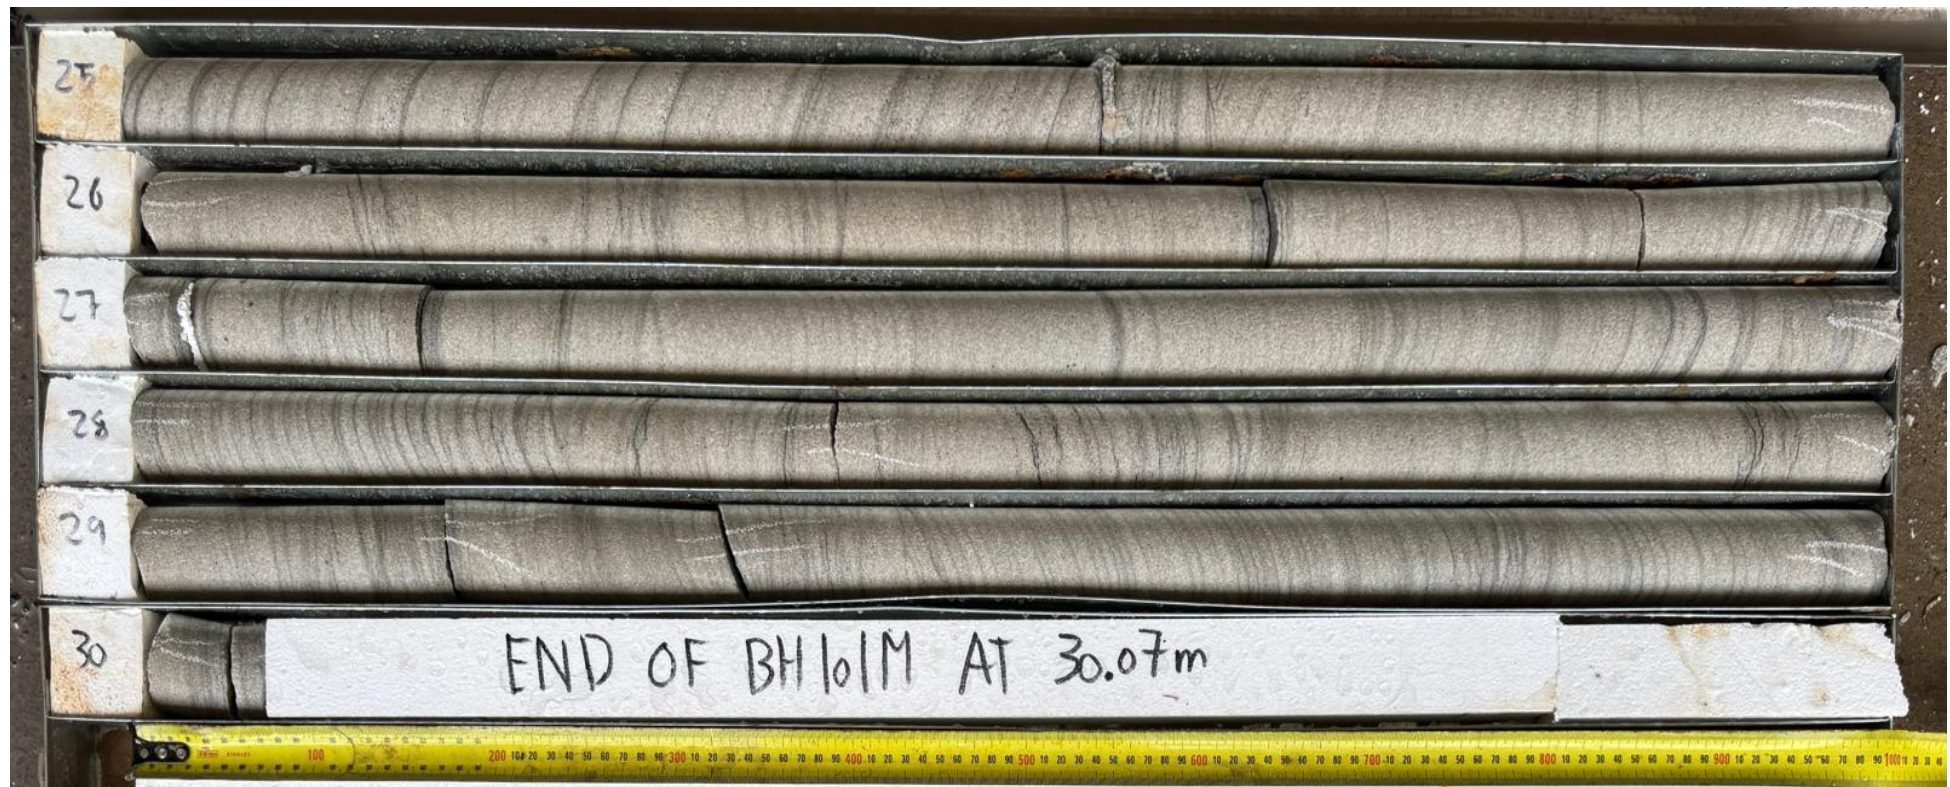
## CORE PHOTOGRAPH OF BOREHOLE: BH101M

| <b>Project</b> | Proposed Development | <b>East</b> | - | <b>Depth Range</b> | 25m to 30.07m | |

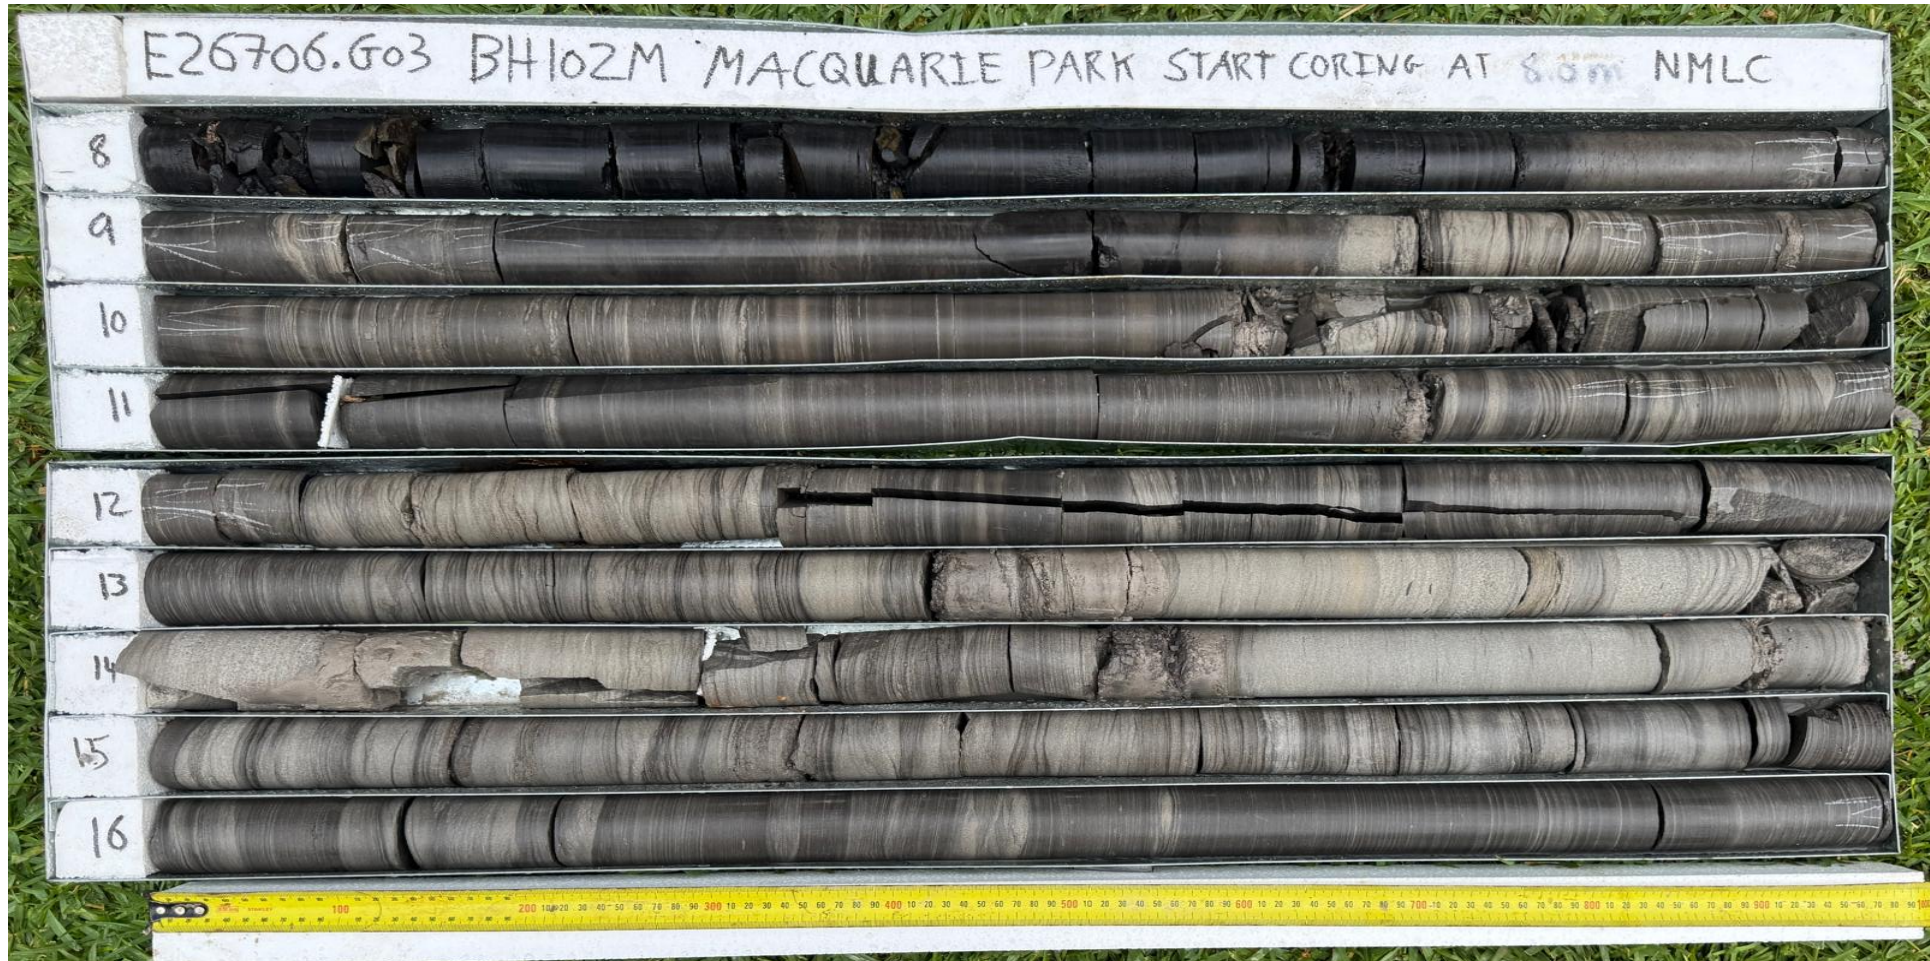
## CORE PHOTOGRAPH OF BOREHOLE: BH102M

| <b>Project</b> | Proposed Development | <b>East</b> | - | <b>Depth Range</b> | 0.39m to 6.38m | |

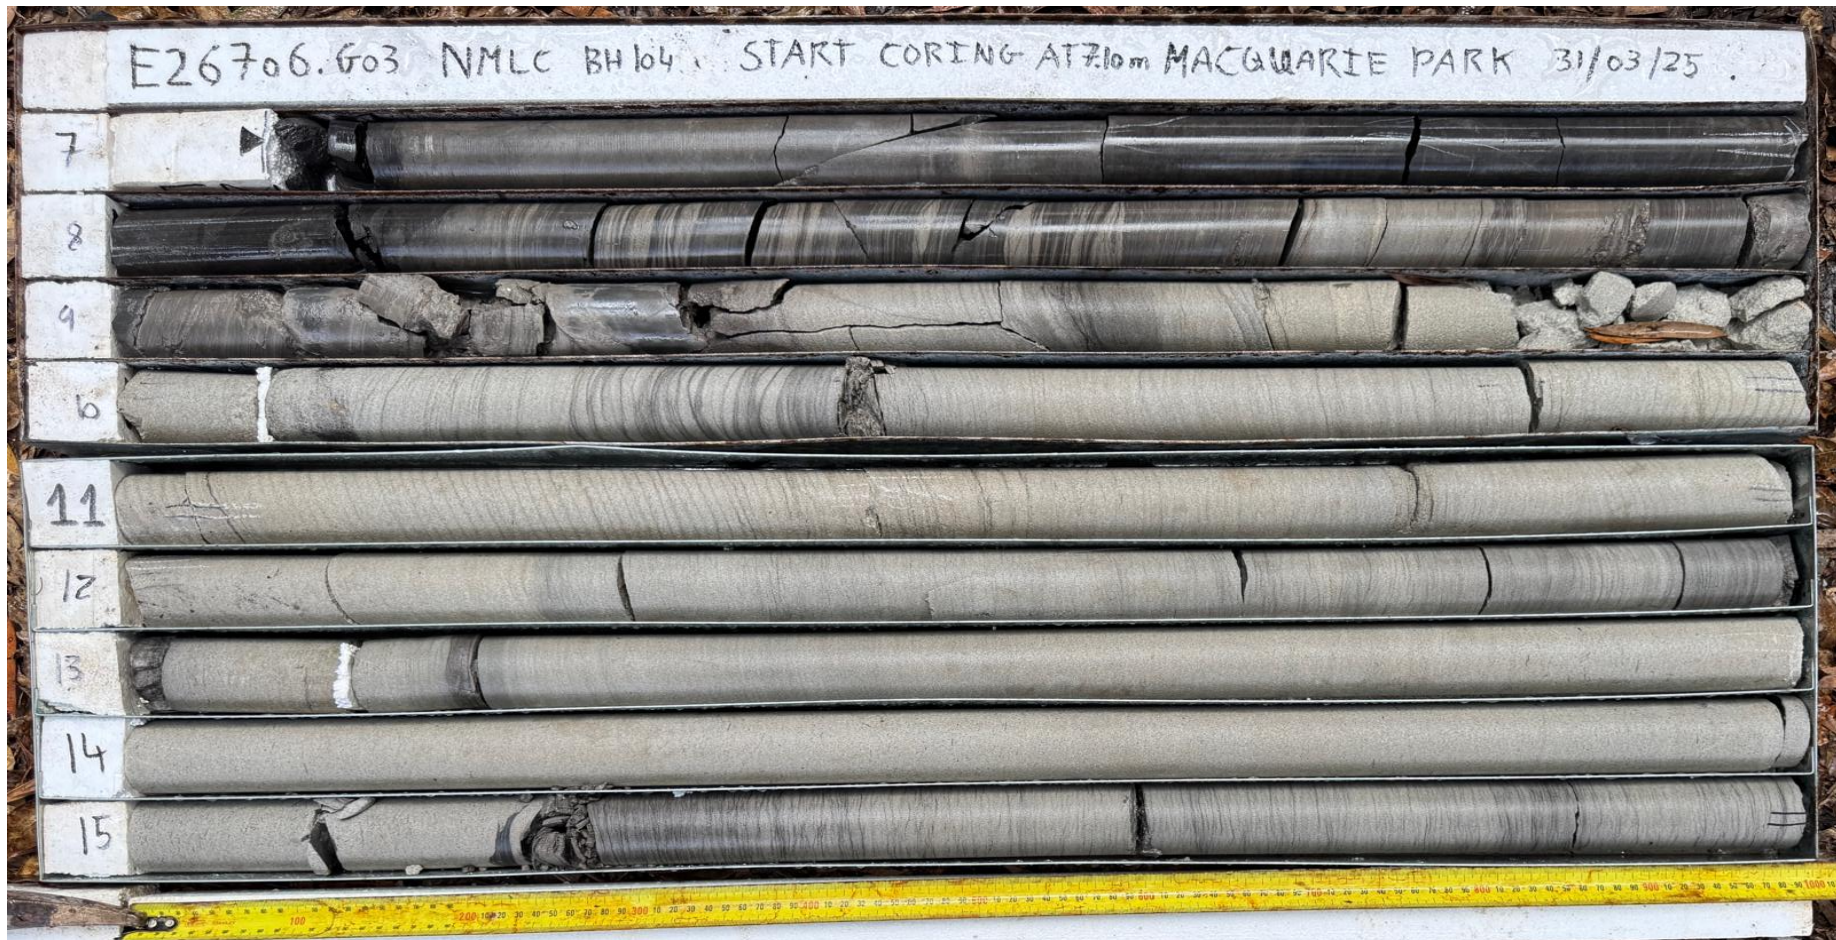
## CORE PHOTOGRAPH OF BOREHOLE: BH104

| <b>Project</b> | Proposed Development | <b>East</b> | - | <b>Depth Range</b> | 16.0m to 20.94m |

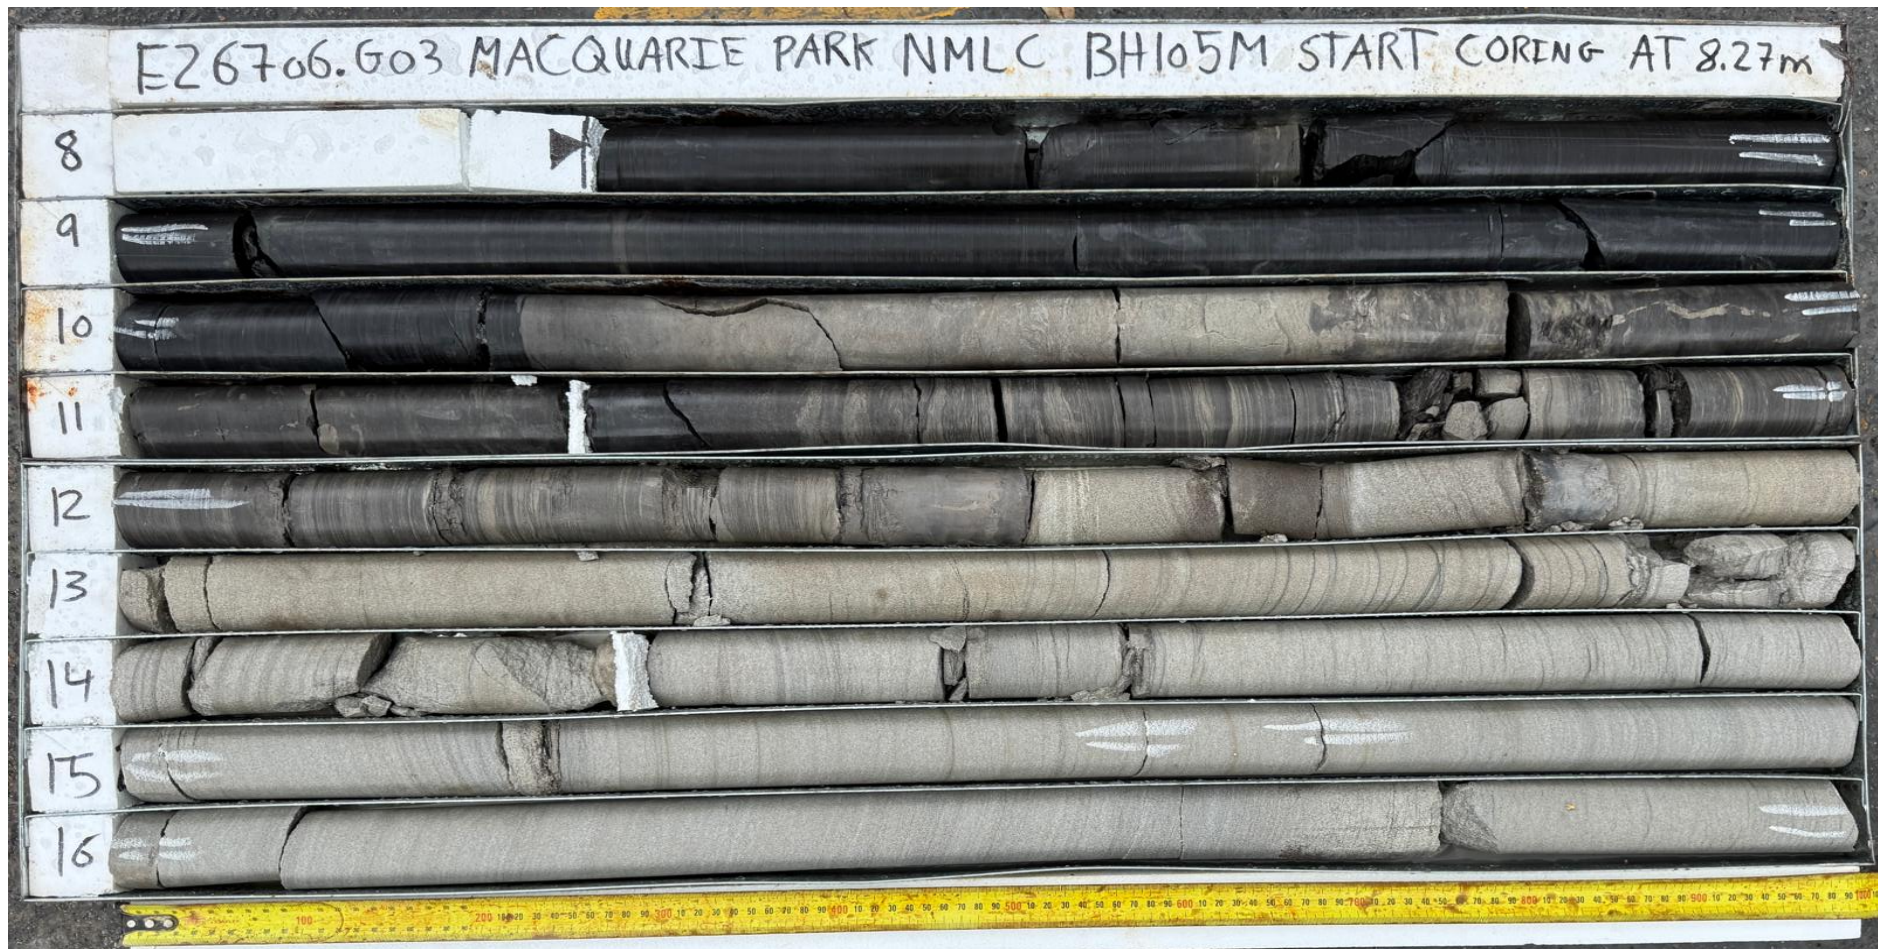
## CORE PHOTOGRAPH OF BOREHOLE: BH105M

| <b>Project</b> | Proposed Development | <b>East</b> | - | <b>Depth Range</b> | 17.0m to 20.31m | |

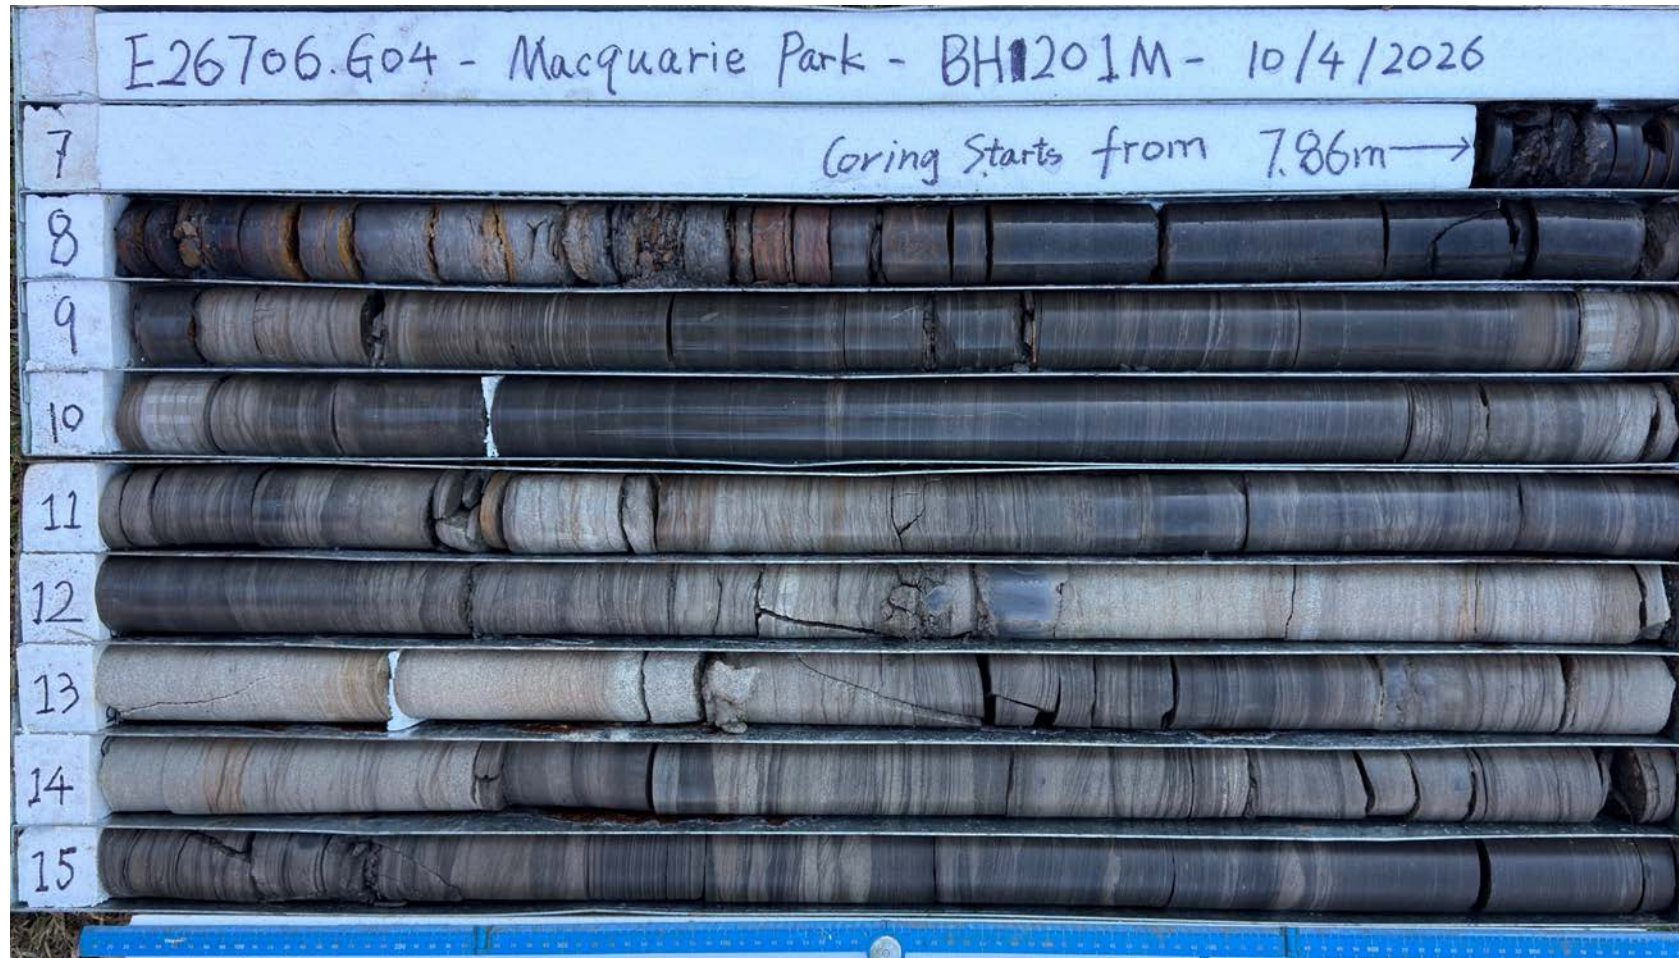
## CORE PHOTOGRAPH OF BOREHOLE: BH201M

| <b>Project</b> | Proposed Development | <b>East</b> | - | <b>Depth Range</b> | 16m to 26m | | |

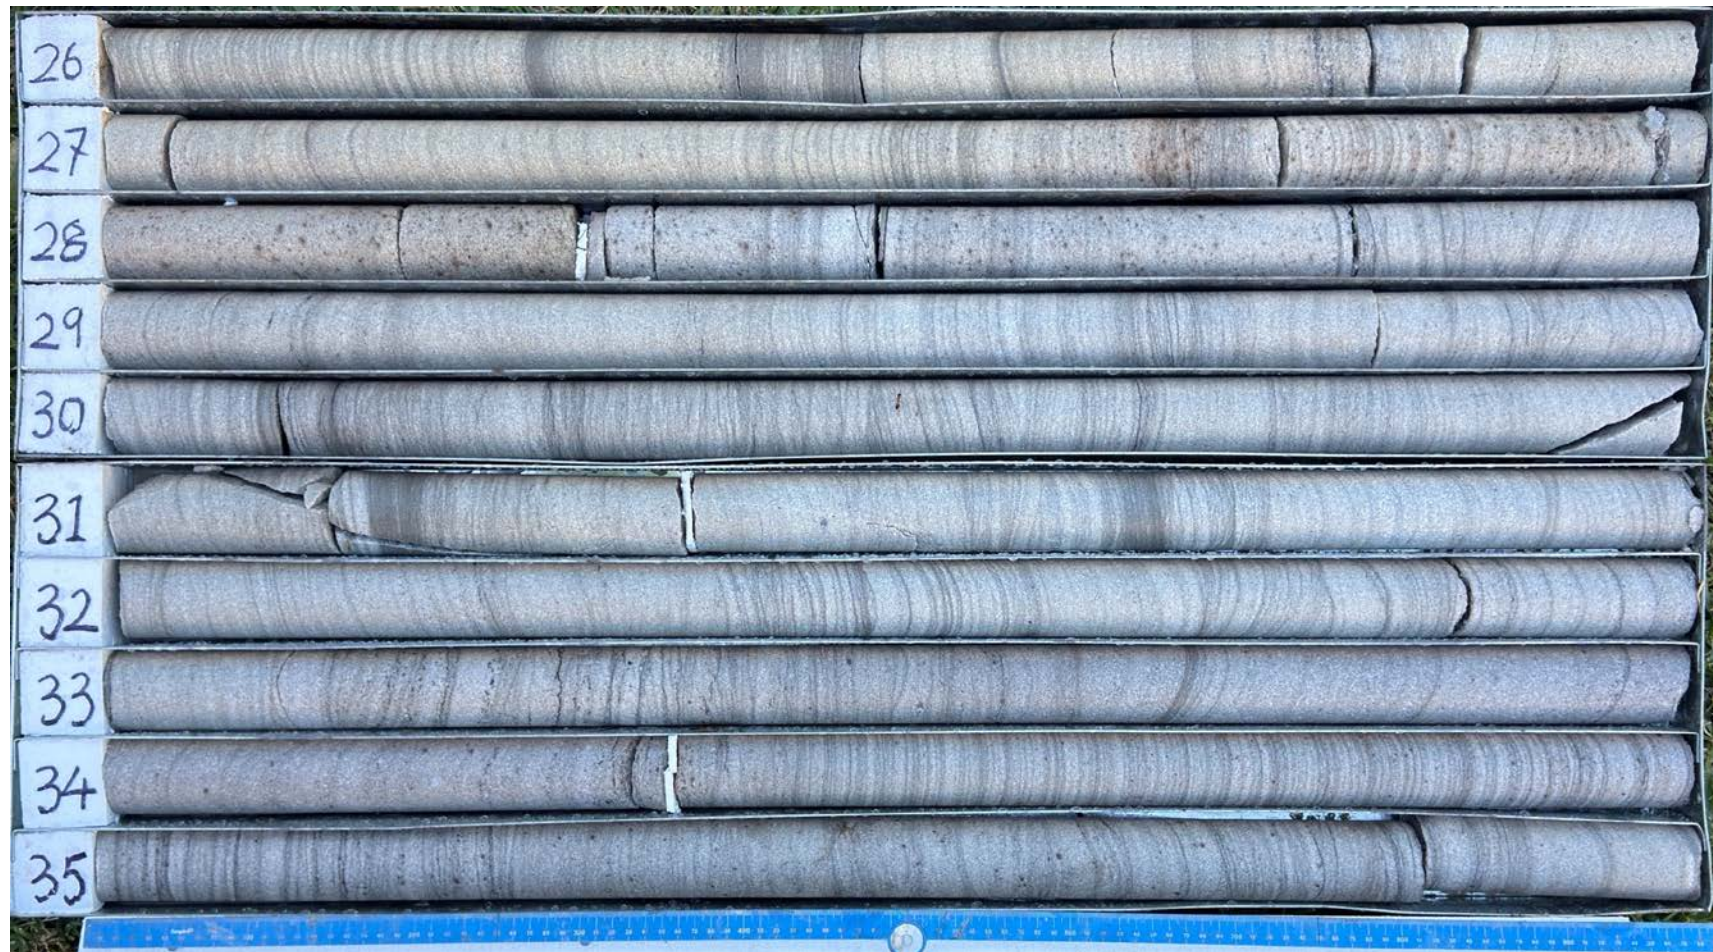
## CORE PHOTOGRAPH OF BOREHOLE: BH201M

| <b>Project</b> | Proposed Development | <b>East</b> | - | <b>Depth Range</b> | 26m to 36m | |

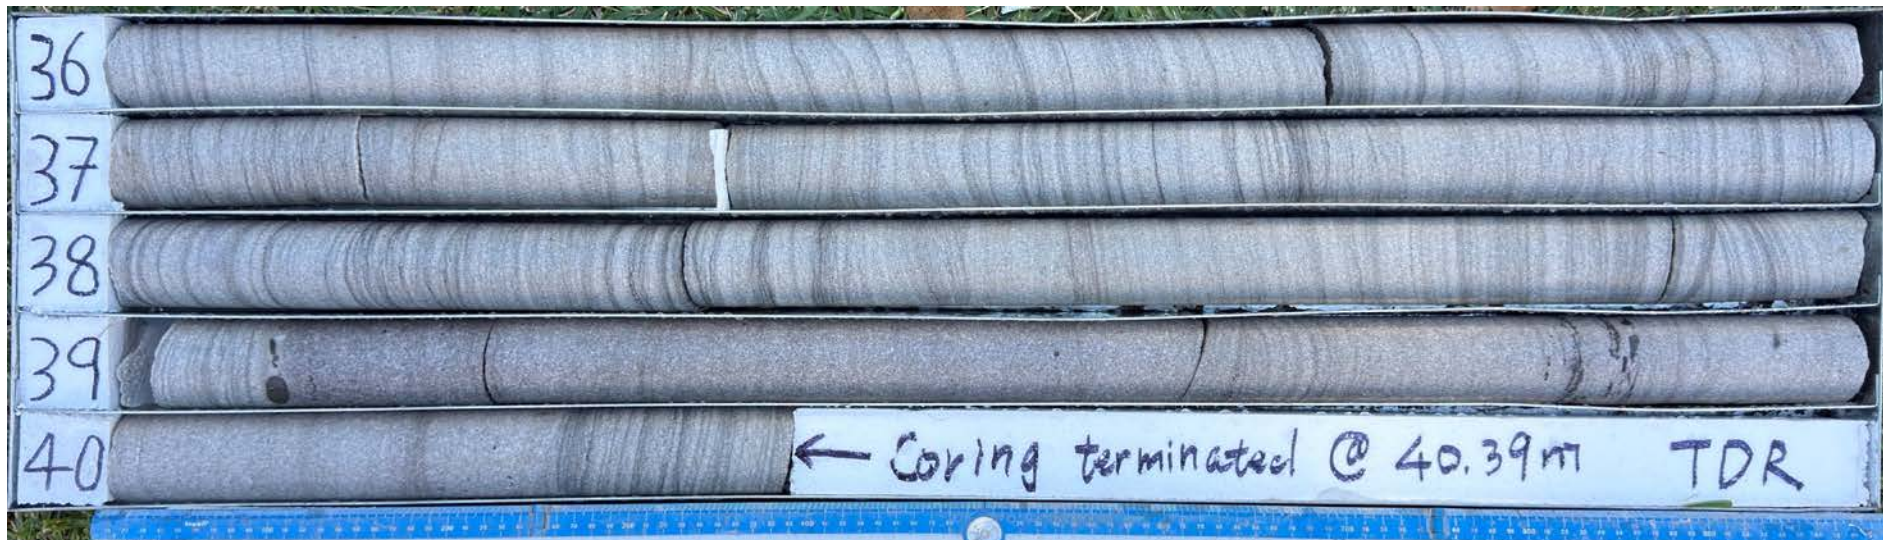
## CORE PHOTOGRAPH OF BOREHOLE: BH201M

| <b>Project</b> | Proposed Development | <b>East</b> | - | <b>Depth Range</b> | 36m to 40.39m |
