**REPORT TO
PYMBLE LADIES COLLEGE**

**ON
GEOTECHNICAL INVESTIGATION**

**FOR
PROPOSED SECONDARY INNOVATION PRECINCT
AND CAMPUS COMMONS**

**AT
AVON ROAD, PYMBLE, NSW**

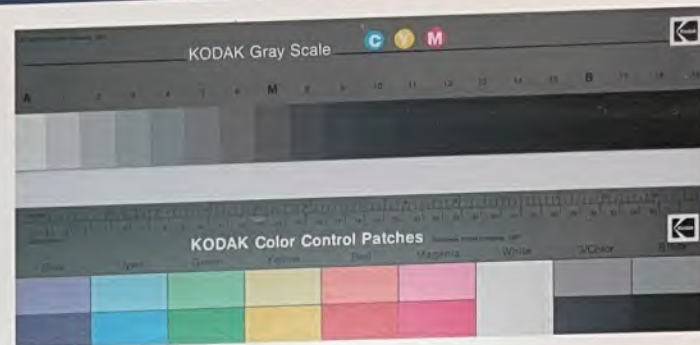
Job No: 34901BC
Borehole No: BHI
Depth: 5.80m - 13.16m

34901BC BHI CORING STARTS AT 5.8m

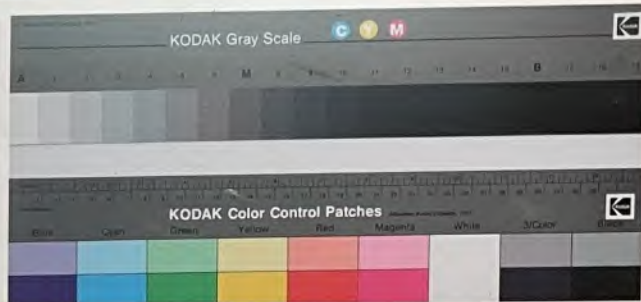
Borehole No: BH2

34901BC BH2 CORING STARTS AT 4.48m

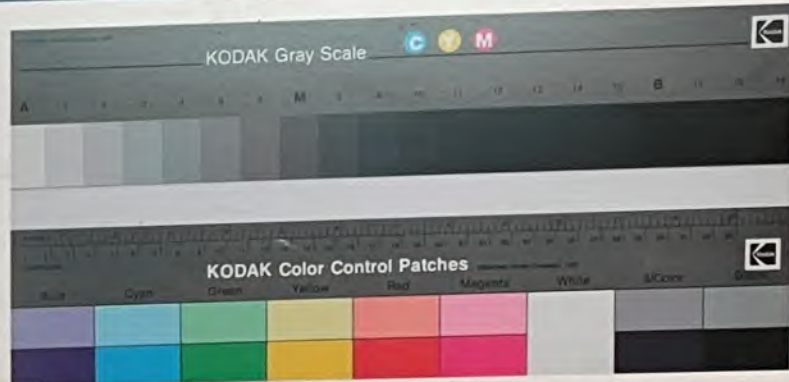
Job No: 34901BC
Borehole No: BH3
Depth: 7.20m - 10.32m

34901BC , BH3 , CORING STARTS AT 7.20m

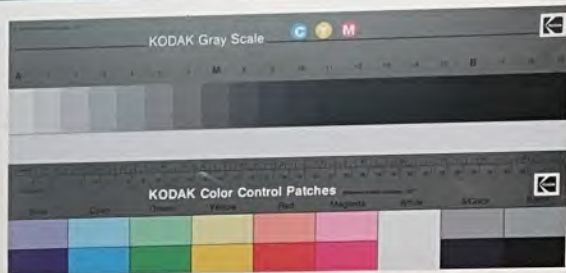
Job No: 34901BC
Borehole No: BH4
Depth: 7.36m - 10.36m

34901BC BH4 CORING STARTS AT 7.30m
