# TREE SURVEY

ARBORICULTURAL IMPACT ASSESSMENT & TREE PROTECTION PLAN

**Pymble Ladies College (PLC)**  
**Secondary Innovation Precinct and Campus Commons**  
Version 7

29 May 2025

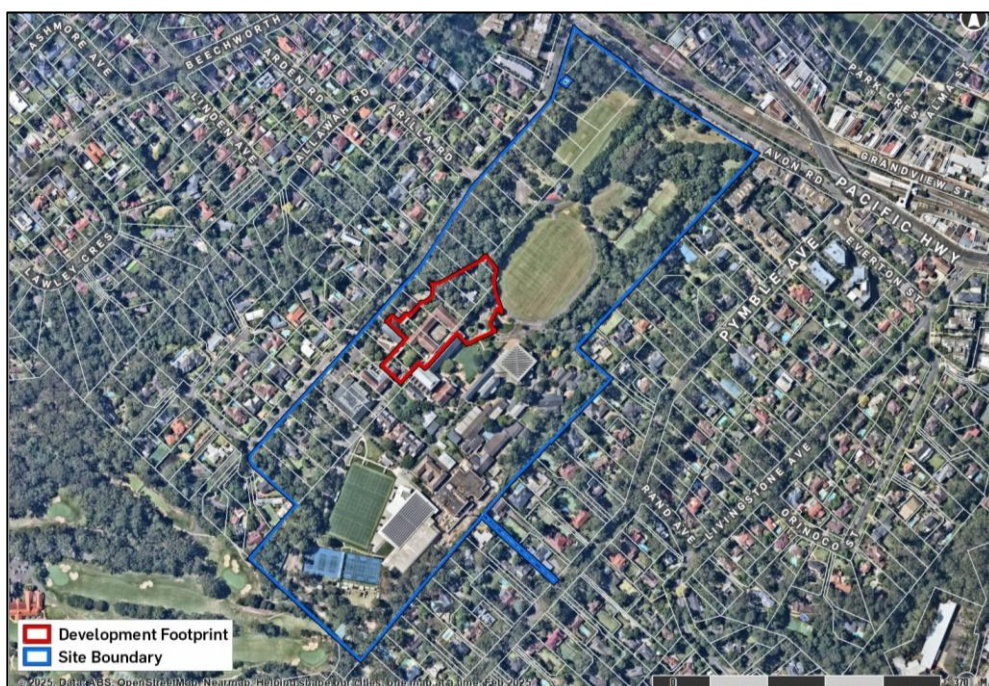
The site and proposed work areas are identified in the figure below.

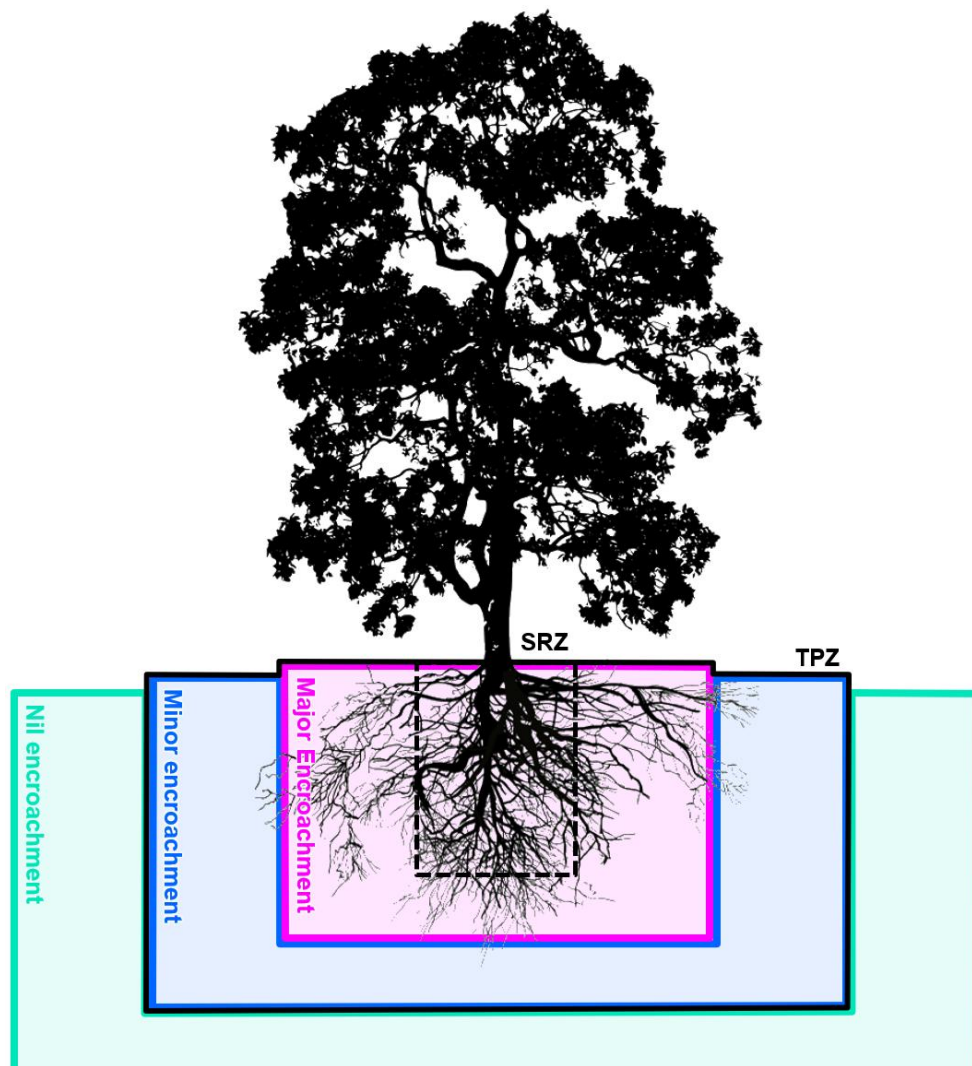
Encroachment within the TPZ is acceptable, providing that the arborist can demonstrate that the tree will remain viable. There are three (3) levels of encroachment defined by AS4970.

Table 3: Levels of encroachment

| Nil encroachment (0%) | Nil encroachment within the TPZ. |
| Minor encroachment (<10%) | The encroachment is less than 10% of the TPZ. |
| Major encroachment (>10%) | The encroachment is greater than 10% of the TPZ. |

Figure 1: Three (3) levels of encroachment

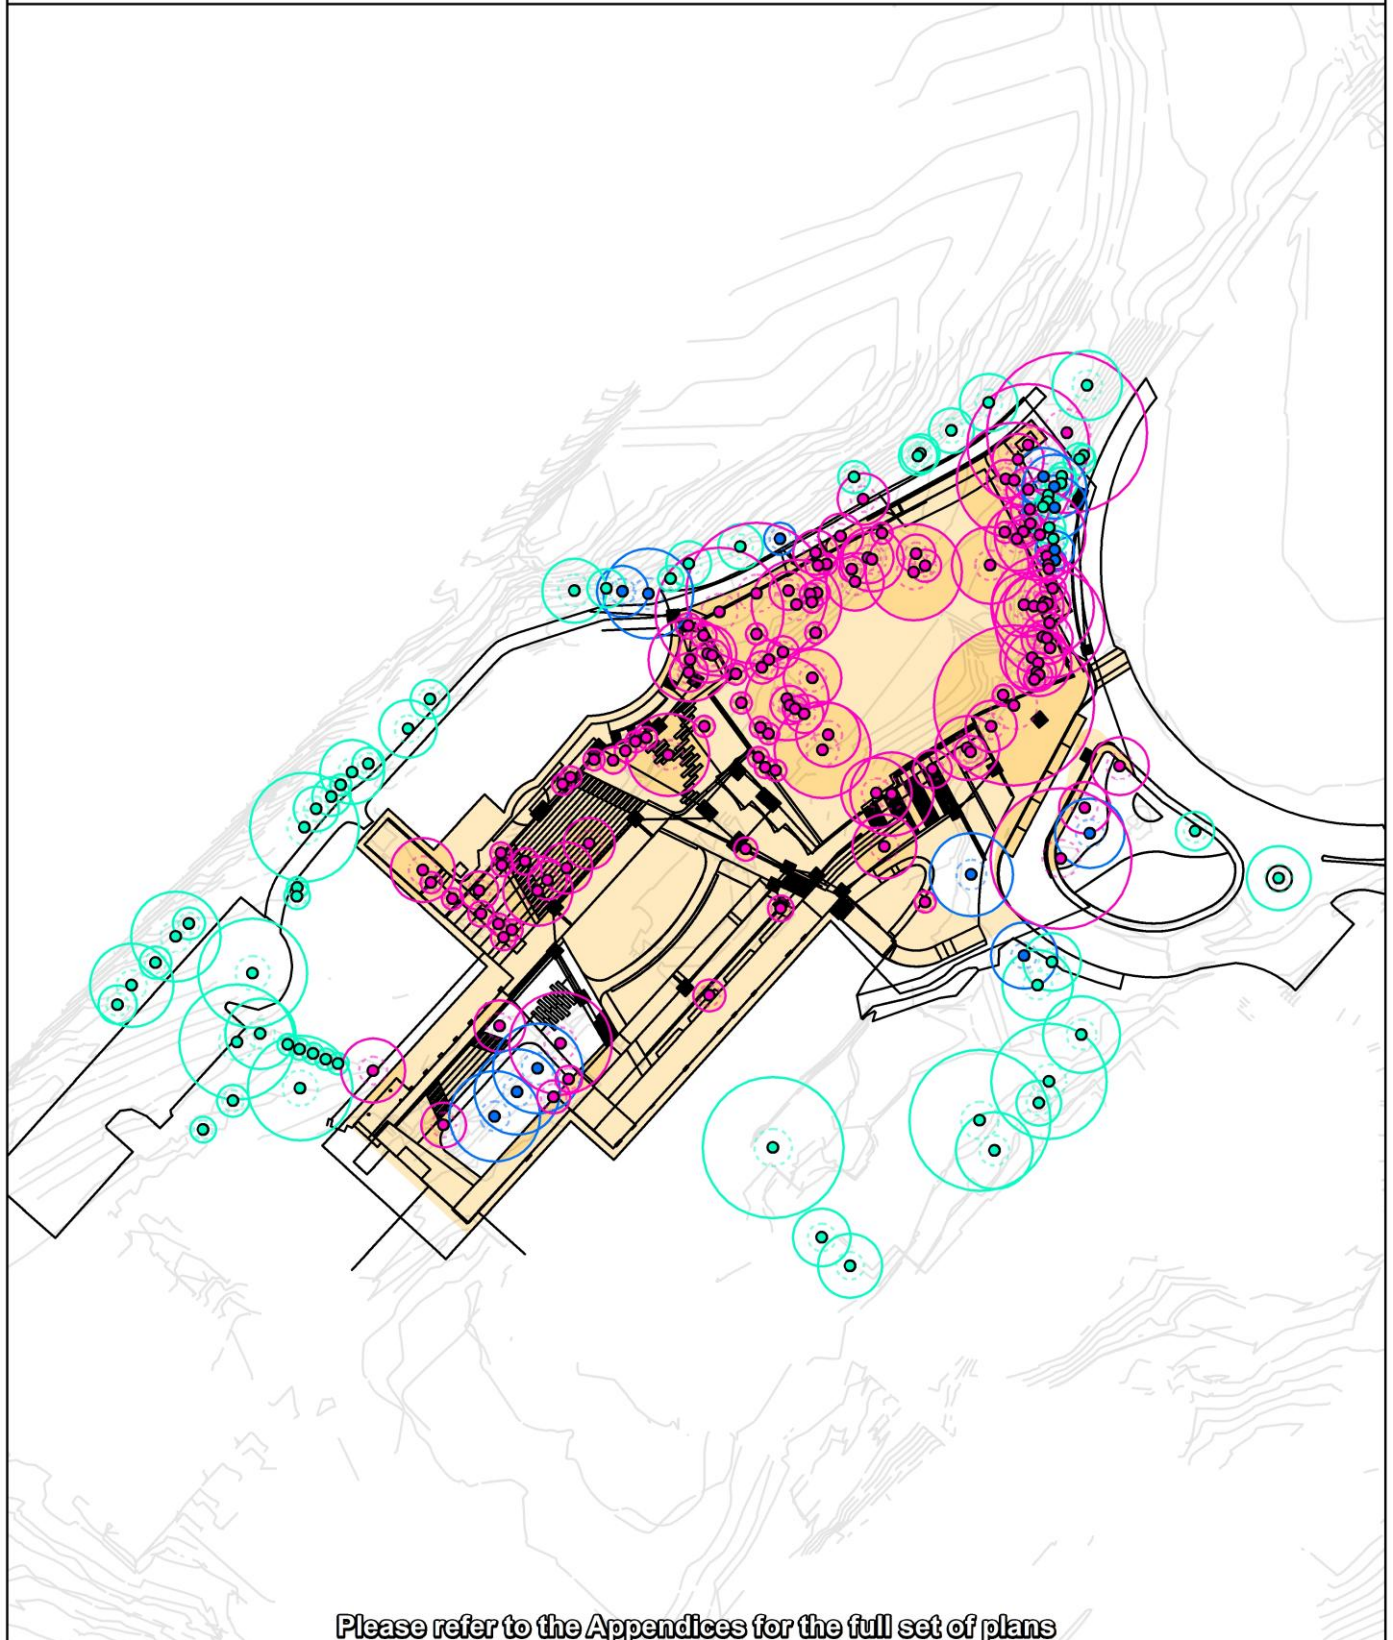
## Arboricultural Impact Assessment

Please refer to the Appendices for the full set of plans

- Nil encroachment
- Minor encroachment
- Major encroachment

- TPZ (continuous line)
- SRZ (dashed line)

- Impact footprint
- Site plan (proposed)

| <b>Nil encroachment (0%)</b><br>Total trees: <b>58</b> | <b>Retain</b><br>A total of <b>51</b> trees will be subject to nil encroachment. No impacts on these trees are foreseeable under the current proposal. |
| | <b>Remove</b><br>A total of <b>116</b> trees will be subject to a major encroachment of greater than 20% within the TPZ. Encroachment of greater than 20% can begin to impact the structural root zone (SRZ) and is more likely to compromise tree stability" (Costello, Watson, and Smiley (2017, p.21). Impacts within the SRZ are not recommended as it may lead to the destabilisation and/or decline of the tree. These trees are located inside or directly adjacent to the proposed construction footprint and cannot be retained under the current proposal. |

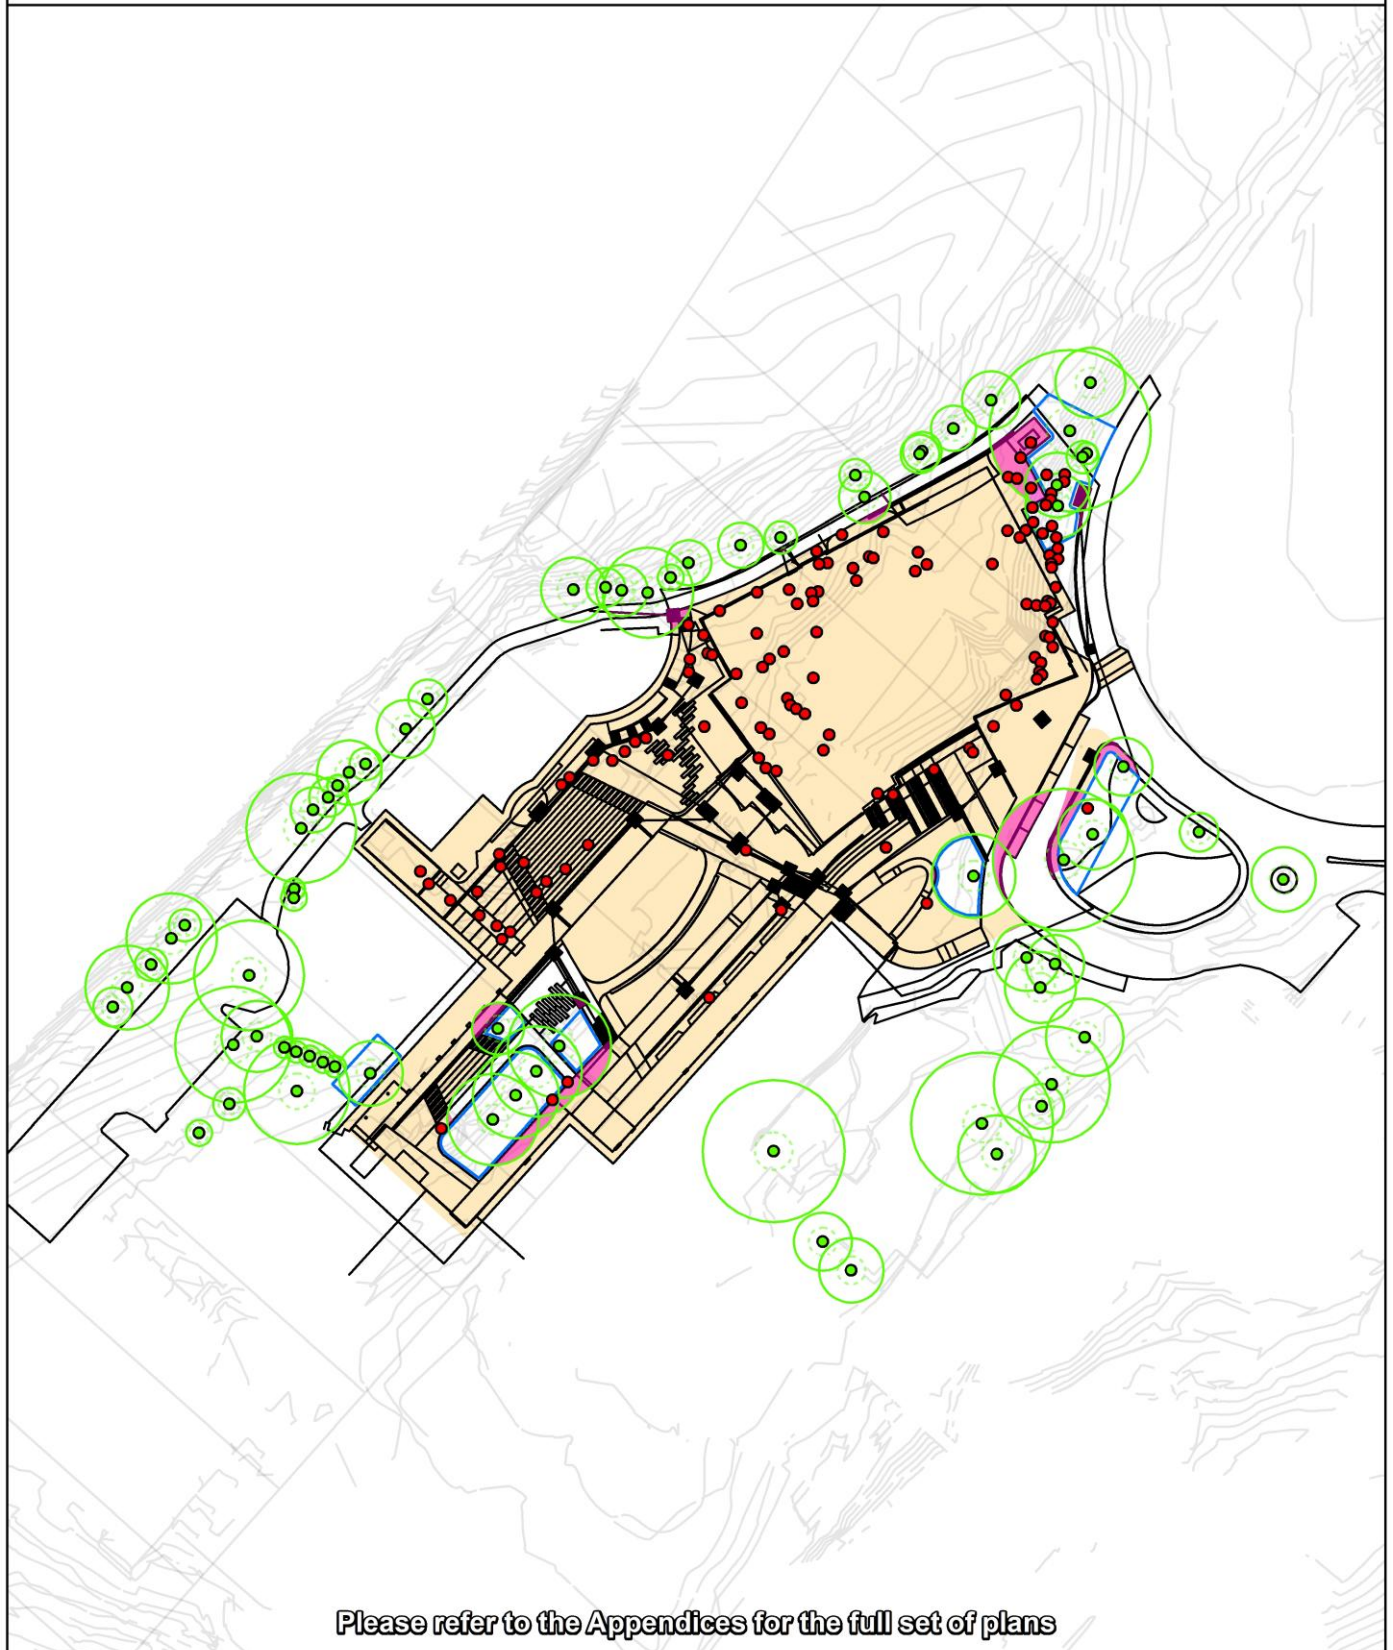
# Tree Protection Plan

- Retain
- Remove

- ▭ TPZ (continuous line)
- ▭ SRZ (dashed line)

- Impact footprint
- Site plan (proposed)

- Tree protection fence
- Arborist to supervise works within the TPZ

Tree protection fencing must be established at the locations shown in the TPP. Existing fencing, site hoarding, or structures (such as a wall or building) may be used as tree protection fencing, providing the TPZ remains isolated from the construction footprint. Tree protection fencing must be installed prior to site establishment and remain intact until the completion of works. Once erected, protective fencing must not be removed or altered without the approval of the project arborist. Specifications for the tree protection fencing are as follows:

Trunk protection must be established at the locations shown in the TPP. Where the provision of tree protection fencing is impractical or must be temporarily removed, trunk protection shall be installed to avoid accidental mechanical damage.
