Northern Wing of the Junior School: Gonzaga Barry Centre (GBC)

3.2.2 Northern Precinct

4.0 Heritage Context

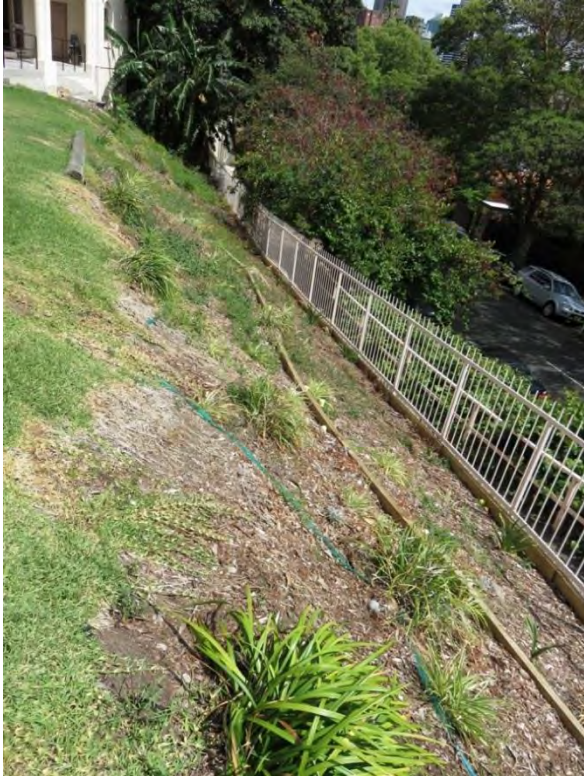
Figure 3.31 The steeply sloping area between the gymnasium and the Elamang Avenue boundary, which is marked by a steel picket fence. (Source: GML, November 2016)

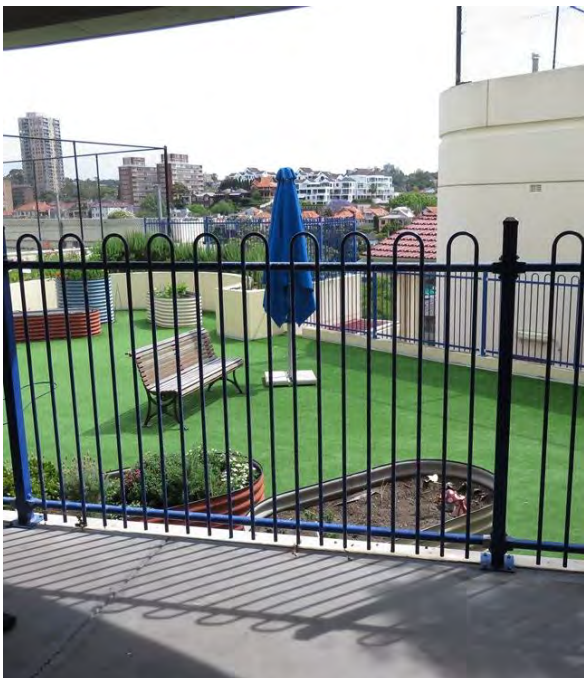
Figure 3.33 The terraced area to the southeast of the gymnasium, as viewed from the south. (Source: GML, November 2016)

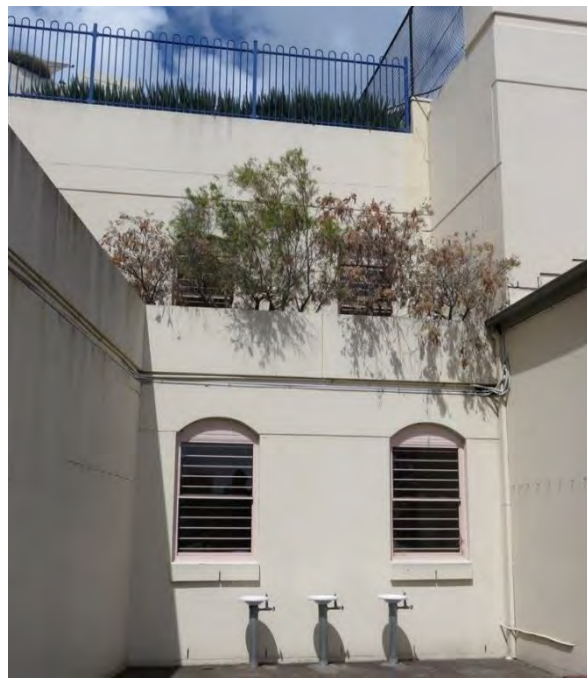
Figure 3.34 Looking up to the landscaped terraces to the southeast of the gymnasium. (Source: GML, November 2016)

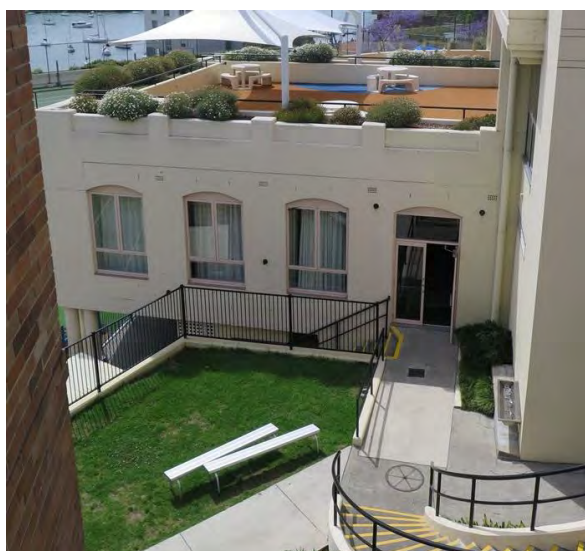
Figure 3.35 The northwestern elevation of the GBC with landscaped area in the foreground. (Source: GML, November 2016)

The northernmost wing of the Junior School, known as the Gonzaga Barry Centre (GBC), is included in the project's Western Precinct together with the landscaped areas of its immediate surrounds. Designed by Leffler Simes Architects and built c1990, the GBC is a one–two storey rendered masonry structure. It consists of single large room at lower ground floor level with roof terrace above. Windows and doors are aluminium framed. The main building form is supported on circular concrete columns, which allow for an undercroft space below, which is partially enclosed with fibrous cement sheeting (Figures 3.35 and 3.37).

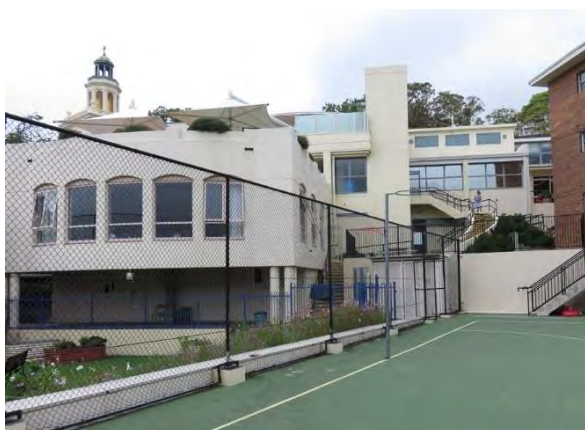
Figure 3.37 The north elevation of the GBC, as seen from the tennis court roof of the gymnasium. (Source: GML, November 2016)

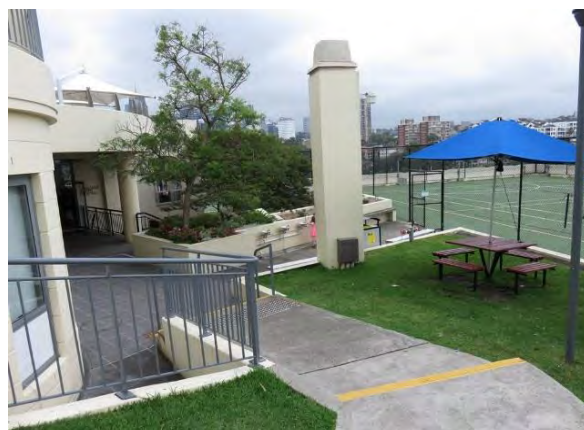
Figure 3.38 The path leading to the eastern entrance of the GBC, through a small area of lawn. (Source: GML, November 2016)

On the west side of the building are concrete stairs and paths, adjacent to which is a small area of open lawn (Figure 3.38). To the north of the building is a small fenced playground. To the east are brick paved and concrete stairs and paths, with rendered masonry planter boxes and low garden walls (Figure 3.36). There is also a small area of lawn to the east (Figure 3.38). All landscaping is contemporary with the GBC.

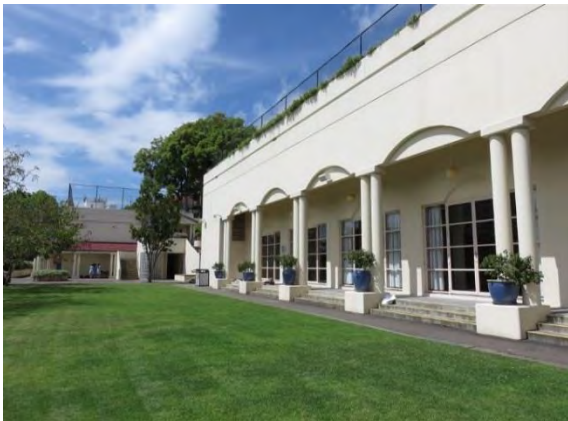
Figure 3.39 The northeastern elevation of Centenary Hall and formal lawn adjacent. (Source: GML, November 2016)

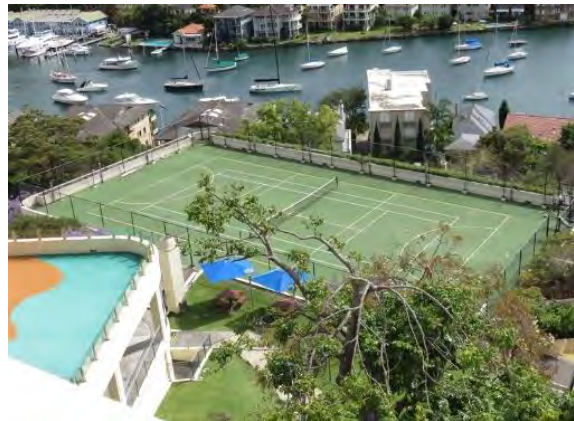
Figure 3.40 Centenary Hall's rooftop tennis court. (Source: GML, November 2016)

Like the gymnasium, Centenary Hall is a flat-roofed rendered masonry building, which is partially subgrade. Its roof—used as a tennis court—is accessible from the adjacent ground level on its southwestern side (Figure 3.40). The two buildings also share a common architectural language and materiality. The building's northeastern elevation (its main elevation) features a colonnade with double columns arranged evenly across its length (Figure 3.39). Between the columns, arched motifs are recessed into the wall above. The recessed arched motif is repeated above the doors which are located along the colonnade. These doors are aluminium framed and consist of two equal width leaves with fixed glazing at the sides. The doors and adjacent glazing are divided into four equal sections by transoms. A flat formal lawn area is located adjacent to the northeastern side of the building. A rendered masonry retaining wall and planter box separates the lawn area from the public footpath adjacent (Figure 3.42).

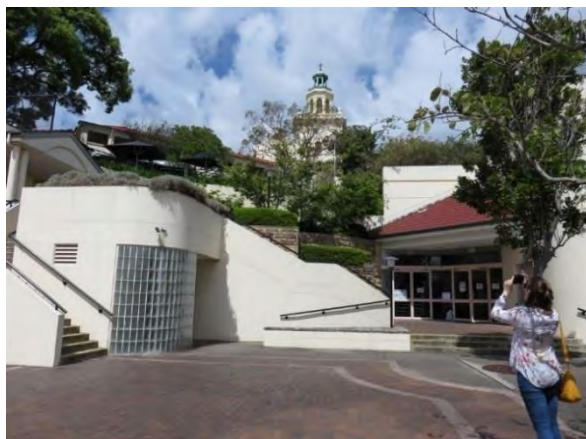
Figure 3.41 The brick paved terrace between Centenary Hall and the Science Building. The single storey structure on the left houses the carpark lift. The main entrance to Centenary Hall can be seen on the right, with red tiled roof over. (Source: GML, November 2016)

On the northeastern corner of the building is a pitched tiled roof, which covers the main entrance to the building (Figure 3.41). The entrance consists of a series of glazed aluminium framed doors. Between the Science Building and Centenary Hall (at the end of the formal lawn) is a brick paved terrace (Figure 3.44). This terrace is connected to higher areas of the campus to the southwest by external stairs (concrete) and landscaped terraces with rendered masonry and sandstone block retaining walls (Figures 3.41 and 3.43).

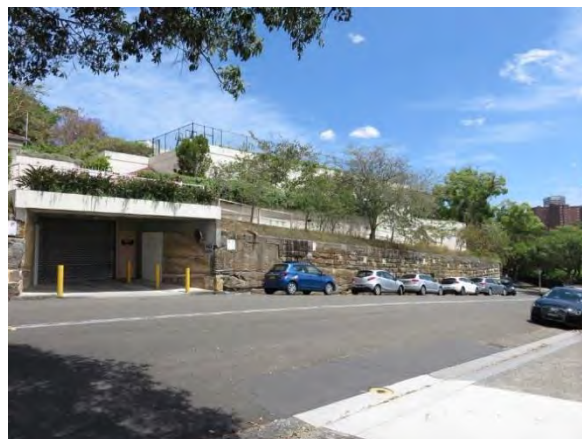
Figure 3.42 The partially concealed view of Centenary Hall from Elamang Avenue. (Source: GML, December 2016)

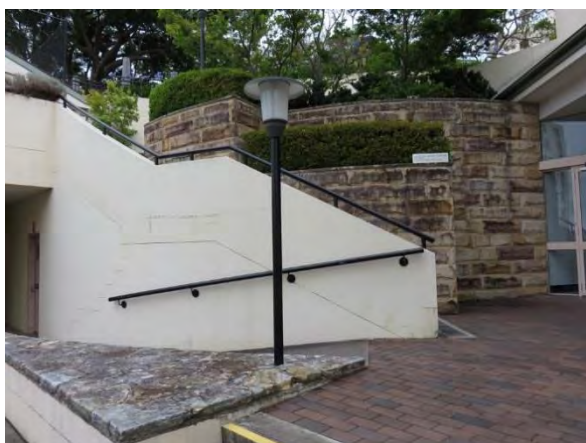
Figure 3.43 The rendered masonry and sandstone retaining walls on the southeastern side of Centenary Hall. (Source: GML, December 2016)

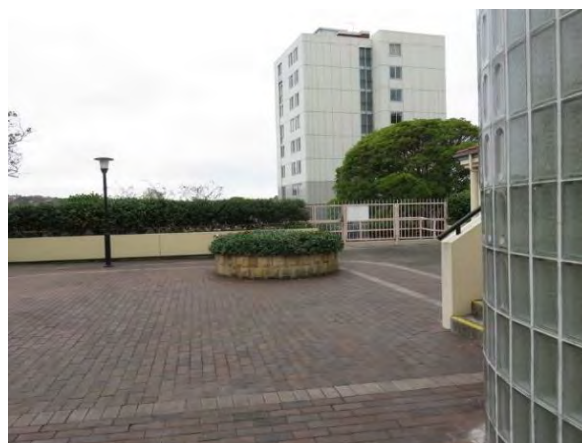
Figure 3.44 The brick paved terrace between Centenary Hall and the Science Building, looking northeast. The apartment block at 21 Elamang Avenue can be seen in the background. (Source: GML, December 2016)

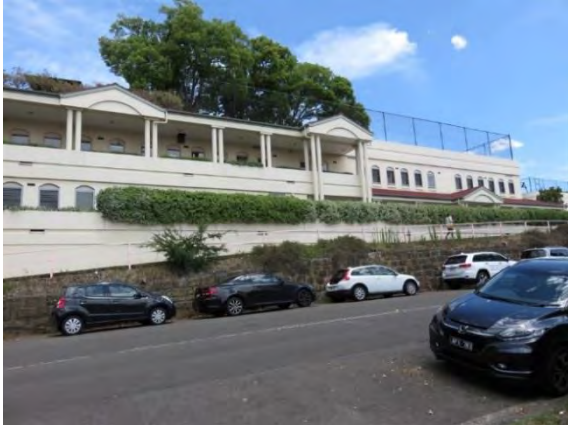
Figure 3.45 The Science Building as viewed from Elamang Avenue. (Source: GML, November 2016)

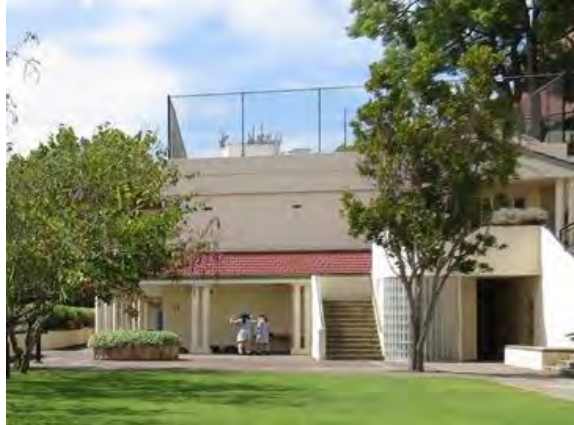
Figure 3.46 The northwestern elevation of the Science Building. (Source: GML, November 2016)

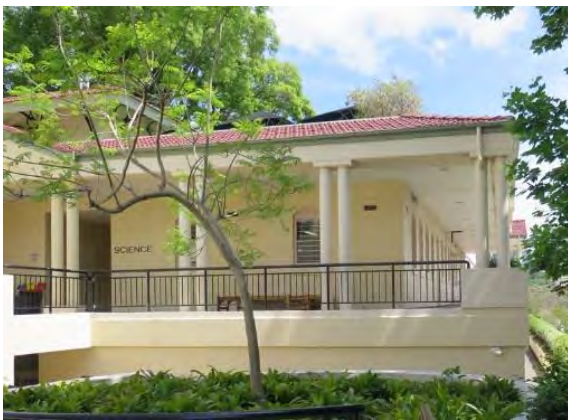
Figure 3.47 The southwestern elevation of the Science Building. (Source: GML, November 2016)

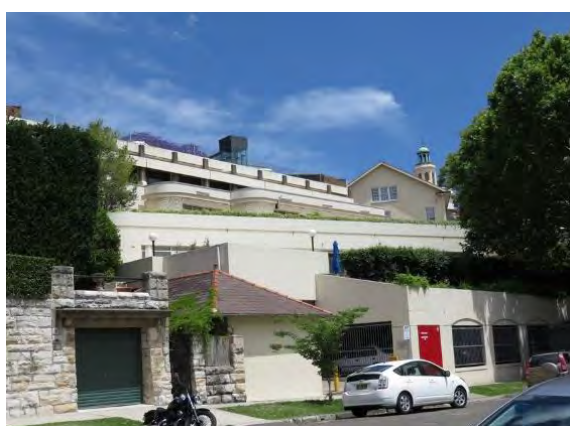
Figure 3.51 The Music and Performing Arts Building, as viewed from Elamang Avenue. The basement carpark is at street level. (Source: GML, November 2016)

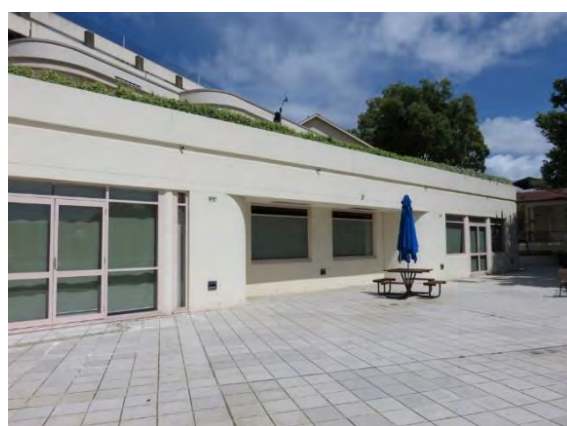
Figure 3.52 The lower level roof terrace and northeast elevation of Music and Performing Arts. The upper floor steps back and as such is not clearly visible. (Source: GML, November 2016)

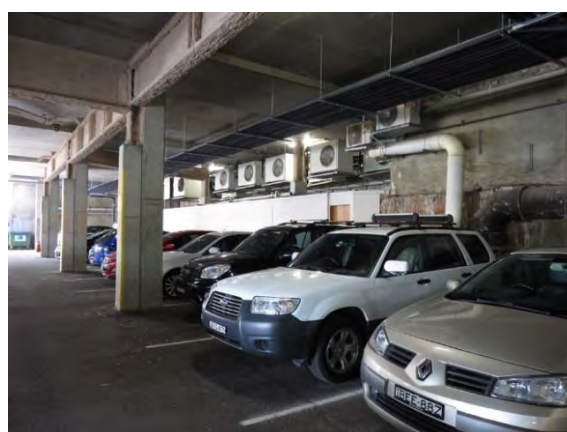
Figure 3.54 The basement carpark below the building (Source: GML, November 2016)

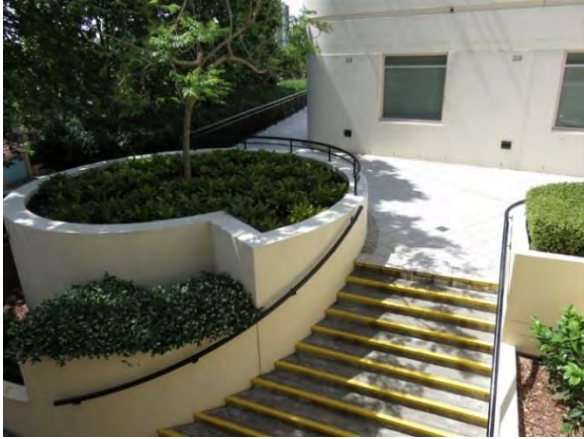
Figure 3.55 The external stair on the northwestern side of the building which leads up to the lower roof terrace. (Source: GML, November 2016)

On the northwestern side of the building is a pedestrian thoroughfare consisting of external stairs, landscaped terraces and gardens, which descends through the site. This landscape is contemporary in character, with brick paved terraces, concrete stairs, painted metal balustrades and low walls (retaining walls and planters) of rendered masonry. The planters contain low-height shrubs and small trees (Figures 3.55 and 3.56).

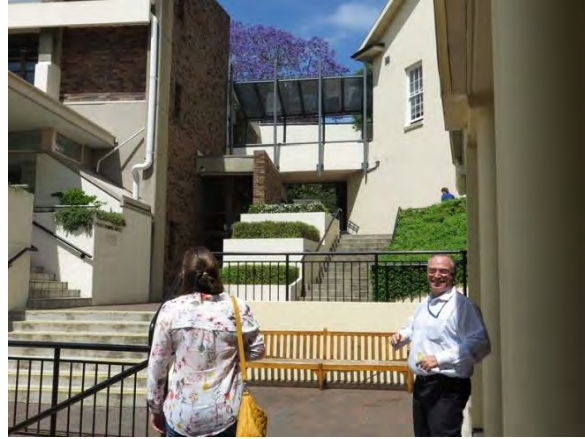
Figure 3.56 The stepped thoroughfare on the northwestern side of the building. The connection between the Music and Performing Arts Building and the Mary Ward building can be seen. (Source: GML, November 2016)

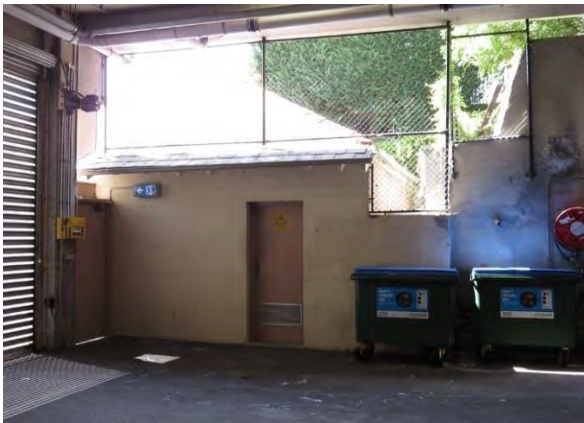
Figure 3.57 The northwestern wall of the garbage room (rendered and painted, with door) encroaches into the carpark. (Source: GML, November 2016)

The garbage room is a small detached single storey building, located in the eastern corner of the campus, adjacent to the school's property boundaries. External walls are generally rendered and painted masonry walls, although some original face brickwork can be seen on its northeastern corner. The roof is hipped and slate-clad with terracotta tile cappings, and timber rafters are a feature of its modest projecting eaves. Exposed timber roof framing is visible internally. All doors to the building are located on its northwestern side and are contemporary. The building has no windows. The Music and Performing Arts Building cantilevers slightly over the building (Figures 3.57 and 3.58).

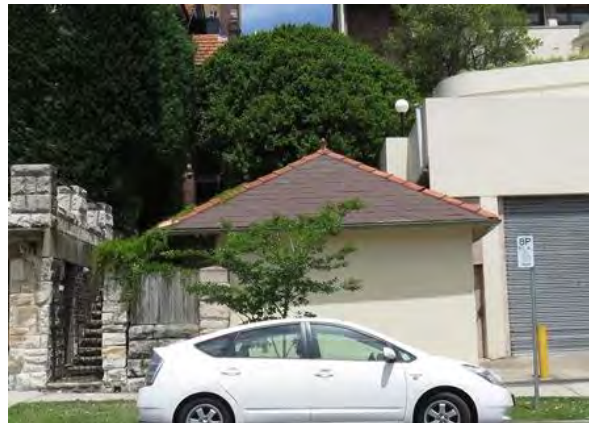
Figure 3.58 The view of the garbage room from Elamang Avenue. (Source: GML, November 2016)

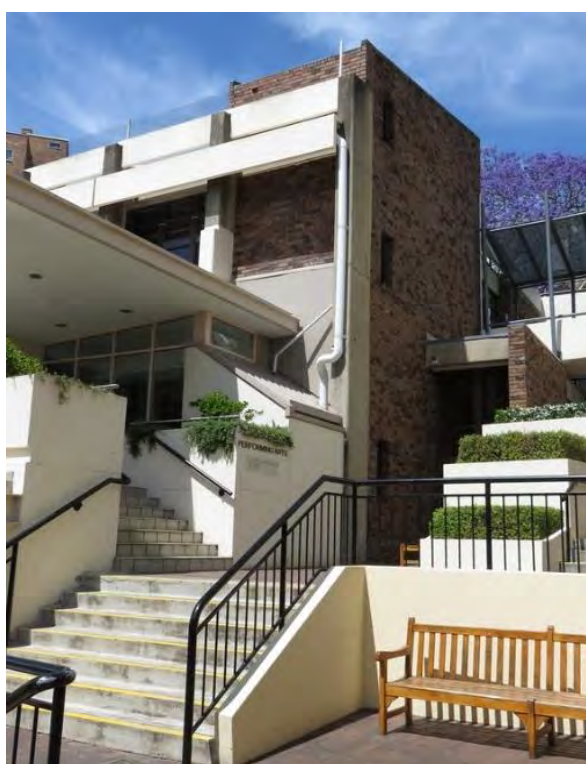
Figure 3.59 The northern corner of the Mary Ward building, with the Music and Performing Arts Building on the right. The northeastern elevation of the Mary Ward building is largely concealed by the other building. (Source: GML, November 2016)

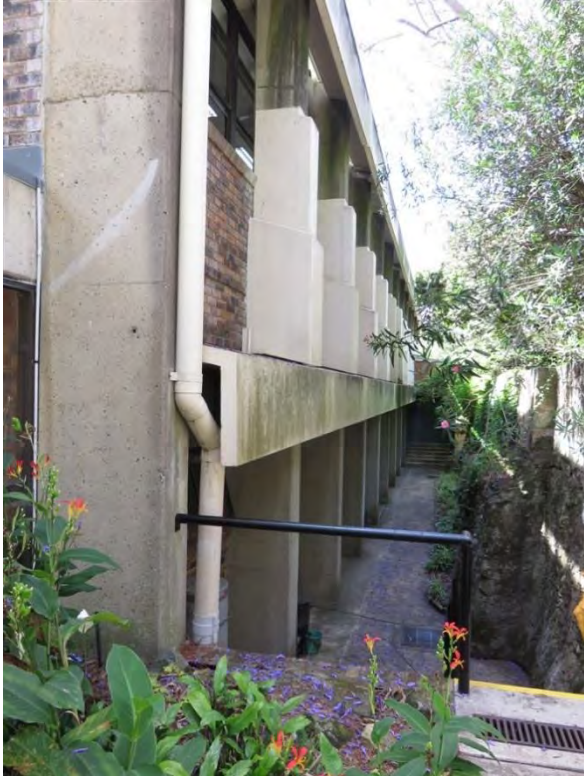
Figure 3.61 Looking along the southwestern elevation of the building. The sandstone retaining wall on the property boundary is on the right. (Source: GML, November 2016)

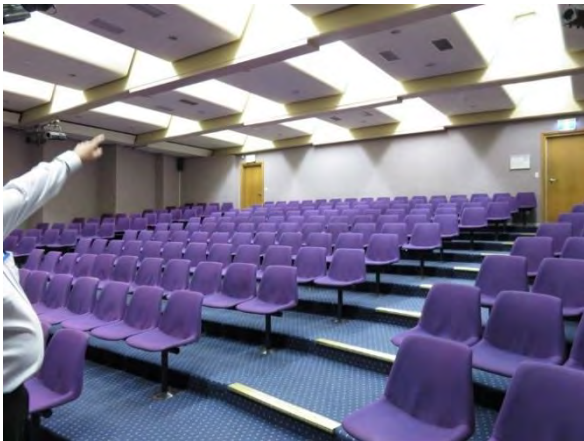
Figure 3.63 The stepped auditorium, Mary Ward building. (Source: GML, November 2016)

A stepped auditorium with stage is a feature of the building's interior (Figure 3.63). The auditorium has a distinctive profiled ceiling with recessed lighting. Lobby areas have timber boarded ceilings and terrazzo floors, and appear to be original to the building (Figure 3.62). Elsewhere however interiors have been altered over time.

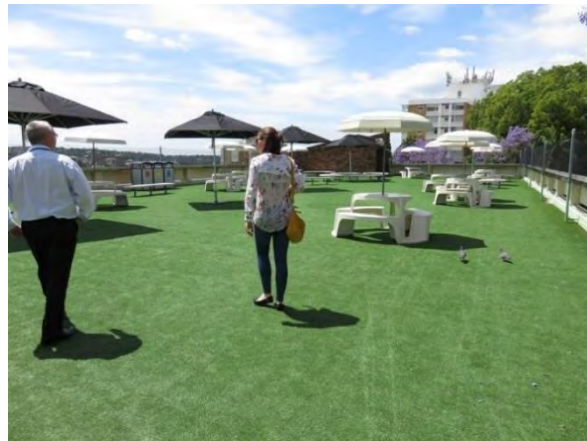
Figure 3.64 The roof of the Mary Ward building, used as a recreational space. (Source: GML, November 2016)

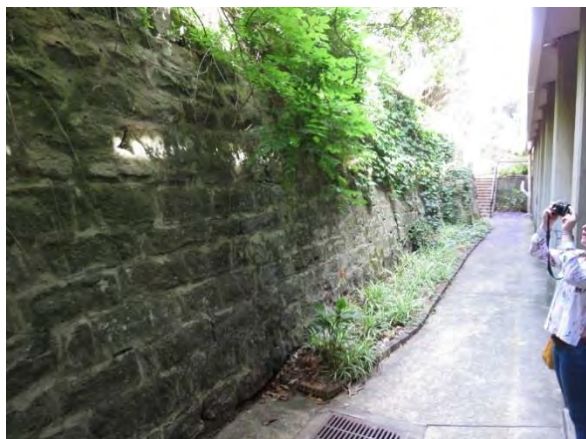
Figure 3.65 The sandstone retaining wall adjacent to the building. (Source: GML, November 2016)

A sandstone retaining block is located close to the Mary Ward building on its southwestern side. The retaining wall is nominally four metres high, and is located close to the property boundary of the school and Araluen House and 69 Carabella Street. The northwestern end of the wall is built on top of a hewn sandstone cliff. This wall most likely dates from c1904, when the Eversfield house was constructed (demolished 1968), and was most likely built to provide a level area for the construction of the tennis court which existed at the rear of the house (Figures 3.65 and 3.66).

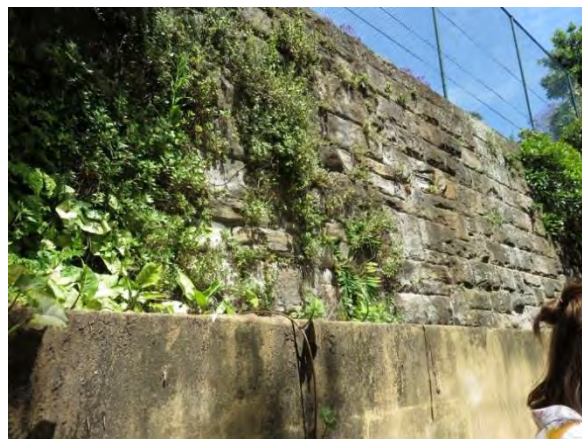
Figure 3.66 The sandstone retaining wall adjacent to the building, on the property boundary of 69 Carabella Street. (Source: GML, November 2016)

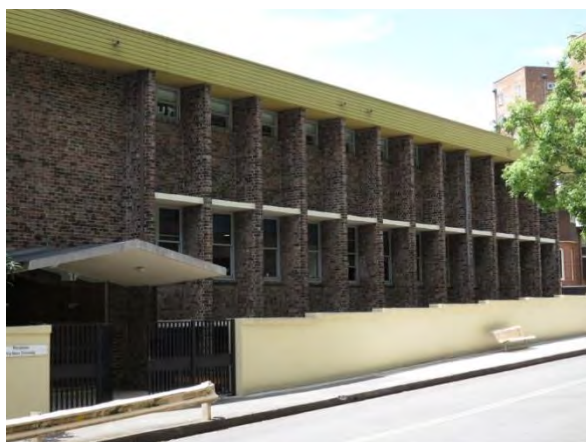
Figure 3.67 J-Block, as seen from Carabella Street. The cantilevered concrete awning marks the original entrance to the building. (Source: GML, November 2016)

J-Block is a three–four storey building located close to the school's Carabella Street boundary (two and a half storeys are visible from Carabella Street) (Figures 3.67 and 3.68). Built in 1965 (with top floor added in 1970), the building is L-shaped in plan. Walls are face brickwork (bricks are rough-cast and speckled) and fenestration is incorporated into the rhythmic articulation of the building's façades. A high metal fascia borders all sides of the low-pitch metal deck roof, and a cantilevered concrete awning marks the entrance to the building on its southwestern elevation. Parts of the building (library) have recently been refurbished internally, with the refurbishment including distinctive changes to fenestration locally (Figure 3.69). Other areas of the building maintain original interior finishes—terrazzo floors and timber boards as wall lining (Figure 3.70).

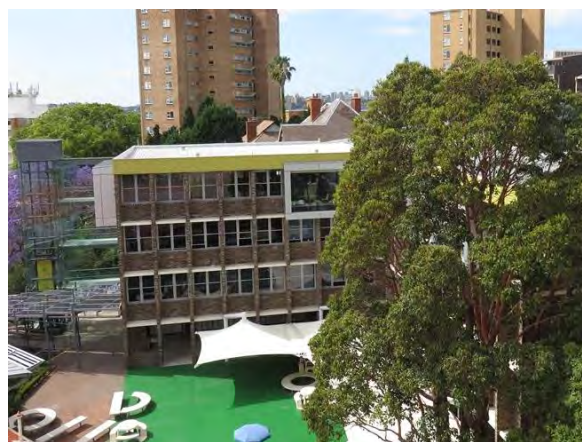
Figure 3.68 The northeastern wing of the building, as seen from the northwest. (Source: GML, November 2016)

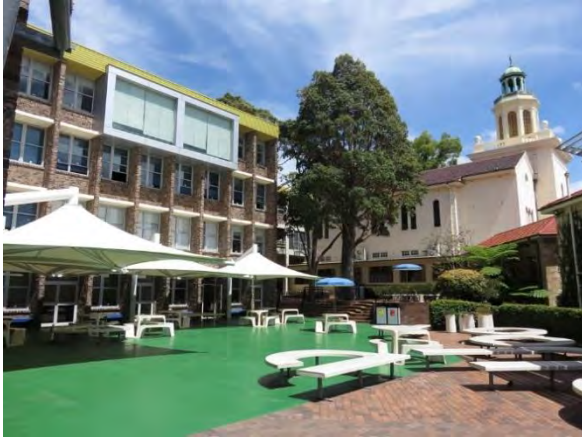
Figure 3.69 The northeast elevation of the building. Recent alterations to the top floor fenestration are evident. The chapel building can be seen on the right. (Source: GML, November 2016)

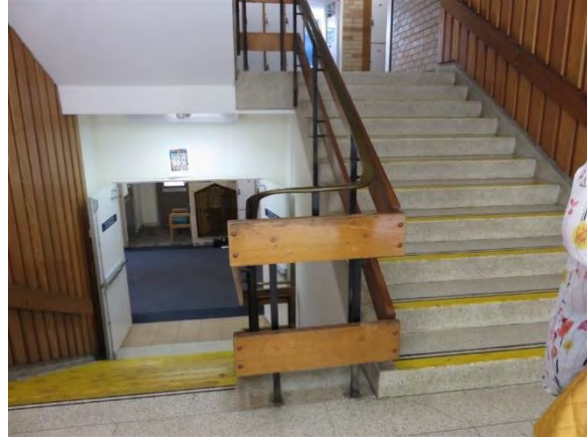
Figure 3.70 The interior stairwell retains original finishes and detailing. (Source: GML, November 2016)

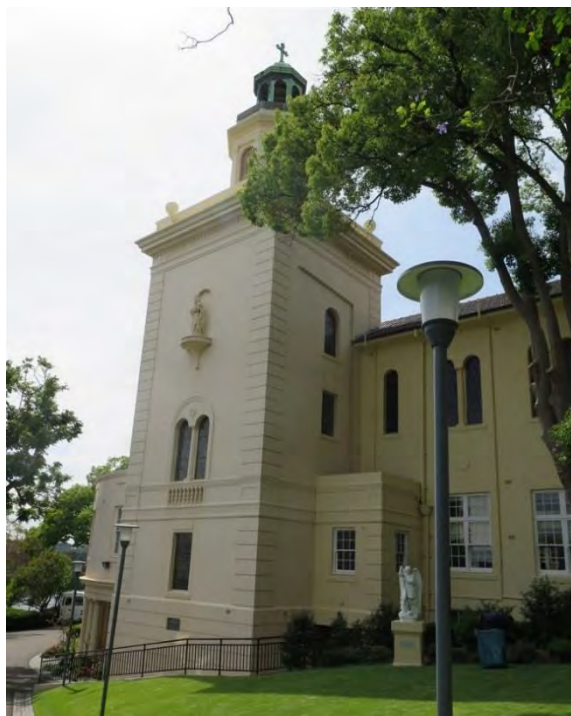
Figure 3.71 The tower at the northern corner of the chapel building, which is a local landmark visible from the harbour and surrounding areas. (Source: GML, November 2016)

The chapel building is a two–three storey rendered masonry building, constructed in 1929-30, located close to the Carabella Street property boundary (Figures 3.71–3.73). The building is T-shaped in plan: the dominant central building has symmetrical secondary projecting wings built adjacent to Carabella Street. Rising above the central building at its northern corner is an elaborate Italianate tower (also rendered masonry) at the top of which is a golden stained glass octagonal lantern with copper lantern, cupola and cross above (Figure 3.71). The tower is a landmark of the area, being visible from many vantage points in the surrounding area and the harbour. On the southeastern side of the main building is the single storey St Aloysius' Verandah, built at the same time as the chapel building (Figure 3.75). The wings were designed in the Victorian Georgian style, the northern wing having two storeys with a hipped terracotta tiled roof (Figure 3.72). The southeastern wing has three storeys and a flat roof: an unsympathetic addition was built in the 1970s, which included an additional floor in place of the original pitched roof, and concrete framed verandahs on the northeastern elevation (Figure 3.74). This wing is now used as classrooms.

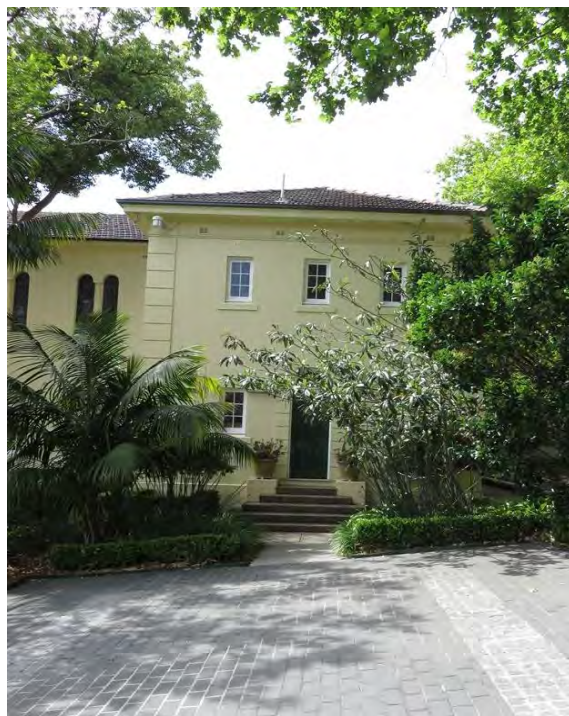
Figure 3.72 The northwestern elevation of the northwestern wing. (Source: GML, November 2016)

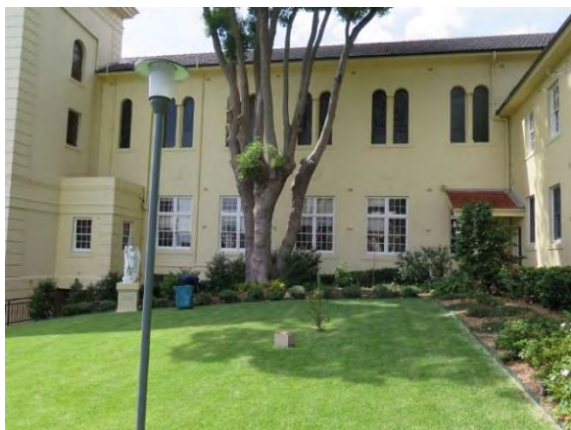
Figure 3.73 The northwestern elevation of the chapel's main building, with landscaped gardens in the foreground. (Source: GML, November 2016)

The main school entrance drive extends around the northwestern side of the chapel building, making the building's northwestern side its most visually prominent (Figure 3.73). Landscaped gardens are located adjacent to the building on its northwestern side.

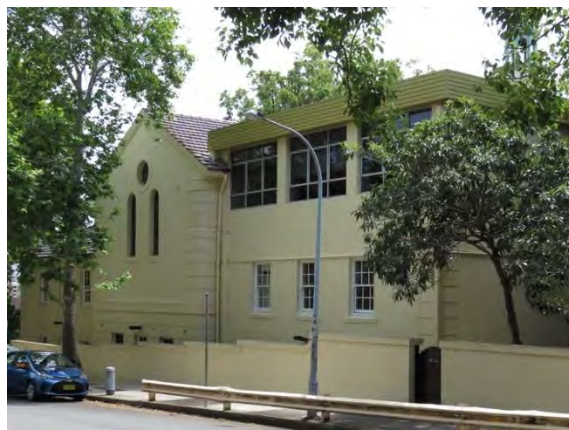
Figure 3.74 The southeastern wing, as seen from Carabella Street. The unsympathetic upper floor addition is evident. (Source: GML, November 2016)

Extension to southern wing of chapel	Intrusive	This 1972 addition to the southern wing detracts from the architectural qualities of the original building, and is highly visible from Carabella Street. The form and style of the addition is not sympathetic to the original.
Elamang	Exceptional	Elamang is the only remaining building on the site from the nineteenth century (built 1851). It is an important early house in Kirribilli associated with a prominent local family. It is important to the school as its first building on the campus. The driveway approach to Elamang from Carabella Street is significant as it follows the path of the original approach to the building.
Administration—1921 extension	High	The administration wing is a 1921 eastern addition to Elamang. Although the building's interior has been modified over time and minor additions made externally, the form and character of the building remains legible. It has historical significance as evidence of the early growth of the school. Together with Elamang and the chapel, it forms the core of the school.

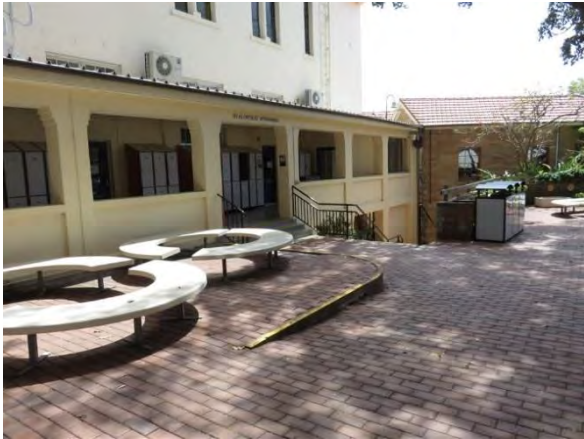
Figure 3.75 St Aloysius' verandah on the southeastern side of the chapel building. (Source: GML, November 2016)

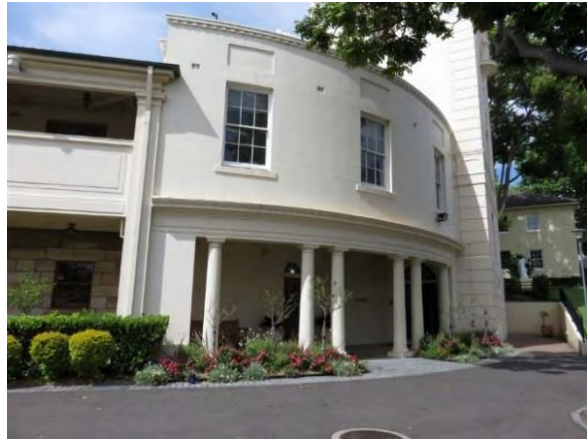
Figure 3.76 The curved façade of the connection between the chapel building and Elamang. (Source: GML, November 2016)

The northeastern end of the building is physically connected to Elamang by a two-storey rendered masonry building with curved façade and ground floor colonnade, built at the same time as the chapel building (Figure 3.76). The main entrance to the school's chapel is by way of this colonnade.

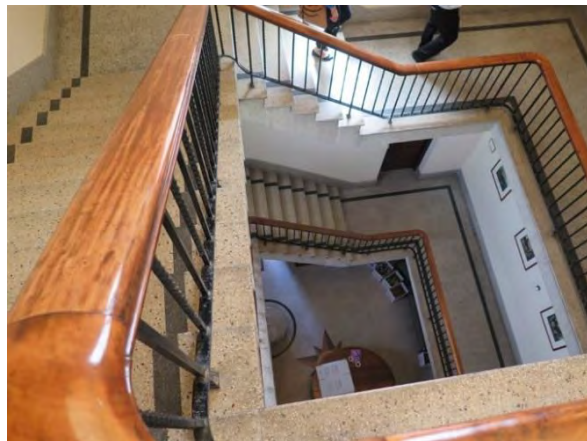
Figure 3.78 The distinctive winding terrazzo stair within the tower. (Source: GML, November 2016)

The school's chapel—Chapel of Our Lady of The Sacred Heart—occupies the upper floor of the building (Figure 3.77). It is a single room with mezzanine choir gallery at the rear. The lower floor is divided into classrooms, which are accessed from St Aloysius' Verandah. Within the tower is a distinctive winding terrazzo stair with central void to the lobby space at the base of the stair (Figure 3.78).

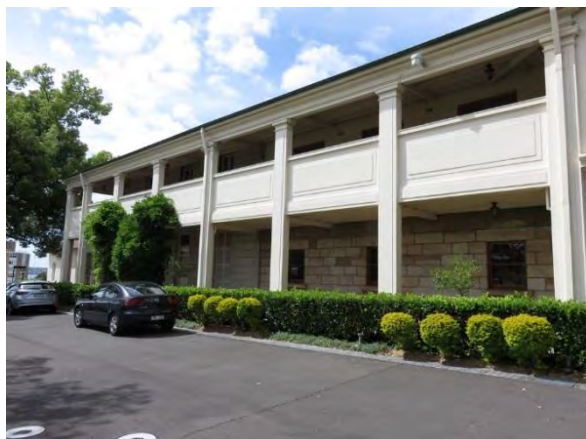
Figure 3.79 Elamang, as viewed from the north. (Source: GML, November 2016)

Elamang is a two-storey building with external walls of sandstone block tiled roofs. The building has open verandahs on its northern and eastern sides at ground floor and upper floor levels, the original verandahs having been replaced in 1924. (Figures 3.79 and 3.80). Regularly spaced verandah posts are rectangular in plan, and extend in a single uninterrupted length from ground floor level up to the roof structure. Balustrades at upper floor level extend between the verandah posts, and are constructed of a solid sheet material. The building is connected to adjacent structures on its eastern and western sides.

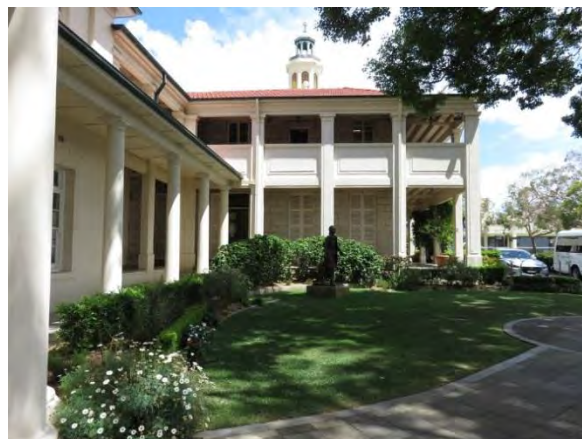
Figure 3.80 Elamang, as viewed from the east. (Source: GML, November 2016)

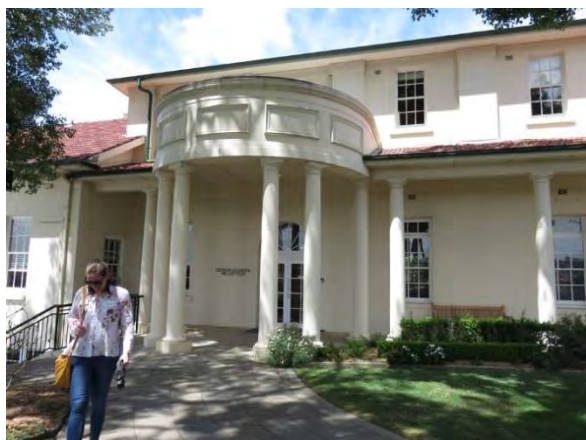
Figure 3.81 The semicircular entry portico marking the main entrance to the school's administration office. (Source: GML, November 2016)

A Classical semicircular entry portico—a recent addition to the building—marks the building's public entrance, and connects to the single storey verandah which runs along the western half of the building's north elevation (Figure 3.81). Classical circular columns extend along the edge of the verandah and entrance portico. A contemporary steel and glass extension and verandah have been added on the south side of the building (eastern end) which connect to raised walkways (Figure 3.82).

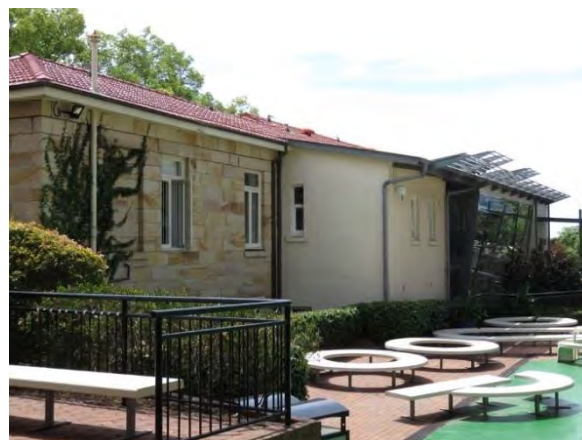
Figure 3.82 The rear of Elamang, viewed from the west. Recent additions can be seen on the right. (Source: GML, November 2016)

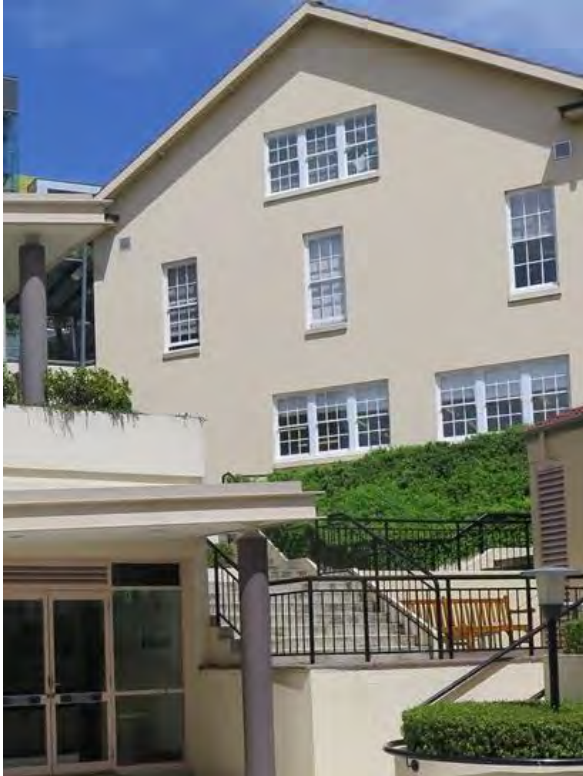
Figure 3.83 The eastern elevation of the eastern additions to Elamang. (Source: GML, November 2016)

A two-storey extension—housing administration and classrooms—abuts Elamang on its eastern side (Figures 3.83 and 3.84). This building has rendered masonry walls and a tiled pitched roof. Windows and external doors are generally timber framed and multipaned.

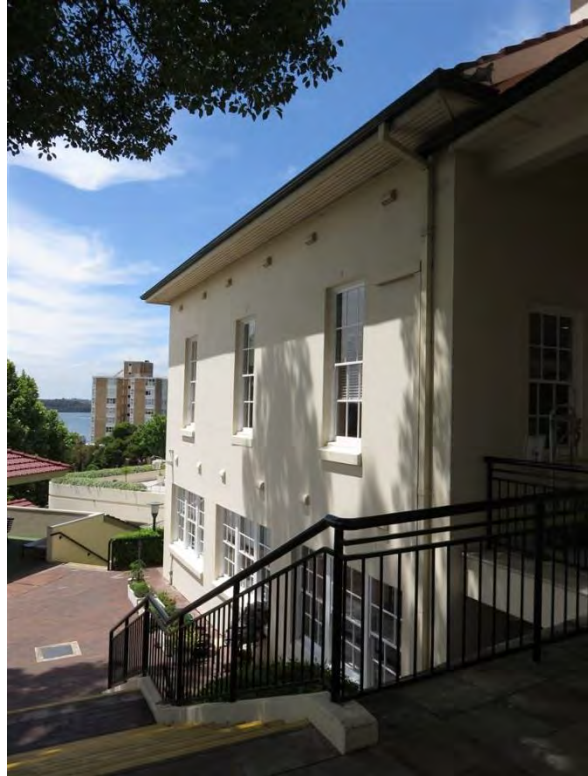
Figure 3.84 The northern elevation of the eastern additions to Elamang. (Source: GML, November 2016)

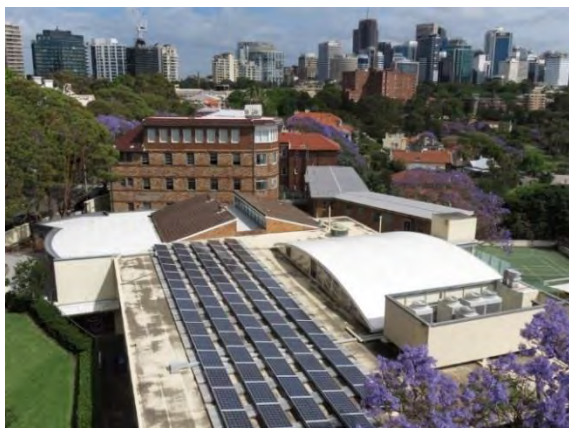
Figure 3.85 The view over the roof of the Junior School. The many additions to the original 1960s building can be seen. (Source: GML, November 2016)

The Junior School consists of a 1960s purpose-built classroom building, which has been progressively altered and extended (the most recent works dating from 2006) such that the original building is almost illegible (Figure 3.85–3.90). The original two-storey 1960 building was U-shaped in plan, with brickwork walls and a flat concrete slab roof. External walls are now rendered and painted, and the centre of the ‘U’ has been covered with a curved shade structure (Figure 3.87). A 1970s extension to the original building on its western side remains—originally a two-storey face brick building with concrete tiled pitched roofs—but external walls of this building are now rendered and painted (Figure 3.88). Further extensions on the northern and southwestern sides of the building include a new entrance on the southwest corner and new open terraces to the north (Figure 3.86). Interiors have been updated over time and are contemporary in character (3.90).

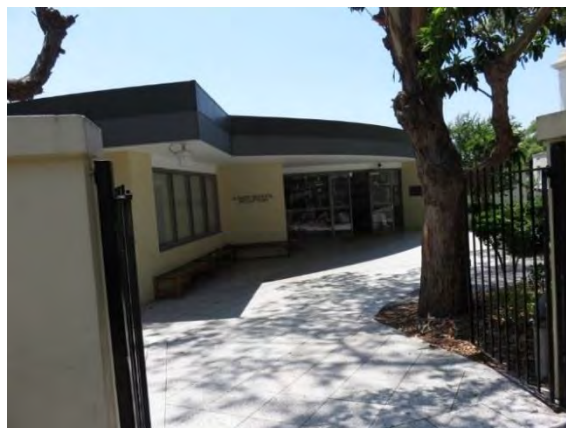
Figure 3.86 The front entrance to the Junior School, as seen from Carabella Street. (Source: GML, November 2016)

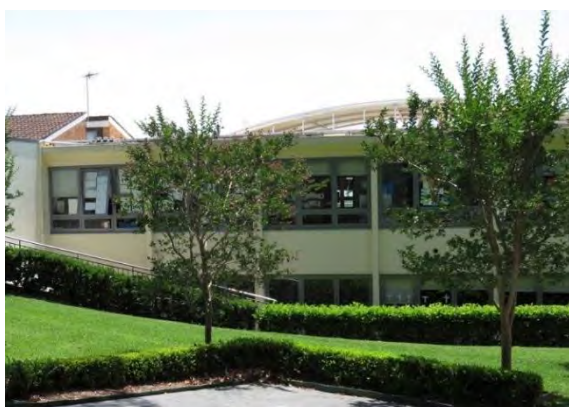
Figure 3.87 Junior School, east elevation. This is part of the original 1960s classroom block. (Source: GML, November 2016)

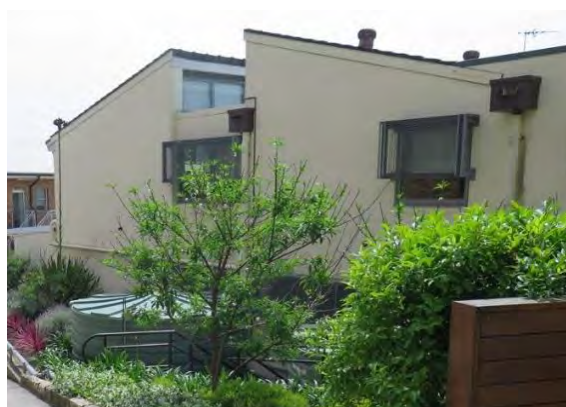
Figure 3.88 The distinctive form of the 1970s extension to the Junior School. (Source: GML, November 2016)

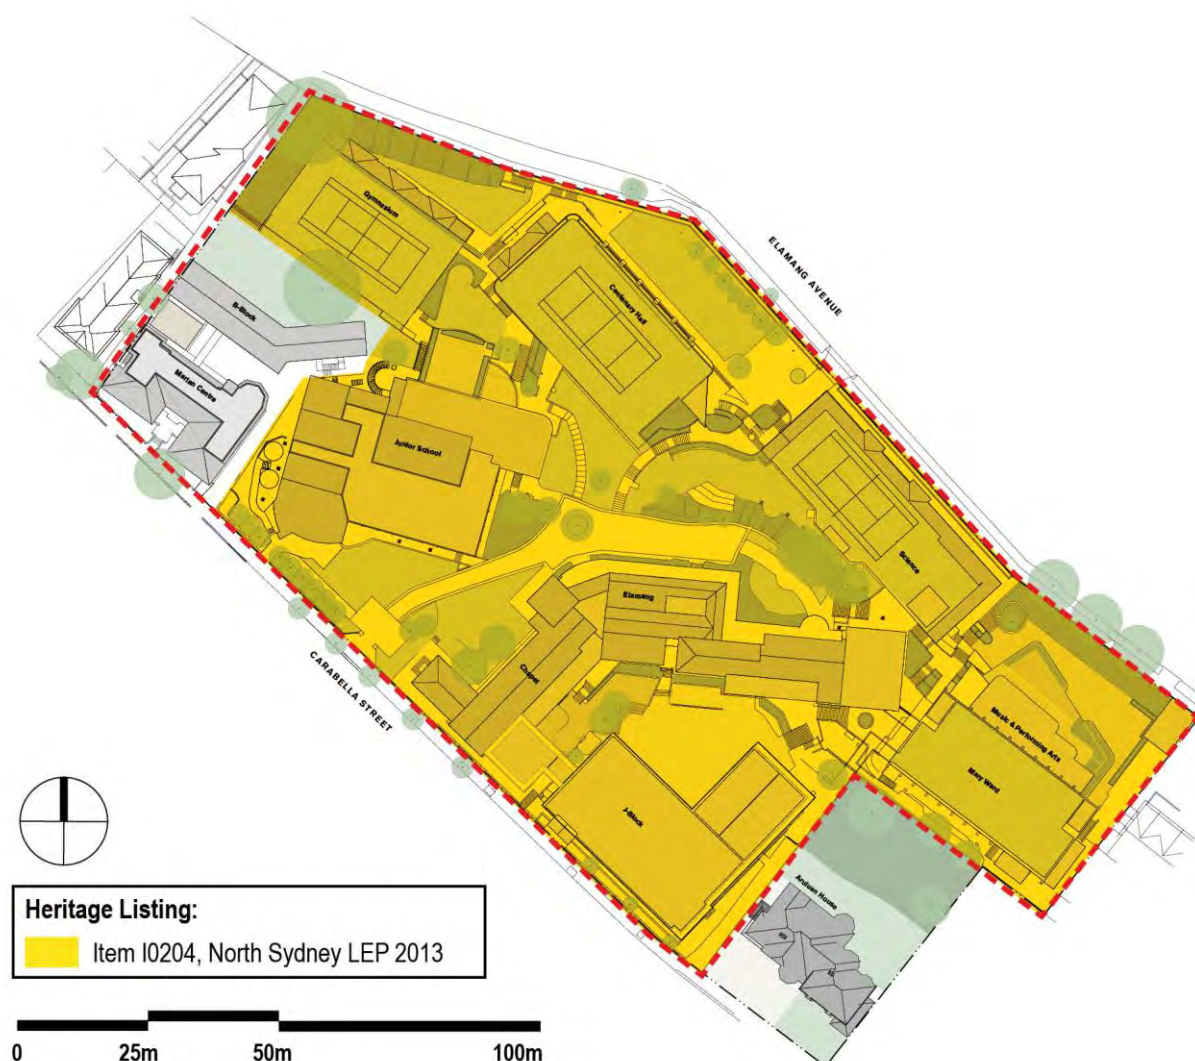
Figure 4.2 Site plan of Loreto Kirribilli: the school's boundaries are outlined in red. The area included in the school's heritage listing is coloured yellow. Araluen House, adjacent to the school, is listed as a separate heritage item. (Source: fjmt, with GML overlay)

An area of land in the western part of the campus is not included in the listing. This land was purchased by the school in 2010, and includes the Marian Centre and B-Block (Figure 4.2).

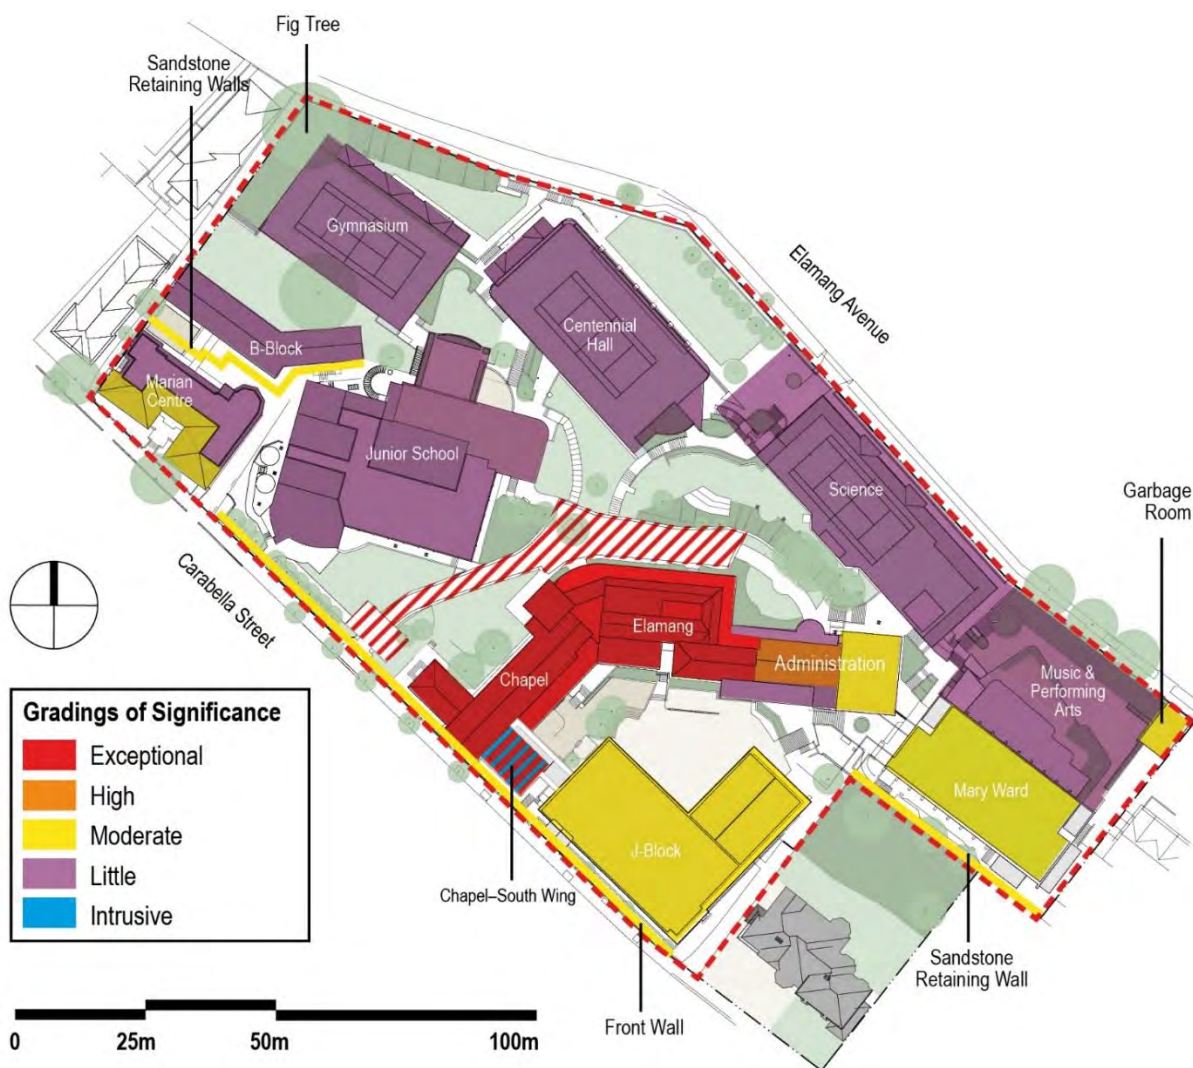
Figure 4.3 Diagram summarising the grading of significance of the buildings on the Loreto Kirribilli campus. (Source: fjmt drawing SK-201, with GML overlays)

Although the whole of the Loreto Kirribilli campus is included in the site's heritage listing, the various buildings and elements within the campus make a different relative contribution to the site's heritage value. As such, the buildings within the campus have been graded in accordance with 'grading of significance', as described in the NSW Heritage Office document *Assessing Heritage Significance*, 2001. In this document the various components that make up a heritage item can be graded as exceptional, high, moderate, little and intrusive (Table 4.1). The grading of significance of the buildings at Loreto Kirribilli is summarised in Table 4.2, and illustrated in Figure 4.3.

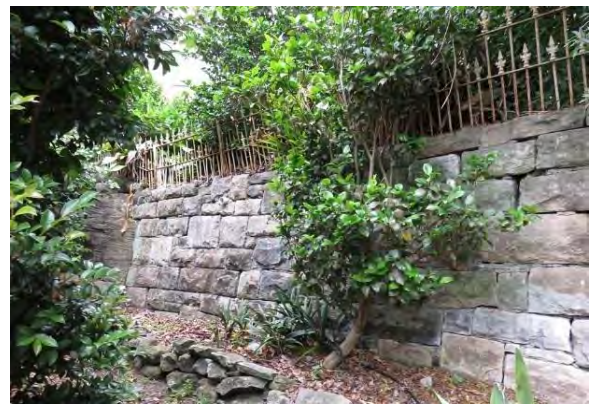
Figure 4.7 The sandstone retaining wall with metal picket fence at the edge of the gently sloping lawn. From this point the garden falls steeply to the northeast. (Source: GML, December 2016)

The house has extensive landscaped rear (northeastern) gardens (Figures 4.7–4.9). There is a significant drop in level across the gardens, from a high point adjacent to the house to a much lower area near the northeast property boundary—a fall of some eight metres. There is a gently sloping area adjacent to the house consisting primarily of open lawns. A sandstone block retaining wall topped with a cast iron picket fence runs across the width of the property, defining the edge of this area (Figure 4.7). The stonework of this retaining wall matches stonework used on the lower floor of the house, and was most likely constructed at the same time as the house.

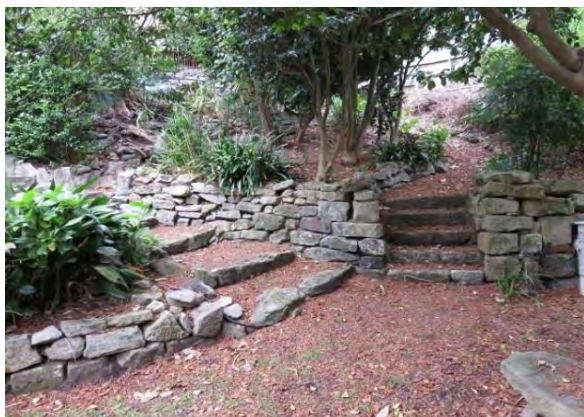
Figure 4.8 The garden features dry stone walls, garden beds, stone steps and pathways. (Source: GML, December 2016)

Beyond the retaining wall, the garden descends steeply down to the northeast. This part of the garden consists of terraced garden beds, bordered with dry sandstone walls, dilapidated in some sections (Figure 4.8). Unpaved paths and sandstone stairs crisscross the area between garden beds, which also features natural stone outcrops. Planting is dense and informal, and consists of exotic shrubs and small trees: there is little, if any, native vegetation. At the bottom of the garden (adjacent to the Mary Ward building) is a flat area of lawn and garden about 10 metres in width (Figure 4.9). A large jacaranda tree is located in the northern corner of this part of the garden. A high sandstone wall separates this area from the school campus.
