Northern Wing of the Junior School: Gonzaga Barry Centre (GBC)

3.2.2 Northern Precinct

4.0 Heritage Context

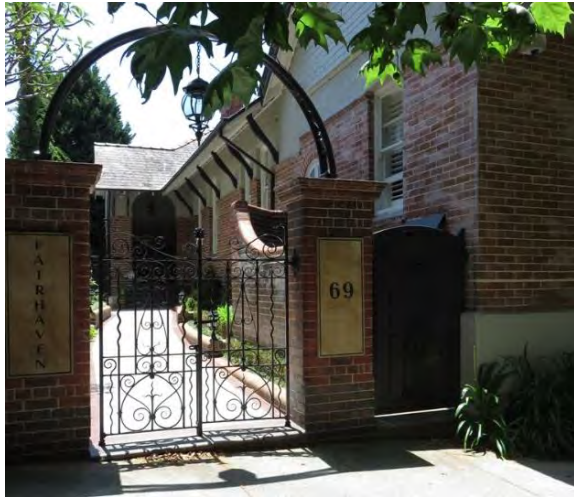
Figure 4.10 The view of Fairhaven from Carabella Street.
(Source: GML, 2016)

Fairhaven, a detached masonry house dating from the early twentieth century, was designed by James Peddle (Figures 4.10 and 4.11). It is located adjacent to Araluen House on its southeastern side. Fairhaven's northeastern property boundary partly abuts that of the school. It is listed as an item of local heritage significance in the North Sydney LEP 2013 (Item I0202) (Figure 4.1). The State Heritage Inventory includes the following Statement of Significance for Fairhaven.

This building is designed in the Federation Arts and Crafts style. Single storey brick house on sandstone basement with slate roof. Boarded and shingled gables; octagonal turretted tower. Multi-gables with terracotta ridge caps, rough-cast walls below eaves and tall brick chimneys.⁶

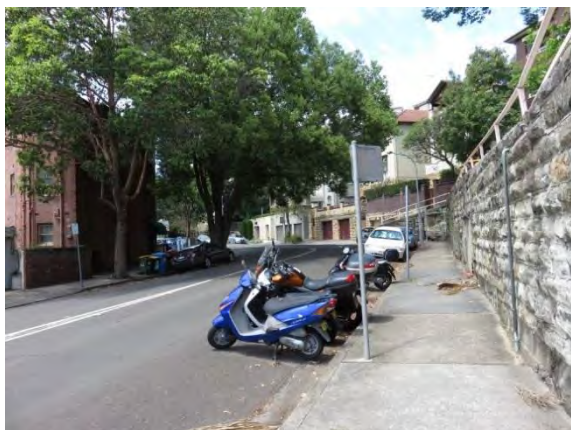
Figure 4.16 Looking east along Elamang Avenue, within the Careening Cove Conservation Area. The sandstone retaining walls are a characteristic of the area. (Source: GML, 2016)
