PRELIMINARY STAGE 2 ENVIRONMENTAL SITE ASSESSMENT AND REMEDIAL ACTION PLAN

PROPOSED SCHOOL DEVELOPMENT

**LORETO KIRRIBILLI,
85-87 CARABELLA STREET, KIRRIBILLI, NSW**

REF: E30067KMrpt2

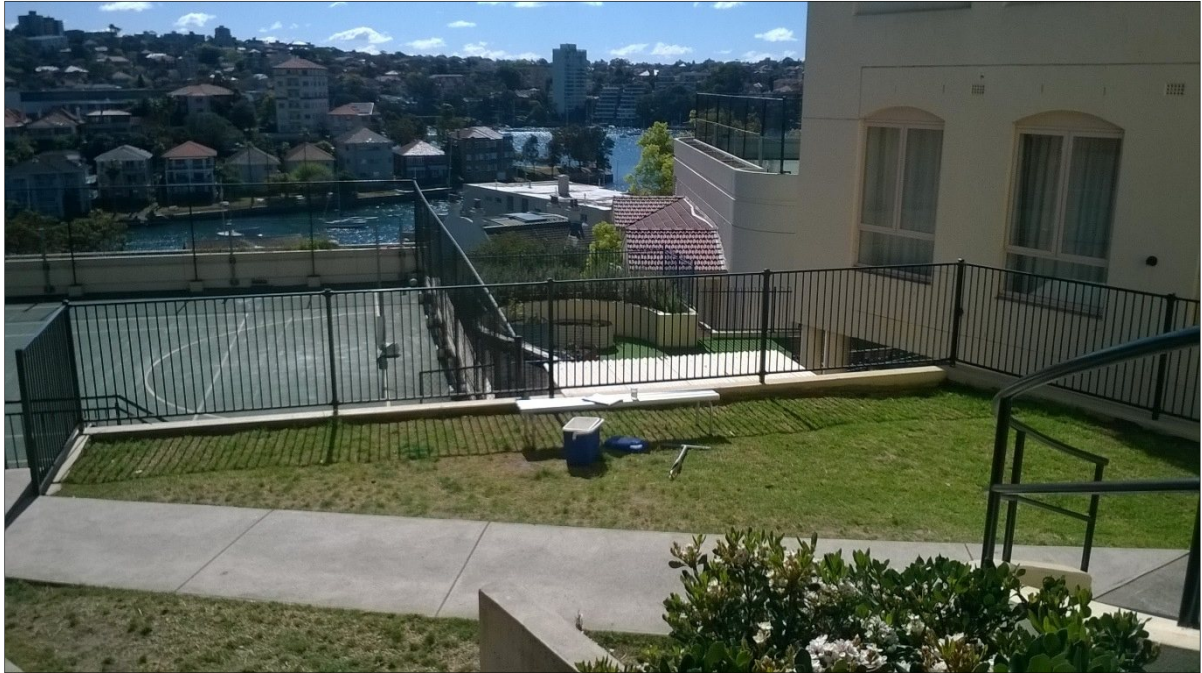
Plate 1: the location of BH4 between the Junior School and the Gymnasium.

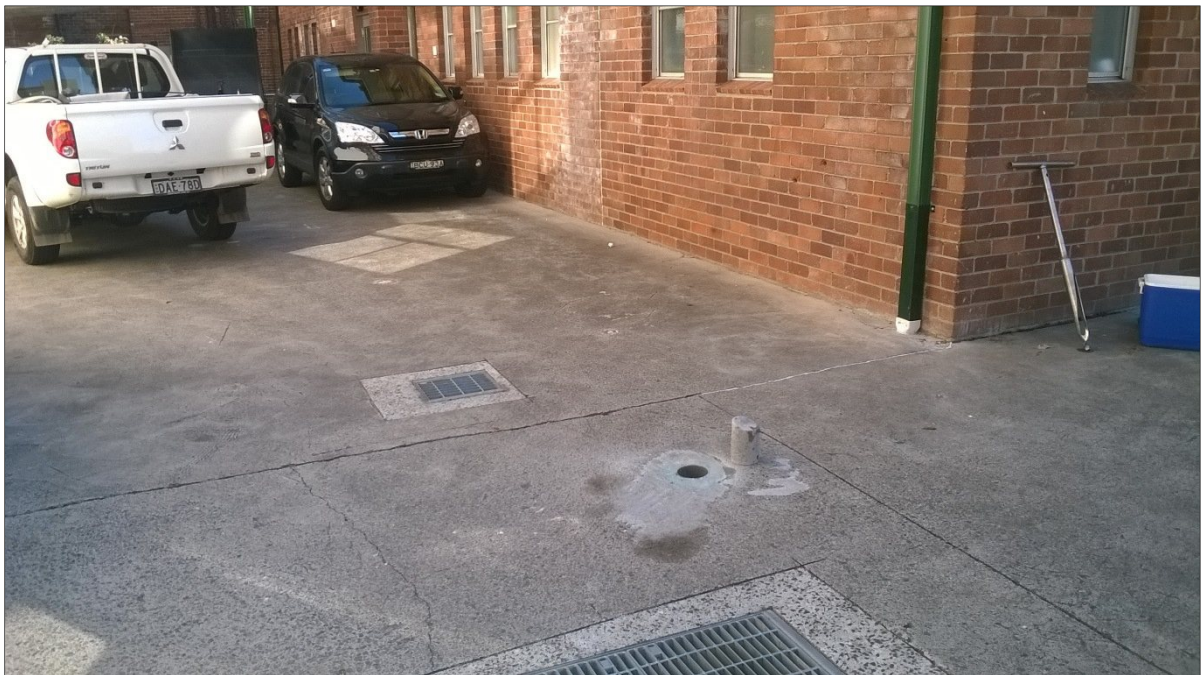
Plate 2: the location of BH5 between the Marian Centre and B-Block. BH2 and BH3 were drilled close to this area

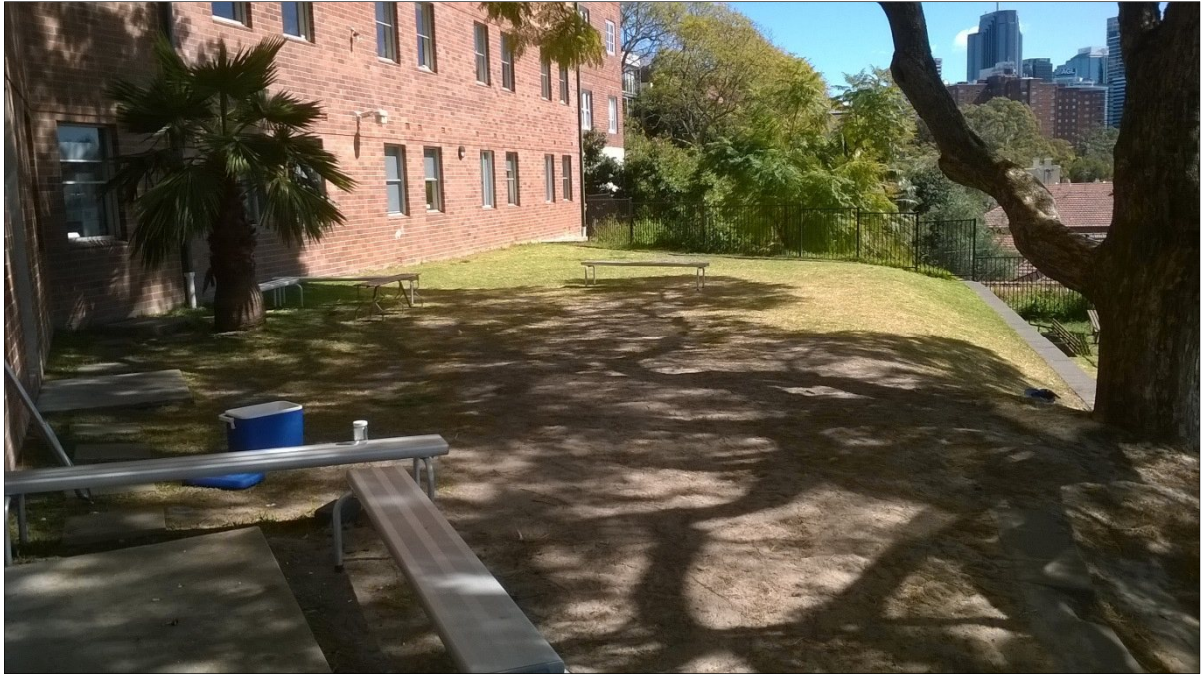
Plate 3: the grassy area where BH6 and BH7 were located, viewed facing west with B-Block in the left of the photograph.

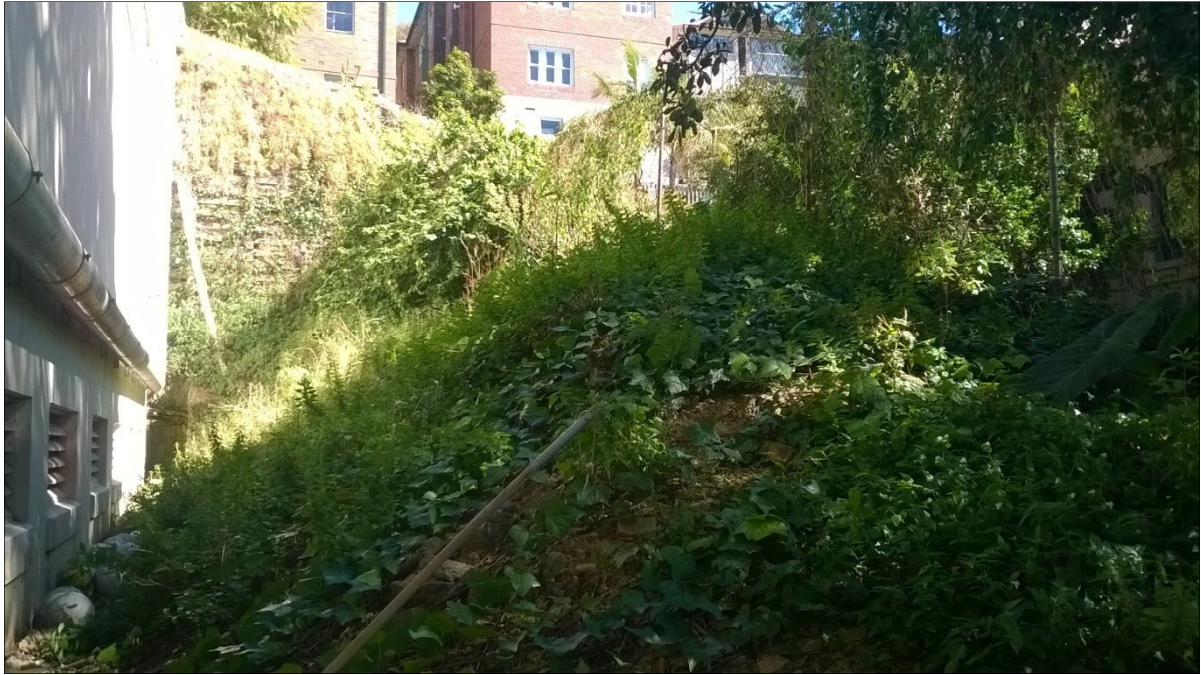
Plate 5: the fill mound located to the west of the Gymnasium, where BH9 was located.

Potential contamination sources at the site include imported fill material, the use of pesticides and hazardous building materials. Soil samples were collected from 10 sampling points and analysed for contaminants of potential concern. The subsurface conditions at the site generally consisted of relatively shallow fill material directly overlying sandstone bedrock or concrete slabs. A stockpile of fill material was located to the west of the Gymnasium.
