Re: Loreto Kirribilli—Response to Submissions SSD 7919

the building, with particular consideration given to the theatre as the most significant space within the building.

Theatre

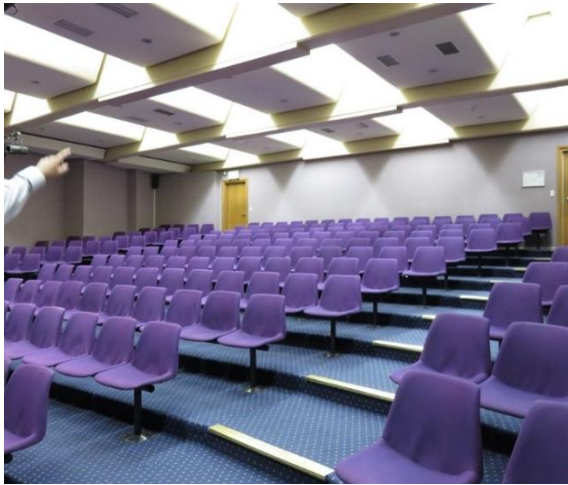
Figure 3 Interior of the Theatre. (Source: GML, November 2016)

Additional research has shown that few of the building's original interior qualities remain intact in the current theatre. The original space was constructed as a multipurpose hall, designed to be used for 'concerts, workshops and gymnasium work'¹ (Figure 1). The hall had a flat floor, windows along its northern and southern sides, and a stage at the eastern end of the room. The multipurpose hall was later subjected to substantial alterations. It was divided—most likely in the late 1990s—into two main spaces, with the western portion becoming a drama studio and the eastern portion refurbished to become the theatre (Figure 2). It is considered that many of the interior finishes and fixtures in the theatre date from this time, or later. Unlike the original multipurpose hall, the theatre has a stepped floor with fixed seating. Internal walls have been built inside the original eastern and western walls, and now form the walls that contain the space. The coffered ceiling was also likely to have been added at a later date, and carpet and seats are contemporary (Figure 3). The stage is located in the eastern part of the space, as per the original drawings, but appears to have been widened. In summary, the original design qualities of the space have been substantially compromised by later alterations.

This additional assessment of the significance of the interiors of the Mary Ward Building has concluded that the theatre was constructed as a later alteration to the original building. It contains little evidence of the original interior finishes or fixtures, and the space itself is substantially altered from the original multipurpose space.

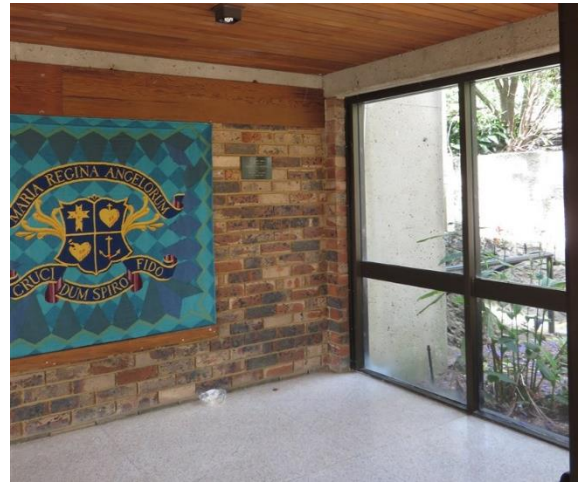
An assessment of this small entrance lobby has been undertaken as the form of the space and original finishes remain substantially intact (Figure 4). Original fabric includes the timber boarded ceiling, terrazzo floor and timber handrails. Original aluminium framed windows remain intact. However, the space does not have particular architectural or design merit. Whereas it provides evidence of the original interior finishes, it is not of significance as an interior space. The finishes are typical for their time, and are without notable design qualities. A plaque within the space commemorating the construction of the building is the only item considered to be of heritage significance.

Figure 4 Interior of the Western Entry Lobby. The original interior is intact but is not of particular architectural or design merit. (Source: GML, November 2016)

The western entry lobby remains as an intact example of the original interior of the building. It provides evidence of an interior that was typical for its era, without notable architectural or design merit.

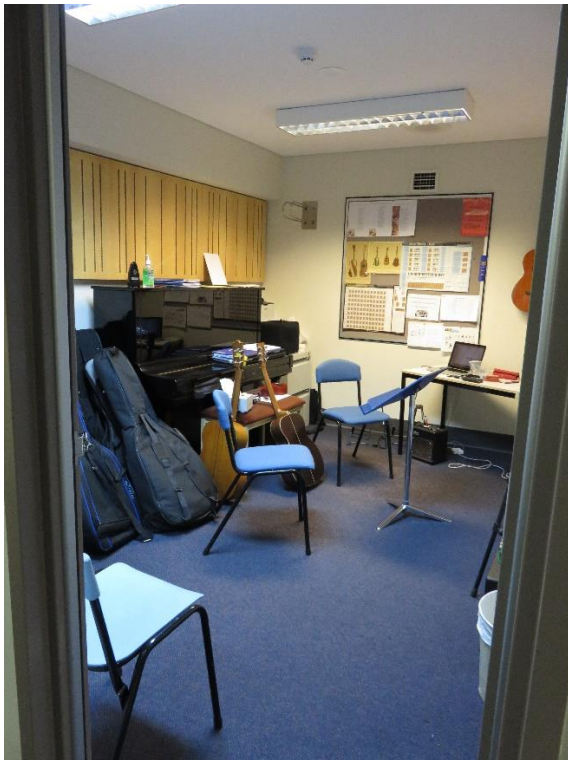
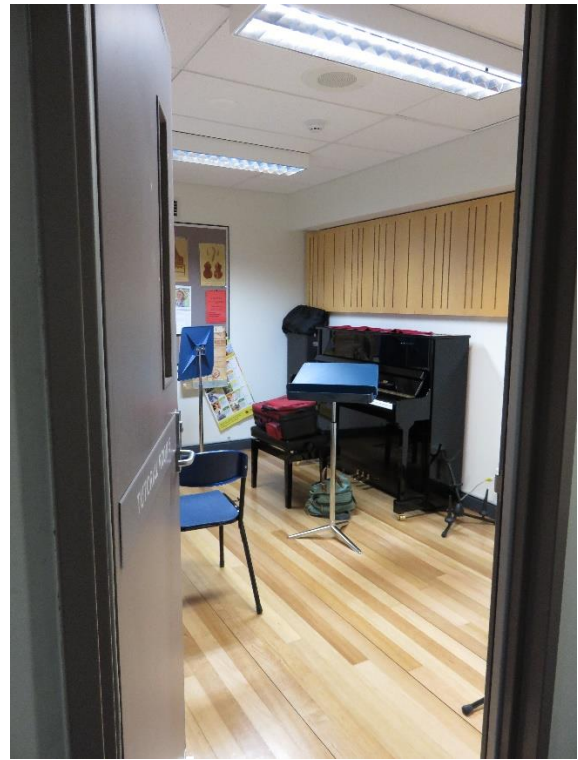
The spaces within the building's undercroft were repurposed as music practice rooms in conjunction with the construction of the Music and Performing Arts Building, with interiors completely renewed (Figures 5 and 6). The building's upper floor contains classrooms. Finishes in these rooms have been updated over time as needed.

Figure 5 Interior of a music practice room in the building's undercroft. (Source: GML, November 2016)

Figure 6 Interior of a music practice room in the building's undercroft. (Source: GML, November 2016)
