# GEOTECHNICAL SITE INVESTIGATION

**Project** : 1-3 REID STREET & 2-4 WOODSIDE AVE, LINDFIELD NSW  
**Client** : CPDM  
**Date** : 12 March 2025  
**Report No** : NE1995  
**Revision** : 2

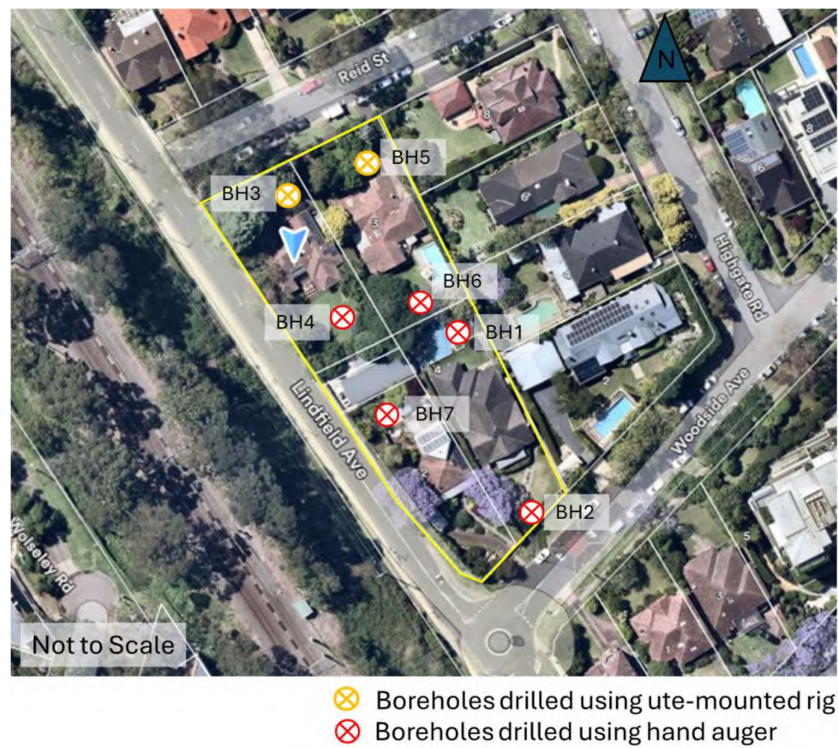
**Figure 2. Borehole locations.**

A summary of the borehole drilling investigation is presented below in Table 1. The borehole locations are shown in Figure 2.

The fieldwork for the geotechnical site investigation was conducted on 04<sup>th</sup> November 2024. The fieldwork included drilling a total of seven (7) boreholes across the site. During the investigation, the existing residential structures remained in place, necessitating the use of a combination of Ute-mounted drilling equipment and hand tools, depending on site accessibility. Two (2) boreholes were drilled using a Ute-mounted drilling rig to the refusal depth, and the remaining five (5) boreholes were drilled to 1.4-1.7m depth using a hand auger (hand tool). Dynamic Cone Penetration (DCP) testing was performed adjacent to each borehole to determine the soil consistency and strength.

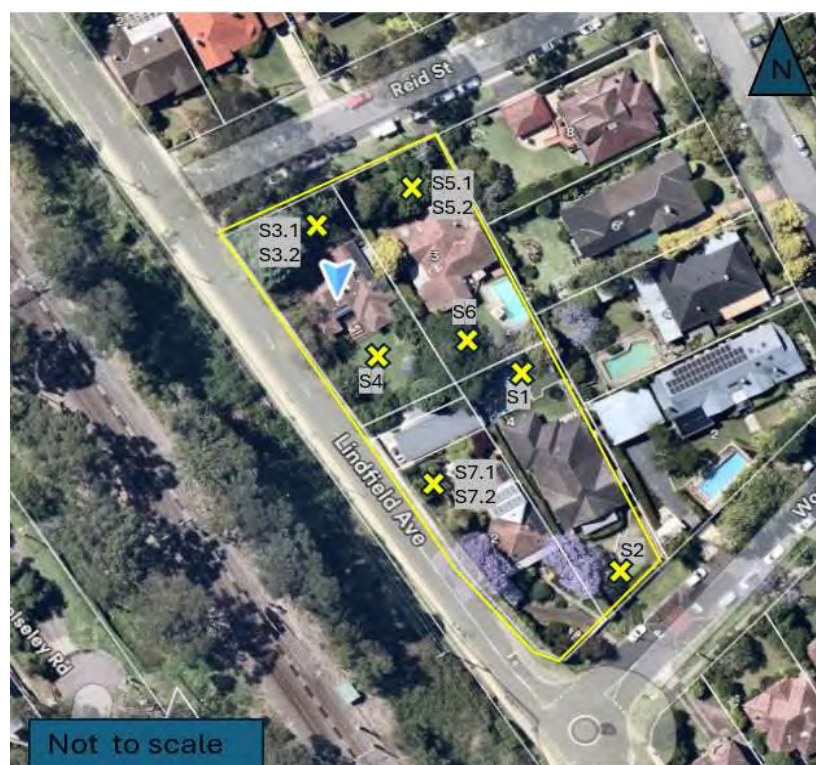
Figure 4. Salinity sampling locations.

Ten (10) soil samples were submitted to Eurofin MGT Laboratory, a NATA-accredited laboratory, for chemical tests for the salinity and aggressivity assessment. The testing was carried out for the aggressivity suite and to assess the exposure classification for the proposed development. The sampling locations are presented in Figure 4.
