# **ABORIGINAL OBJECTS DUE DILIGENCE ASSESSMENT**

1-3 Reid Street & 2-4  
Woodside Avenue Lindfield,  
NSW

Prepared for  
**CPDM**  
14 April 2025

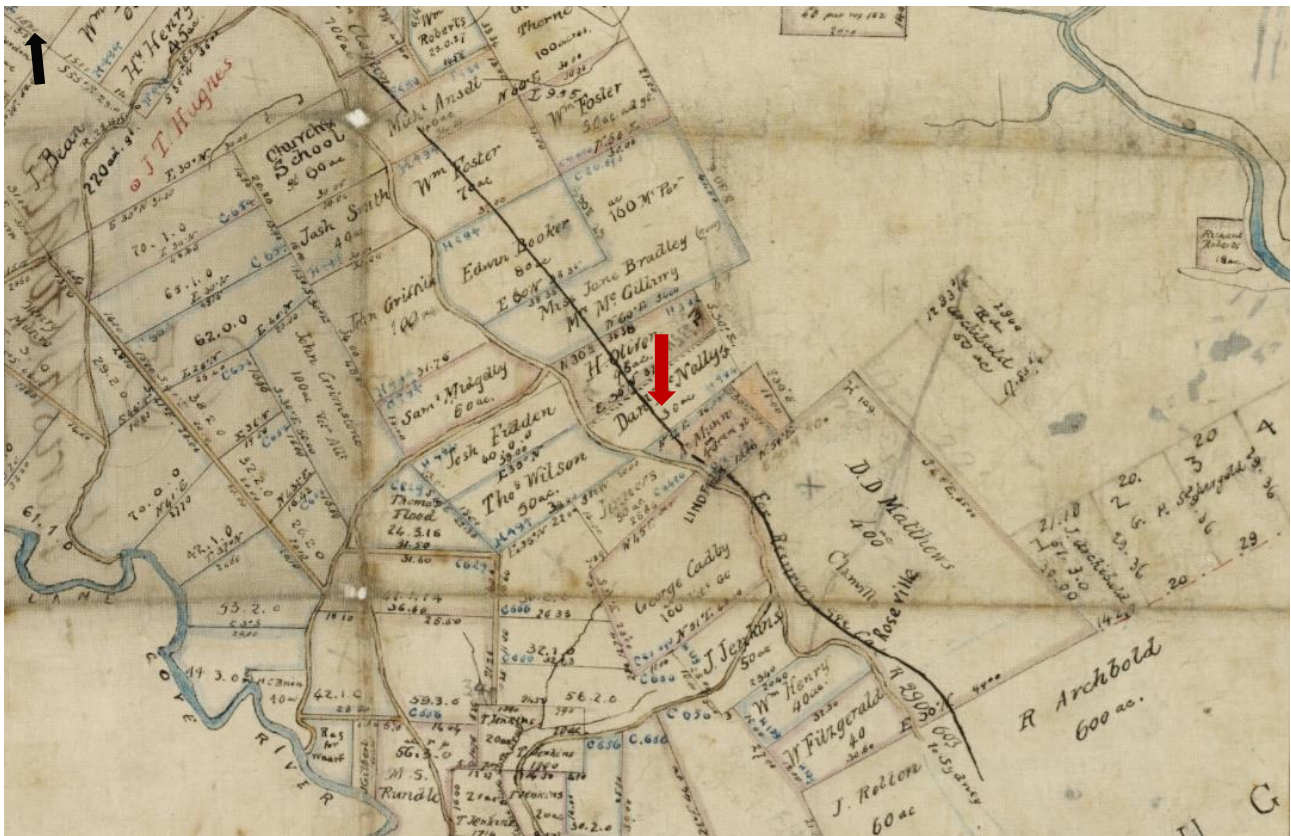
Figure 15 – 1840 map of the Gordon parish showing the approximate location of the subject area within Dan McNally's land grant indicated by the red arrow.

The Lindfield area was initially subdivided in the early 19<sup>th</sup> Century. The first identified map is noted as from 1840 showing the rapid development of the Lindfield and surrounding areas (Figure 15). The Pacific Highway was the main thoroughfare through North Sydney leading to northern NSW. The subject area is located within a 30-acre allotment of land granted to Daniel McNally. Broadly during this time Lindfield was subject to timber-getting and farming (Edwards and Rowland, 2012). It is therefore likely then that the main ground disturbing activities during this time would have been associated with the clearing of vegetation, timber felling and agriculture.

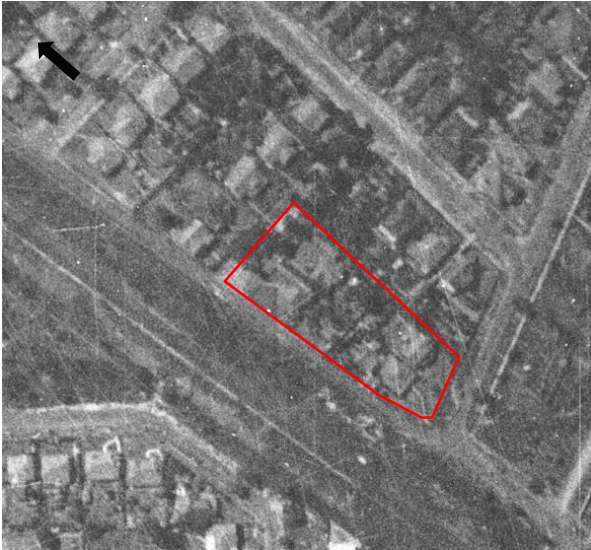
Figure 16 – 1930 aerial image of the subject area (outlined in red).

An aerial image from 1930 shows multiple residential buildings are located within separate lots within the subject area (Figure 16). These dwellings were likely constructed in the early 20<sup>th</sup> Century. In addition to the residential structures, driveways and fences were also established.

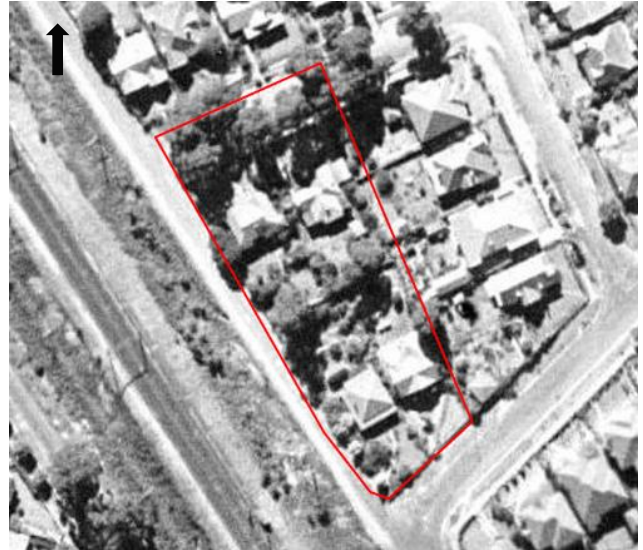
Figure 17 – 1943 aerial image of the subject area (outlined in red).

An aerial image from 1943 (Figure 17), shows little change over the following decade. However, there is evidence of landscaping in the garden spaces of properties. By 1986 (Figure 18), additional structures have been constructed in the rear yards of 1 Reid Street and 2 Woodside Avenue and vegetation. In the image from 2025 (Figure 19), further changes are observed. Swimming pools are evident within 3 Reid Street and 4 Woodside Avenue. A detached secondary dwelling had also been constructed.

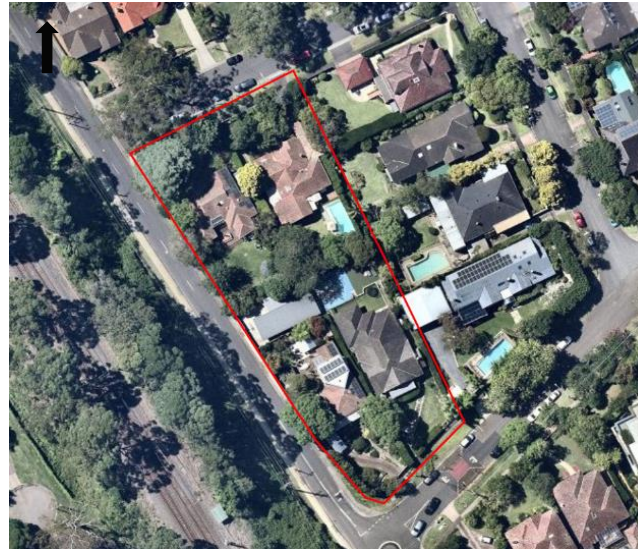
Figure 19 – 2025 aerial image of the subject area (outlined in red).

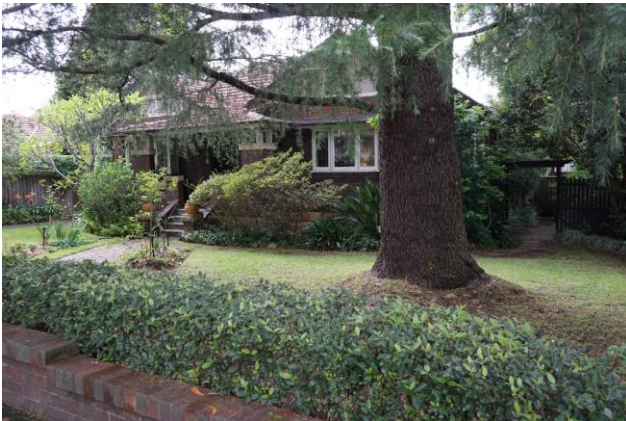
Figure 20 – Front yard at No. 1 Reid Street – view southeast.

The visual inspection confirmed that the entire site has been subject to various degrees of disturbance including the construction of the existing dwellings (Figure 20 and Figure 21), a pool located on the rear yard of No. 3 Reid Street (Figure 22) and evidence of cut and fill located at the rear yard of No. 4 Woodside Avenue (Figure 23). Heavy landscaping was evident throughout the site with young and mature planting suggesting a high level of bioturbation (Figure 24 and Figure 25). Various service pits, drainage systems and plumbing connections were also identified (Figure 26). A stormwater manhole outside the southern boundary of the site was also identified that appears to have truncated the prior creek line (Figure 27).
