## **Supplementary Remediation Action Plan**

URBNSURF Sydney Project  
Corner Hill Road and Holker Busway, Sydney Olympic Park NSW  
URBNSURF Sydney Pty Ltd  
P034987.007  
Version D | December 2022

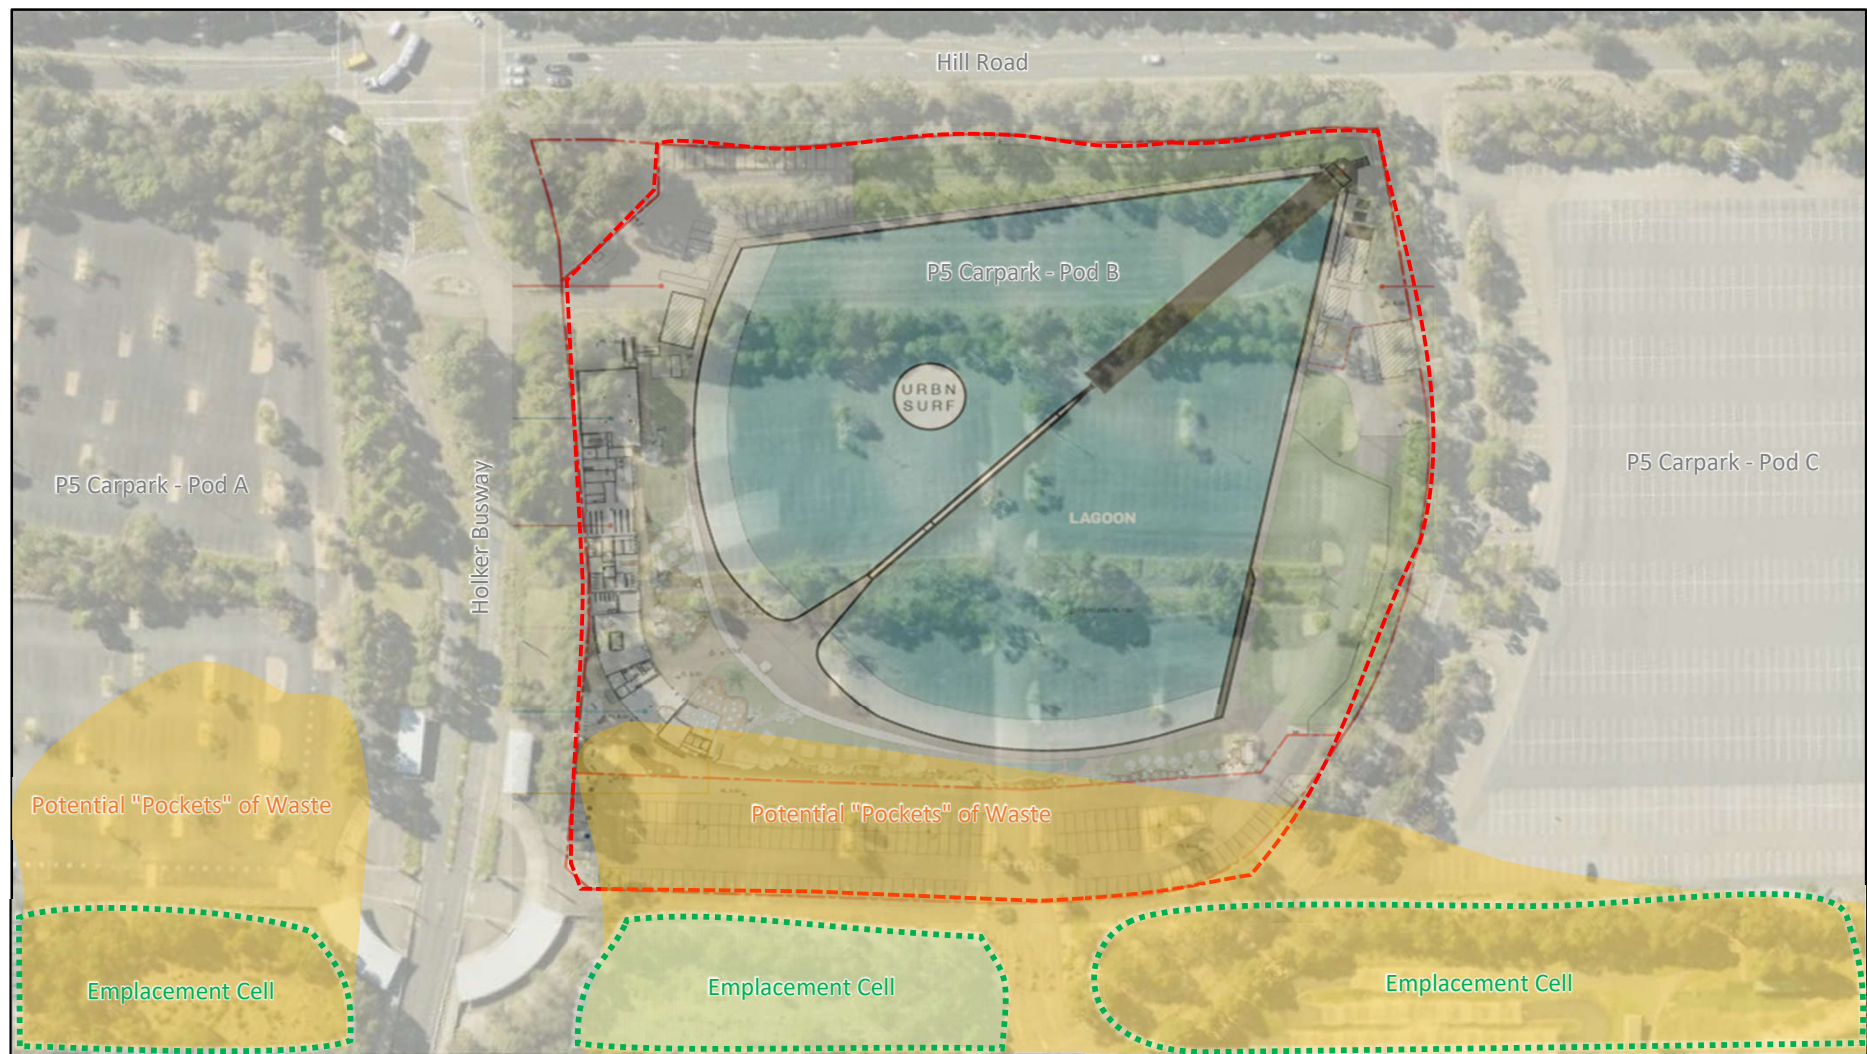
**Figure Number:** 2

**Figure Name:** Site Layout

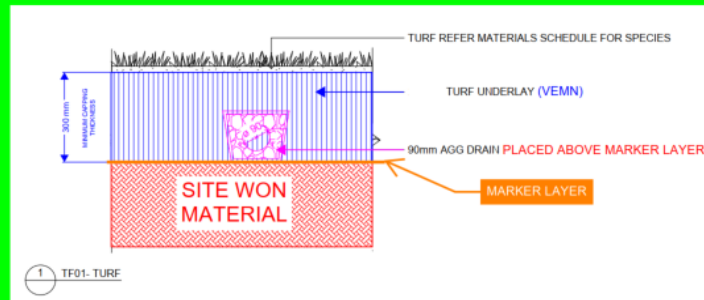
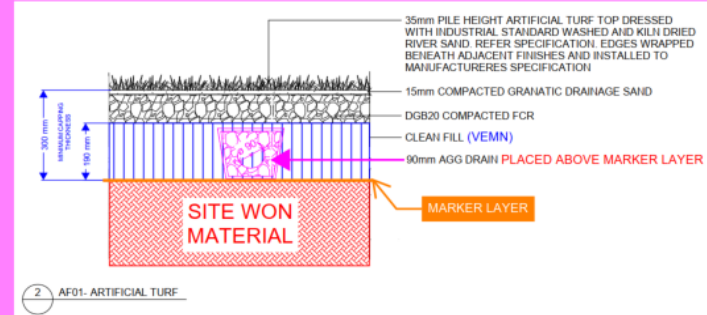
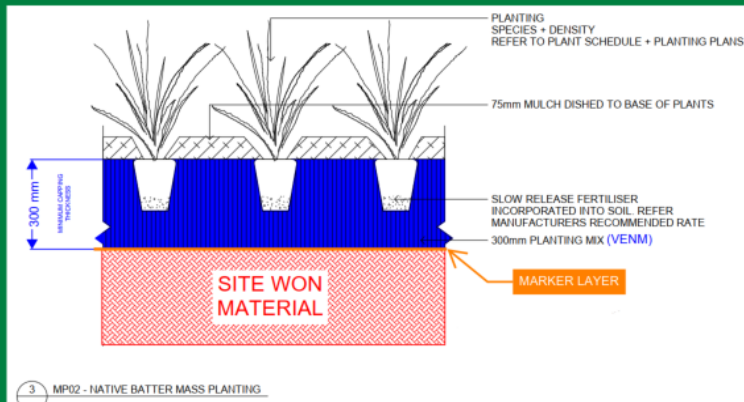
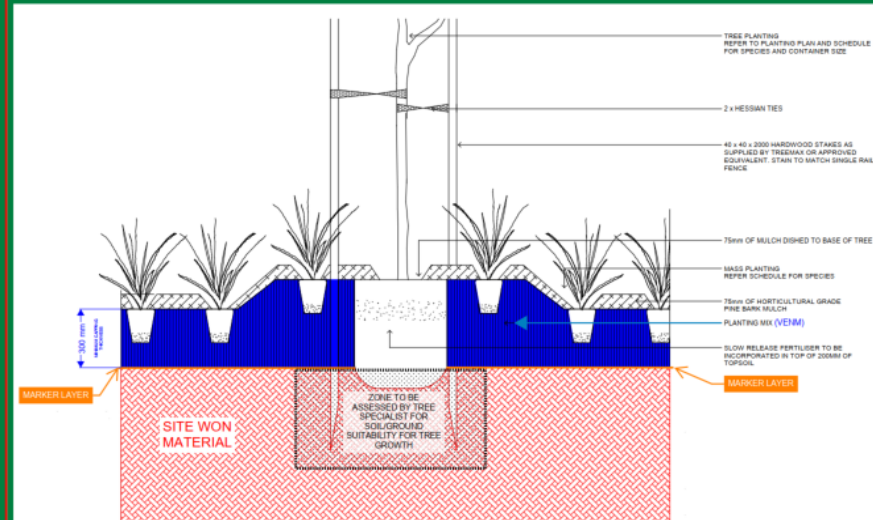
**Figure Number:** 5

## NATURAL TURF

## ARTIFICIAL TURF

## MASS PLANTING

## TREES & MASS PLANTING

**Figure Name:** Typical Capping Details

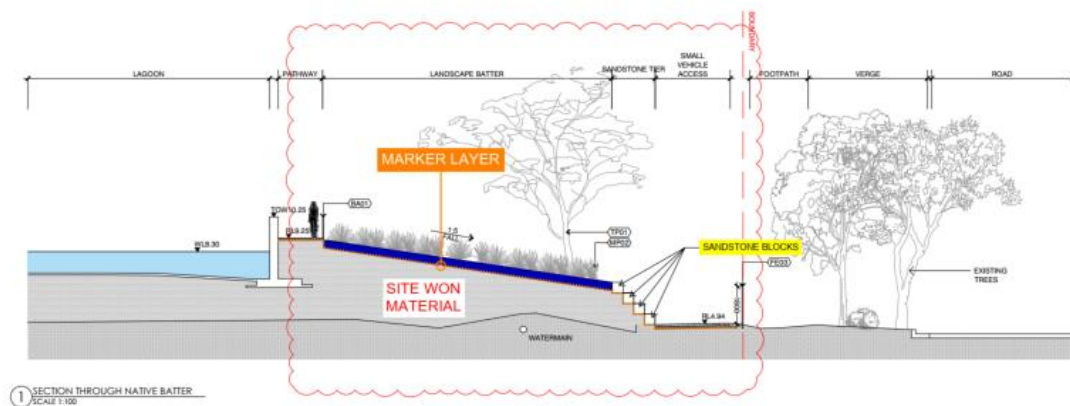
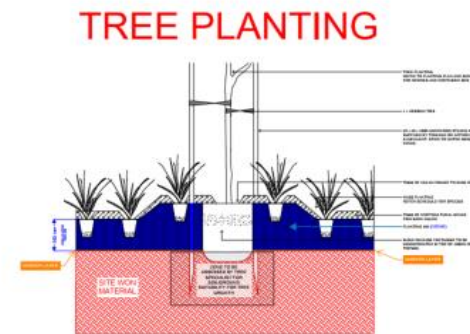
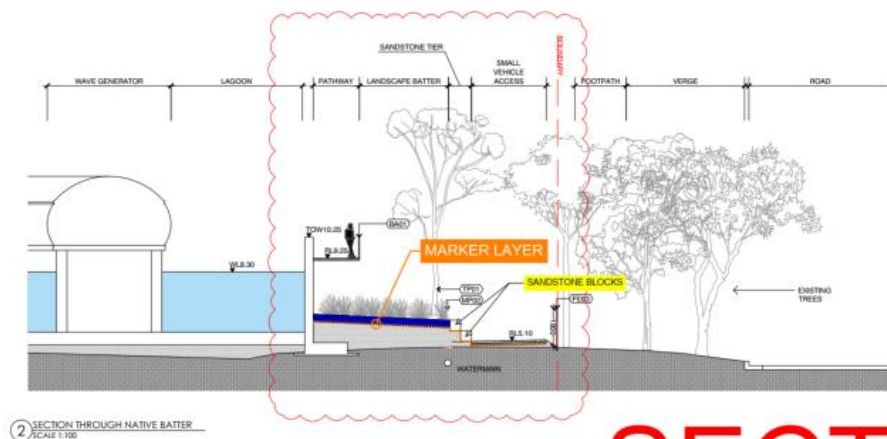
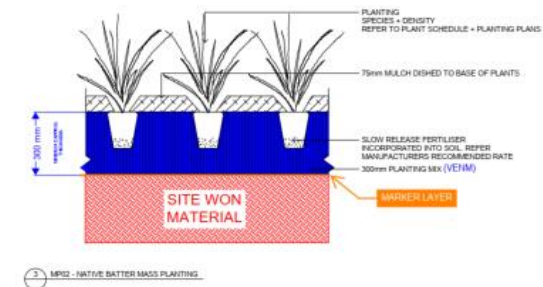
# SECTION 3

## MASS PLANTING (GENERAL)

Image courtesy of Oculus, 2022, Drawing L603

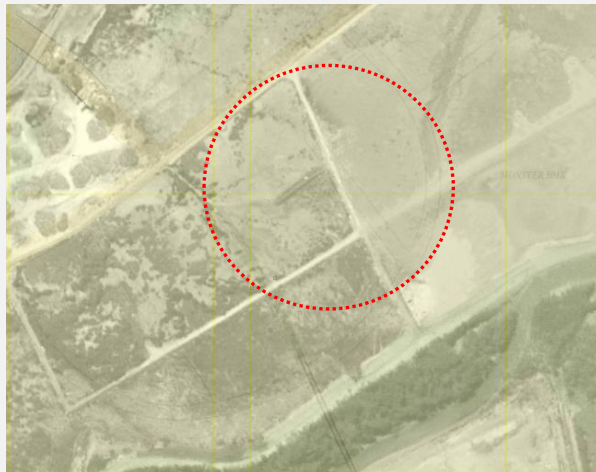
**1970:** Land reclamation works apparent.

A review of historical aerial images provided in **Appendix B** confirms the original site setting, key milestones and location of emplacement cells outside the site boundary.

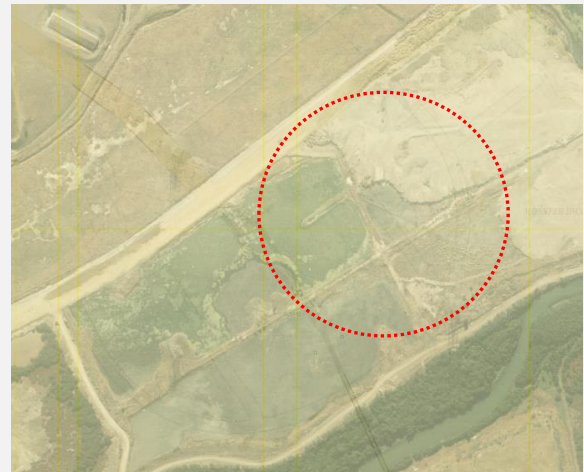
**1986:** Land reclamation works and uncontrolled tipping apparent.

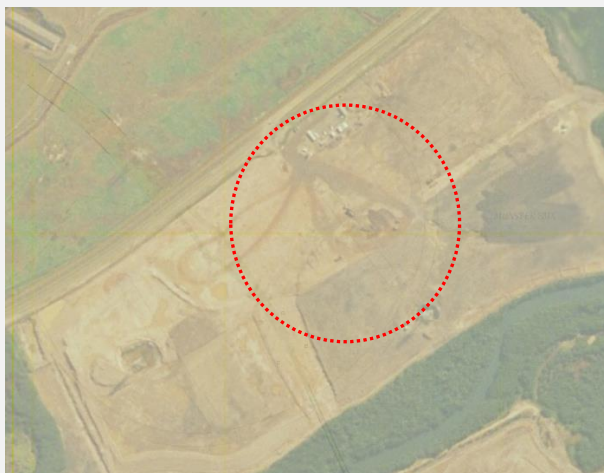
**1996:** Imported fill to raise the ground level during the remediation of Haslam's Reach.
