# Honeman Close, Huntingwood, NSW

Goodman Property Services (Aust) Pty Ltd (SSD 79500208)

## Remedial Action Plan

68310 | 165,577 (Rev 1)

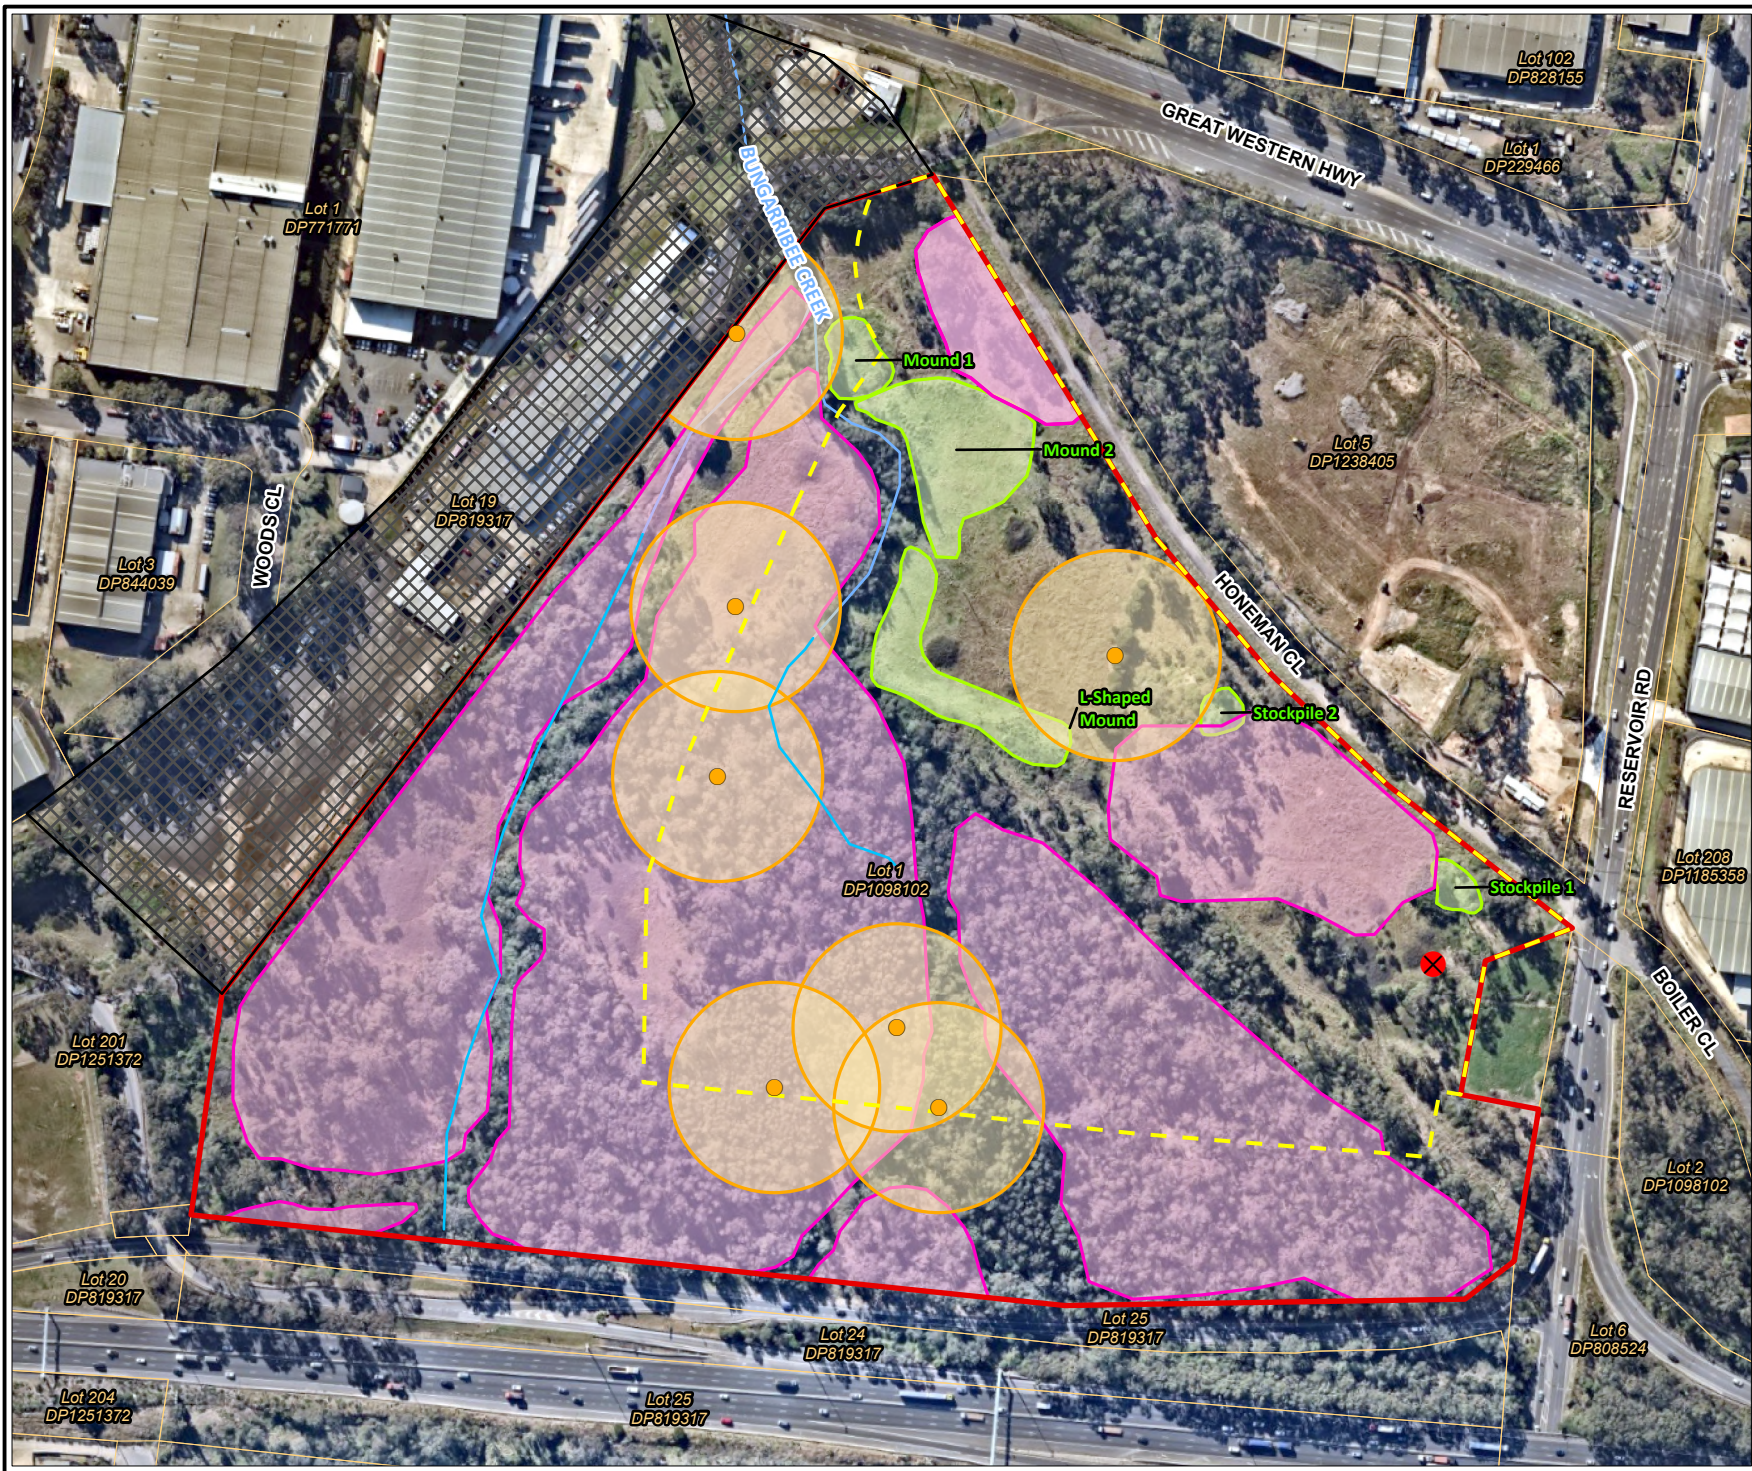
**FIGURE 2**

**SITE LAYOUT**

The ground surfaces within the northern portion of the site were observed to be covered in a mixture of thick grass, some open woodland/eucalypt vegetation (within the northern Areas of Ecological sensitivity, as marked on **Figure 2**), and a number of fill mounds (Mound 1, Mound 2, and the L-shaped Mound) as shown in **Figure 2**. Mound 1 was observed to be between approximately 2 to 3 m high and was covered in thick grass. North of mound 1, an existing groundwater well was also observed to be present (stickup PVC pipe).

All three of the above-mentioned mounds were observed to be situated to the east of a surface water tributary associated with Bungarabee Creek, as shown on **Figure 2**. The creek and associated drainage channel were observed to be covered with dense vegetation, including bullrush, cattails, and reeds. The banks of the tributary in the northern and centre portion of the site were also observed to be between approximately 1 and 2 m deep. Most areas along the creek were inaccessible due dense vegetation present along access trails and the banks of the creek. Where water was visible, water appeared to be flowing and clear, with the exception of the low-lying wetlands in the centre of the site, where water appeared to be stagnant.

Additionally, a suspected septic tank was also observed by client commissioned surveyors working on-site. This feature had previously been observed during historical investigations, as noted in **Section 4.2** below. The approximate location of the septic tank is shown in **Figure 2**.

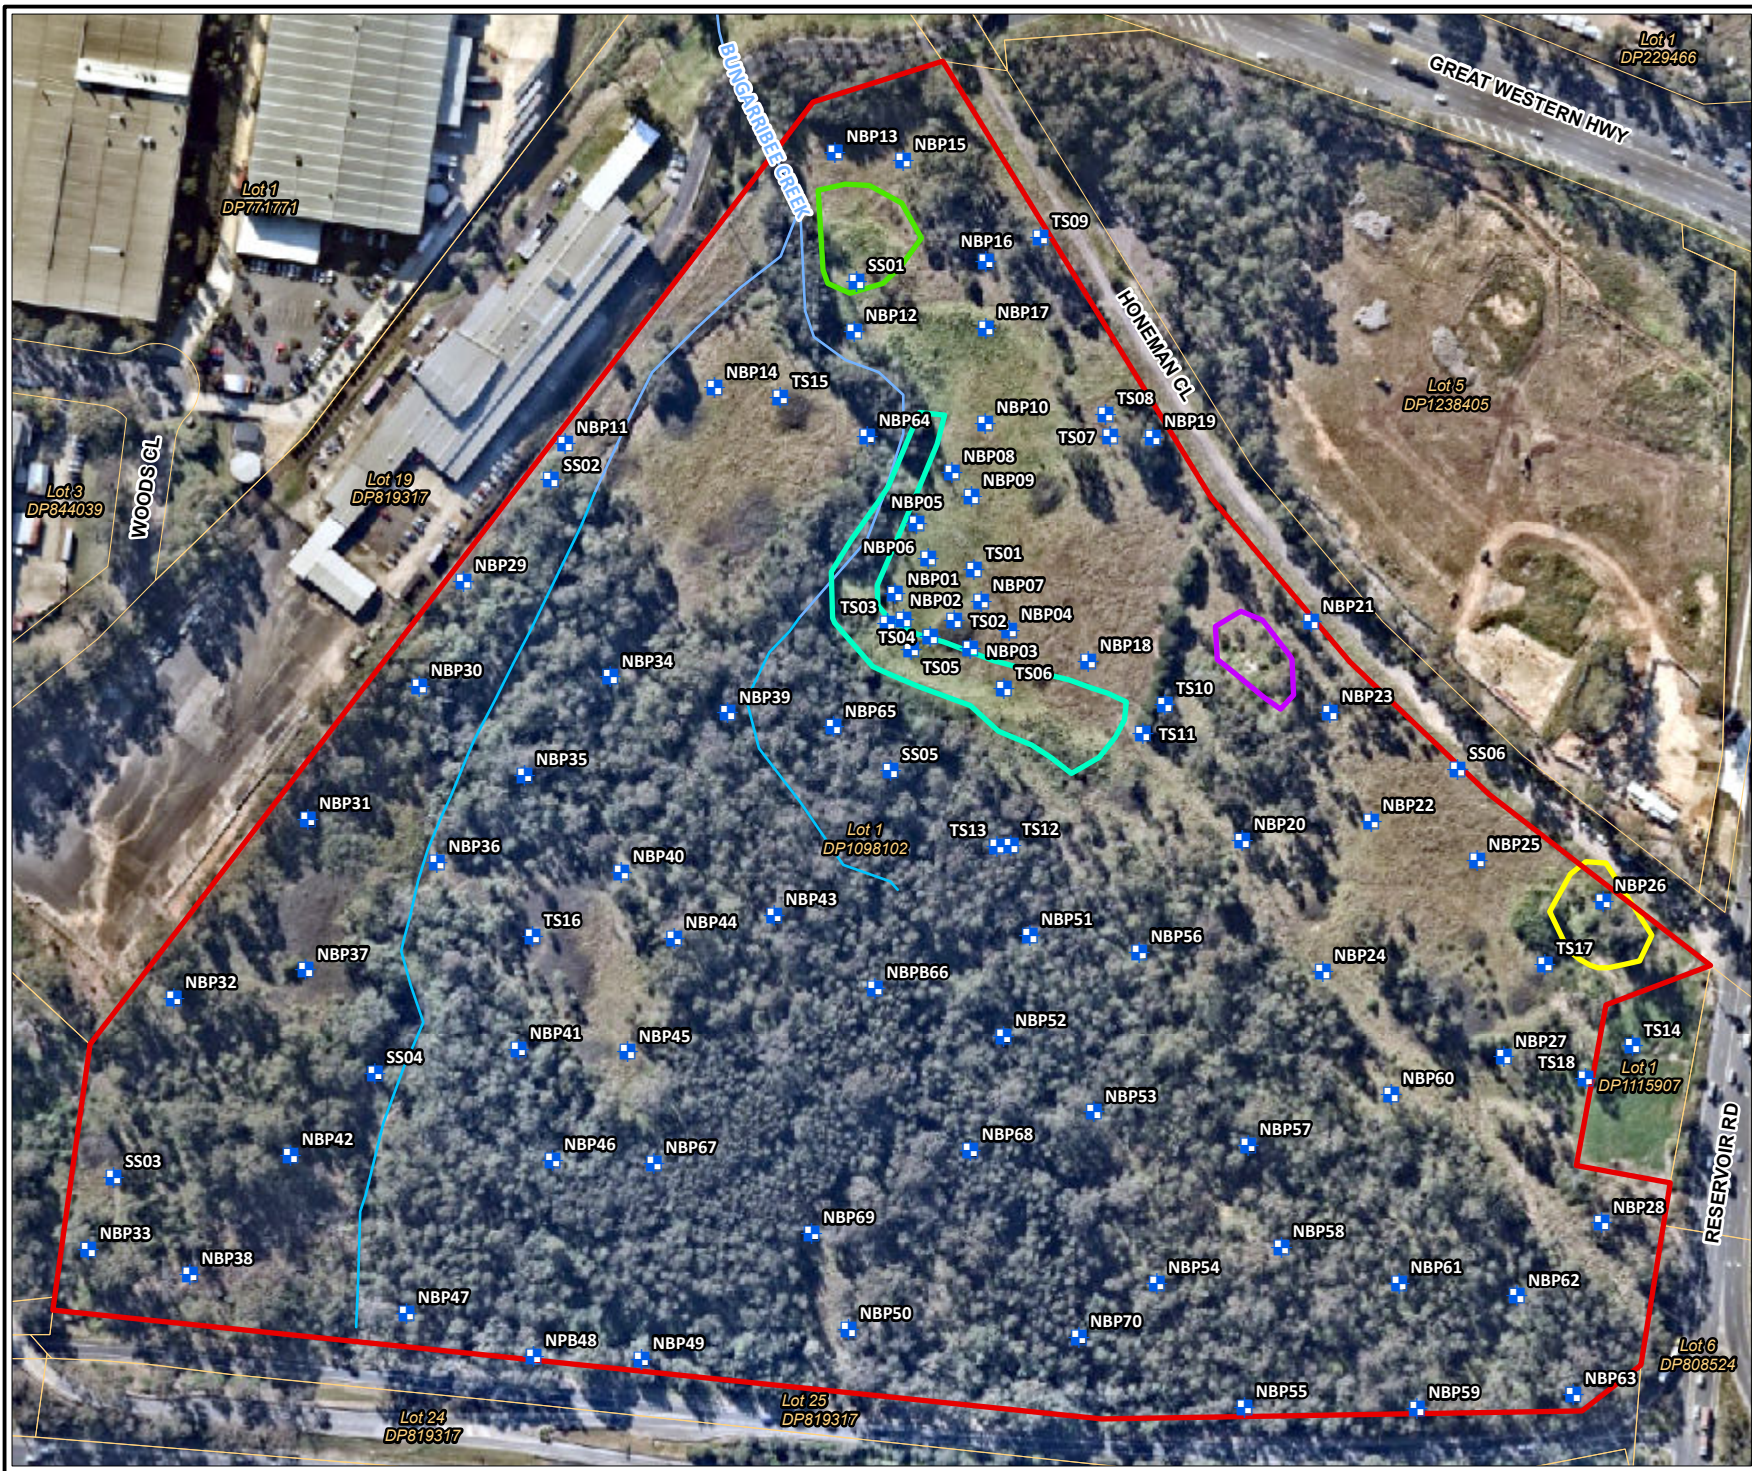
FIGURE 3

**HISTORICAL SAMPLE LOCATIONS AND  
SITE LAYOUT**

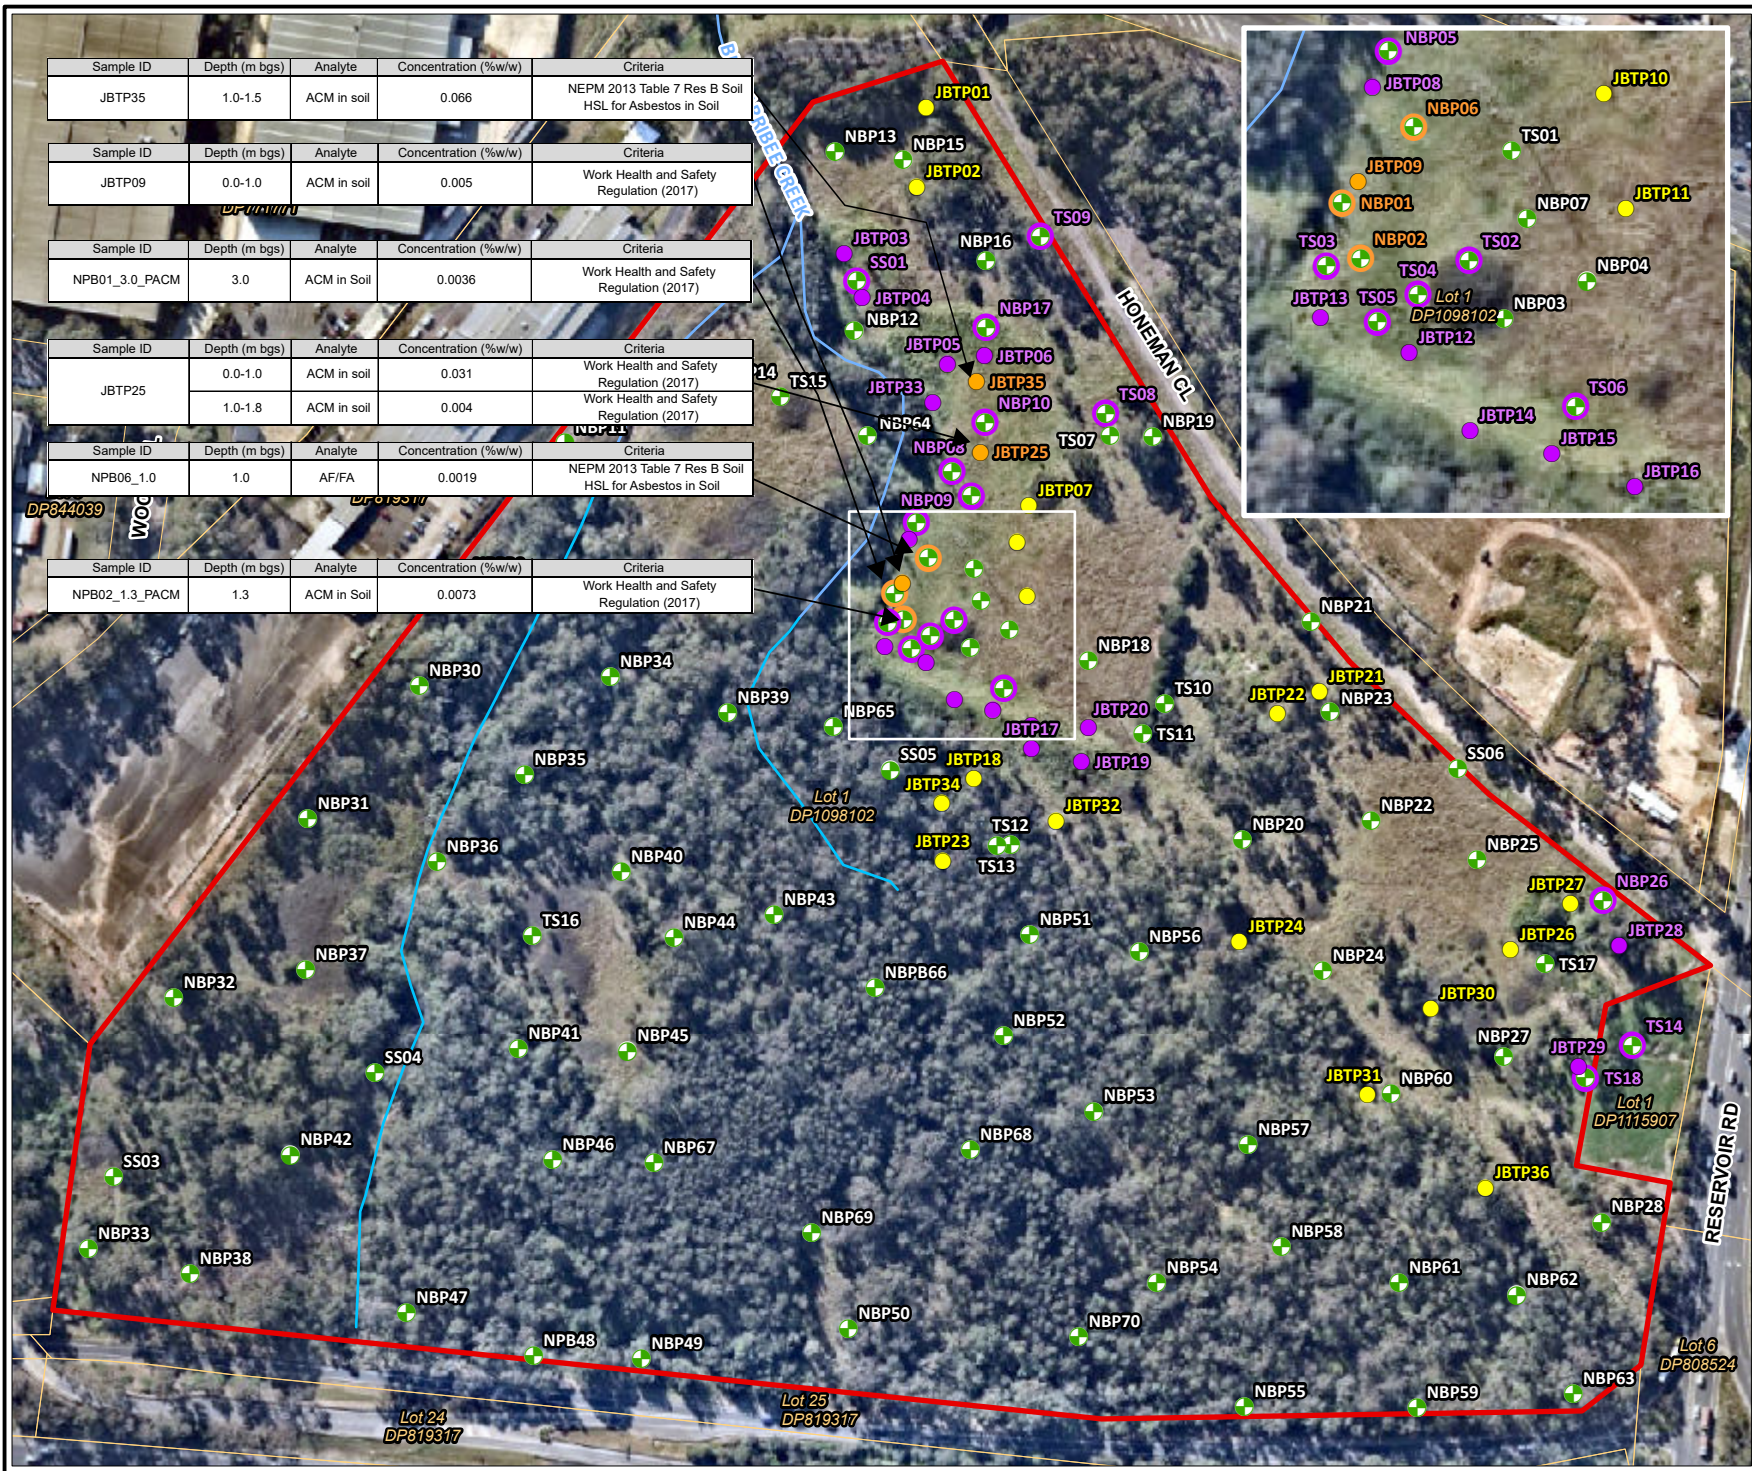
FIGURE 5

Sample ID	Depth (m bgs)	Analyte	Concentration (%w/w)	Criteria
NPB06_1.0	1.0	AF/FA	0.0019	NEPM 2013 Table 7 Res B Soil HSL for Asbestos in Soil

Sample ID	Depth (m bgs)	Analyte	Concentration (%w/w)	Criteria
NPB02_1.3_PACM	1.3	ACM in Soil	0.0073	Work Health and Safety Regulation (2017)

**SOIL EXCEEDANCES**

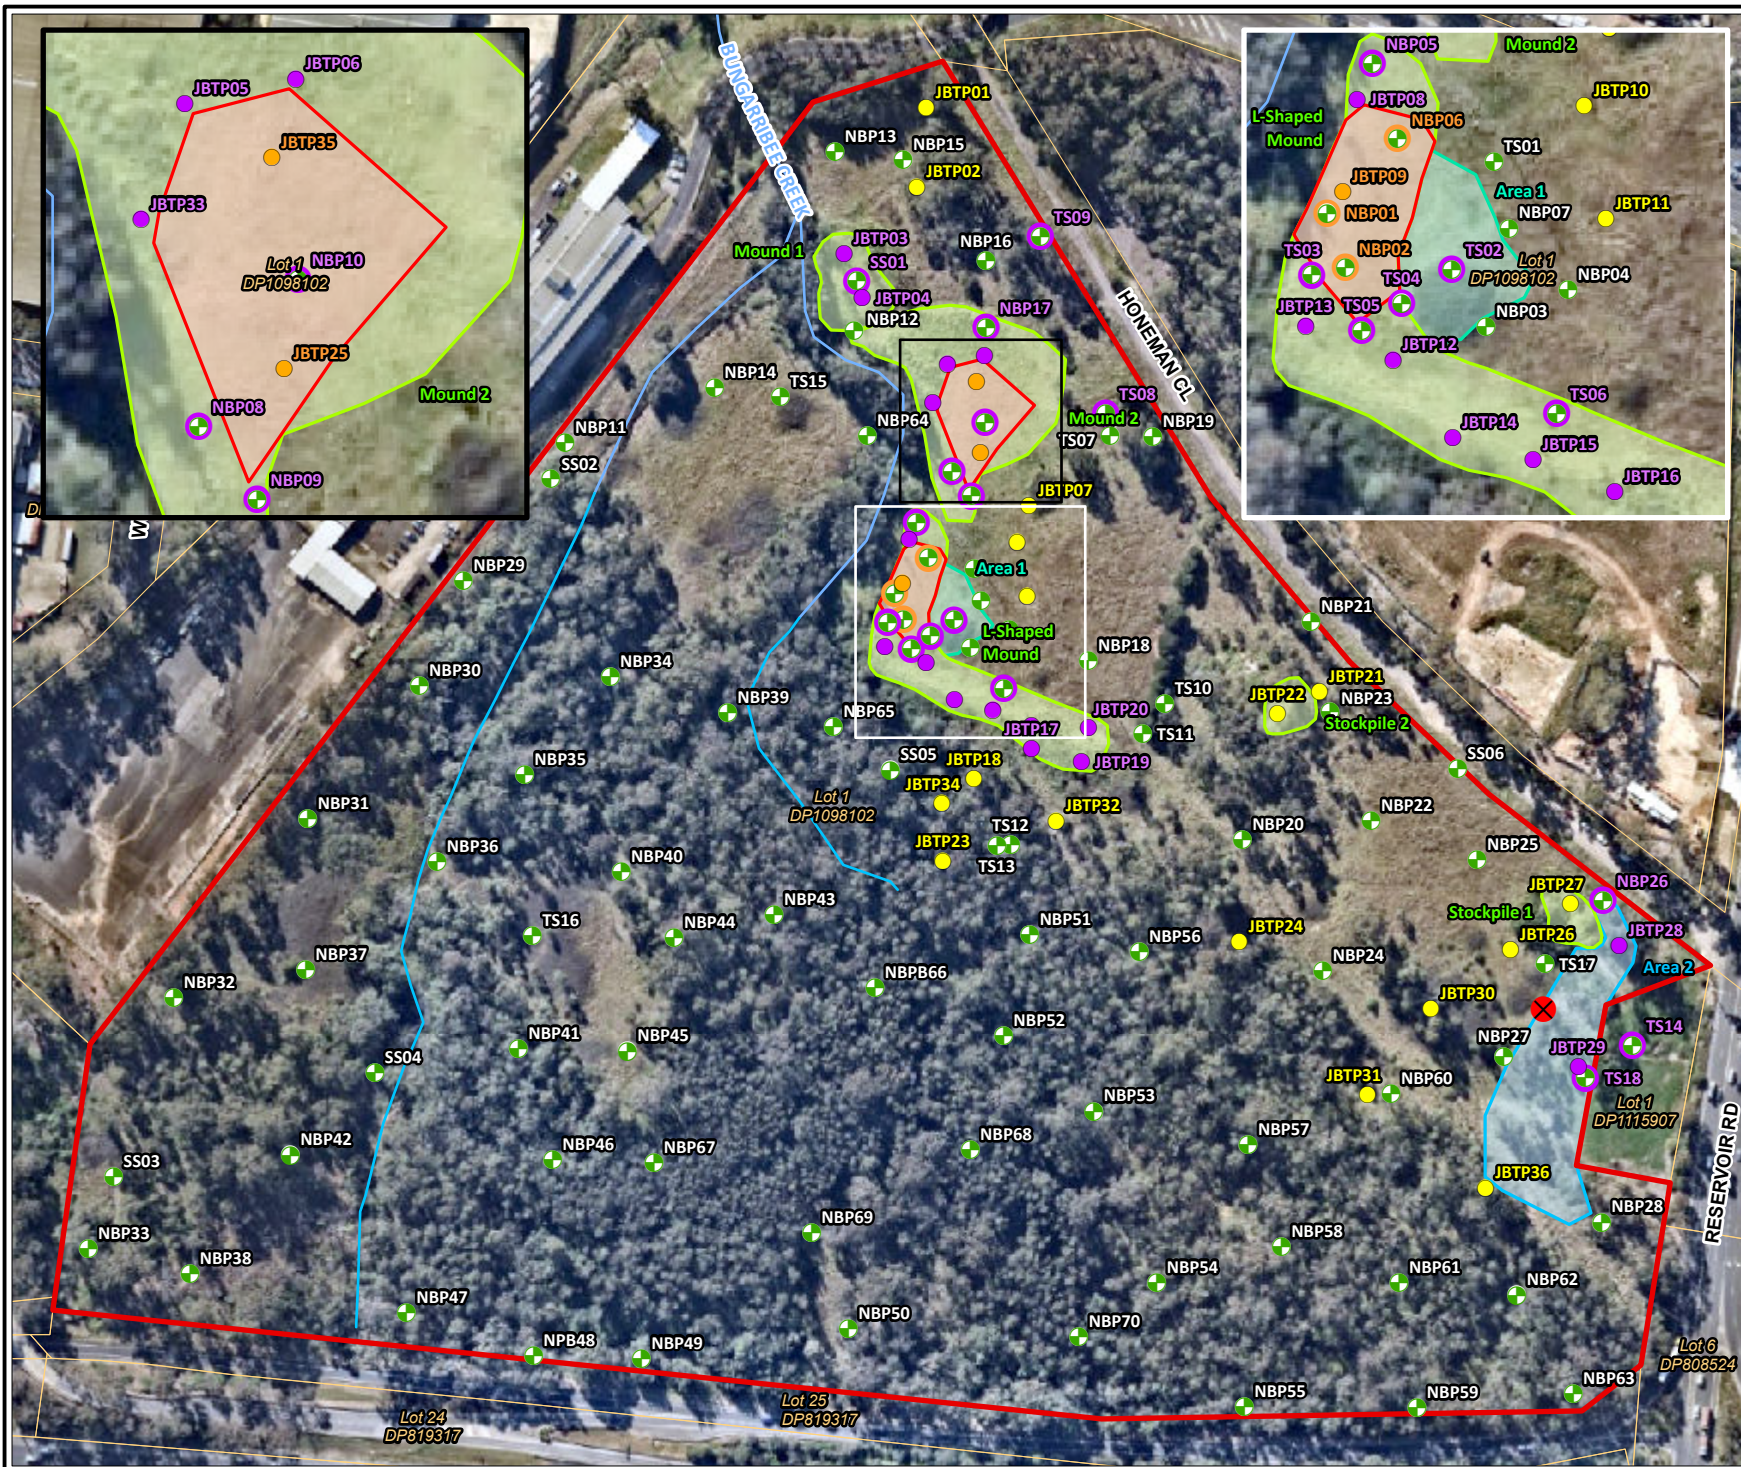
- Legend
- ▬ Approximate Site Boundary
  - ▬ NSW Cadastre
  - ▬ Hydro Line
  - ▬ Approximate Creek Location
  - ▭ Area 1 (Inferred Extent of B&D Rubble)
  - ▭ Area 2 (Inferred Extent of B&D Rubble)
  - ▭ Mound/Stockpile
  - ⊗ Known Asbestos Impact
  - ⊗ Approximate Location of Septic Tank
- Historical Sample Locations CH2M Hill 2015b
- ⊕ Asbestos Observed or Reported
  - ⊕ B&D Rubble
  - ⊕ Test Pit Location
- Sample Locations (JBS&G 2024)
- Asbestos Observed or Reported
  - B&D Rubble
  - Soil Test Pits

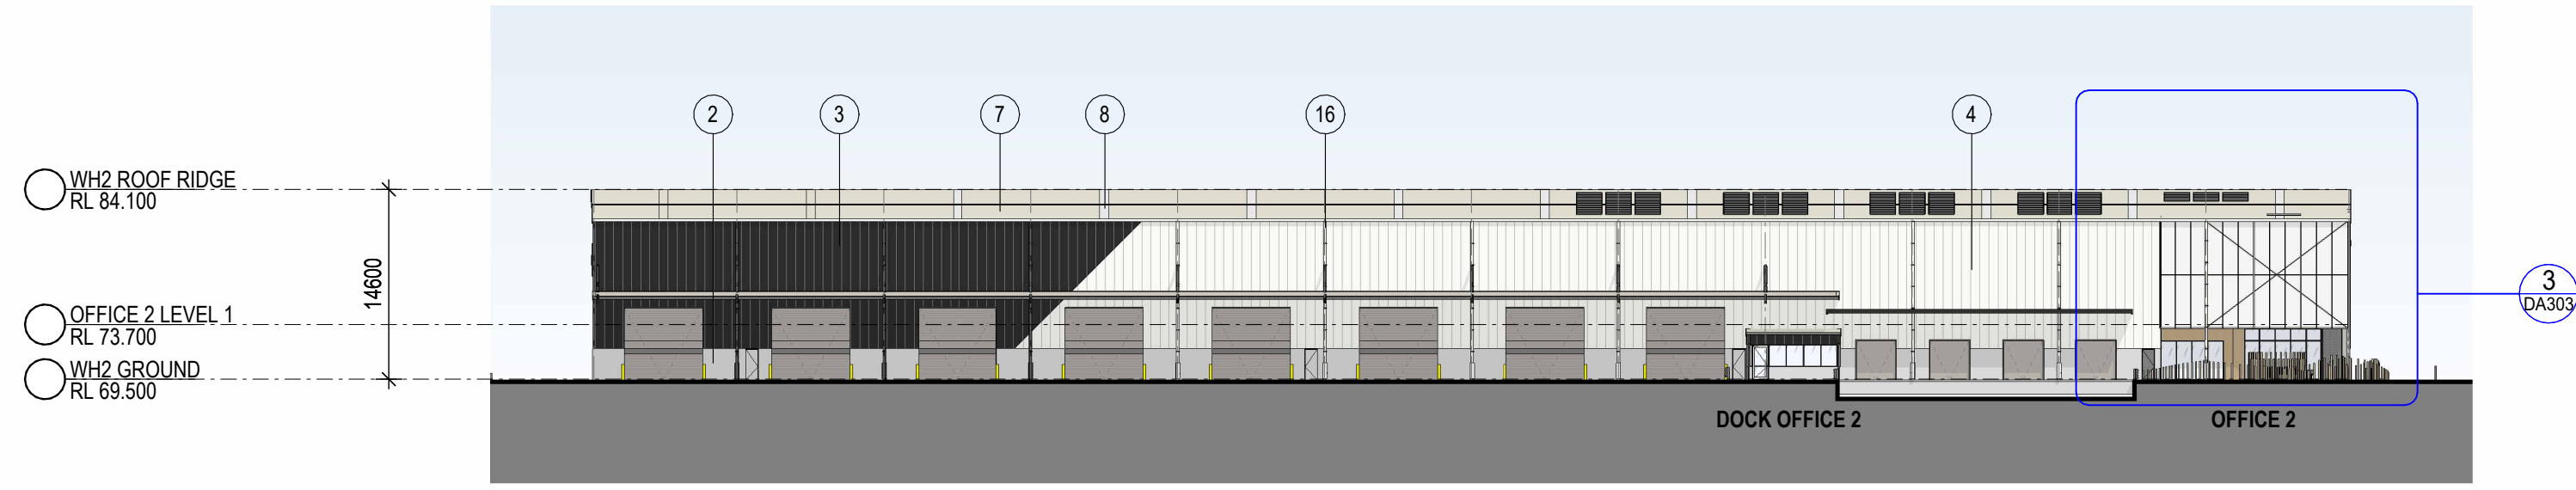
1 WAREHOUSE 2 - EAST ELEVATION 1 : 500

1. <b>BLOCKWORK</b> - EQUAL TO AUSTRAL BLOCK 'ARCHITEC' - HONED - CHARCOAL' 390 X 190 X 190mm - STACK BOND PATTERN - COLOUR-MATCHING FLUSH MORTAR JOINTS	2. <b>PRECAST CONCRETE PANEL</b> - OFF-FORM FINISH	3. <b>PREFINISHED METAL WALL SHEET CLADDING</b> - COLORBOND 'MONUMENT'	4. <b>PREFINISHED METAL WALL SHEET CLADDING</b> - COLORBOND 'DOVER WHITE'	5. <b>PREFINISHED METAL WALL SHEET CLADDING</b> - COLOURBOND 'SHALE GREY'	6. <b>PREFINISHED CFC CLADDING</b> - EQUAL TO 'EQUITONE - TECTIVA - GREY' 1200X2400mm - CONCEALED FIXING	7. <b>METAL DECK ROOFING</b> - COLORBOND 'DOVER WHITE'	8. <b>TRANSLUCENT ROOF SHEET</b> - OPAL COLOUR	9. <b>TIMBER LOOK METAL CLADDING</b> - SCULPTFORM ALUMINIUM CLICK ON PANELS	10. <b>GLAZING</b> - LIGHT GREY TINT OR SIMILAR	11. <b>PREFINISHED ALUMINIUM WINDOW FRAME</b> - COLORBOND 'MONUMENT'	12. <b>STEEL BALUSTRADE &amp; PANEL</b> - COLORBOND 'MONUMENT'	13. <b>METAL ROLLER SHUTTER</b> - PREFINISHED IN 'SHALE GREY'	14. <b>EXPOSED STEEL STRUCTURE &amp; STEEL AWNING</b> - COLORBOND 'SHALE GREY'	15. <b>SOLID DOOR LEAF</b> - TO MATCH 'SHALE GREY'	16. <b>DOWNPIPE</b> - COLOUR TO MATCH BACKGROUND CLADDING COLOUR	17. <b>POWDERCOATED METAL MESH IN STEEL FRAME</b> - COLORBOND 'DOVER WHITE'	18. <b>PAVER</b> - AUSTRAL BRICKS 230 x 76 x 5 mm - ALLOW 3 COLOURS AND PATTERNS	19. <b>TIMBER POSTS &amp; METAL OUTDOOR BENCHES IN CUSTOMISED FORM</b>	20. <b>LOUVRE DOOR</b>

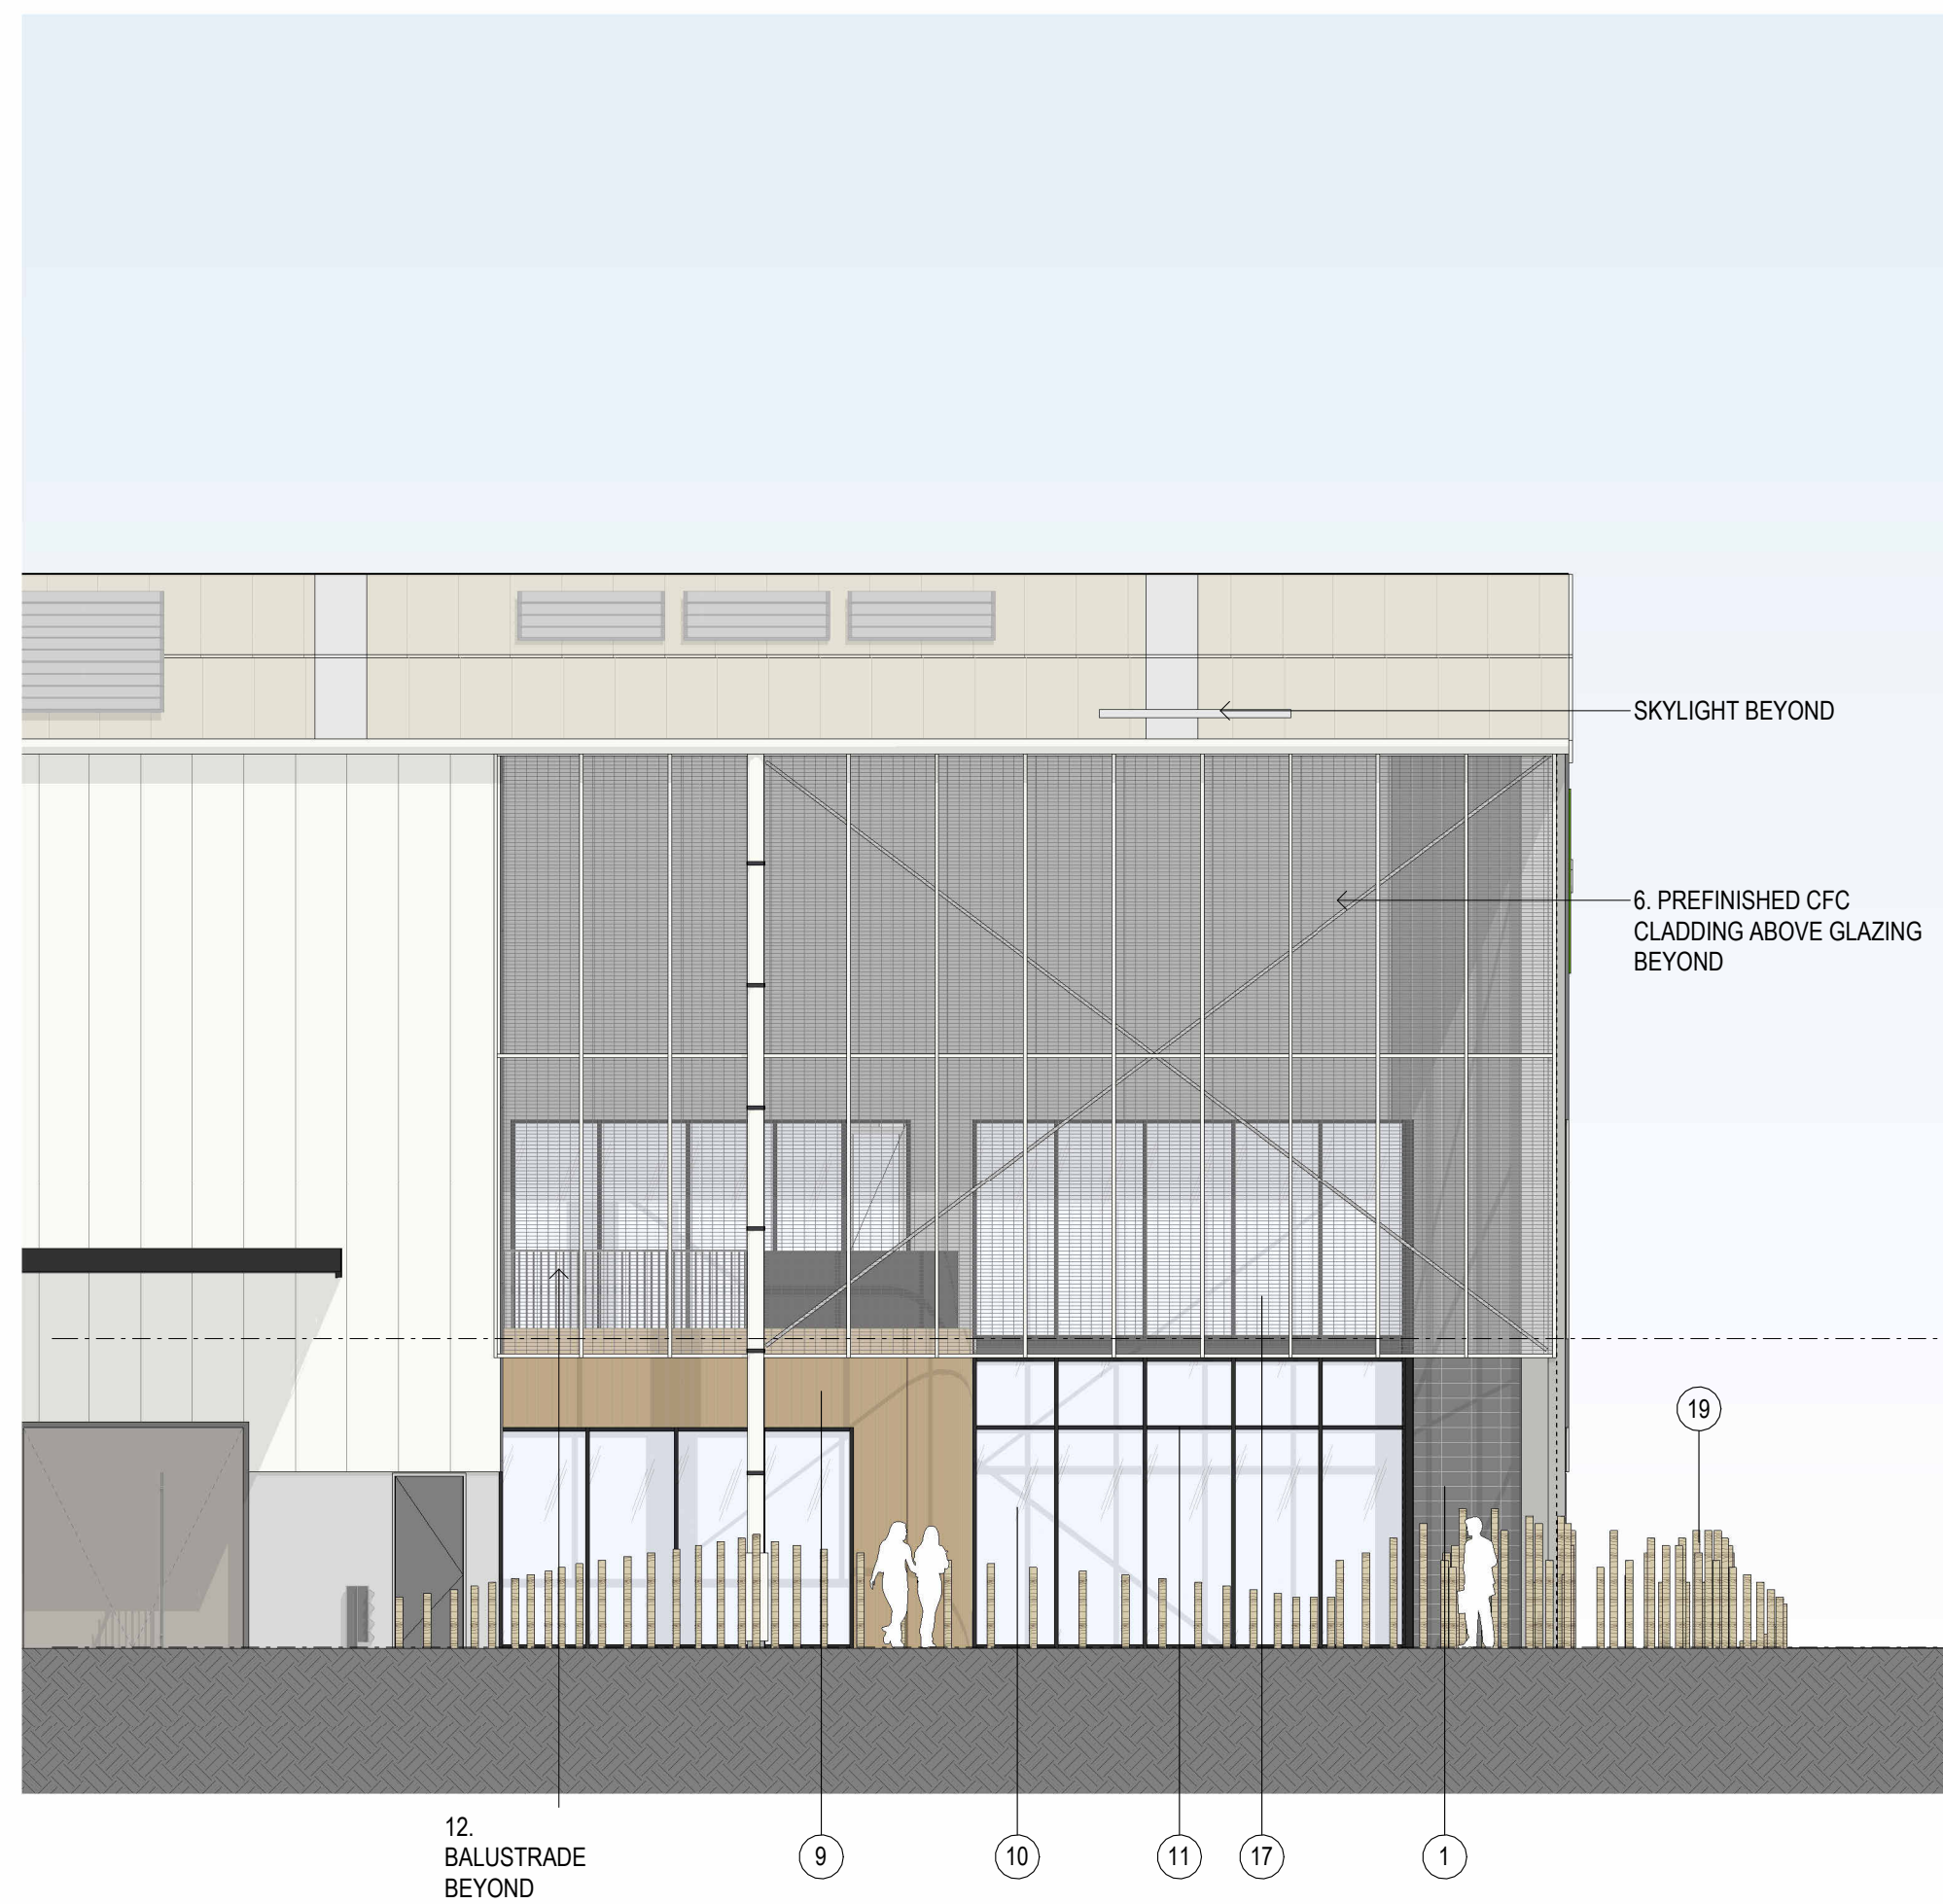
1 OFFICE 2 - EAST ELEVATION 1 : 100

1. <b>BLOCKWORK</b> - EQUAL TO AUSTRAL BLOCK 'ARCHITECT' - HONED - CHARCOAL' 390 X 190 X 190mm - STACK BOND PATTERN - COLOUR-MATCHING FLUSH MORTAR JOINTS	2. <b>PRECAST CONCRETE PANEL</b> - OFF-FORM FINISH	3. <b>PREFINISHED METAL WALL SHEET CLADDING</b> - COLORBOND 'MONUMENT'	4. <b>PREFINISHED METAL WALL SHEET CLADDING</b> - COLORBOND 'DOVER WHITE'	5. <b>PREFINISHED METAL WALL SHEET CLADDING</b> - COLOURBOND 'SHALE GREY'	6. <b>PREFINISHED CFC CLADDING</b> - EQUAL TO 'EQUITONE - TECTIVA - GREY' - 12000X2400mm - CONCEALED FIXING	7. <b>METAL DECK ROOFING</b> - COLORBOND 'DOVER WHITE'	8. <b>TRANSLUCENT ROOF SHEET</b> - OPAL COLOUR	9. <b>TIMBER LOOK METAL CLADDING</b> - SCULPTFORM ALUMINIUM CLICK ON PANELS	10. <b>GLAZING</b> - LIGHT GREY TINT OR SIMILAR	11. <b>PREFINISHED ALUMINIUM WINDOW FRAME</b> - COLORBOND 'MONUMENT'	12. <b>STEEL BALUSTRADE &amp; PANEL</b> - COLORBOND 'MONUMENT'	13. <b>METAL ROLLER SHUTTER</b> - PREFINISHED IN 'SHALE GREY'	14. <b>EXPOSED STEEL STRUCTURE &amp; STEEL AWNING</b> - COLORBOND 'SHALE GREY'	15. <b>SOLID DOOR LEAF</b> - TO MATCH 'SHALE GREY'	16. <b>DOWNPIPE</b> - COLOUR TO MATCH BACKGROUND CLADDING COLOUR	17. <b>POWDERCOATED METAL MESH IN STEEL FRAME</b> - COLORBOND 'DOVER WHITE'	18. <b>PAVER</b> - AUSTRAL BRICKS 230 x 76 x 5 mm - ALLOW 3 COLOURS AND PATTERNS	19. <b>TIMBER POSTS &amp; METAL OUTDOOR BENCHES IN CUSTOMISED FORM</b>	20. <b>LOUVRE DOOR</b>

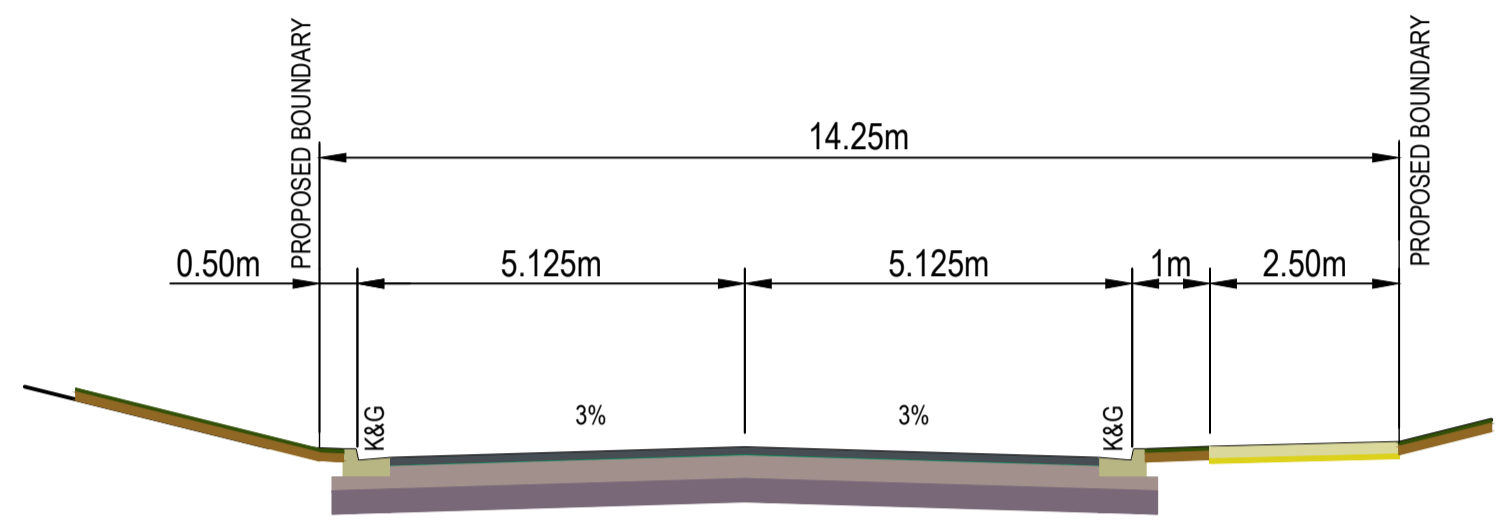
TYPICAL ESTATE AND CRASH LAB ROAD

SCALE 1:100 HORI.  
1:100 VERT.

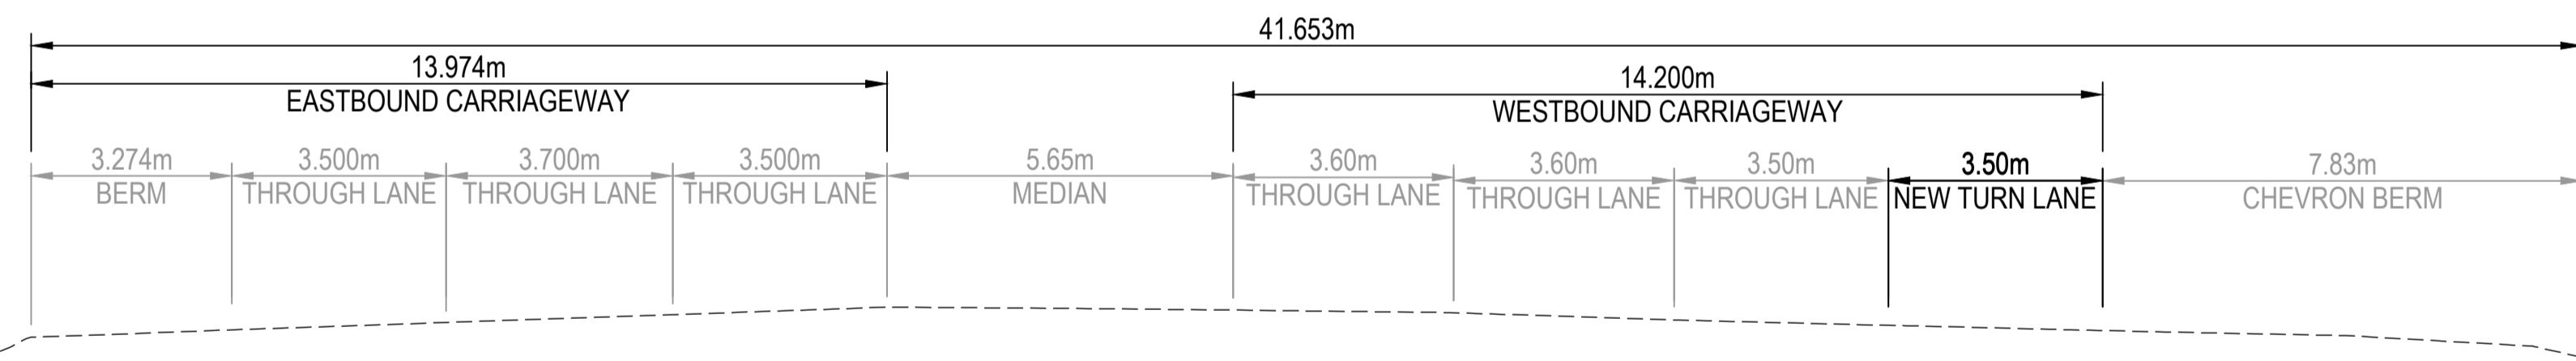
TYPICAL GREAT WESTERN HIGHWAY AT LEFT TURN INTO SITE

SCALE 1:100 HORI.  
1:100 VERT.

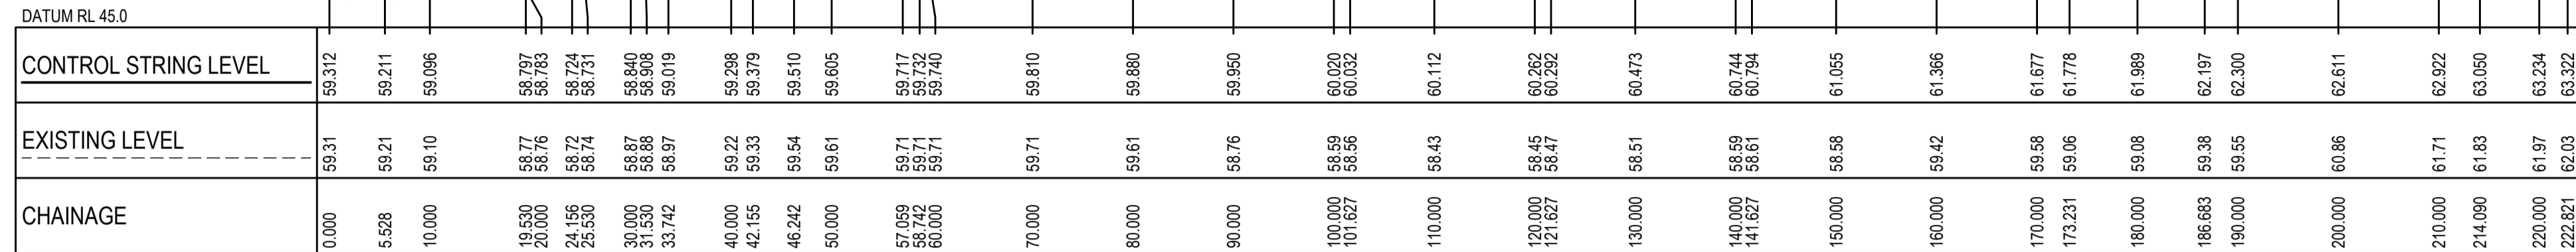
MC01 LONGITUDINAL SECTION  
SCALE 1:500 HORI.  
1:250 VERT.

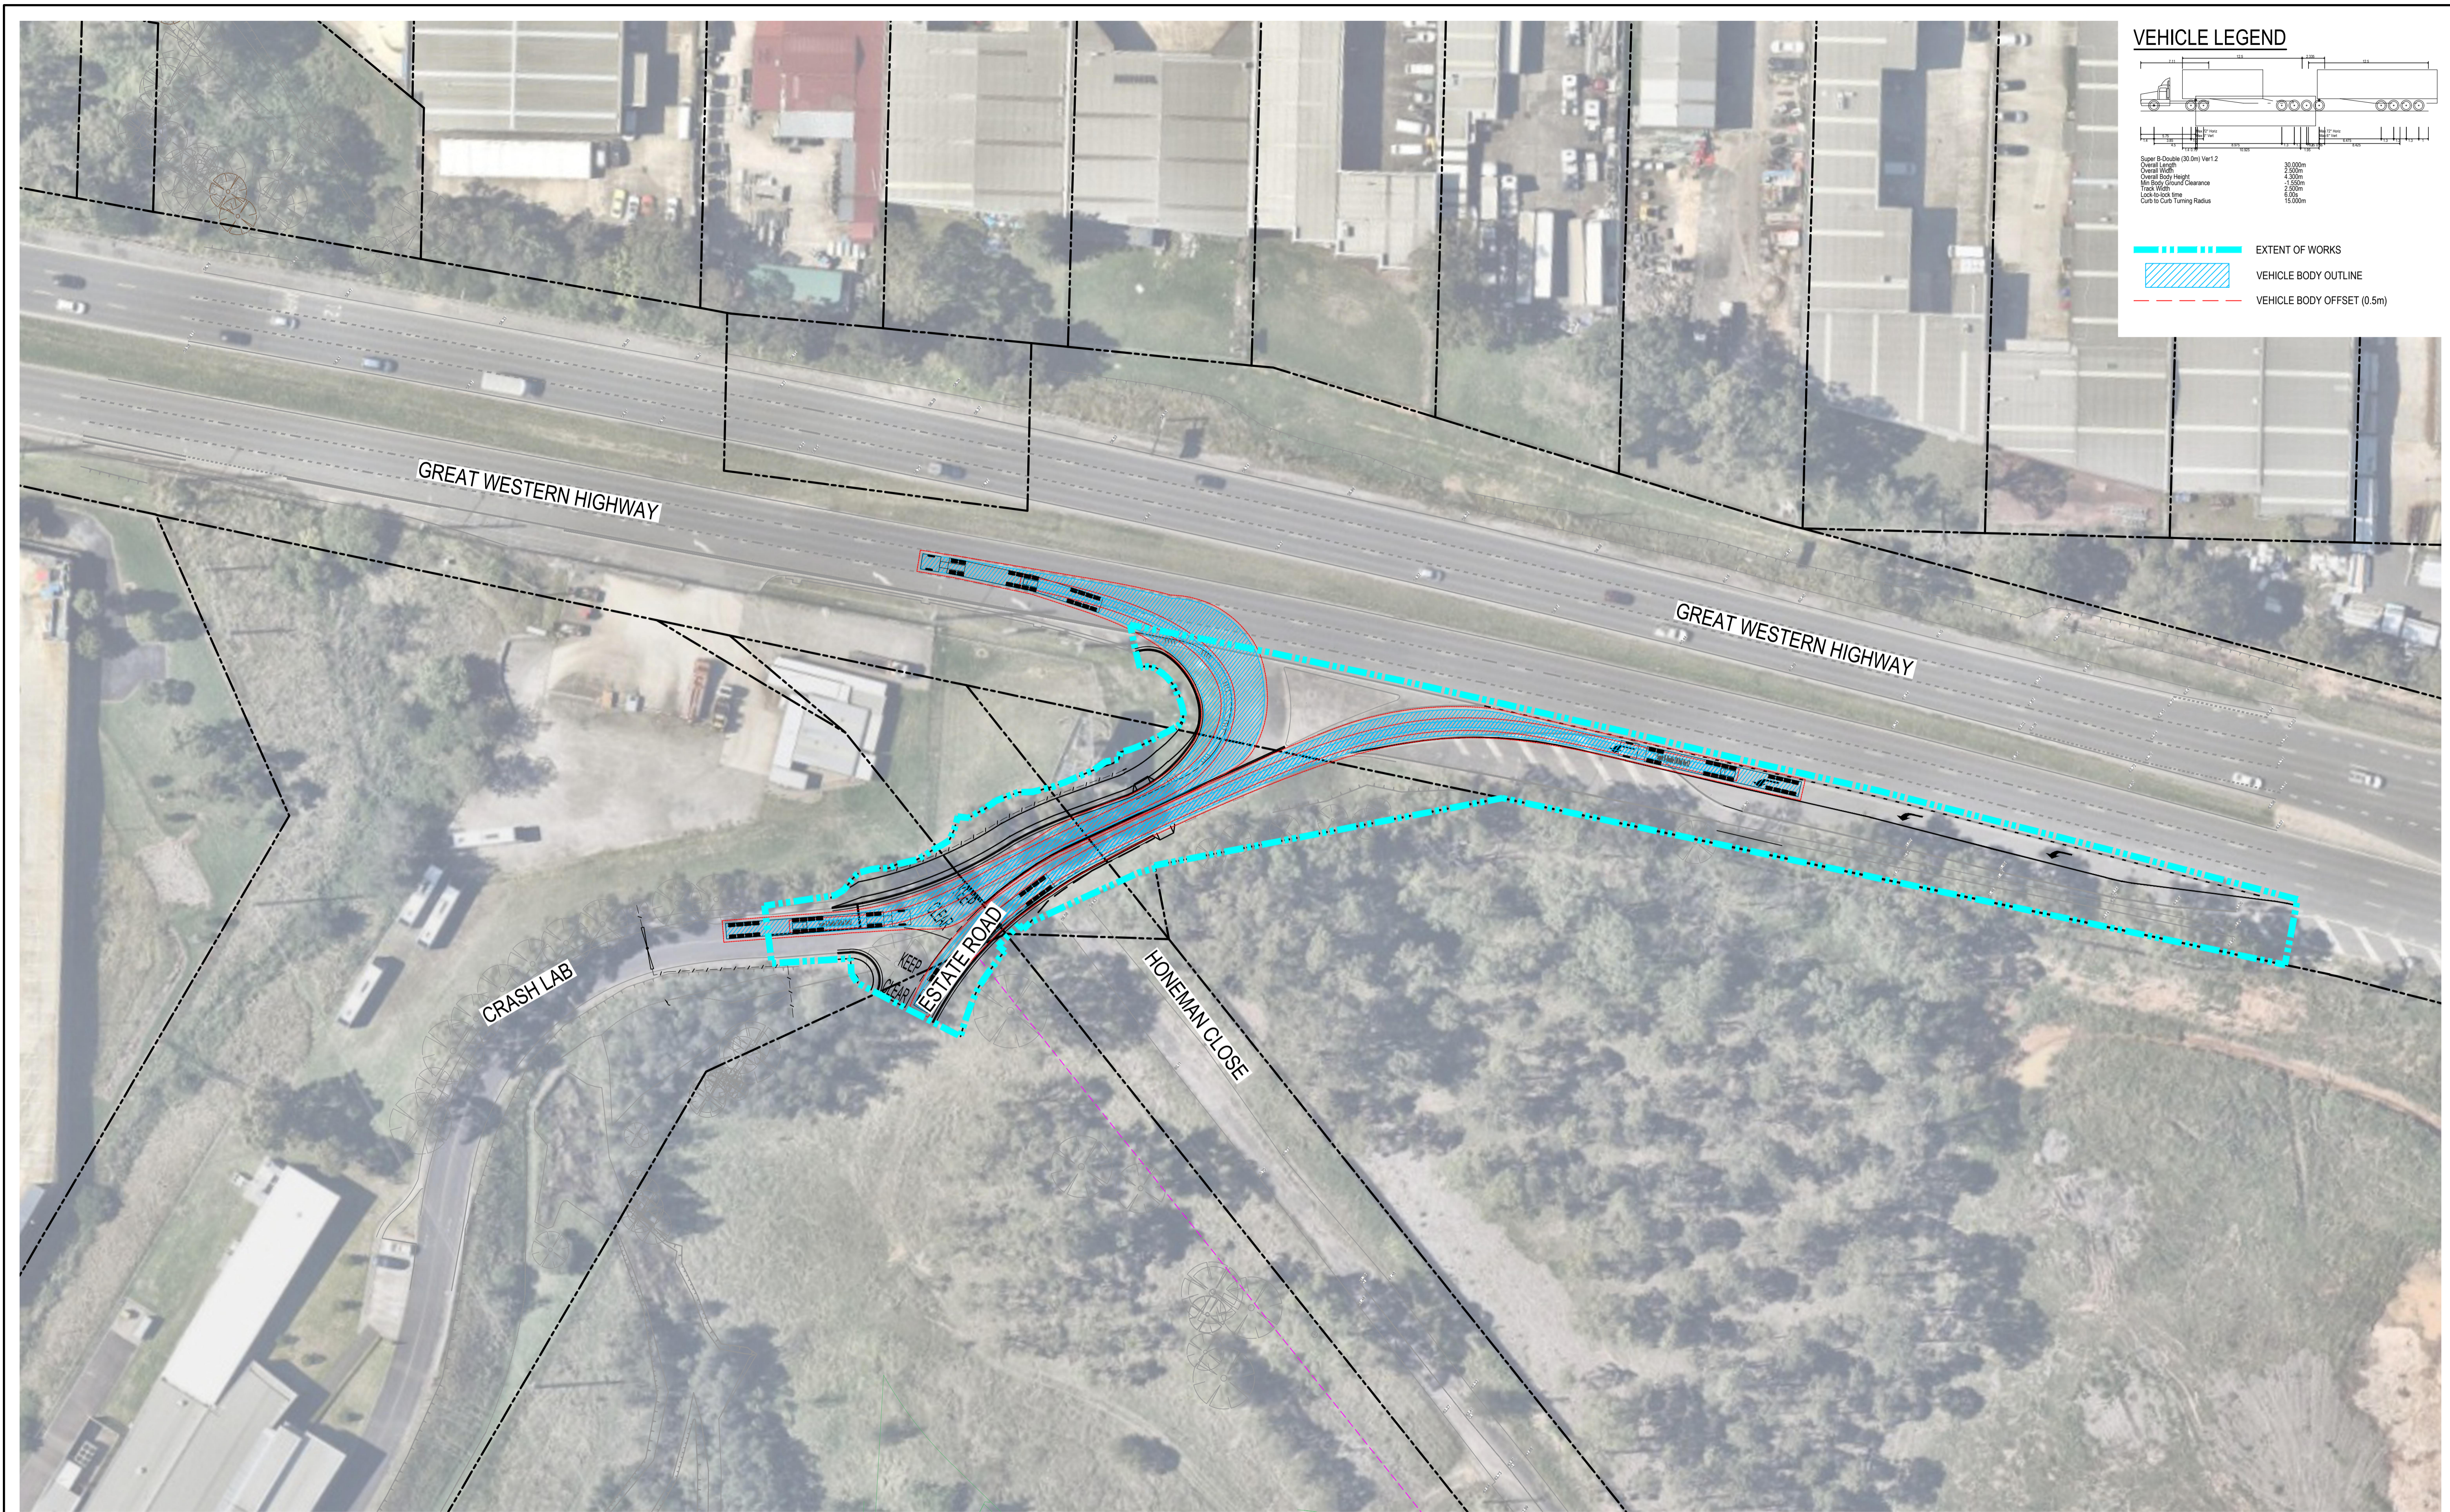
Super B-Double (30.0m) Ver1.2	30,000mm
Overall Length	2,500mm
Overall Width	4,500mm
Overall Body Height	1,500mm
Min Body Ground Clearance	2,500mm
Track Width	6.0s
Lock-to-lock time	15,000m
Curb to Curb Turning Radius
