Report on Geotechnical Investigation

Proposed Mixed-Use Development

270 Pacific Hwy, Crows Nest, NSW

Project 214296.02

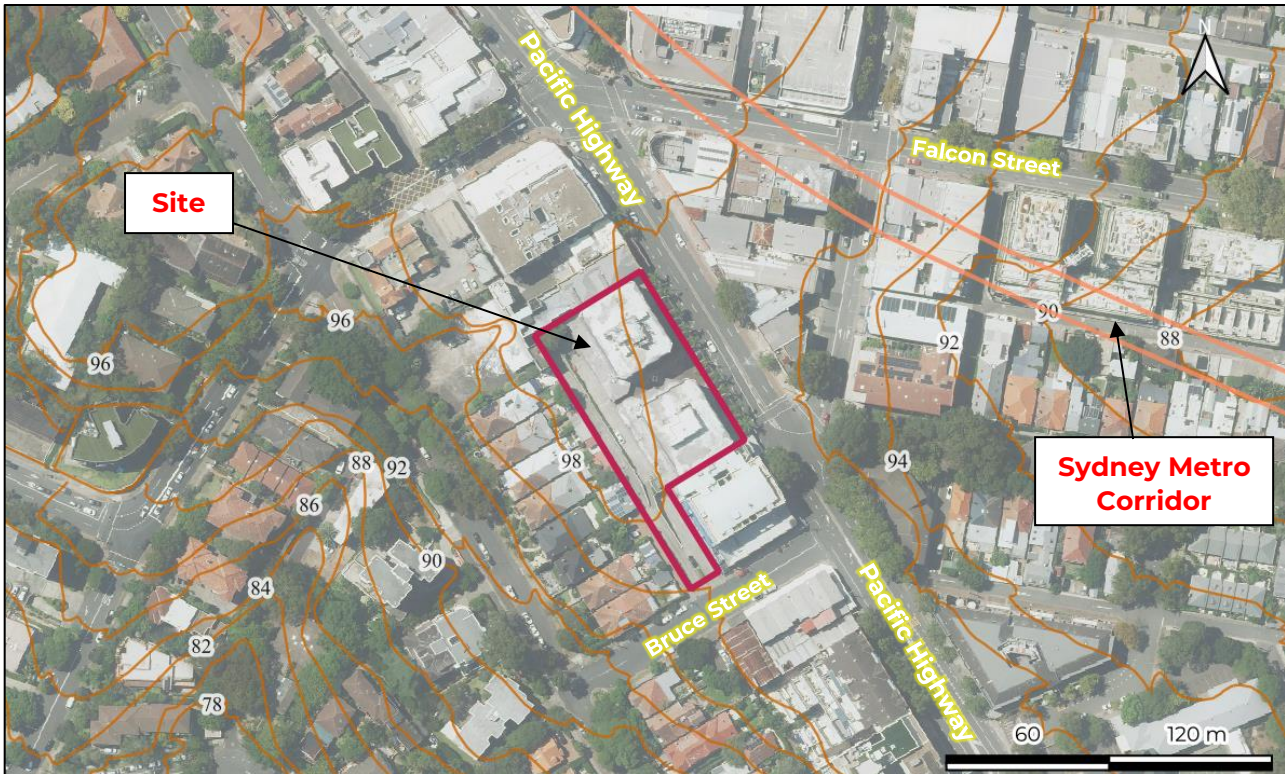
Figure 1: Site overview with 2 m surface contours and Metro rail corridor shown

The site is located at an approximate offset of about 60 m to the Sydney Metro rail tunnel that runs underneath the corner of Falcon Street and Pacific Highway, as shown in Figure 1. It is understood that the site is located outside the second protection reserve (further than 25 m away from the tunnel stratum). This however should be confirmed with TfNSW/Sydney Metro.

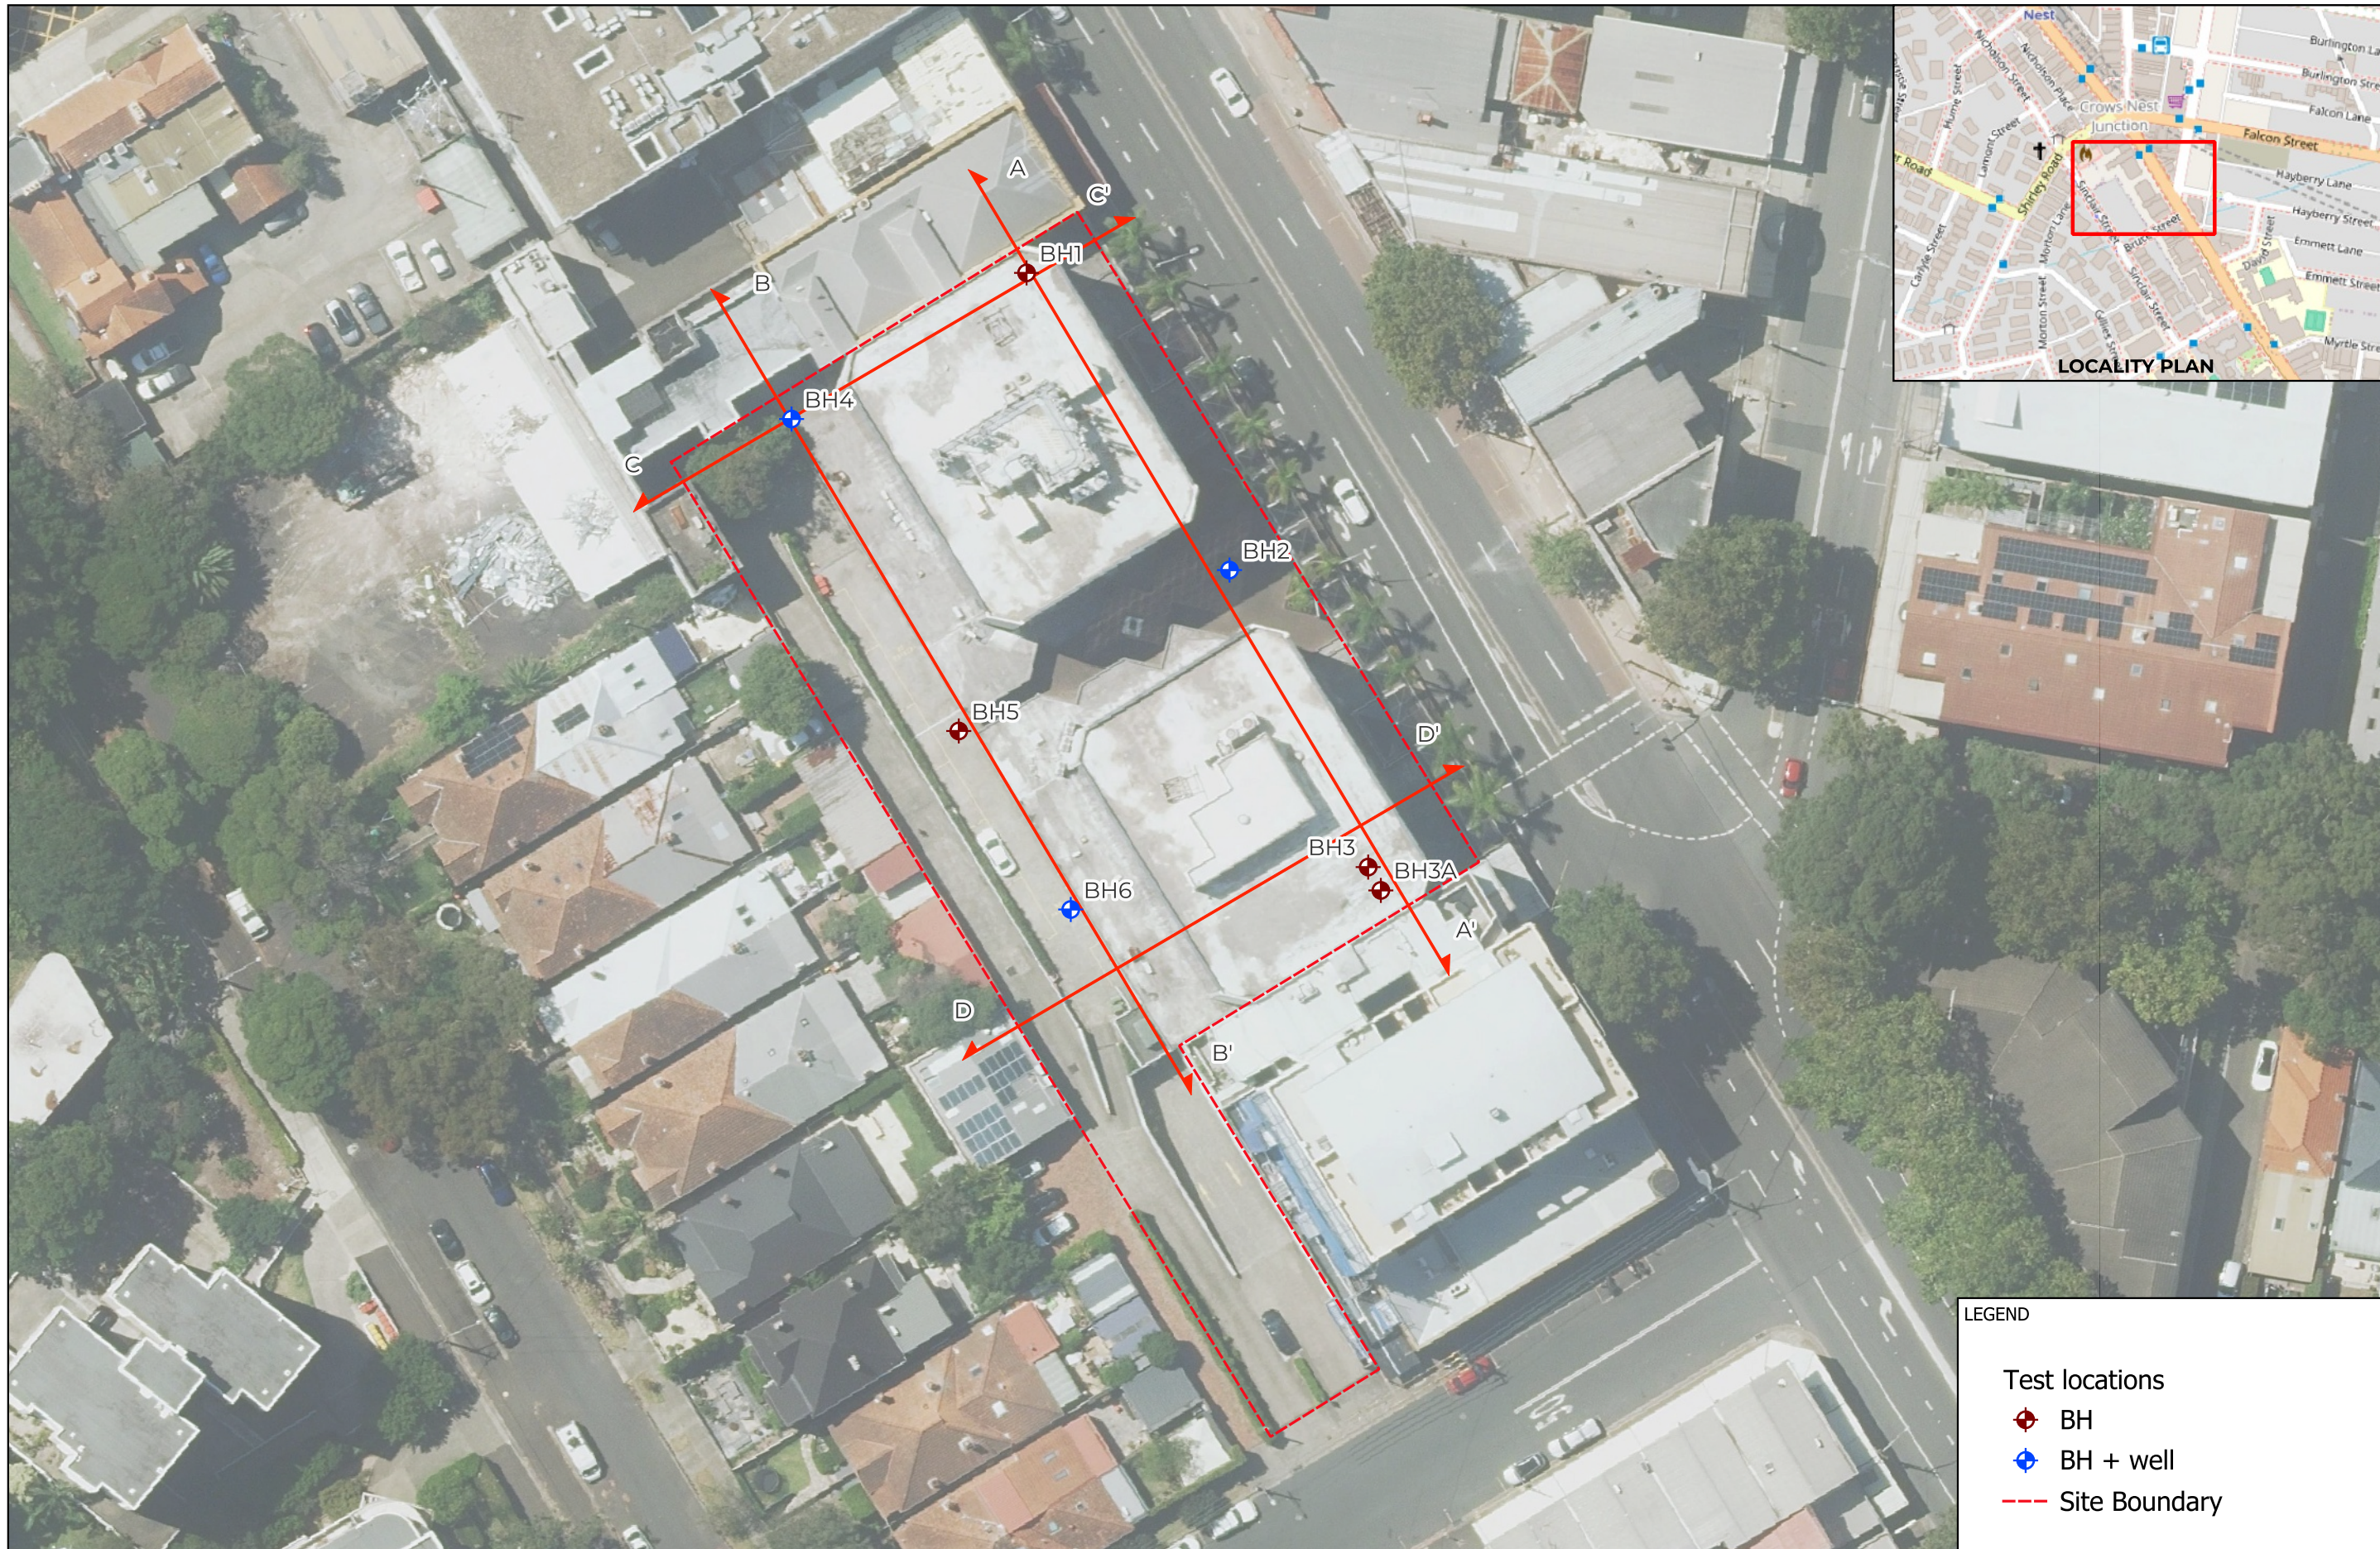
DRAWING NO:
1

- Test locations
- ◆ BH
- ◆ BH + well
- - - Site Boundary

The geotechnical investigation included the drilling of six rock-cored boreholes, installation of three groundwater monitoring wells in selected boreholes, follow-up measurement of groundwater levels and laboratory testing of selected samples. The details of the geotechnical field work are presented in this report, together with comments and recommendations on geotechnical aspects. Groundwater monitoring is ongoing within the monitoring wells installed on site and the results of the long-term monitoring will be reported separately, together with further details on the hydrogeological conditions encountered on site and applicable groundwater management. The geotechnical investigation was carried out concurrently with a Detailed Site (Contamination) Investigation (DSI, ref: 214296.03.R.001), which is reported separately.

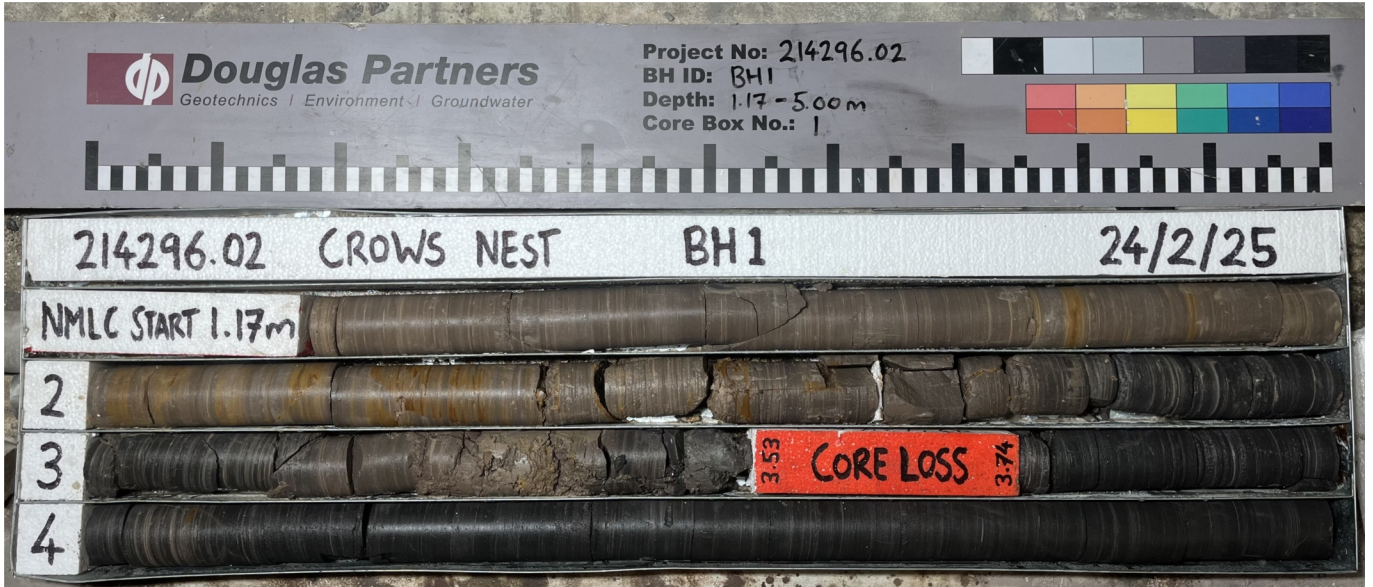
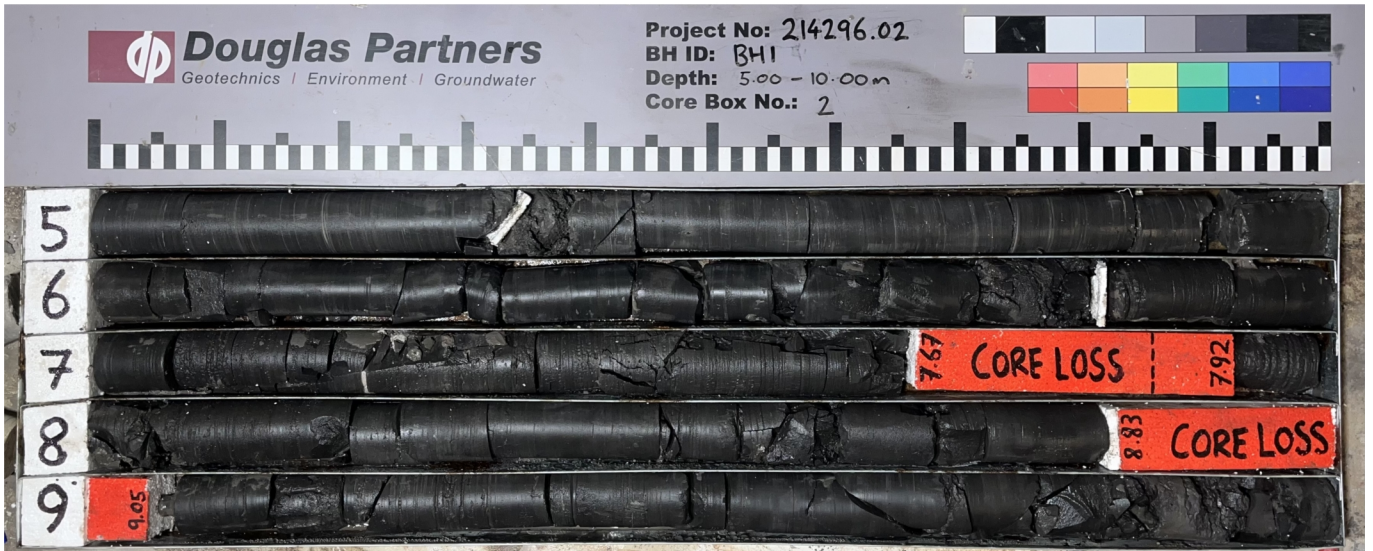
LOCATION ID: BH1
PROJECT No: 214296.02
DATE: 24/02/25
SHEET: 1 of 1

1.17-5.00 m depth

5.00-10.00 m depth

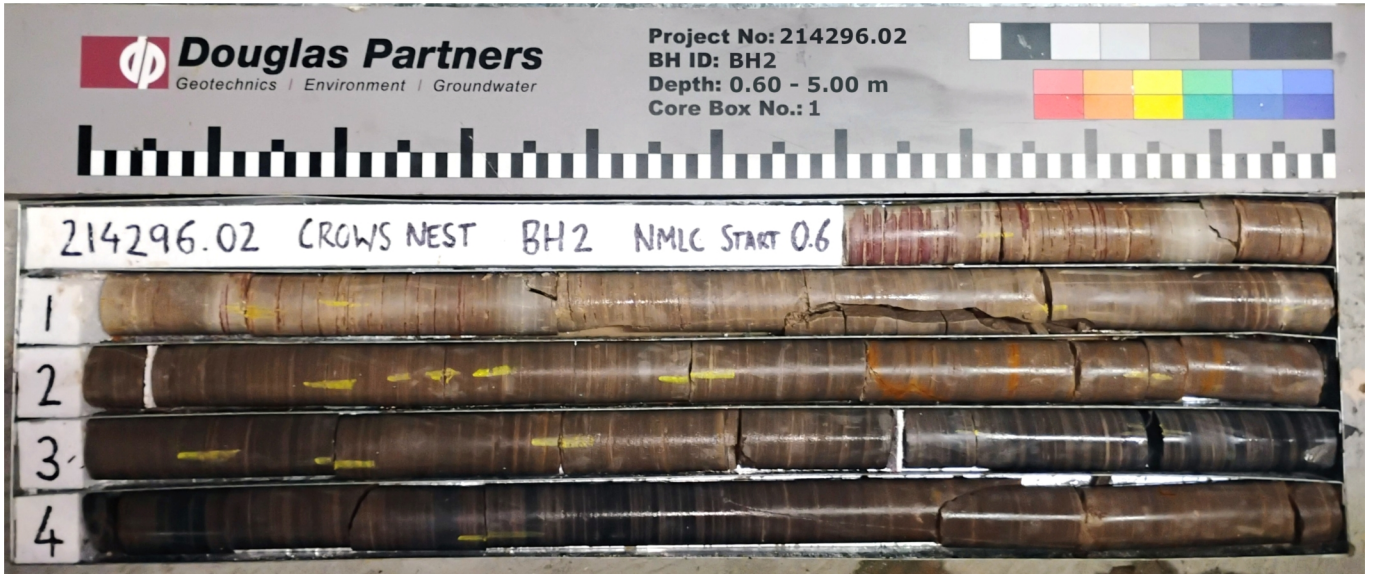
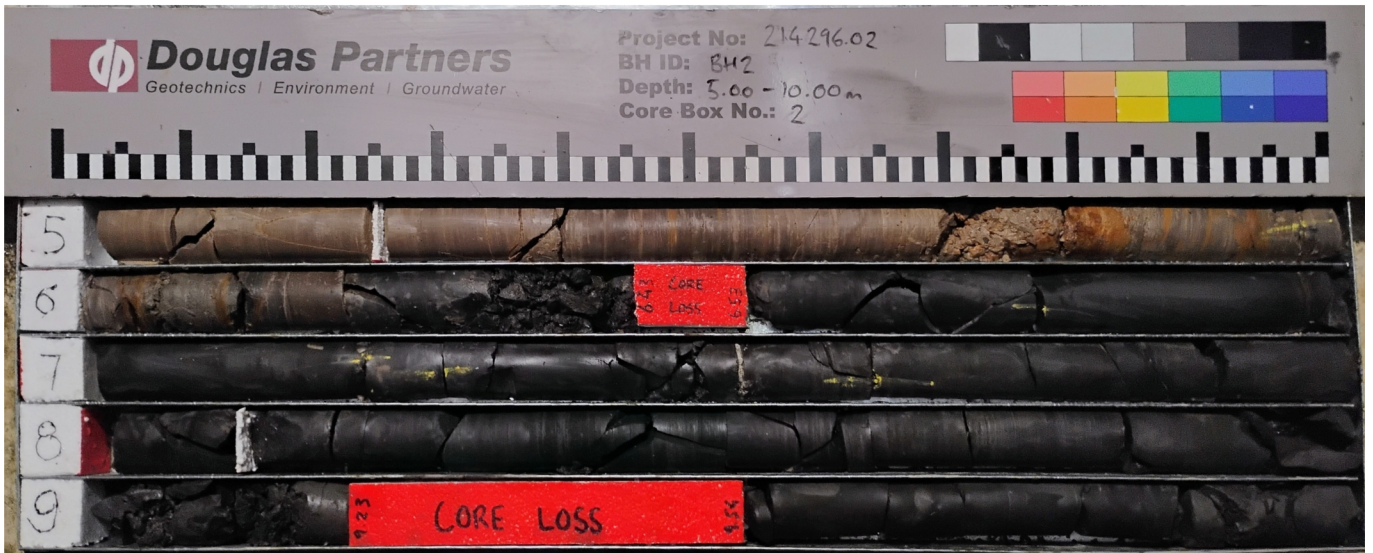
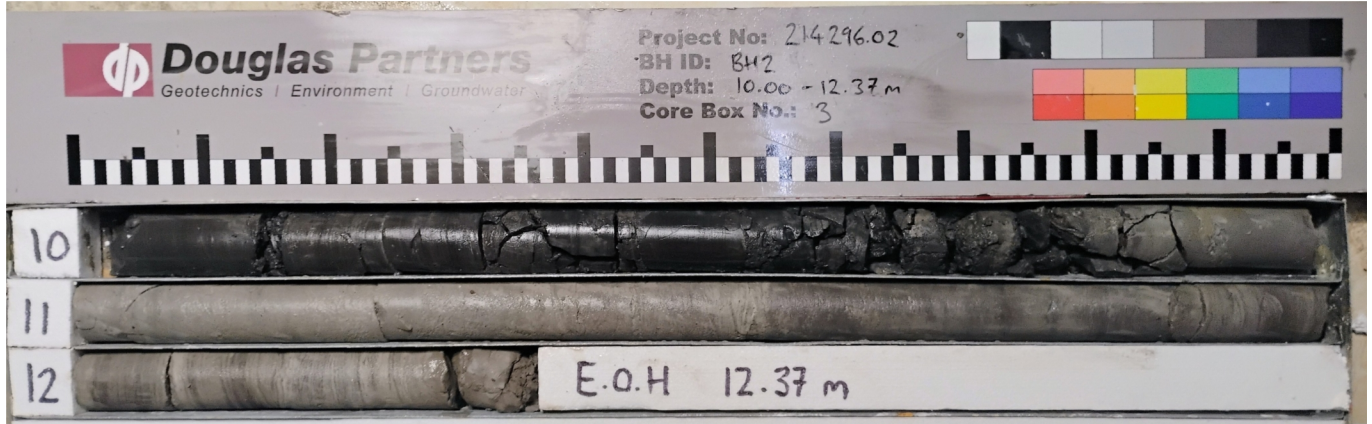
LOCATION ID: BH2
PROJECT No: 214296.02
DATE: 17/02/25
SHEET: 1 of 2

0.60-5.00 m depth

5.00-10.00 m depth

10.00-12.37 m depth

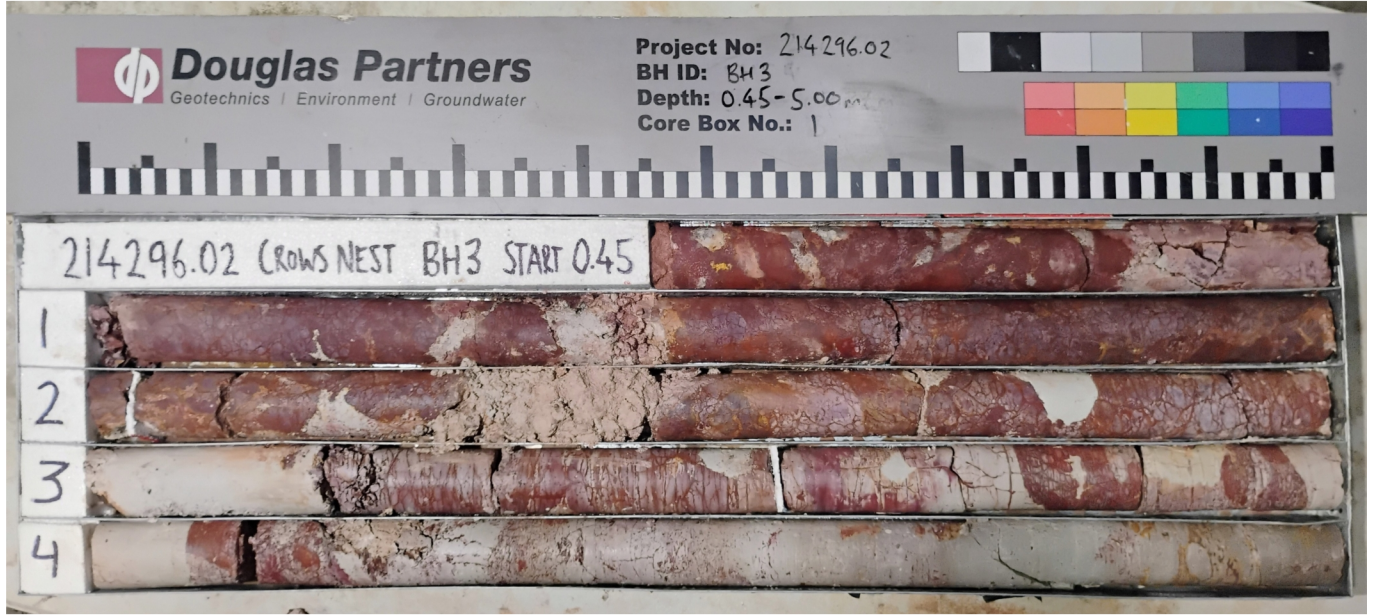
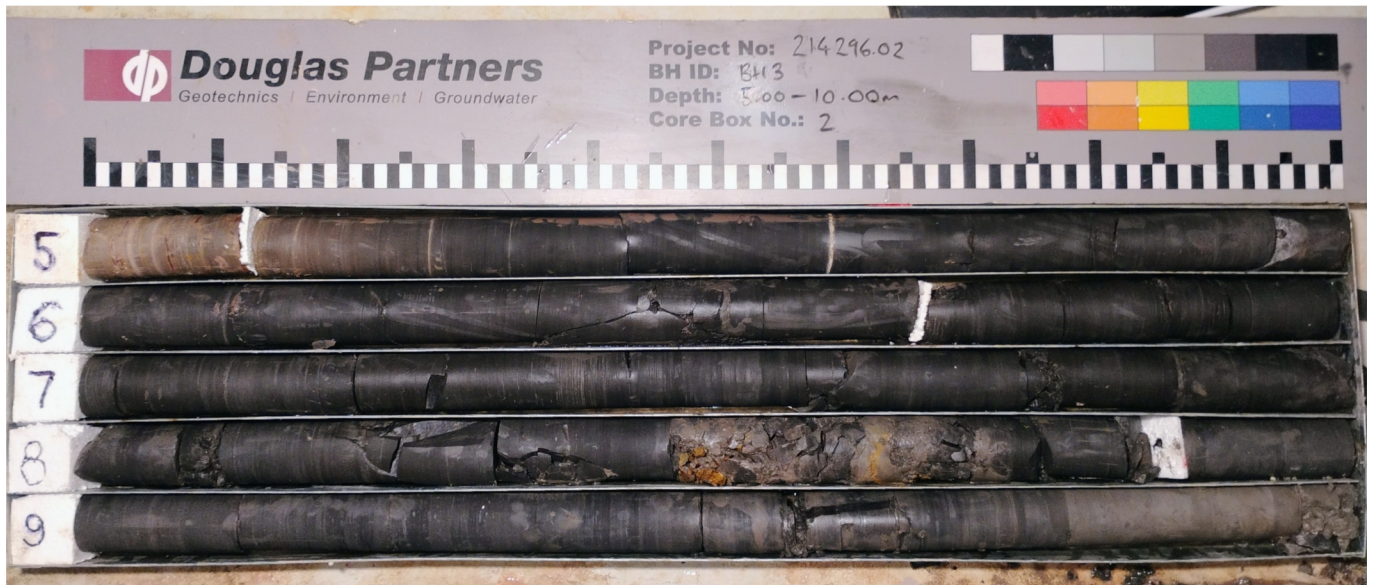
LOCATION ID: BH3
PROJECT No: 214296.02
DATE: 18/02/25
SHEET: 1 of 1

0.45-5.00 m depth

5.00-10.00 m depth

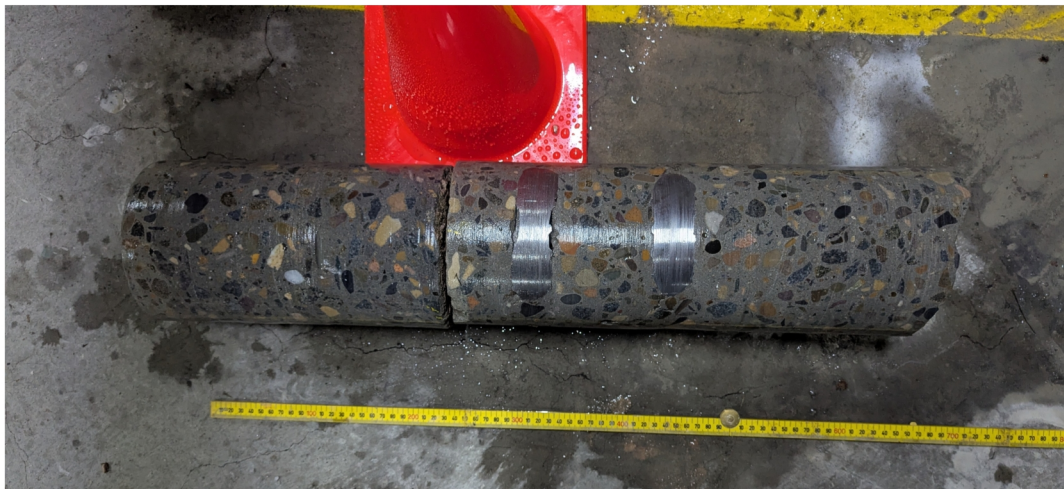
LOCATION ID: BH3A
PROJECT No: 214296.02
DATE: 12/02/25
SHEET: 1 of 1

GROUNDWATER		CONDITIONS ENCOUNTERED					SAMPLE			TESTING AND REMARKS				
		RL (m)	DEPTH (m)	DESCRIPTION OF STRATA	GRAPHIC	ORIGIN (#)	CONSIS. (%)	DENSITY (%)	MOISTURE	REMARKS	TYPE	INTERVAL	DEPTH (m)	TEST TYPE
	93		CONCRETE: 30-40% 20 mm angular to sub-angular aggregate, 3 mm voids 0.32m: 30 mm Ø rebar 0.45m: 30 mm Ø rebar											
	92	1	Borehole discontinued at 0.70m depth.											
	91	2												
	90	3												
	89	4

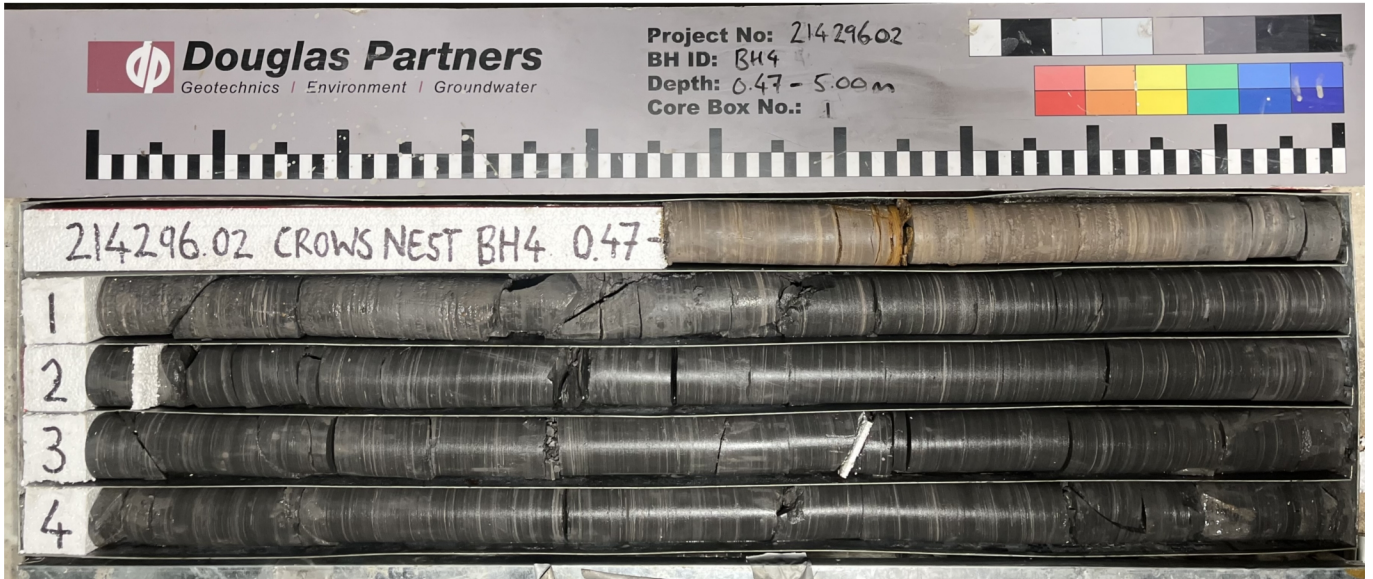
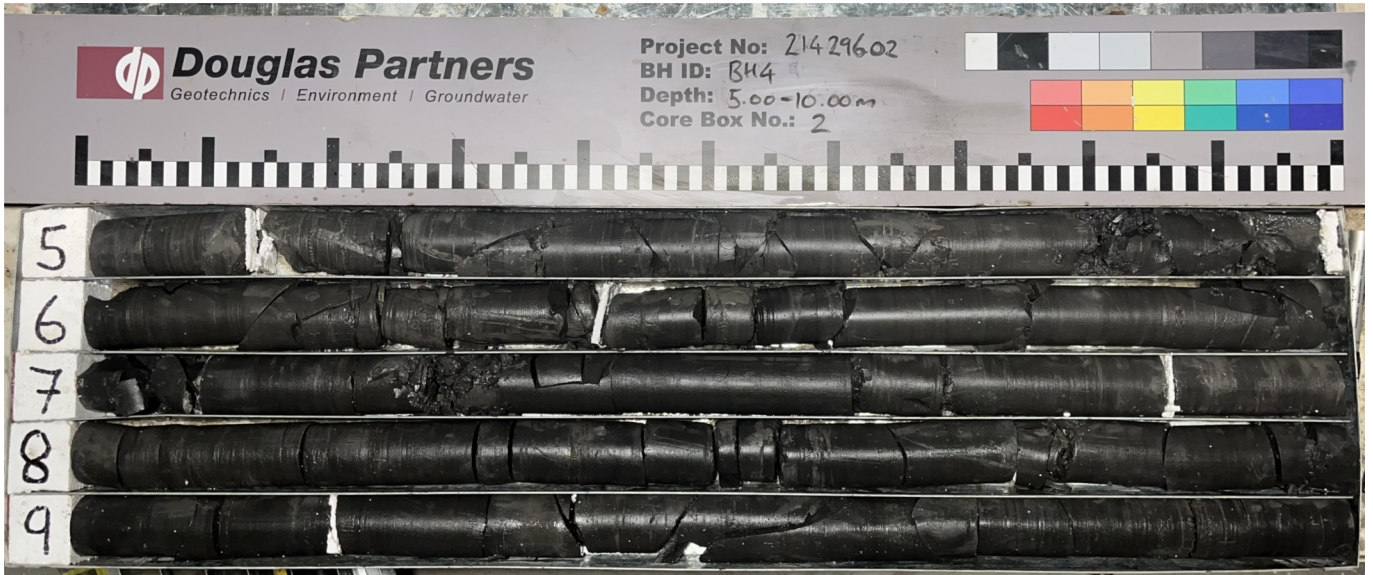
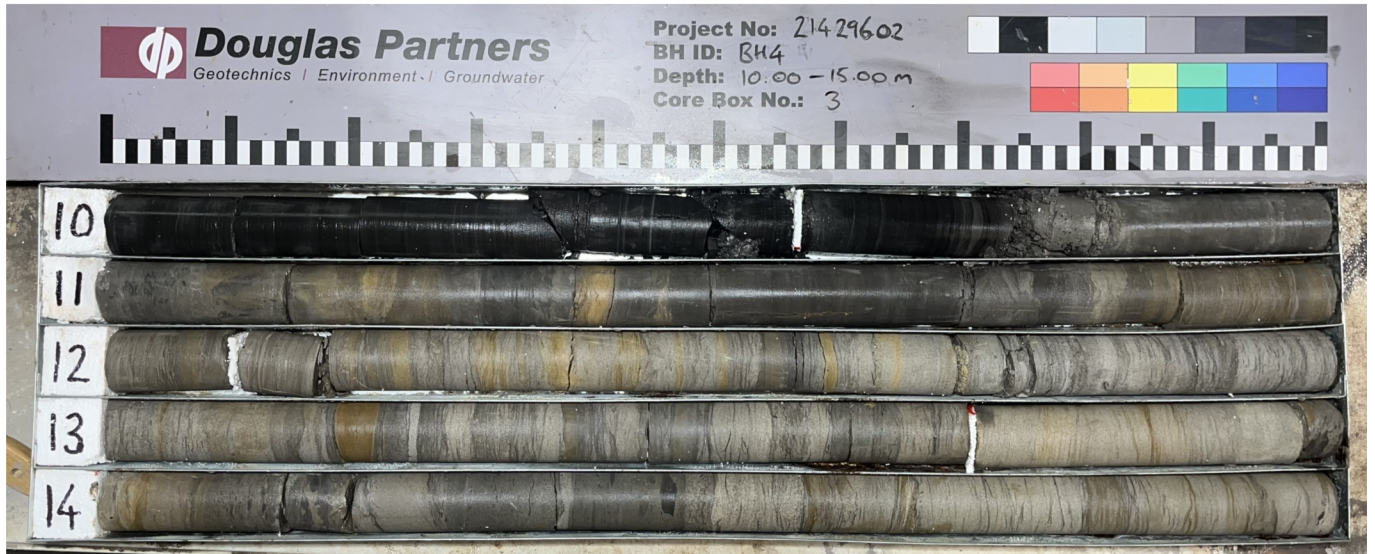
LOCATION ID: BH4
PROJECT No: 214296.02
DATE: 20/02/25
SHEET: 1 of 2

0.47-5.00 m depth

5.00-10.00 m depth

10.00-15.00 m depth

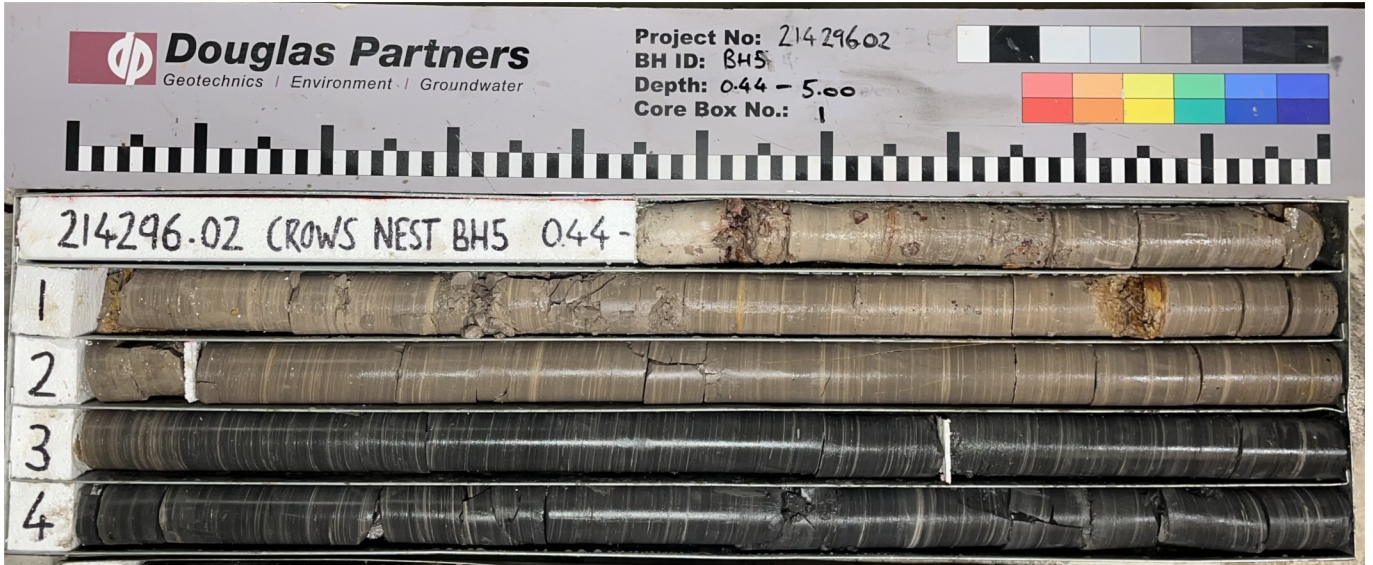
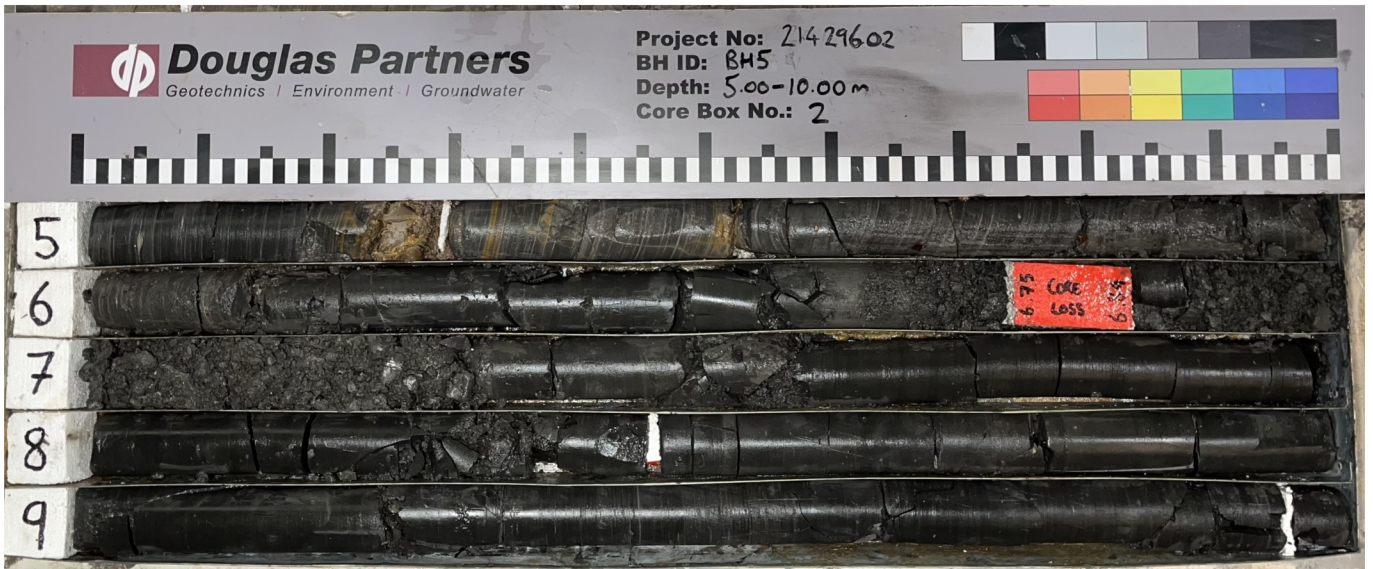
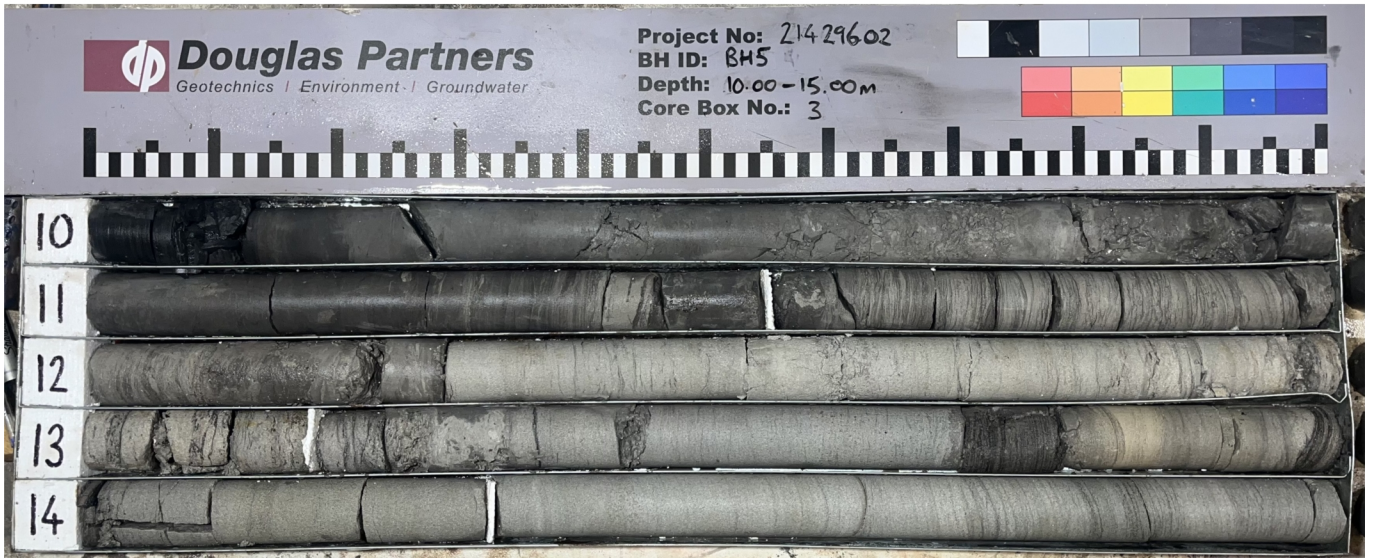
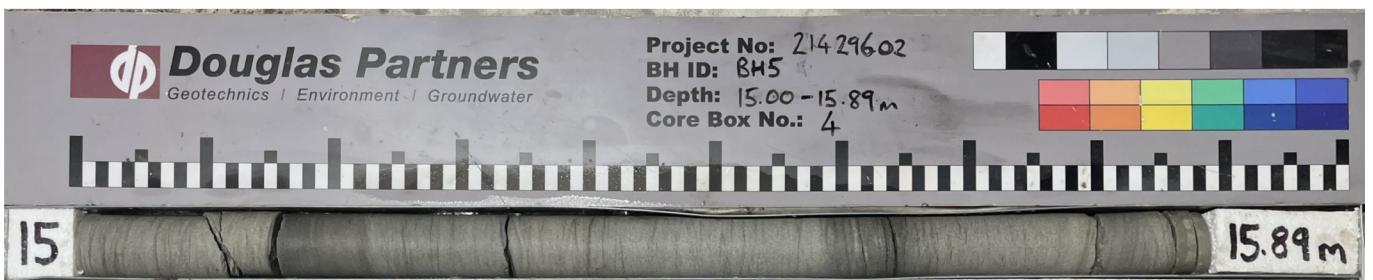
LOCATION ID: BH5
PROJECT No: 214296.02
DATE: 21/02/25
SHEET: 1 of 2

0.44-5.00 m depth

5.00-10.00 m depth

10.00-15.00 m depth

15.00-15.89 m depth

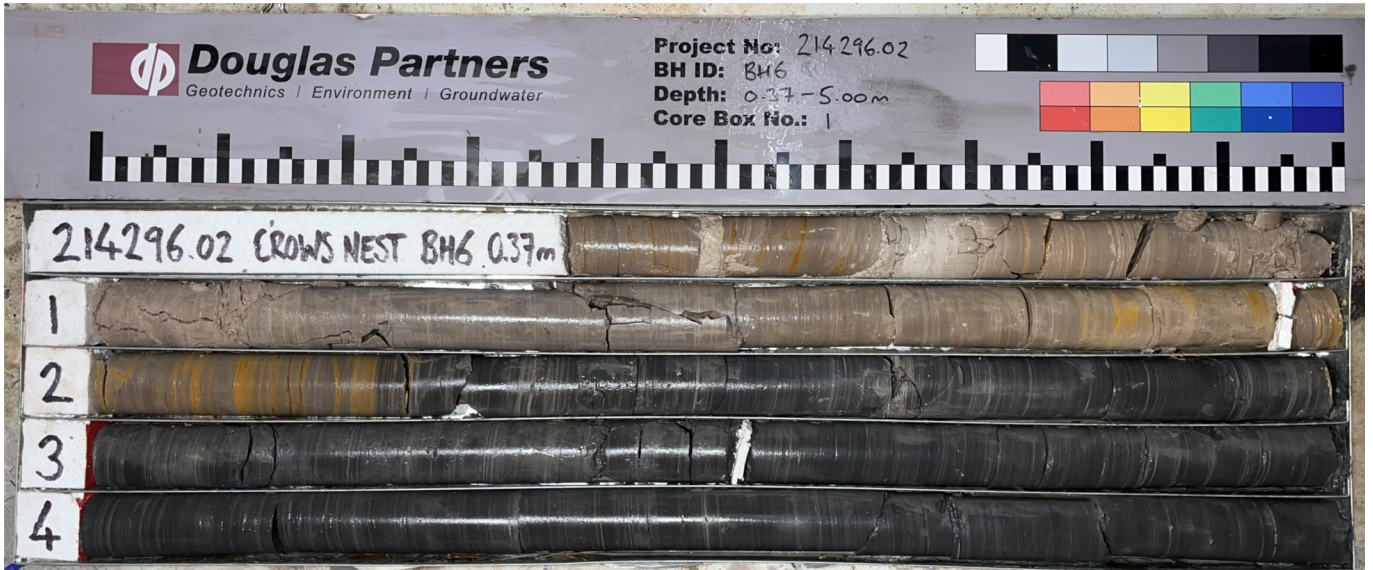
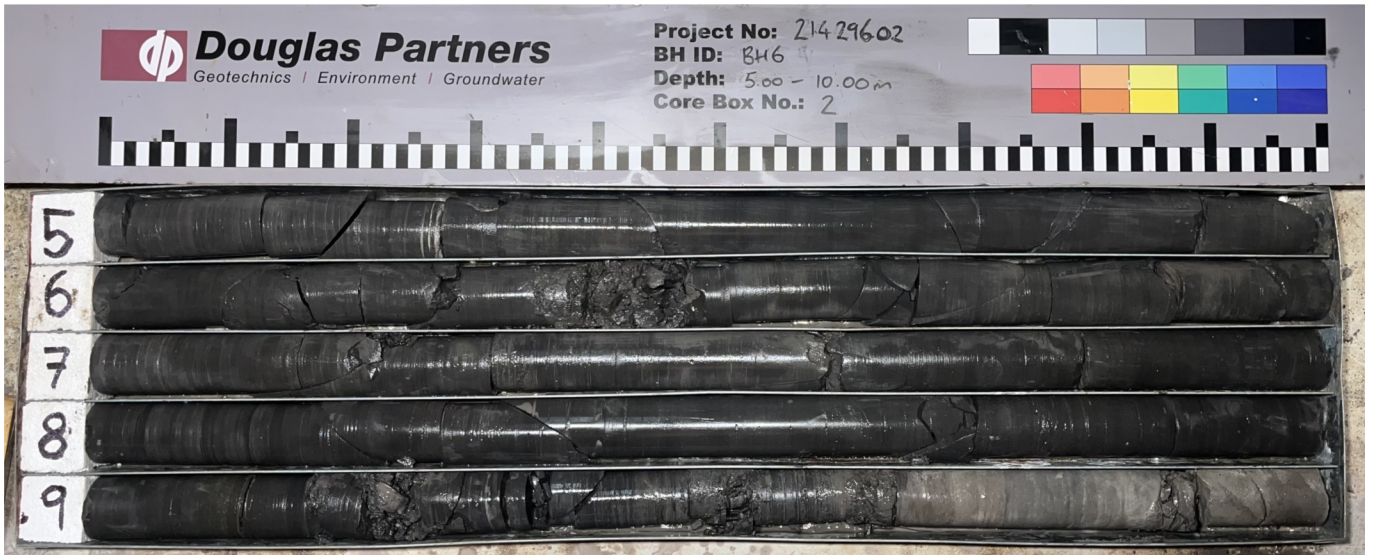
LOCATION ID: BH6
PROJECT No: 214296.02
DATE: 19/02/25
SHEET: 1 of 1

0.37-5.00 m depth

5.00-10.00 m depth
