**SPECIALIST ADVICE TO
SUSTAINABLE DEVELOPMENT GROUP LTD**

**ON
GEOTECHNICAL INVESTIGATION**

**FOR
PROPOSED MIXED USE DEVELOPMENT**

**AT
461 CHAPEL ROAD, BANKSTOWN, NSW**

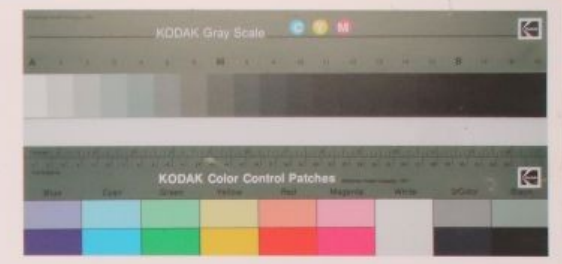
Job No: 37148PE
Borehole No: BH1
Depth: 2.80m to 11.00m

37148PE BH1 START CORING AT 2.80m

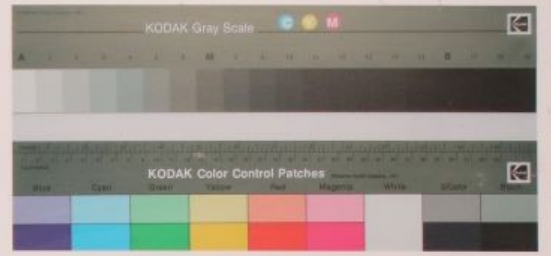
Job No: 37148PE
Borehole No: BH1
Depth: 11.00m to 12.03m

12 ← END OF BOREHOLE AT 12.03m

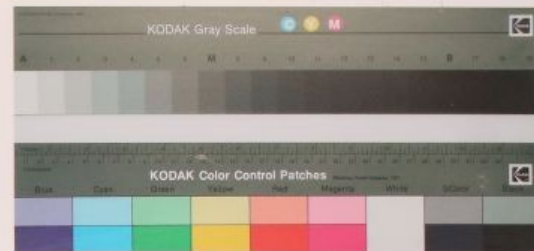
Job No: 37148PE
Borehole No: BH2
Depth: 5.80m to 12.04m

37148PE BH2 START CORING AT 5.80m

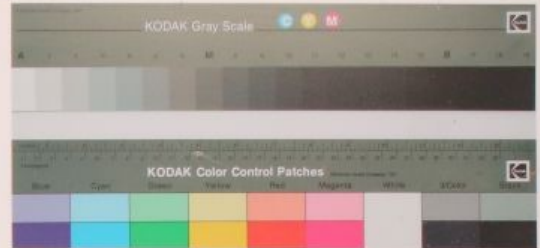
Job No: 37148PE
Borehole No: BH3
Depth: 3.67m to 12.00m

37148PE BH3 START CORING AT 3.67m

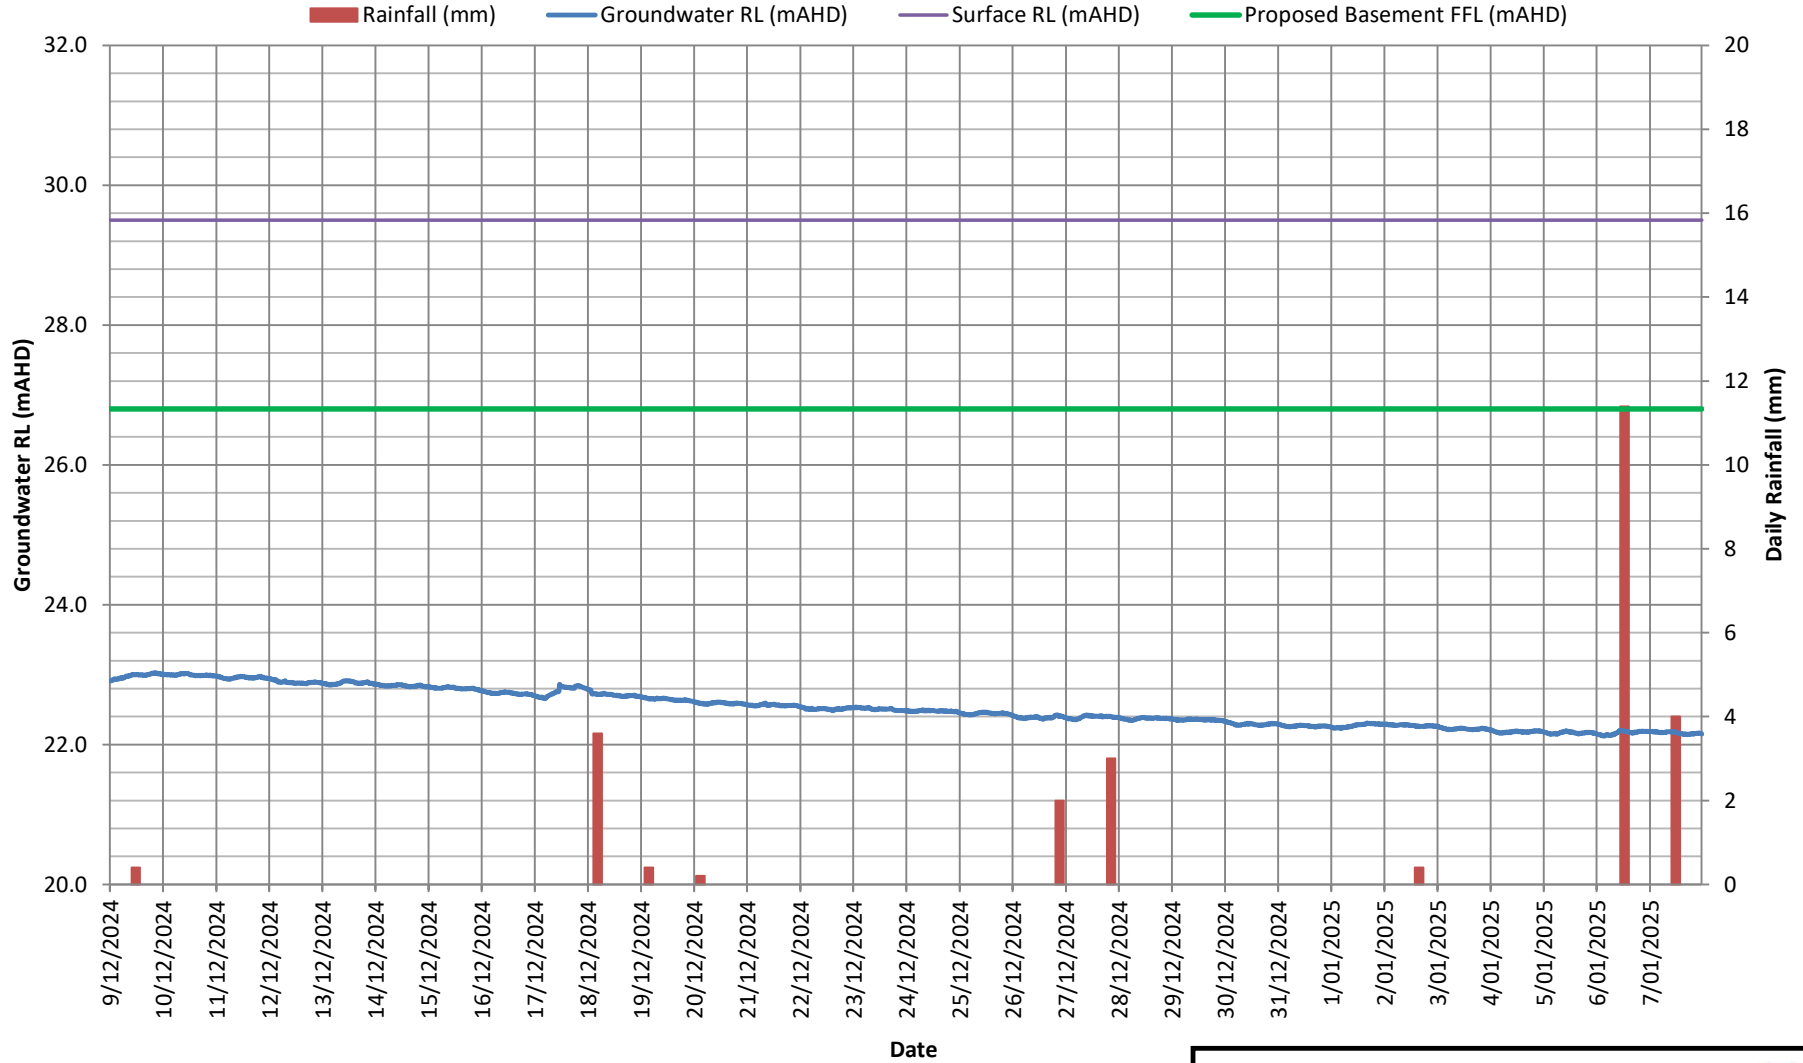
Groundwater Level and Daily Rainfall -v- Time Plot BH3

Rainfall data from Bankstown Airport, Station No. 066137

From the above table, attached borehole logs and groundwater RL versus time plot for BH3, groundwater was only encountered in BH3 and the shallowest groundwater level recorded over the monitoring period was approximately 3.9m below the proposed basement FFL at RL26.8m. In addition, there was no increase in groundwater level due to the relatively large single (i.e. 54mm of rainfall on 16 January 2025) or cumulative (i.e. 126mm of rainfall between 7 and 16 January 2025) rainfall events. Further comments and recommendations on groundwater seepage are presented in Section 4.2.4 below.
