DEMOLITION REPORT

**459-461 CHAPEL ROAD, BANKSTOWN
ST PAUL'S ANGLICAN CHURCH**

SSD-79709963

Issue B, March 2025

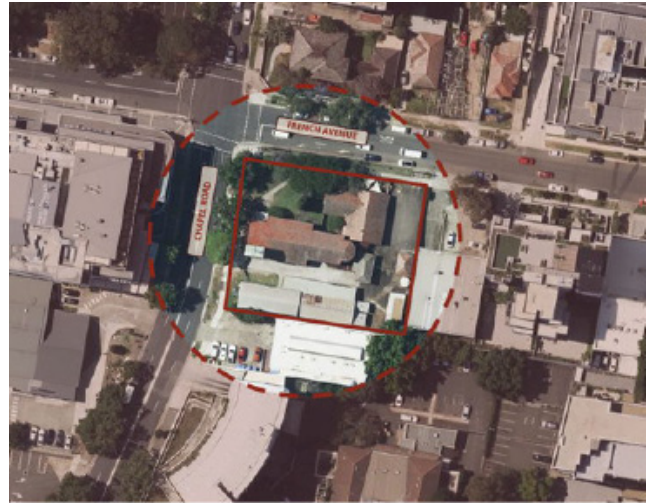
Figure 1
Aerial view of vicinity with subject site outlined in red.
Source: Courtesy of applicant

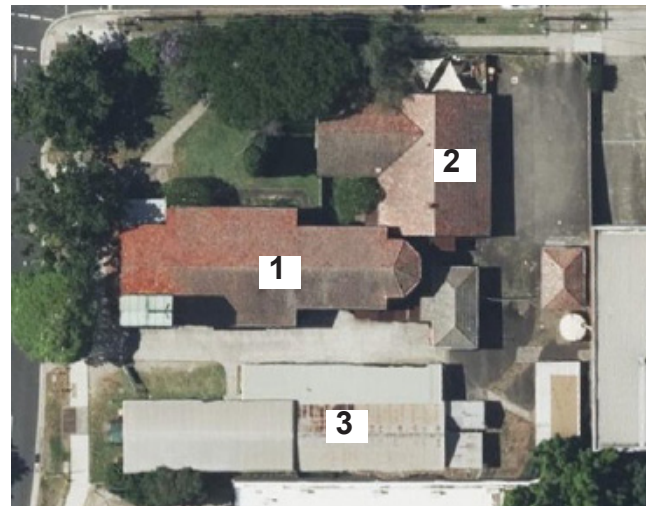
Figure 2
Aerial view showing (1) St Paul's Anglican Church, (2) the Rectory and (3) the Hall. Other buildings are Church offices, a WC block and a garage. North is to the top.

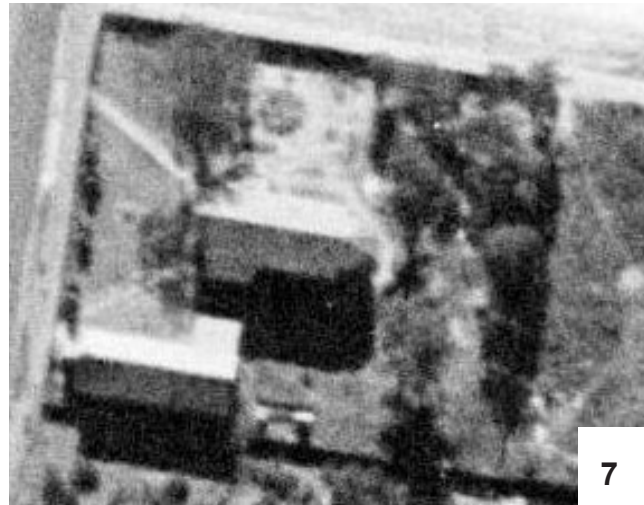
- 4 McPherson's 1938 concept drawing showing Church at centre, Hall at right and Rectory at left, with arched linking walls.
- 5 The 1939 Church as built. Note the highly simplified front facade.
- 6 The c1914-20 Church as it was c. late 1930s.
- 7 Aerial view of site, 1943
- 8 Aerial view of site, 1961
- 9 Current aerial view of site, with 1939 Church footprint outlined in yellow

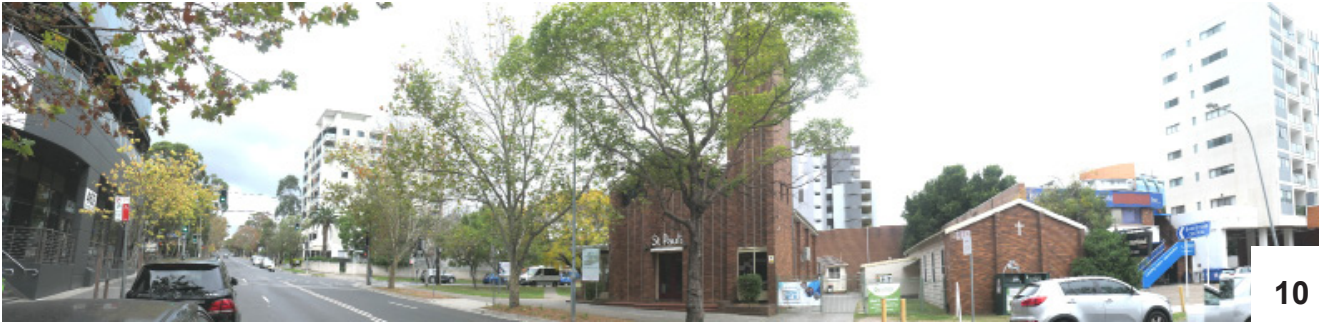
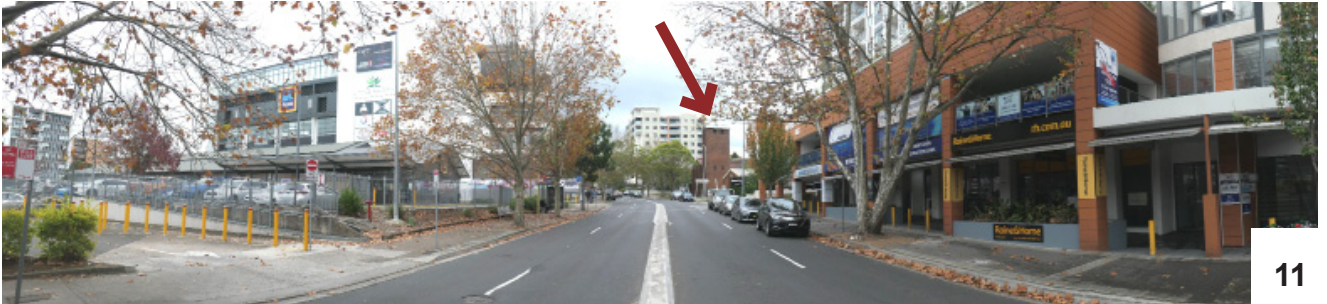
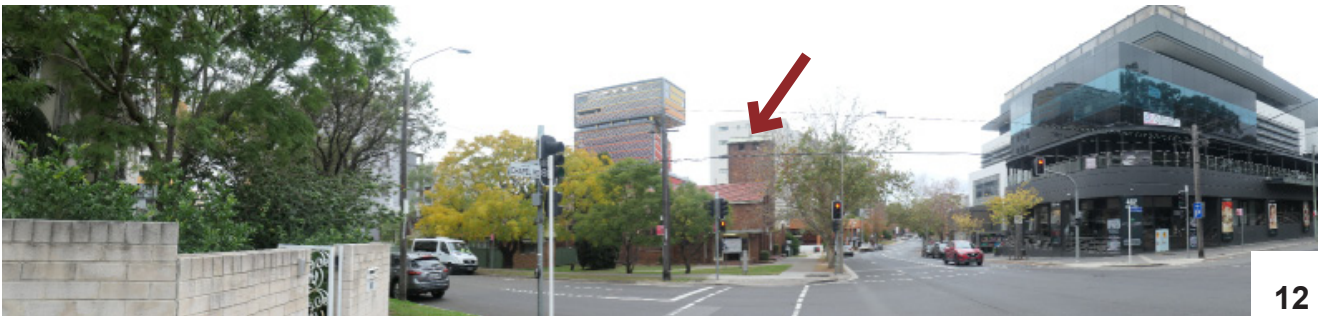
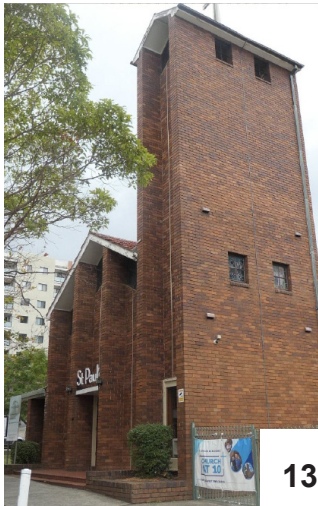
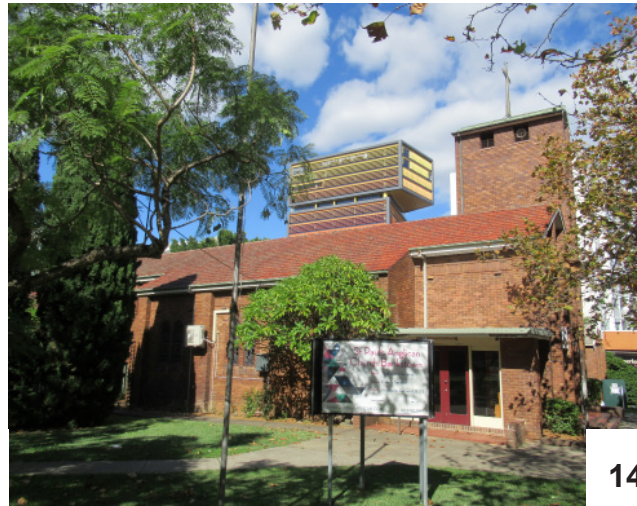
- 10 View east from Chapel Road with subject site at centre right
- 11 View north along Chapel Road with Church indicated by arrow
- 12 View south along Chapel Road with Church indicated by arrow
- 13 Front facade of Church
- 14 Northern facade of Church with entrance porch

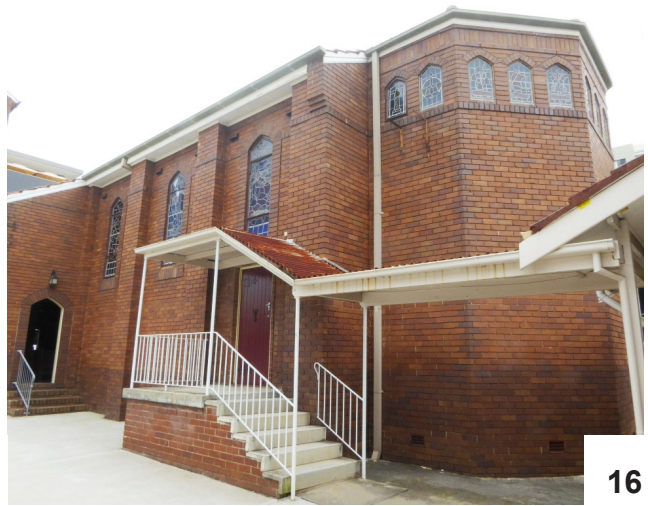
16 View of Church from south-east
 18 Protruding key bricks, southern facade
 20 View west in Church, showing gallery, steel rafters and green acoustic panels

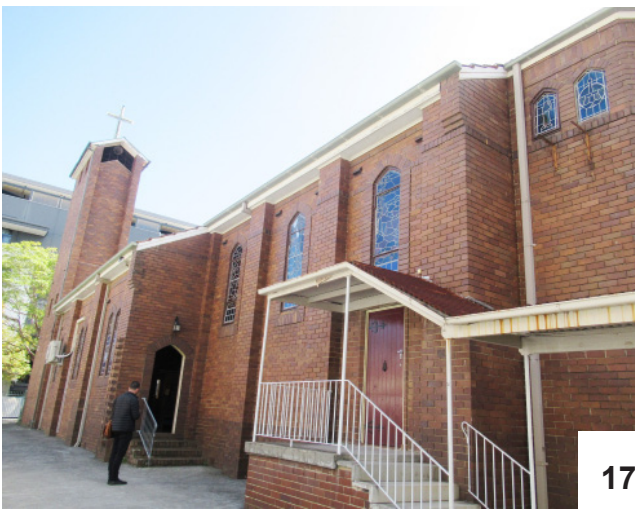
15 View to Community Hall from Chapel Road
 17 Southern facade of Church
 19 View east in 1939 Church remnant, showing timber rafters

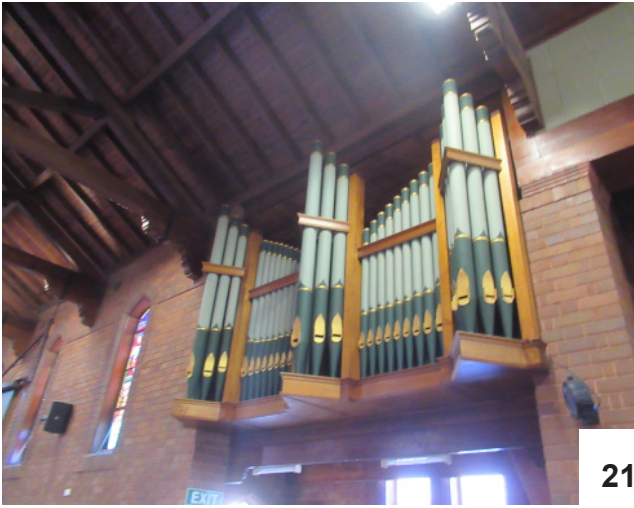
21 *Faux* organ pipes, south wall of Church

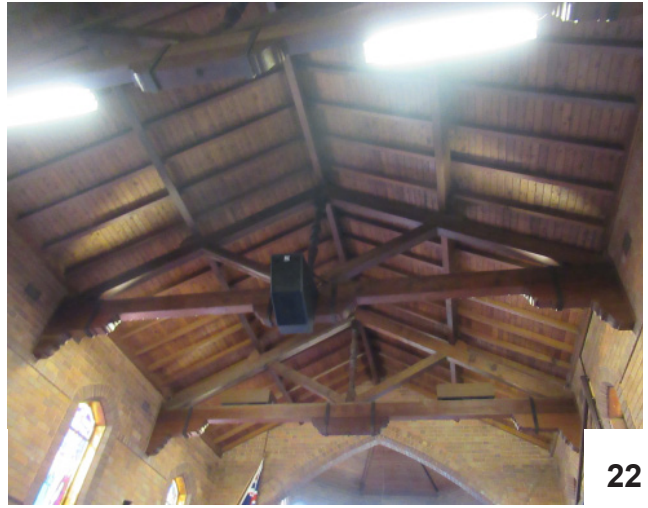
22 Original timber trusses in 1939 Church remnant

Internally, this section features face brick walls in a Flemish bond pattern, with an expressed course at the springing point of the window arches. The timber rafters and timber-lined soffits of the high roof are exposed, augmented at intervals by heavy timber trusses with decorative support brackets and turned centre chords, reflecting a degree of care invested in the modest building. The five-sided apse at the eastern end features an almost full-height pointed

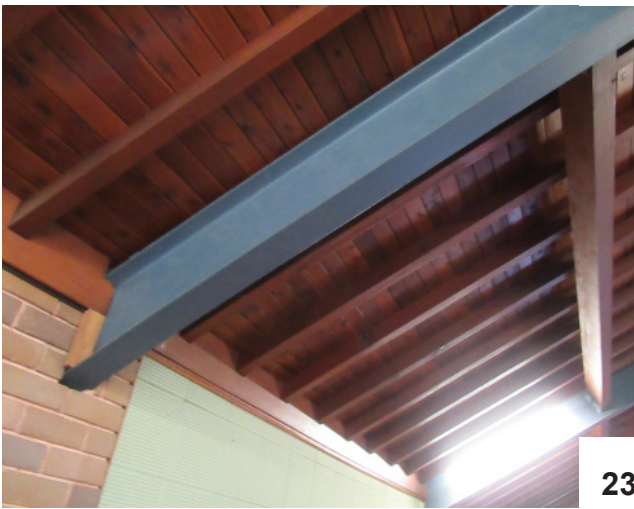
23 Steel portals in 1961 addition

The demolition of the 1939 Church's primary facade, its replacement with a facade of a completely different style, the abrupt insertion of steel structural, *faux* 'heritage' elements, starkly different window styles and the obstruction of public views to the remnant Church by the new addition could all be regarded as intrusive impacts on the significance of the original building.

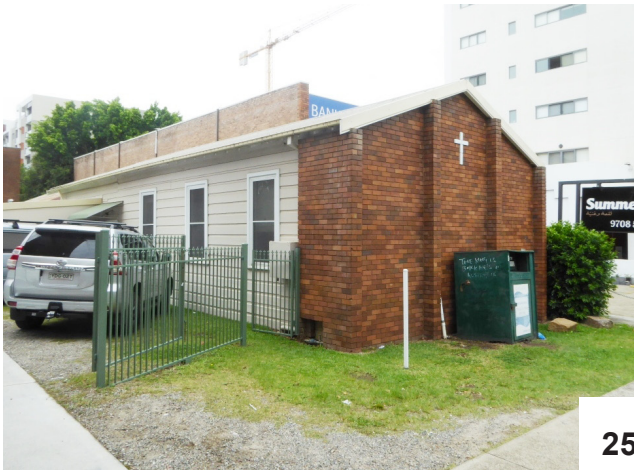
25 West section of Community hall

The c.1914-1920 timber Church building remains, in modified form, with a brick western facade in the style of the 1961 addition to the Church, and later fibre-cement-clad extensions to the east and north.

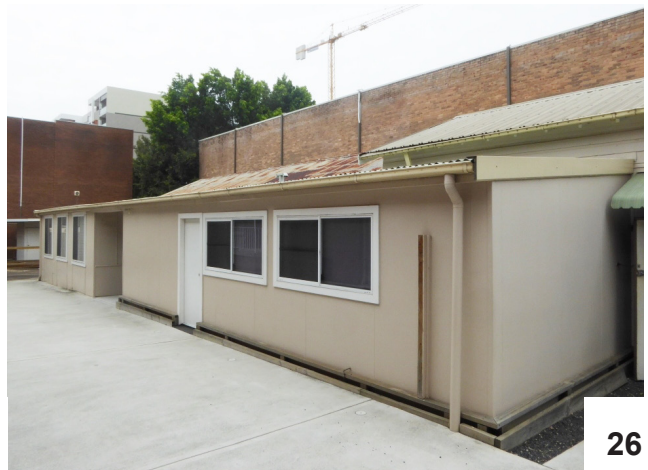
26 East section of Community Hall

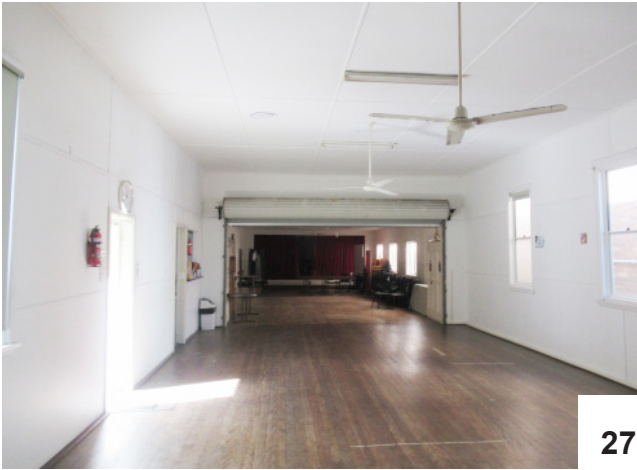
- 27 Westward view inside Community Hall
- 28 West facade of Rectory
- 29 West facade of Church office/Vestry
- 30 WC block
- 31 Garage and driveway

Internally the Hall is a large open space with timber floors and fibre-cement lining and ceilings.

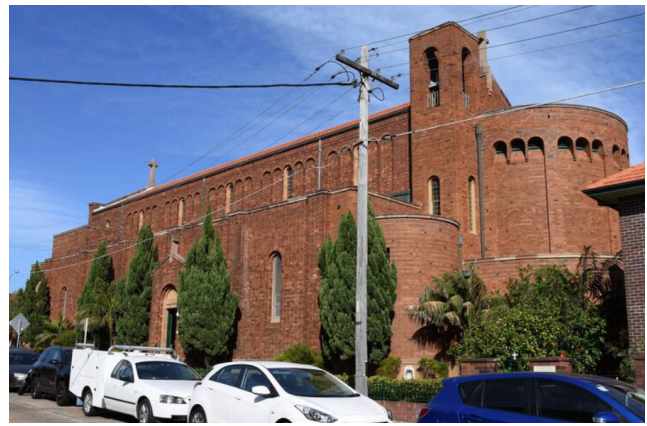
Figures 32-33
St Annes's Catholic Church

The church is a fine and representative example of the interwar Romanesque style. The main body of the church was constructed in 1934, but the sanctuary and apses were not completed until 1964. The façade is of textured red brick with sandstone

plinth, entry portico, door and window surrounds and parapet copings. The roof is of red tiles over the nave and aisles, and copper over the northern apses. The building won the Sulman Award for architecture in 1935 and offers a historical insight to the interwar aesthetics of Sydney in the 1930s.

It is noted that the 1934 and 1964 sections of the church are in the same style.

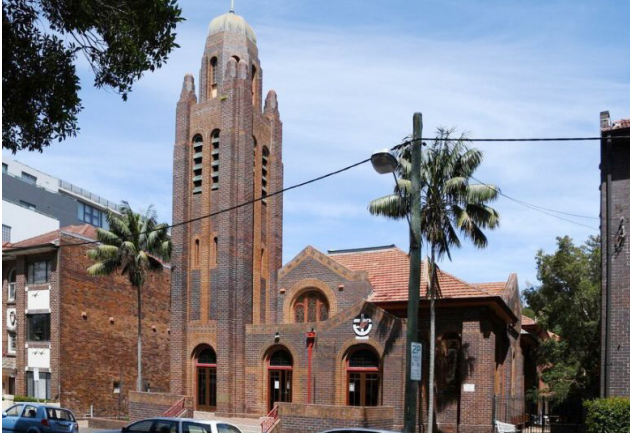
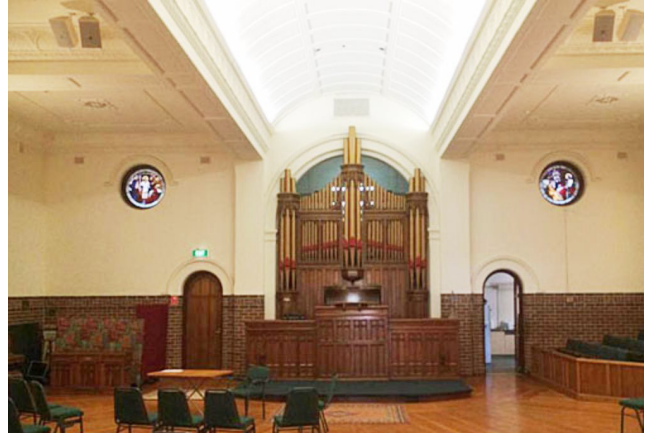
Figures 34-35
Manly Village Uniting Church

A dark brick Inter-War Romanesque style church with 3 entry doors with arched leadlight fanlights, a 4 storey spire with arched leadlight windows and arched vents, a copper dome and copper finial. Side windows are also arched and either stained glass or leadlight.

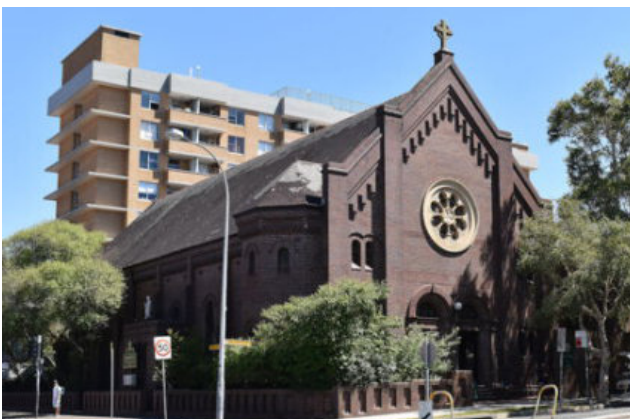
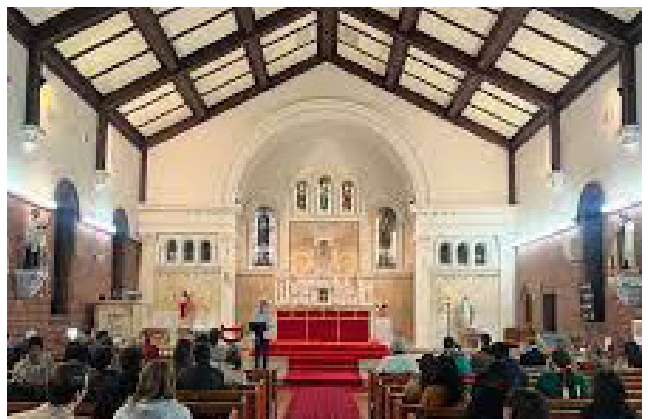
Figures 38-39
St Patrick's Church

All brick construction, with characteristic machicolations and gabled form. Chancel on corner. Slate roof. Good decorative brickwork with stone relief to feature, stained glass window to main façade and round arched openings. The church is significant as an intact example of an all brick church, typical of its period. It features some fine decorative work. Special historical interest to local Catholic community as the second St Patrick's Church, and part of the important church-school grouping on Wellington Street.

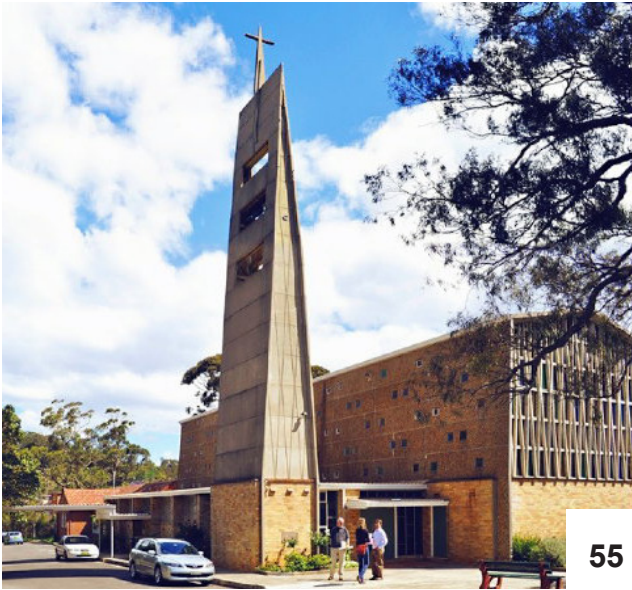
- 55 St Mark's Anglican Church, West Wollongong, as it once was
- 56 St Mark's, recent image showing later addition abutting front facade of original building
- 57 Port Authority Building, Antwerp
- 58 Elbphilharmonie, Hamburg
- 59 Substation 164, Sydney

It is noted that such significance as St Mark's in West Wollongong once had has been detrimentally impacted by the construction, in front of it, of an obstructive, unsympathetic addition - just as the 1961 addition to St Paul's impacted the 1939 Church.
