## **Lend Lease Building Pty Ltd**

### **Contamination Assessment**

University of Sydney Health Precinct  
Blackburn Building (D06), Dangerous Goods  
Store (D15) and Proposed Shared Pedestrian &  
Vehicular Pathway  
Camperdown NSW

9 January 2017

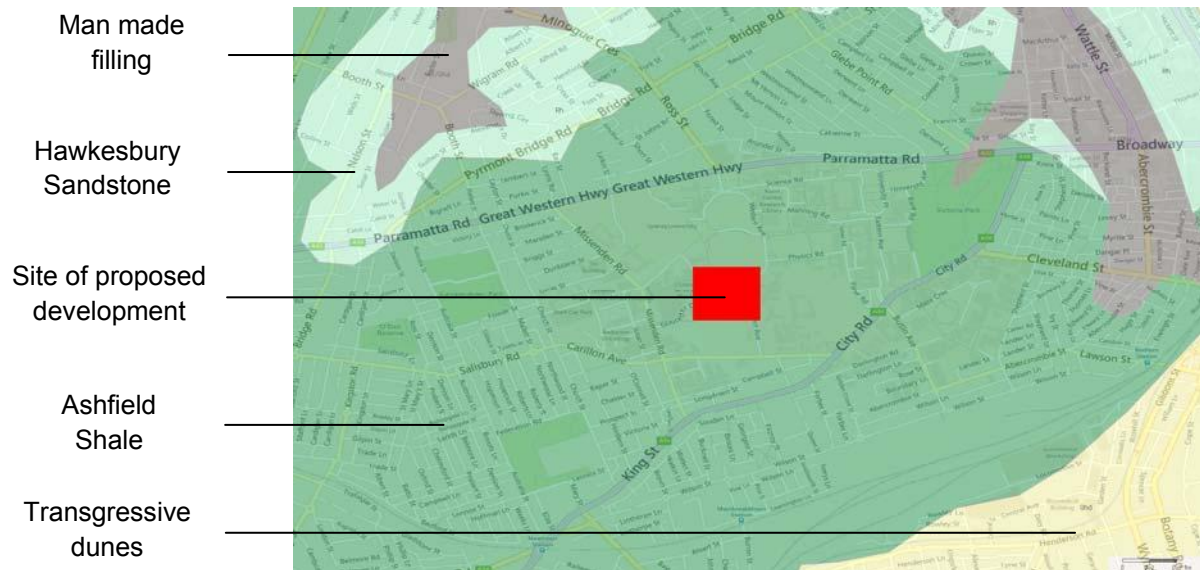
**Figure 1: Extract from Sydney 1:100,000 Geology Sheet**

Reference to the Sydney 1:100,000 Geology Sheet indicates that the site is underlain by Ashfield Shale, typically comprising black to dark grey shale and laminite. An extract from the geology map is shown in Figure 1.
