**Report on Geotechnical Investigation  
Report**

**Proposed Commercial Development**

**6-8 Julius Ave, North Ryde NSW**

**Project 233059.01**

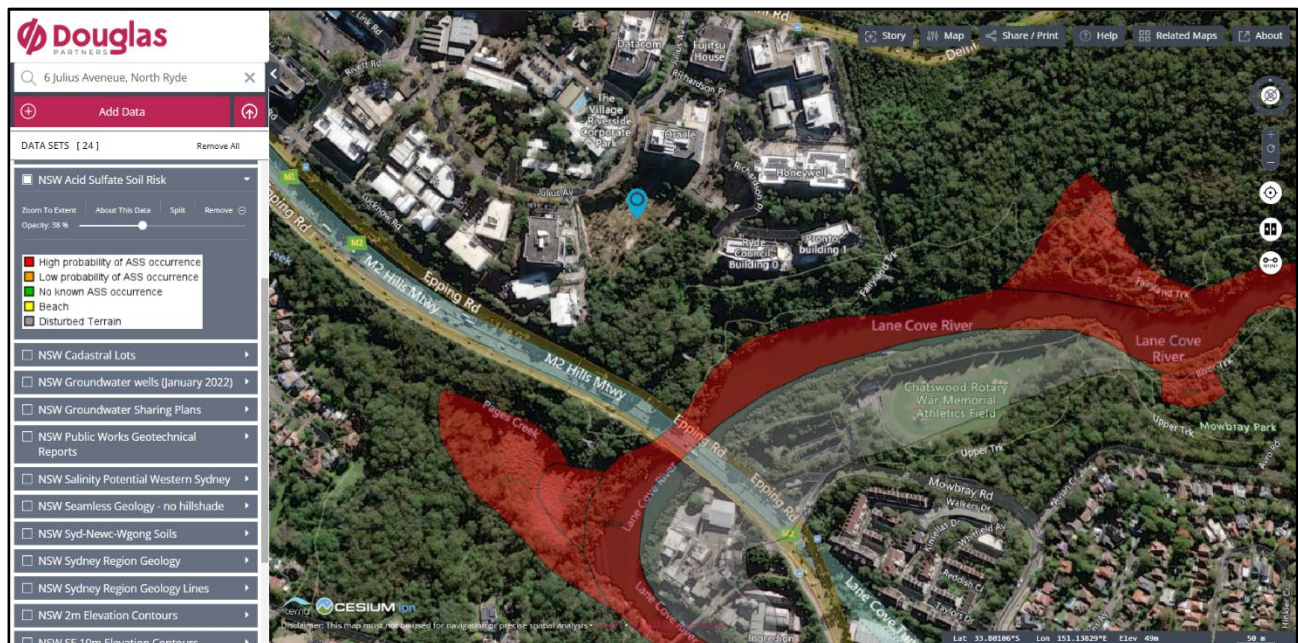
**Figure 4: Excerpt of Sydney 1:100,000 Soils Landscape Sheet with site indicated with blue marker.**

Douglas has reviewed the site location in relation to the mapped areas for presence and probability of ASS (see NSW Acid Sulphate Soil Risk extract, Figure 4). Based on the data provided by eSPADE, the site is located outside of any mapped Acid Sulphate Soils (ASS) risk areas. The critical elevation of the upper level of ASS occurrence is RL 1 m, indicating that the depth of the ground surface (RL 36 m) to the ASS layer is about 35 m or more metres depth.

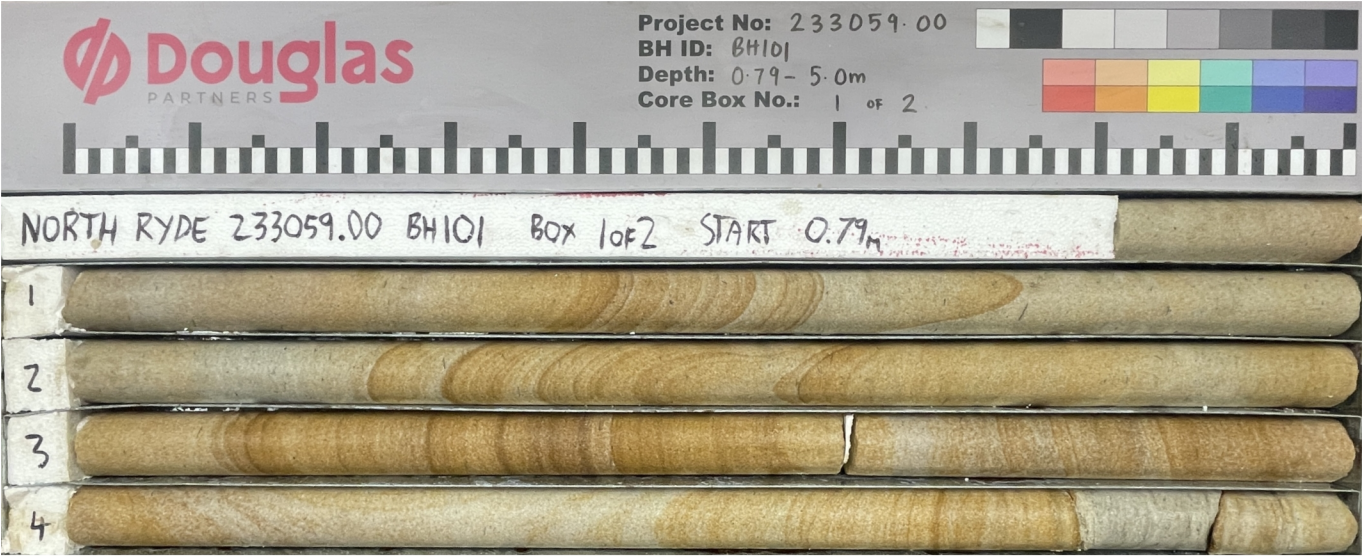
0.79-5.00 m depth

Details of the subsurface conditions encountered in each borehole are given in the logs in Appendix D together with notes defining classification methods and descriptive terms. Photographs of the recovered core are also included.

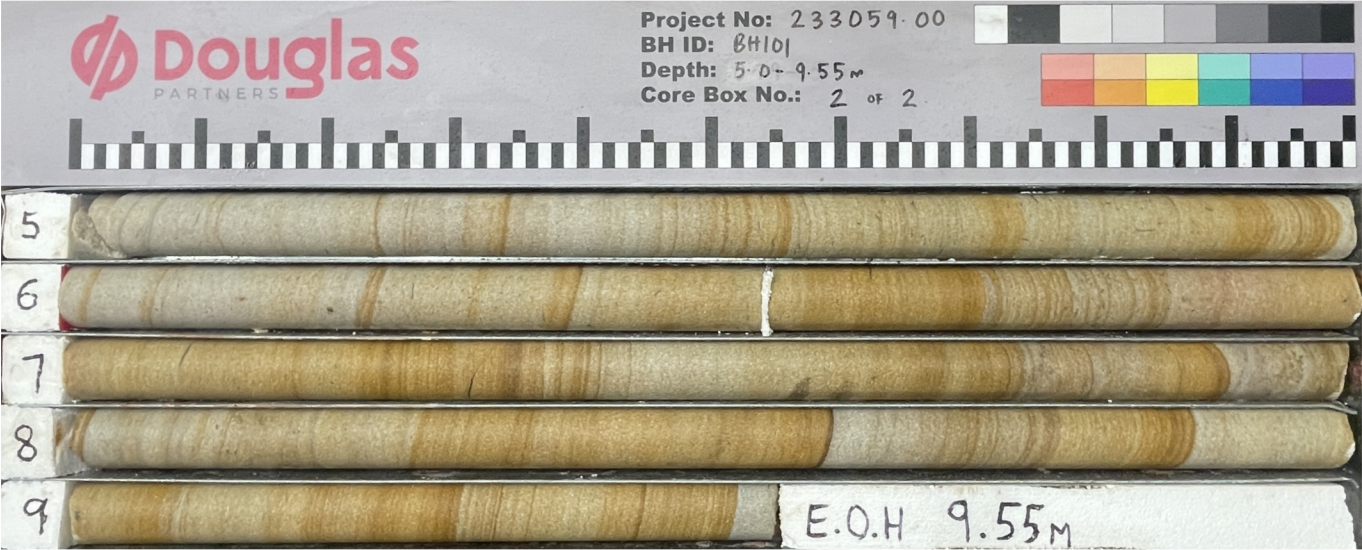
5.00-9.55 m depth

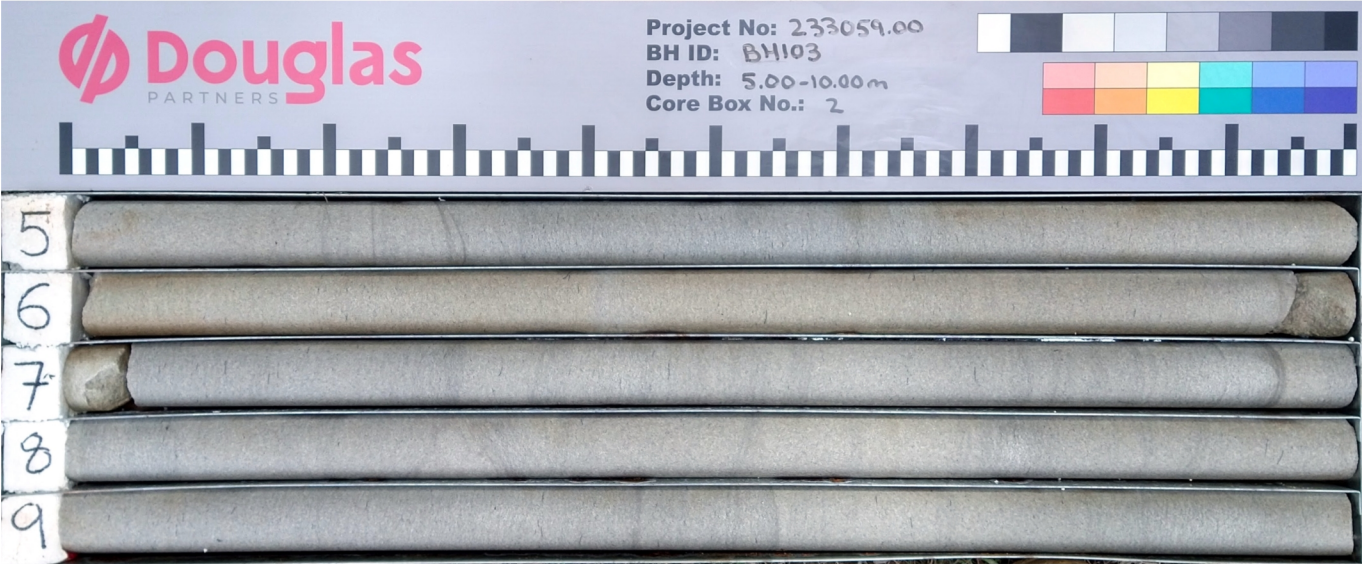
5.00-10.00 m depth

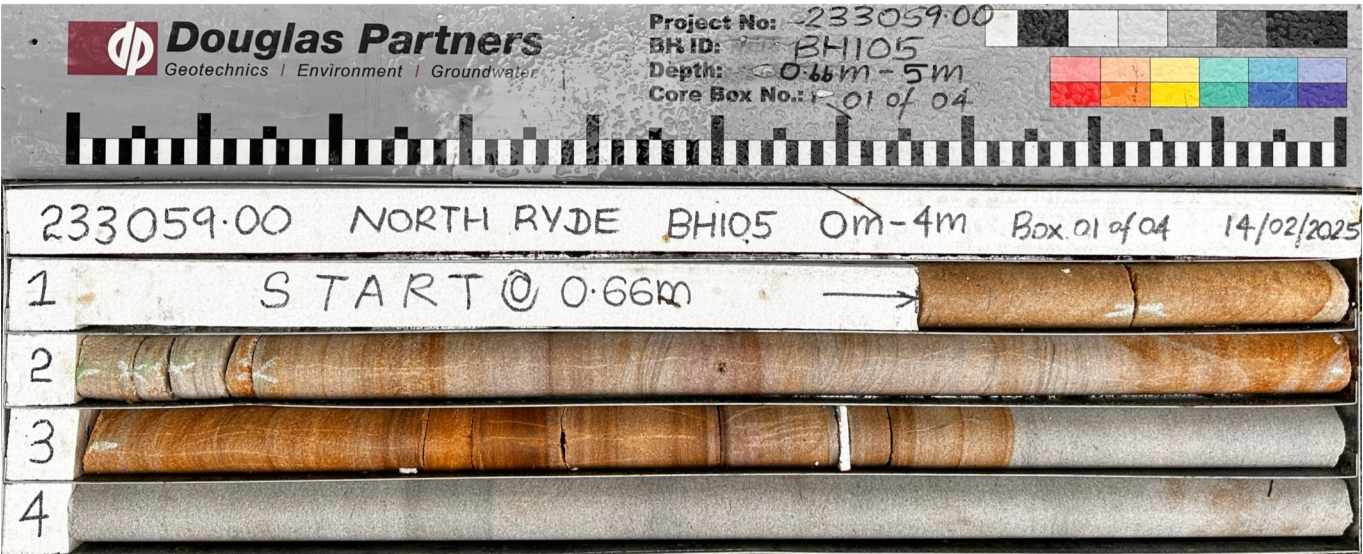
0.66-5.00 m depth
