## **Groundwater Impact Assessment**

**Proposed Commercial Development**

**6-8 Julius Avenue, North Ryde NSW**

**Project 223059.00**

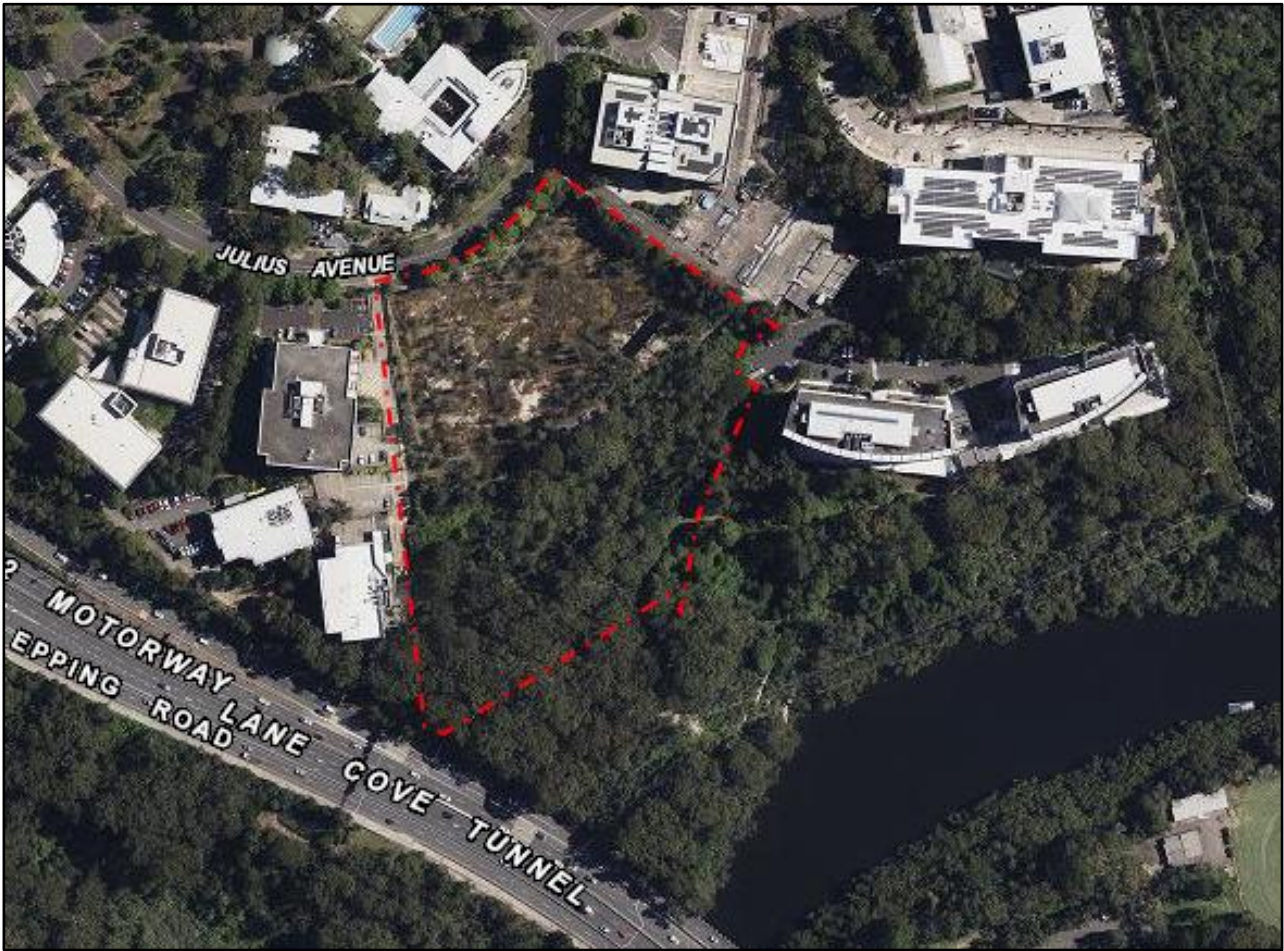
The site is located at 6-8 Julius Avenue, North Ryde within the Riverside Corporate Park (see Figure 1). The site is an irregular shaped block with an area of approximately 3 hectares bound by Julius Avenue to the north, private driveways of office developments on the east and west, and a walking track in Lane Cove National Park and Lane Cove River to the south. The site generally slopes towards the south-east.

The site has been excavated to RL 36 m for a previous development and currently consists of a sandstone platform over most of the site with cut sandstone rock faces along the northern and parts of the western and eastern boundaries.

**Figure 1: Aerial of site, site boundary marked in red dashed line.**

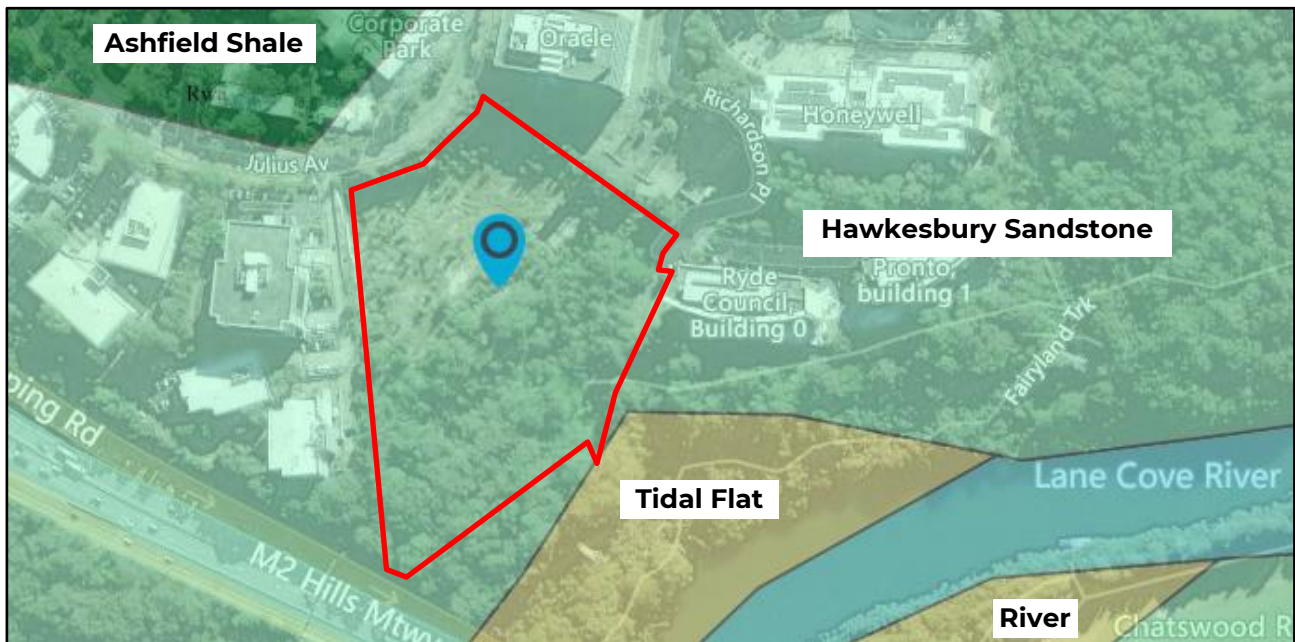
Reference to the Sydney 1:100 000 Series Geological Sheet (9130) indicates that the site is underlain by Hawkesbury Sandstone of Triassic Age (see Figure 2). Hawkesbury Sandstone typically comprises medium to coarse grained quartz sandstone with some shale and laminite bands or lenses.

**Figure 2: Excerpt of Sydney 1:100,000 Geological Series sheet, with site indicated with blue marker.**

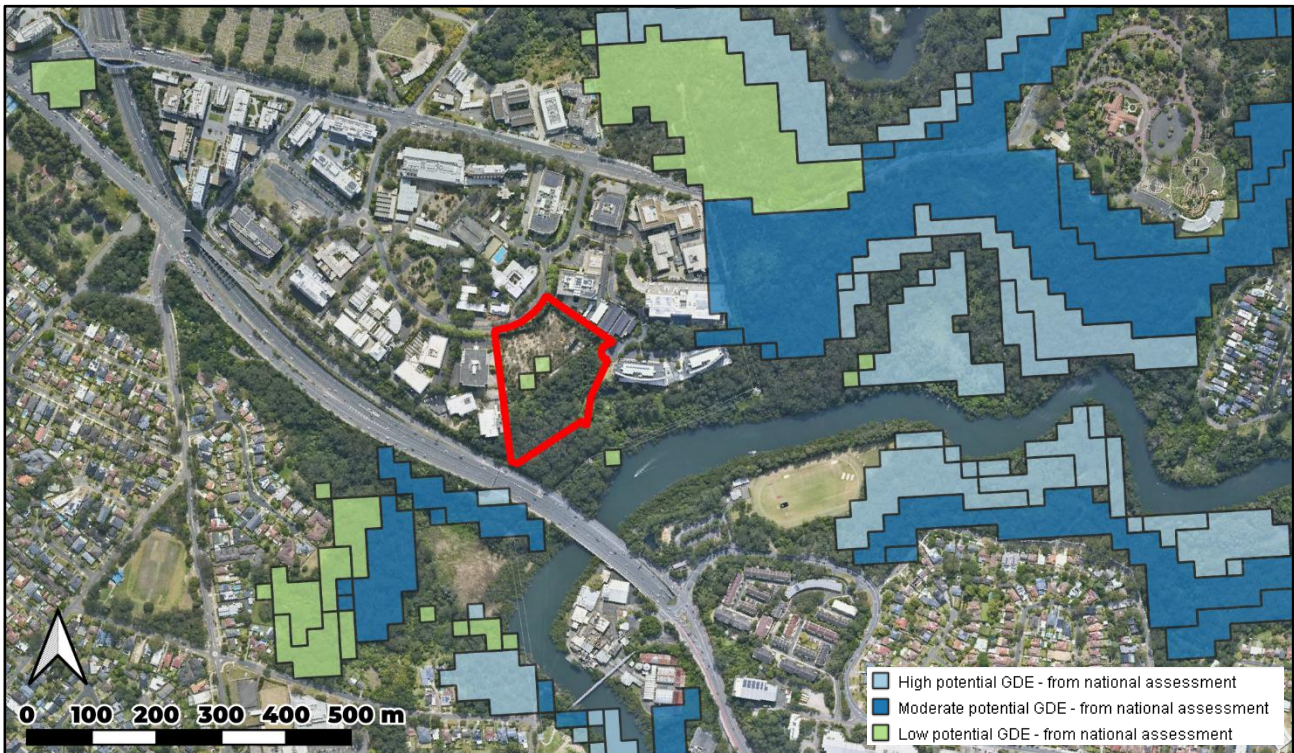
Based on the BoM GDE Atlas, mapped terrestrial GDEs are located within the subject site and the surrounding locality, as a part of the bushland bordering the Lane Cove River. These include:

- Coastal Sandstone Ridgetop Woodland, (within and nearby the site);
- Hinterland Sandstone Gully Forest (closest proximity 60 m southwest); and,
- Estuarine Mangrove Forest (closest proximity 400 m south of the site).

**Figure 3: Mapped Groundwater Dependent Ecosystems (GDEs) near the site**

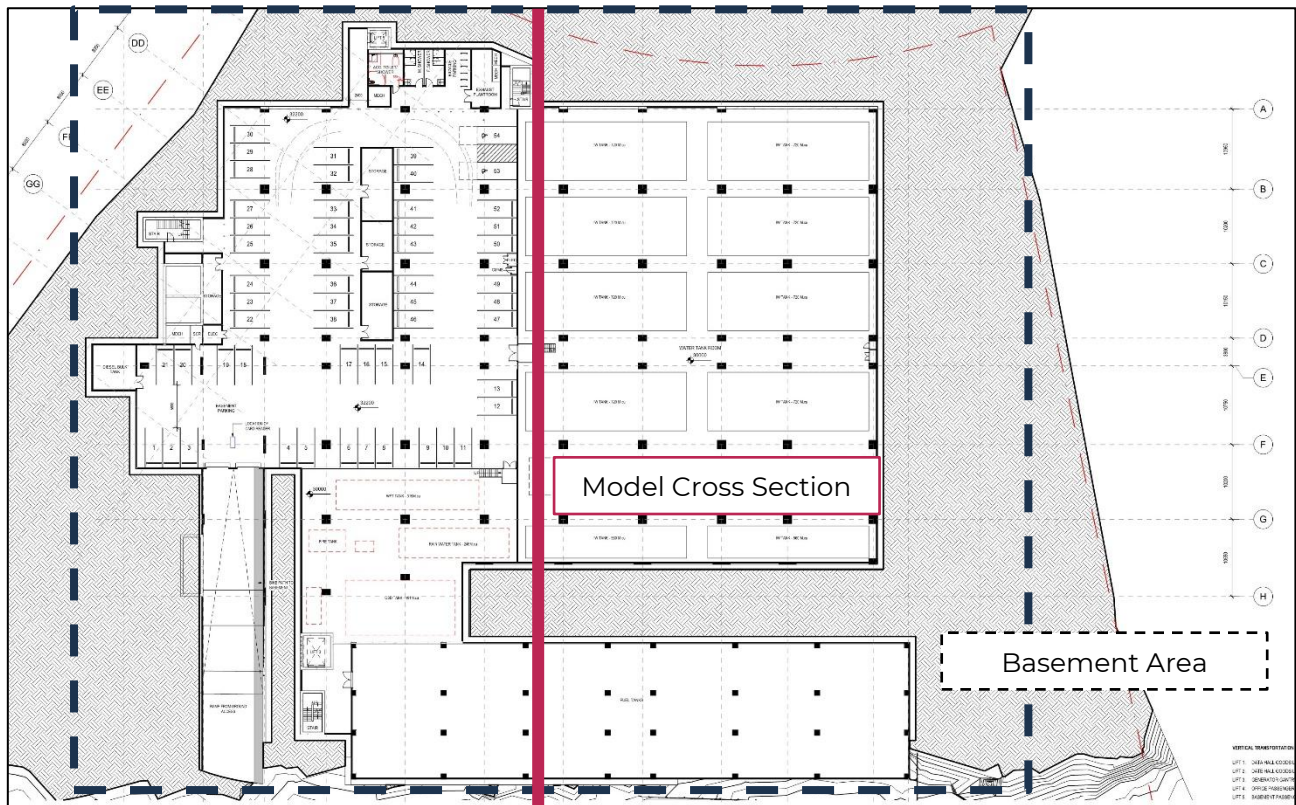
A cross section in the north-west to south-east direction intercepting the basement footprint was selected to run the 2D analysis. The cross section is presented in Figure 4.

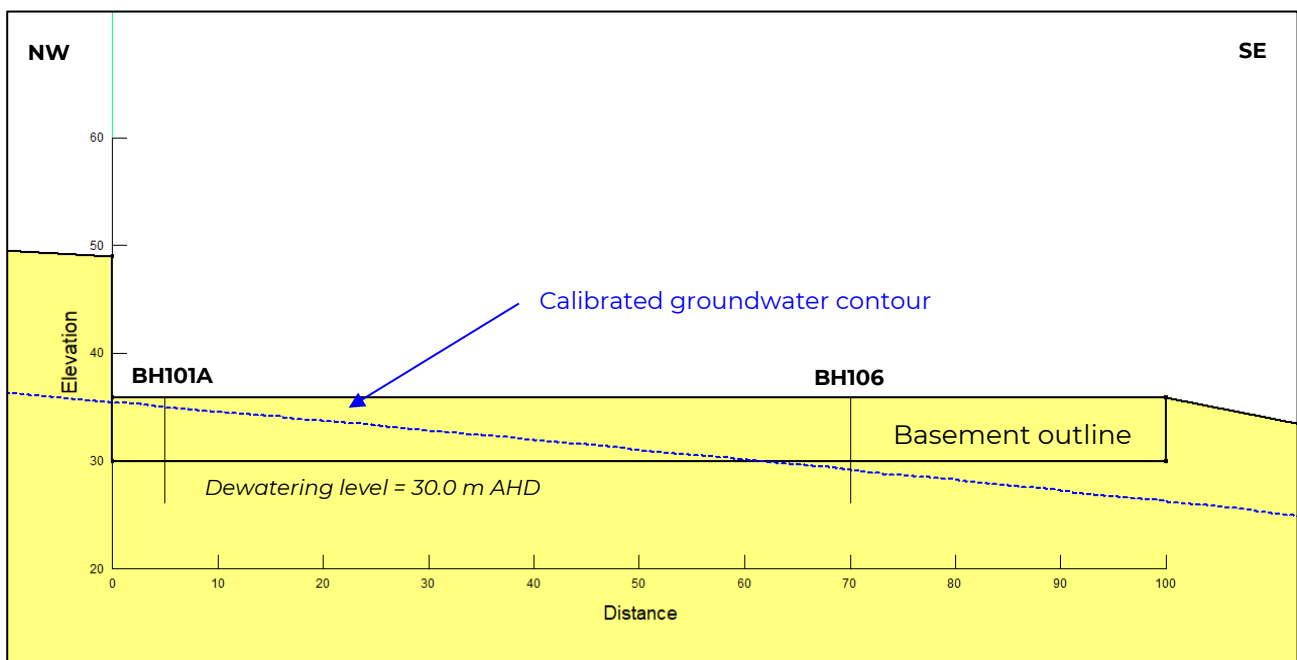
The average annual rainfall in Sydney is 1.2 m/year, however for modelling purposes, the infiltration rate into the site was assumed to be negligible due to the low permeability rock exposed from previous excavation. Rainfall recharge is instead represented in the model through the constant upstream head boundary condition, calibrated to 50 m AHD to replicate the groundwater levels observed within the site as shown on Figure 5.

**Figure 5: Model cross-section, showing calibrated groundwater contour**

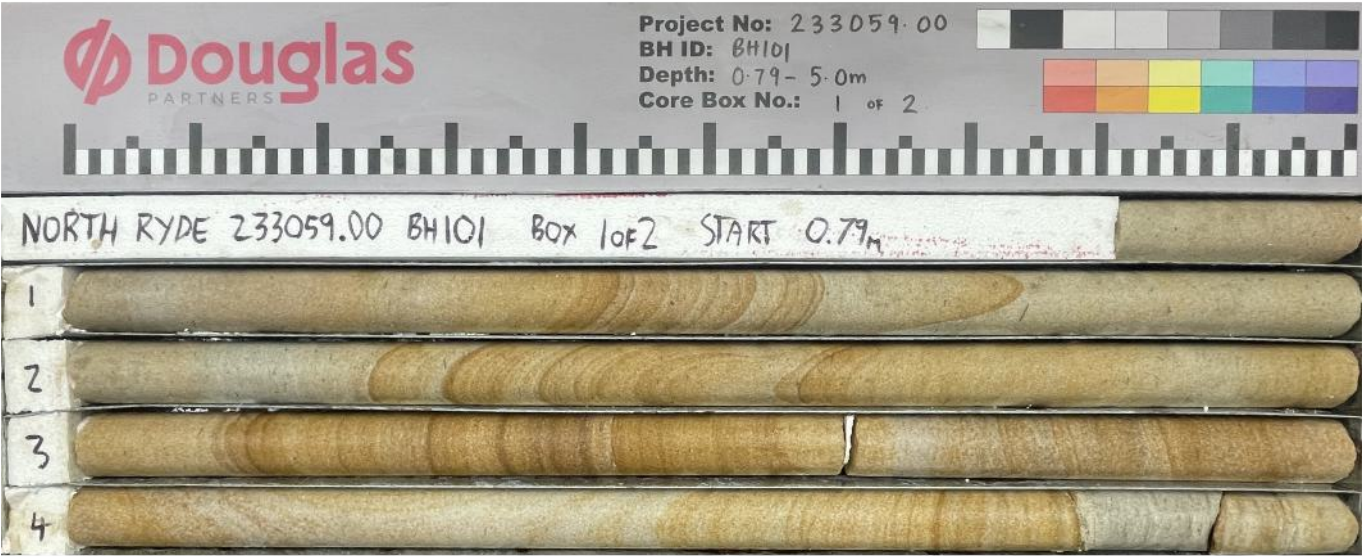
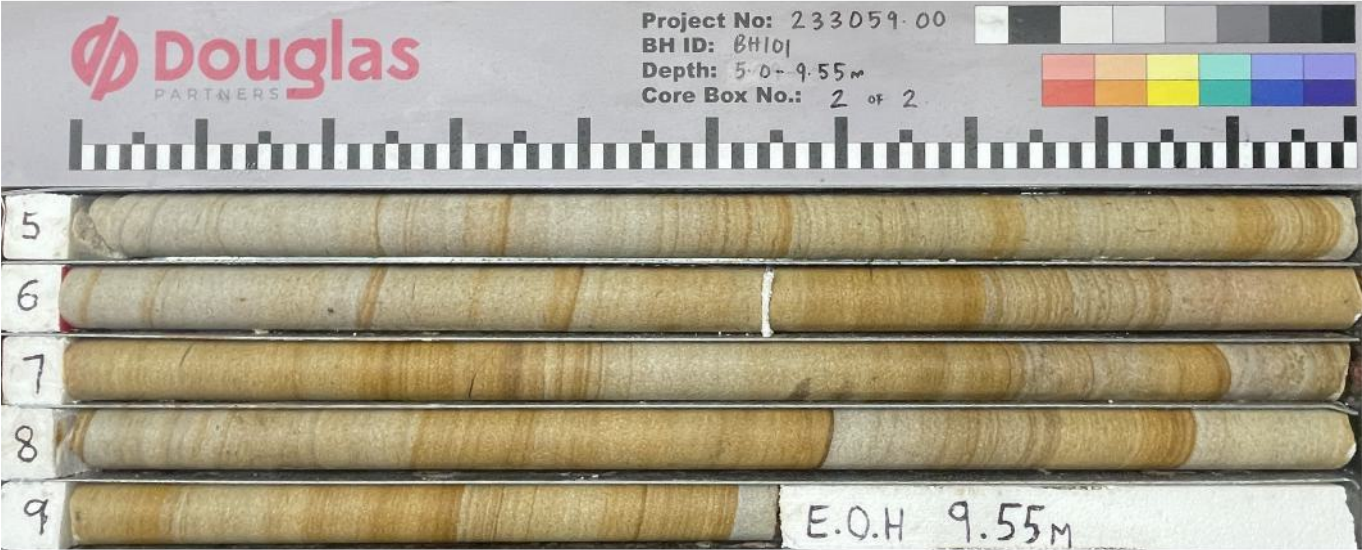
**LOCATION ID:** BH101  
**PROJECT No:** 233059.00  
**DATE:** 17/02/25  
**SHEET:** 1 of 1

0.79-5.00 m depth

5.00-9.55 m depth

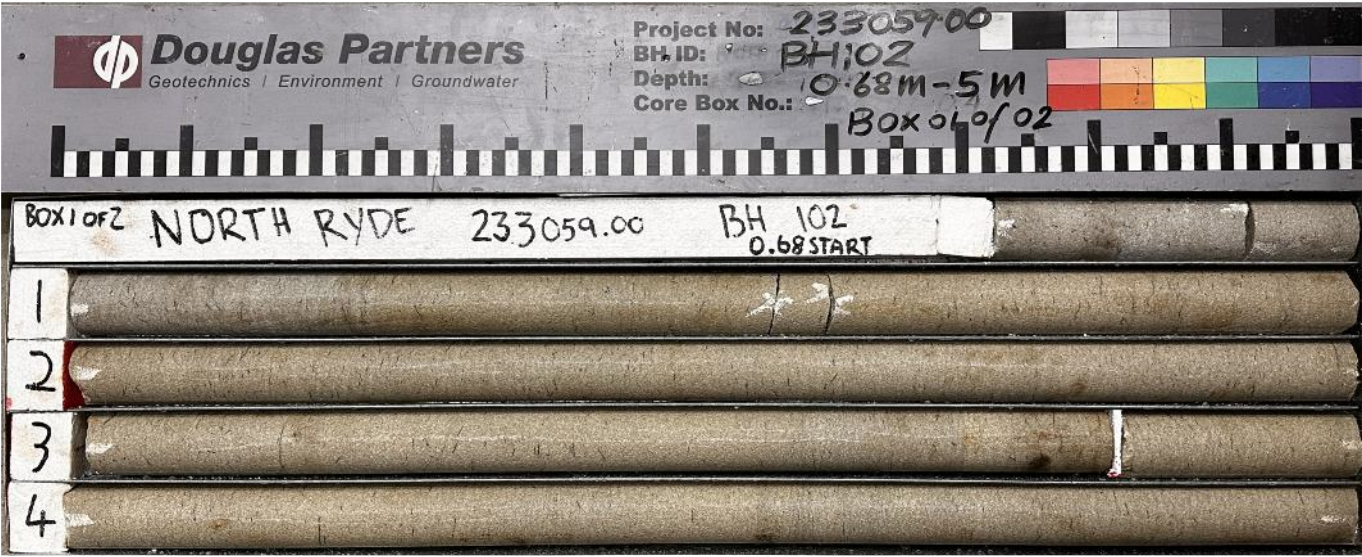
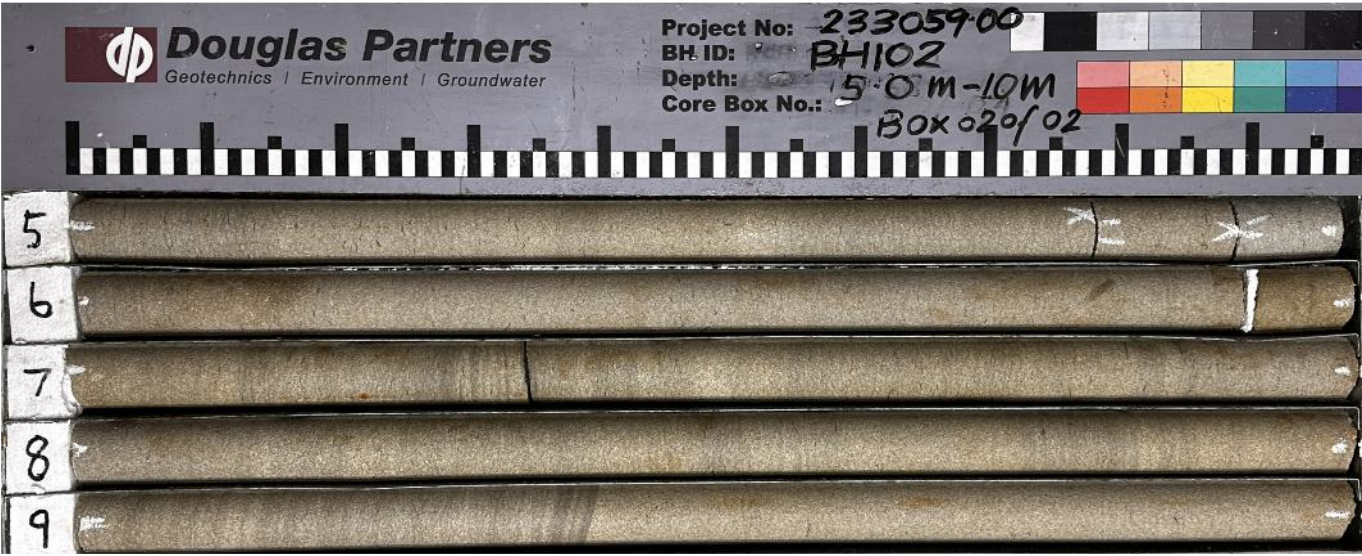
0.68-5.00 m depth

5.00-10.00 m depth

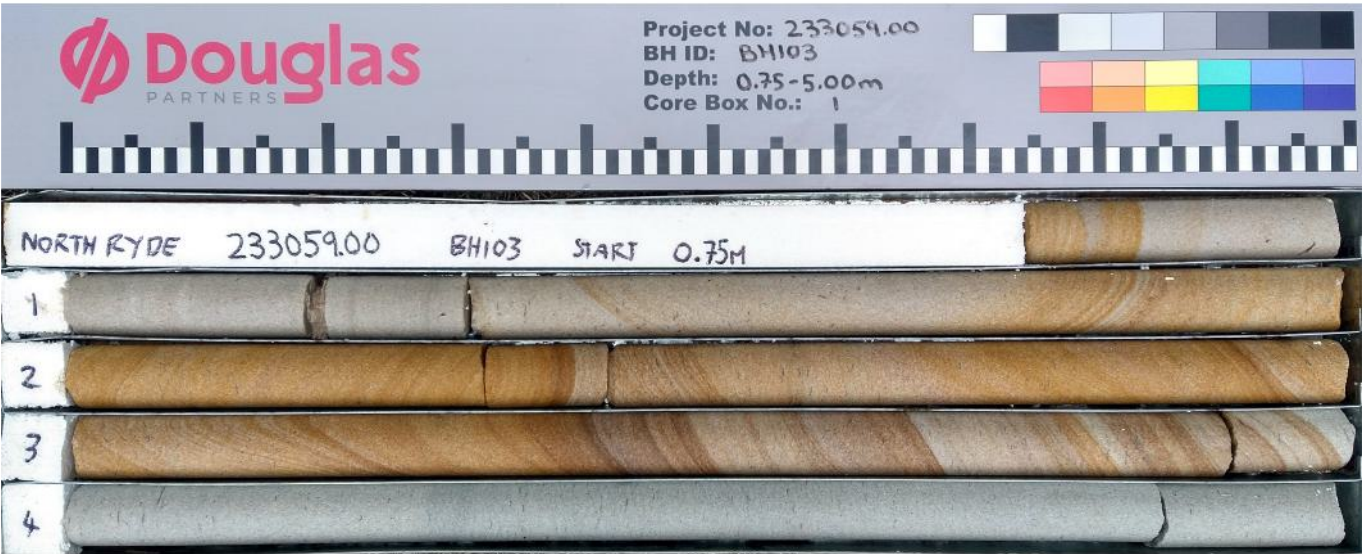
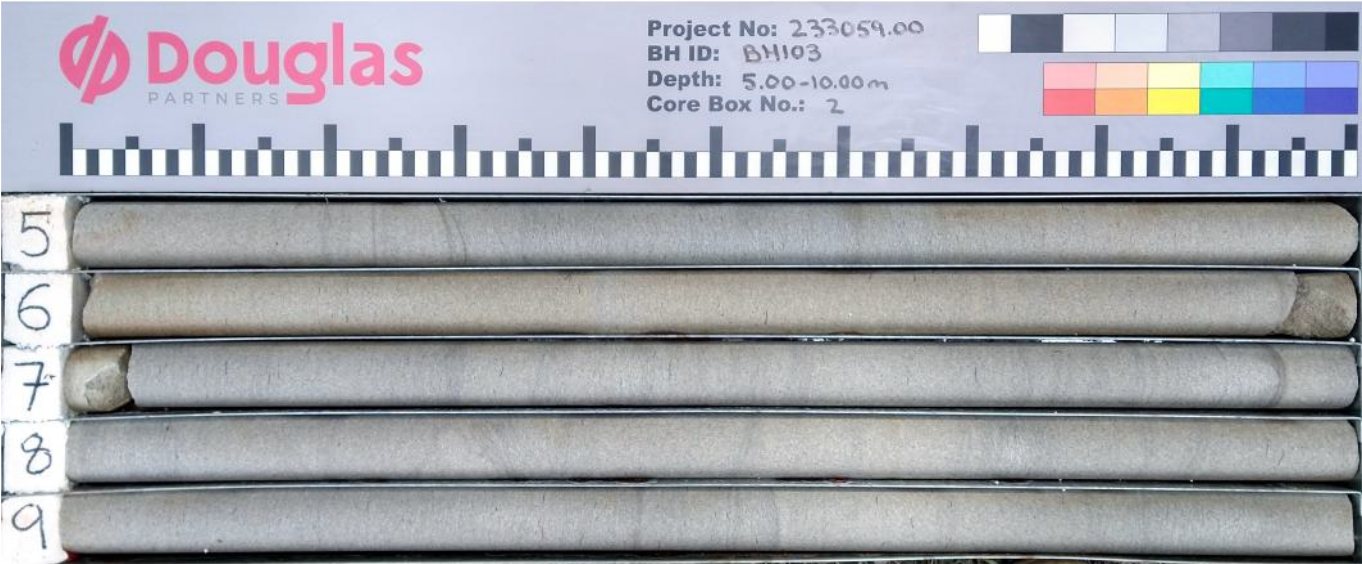
**LOCATION ID:** BH103  
**PROJECT No:** 233059.00  
**DATE:** 18/02/25  
**SHEET:** 1 of 1

0.75-5.00 m depth

5.00-10.00 m depth

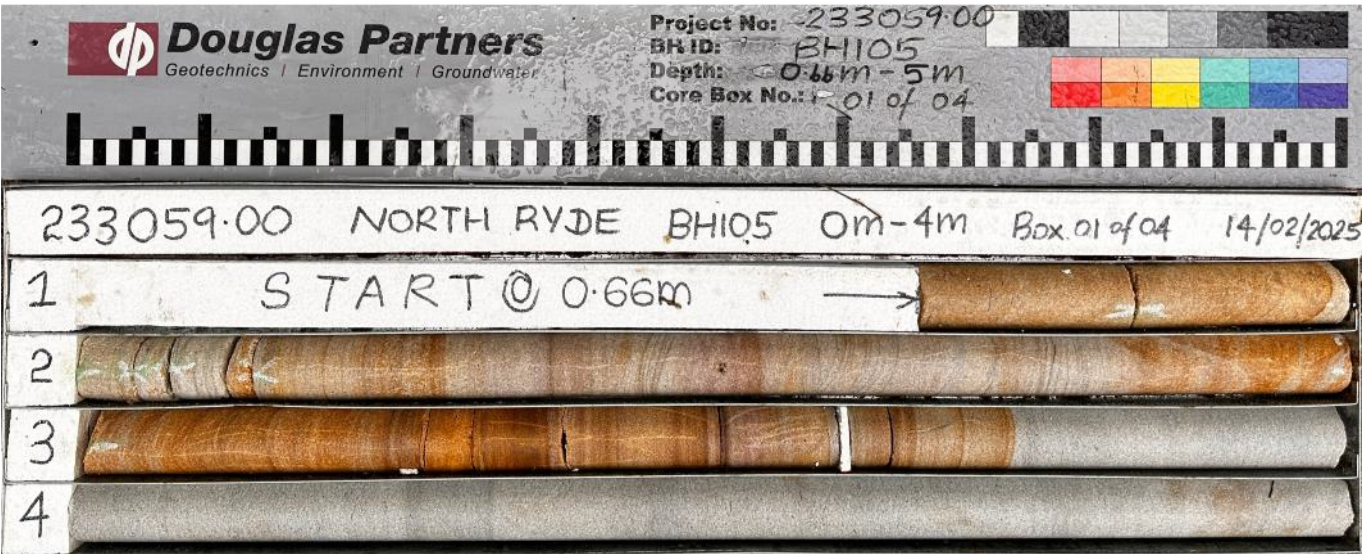
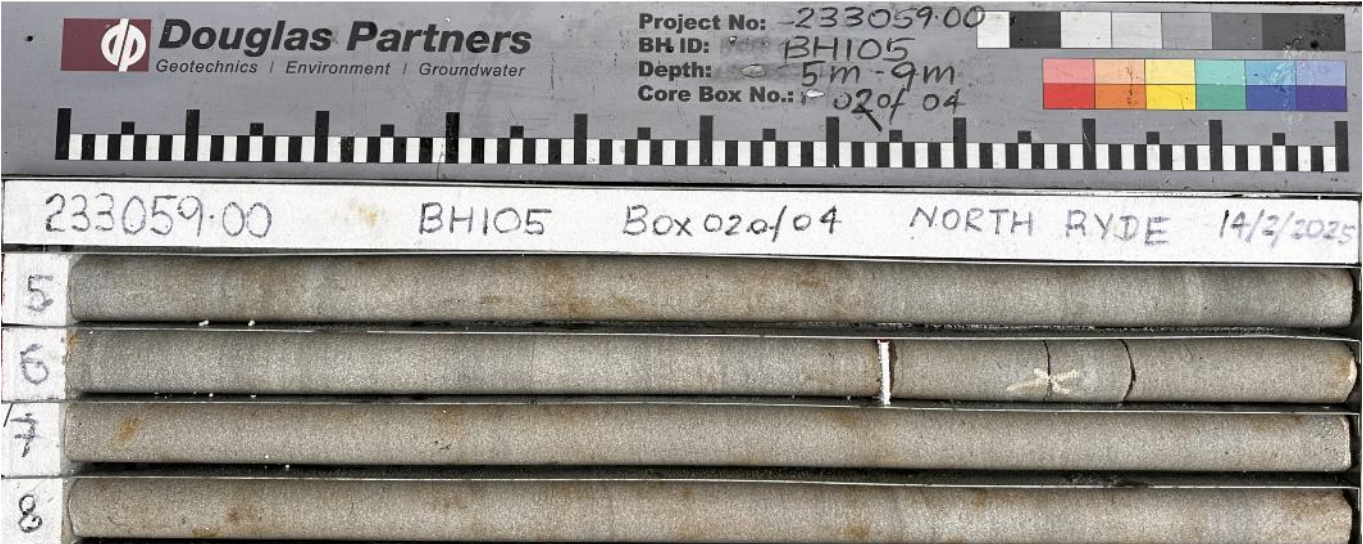
**LOCATION ID:** BH105  
**PROJECT No:** 233059.00  
**DATE:** 14/02/25  
**SHEET:** 1 of 2

0.66-5.00 m depth

5.00-9.00 m depth

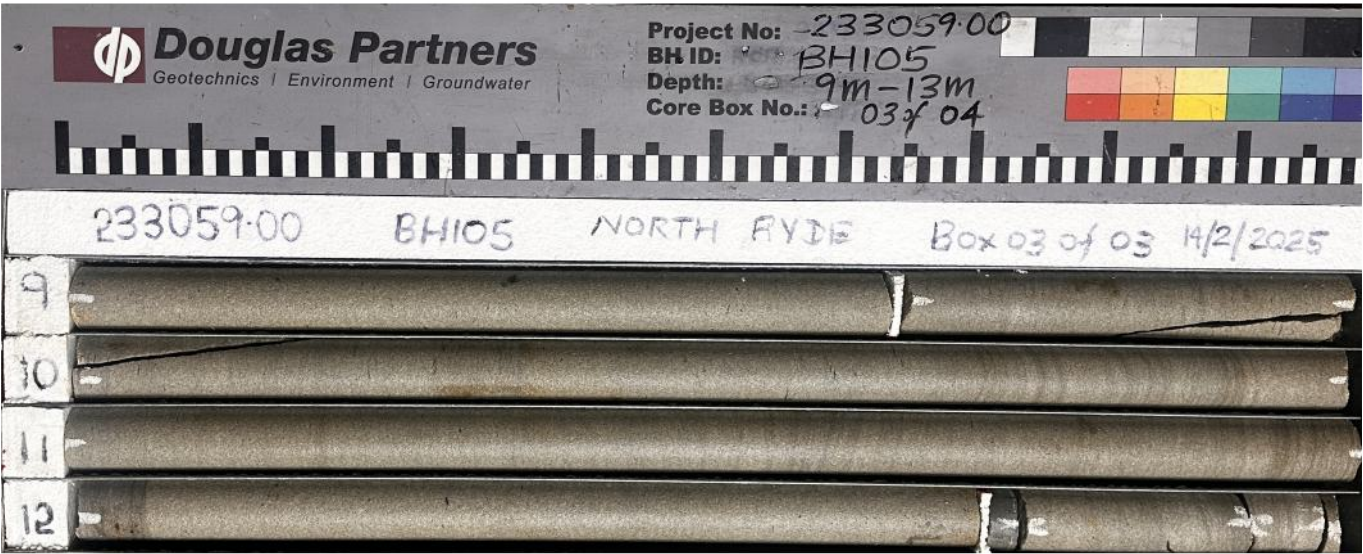
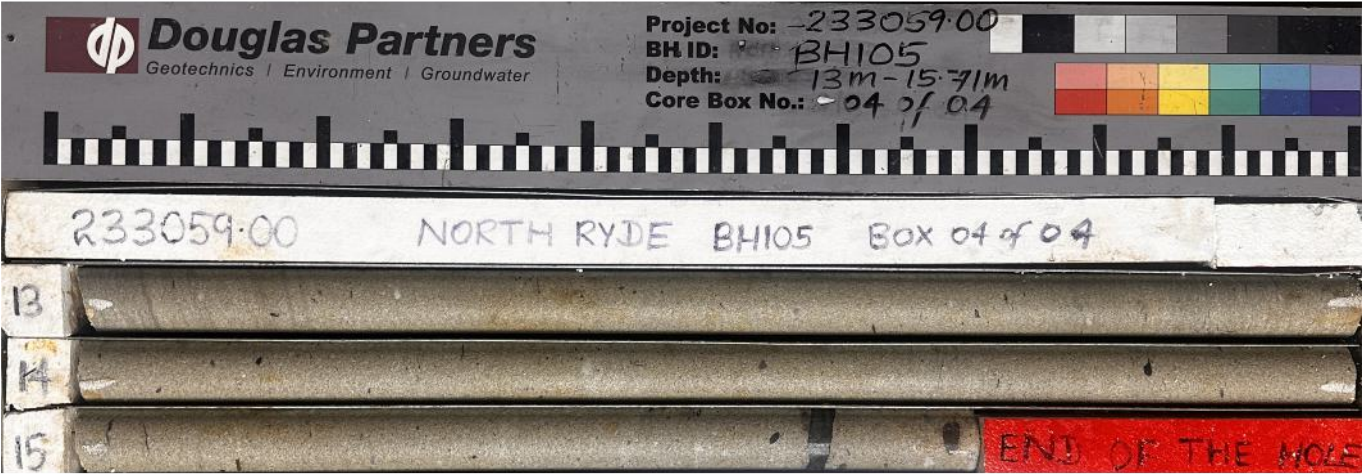
**LOCATION ID:** BH105  
**PROJECT No:** 233059.00  
**DATE:** 14/02/25  
**SHEET:** 2 of 2

9.00-13.00 m depth

13.00-15.71 m depth

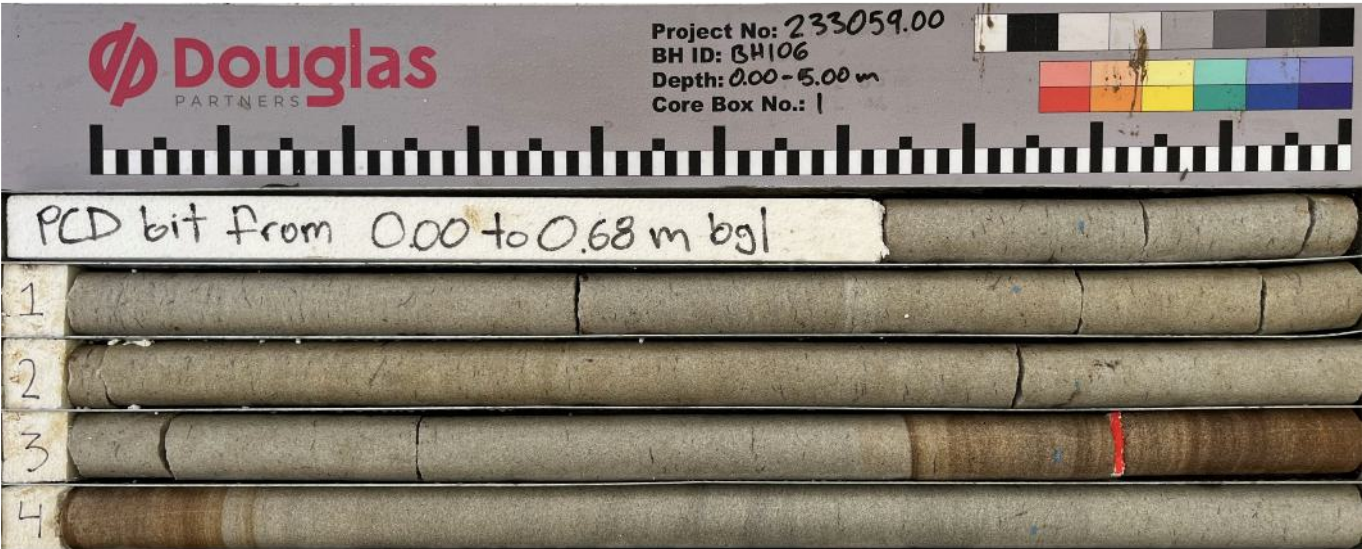
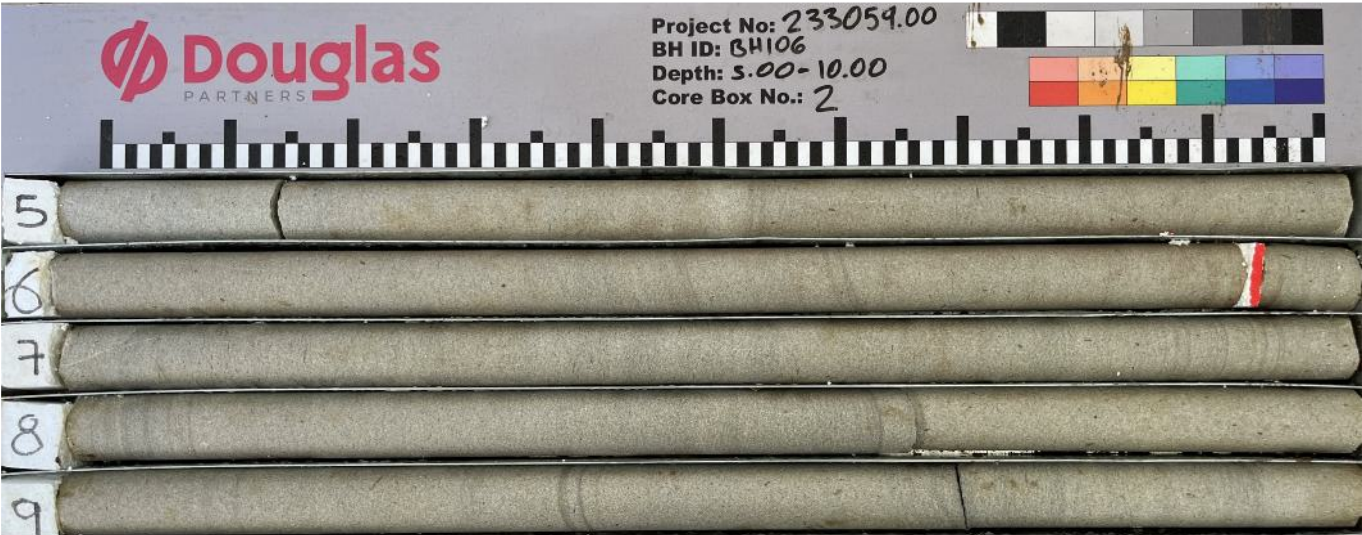
**LOCATION ID:** BH106  
**PROJECT No:** 233059.00  
**DATE:** 19/02/25  
**SHEET:** 1 of 1

0.68-5.00 m depth

5.00-10.00 m depth
