Taronga Zoo, Mosman, NSW

Proposed African Savannah and Congo Exhibition Precincts

Historical Archaeological Assessment

Excavation Permit application under s.140 of the NSW Heritage Act 1977

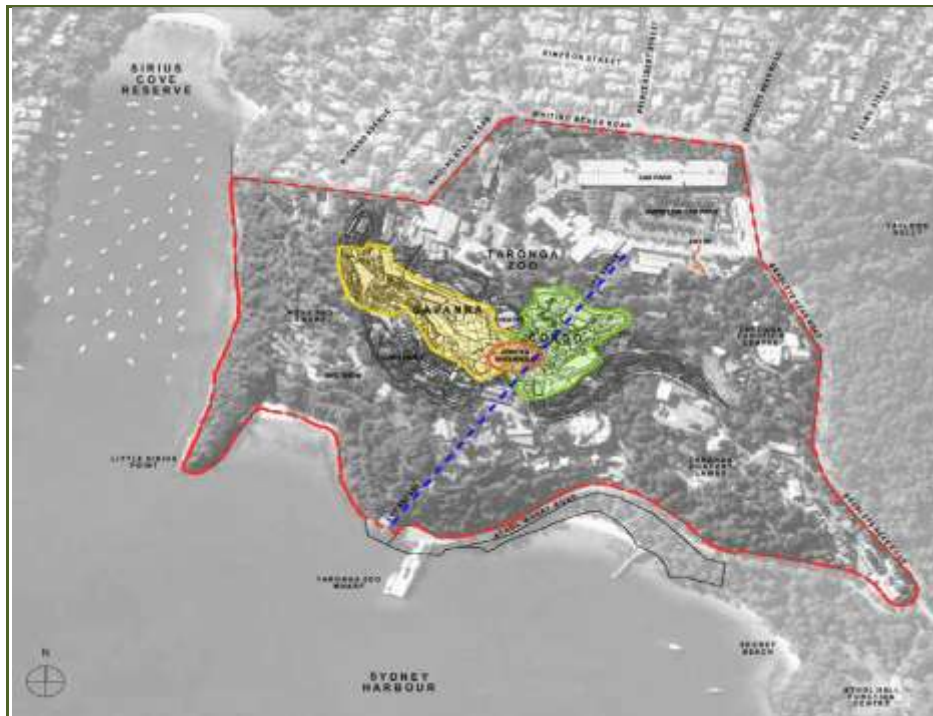
Figure 1.1: Aerial view of the Zoo and location of the proposed Savannah & Congo Exhibit precincts (TZG Architects 2016)

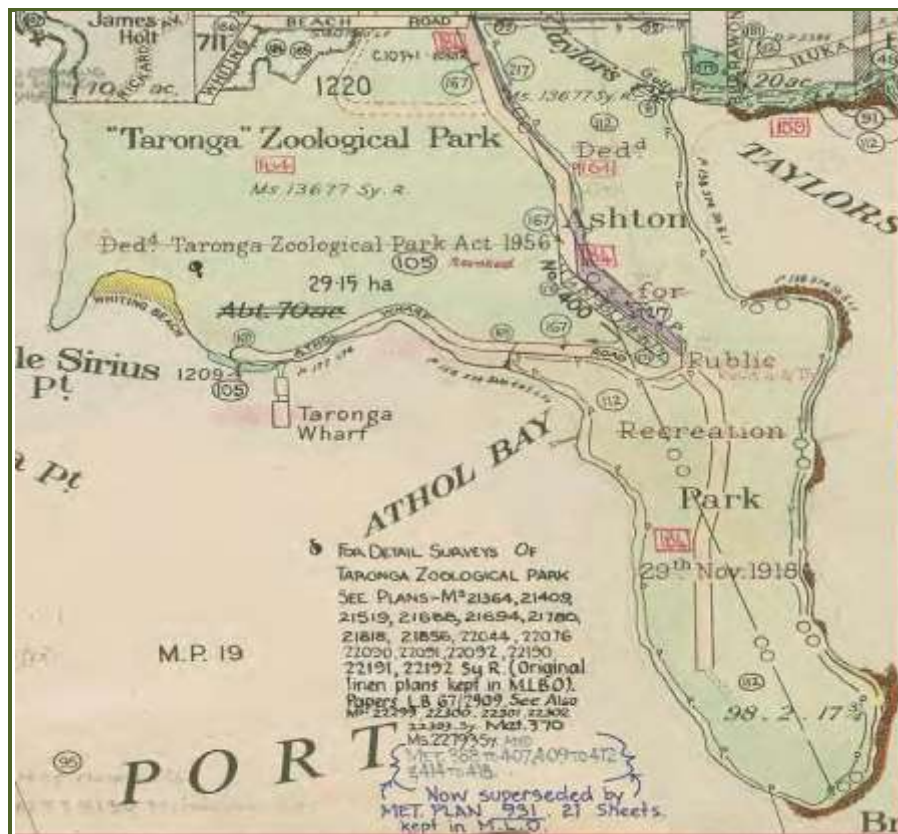
Figure 2.1: Extract from Parish Map showing the site of the Taronga Zoological Park and Ashton Park, which were both part of the former military reserve (Rice 2015 Figure 2.2)

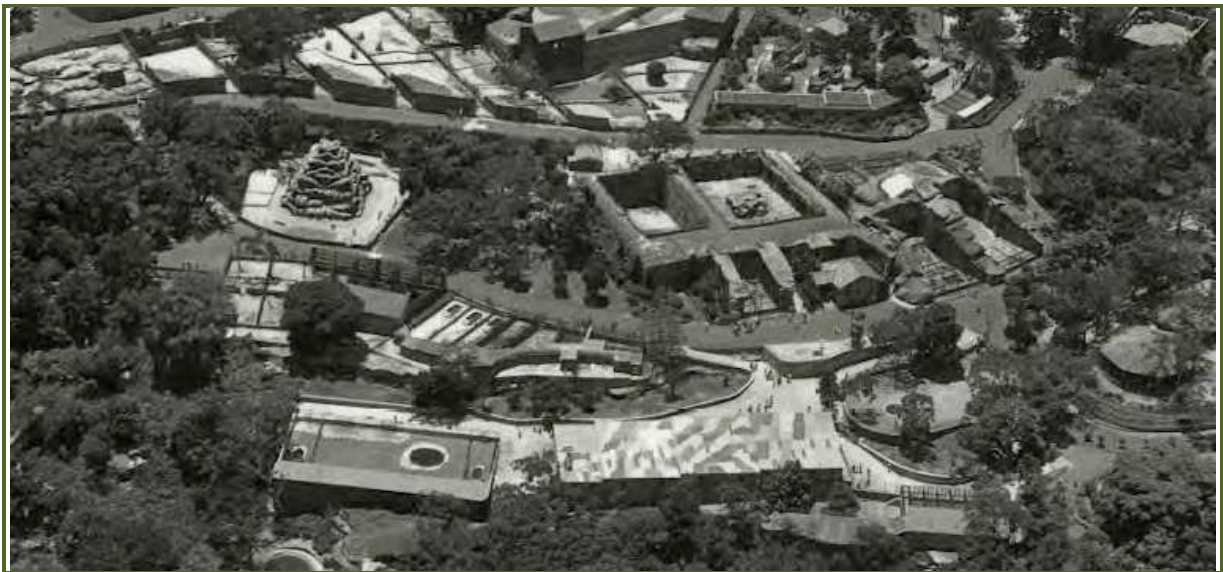
Figure 2.6: Aerial image from the south in c.1962 showing carnivore enclosures top right, Tahr Mountain top left and below the road is a series of enclosures extending around to the right to a ramp leading to a new lower level road and (Ape) enclosures (Rice 2015 Figure 2.16)

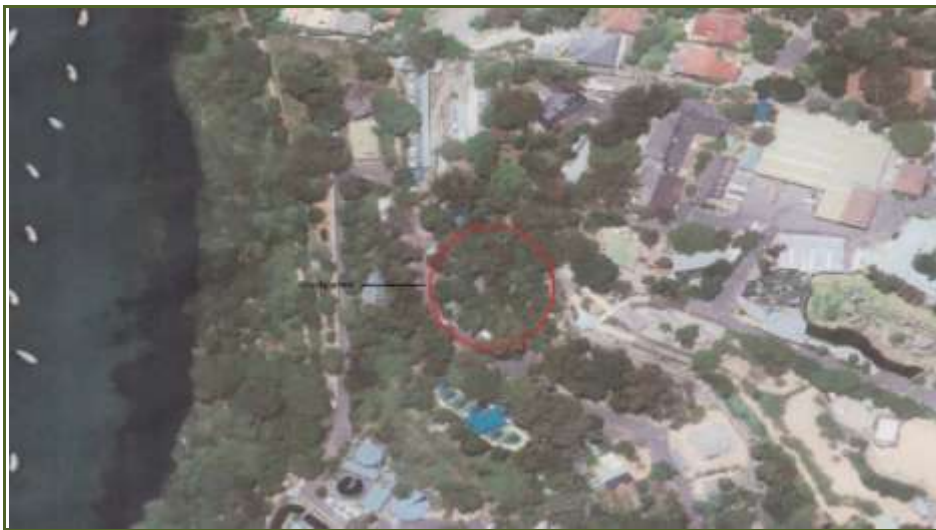
Figure 2.7: Area surveyed in 2016 for a due diligence Aboriginal archaeological assessment

A due diligence Aboriginal archaeological assessment (DSCA May 2016) has evaluated the potential impact of the proposal via a change in use of the locality below. It comprises a small and well defined parcel of vacant space surrounded on all sides by roads and buildings. It retains natural sandstone topography, along with a few native trees interspersed amongst a generally sparse and degraded ground cover. It is sloping land and dominated by a series of large and irregular outcrops of benched, boulder and shelved sandstone.

Field survey located a collection of broken beer and medicinal and ceramic items on the ground surface, and a sample were (temporarily) collected and recorded. Possibly 100+ more fragmentary items were also observed. The materials extended down the sloping ground and had been probably dumped from higher topography at some point in the past. The beer bottles and a few of the medicinal bottles are all dated 1925 to 1927, and no obviously recent materials (plastic, late twentieth century glass types) were identified. This may suggest the 'leftover' bit of topography may have remained unused and undisturbed for a considerable period of time.

The artefacts may relate to the discard of objects by workers for example during construction activities (for possibly the roadways) in the 1920s that have only recently been disturbed by recent brush turkey nesting activity. The materials could also relate to historic 'clean up'(s) of this type of domestic rubbish which has been dumped down the slope from the north, along with other soil and mulch materials.

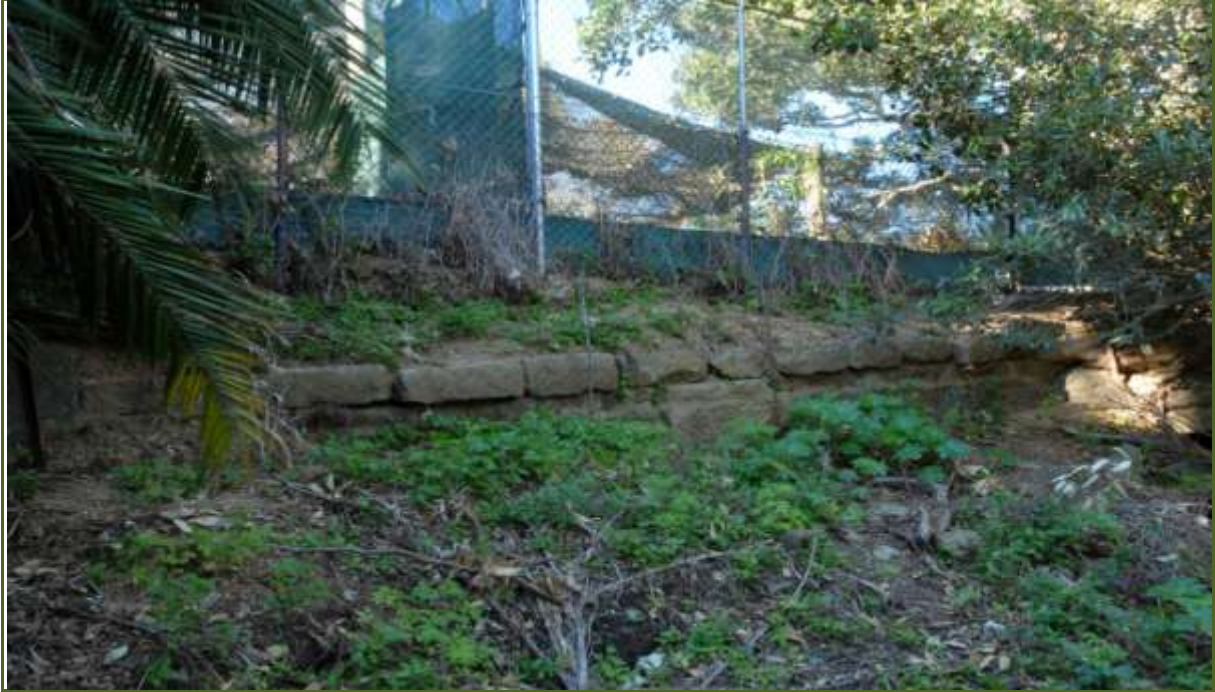
Figure 2.8: Garden planter edge/low retaining wall at the north-western corner of the study area. The humic soil materials with artefacts seemingly accumulated as a result of one or successive 'dumping' episodes that included the glass and ceramic materials

The likelihood that intact subsurface archaeological deposits with further artefacts remain buried at the site is low, but it is probable that further artefacts remain buried below current ground levels but which occur within the fill and underlying redeveloped loam mantle is possible.

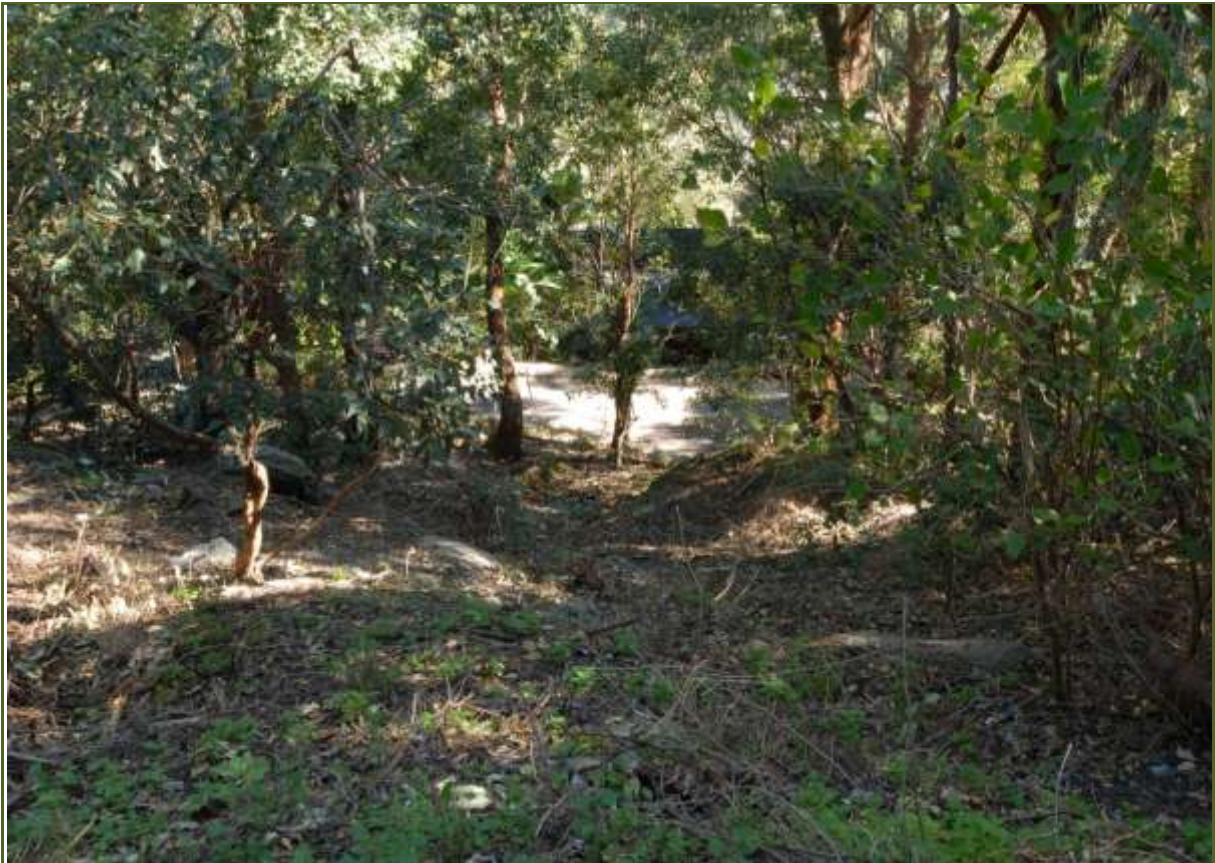
Figure 2.9: Distribution of dark soils materials with European artefacts down slope

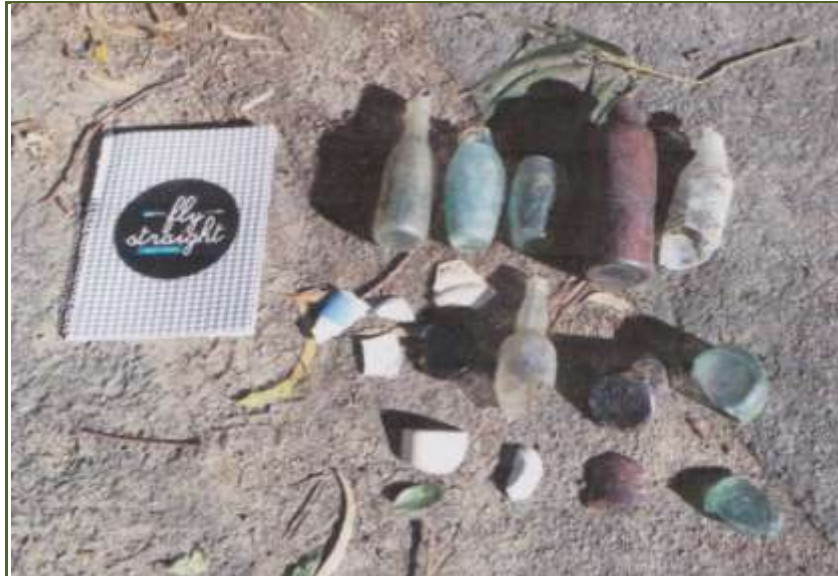
Figure 2.10: Date stamped beer and medicinal (and aerated Schweppes) bottles (the items have been put back in their place of recording). These items may date the deposit they are in, and may have remained undisturbed since that time (1920s) and/or they may relate to the dumping periodically, or in one go, of these materials at any time since

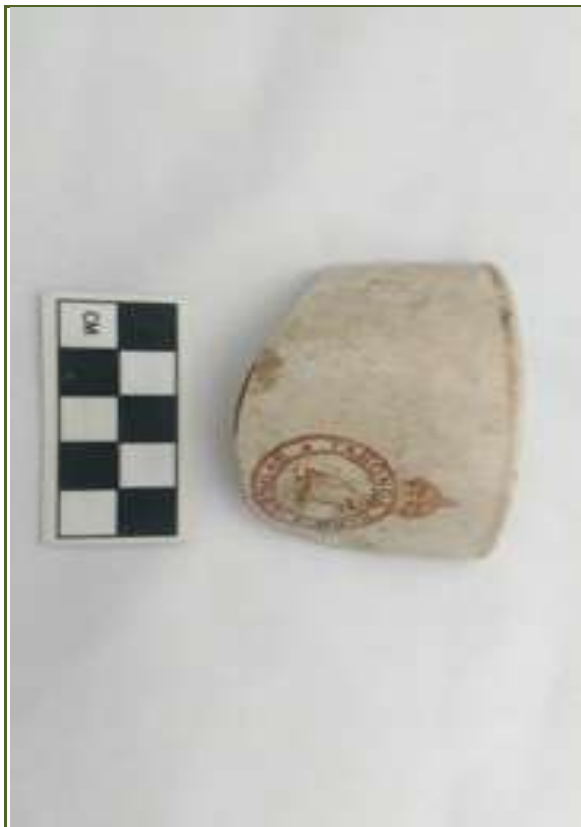
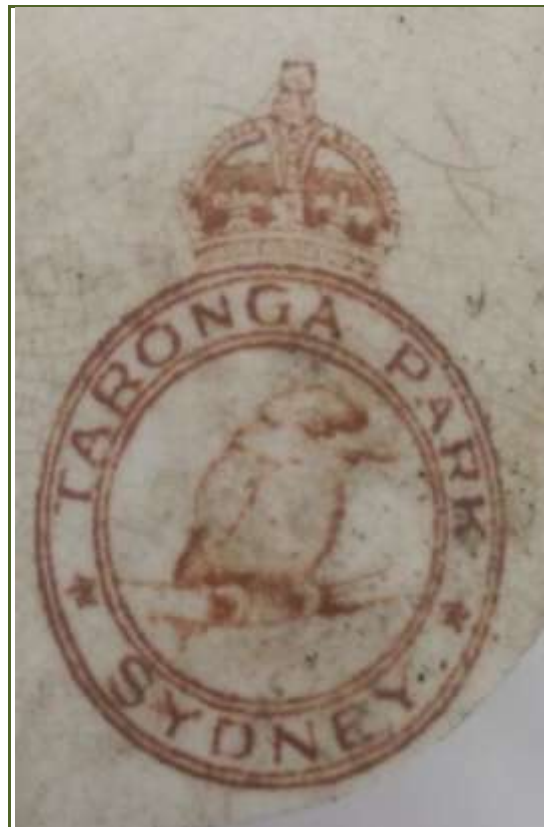
Figure 2.11: Tea cup fragment with printed gold rim (3mm wide) and image of a kookaburra upon a branch. The kookaburra is encircled by the words 'Taronga Park Sydney'. Atop the circle is a bejewelled crown. The insignia is a dark reddish/brown in colour. Printed on the inside of the cup is a thin gold line (1mm)

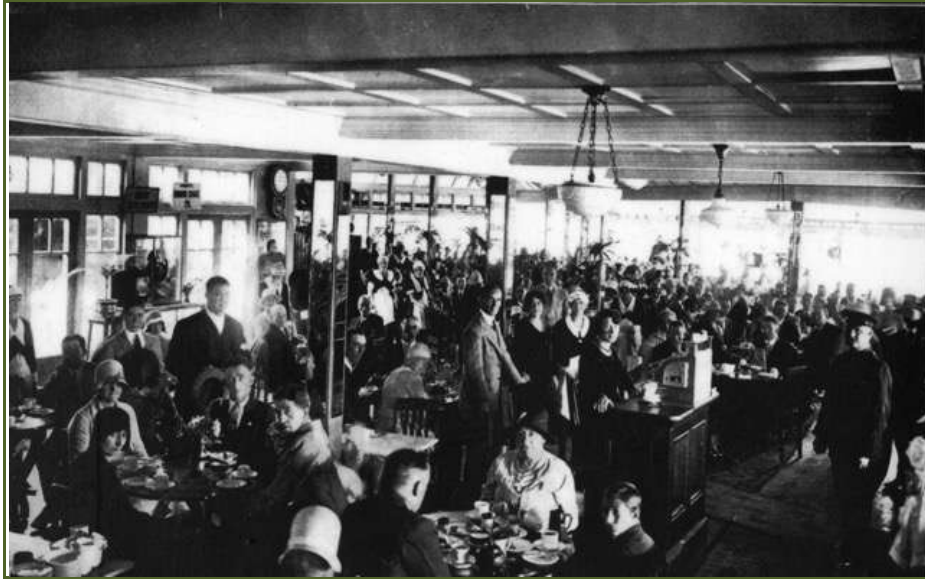
Figure 2.12: The Zoo tearooms/refreshment rooms had their own china and had a high reputation (jean Rice). This cup fragment would have been from there (note china in the foreground)

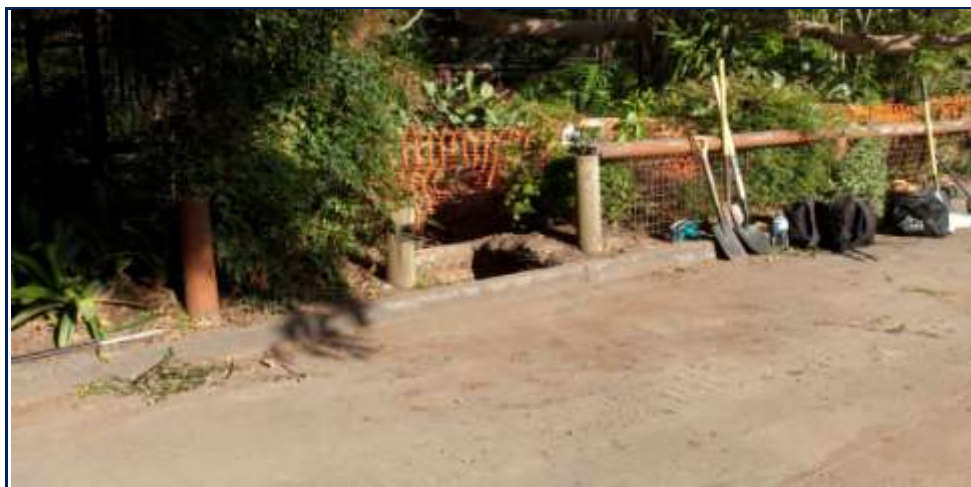
Figure 2.13: Location of 2016 test excavation for the path in the Tiger exhibit

A Heritage Management Plan prepared for the Sumatran Tiger exhibit development (DSCA January 2016) identified the proposal would impact one location with potential to contain archaeological evidence for a section of path forming part of the original Zoo pathway network (99L). The remainder of the redevelopment was assessed to be situated in an area of low to no identified historical archaeological sensitivity. However, the proposal would require the removal of ‘mock rock’ features within (redundant) 1930s carnivore enclosures that potentially included (buried and/or incorporated) earlier construction/modification features and fabrics of value. The HMP recommended the paths site be tested archaeologically using manual excavation methods and machine-assisted excavation methods for the removal of (hard) mock rock materials in the carnivore dens.

For the paths, excavation revealed a comparatively uniform profile of crushed sandstone and clay loam in the space between the older (rounded) kerb and gutter that runs parallel with the modern roadway and edging. The loam appeared re-deposited (or recently redeveloped) and overlay a uniform deposit of crushed sandstone and clay loam fill that is likely to extend across and along much of the roadway length. No evidence was found, or survives in this locality, of any former path surfaces and fabrics. Excavation in the dens revealed a similar shallow of sandstone and rubble clay (construction) materials over bedrock and no features or deposits of noted were recorded during the work.

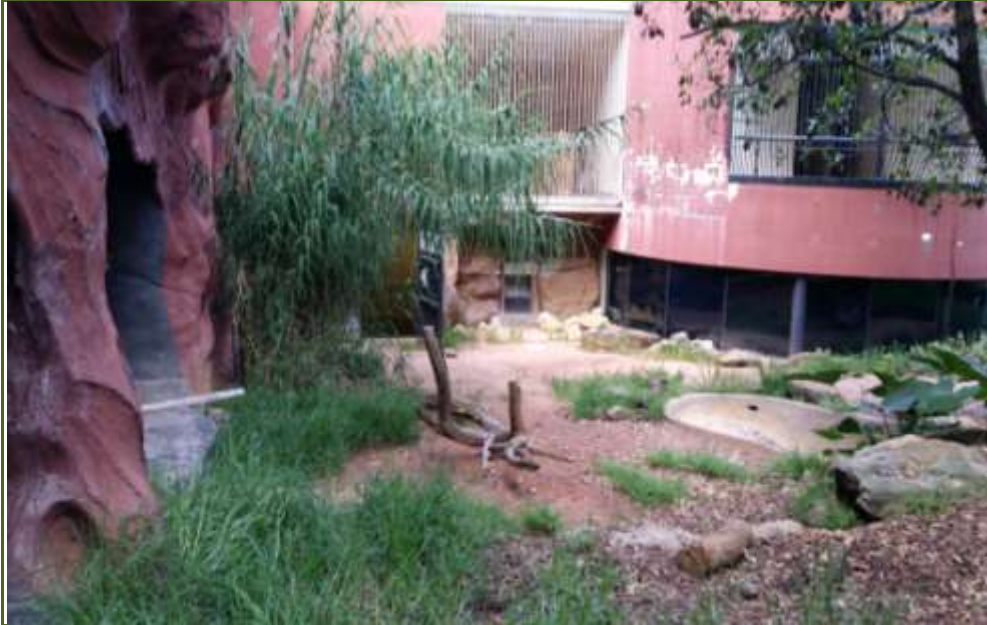
Figure 2.14: The Sumatran Tiger HMP identified that the enclosures within the redevelopment site with heritage significance had a mix of mock rock (of different periods), natural sandstone, and other later fabrics. Archival recording of the 'dens' and 'caves' was undertaken independent of this study but compliments the results of the subsurface investigations reported here

Test excavation for the paths and in the carnivore dens both revealed unremarkable subsurface profiles comprising largely crushed sandstone rubble and clay fill deposits over modified sandstone bedrock. No significant archaeological deposits or features were identified in either locality. Neither area has been assessed to retain any further archaeological potential in the areas that are to be affected by the project works.

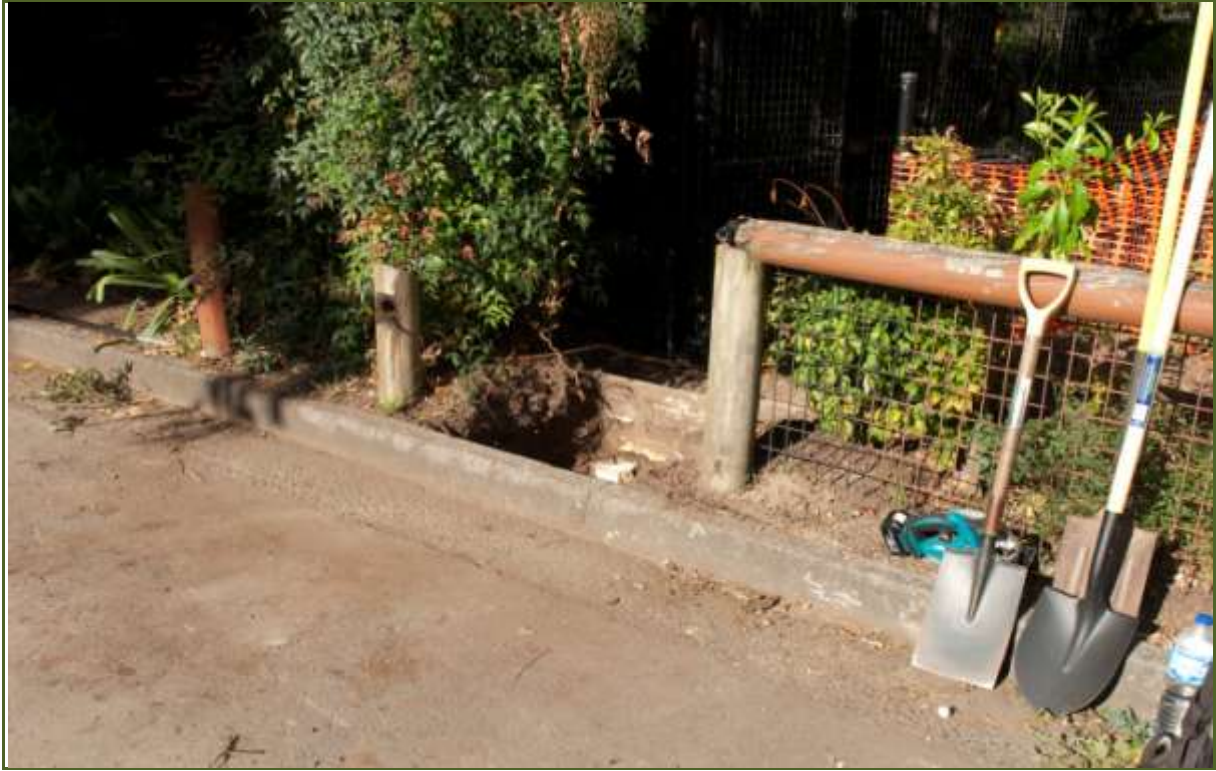
Figure 2.15: Excavation for the path was restricted to one side of the existing (innermost) kerb and gutter. The road alignment has been used for service routing progressively over time and retains minimal to no archaeological potential

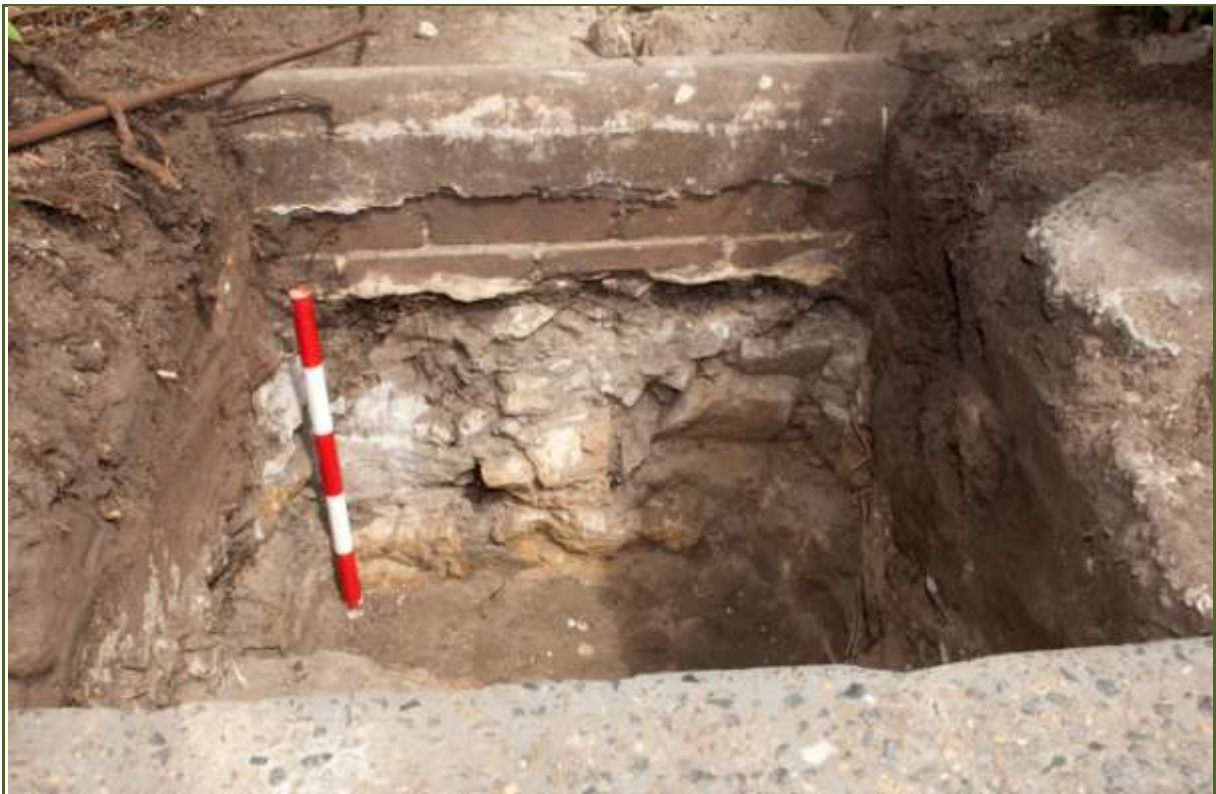
Figure 2.16: Sandstone rubble exposed below brick kerb with rounded cement render finish

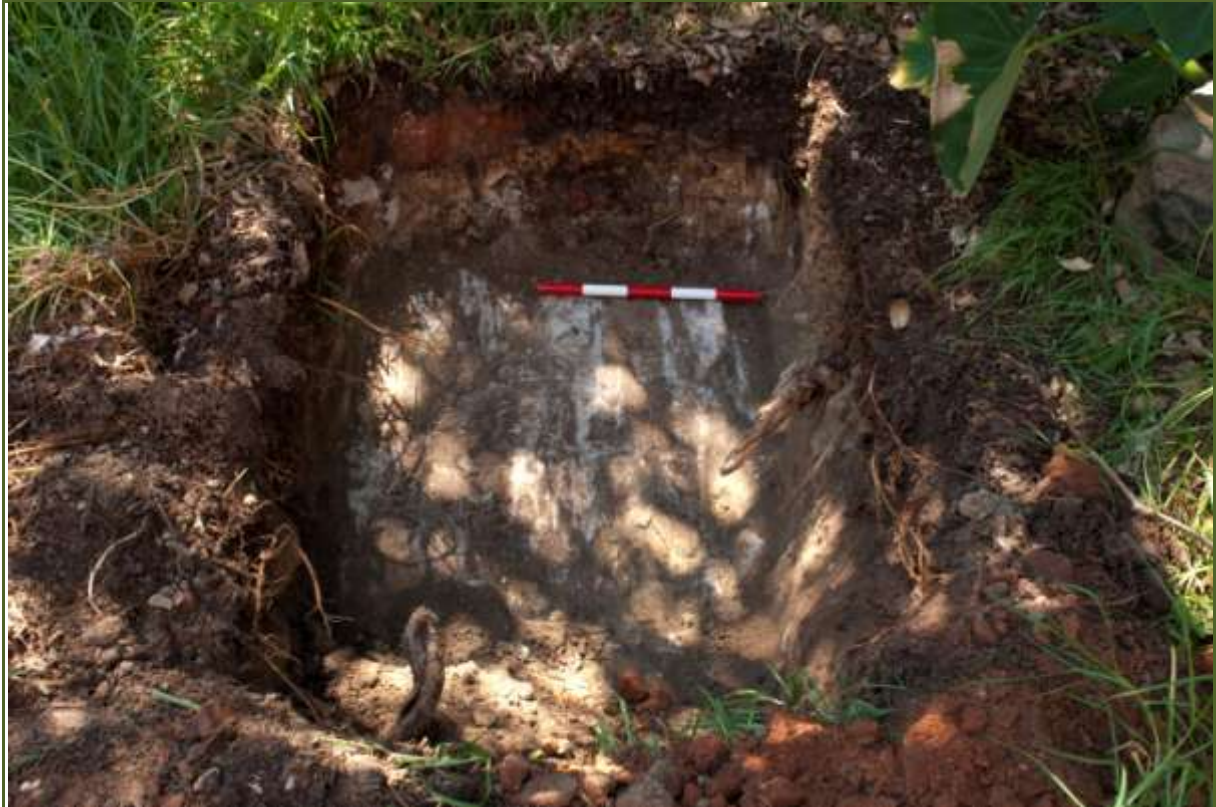
Figure 2.17: Excavation in the carnivore dens used a mechanical excavator to remove building fabrics and fill of low archaeological sensitivity and significance. Shown below is 'topsoil' over brick & mortar (modern) and sandstone clay-rubble fill over sandstone bedrock

Excavation in the den revealed a very shallow profile consisting of modern soft fall and soil materials over very compact sandstone and clay (and some surface and modern) brick rubble fill over sloping but graded sandstone bedrock. The materials appear to have been reused from the construction of the enclosures in the 1920s for the filling of the interior of the 'box' at foundation level prior to the introduction of the ground coverings.

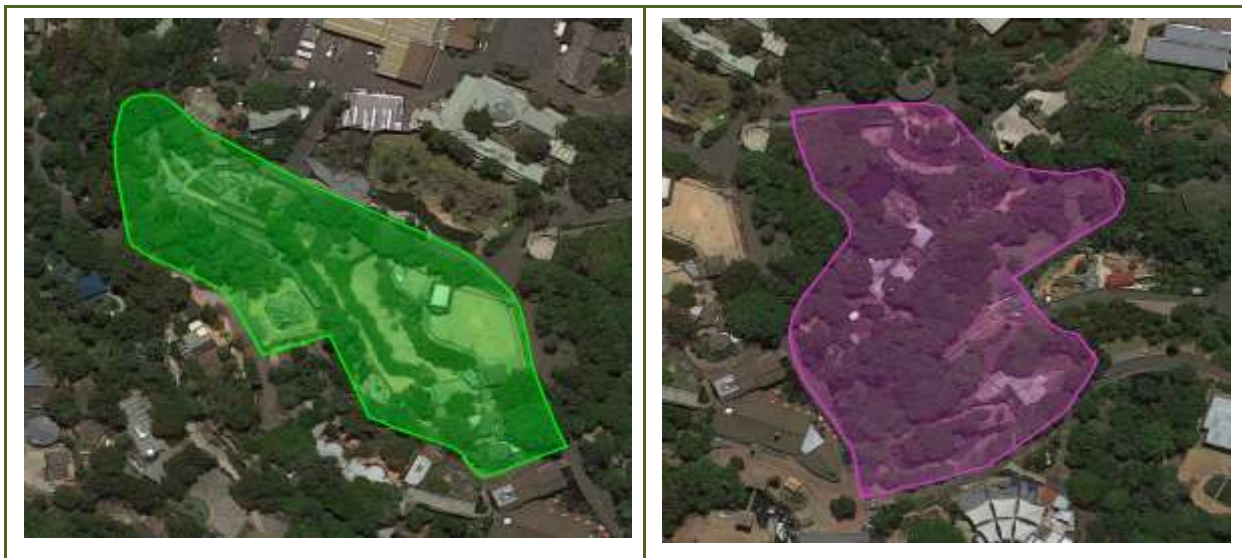
Figure 3.1: Existing condition of the proposed Savannah (left) and Congo Exhibit precincts (TCSA March 2016 a & b)

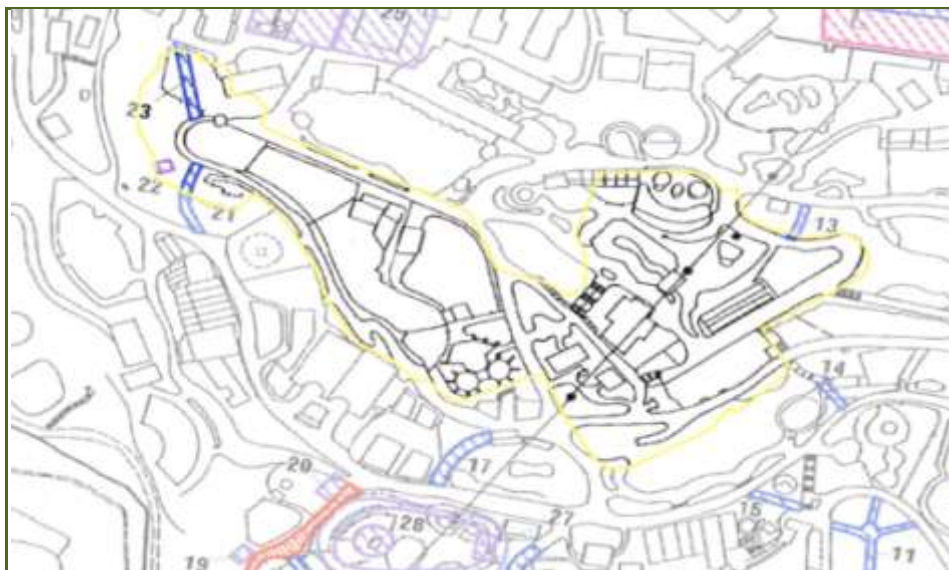
- Item 21- Former pathway 1935 to 1988
- Item 22 – Shelter shed 1935 (see note below)
- Item 23 – Original pathway 1916 to 1956

Figure 3.3: Historical archaeological management zones in the proposed development area (TCSA October 2017)

The map below identifies potential historical-archaeological items previously assessed to occur within the study area. The remainder of the proposed development area was identified in the 2004 AMP to retain no potential for sub-surface historical-archaeological deposits to survive.

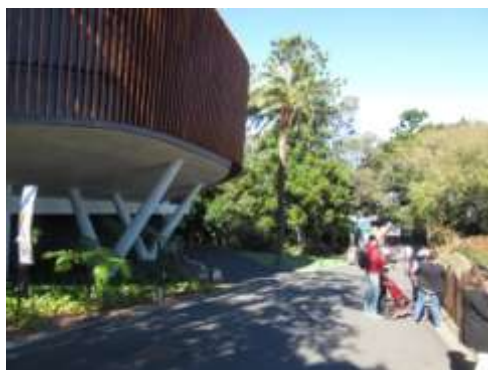
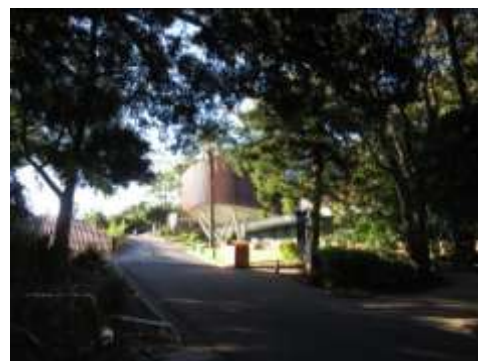
The excavation of one or two archaeological strip trenches placed across the width of the existing path (from ‘kerb to kerb’) may reveal evidence for the alignment, form, fabric and possible phasing of the original path in this locality. On the basis of what was seen in a comparable s.140 excavation context in the Tiger exhibit, the original surface fabric(s) of the former path had been removed entirely by previous services routed under the existing bitumen path, where in that instance only edge fabric such as kerb and gutter materials survived

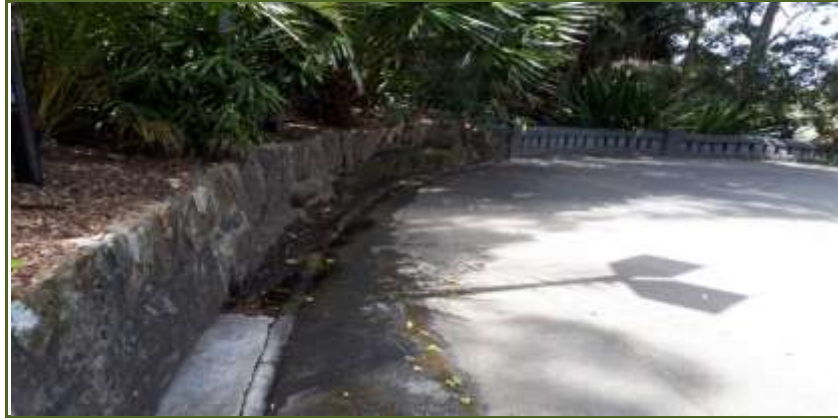
The form and complexity of changes to the original path network can be appreciated in this image where there are a number of different types and materials of construction along and lining the path. This section will not be affected by the development

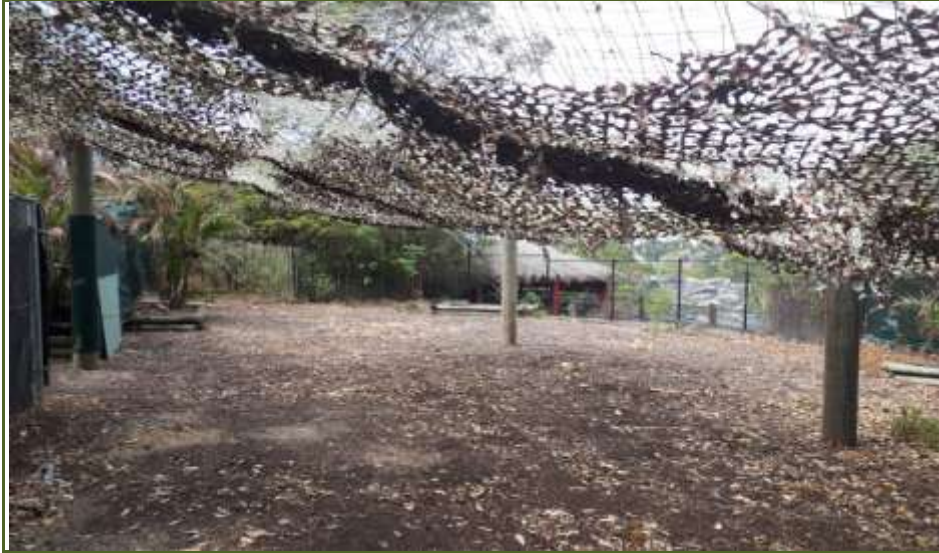
Stevens Lookout (archaeological monitoring).

Archaeological monitoring of machine work in this locality is proposed to identify whether 'relics' associated with the Lookout are present
