PRELIMINARY SITE INVESTIGATION

Proposed Apartment Building

Lot 1 DP 781624, Lot 1 DP 419177 & Lot 2 DP 300515
12-16 Florence Street
Tweed Heads NSW

HMC2024.1001.02

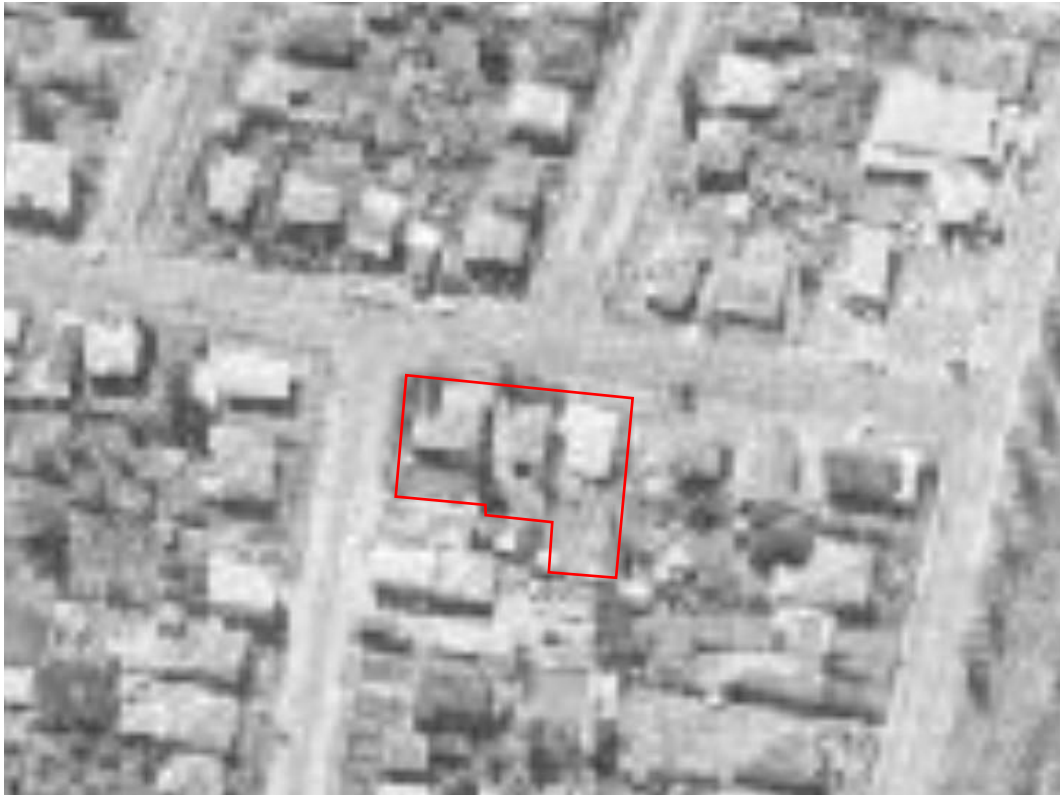
Figure 7 - Historical Aerial 1962 (NSW Spatial Services Historical Imagery <https://portal.spatial.nsw.gov.au>)

| Year | Source | Comments | Areas of Potential Concern Yes/No |
|---|---|---|---|
| 1962 | NSW Government (Historical Imagery) ⁽¹⁾ | The poor quality aerial is difficult to distinguish, however, it appears that all three existing structures are visible on site. The existing smaller brick structure adjacent south of the funeral home is also visible, however, it is difficult to determine if any other structures are existing on the properties. The surrounding area appears to be generally developed for residential use. | Yes. Given the age of the existing structures, hazardous building materials (including lead paint and ACM) may have been used in their construction. |

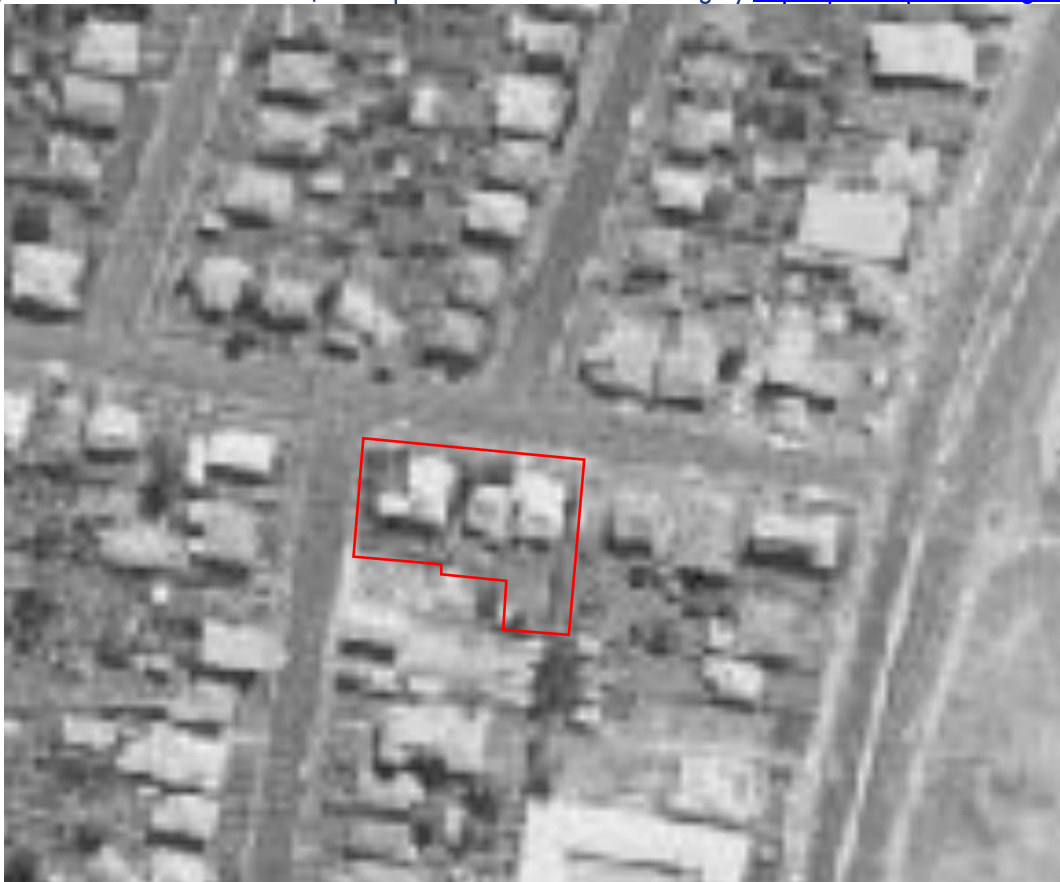
Figure 8 - Historical Aerial 1972 (NSW Spatial Services Historical Imagery <https://portal.spatial.nsw.gov.au>)

| Year | Source | Comments | Areas of Potential Concern Yes/No |
|---|---|---|---|
| 1972 | | Similar to 1962. No visible changes noted to the subject sites. | |

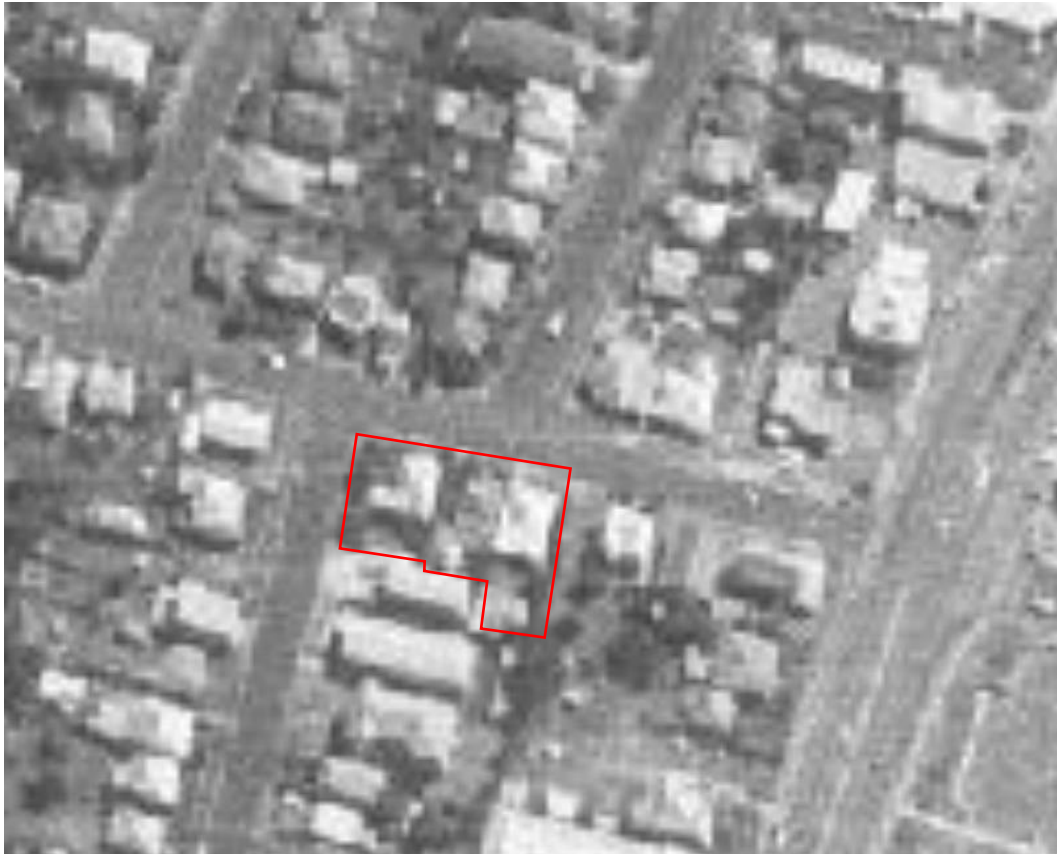
Figure 9 - Historical Aerial 1979 (NSW Spatial Services Historical Imagery <https://portal.spatial.nsw.gov.au>)

| Year | Source | Comments | Areas of Potential Concern Yes/No |
|---|---|---|---|
| 1979 | | The structures at the rear of No. 16 now appear to be existing. No other changes are noted to the subject site. | |

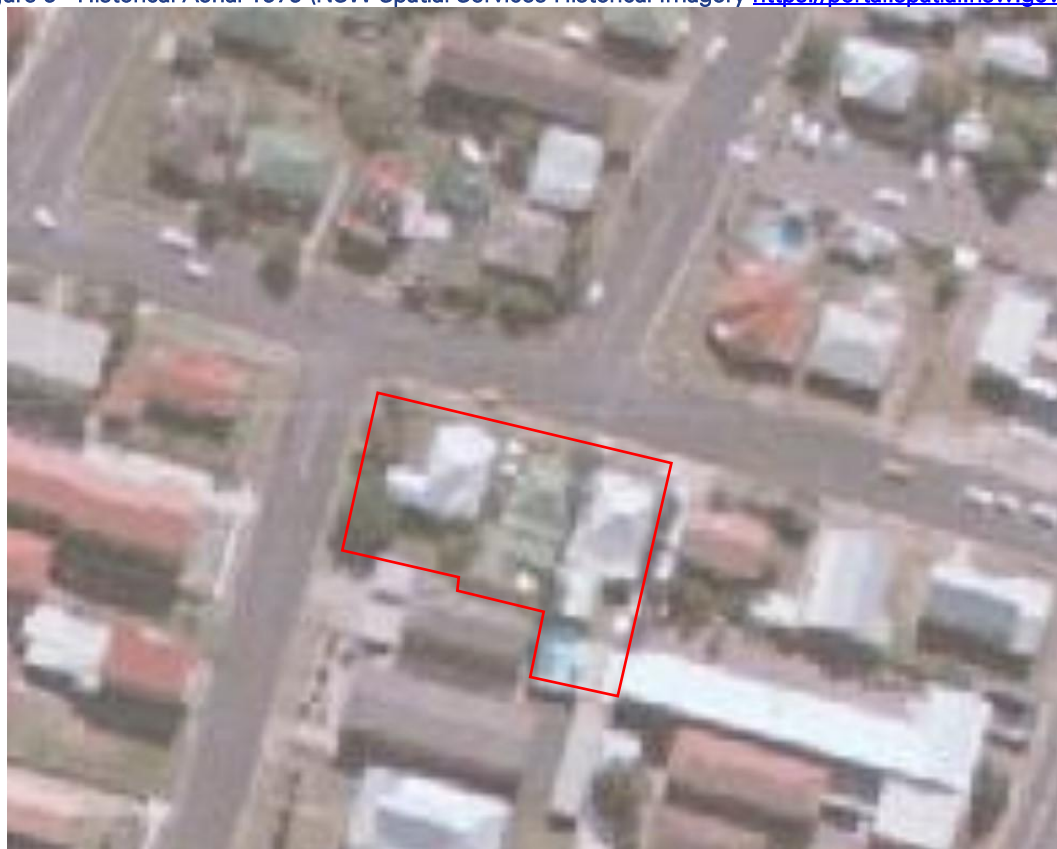
Figure 10 - Historical Aerial 1991 (NSW Spatial Services Historical Imagery <https://portal.spatial.nsw.gov.au>)

| Year | Source | Comments | Areas of Potential Concern Yes/No |
|---|---|---|---|
| 1991 | | Similar to 1979. All existing structures are visible across the subject sites besides the metal awning structure at the rear of No. 16. The surrounding area appears to be heavily developed for residential and commercial uses. No visible potentially contaminating activities are noted on site or within the surrounding area. | |

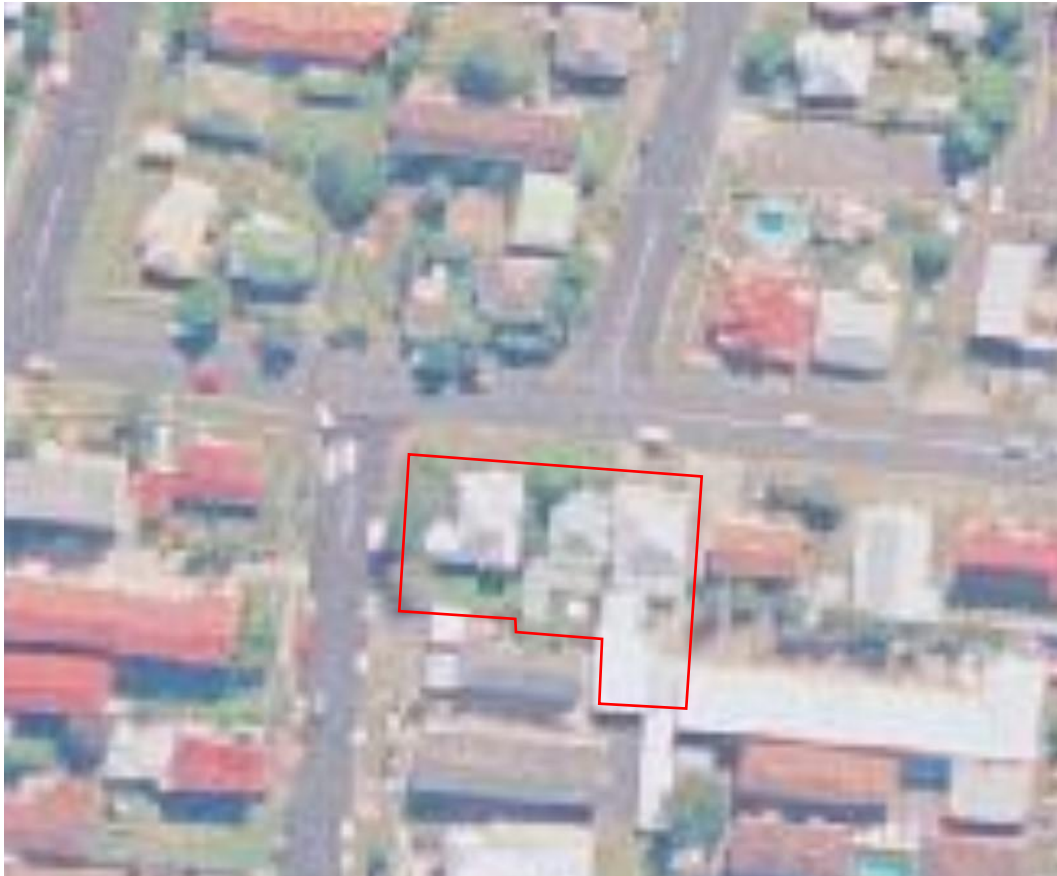
Figure 11 - Historical Aerial 1997 (NSW Spatial Services Historical Imagery <https://portal.spatial.nsw.gov.au>)

| Year | Source | Comments | Areas of Potential Concern Yes/No |
|---|---|---|---|
| 1997 | | The metal awning at the rear of No 16. is now visible. No other changes noted. | |

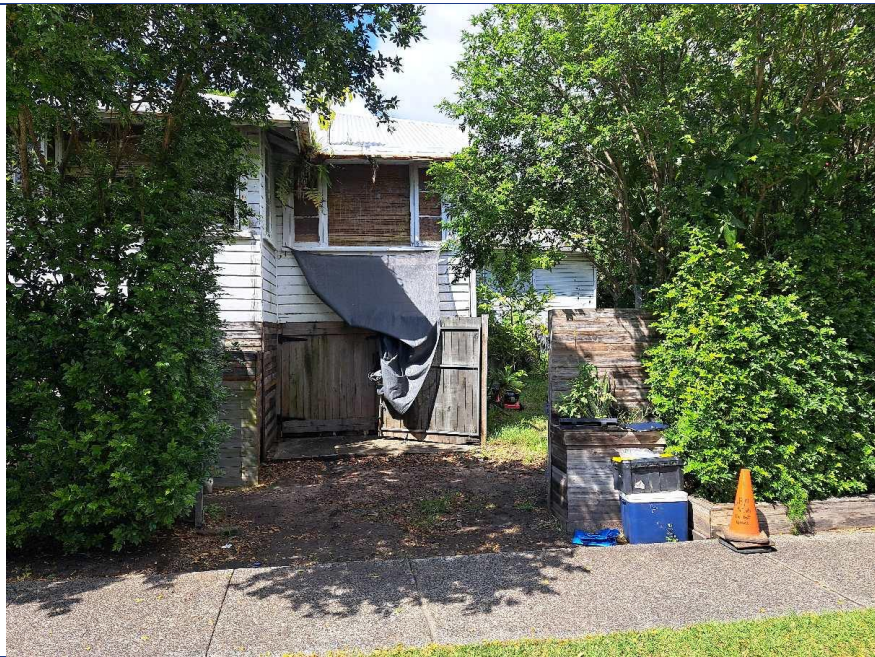
Description:
View south overlooking existing weatherboard dwelling to be demolished on 12 Florence Street.

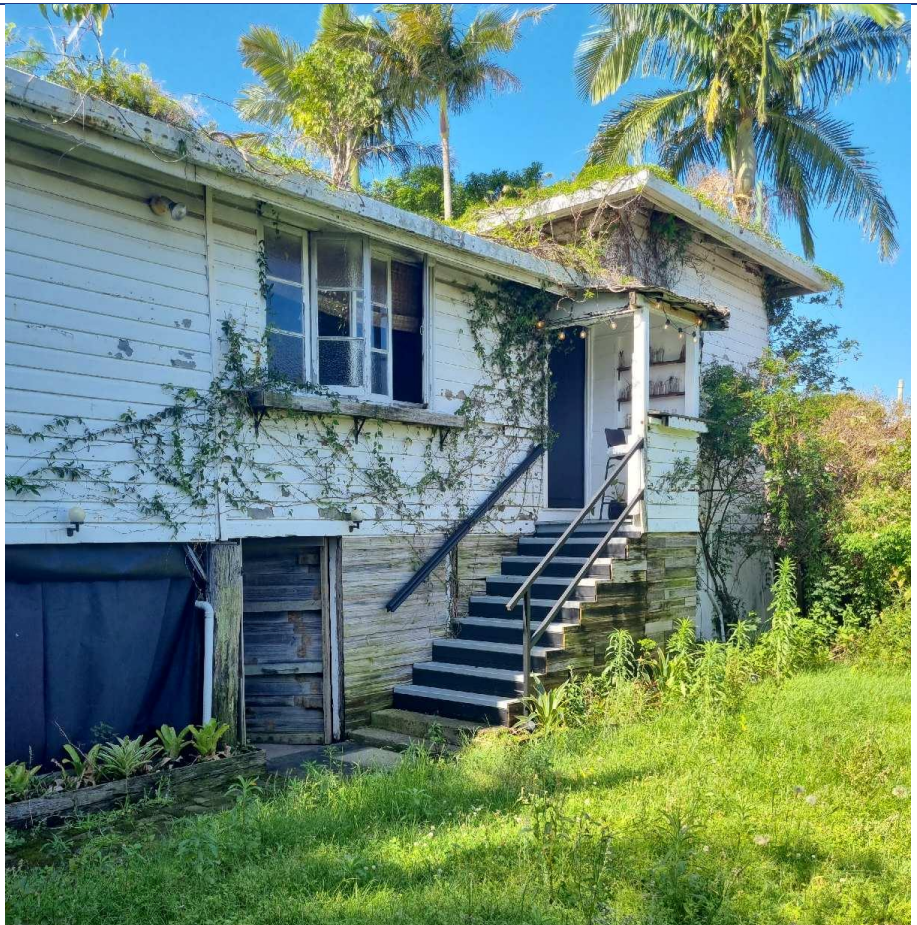
| Photo No. 2 | Date |

Description:
View northeast overlooking existing weatherboard dwelling to be demolished on 12 Florence Street.

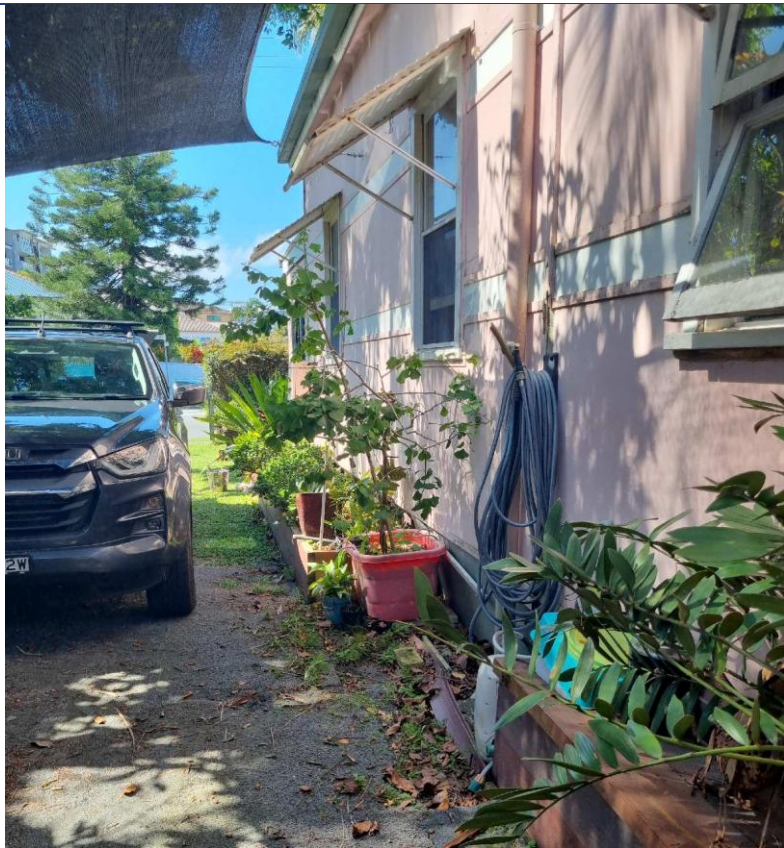
| Photo No. 3 | Date |

| Photo No. 3 | Date |
|--|---|
| Description: View northeast overlooking existing fibrous cement dwelling to be demolished on 14 Florence Street. | |

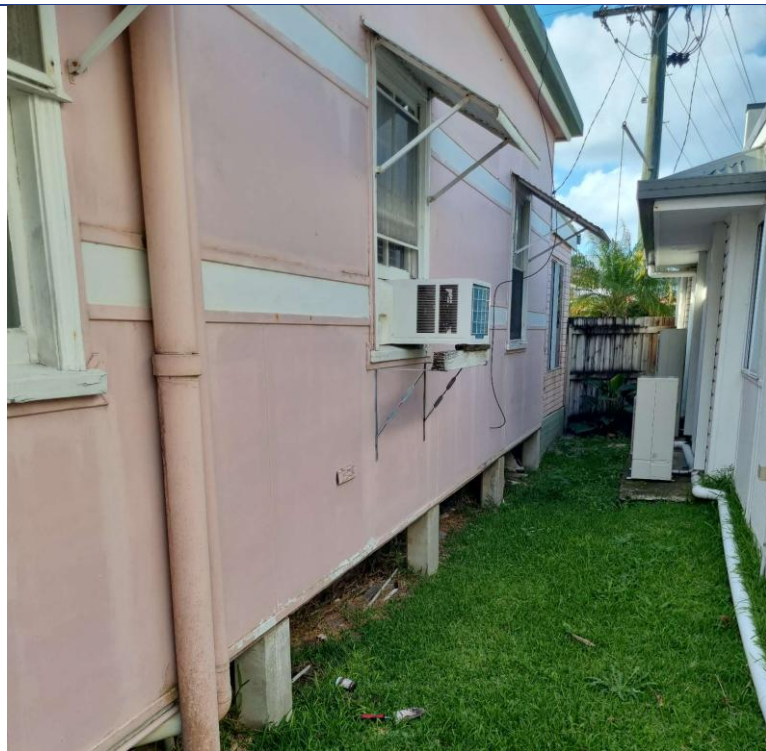
| Photo No. 4 | Date |

| Photo No. 4 | Date |
|--|---|
| Description: View southwest overlooking existing fibrous cement dwelling to be demolished on 14 Florence Street. | |

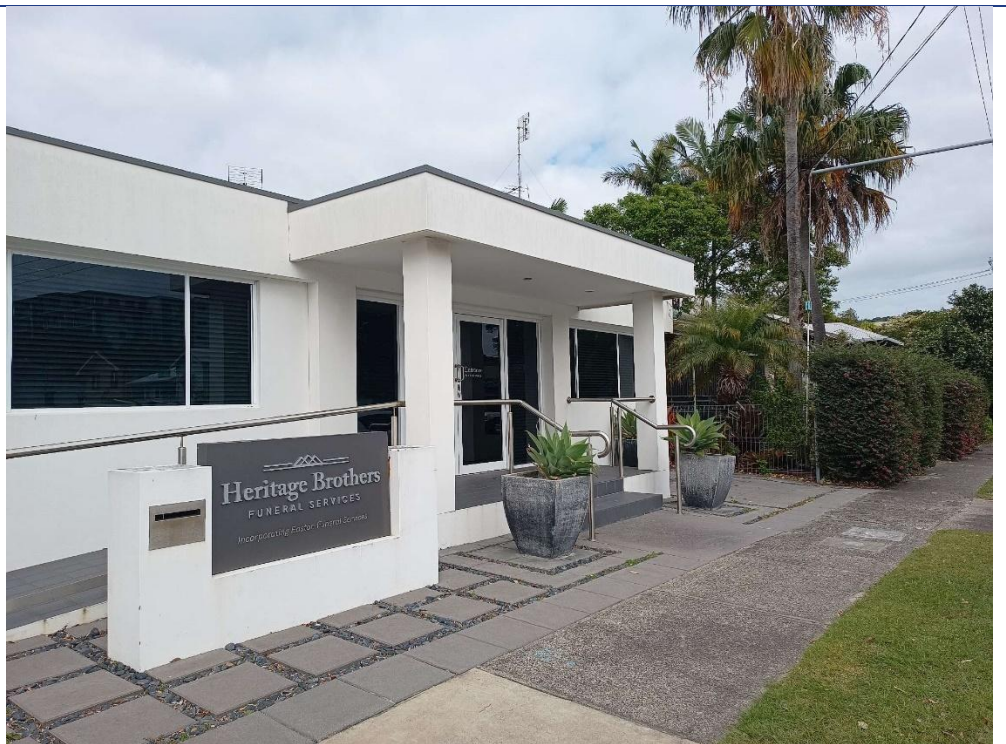
| Photo No. 5 | Date |

Description:
View southwest overlooking existing rendered cement funeral home to be demolished on 16 Florence Street.

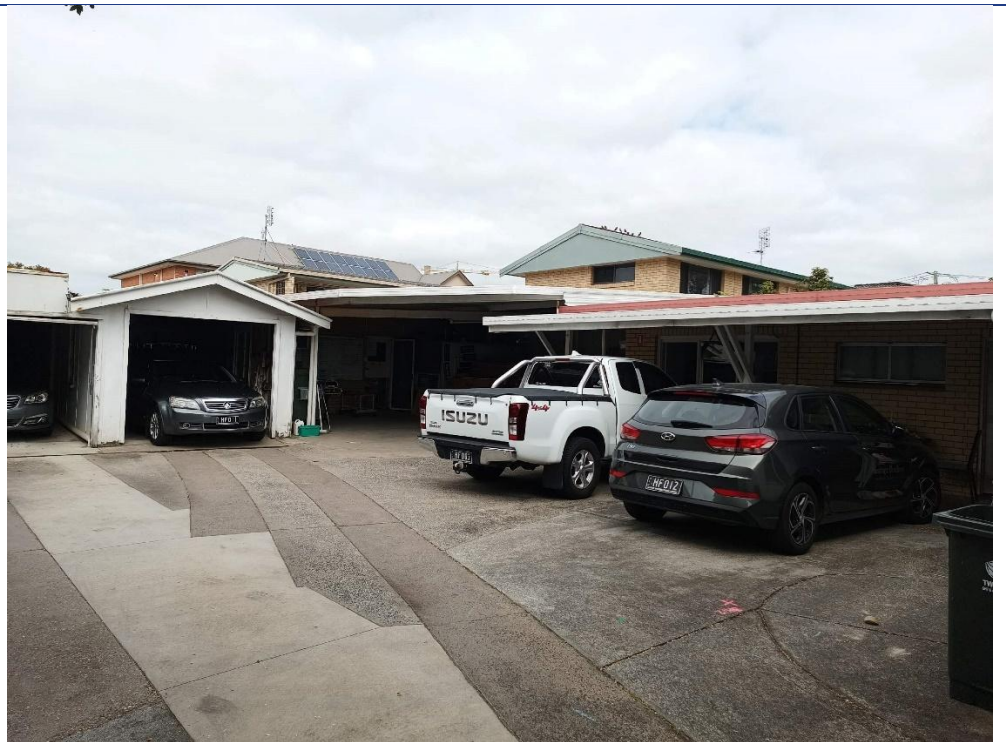
| Photo No. 6 | Date |

Description:
View southwest overlooking the existing structures to be demolished at the rear of the funeral home on 16 Florence Street.
