MAIN WORKS FOR  
WATERLOO MIXED USE DEVELOPMENT (HDA)

STATE SIGNIFICANT DEVELOPMENT APPLICATION  
(SSDA) NUMBER SSD-80441462

# Acid Sulfate Soil Assessment

881-885 Bourke Street, Waterloo, NSW

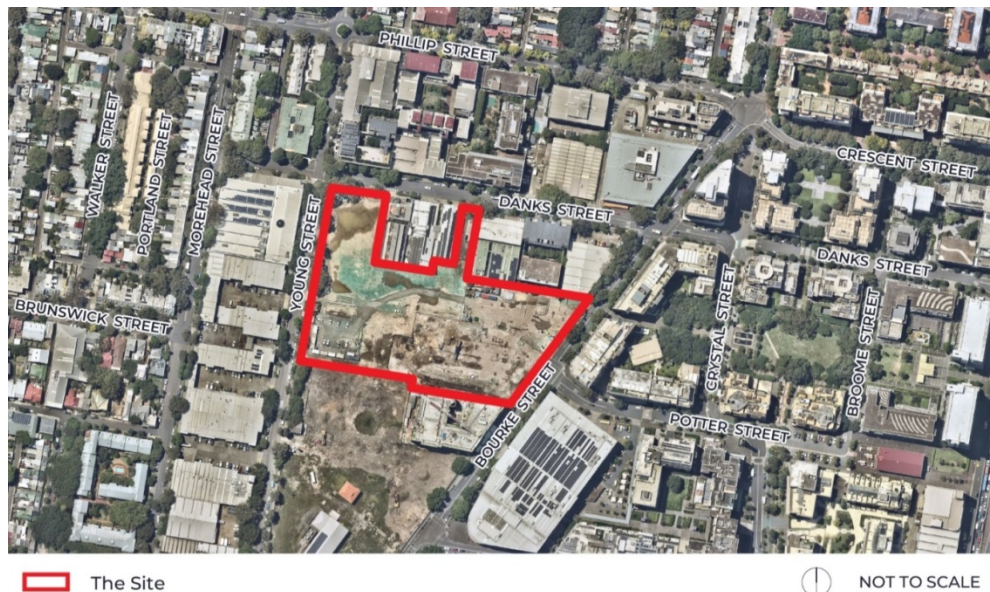
**Figure 1 Site Aerial**  
(Source: Nearmap, Ethos Urban)

An aerial of the site is provided in **Figure 1**.
