THE TRUSTEE FOR WATERLOO  
PROPERTY UNIT TRUST  
MAIN WORKS FOR WATERLOO  
MIXED USE DEVELOPMENT (HDA)

**Geotechnical Investigation**

881-885 Bourke Street, Waterloo, NSW

Report Title: Geotechnical Investigation, 881-885 Bourke Street, Waterloo, NSW  
Report No: E26442.G03.Re2

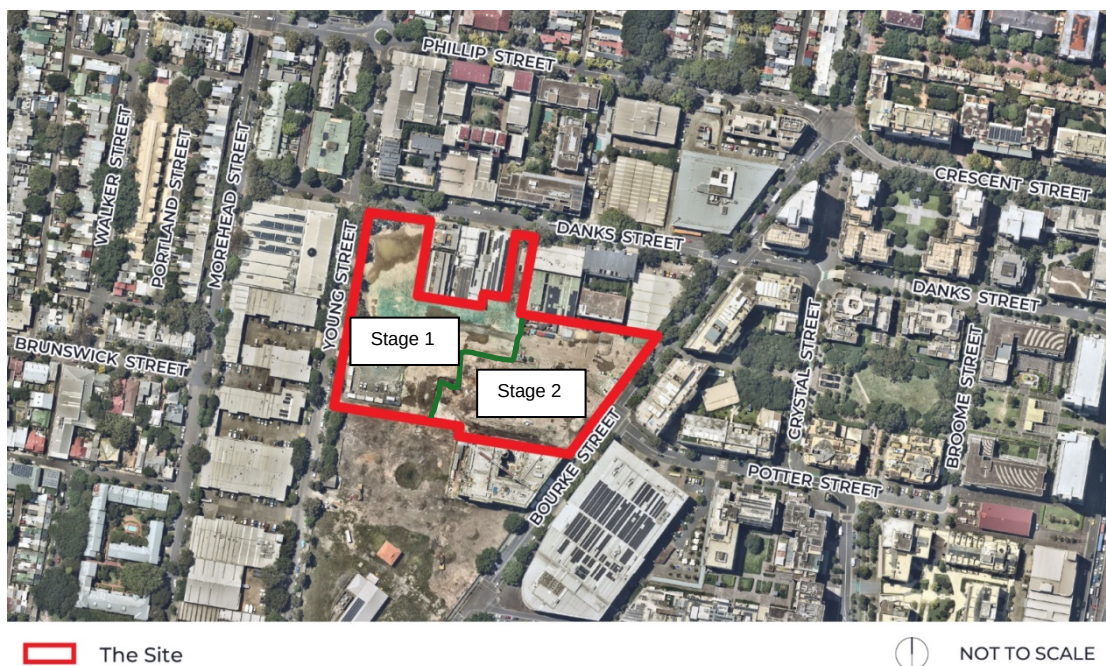
**Figure 1** Site Aerial

An aerial of the site is provided in **Figure 1** below.

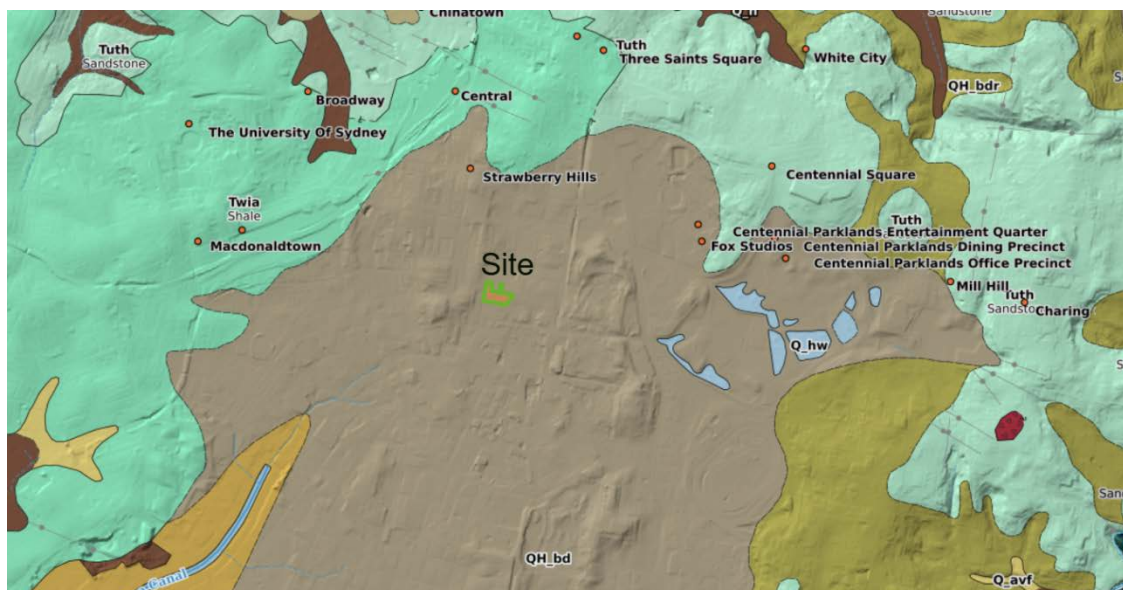
**Plate 1** Excerpt of geological map showing location of site. Source: MinView

| Attribute | Description |
|---|---|
| <b>Regional Geology</b> | Reference to the 'NSW Seamless Geology' by the Geological Survey of New South Wales, version 2.4 (Source: <a href="#">MinView</a> ) and the Department of Mineral Resources Geological Map Sydney 1:100,000 Geological Series Sheet 9130 (DMR 1983), indicates the site to be comprise Marine-deposited and Aeolian-reworked coastal sand dunes at the surface, underlain by Hawkesbury Sandstone (Rh), which consists of medium to coarse-grained quartz sandstone with very minor shale and laminite lenses. |

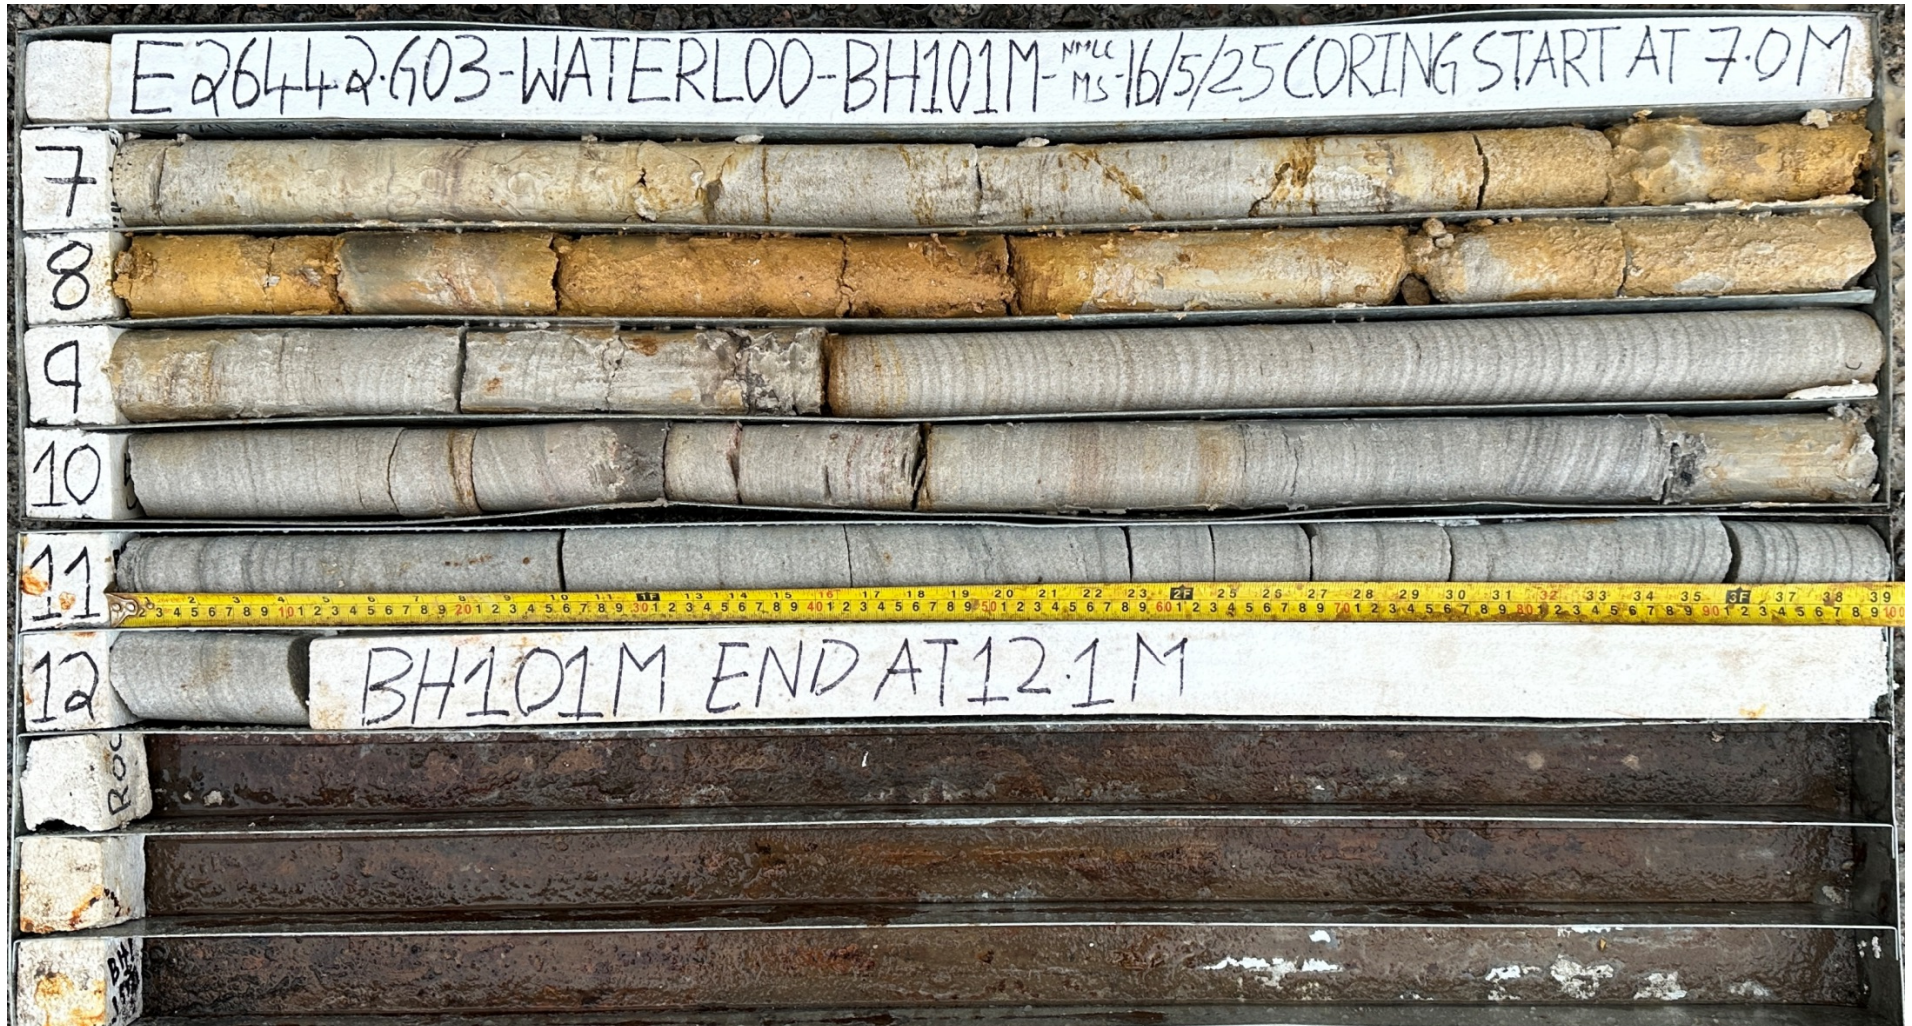
| <b>Job No.</b> | E26442.G03 | <b>Inclination</b> | 90° | <b>Logged</b> | MS | <b>Date</b> | 16/05/2025 |

| <b>Client</b> | The Trustee for Waterloo Property Unit Trust | <b>Box</b> | 1 of 1 | <b>Checked</b> | TW | <b>Date</b> | 10/06/2025 |

- Continuation of all boreholes using NMLC diamond coring techniques to termination depths between 11.6 and 20.55 m BEGL, as shown **Table 3-1**Error! Reference source not found.. The rock core photographs are presented in **Appendix A**;

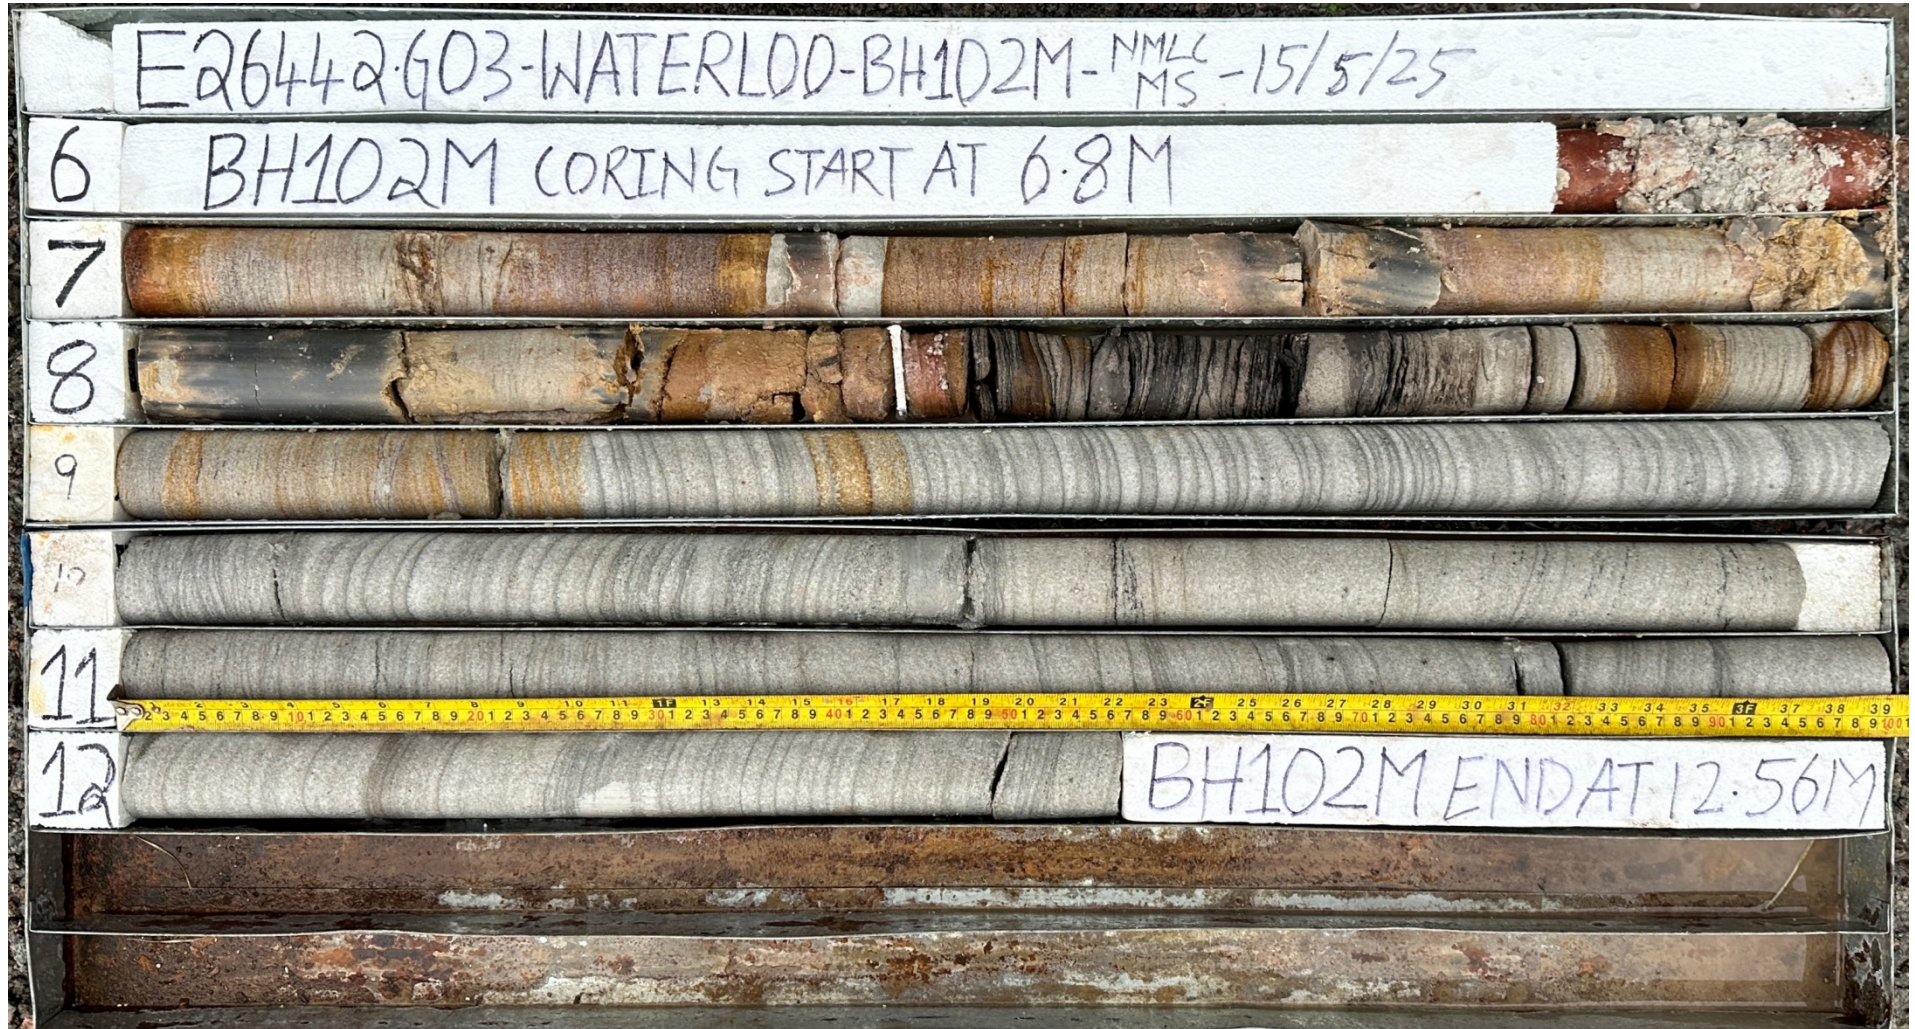
| Unit | Material <sup>2</sup> | Depth to Top of Unit (m BEGL) <sup>1</sup> | RL of Top of Unit (m AHD) <sup>1</sup> | Observed Thickness (m) | Comments |
|---|---|---|---|---|---|
| 3 | Class V Sandstone | 6.6 to 12.0 | 20.65 | 0.4 to 2.4 | SANDSTONE, distinctly weathered, very low strength. Encountered in BH103, BH108, BH109M, and BH111. Core loss was observed in BH103, inferred to be bands of decomposed or highly fractured material. |

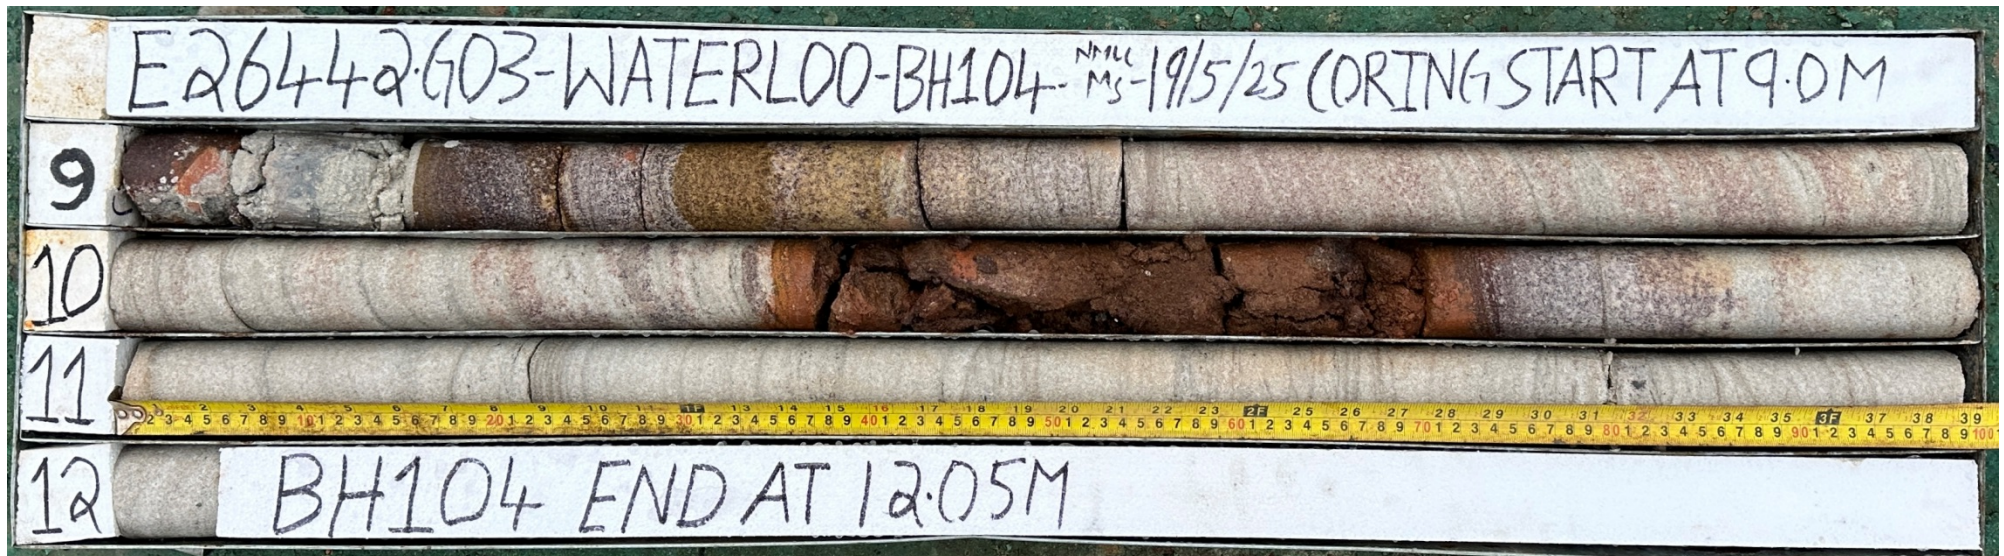
| <b>Job No.</b> | E26442.G03 | <b>Inclination</b> | 90° | <b>Logged</b> | MS | <b>Date</b> | 19/05/2025 |

| <b>Client</b> | The Trustee for Waterloo Property Unit Trust | <b>Box</b> | 1 of 1 | <b>Checked</b> | TW | <b>Date</b> | 10/06/2025 |

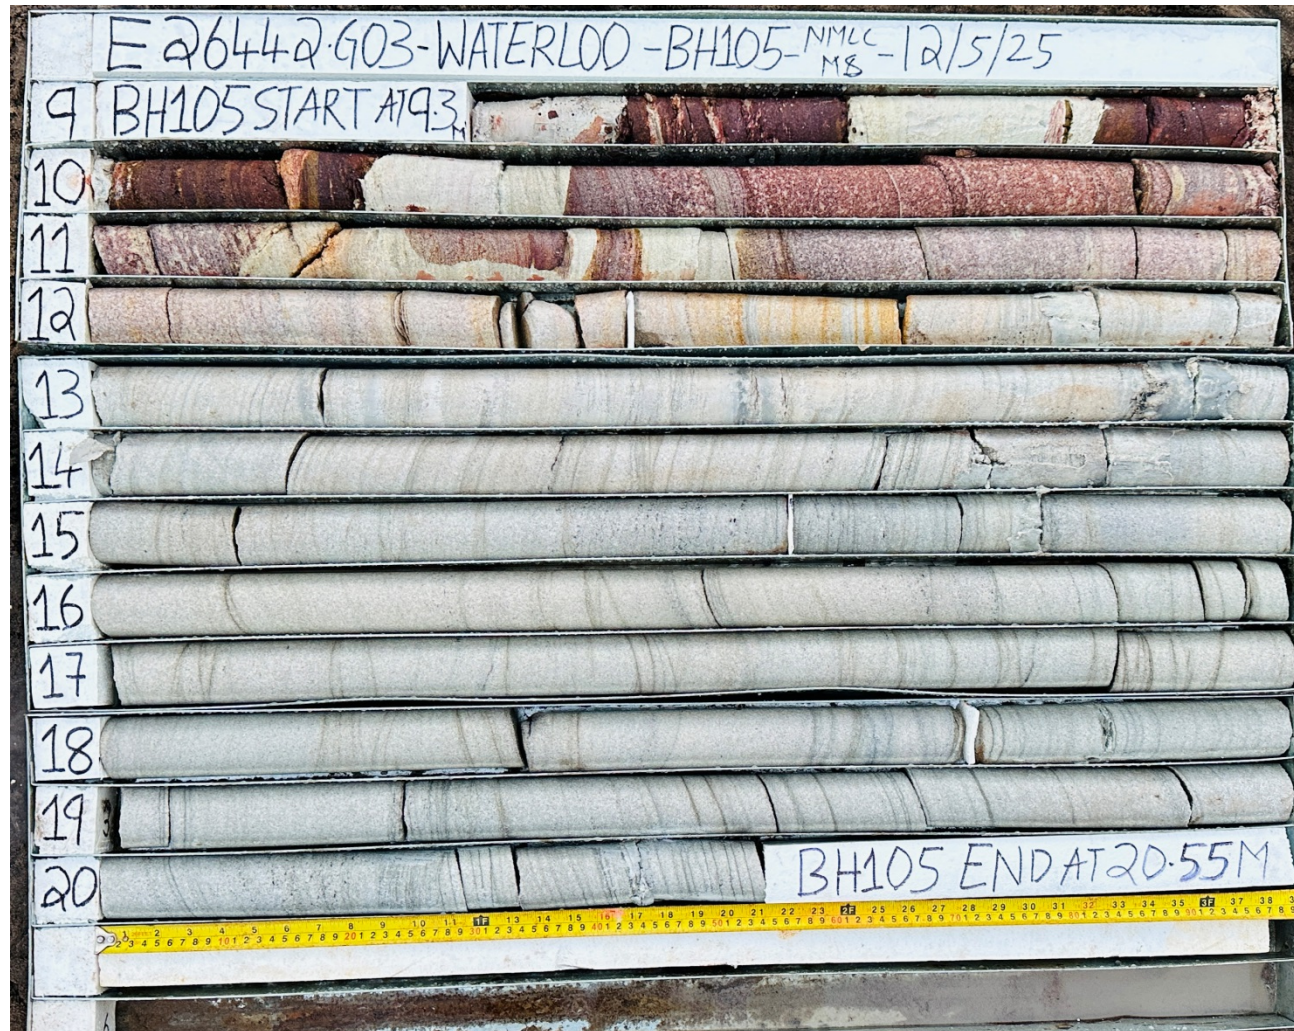
| <b>Job No.</b> | E26442.G03 | <b>Inclination</b> | 90° | <b>Logged</b> | MS | <b>Date</b> | 12/05/2025 |

| <b>Client</b> | The Trustee for Waterloo Property Unit Trust | <b>Box</b> | 1 of 1 | <b>Checked</b> | TW | <b>Date</b> | 10/06/2025 |

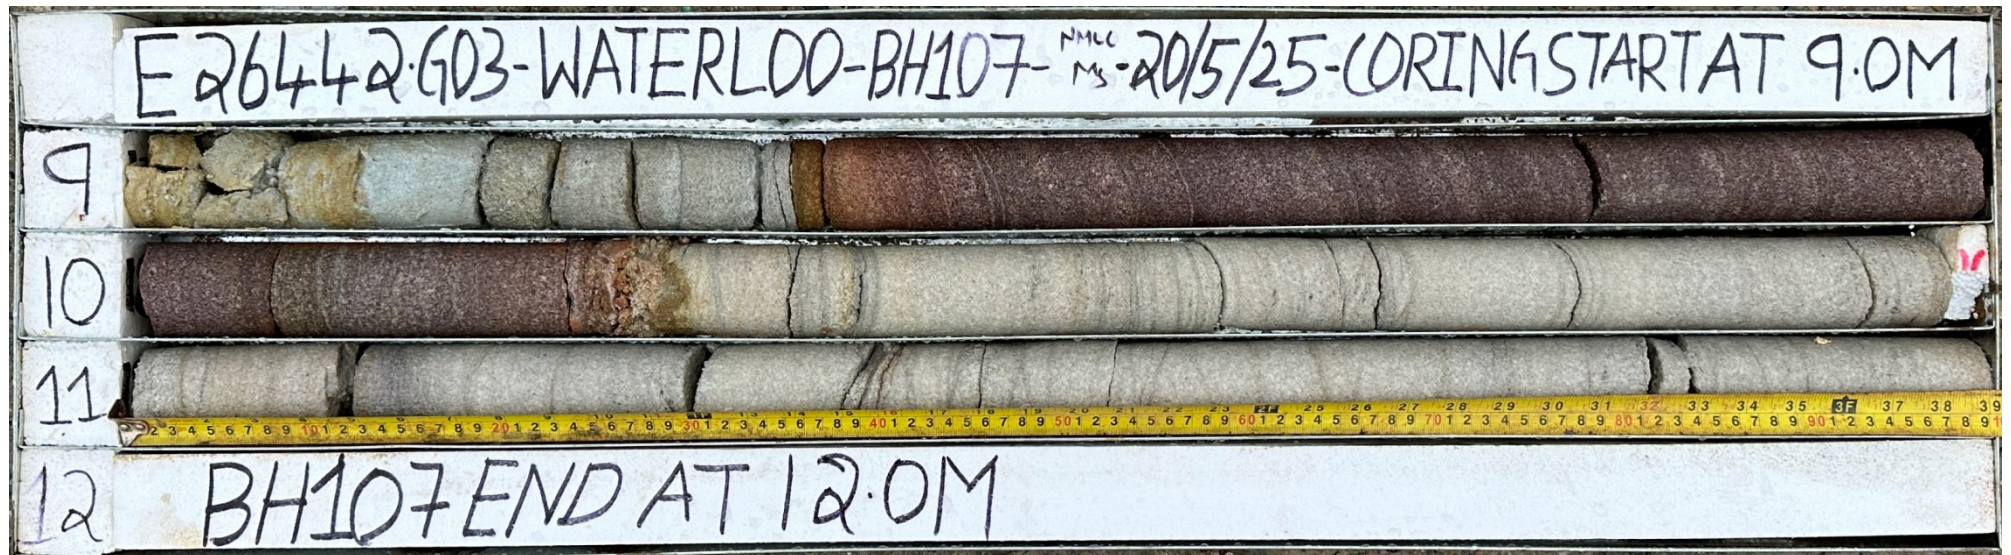
| Job No. | E26442.G03 | Inclination | 90° | Logged | MS | Date | 20/05/2025 |

| Client | The Trustee for Waterloo Property Unit Trust | Box | 1 of 1 | Checked | TW | Date | 10/06/2025 |

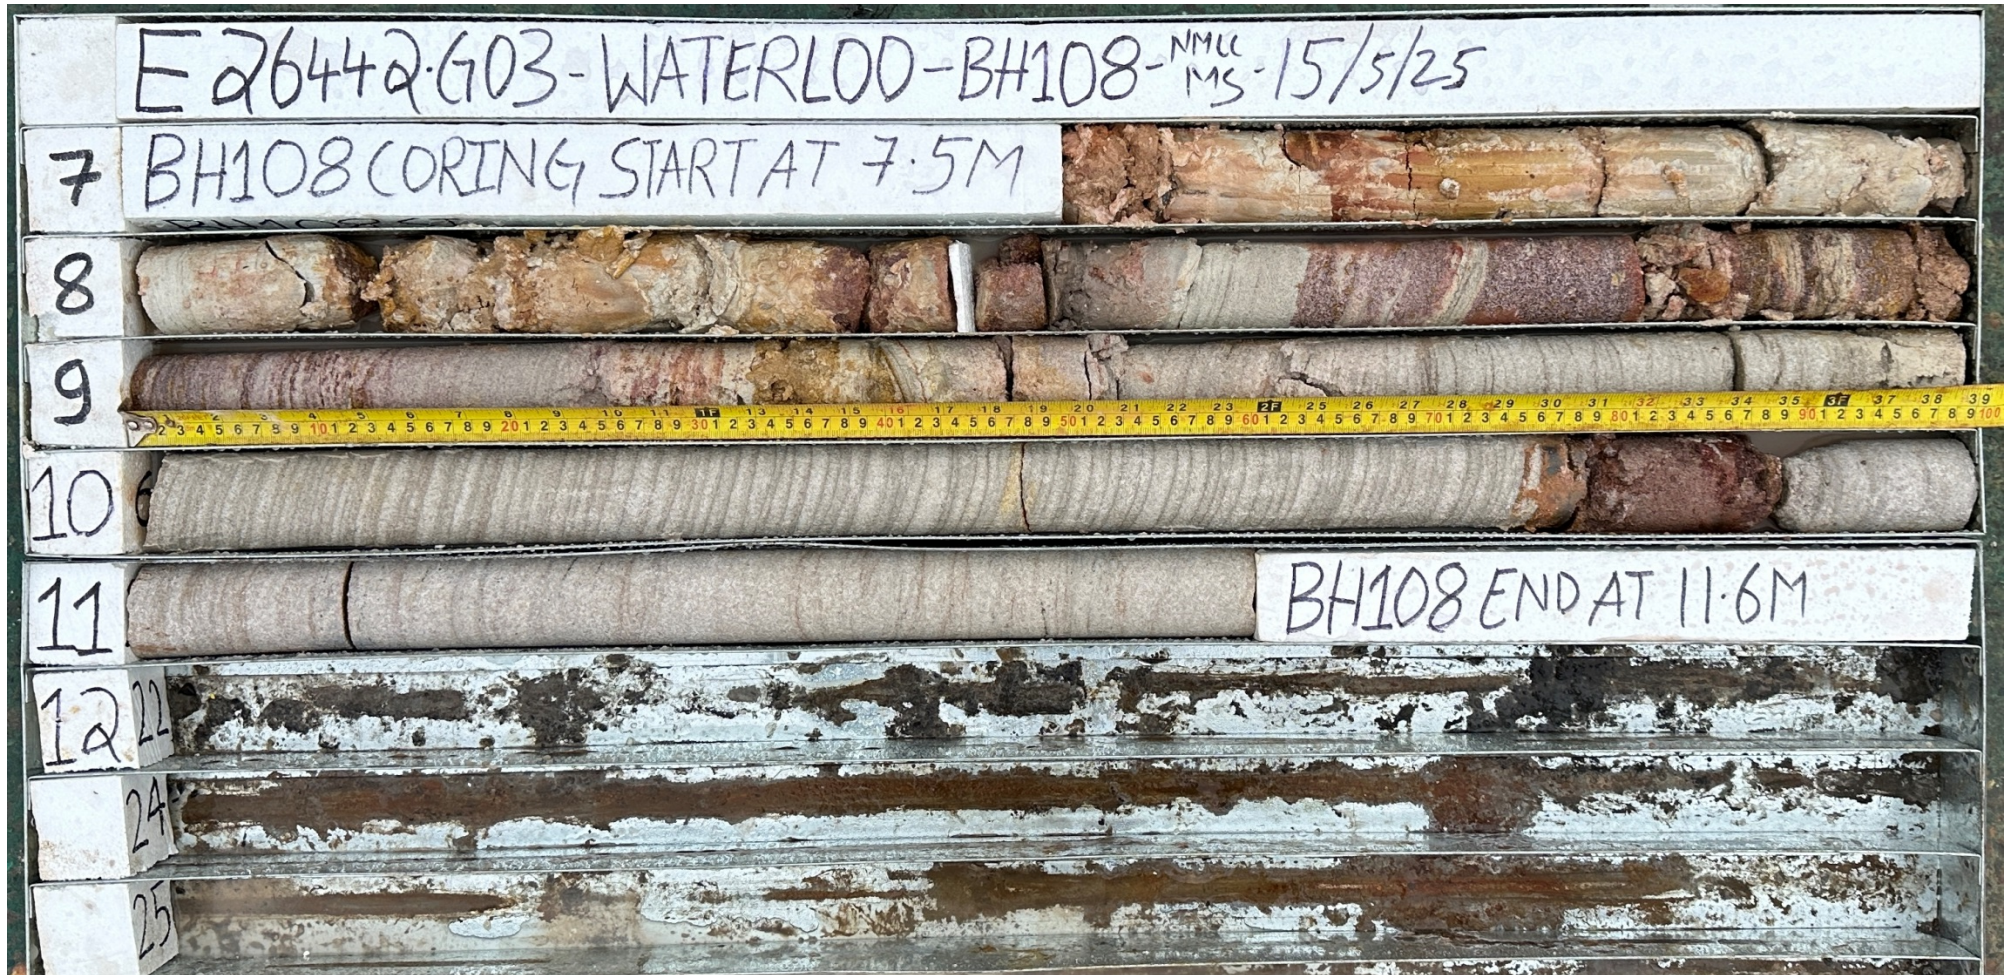
| <b>Job No.</b> | E26442.G03 | <b>Inclination</b> | 90° | <b>Logged</b> | MS | <b>Date</b> | 15/05/2025 |

| <b>Client</b> | The Trustee for Waterloo Property Unit Trust | <b>Box</b> | 1 of 1 | <b>Checked</b> | TW | <b>Date</b> | 10/06/2025 |

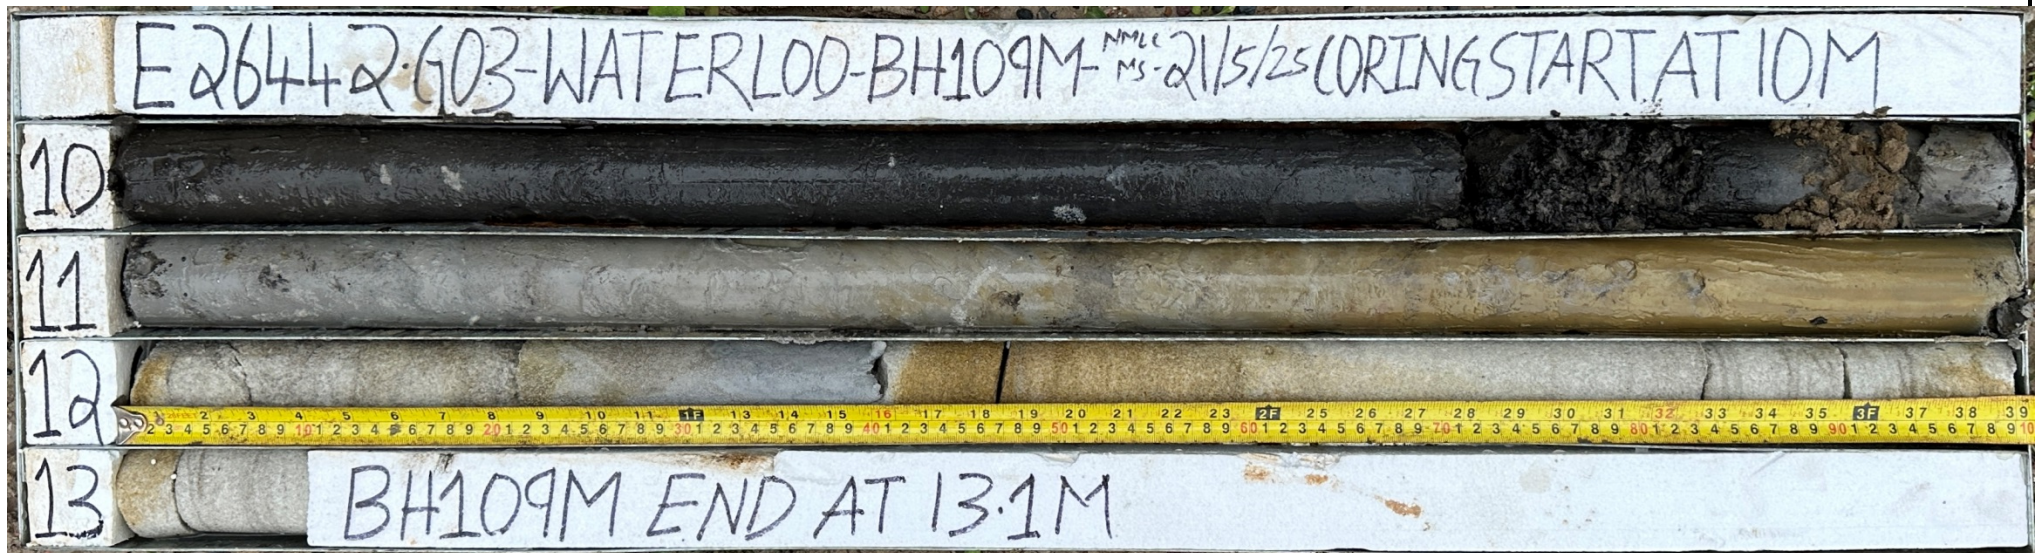
| <b>Job No.</b> | E26442.G03 | <b>Inclination</b> | 90° | <b>Logged</b> | MS <b>Date</b> 21/05/2025 |

| <b>Client</b> | The Trustee for Waterloo Property Unit Trust | <b>Box</b> | 1 of 1 | <b>Checked</b> | TW <b>Date</b> 10/06/2025 |

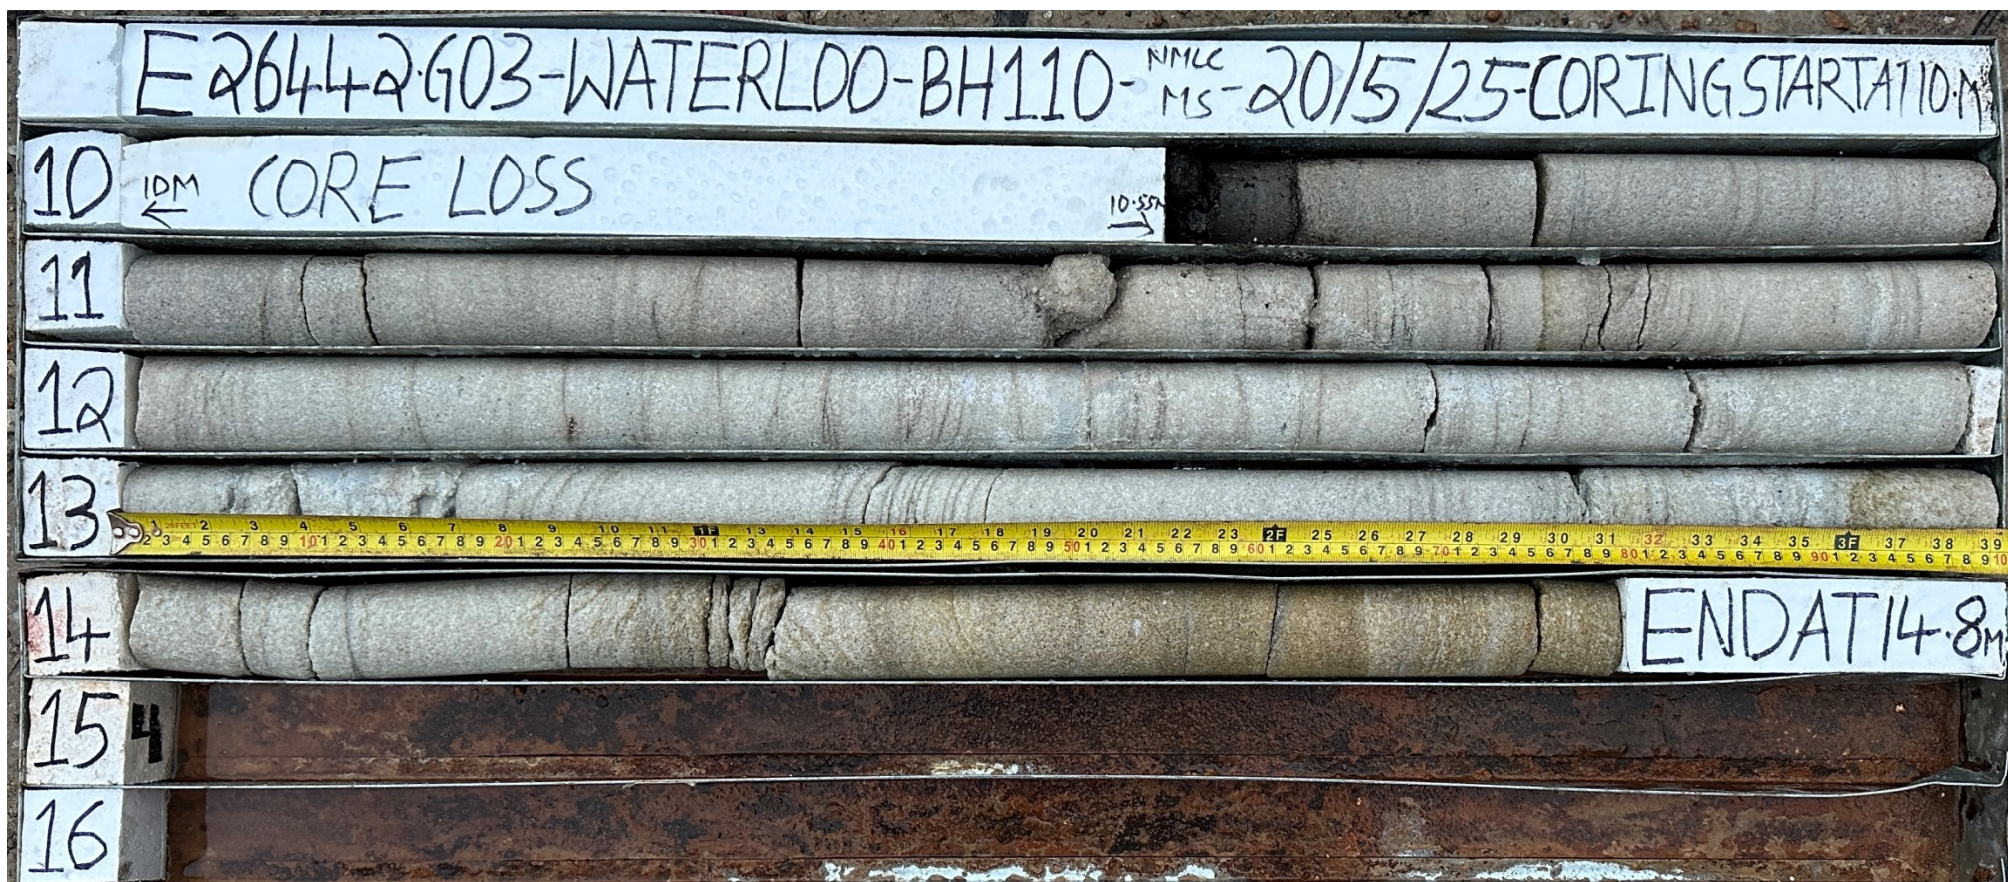
| <b>Job No.</b> | E26442.G03 | <b>Inclination</b> | 90° | <b>Logged</b> | MS | <b>Date</b> | 20/05/2025 |

| <b>Client</b> | The Trustee for Waterloo Property Unit Trust | <b>Box</b> | 1 of 1 | <b>Checked</b> | TW | <b>Date</b> | 10/06/2025 |

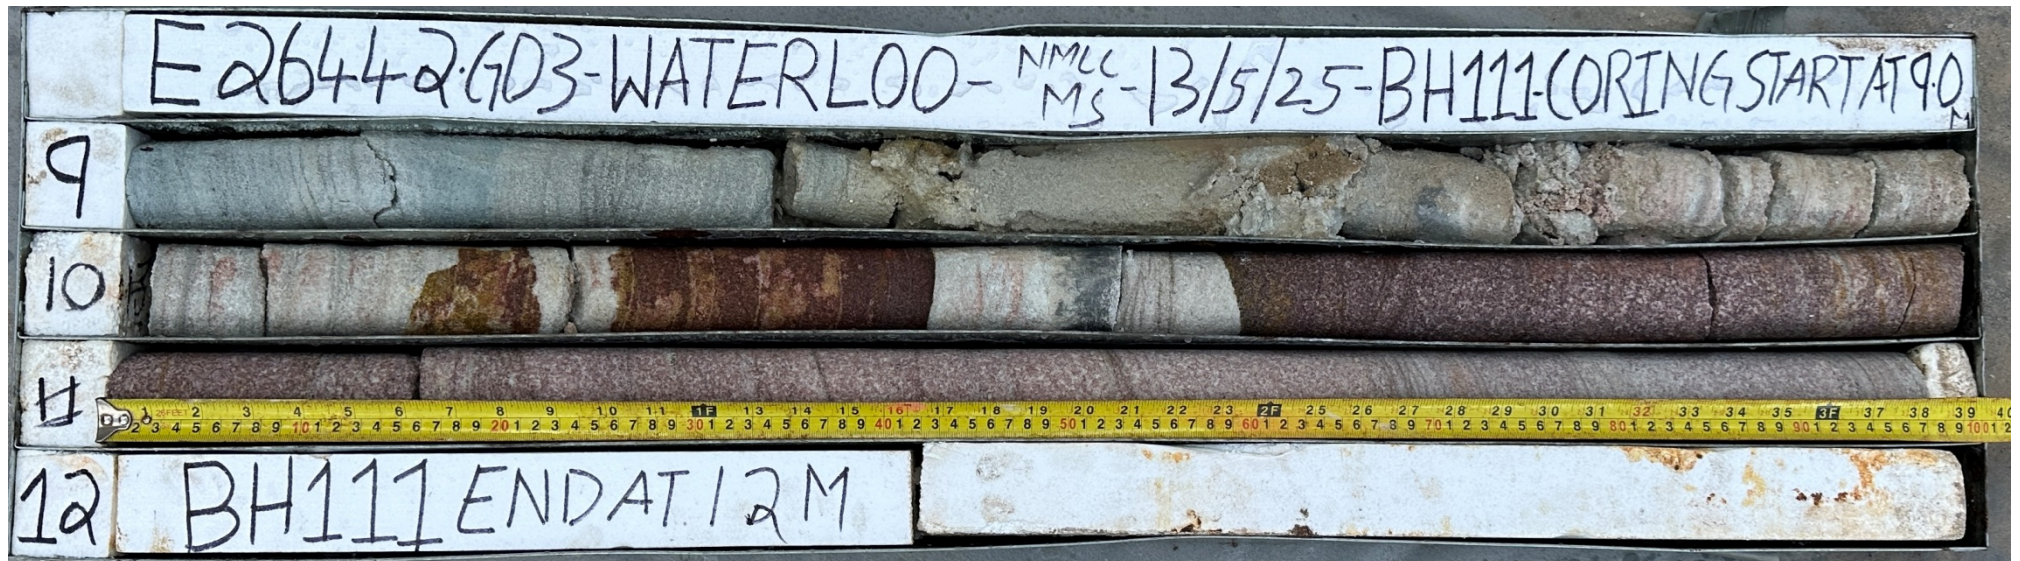
| <b>Job No.</b> | E26442.G03 | <b>Inclination</b> | 90° | <b>Logged</b> | MS | <b>Date</b> 13/05/2025 |

| <b>Client</b> | The Trustee for Waterloo Property Unit Trust | <b>Box</b> | 1 of 1 | <b>Checked</b> | TW | <b>Date</b> 10/06/2025 |

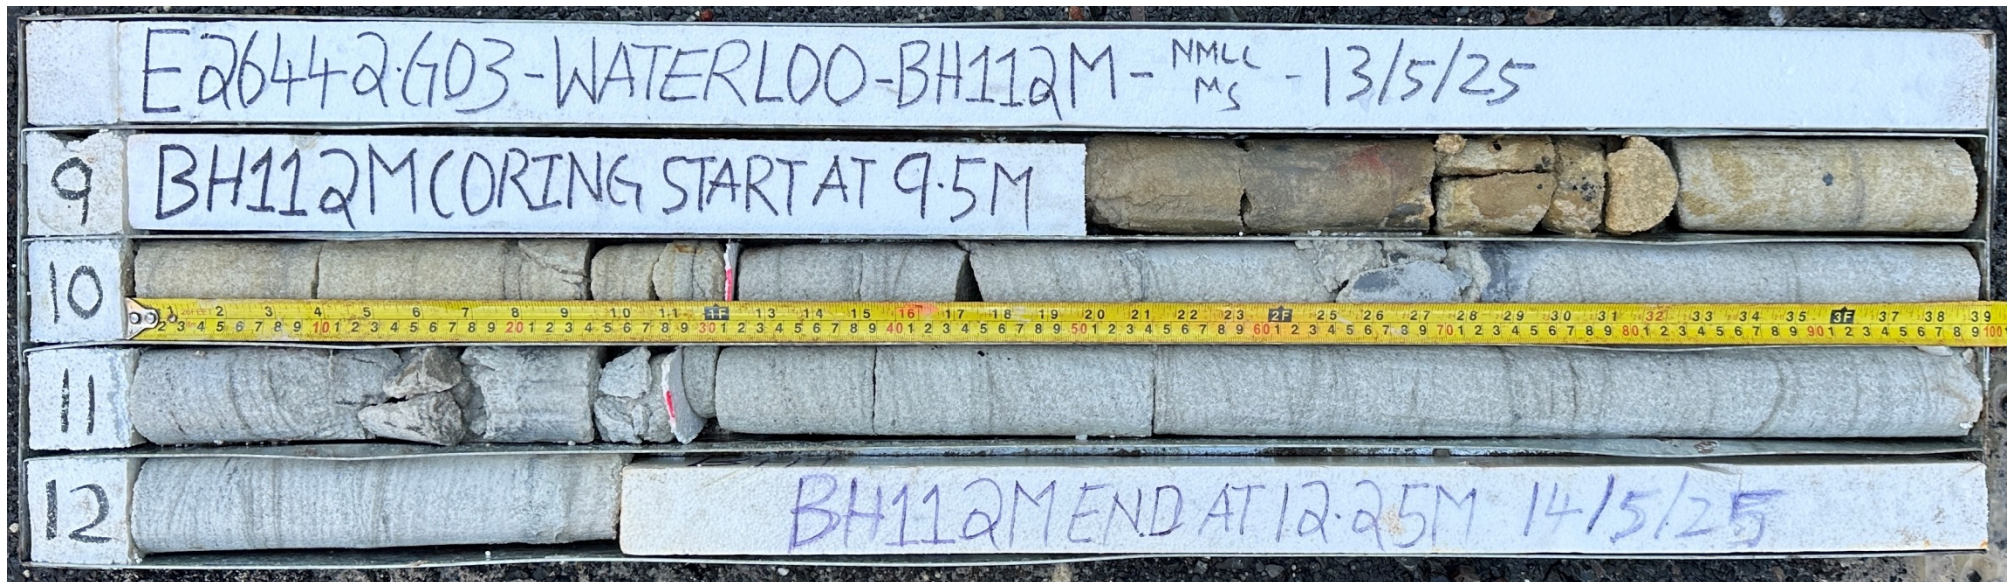
| <b>Job No.</b> | E26442.G03 | <b>Inclination</b> | 90° | <b>Logged</b> | MS <b>Date</b> 13/05/2025 |

| <b>Client</b> | The Trustee for Waterloo Property Unit Trust | <b>Box</b> | 1 of 1 | <b>Checked</b> | TW <b>Date</b> 10/06/2025 |
