# Dewatering Management Plan Building A – Lot 102, 3 Halifax Street, Macquarie Park NSW

Reference: P3006\_19

Date: 23 February 2026

## **Morrow Geotechnics Pty Ltd**

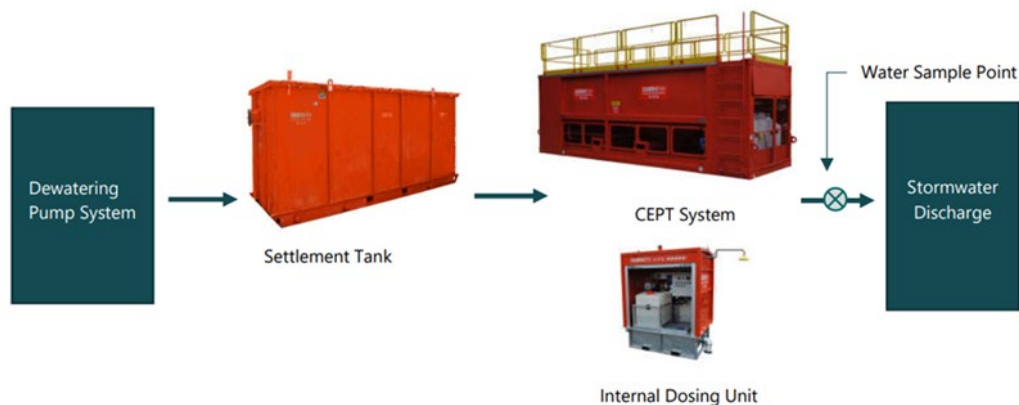
**Figure 6:** Indicative possible treatment system where analyte values exceed Council, ANZG or NEPM threshold values

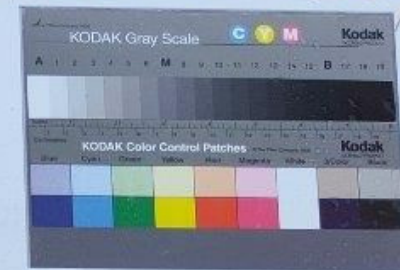
CLIENT NAME: LANDMARK GROUP  
PROJECT: 5 HALIFAX STREET  
LOCATION: MACQUARIE PARK  
JOB NUMBER: P2968  
LOGGED BY: AB+FL

BOREHOLE ID: BH2  
DEPTH: 1.09 - 6.00m  
CORE TRAY NO.: 1 of 4  
DATE: 8/8/23

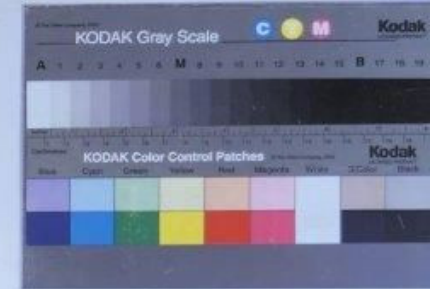
CLIENT NAME: LANDMARK GROUP  
PROJECT: MACQUARIE PARK  
LOCATION: 5 HALIFAX STREET  
JOB NUMBER: P2968  
LOGGED BY: MP

BOREHOLE ID: BH3  
DEPTH: 6.0m to 11.0m  
CORE TRAY NO: Box 2 of 6  
DATE: 10/08/23

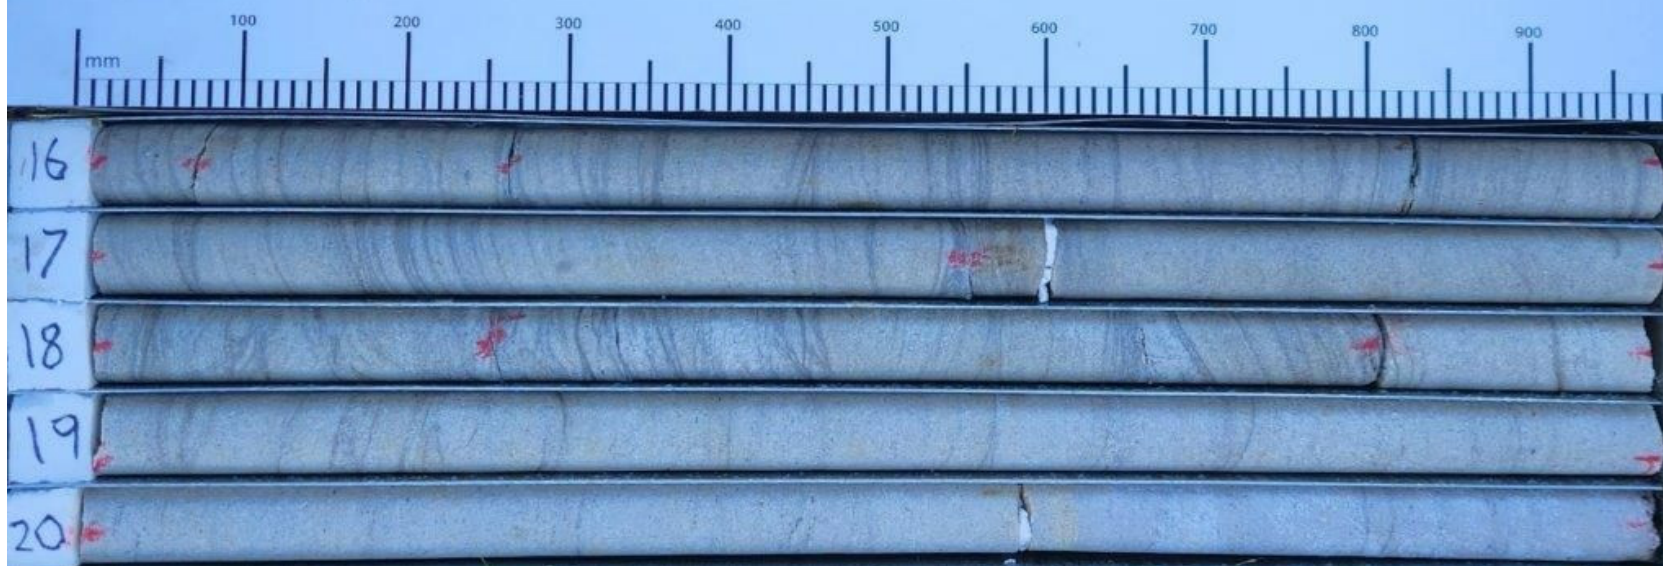
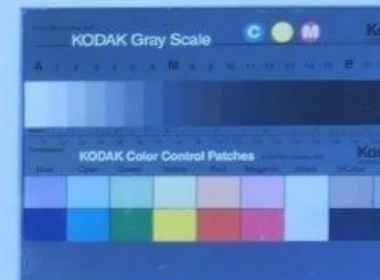
CLIENT NAME: LANDMARK GROUP  
PROJECT: MACQUARIE PARK  
LOCATION: 5 HALIFAX STREET  
JOB NUMBER: P2968  
LOGGED BY: MP

BOREHOLE ID: BH3  
DEPTH: 16.0m to 21.0m  
CORE TRAY NO: Box 4 of 6  
DATE: 11/08/23

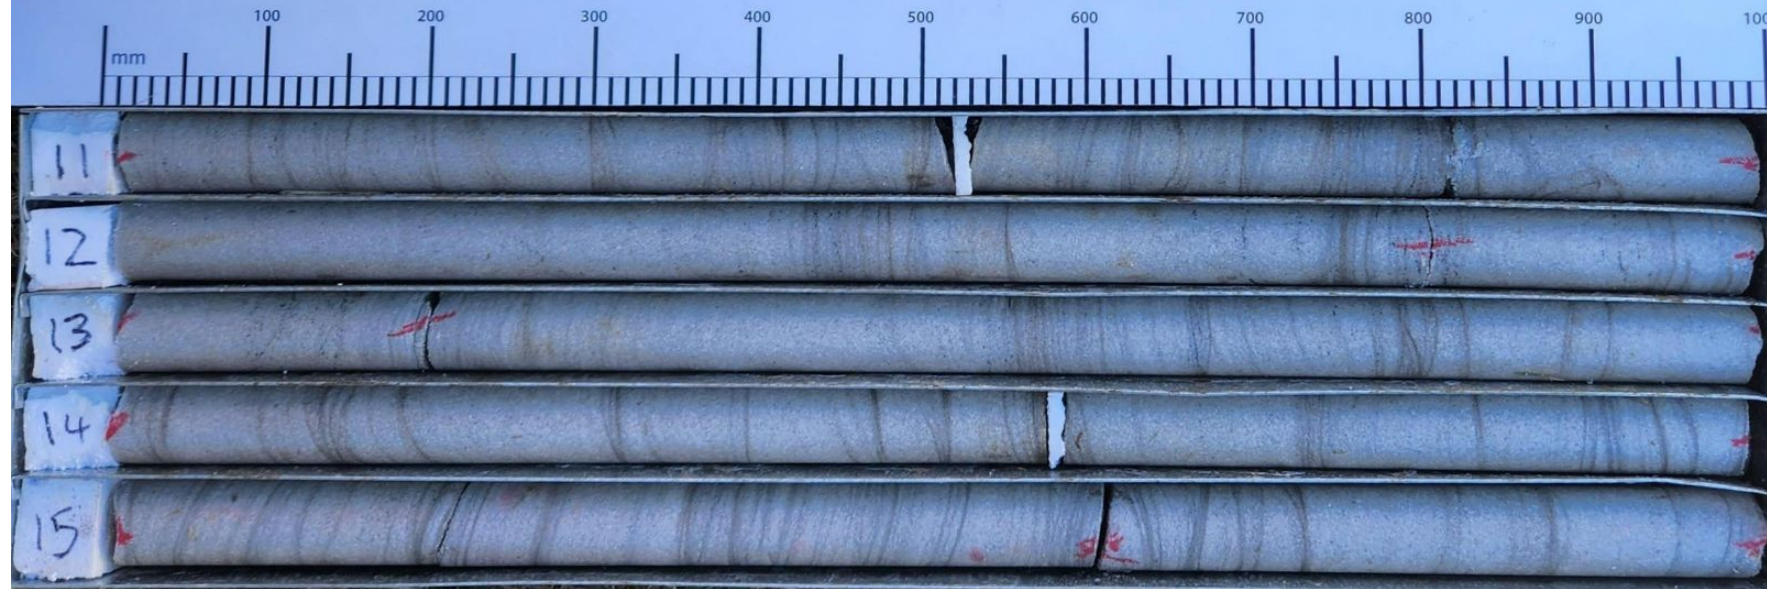
CLIENT NAME: LANDMARK GROUP  
PROJECT: MACQUARIE PARK  
LOCATION: 5 HALIFAX STREET  
JOB NUMBER: P3006  
LOGGED BY: MP

BOREHOLE ID: BH4  
DEPTH: 11.0m to 16.0m  
CORE TRAY NO.: Box 3 of 4  
DATE: 17.08.23

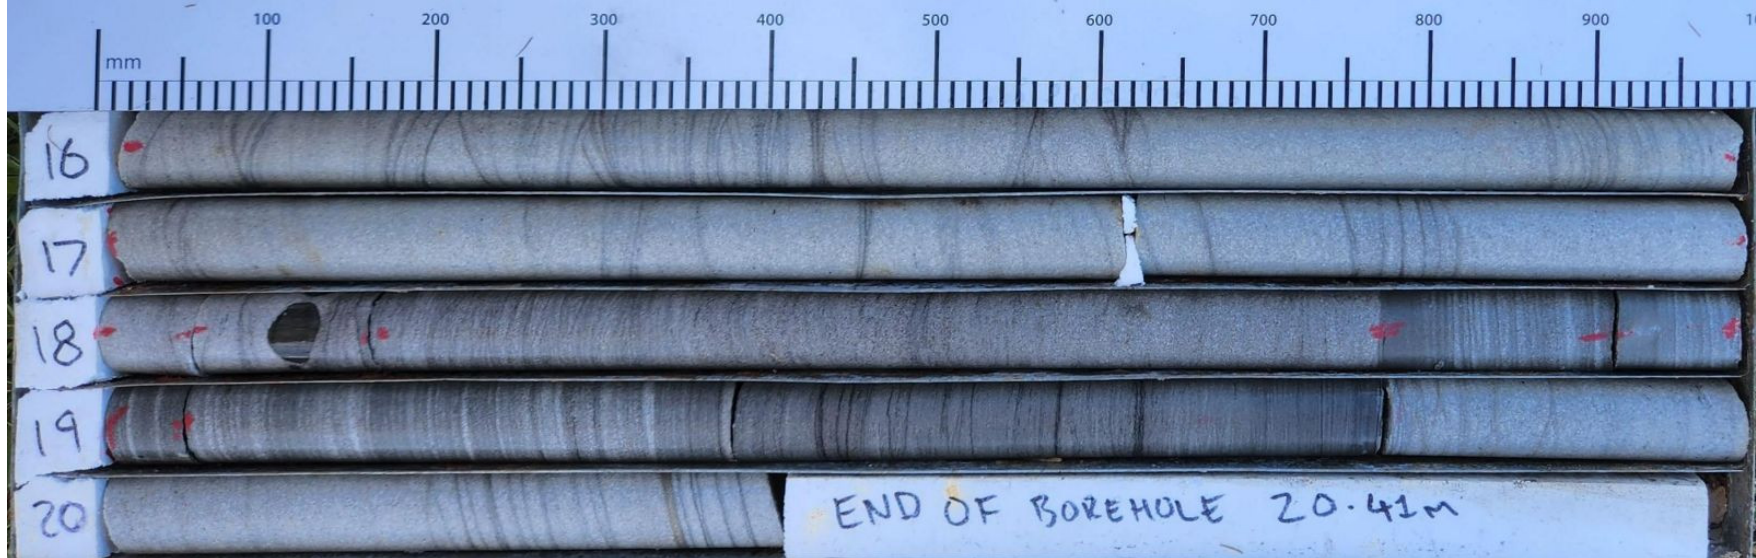
CLIENT NAME: LANDMARK GROUP  
PROJECT: MACQUARIE PARK  
LOCATION: 5 HALIFAX STREET  
JOB NUMBER: P3006  
LOGGED BY: MP

BOREHOLE ID: BH4  
DEPTH: 16.0 m to 20.41 m  
CORE TRAY NO.: Box 4 of 4  
DATE: 17.08.23
