Proposed Gas Plant, 340 Bolong Road, Bomaderry NSW  
Report on Geotechnical Investigation

Our Ref: TERRA25-1264.Rep1.Rev1

13 March 2026

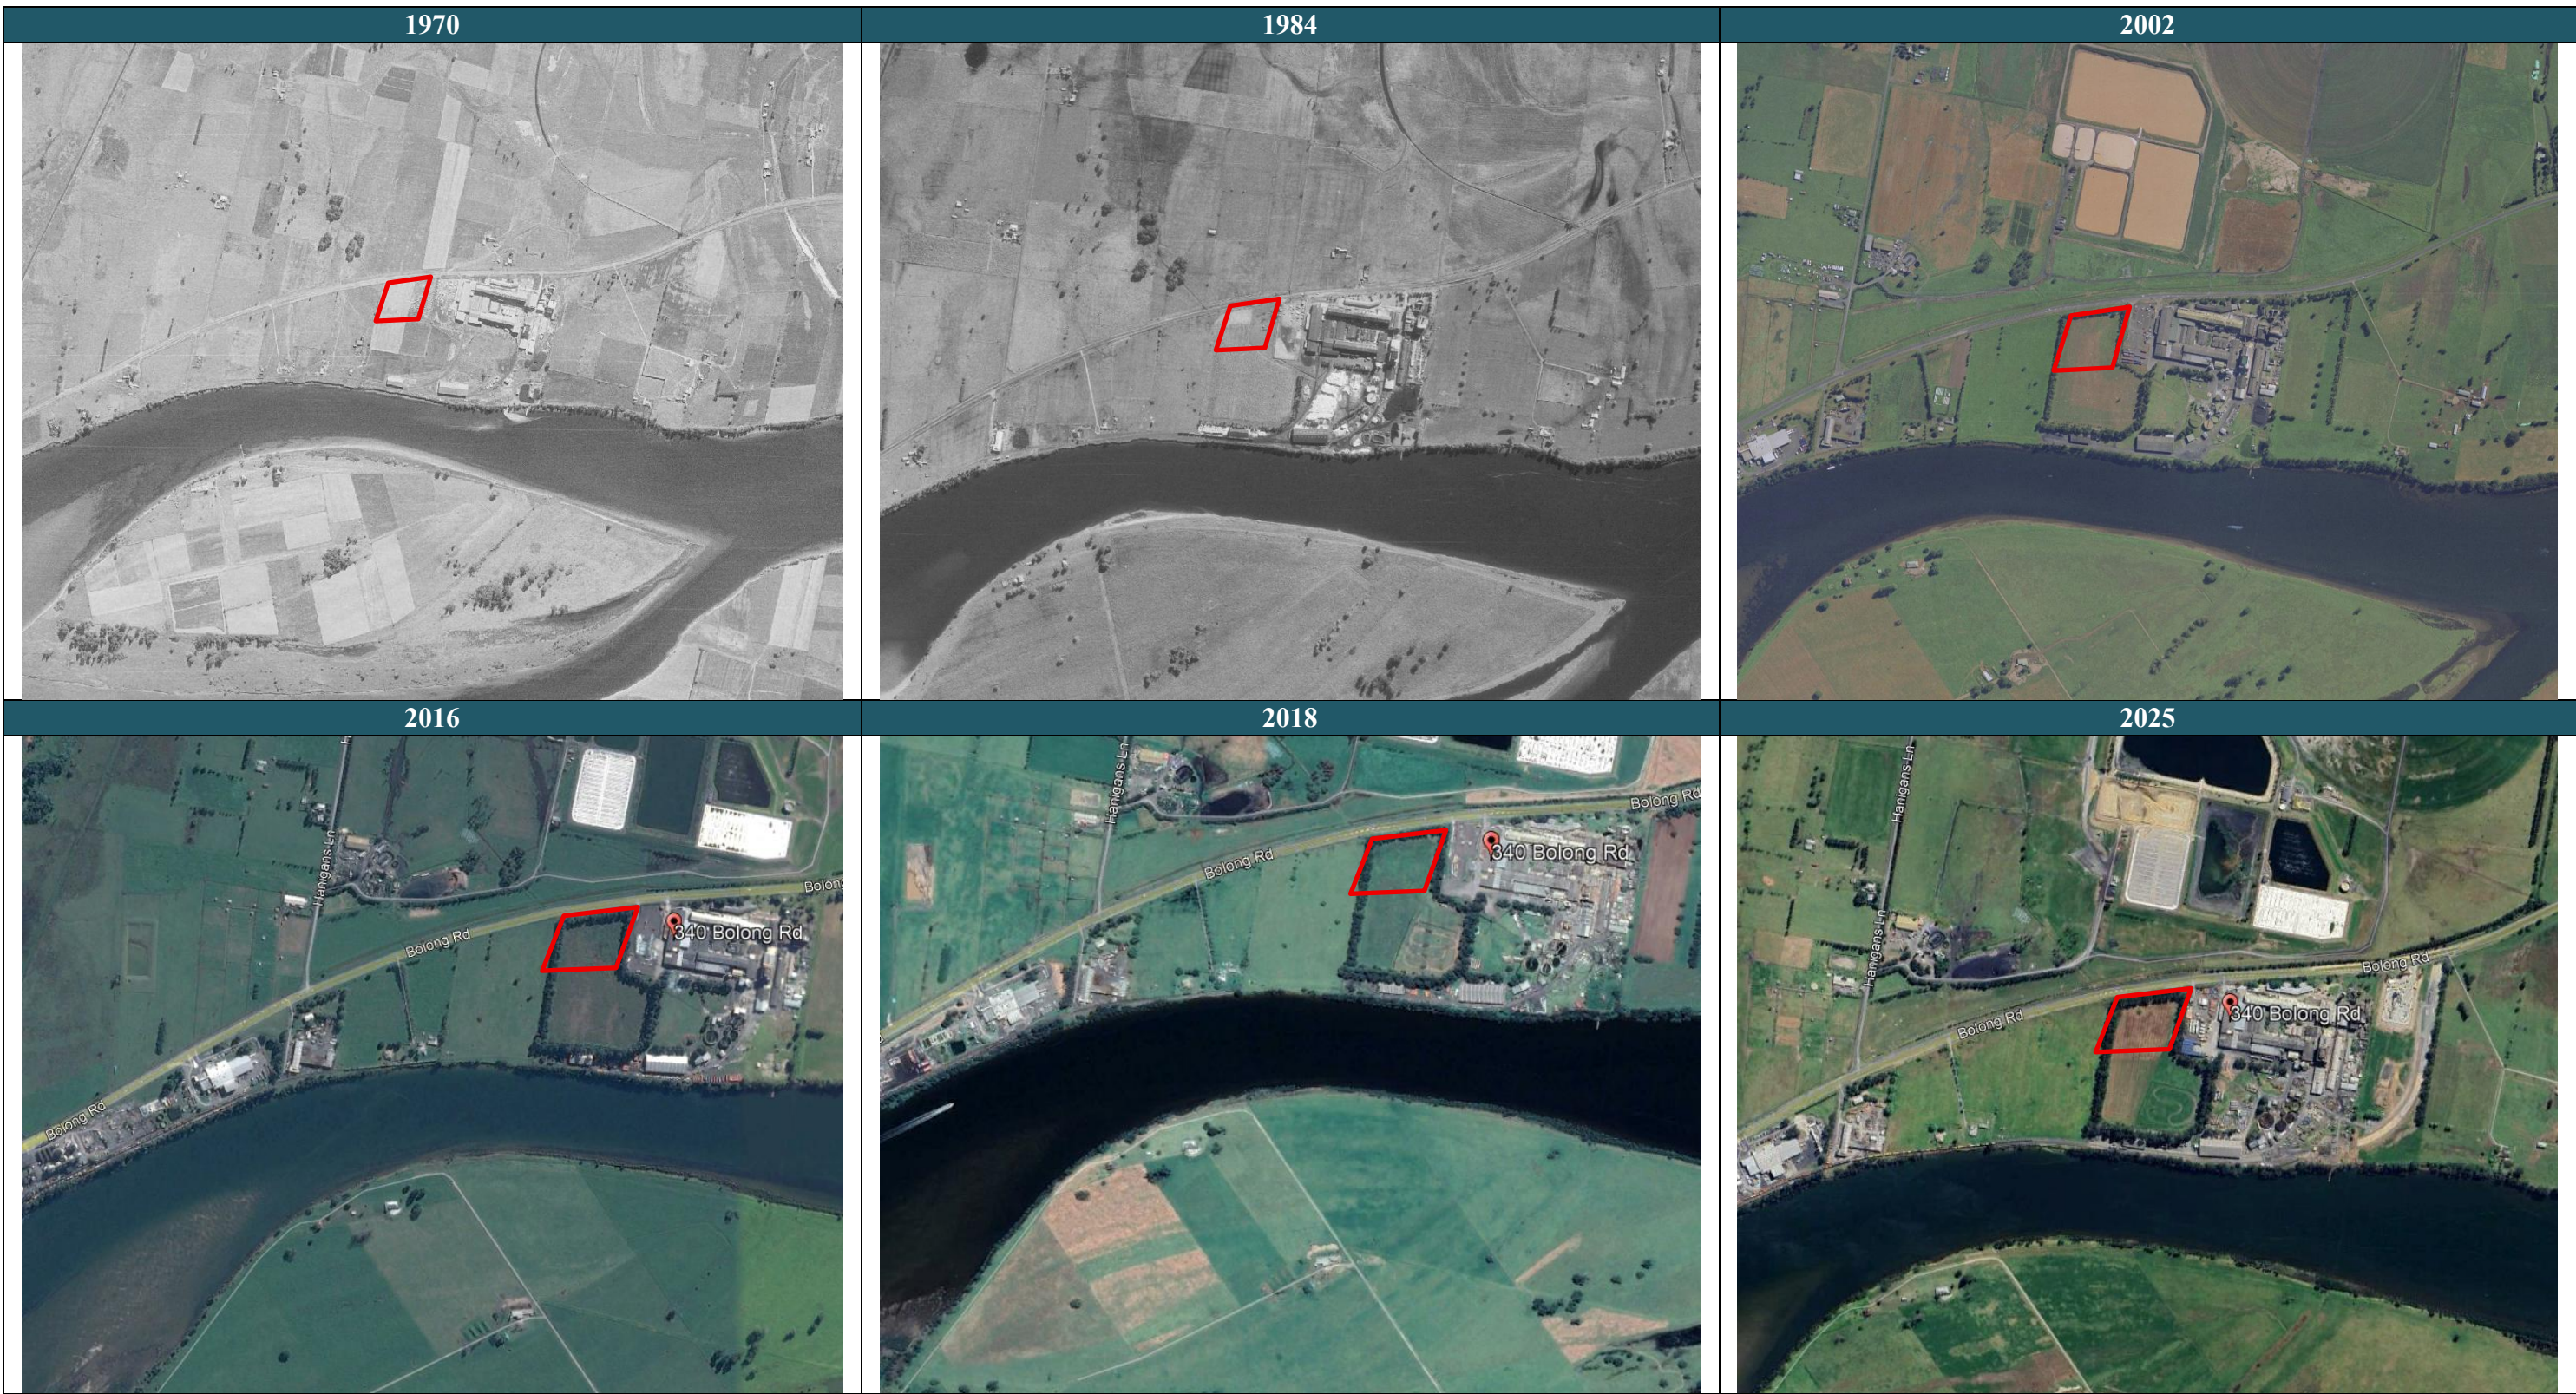
Historical Aerial Imagery

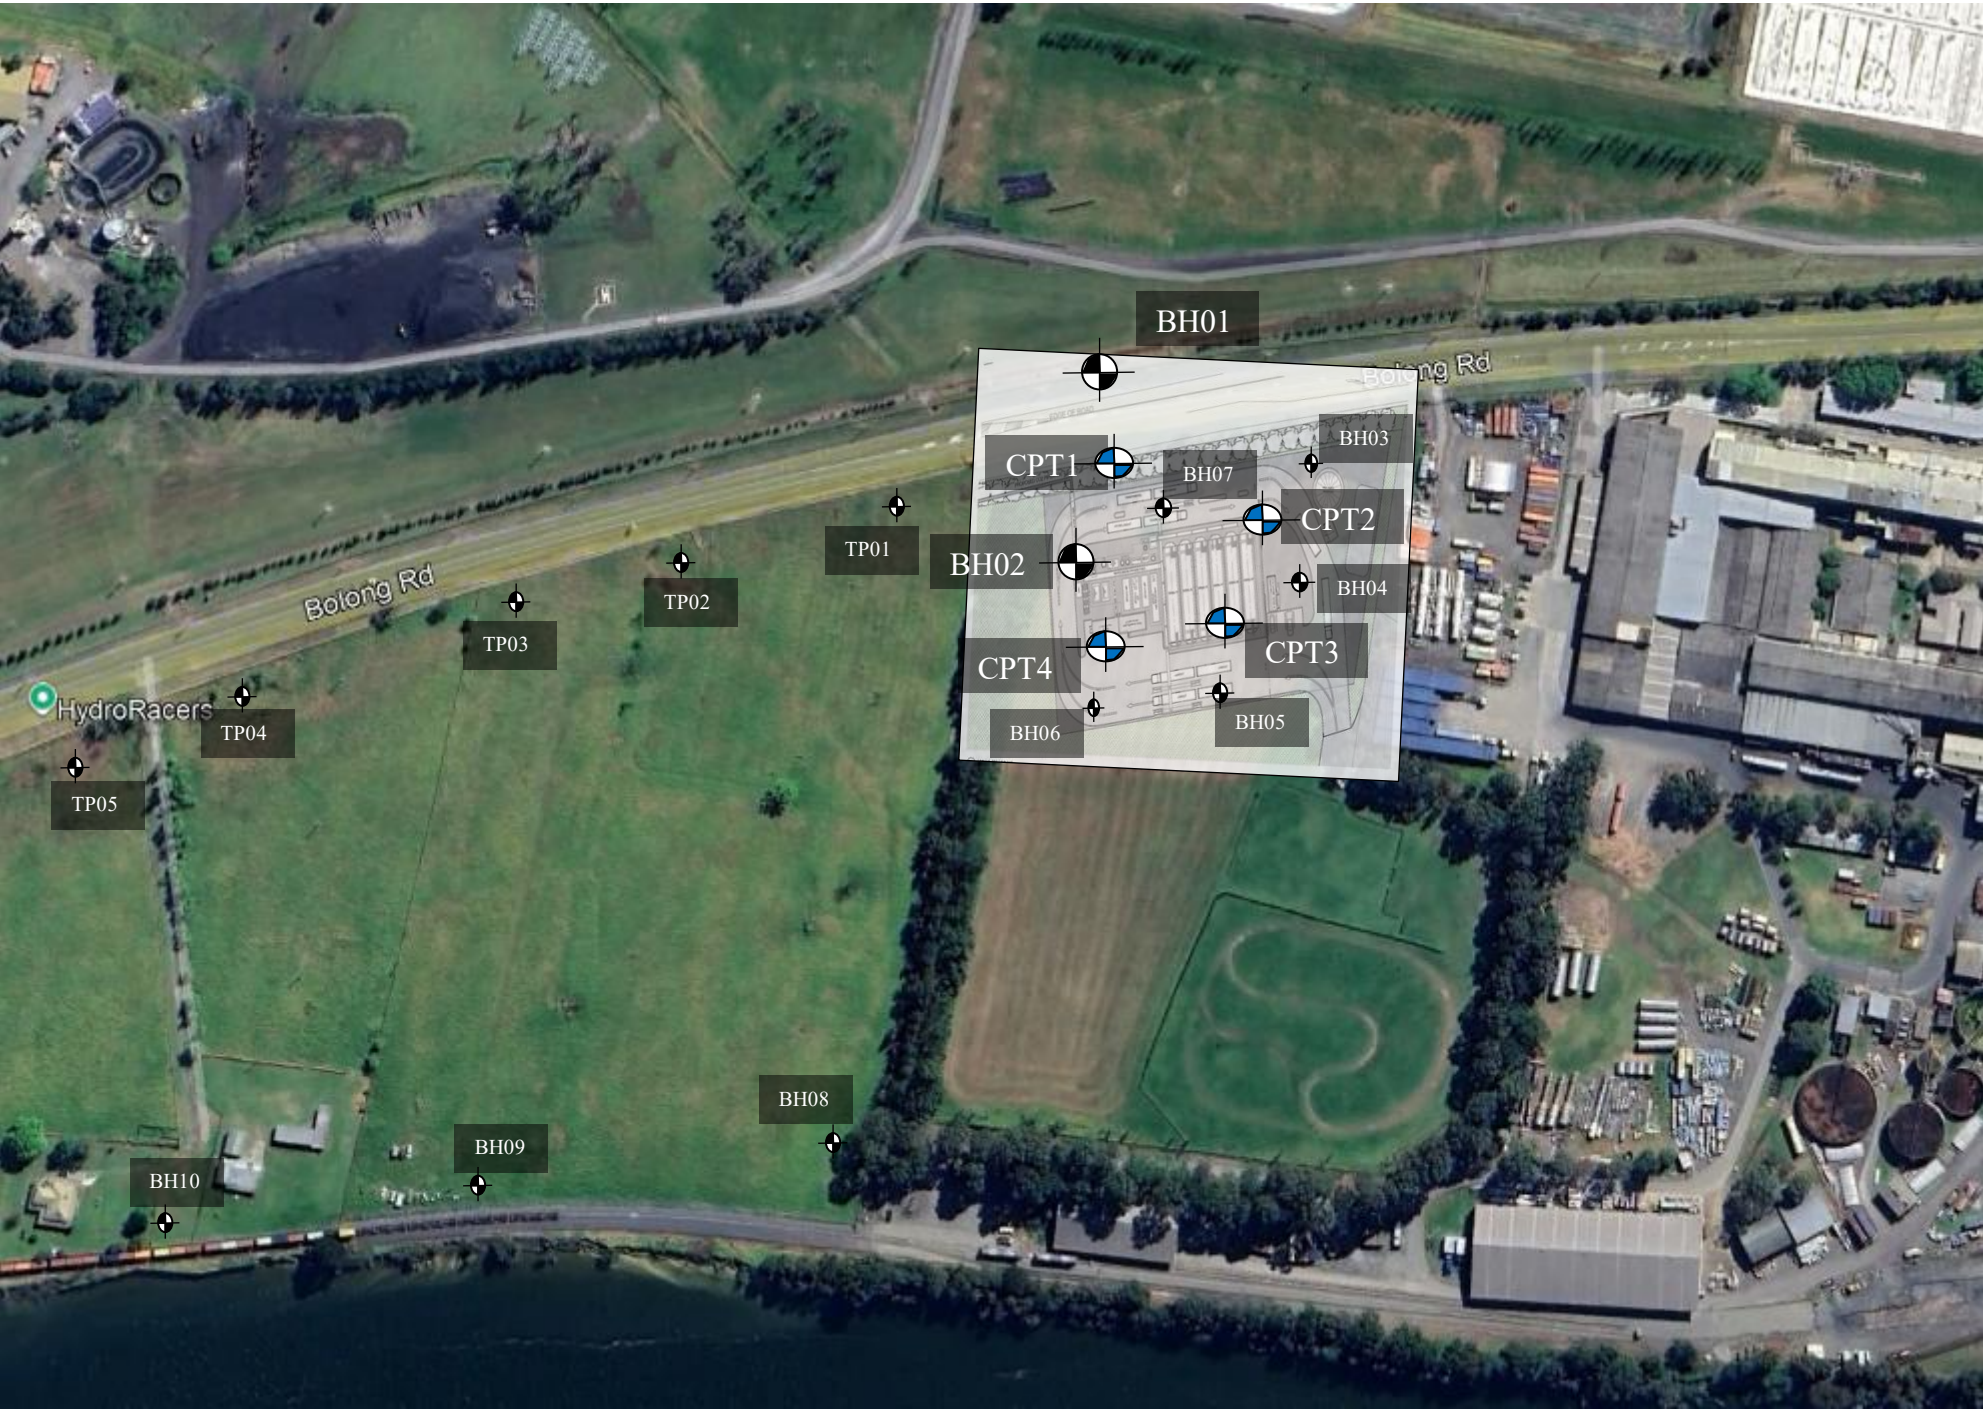
The locations of the boreholes and DCP test locations along the southern pipeline corridor are shown on Figure 4. The subsurface conditions encountered can be summarised as follows:

The locations of the boreholes and DCP test locations along the pipeline corridor are shown on Figure 4. The subsurface conditions encountered can be summarised as follows:

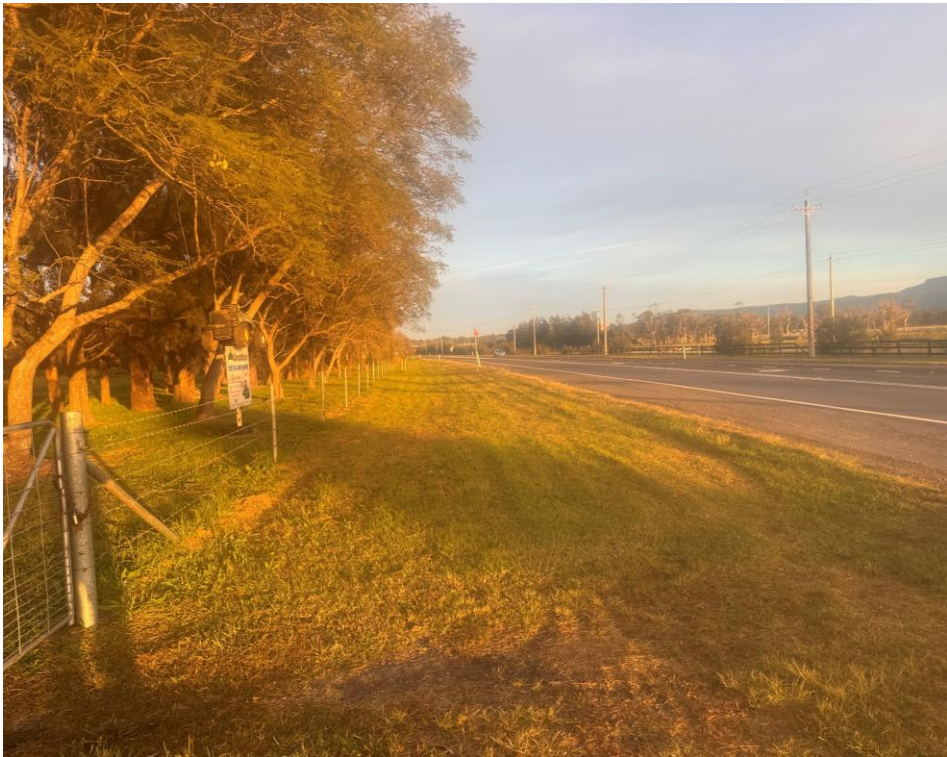
Photograph 1: View of Bolong Road and proposed location of underbore. Borehole BH01 on northern side of road

| Area | Observations |
|---|---|
| Underbore | <ul style="list-style-type: none"><li>• The pavement of Bolong Road appeared to be in fair condition.</li><li>• In the proposed underbore location, Bolong Road is a single carriageway road. At the approximate underbore location, a third lane has been added to permit turning into the former paper mill.</li><li>• Ponded water was observed to the north of Bolong Road and the near-surface soils were waterlogged.</li><li>• On the neighbouring property north of Bolong Road, there were several young pine trees growing.</li></ul> |

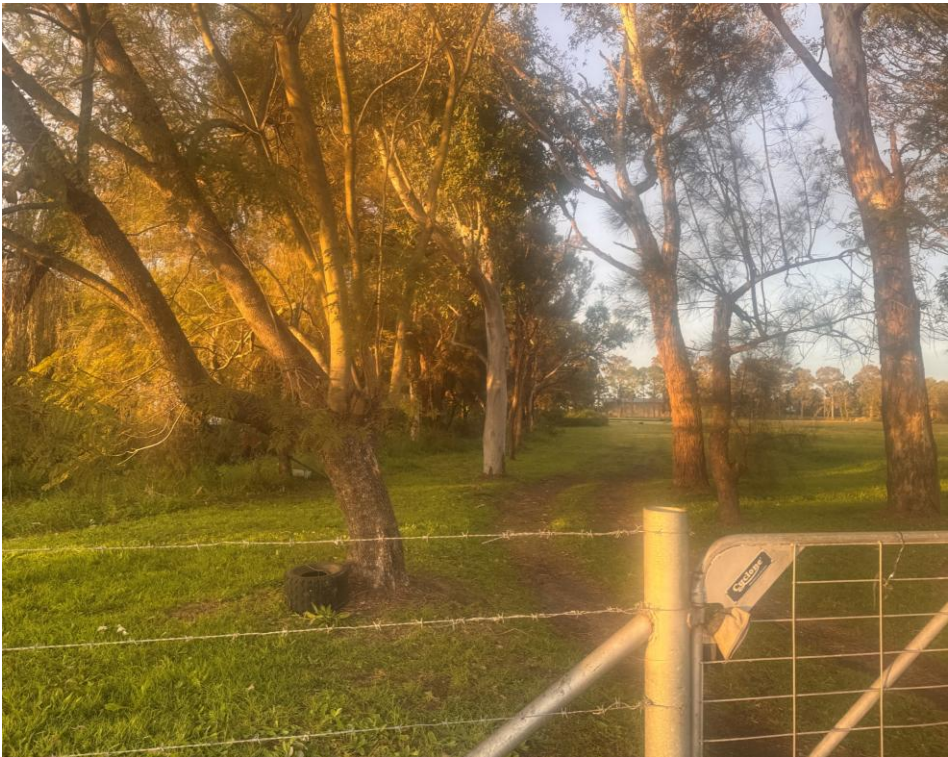
Photograph 2: View of north eastern corner of main plant site looking south towards borehole BH03

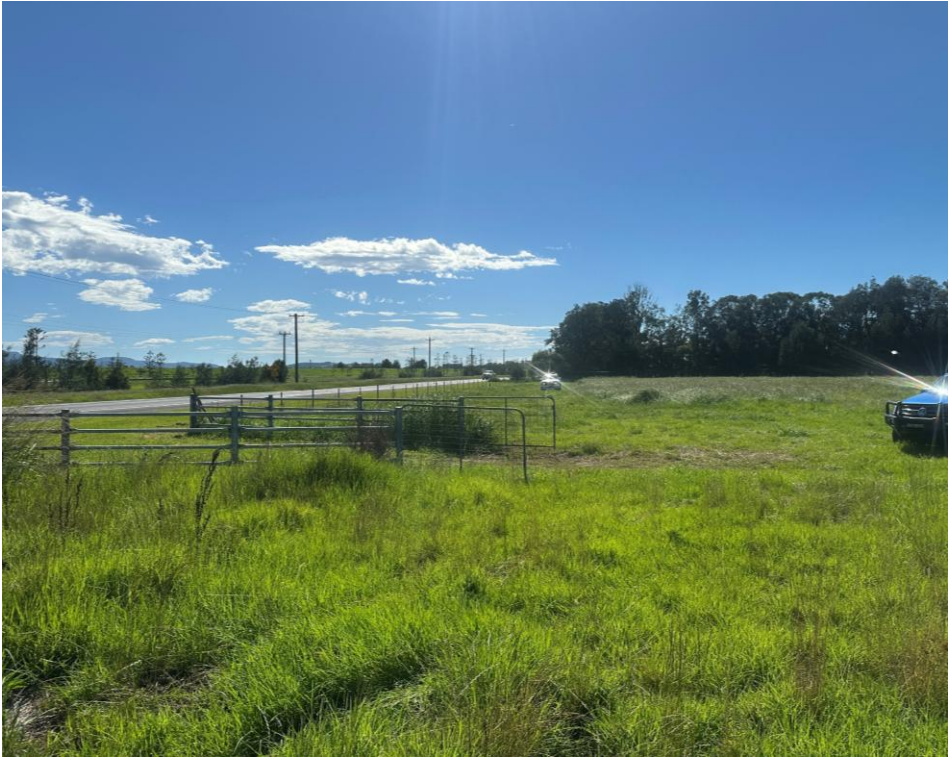
Photograph 15: 2026 View of pipeline corridor looking east from TP02.

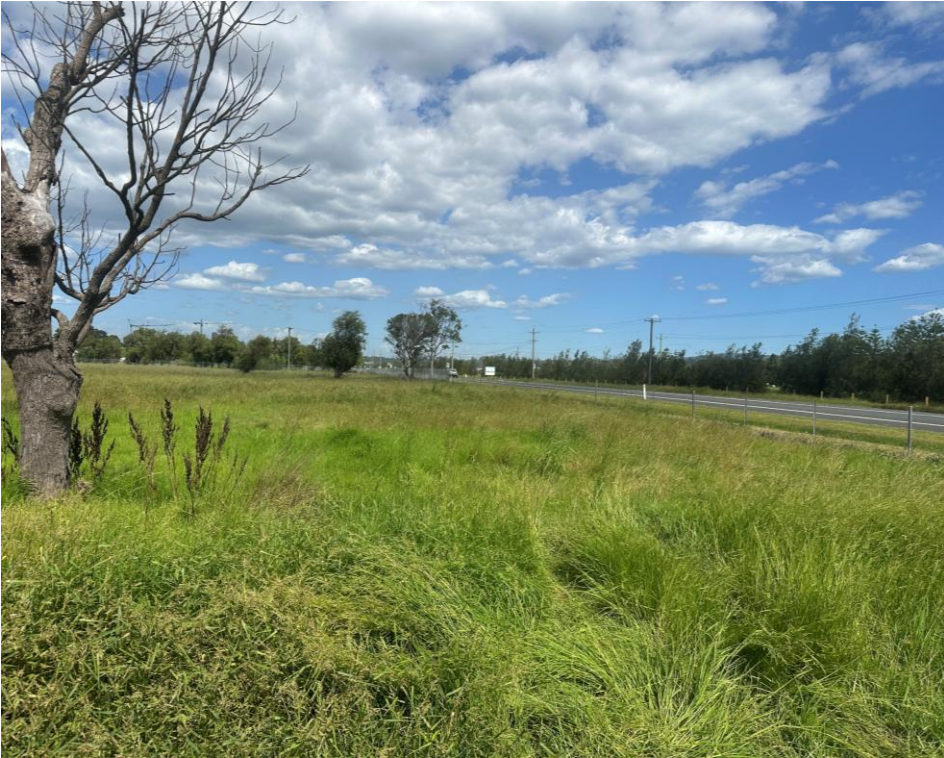
Photograph 16: 2026 View of pipeline corridor looking west from TP02.
