## Geotechnical Investigation

68 & 80 O'Connell Street, Caddens NSW

**Report Title:** Geotechnical Investigation, 68 & 80 O'Connell Street, Caddens NSW

**Report No:** E25834.G03\_Rev3

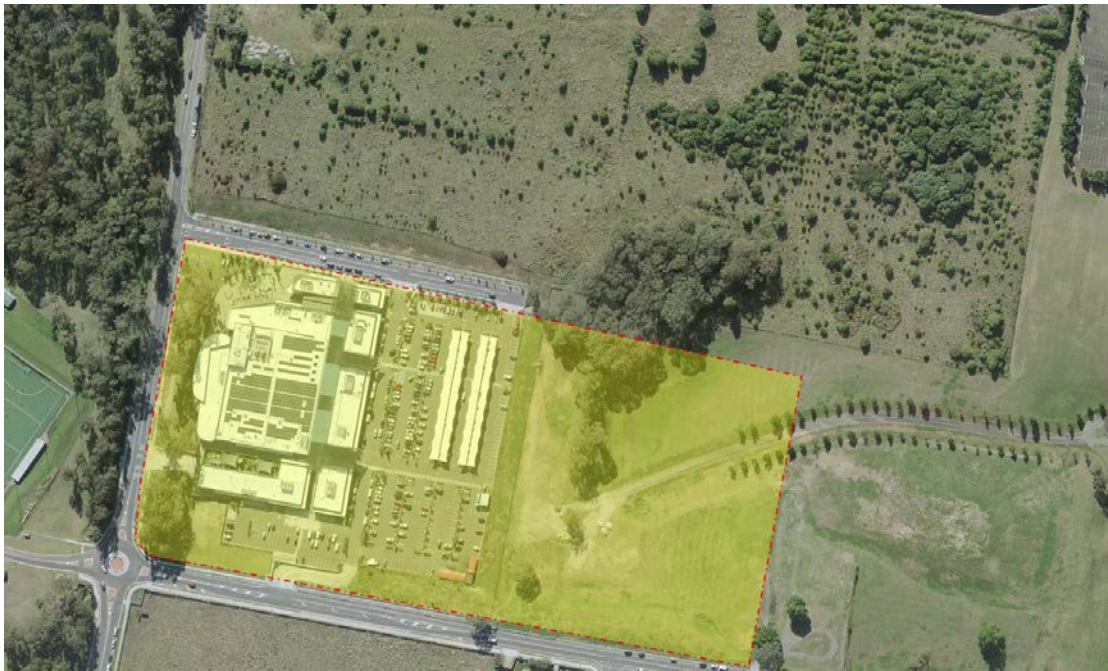
**Plate 1:** Aerial photograph of the site (source: Sixmaps, accessed 18 August 2025)

| Information | Detail |
|---|---|
| <b>Brief Site Description</b> | At the time of our investigation, the site was occupied by a carpark area with asphalt pavement at the western portion and vacant grassy area on the eastern portion. There is an existing asphalt paved road that runs through the middle eastern portion of the site. |

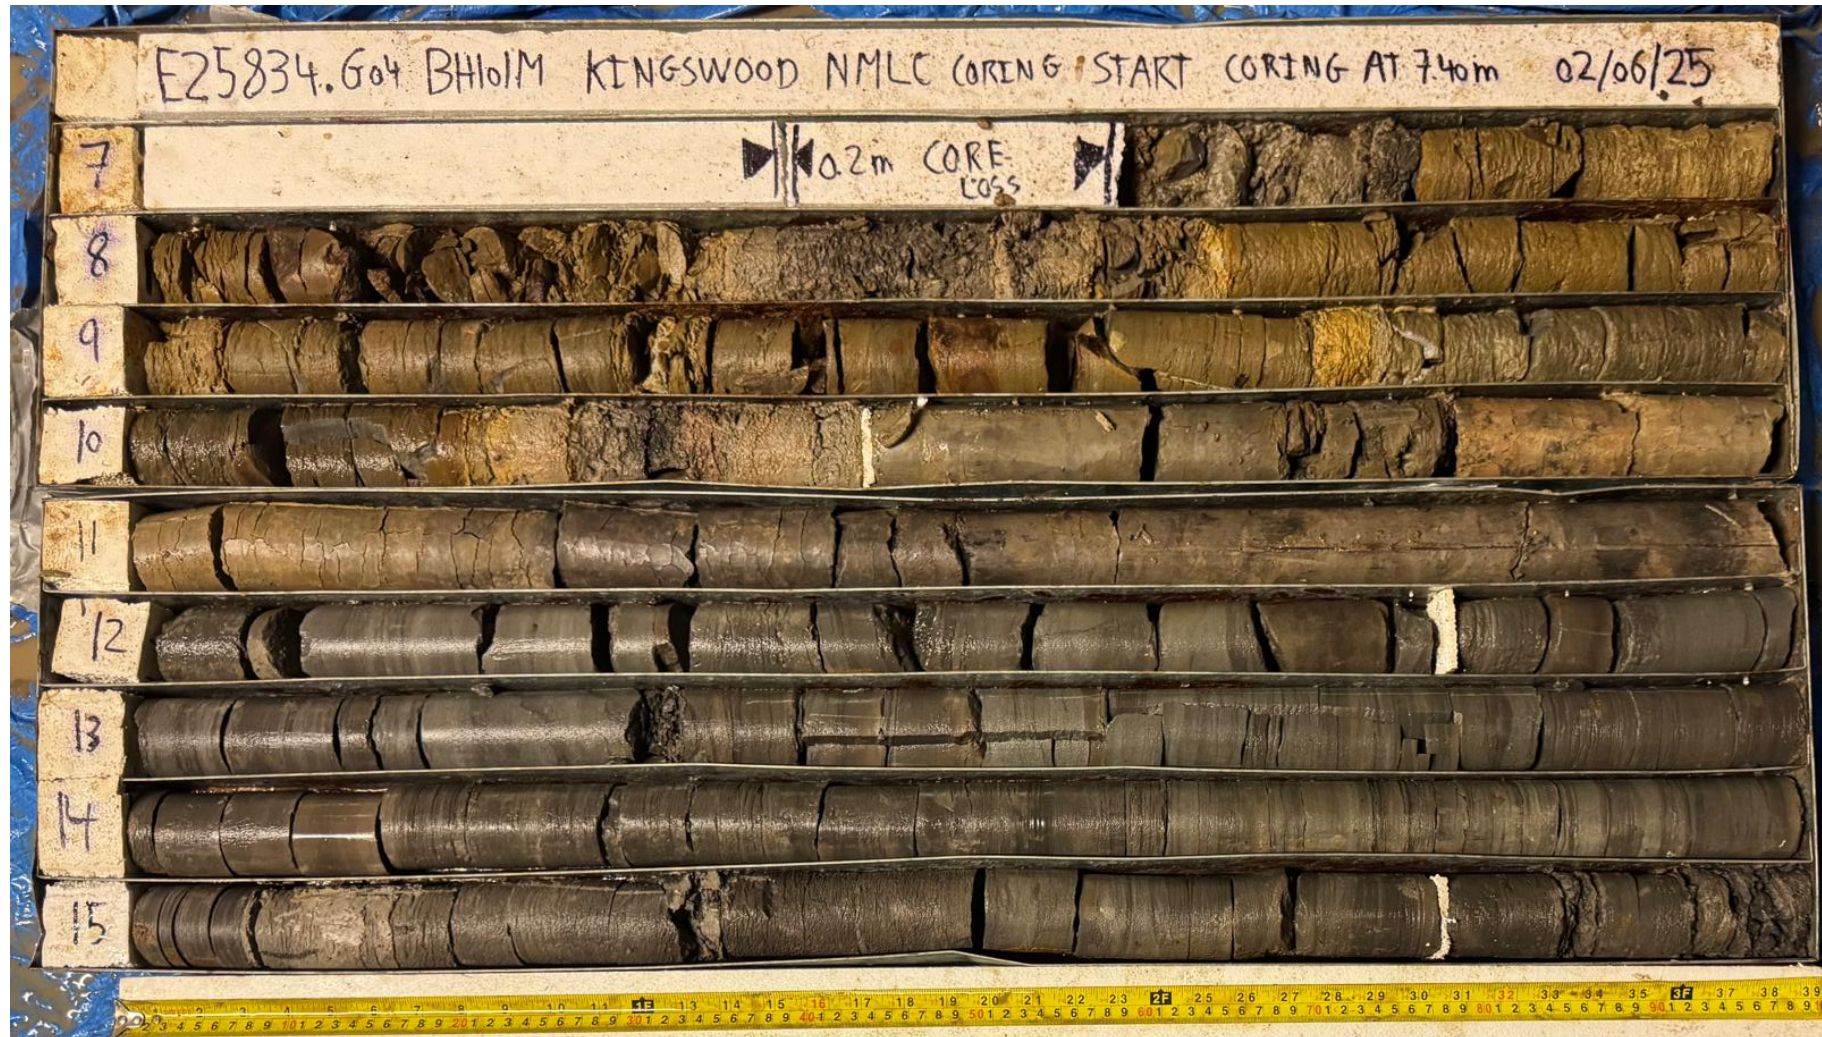
## CORE PHOTOGRAPH OF BOREHOLE: BH101M

| <b>Project</b> | Multiple Mixed-use Developments | <b>East</b> | 6261179.3812 | <b>Depth Range</b> | 16.0 m to 20.7 m | | |

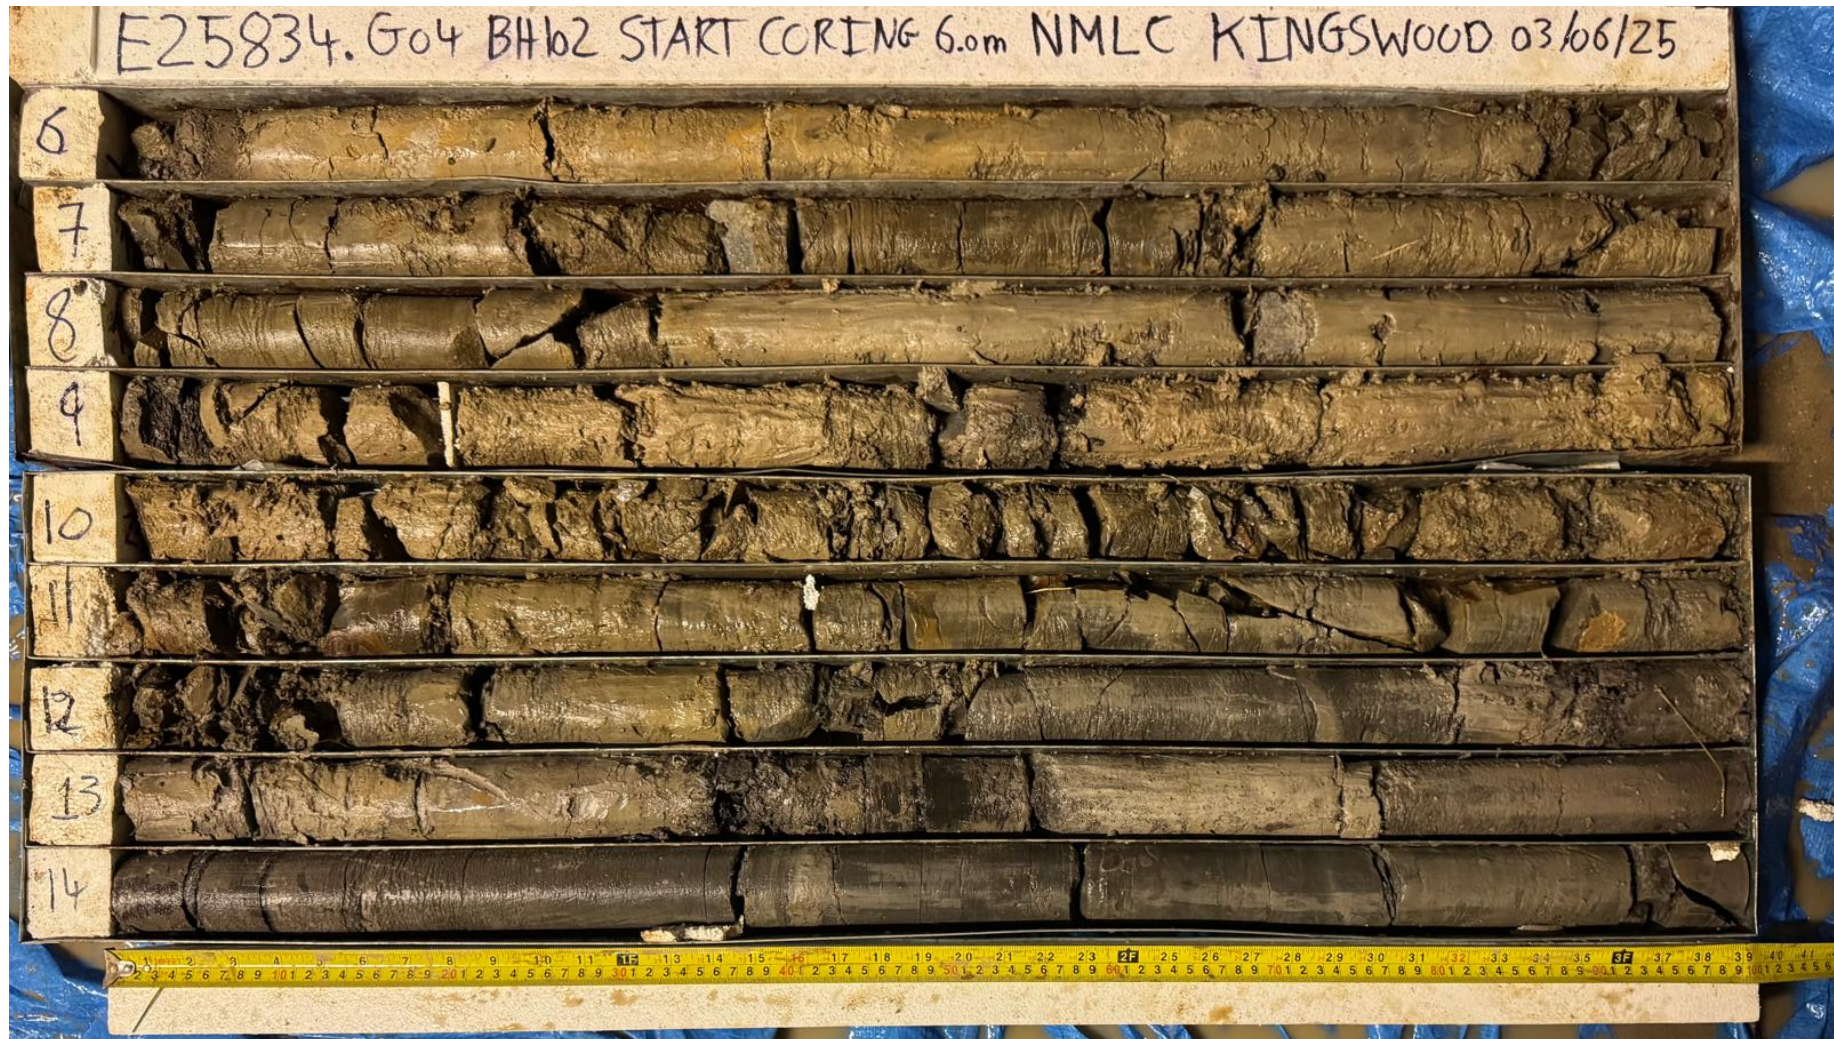
# CORE PHOTOGRAPH OF BOREHOLE: BH102

| <b>Project</b> | Multiple Mixed-use Developments | <b>East</b> | 6261111.0313 | <b>Depth Range</b> | 15.0 m to 16.57 m |
