Lindfield Learning Village Stage 2 and 3 - Car and Bus Access Option 4

Road Safety Audit

Concept Design Stage

JN20045_Report01 Rev02 - Savills LLV Bus Loop Option 4

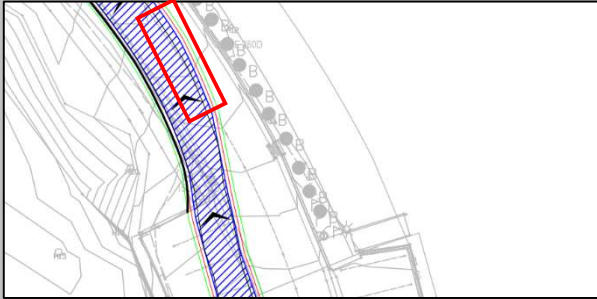
Item Location	Safety Hazard Finding	Frequency	Severity	Level Of Risk	Project Manager Response
1. Turn Paths Bus Stopping Area	<p>The turning path is shown to overhang approaching traffic.</p> <p>There is a risk that an exiting bus may impact oncoming traffic.</p>

Probable	Minor	High	In the updated design, the roadway is 8m wide in this section which allows the bus to keep to their lane and reduce the risk of collision.

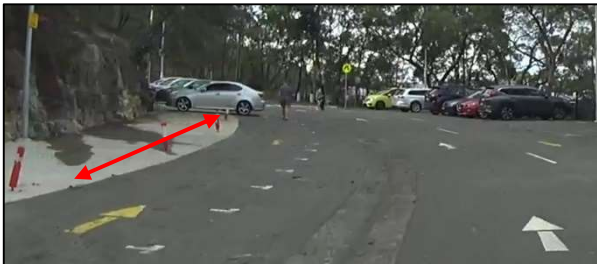
2. Access to Bus Bus Stopping Area	<p>The proposed bus stopping area is at road level.</p> <p>There is a significant height difference from the road level to the bus door.</p> <p>There is a risk that a passenger may trip/fall at significant height differences, in particular mobility impaired passengers.</p>

Occasional	Limited	Low	Noted. Mobility impaired students are required to make special arrangements for direct access to the school as part of the Department of Education's policies and therefore are unlikely to be taking the bus.

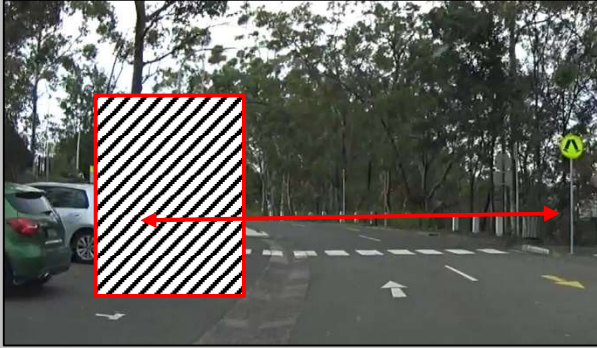
Item Location	Safety Hazard Finding	Frequency	Severity	Level Of Risk	Project Manager Response
3. Pedestrian Conflict Point Bus Stopping Area	<p>There is a pedestrian crossing at the point where bus stopping vehicles merge back in with through vehicles.</p> <p>There is a risk that a bus may block sight to a pedestrian using the pedestrian crossing resulting in pedestrian-vehicle collisions.</p>

Occasional	Serious	High	Noted, this northern crossing would be removed in the updated design.

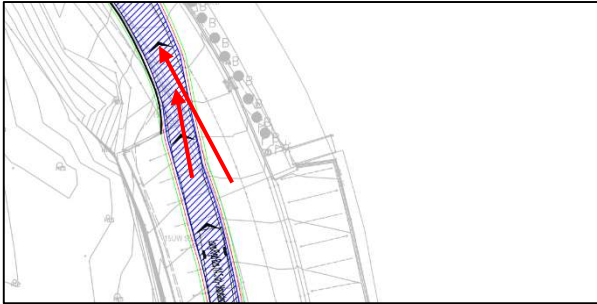
4. Merge-Diverge Bus Stopping Area	<p>It is unclear to the audit team to how vehicle diverge and merge is to be conveyed/managed for vehicles using the stopping area and for vehicles continuing through.</p> <p>There is a risk that a through vehicle may not anticipate a vehicle entering or exiting the stopping area resulting in sideswipe collisions.</p>

Occasional	Limited	Low	The design of this area is proposed to match the design of on-road bus bays and therefore buses would have to merge back with through traffic. When buses are indicating, other vehicles must give way to them.

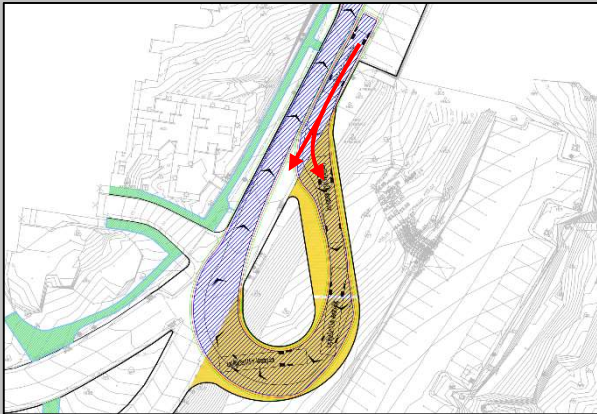
Item Location	Safety Hazard Finding	Frequency	Severity	Level Of Risk	Project Manager Response
5. Turning Area Turnaround Turning Path	<p>It is unclear to the audit team to what vehicles are allowed to use the turning area and how this information is to be conveyed.</p> <p>No further assessment has been carried out.</p>

Note			<p>The turning area has been redesigned to send all vehicles through, as per a roundabout which should clear up potential confusion with the previous iteration of the design.</p>

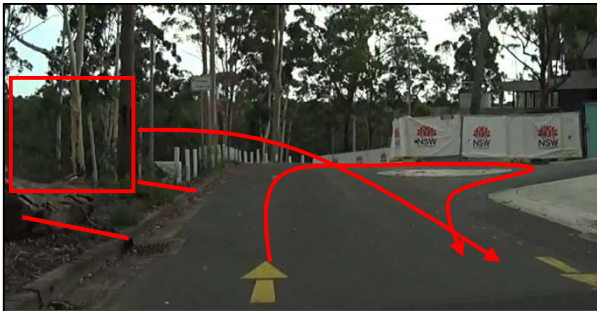
6. Roundabout Turnaround Turning Path	<p>It is unclear to the audit team if the existing roundabout is to remain, if vehicles can turn at this point, if vehicles are required to turn at the turning head DOPU area, if vehicles may attempt to U-turn in the parking area.</p> <p>There is a risk that motorists may undertake unsafe turn around movements, such as U-turns, 3 point turns, mounting kerbs/footpaths etc. resulting in side swipe collisions, property damage to roadside objects or vehicle-pedestrian collisions.</p>

Occasional	Serious	High	<p>The existing roundabout is to be expanded upon with the section of road to be one way north as part of the roundabout.</p>

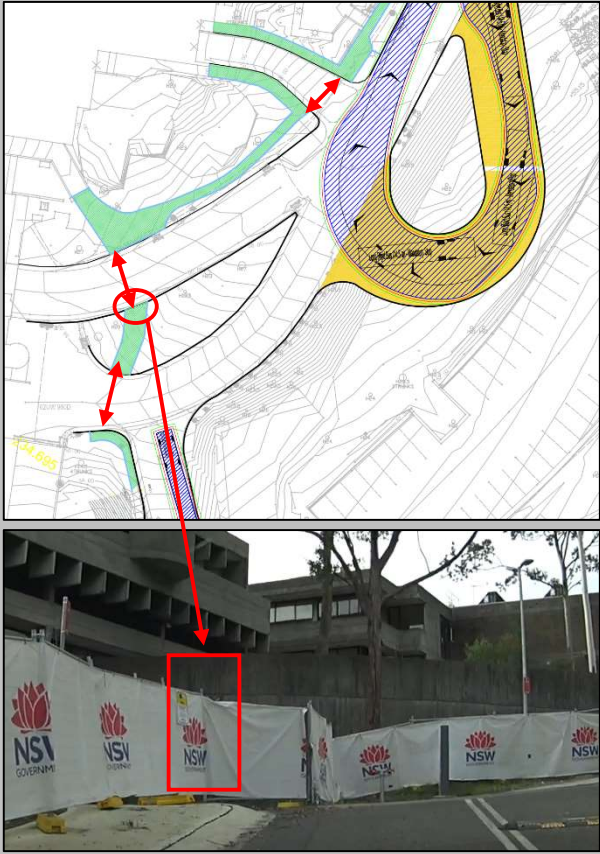
Item Location	Safety Hazard Finding	Frequency	Severity	Level Of Risk	Project Manager Response
7. Pedestrian Paths Turnaround Turning Path	<p>It is unclear to the audit team of the grades of proposed pedestrian paths, requirements for demolition of retaining structures, and vehicle priority or pedestrian crossings, required infrastructure such as steps or handrails, etc.</p> <p>No further assessment has been carried out.</p>

Note			Noted, this is still being determined as the design is progressing.

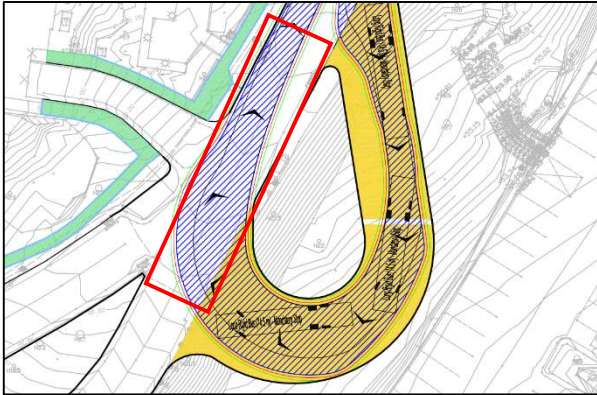
Item Location	Safety Hazard Finding	Frequency	Severity	Level Of Risk	Project Manager Response
8. Bus Turn Path Turnaround Turning Path	<p>The bus turn path requires a significant amount of both travel lanes.</p> <p>There is a risk that through vehicles may block the turning path resulting in sideswipe collisions.</p>

Probable	Minor	High	In the roundabout scenario, this area is one way which removes the conflict.
9. Bus Sightlines Turnaround Turning Path	<p>The position of the bus as it is about to turn into the through travel lane is angled.</p> <p>There is a risk that a driver may not have sufficient sight distances to approaching vehicles resulting in side impact collisions.</p>

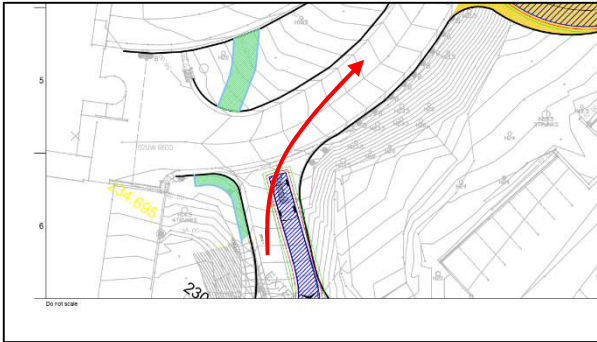
Item Location	Safety Hazard Finding	Frequency	Severity	Level Of Risk	Project Manager Response
10. Vehicle turn paths Turnaround Turning Path	<p>There are no turning paths provided for vehicles traveling to the rear of the complex.</p> <p>There is a risk that opposing vehicles may not be about to undertake concurrent turns resulting in sideswipe collisions.</p>

Probable	Minor	High	In the roundabout design, this intersection has been widened to allow two cars to make this turn simultaneously.

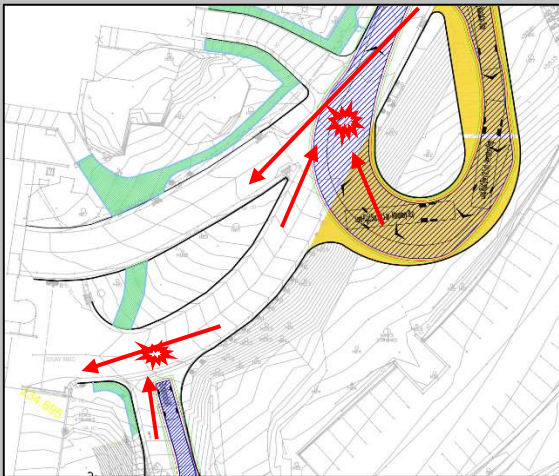
11. Intersection Controls Turnaround Turning Path	<p>There are no intersection controls provided for most conflict points.</p> <p>There is a risk that vehicles may not give way to other traffic or may cut across intersections resulting in sideswipe or head on collisions.</p>

Probable	Minor	High	The roundabout design would implement roundabout style conflict points at the upper point, and the lower point, the through movement is more obvious for cars coming up the hill past the driveway.

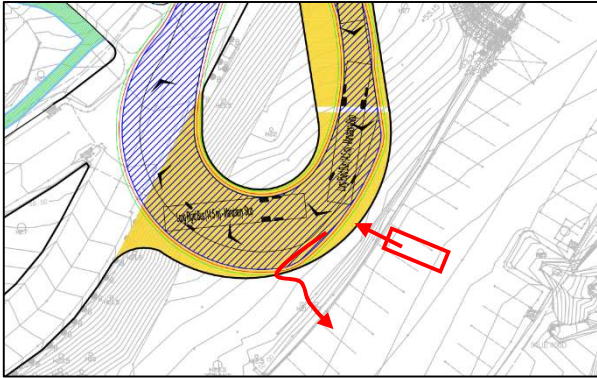
Item Location	Safety Hazard Finding	Frequency	Severity	Level Of Risk	Project Manager Response
12. Structure Design Turnaround Turning Path	<p>There is no information provided regarding the turning structure construction, or any upper barriers, handrails, batters, or pier protection from lower levels required.</p> <p>No further assessment has been carried out.</p>

Note			The turnaround is about 8m above the car park and will include crash barriers along the upper level. The piers will be designed to withstand some impact as per the Building Code of Australia.

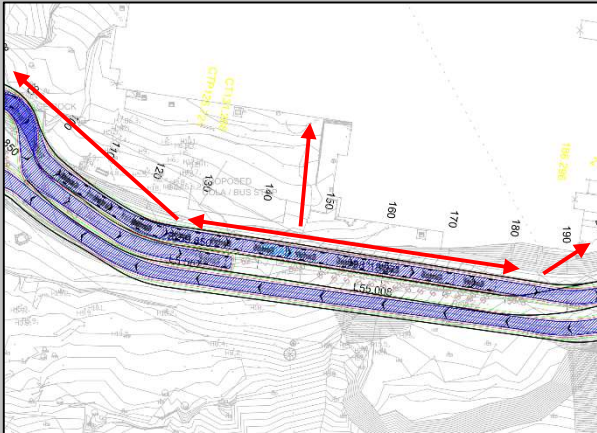
13. Pedestrian Routes DOPU Area	<p>It is unclear to the audit team of the proposed pedestrian routes/waiting areas/footpath width/etc.</p> <p>No further assessment has been carried out.</p>

Note			The pedestrian area is being developed as part of the landscape design and will include fencing along this area that defines entry points to the school when the DOPU area is in operation. 1.5m has been provided between the kerb and the fence.

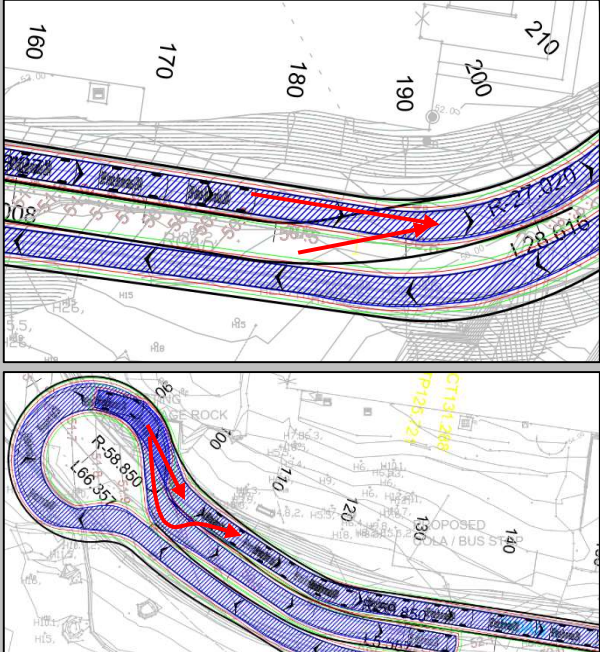
15. Merge-Diverge DOPU Area	<p>It is unclear to the audit team to how vehicle diverge and merge is to be conveyed/managed for vehicles using the stopping area and for vehicles continuing through.</p> <p>There is a risk that a through vehicle may not anticipate a vehicle entering or exiting the stopping area resulting in sideswipe collisions.</p>

Occasional	Limited	Low	The turnaround has been redesigned to add the DOPU lane more clearly after the turnaround point to ease this decision point. The DOPU exit will be signed as a parking lane ending requiring drivers to give way to through traffic.

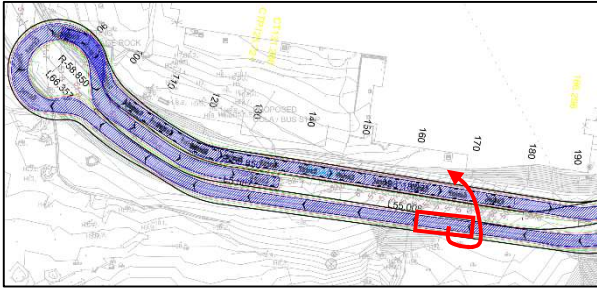
Item Location	Safety Hazard Finding	Frequency	Severity	Level Of Risk	Project Manager Response
16. Drop off Location DOPU Area	<p>There is a considerable distance for a parent to drive and turn around before being able to DOPU.</p> <p>There is a risk that parents, while stopped in a long queue, may encourage children to exit the vehicle and walk in between traffic resulting in pedestrian-vehicle collisions.</p>

Occasional	Minor	Medium	<p>This behaviour is unlikely to occur as the parent would not be able to turn around within only two lanes and our queueing estimates suggest that the queue would be between 6-10 vehicles and clear relatively quickly. Additionally, parents will be instructed in how to safely drop their kids off at the school as part of the School Travel Plan.</p>

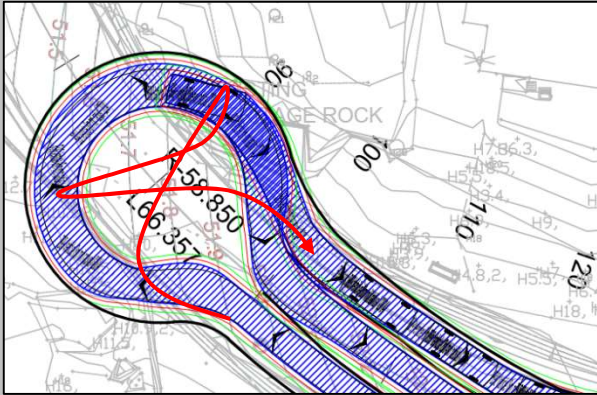
17. Turn area DOPU Area	<p>There is limited delineation provided for motorists to turn at the turning head in one movement and enter the correct lane.</p> <p>There is a risk that a motorist may undertake unsafe turn around movements, 3 point turns, mounting kerbs/footpaths etc. resulting in side swipe collisions, property damage to roadside objects or vehicle-pedestrian collisions.</p>

Occasional	Minor	Medium	<p>Pavement markings will be included in the final design that explain that this a turnaround and that vehicles are expected to drive forward through this turnaround.</p>
