University of New South Wales
Remedial Action Plan

UNSW's Cliffbrook Campus Redevelopment Project
Corner of Battery and Beach Streets
Coogee, NSW

18 September 2017

54176-111021 (Rev B)

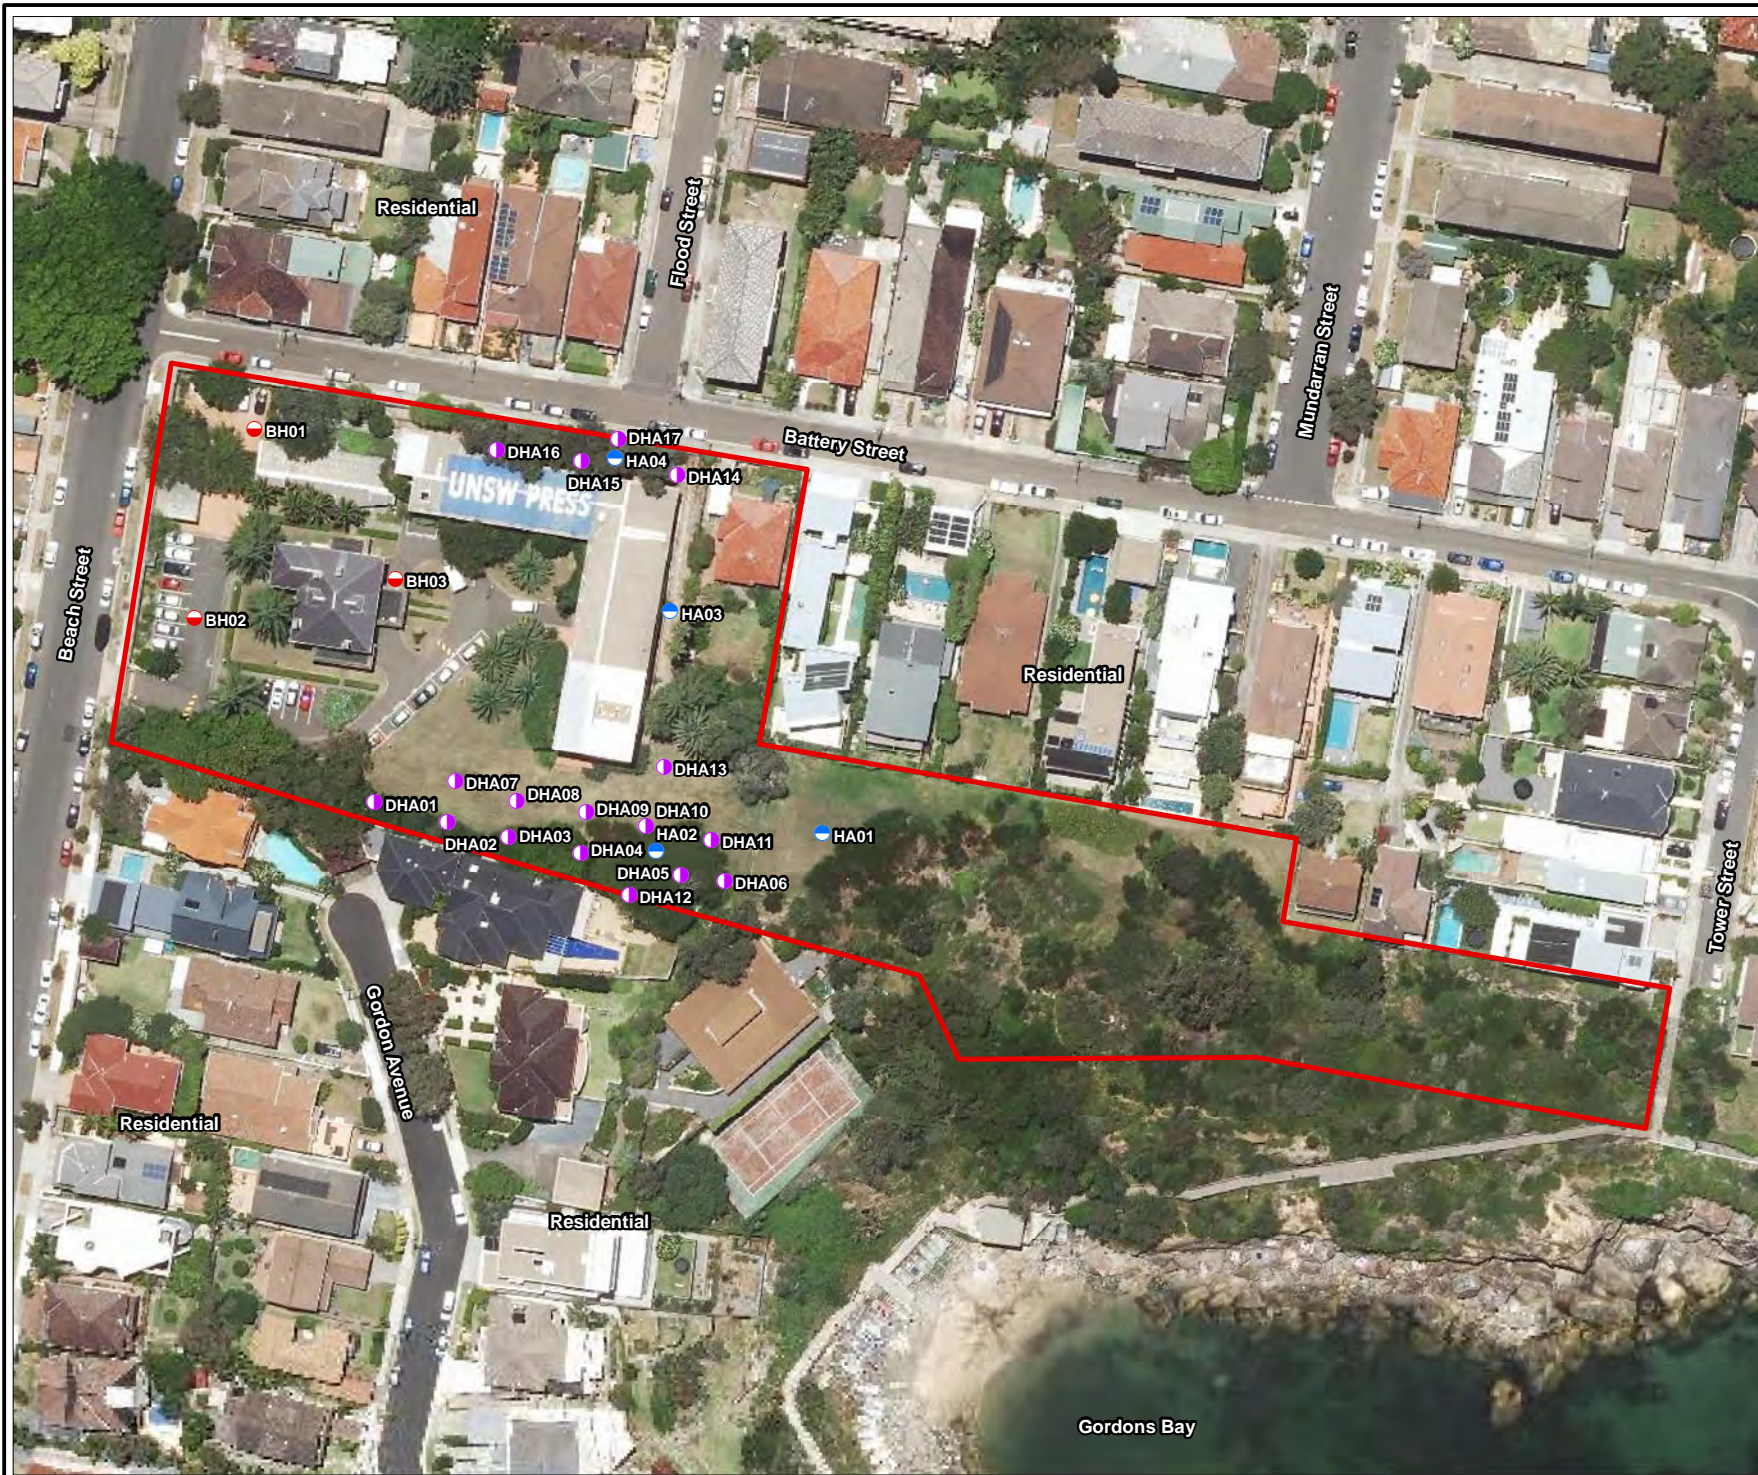
FIGURE 2

SAMPLE LOCATIONS

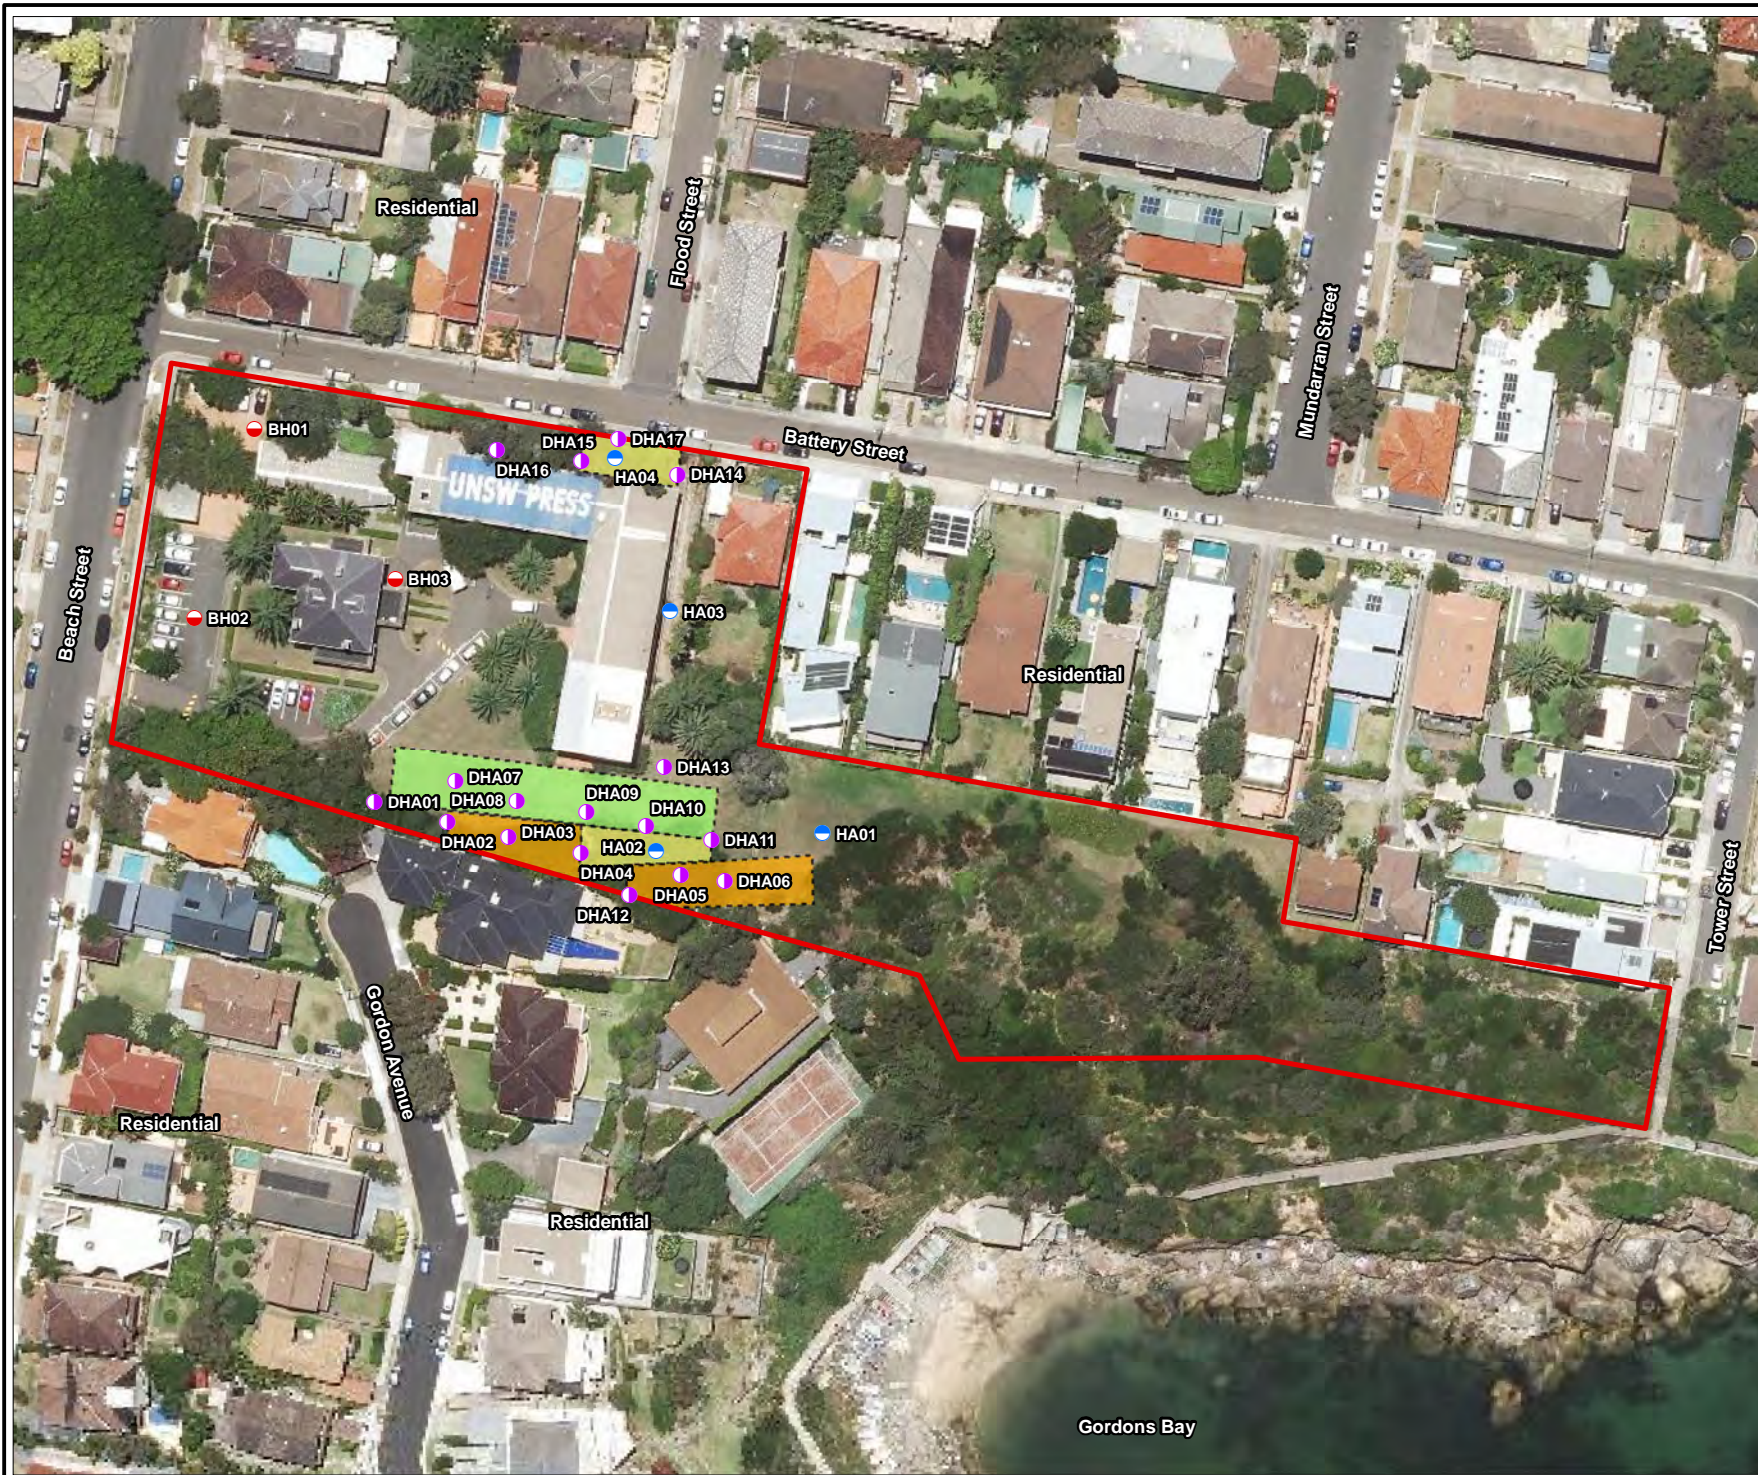
- Legend:**
- Approximate Site Boundary
 - Soil with ACM Below HILC Criteria
 - Soil with AF and ACM Below HILC Criteria
 - Soil with AF and ACM Above HILC Criteria
 - Hand Auger Location
 - Previous Borehole Location
 - Previous Hand Auger Location

- The asbestos removal works shall be conducted by a Class A Licensed Asbestos Removalist.
- Excavation of impacted fill material and impacted natural soils within the area delineated on Figure 3, to be guided by the Environmental Consultant.
- Disposal of the material to an appropriately licensed waste facility with appropriate waste classification documentation.
- Remediated areas are to be validated as per **Section 6**. Should validation fail, excavation shall continue within the failed location and the validation process repeated until validation is achieved.
- Reinstatement of the excavations with approved soils.
