# Appraisal

## History

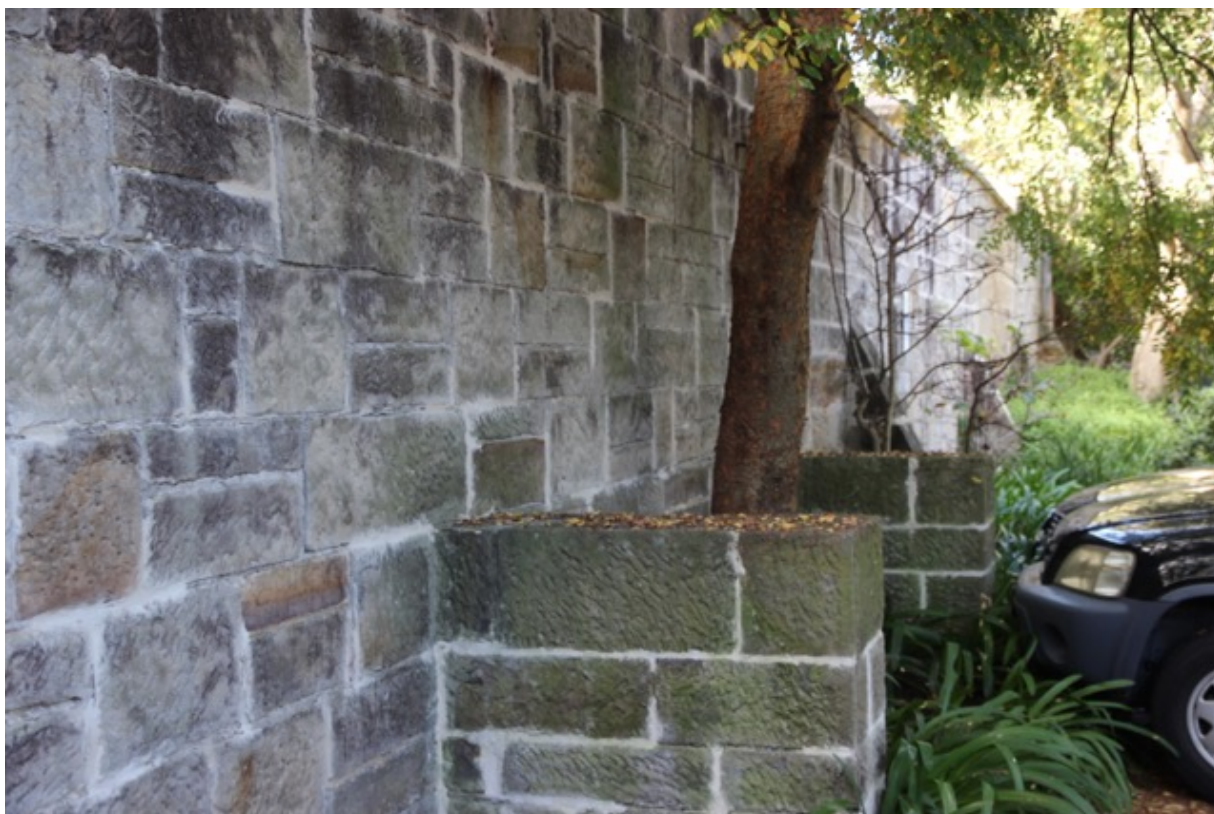
View E - Dan Tuck 2016

Figure 57: CliffBrook Campus (northern boundary wall buttressing)

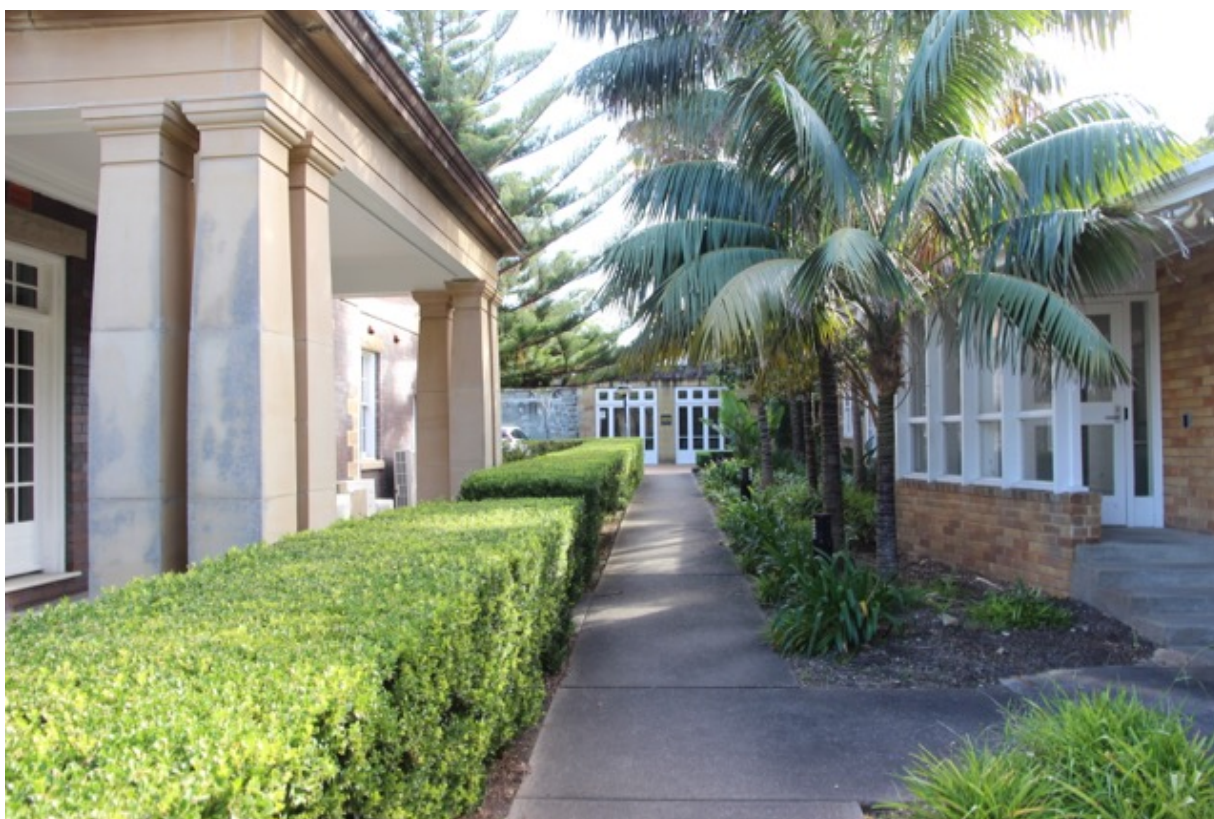
View W - Dan Tuck 2016

Figure 60: CliffBrook (pathway between northern facade & CC2 brick building with CC3 garage at rear)

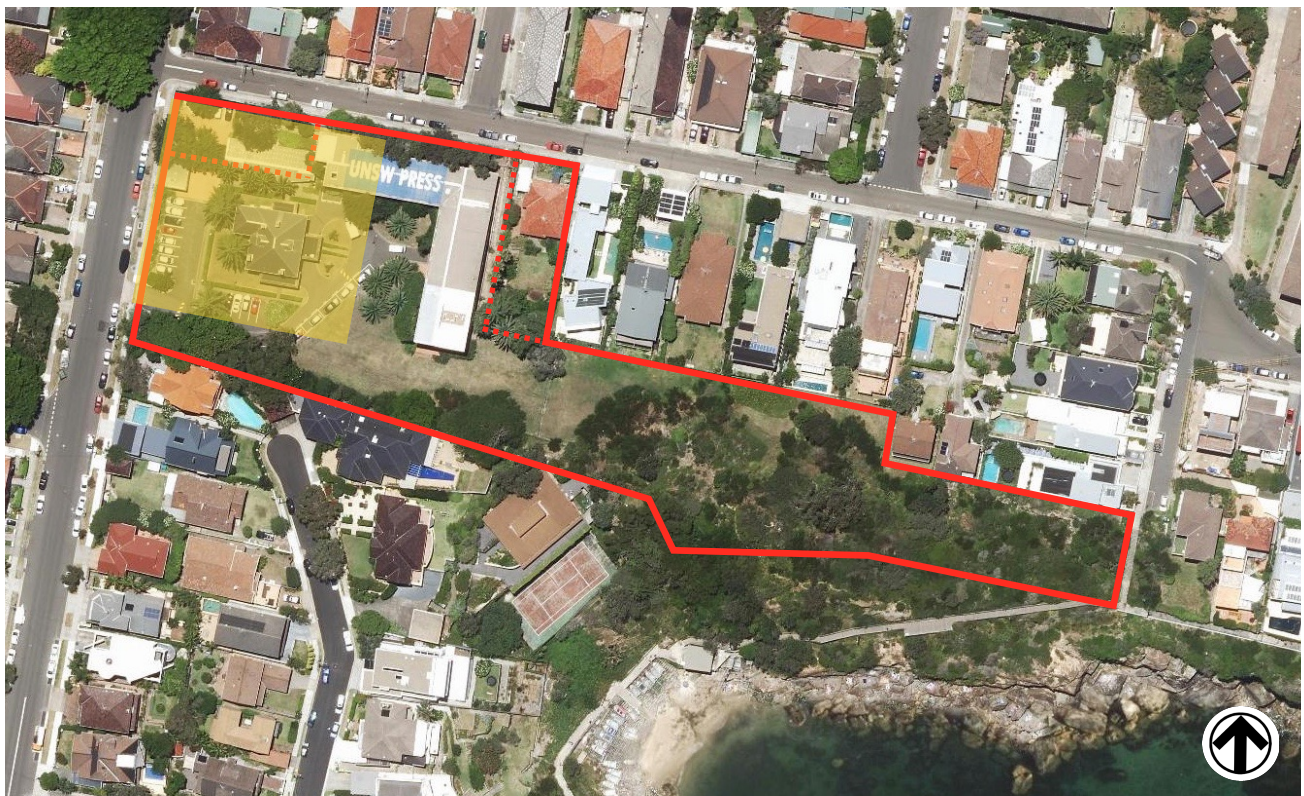
Google Earth Pro 2016

Figure 69: Archaeological Sensitivity Plan

The yellow shading indicates the assessed area of historical archaeological sensitivity

- The locality of the former outbuilding complex has historical archaeological significance, potential and sensitivity - though the nature, extent and integrity of the sub-surface archaeological resource cannot be adequately determined at this stage without investigation. At present the location is variously covered by extant structures, bitumen and brick pavement, and gardens.

Refer **figures 68 & 69**.
