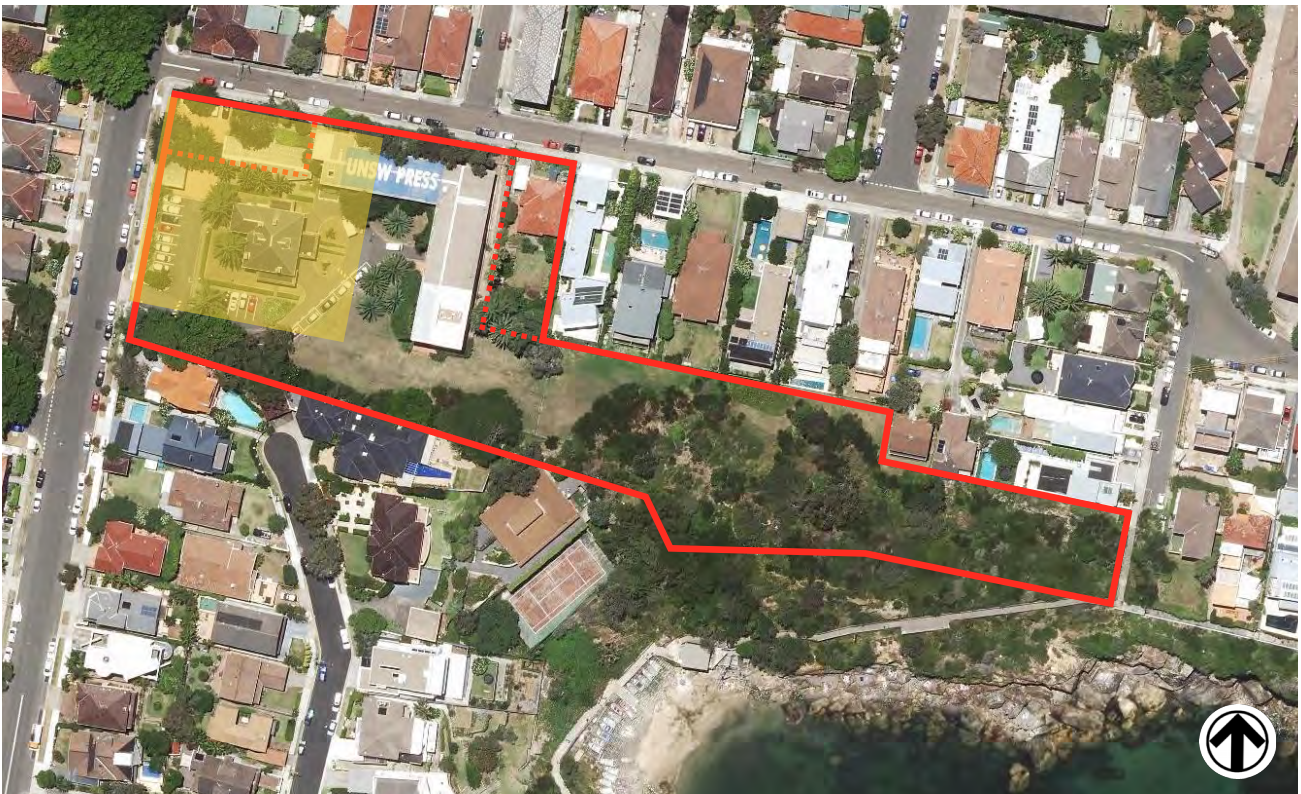
Figure 69: Archaeological Sensitivity Plan

The yellow shading indicates the assessed area of historical archaeological sensitivity (the location of the former outbuildings complex)

- The locality of the former outbuilding complex has historical archaeological significance, potential and sensitivity - though the nature, extent and integrity of the sub-surface archaeological resource cannot be adequately determined at this stage without investigation. At present the location is variously covered by extant structures, bitumen and brick pavement, and gardens.

- Testing will likely be necessary to further assess the historical archaeological sensitivity of this location and to inform detailed campus redevelopment planning (including the provision of inground services, hardscaping and landscaping).

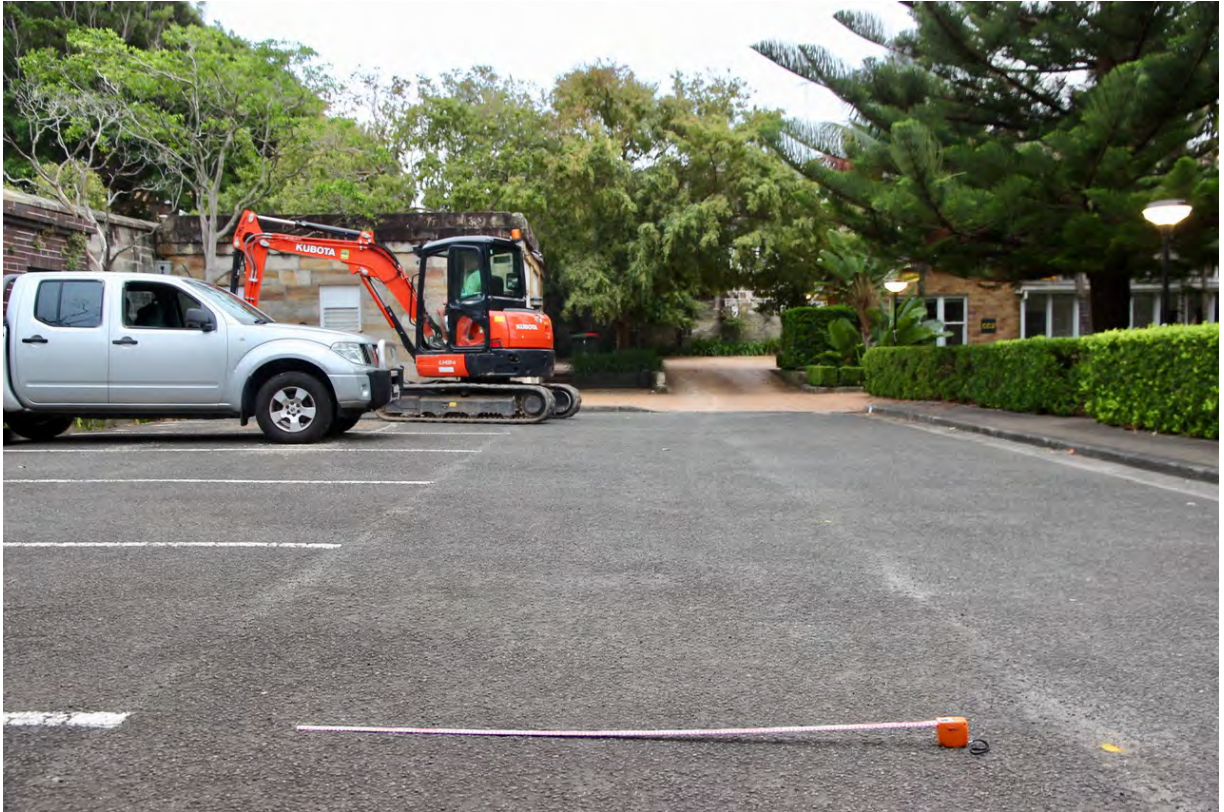
Figure 81: TT 2 - Prior to excavation

The location was found to have been significantly raised to acquire the current ground level via the introduction of various fill materials. The ubiquitous surface bitumen (50 mm thick) was set on set on hard blue metal/road base (up to 200 mm). This in turn overlaid crushed clayey-sandstone levelling fill (250 - 400 mm thick) over introduced sandy brown loam containing fragments of dry-pressed brick, asbestos, ceramic tile and tin (200 - 300 mm thick). Beneath this layer of imported material, at around 800 mm below ground level, was truncated, undulating black loamy-sand (remnant A1-horizon) over mottled, medium-grey sand (remnant A2-horizon). The latter graded into a lighter coloured, charcoal flecked sand interface with the massive, bleached local sand sheet immediately below. Excavation ceased where the sand was clearly natural, at around 900 mm below ground level, excepting where discussed below.

Current architectural design drawings indicate that a new electrical substation, pathways and a ramp are to be constructed in this area. Excavations for footings and/or associated inground services that are greater than 900 mm below existing GL will warrant historical archaeological monitoring.

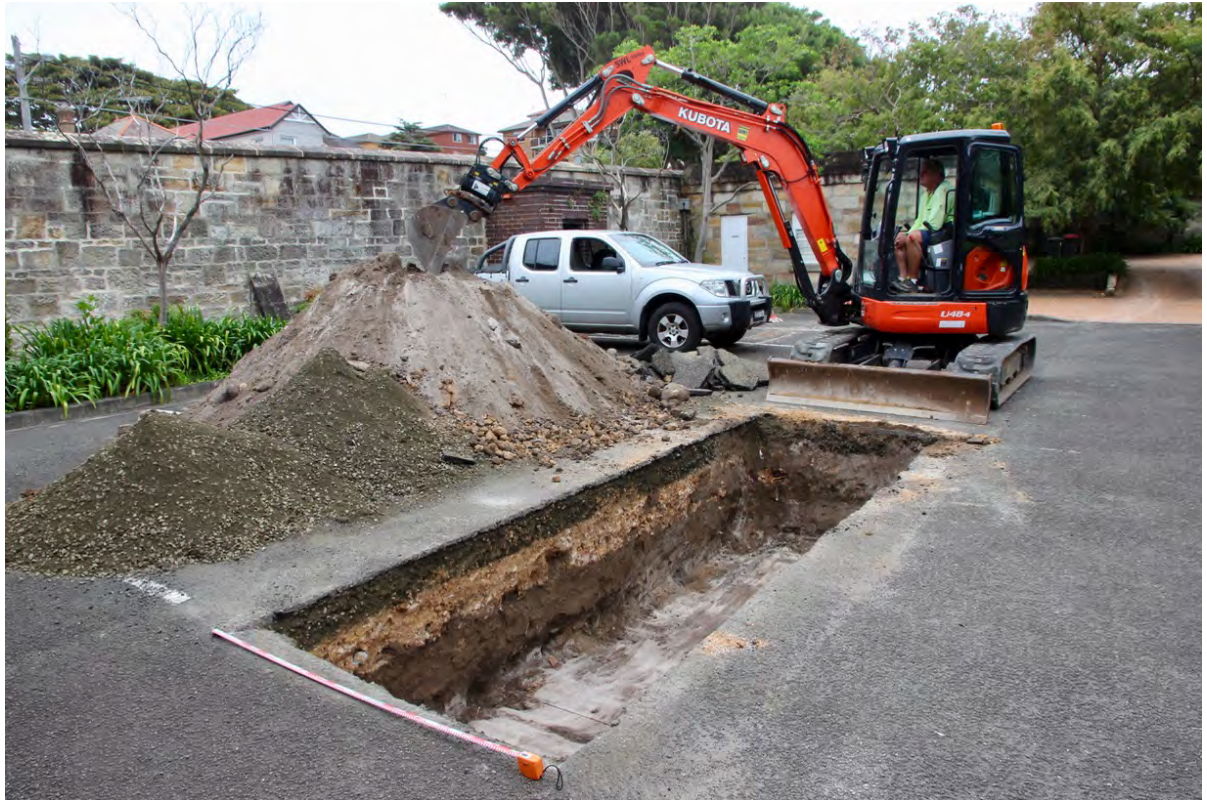
Figure 85: TT2 - Excavation at completion

Summary: Excavations revealed multiple units of levelling fill overlaying natural sands at a depth of around 900 mm below GL. There was no evidence of prior structures in this location, which has clearly been heavily modified in the distant and more recent past by service installation and infilling.

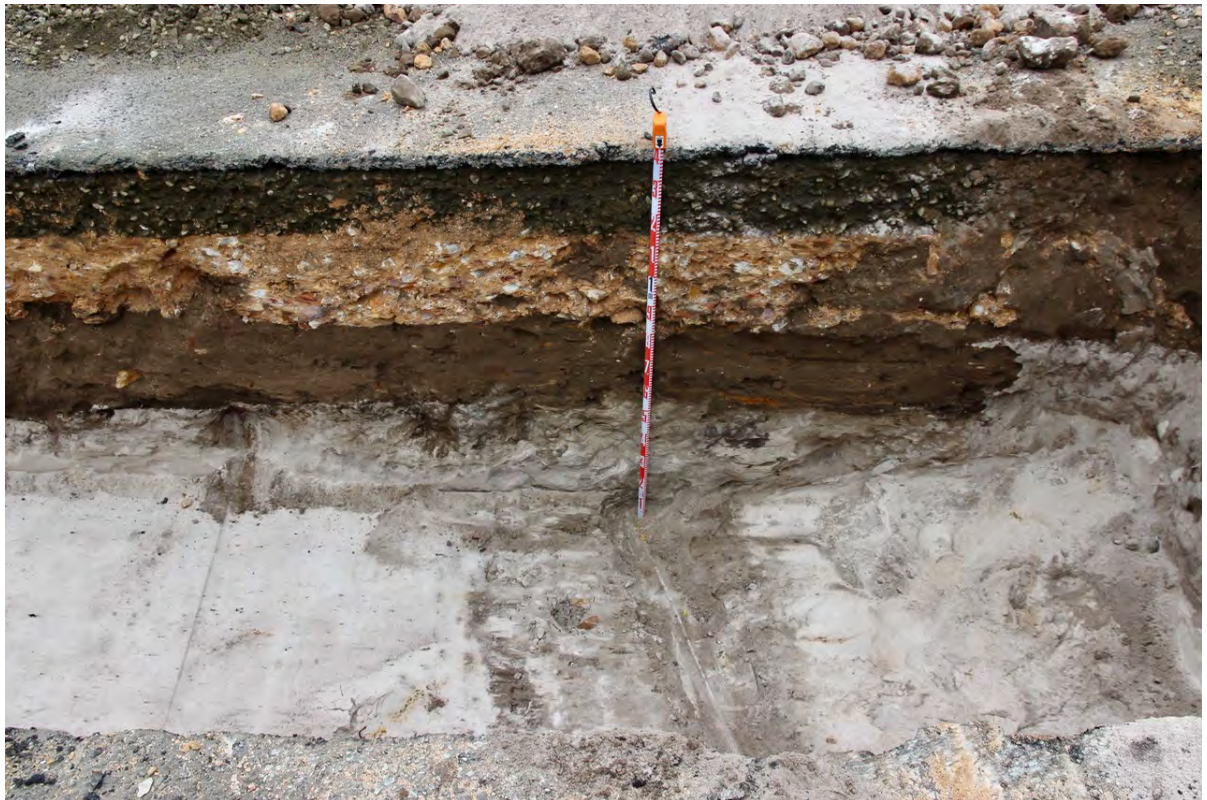
Figure 86: TT2 - West section over gas pipe trench

The trench was unfortunately devoid of features of particular historic interest, but did contain a copper **gas pipe** set within a sand filled trench at depth below the above discussed levelling fills. The trench cut was oriented WSW to ENE at the northern end of the trench and was 500 mm wide. It was visible from about 800 mm below GL, with very fragmented yellow service warning tape evident in the trench fill from 1000 mm below GL. The pipe itself was 1" (30 mm) copper main pipe, which was encountered within the service trench at a depth of 1400 mm.

Current architectural design drawings indicate that a new electrical substation, pathways and a ramp are to be constructed in the location of the former gatehouse. Though no evidence of this building was unearthed during the excavation of TT2, all excavations for footings and/or associated inground services *that are greater than 900 mm below existing ground level* will require historical archaeological monitoring as a precautionary measure.

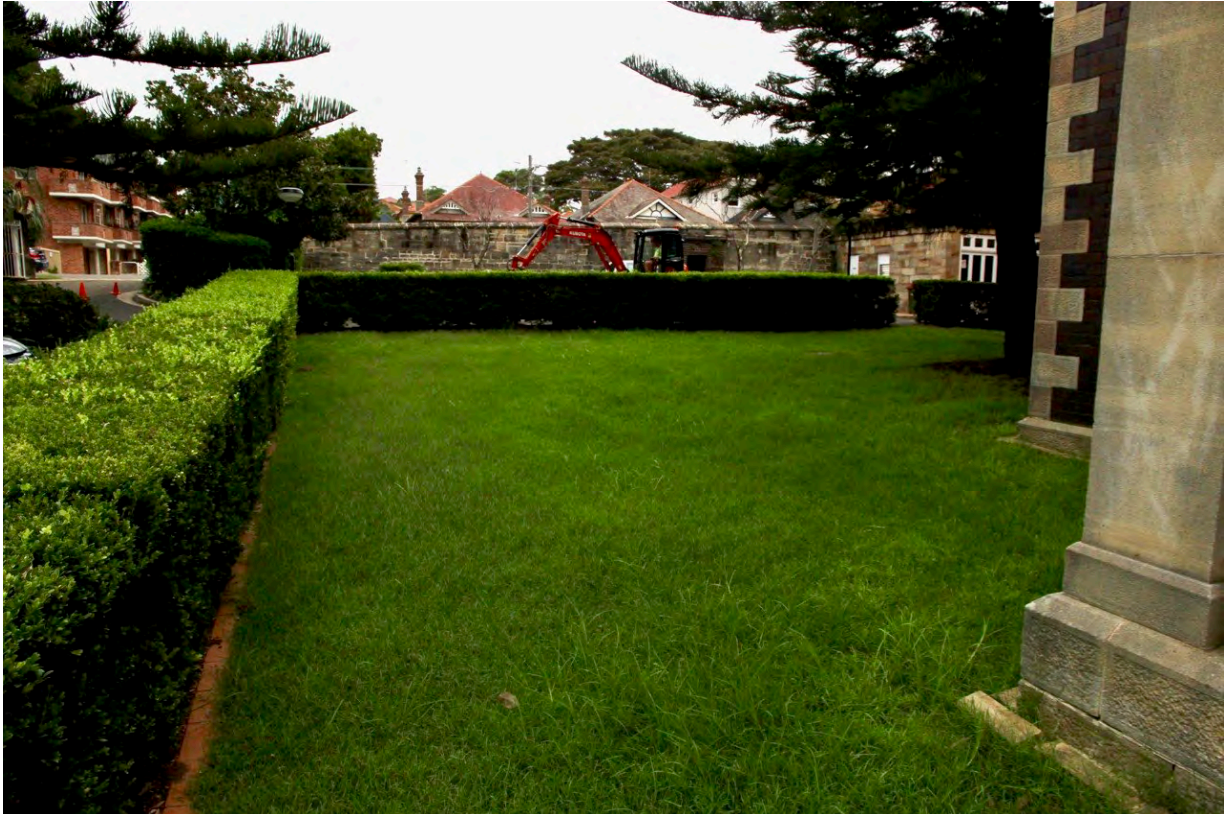
Figure 90: TT3 - Prior to excavation

Removal of the immediate grass cover (lawn) revealed 100 - 200 mm of black-brown, sandy loam (modern A-horizon topsoil). Below this, was a 150 - 200 mm layer of compacted, crushed clayey-sandstone. One fragment of dry-pressed liver brick - consistent with the brickwork evident in the external walls of the extant Cliffbrook - was observed within this unit. This perhaps suggests that the unit constitutes a construction deposit associated with the erection of the extant mansion in the 1920s. Natural sandy soils were evident thereafter from around 300 mm below GL and comprised dark grey, modified loamy sand (disturbed A1-horizon) over light grey sand (A2-horizon) at the base of excavation (500 mm below GL).

No notable archaeological features or deposits associated with the gatehouse-stables complex were observed.

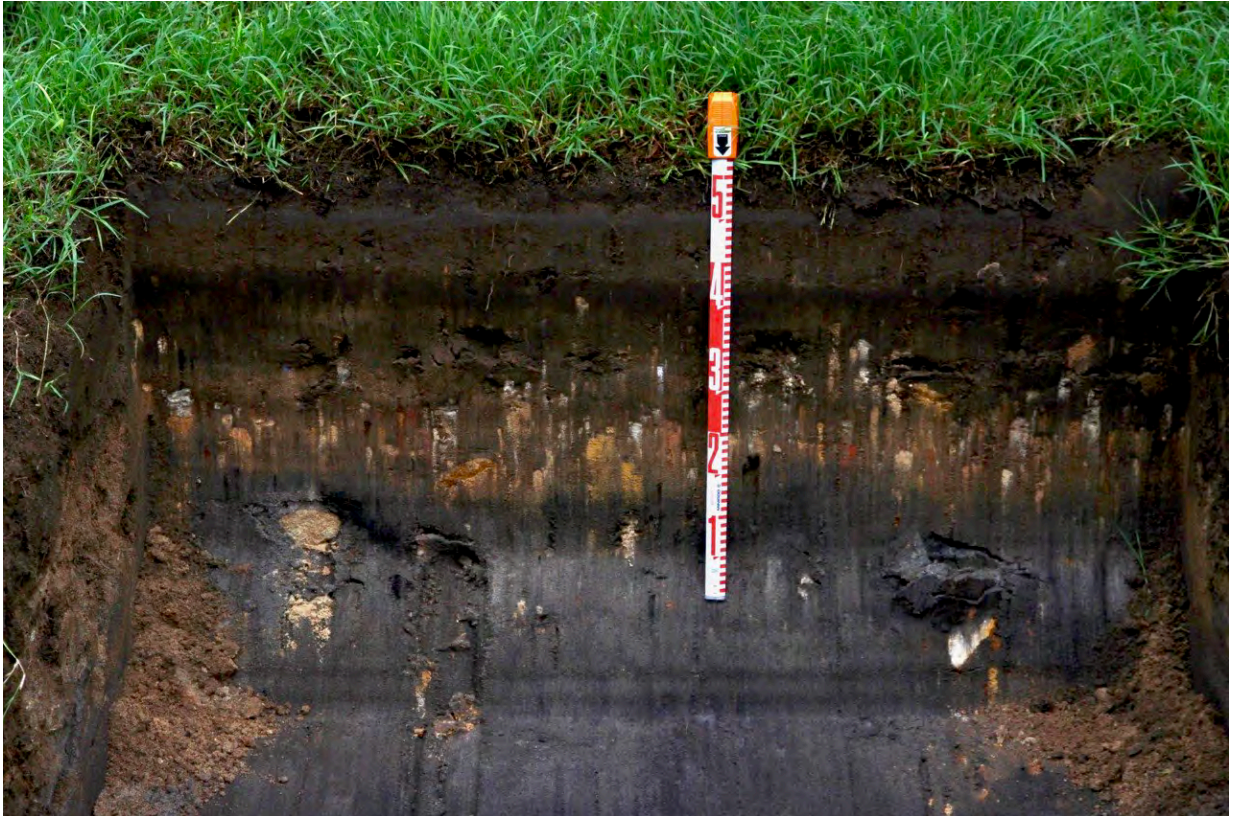
Figure 92: TT3 - South section (with remnant A1-horizon sands exposed at base of trench)

Summary: Excavations revealed some minor deposit of crushed sandstone that may be related to construction of Cliffbrook mansion. Natural sandy soils were evident from around 300 mm below GL.

Landscaping and tree management plans suggest that there is to be minor landscaping only in this general area. Future historical archaeological oversight unlikely to be required unless unexpected finds encountered.

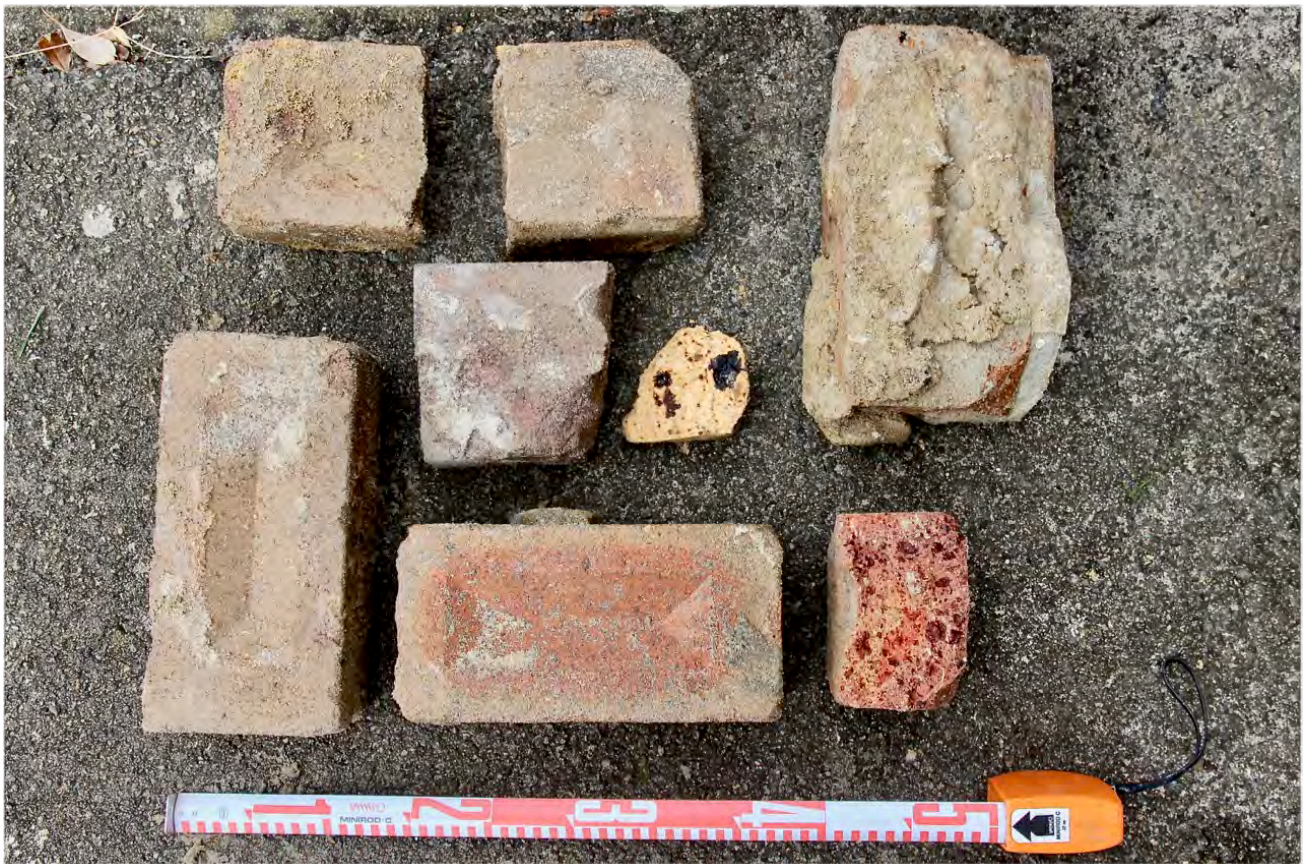
- an upper **construction deposit** associated with the construction of Cliffbrook (as denoted by fragments of roof tile and early twentieth century liver brick)
- a lower **demolition deposit** associated with deconstruction of the prior gatehouse-stables complex structure in the locality (as denoted by fragments of mid-late nineteenth century sandstock brick).

TT4: Bricks and brick fragments from demolition & construction deposit (including liver, near modern dry-pressed & sandstock bricks)

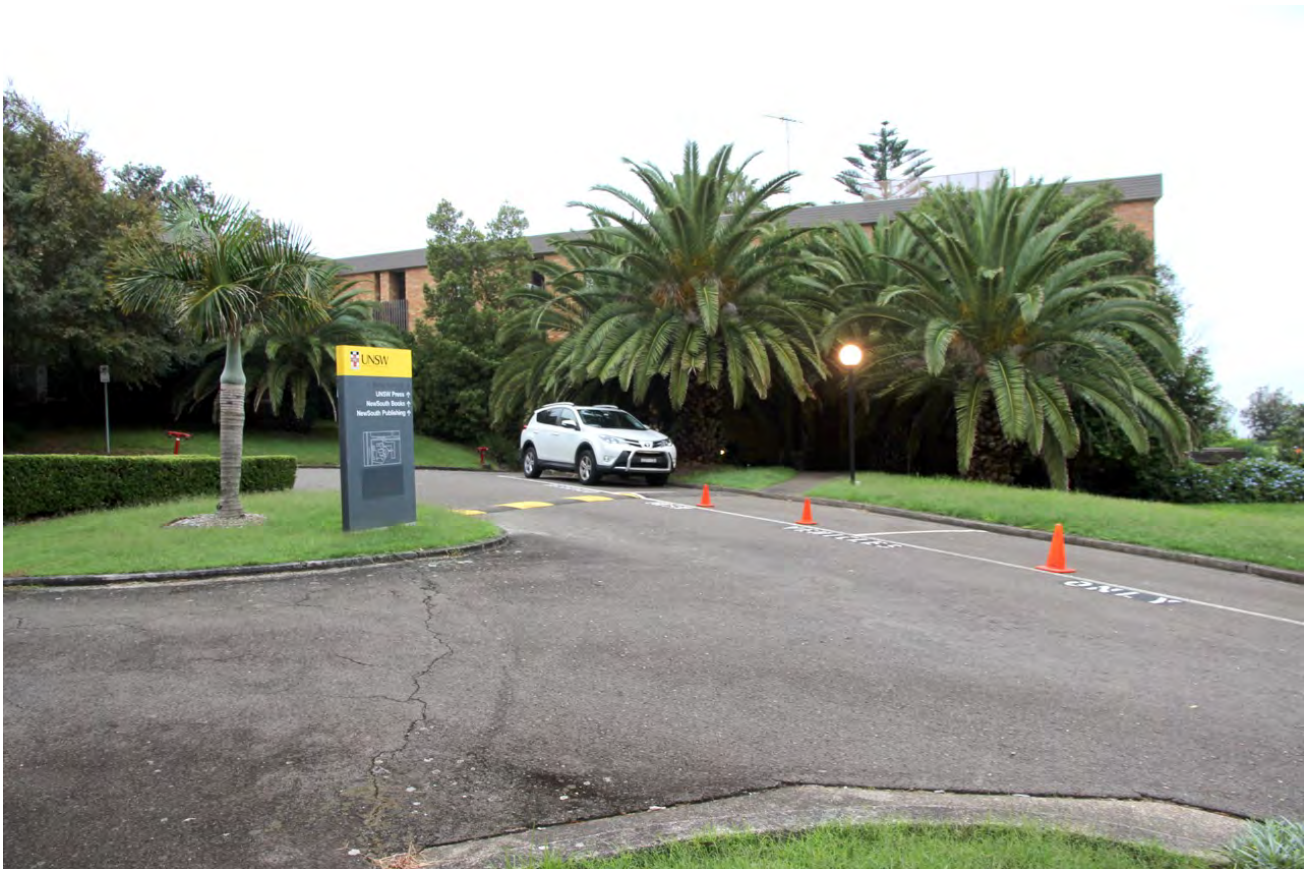
Figure 96: TT4 - Prior to excavation

Removal of the bitumen road surface (50 mm thick) revealed a compacted layer of road base/blue metal (200-250 mm thick). Below this was a thick deposit of sandstone and concrete fragments, gritty sand and occasional pieces of broken brick (400 - 600 mm thick). This unit featured concrete, sandstone blocks/fragments and pieces of dry-pressed in the upper part and sand, sandstone fragments and pieces of sandstock brick in the lower. In section, the deposit appeared to be a compressed admixture of two distinct sequential layers:

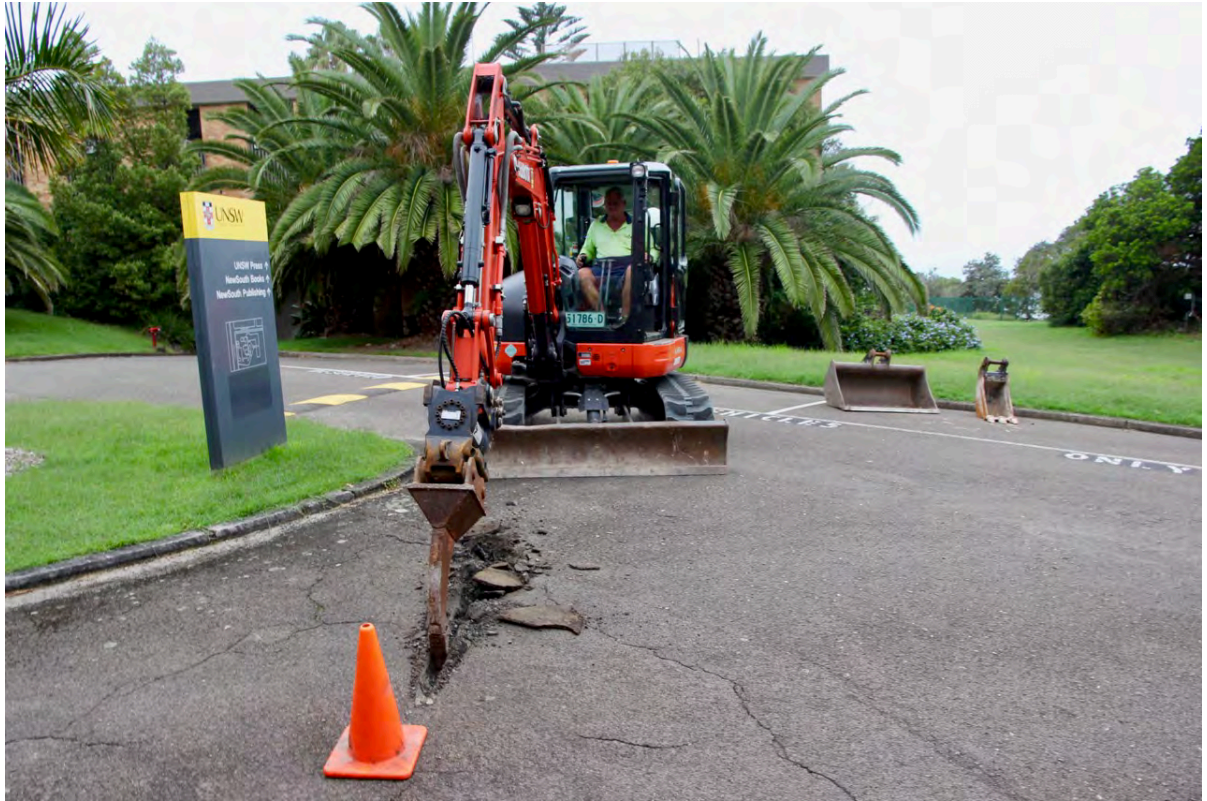
Figure 97: TT4 - Cutting surface bitumen

The trench was spray marked and the surface bitumen cut and removed. Machine excavation continued until substantial in situ sandstone foundations were encountered. Cleaning and recording occurred thereafter, with the trench backfilled and made safe on completion.

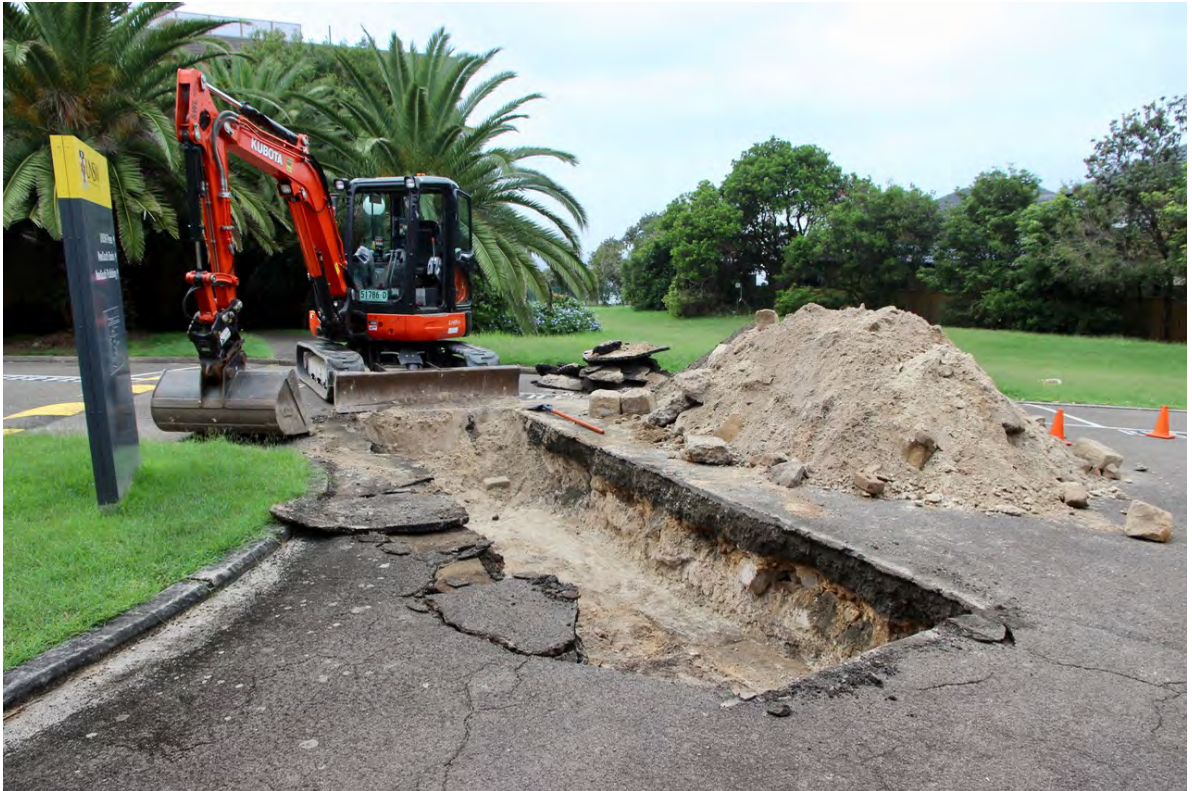
Figure 99: TT4 - Removal of construction & demolition deposit (with in situ footings exposed at base)

This combined deposit appears to have been compressed (and possibly rolled) to aid in the build up and creation of the existing roadway, with its natural fall to the south and east away from the Cliffbrook mansion. Below this demolition deposit, at a depth of 800 mm below GL, in situ footing material was encountered (see below).

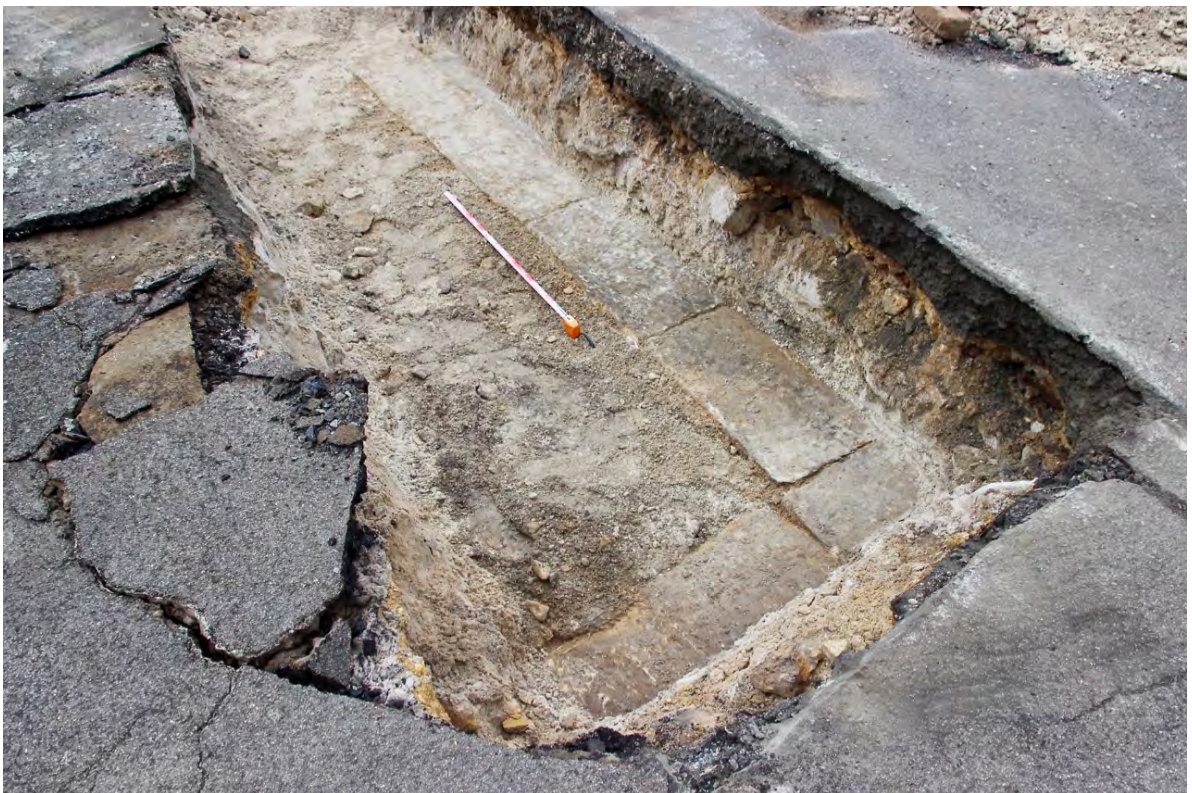
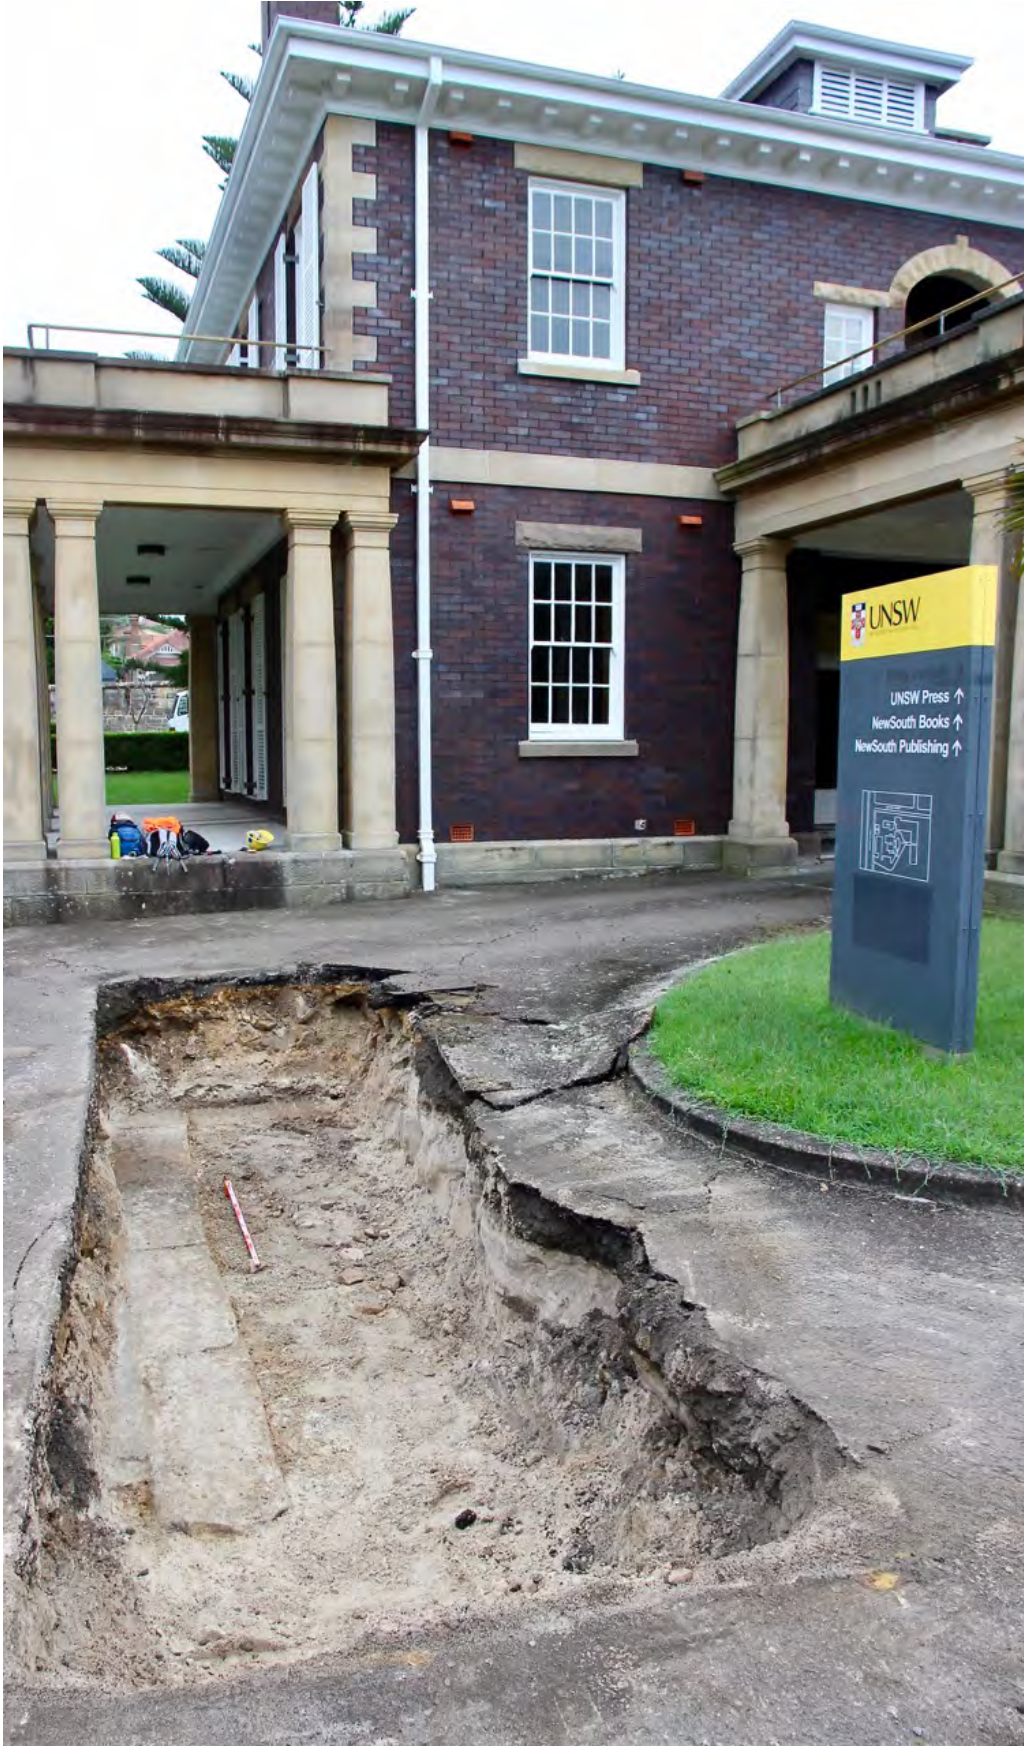
Figure 100: TT4 - In situ sandstone footings at base of trench

Sandstone foundations were encountered at a depth of 800 mm below GL. These comprised an east-west alignment of well-cut and finished, unbonded sandstone blocks (450 mm wide) with associated stonework running north-south at the base of the western trench section. North of the former, and within the angle of the footings, was more demolition rubble, while to the south of the east-west footing a **hard floor surface** (likely smoothed cement) was observable at the base of the southern trench section. The depth of the latter, relative to current ground levels, suggest that it may be a cellar floor though this cannot be stated conclusively. The

Summary: TT4 provided clear evidence of the remnants of the former Cliffbrook outbuildings complex structure that formerly occupied the locale. This comprised in situ nineteenth century stonework (neatly worked sandstone footings) and an associated cement floor, at 800 mm below GL. Immediately above the footings, demolition material was observed, over which construction deposit (associated with the erection of the extant Cliffbrook mansion and more recent buildings) was superimposed.

Redevelopment design drawings indicate that this location is relatively close to the approach ramp for the proposed underground carpark. Earthworks in this general area that extend more than 650 mm below ground level will need to be subject to archaeological monitoring (with salvage if required).

Bulk excavation for the underground carpark approach ramp should be subject to historical archaeological monitoring, with recording of Cliffbrook outbuildings archaeology should it be exposed.

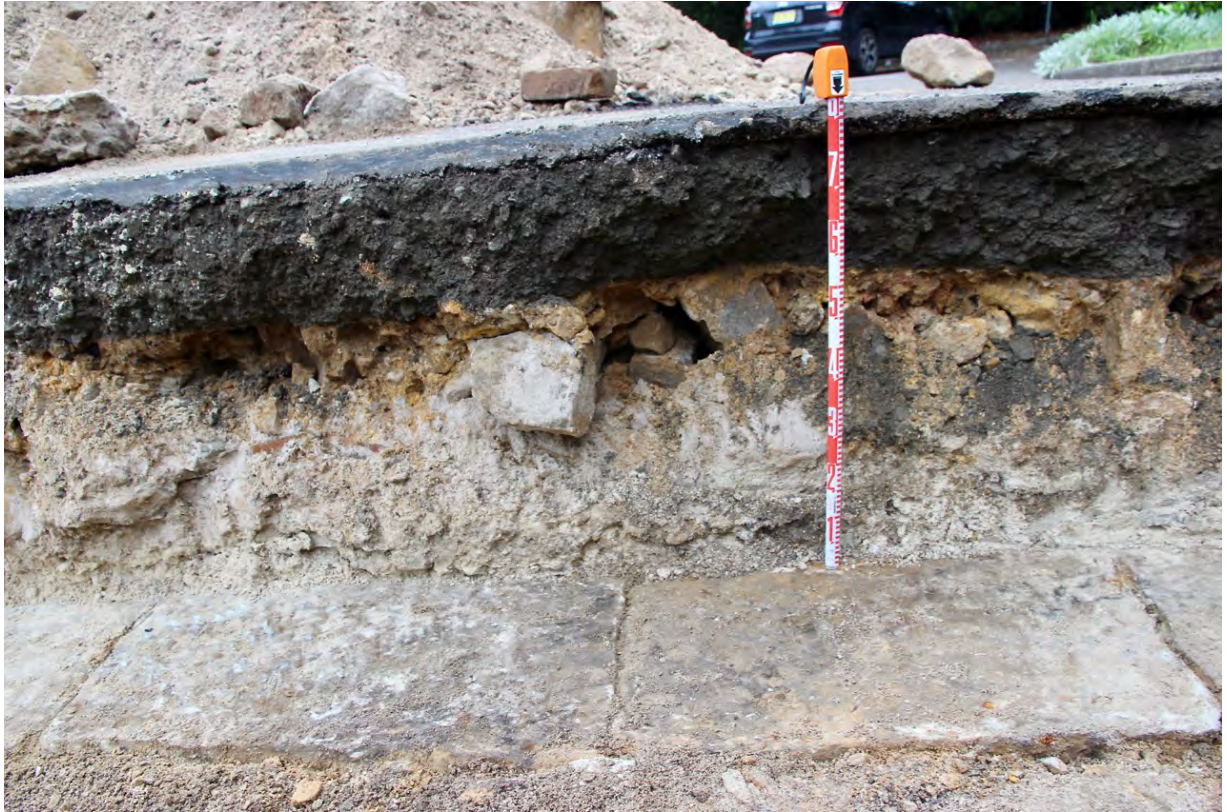
Figure 102: TT4 - Partial south section

Both the demolition-construction deposit and the stone footings below were cut at the western end but a near-modern pit, which contained sand, sandstone and fragments of dry-pressed brick (comparable with those used in the mid-late twentieth century CC4 building to the immediate east).
