**GEOTECHNICAL AND ACID SULFATE SOILS REPORT
FOR
85-91 THOMAS STREET, PARRAMATTA NSW**

Reference: P2079_ 03

2 July 2025

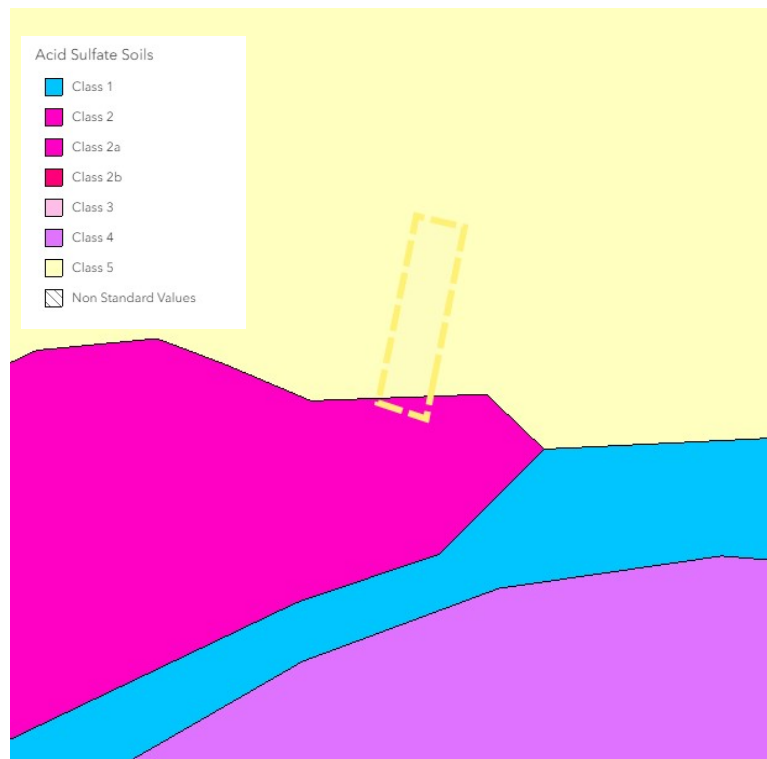
Figure 1: Screenshot from www.planningportal.nsw.gov.au showing Class 5 & 2 ASS at the site location.

The Acid Sulfate Soil Risk Map of Parramatta Local Environmental Plan 2011 indicates that the site overlies the boundary between mapped Class 5 and Class 2 Acid Sulfate Soil areas, shown in **Figure 1** below.

- The Acid Sulfate Soil Risk Map of Parramatta Council area indicates that the site is in a Class 2 Acid Sulfate Soil area. In accordance with Section 6.1 of the Parramatta Local Environmental Plan 2011, development consent for Class 2 sites is required for:
 - Works below the natural ground surface.

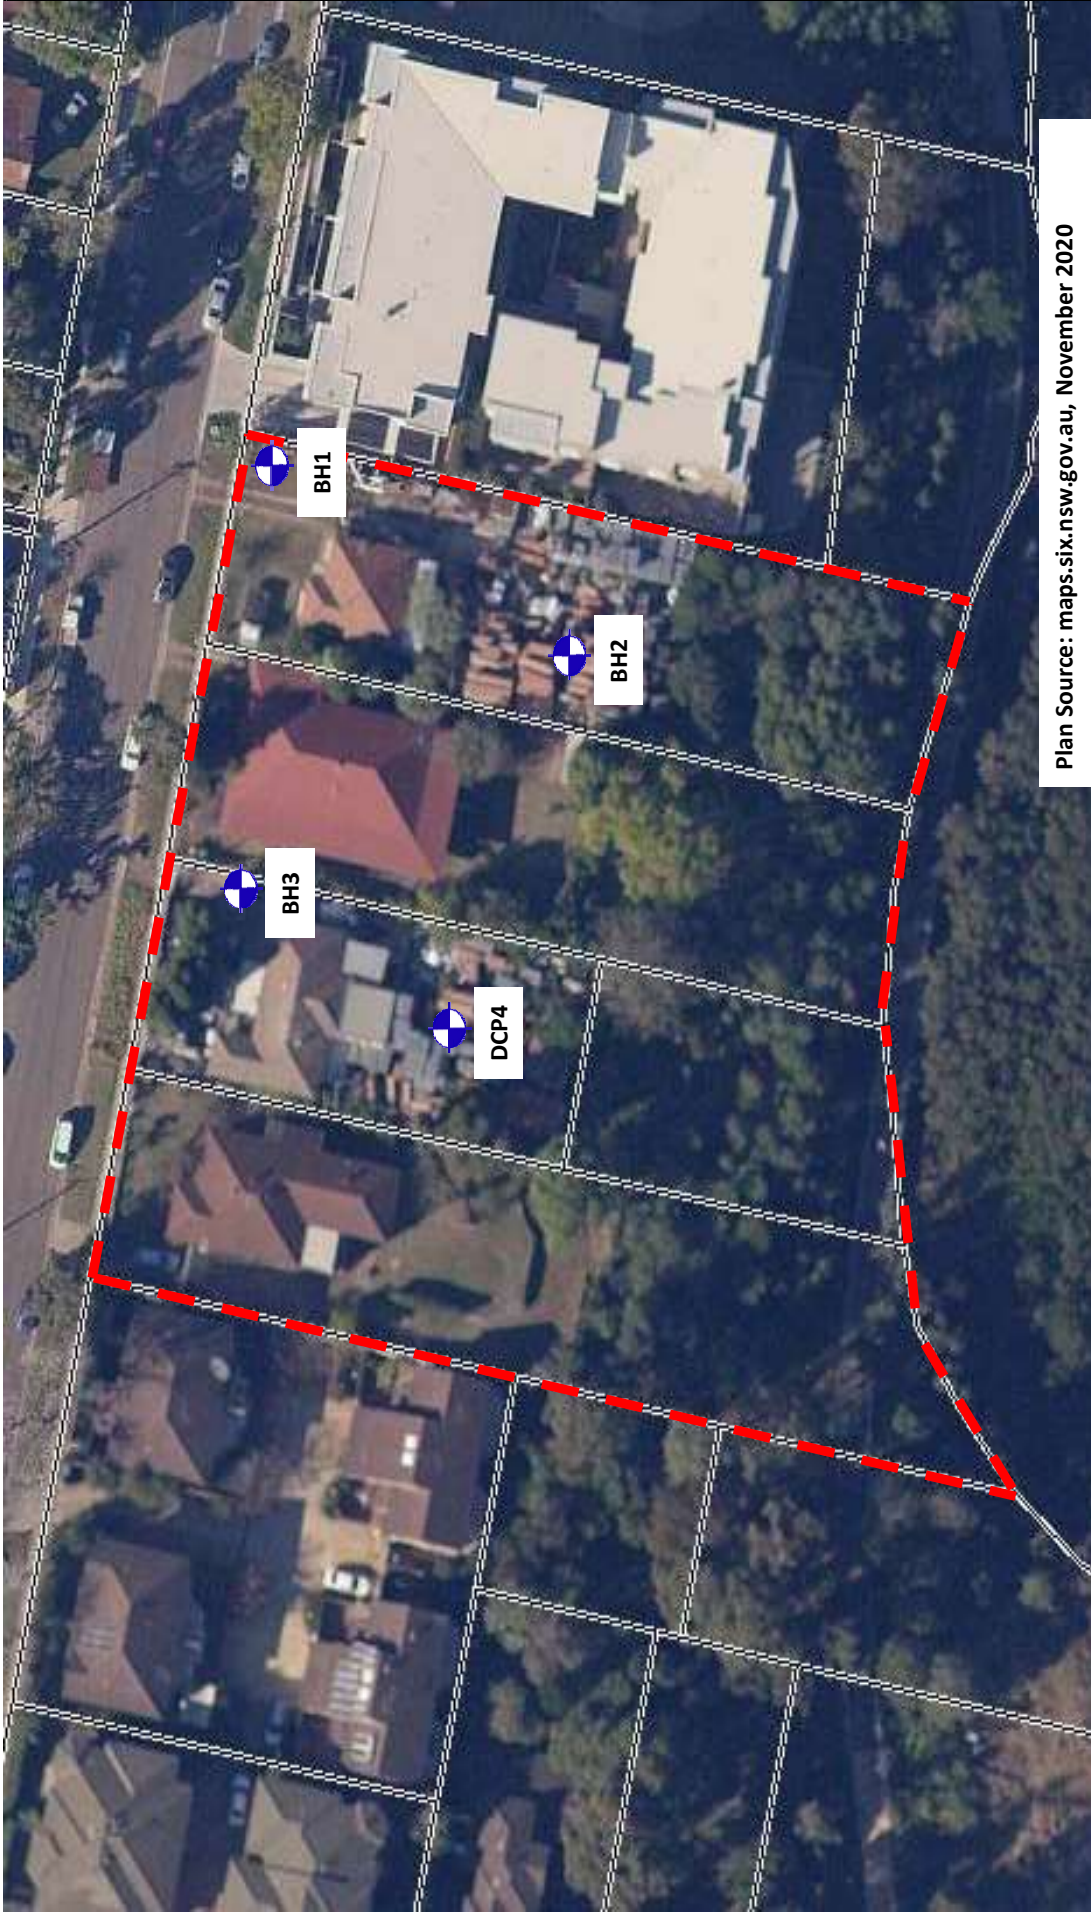
PO Box 4069, Carlton NSW 2218 P: 0405 843 933 E: info@morrowgeo.com.au		Drawn	JB
		Approved	AM
Date	30/11/2020		
Scale	NTS		
Century 888 Pty Ltd 85-91 Thomas Street, Parramatta NSW Geotechnical Investigation Borehole Location Plan		Figure: 1	
		Project: P2079

- Dial Before You Dig (DBYD) services search of proposed borehole locations;
- Drilling of three boreholes (BH1 to BH3) by a track mounted drill rig using solid flight augers equipped with a tungsten-carbide bit (TC bit). The boreholes were extended beyond TC bit refusal by NMLC coring techniques to depths of 10.17, 9.85 and 10.27 m below ground level (mBGL) respectively. Rock core was boxed and photographed and point load tests were undertaken on selected core sample to assess rock strength. Due to restricted access to the rear of one of the lots, one DCP (DCP4) was carried out to assess soil density/consistency and infer top of rock. Borehole and DCP locations are shown on **Figure 1** and borehole logs are presented in **Appendix A**;

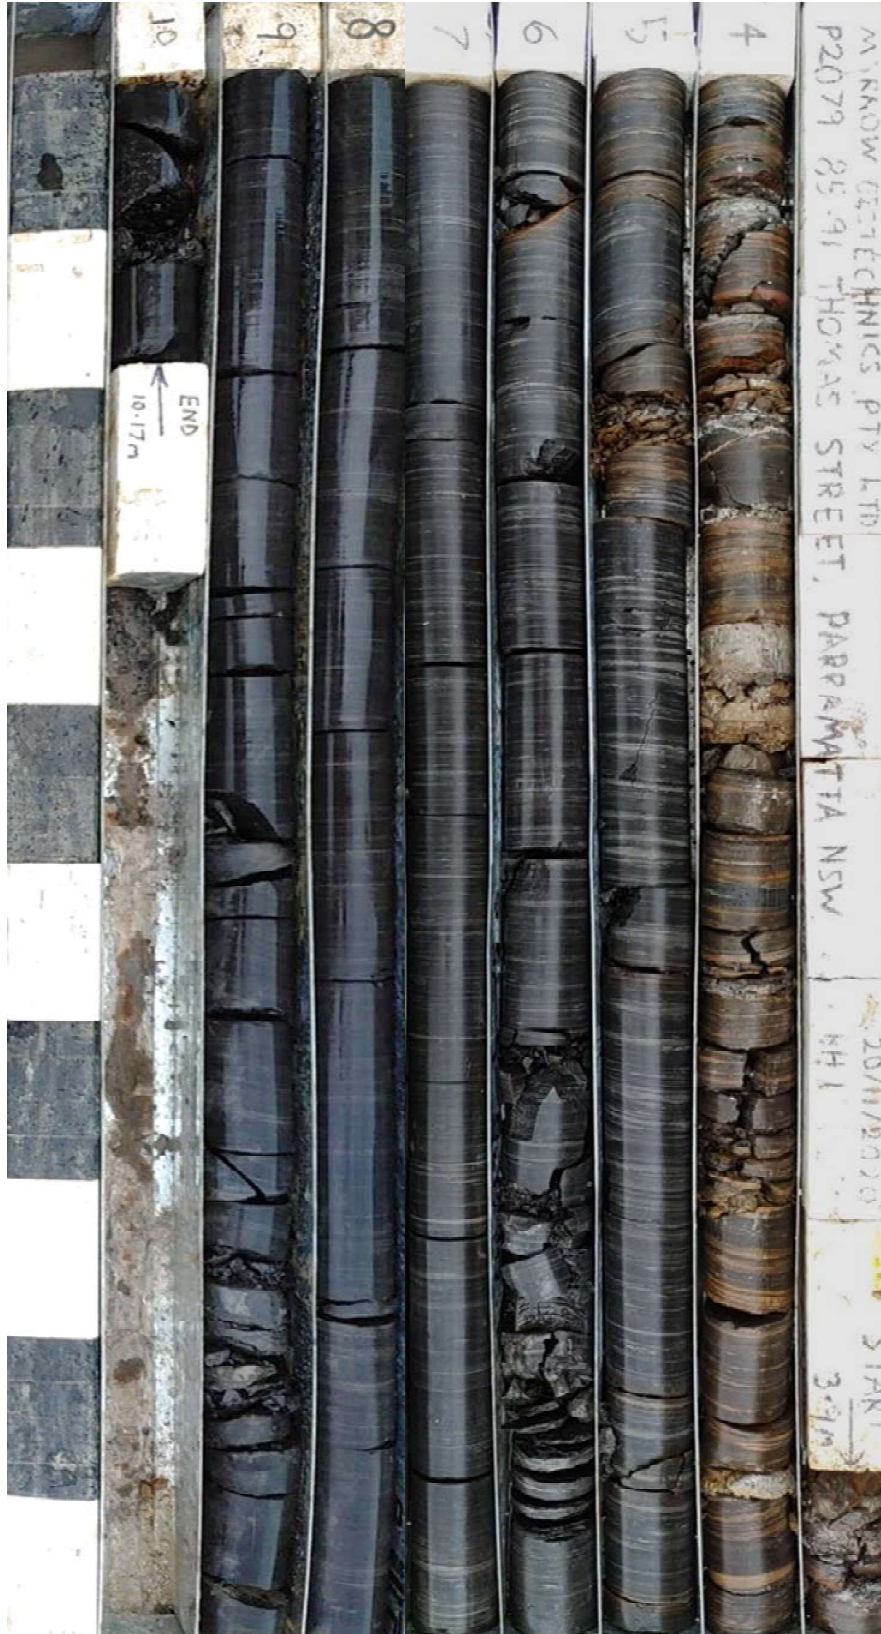
Drilling Method	Resistance	Water	Sampling	USCS	Depth	Stratigraphy	Consistency/Density	Moisture	Additional Observations
SFA	L	GWNE	DS1-1 0.1-0.3 m	CI-CH	0.5	Silty CLAY, medium to high plasticity, red-brown - becoming orange-brown from 0.7 m	VSt	D	RESIDUAL SOIL
			SPT1-2 0.5-0.95 m 4, 4, 9 N=13 DS1-3 0.9-1.0 m		1.0				
	L-M		SPT1-4 1.5-1.95 m 6, 8, 9 N=17		1.5	SHALE, pale grey / orange-brown, extremely weathered, inferred extremely low strength			WEATHERED ROCK
					2.0				
					2.5				
					3.0				
					3.5	SHALE, brown, ironstone bands, distinctly weathered, inferred very low strength			
					4.0	Start Coring at 3.9 m			
					4.5				
					5.0				
					5.5				
					6.0				
					6.5				
					7.0				
					7.5				
					8.0

Drilling Method	Water	TCR	RQD (SCR)	Rock Strength					Weathering	Depth	Stratigraphy	Defect Spacing	Defect Description	
				EL	V	L	M	H						V
NMLC	GWNO	AS ABOVE	AS ABOVE		FR		AS ABOVE, LAMINITE, SILTSTONE (80%), dark grey, and SANDSTONE (20%), fine grained, pale grey, 0-5° laminations at 1-3 mm spacing					10 100 1000 30 300	8.00, HB	8.15-8.87, DBx8, 105mm sp
		100%	50% (75%)				9.00, HB	9.05-9.26, DBx3, 105mm sp						
							End BH1 at 10.17 m Target Depth Reached					9.32-9.34, Bx2, 20°, Pl, Ro, Cn, 20mm sp	9.37, DB	
												9.45-9.50, J, 45°, Pl, Ro, Cn	9.50, DB	
												9.53, J, 5°, Pl, Ro, Cn	9.62, DB	
												9.68-9.72, J, 45°, Pl, Sl, Cn	9.68-9.72, DBx2, 40mm sp	
												9.72-9.85, Jx5, 5°, Pl, Ro, Cn, 30mm sp	9.86-9.96, DBx3, 50mm sp	
												10.00, HB	10.02-10.10, Jx2, 50°, Cv, Ro, Cn, 80mm sp	
												10.10-10.12, Sm, clay, 20mm thk

- BH1 – 6.6 to 6.8 mBGL, shear zone comprising orthogonal jointing and crushed rock.
- BH1 – 9.68 mBGL, 45° joint with slickensided, polished, surface.
- BH3 – 4.15 to 4.4 mBGL, shear zone comprising orthogonal jointing and crushed rock with slickensided surfaces on joints indicative of movement.

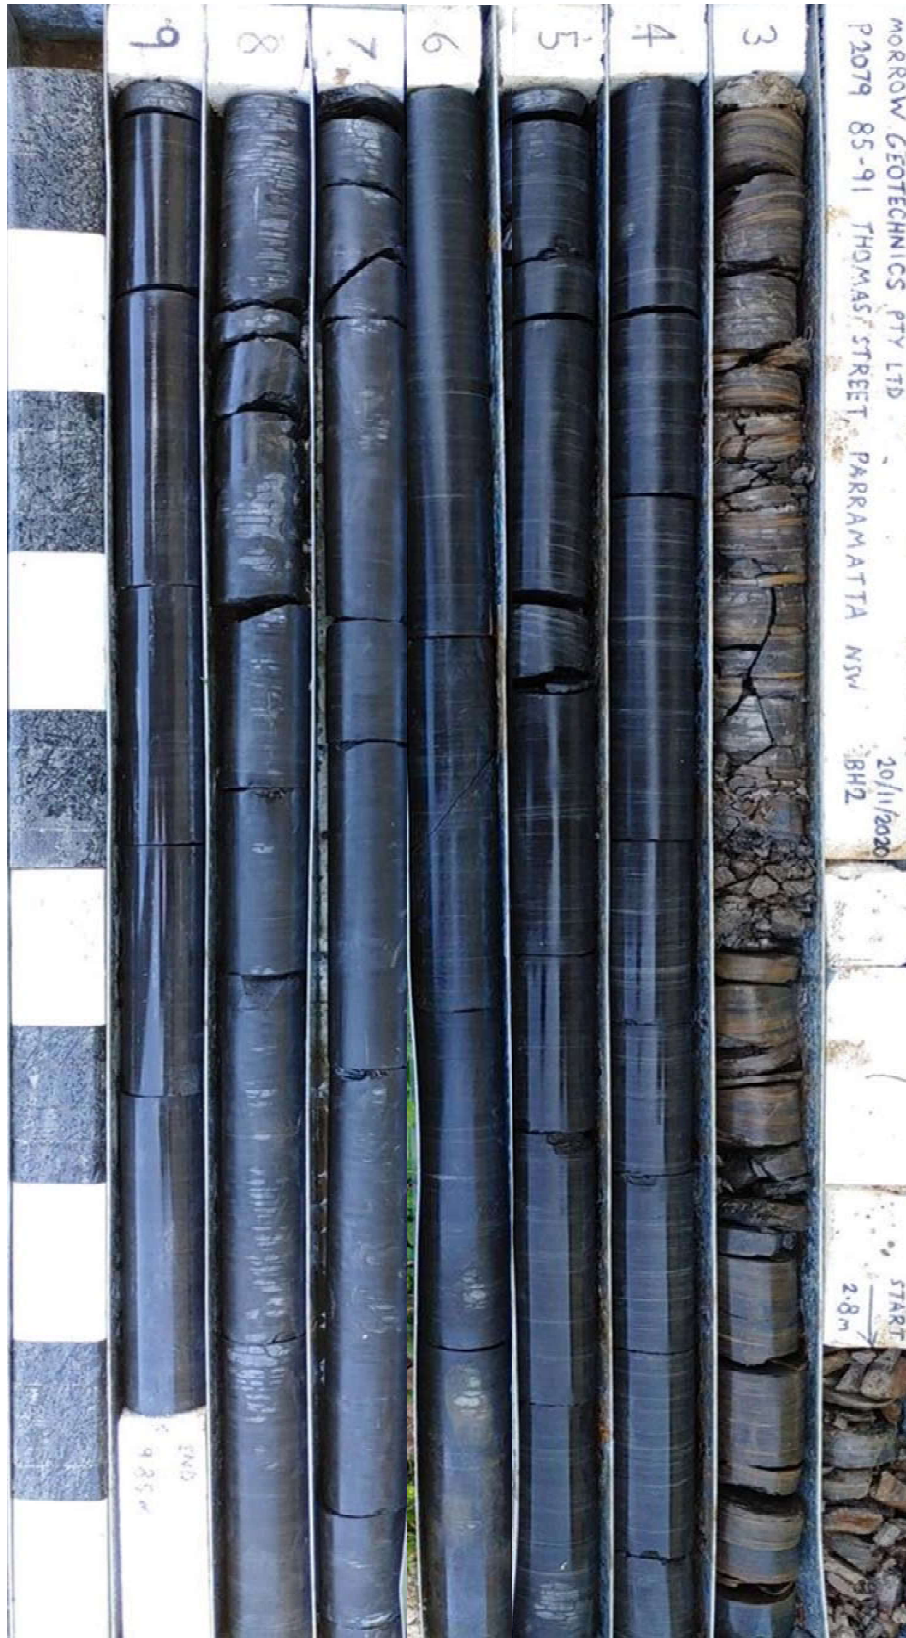
Drilling Method	Resistance	Water	Sampling	USCS	Depth	Stratigraphy	Consistency/Density	Moisture	Additional Observations
SFA	L	GWNE	SPT2-1 0.5-0.95 m 5, 7, 11 N=19 DS2-2 1.0-1.3 m	Cl-CH	0.5 1.0 1.5	Silty CLAY, medium to high plasticity, red-brown	Vst	D	RESIDUAL SOIL
	L-M		SPT2-3 1.5-1.75 m 15, 15/100 mm HB	-	2.0 2.5	SHALE, pale grey / orange-brown, extremely weathered, inferred extremely low strength - becoming brown / orange-brown from 2.0 m - clay seams from 2.5 m	-	-	WEATHERED SOIL
	L				3.0 3.5 4.0 4.5 5.0 5.5 6.0 6.5 7.0 7.5 8.0	Start Coring from 2.8 m

Drilling Method	Water	TCR	RQD (SCR)	Rock Strength					Weathering	Depth	Stratigraphy	Defect Spacing	Defect Description
				EL	VL	L	M	H					
				0.03	0.3	3					10	100	1000
				0	0.1	1	10				30	300	
NMLC	GWNO	100%	20% (20%)		HW MW FR	Depth 0.5 1.0 1.5 2.0 2.5 3.0 3.5 4.0 4.5 5.0 5.5 6.0 6.5 7.0 7.5 8.0	Start Coring at 2.8 m	LAMINITE, laminated SILTSTONE (80%), dark grey / brown, and SANDSTONE (20%), fine grained, orange-brown, 5-10° laminations at 1-5 mm spacing - becoming dark grey with grey laminations, sub-horizontal laminations at 0° from 3.7 m - laminations at 10° from 5.15 to 5.45 m	2.80-3.00, Bx5, core recovered as fragmented rock, 50mm 3.00-3.02, Sm, clay, 20mm thk 3.06-3.19, DBx3, 65mm sp 3.16-3.18, J, 30°, Pl, Ro, Sn fe 3.22, B, 10°, Pl, Ro, Sn fe 3.23-3.28, Jx2, 50°, Pl, Ro, Sn fe, 50mm sp 3.28, B, 10°, Pl, Sm, Ct clay 3.30-3.45, Jx2, 60°, Cv, Ro, Sn fe, 150mm sp 3.45-3.56, Bx5, core recovered as fragmented rock, 25mm sp 3.57-3.69, DBx6, 25mm sp 3.69-3.74, J, 45°, Pl, Ro, Sn fe 3.74-3.83, DBx4, 30mm sp 3.83-3.89, Bx2, 5°, Pl, Ro, Sn fe, 60mm sp 3.91, BD 3.93-3.96, Bx2, 5°, Pl, Ro, Sn fe, 30mm sp 4.00, HB 4.15-4.61, DBx4, 155mm sp 4.70, B, 0°, Pl, Ro, Cn 4.82-4.95, DBx2, 130mm sp 5.00-5.02, HBx2, 20mm sp 5.12-5.15, DBx2, 30mm sp 5.35, B, 10°, Pl, Ro, Cn 5.56-6.00, DBx4, 145mm sp 6.33, DB 6.40-6.45, J, 50°, Pl, Ro, Cn 6.50, B, 0°, Pl, Ro, Cn 6.70, DB 7.00, HB 7.02, B, 0°, Pl, Ro, Cn 7.06, DB 7.10-7.14, J, 45°, Pl, Ro, Cn 7.14-7.98, DBx6, 170mm sp

Drilling Method	Water	TCR	RQD (SCR)	Rock Strength		Weathering	Depth	Stratigraphy	Defect Spacing		Defect Description
				EL	VH				10	300	
NMLC	GWNO	100%	100% (95%)	0.03	0.3	3	8.5	AS ABOVE, LAMINITE, laminated SILTSTONE (80%), dark grey, and SANDSTONE (20%), fine grained, grey, sub-horizontal laminations at 1-5 mm spacing	10	100	8.00, HB 8.13-8.23, Jx2, 30°, Pl, Ro, Cn, 100mm sp
				0	0.1	1	10		30	300	8.33, J, 10°, Pl, Ro, Cn 8.45-8.80, DBx3, 175mm sp
						FR	9.0				9.00, HB 9.02, DB 9.13, B, 0°, Pl, Sm, Ct clay 9.31-9.85, DBx4, 180mm sp
							10.0	End BH3 at 9.85 m Target Depth Reached			
							10.5				
							11.0				
							11.5				
							12.0				
							12.5				
							13.0				
							13.5				
							14.0				
							14.5				
							15.0				
							15.5				
							16.0

A standpipe piezometer was installed within BH2 and bailed dry of drilling fluids on 23 November 2020. Groundwater was not observed within the boreholes during the investigation. A regional groundwater table is not present at the site within the proposed depth of excavation. Minor seepage should be expected from the soil/rock interface and from within open joints in the rock mass during excavation as a response to surface water infiltration.

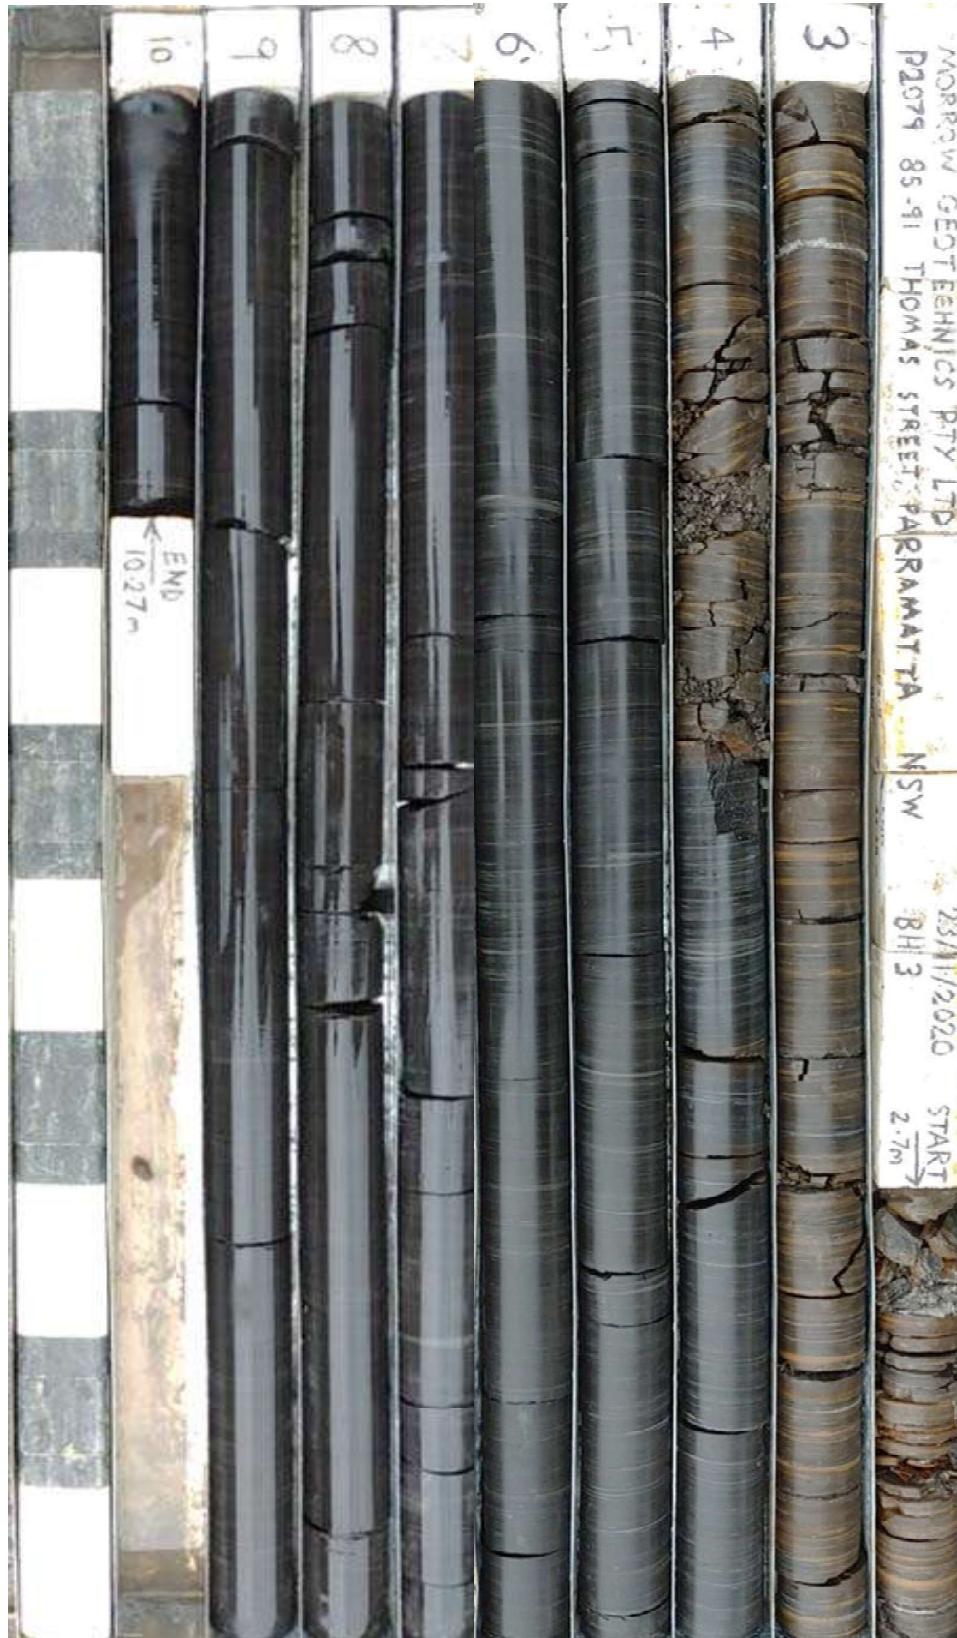
Drilling Method	Resistance	Water	Sampling	USCS	Depth	Stratigraphy	Consistency/Density	Moisture	Additional Observations	
DTC	H	-		-		CONCRETE, 2 slabs, 110 & 90 mm thick	-	-	PAVEMENT	
SFA	L	GWNE	SPT3-1 0.5-0.95 m 3, 3, 4 N=7	Cl-CH	0.5	Silty CLAY, medium to high plasticity, orange-brown mottled grey	St	M<PL	RESIDUAL SOIL	
					1.0					
	M			SPT3-2 1.5-1.95 m 23 R	-	1.5	SHALE, orange-brown / brown, trace thin clay seams, ironstone bands, extremely weathered, extremely low strength	-	-	WEATHERED ROCK
						2.0				
	DS3-3 2.0-2.2 m		2.5	SHALE, orange-brown / brown, ironstone bands, distinctly weathered, inferred low strength						
					3.0	Start Coring at 2.7 m				
					3.5					
					4.0					
					4.5					
					5.0					
					5.5					
					6.0					
					6.5					
					7.0					
					7.5					
					8.0

Drilling Method	Water	TCR	RQD (SCR)	Rock Strength					Weathering	Depth	Stratigraphy	Defect Spacing		Defect Description
				EL	VL	L	M	H				V	HE	
NMLC	GWNO	100%	100% (100%)						FR	8.5	AS ABOVE, LAMINITE, laminated SILTSTONE (70%), dark brown, and SANDSTONE (30%), fine grained, orange-brown, 5° laminations at 1-2 mm spacing	10	30	8.00, HB 8.08-8.15, DBx3, 35mm sp 8.39, DB 8.49-8.57, J, 60°, Pl, Ro, Cn 8.58-8.93, DBx2, 350mm sp
										9.0				9.00, HB 9.03, J, 10°, Pl, Ro, Cn 9.28, J, 10°, Pl, Ro, Cn
										9.5				9.44-9.74, DBx2, 300mm sp
										10.0				10.00, HB 10.19-10.27, DBx2, 80mm sp
										10.5	End BH3 at 10.27 m Target Depth Reached			
										11.0				
										11.5				
										12.0				
										12.5				
										13.0				
										13.5				
										14.0				
										14.5				
										15.0				
										15.5				
										16.0
