**Report on Detailed Site (Contamination)
Investigation**

Proposed Mixed Use Development

138 Maroubra Road, Maroubra NSW

Project 20854.03

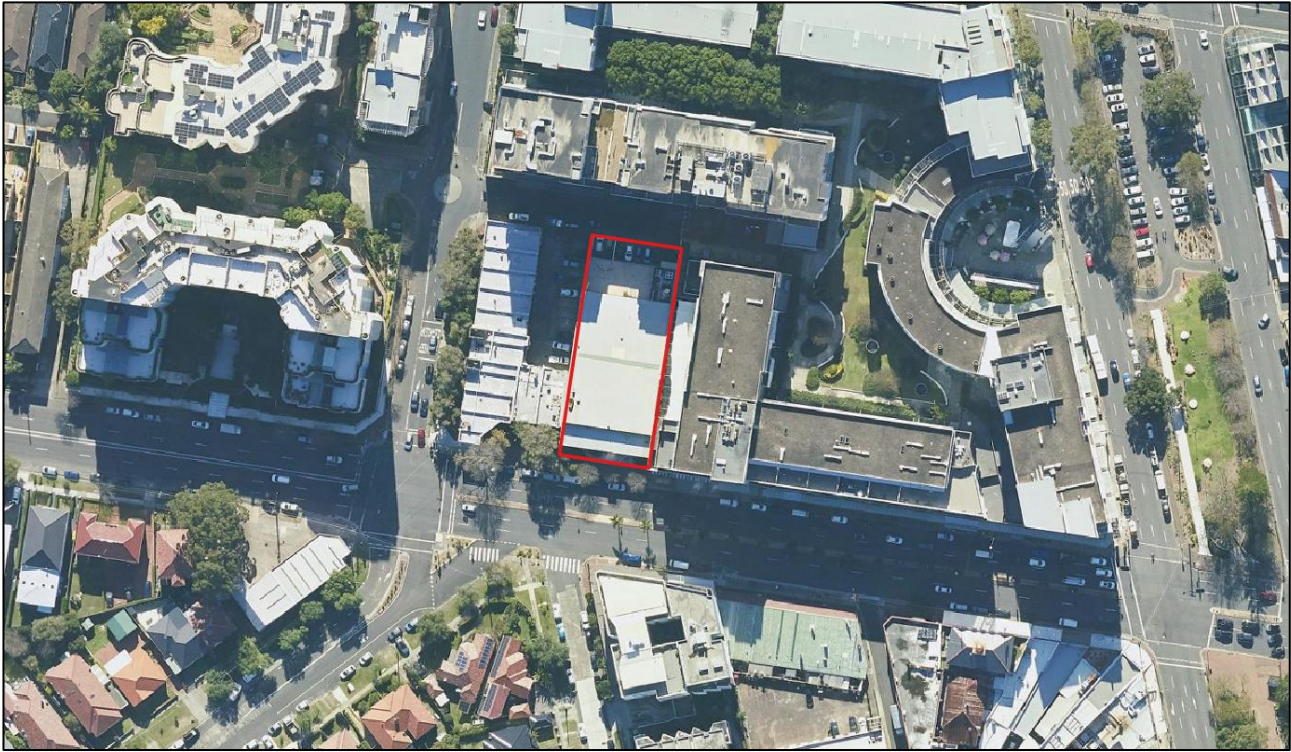
Figure 1: Site location

The site boundary is shown on Figure 1.
