CONTAMINATION REPORT

**Storage & Distribution Warehouse
221-235 Luddenham Road, Orchard Hills NSW**

23 May 2025

Ref: DRM P23.1039.V21-R01

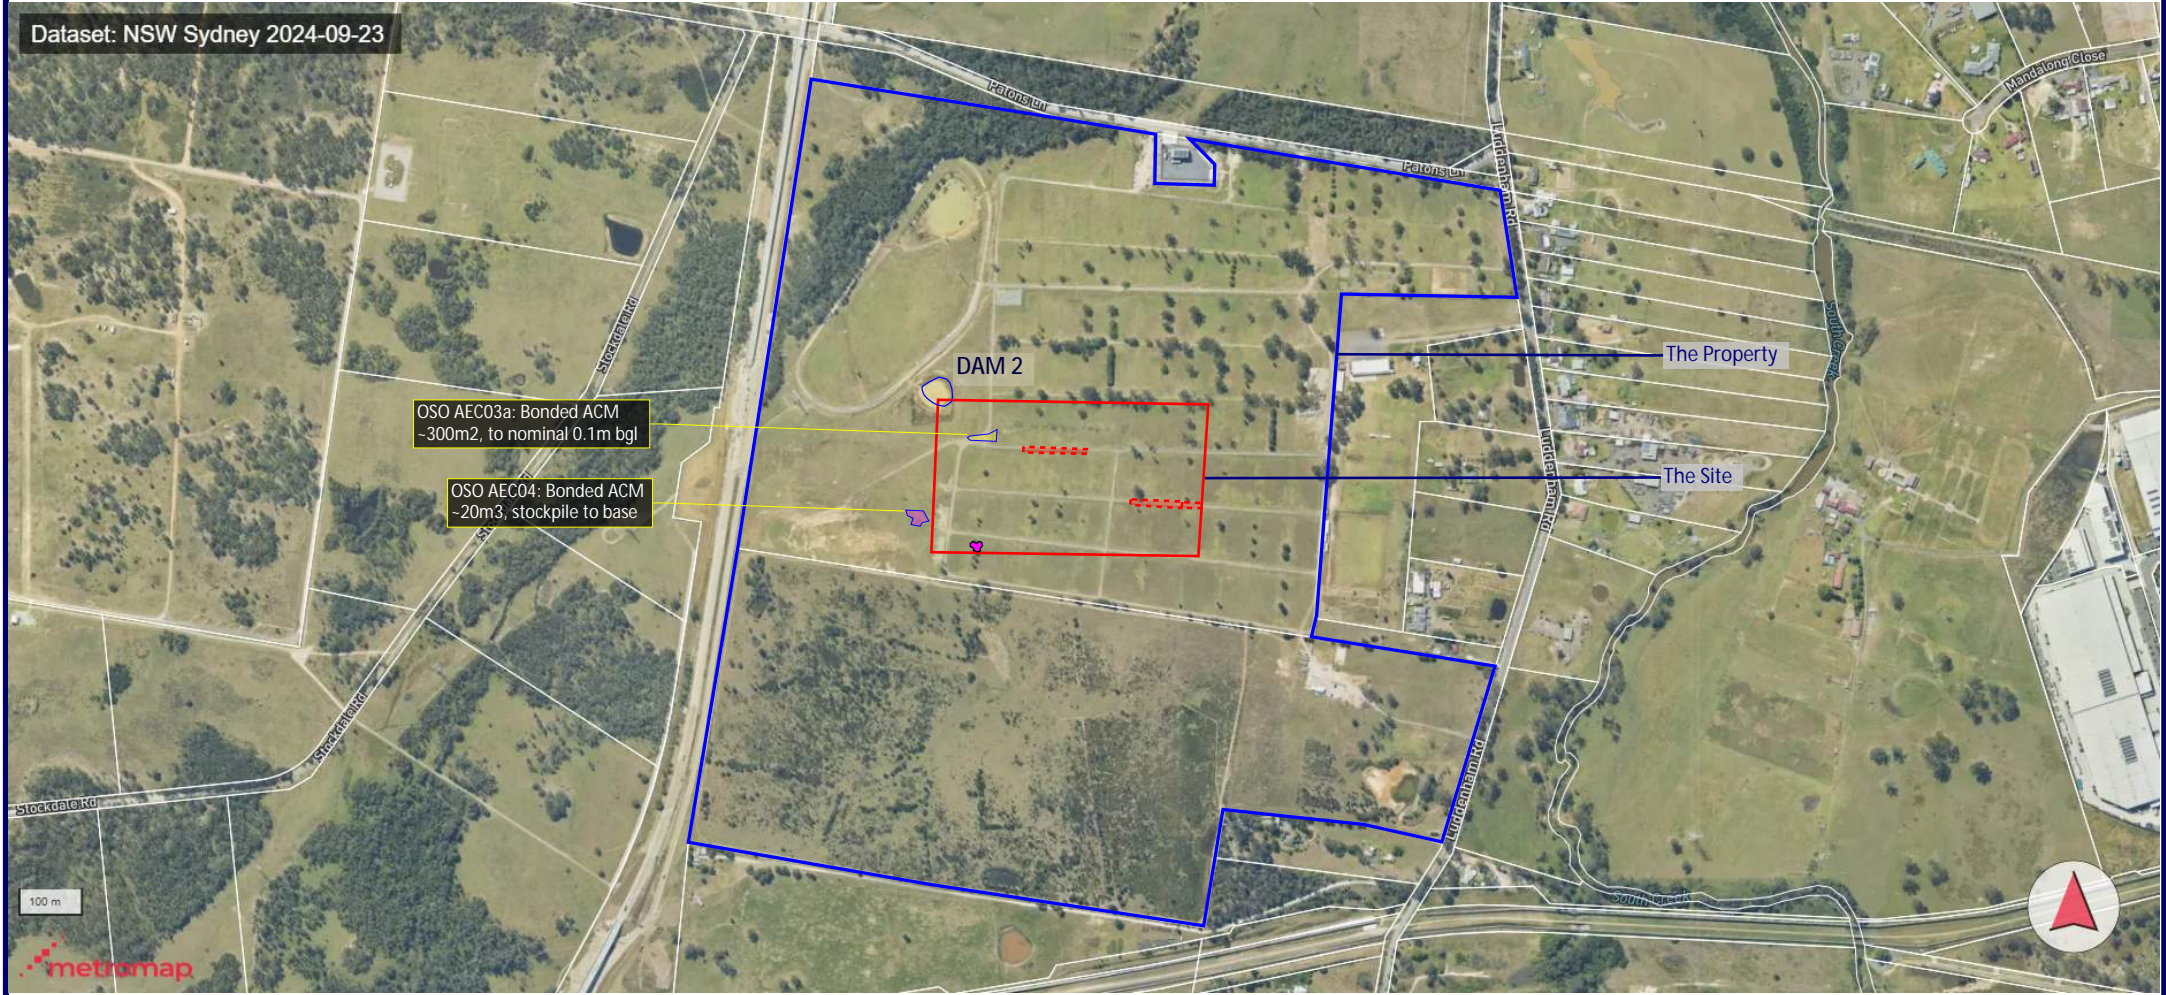
Title: Figure 3 - Relevant Areas of Environmental Concerns

-   Approximate Property Extent
-   Approximate Site Extent
-   AEC02a (DRM, 2025a)
-   AEC06 (DRM, 2025a)
-   OSO AEC03a (DRM, 2025b)
-   OSO AEC04 (DRM, 2025b)

Comparison of the areas of environmental concern (AECs) referenced in DRM (2025a) and DRM (2025b) validation reports against the area proposed to be developed (i.e. the Site as defined above) indicates that several AECs were located within the Site (refer to [Figure 3](#)). These AECs are summarised below.

AEC	Description	Remedial Outcome
AEC02a	Approximately 280m of internal gravel roads that were impacted by asbestos (fines and fibres).	This AEC was remediated and validated successfully by Construction Sciences and is discussed in DRM (2025a) final validation report. Further assessment or management is not warranted.
AEC06	Approximately 30m ³ of household and demolition waste	This AEC was remediated and validated successfully by Construction Sciences and is discussed in DRM (2025a) final validation report. Further assessment or management is not warranted.
OSO AEC03a	Bonded asbestos across an approximate area of 300m ² , to a nominal depth of approximately 0.1m	This AEC was assessed and remediated by DRM in late 2024 (DRM, 2025b). Further assessment or management is not warranted.
OSO AEC04	Stockpile of soil and waste containing bonded and friable asbestos located immediately outside the western boundary of the Site. We have considered this AEC due to the proximity to the Site, despite it being located outside of the Site.	This AEC was assessed and remediated by DRM in late 2024 (DRM, 2025b). Further assessment or management is not warranted.

Dam 2	The site encroaches into the south eastern portion of Dam 2. Water and sediments within the of the dam was considered an AEC.	Assessment of dam water and sediment by DRM indicated that the dam water and sediment did not contain unacceptable contamination and thus were suitable for beneficial re-use on site. Further assessment or management is not warranted.
