Acid Sulfate Soil Management Plan

Proposed Seniors Housing Development

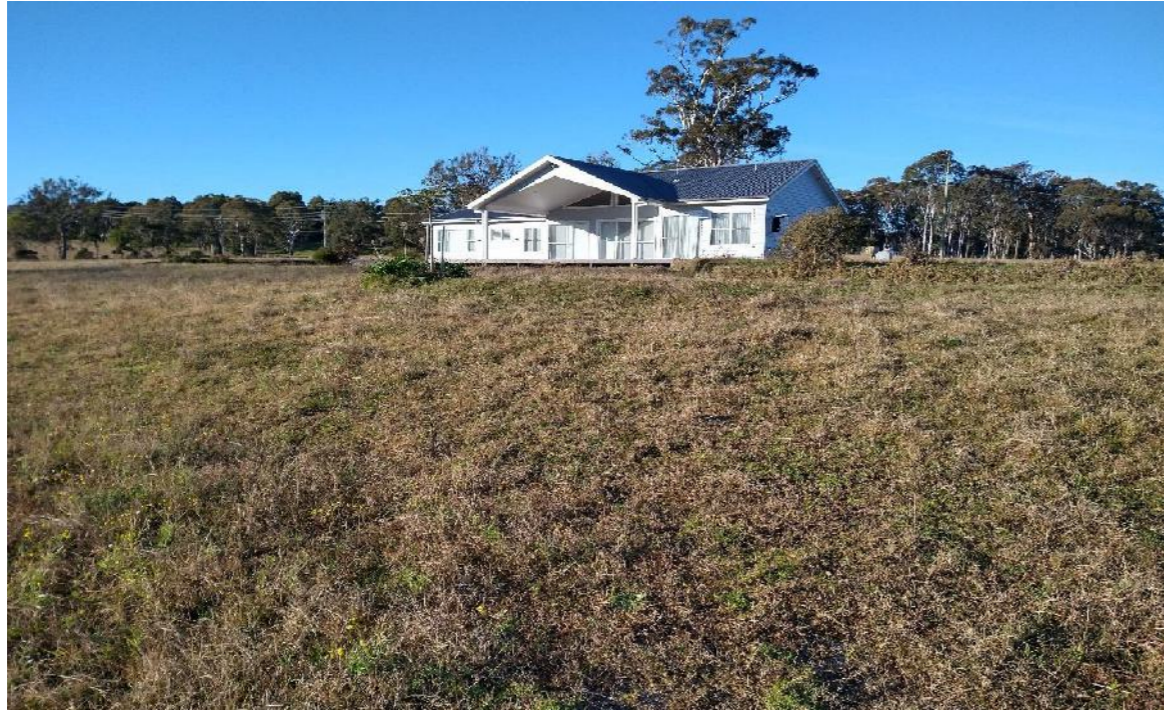
Photo 1: General view of the residential dwelling northern facade, looking east.
