Report on Geotechnical Investigation

Proposed Residential Development

**24, 26 and 28 Middle Harbour Road,
Lindfield NSW**

Project 234319.00

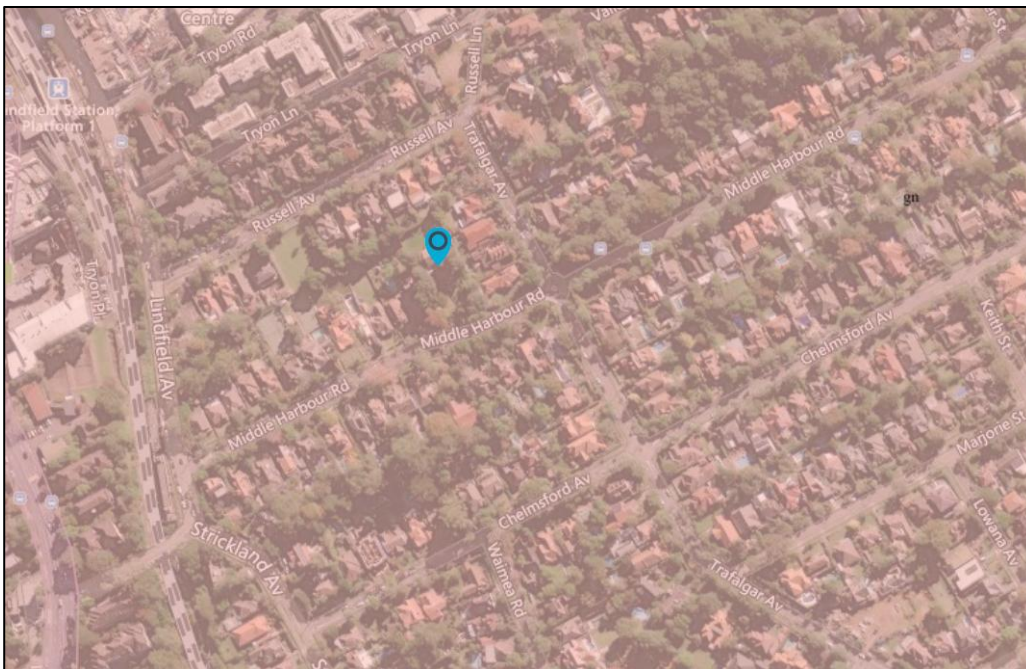
Figure 3: NSW Soil Map with Approximate Site Location (blue marker)

Reference to the Sydney 1:100,000 Soils Landscape Sheet shows the Site is underlain by Glenorie soil, created by erosional processes (refer Figure 3). The landscape consists of undulating to rolling hills over Wianamatta group.

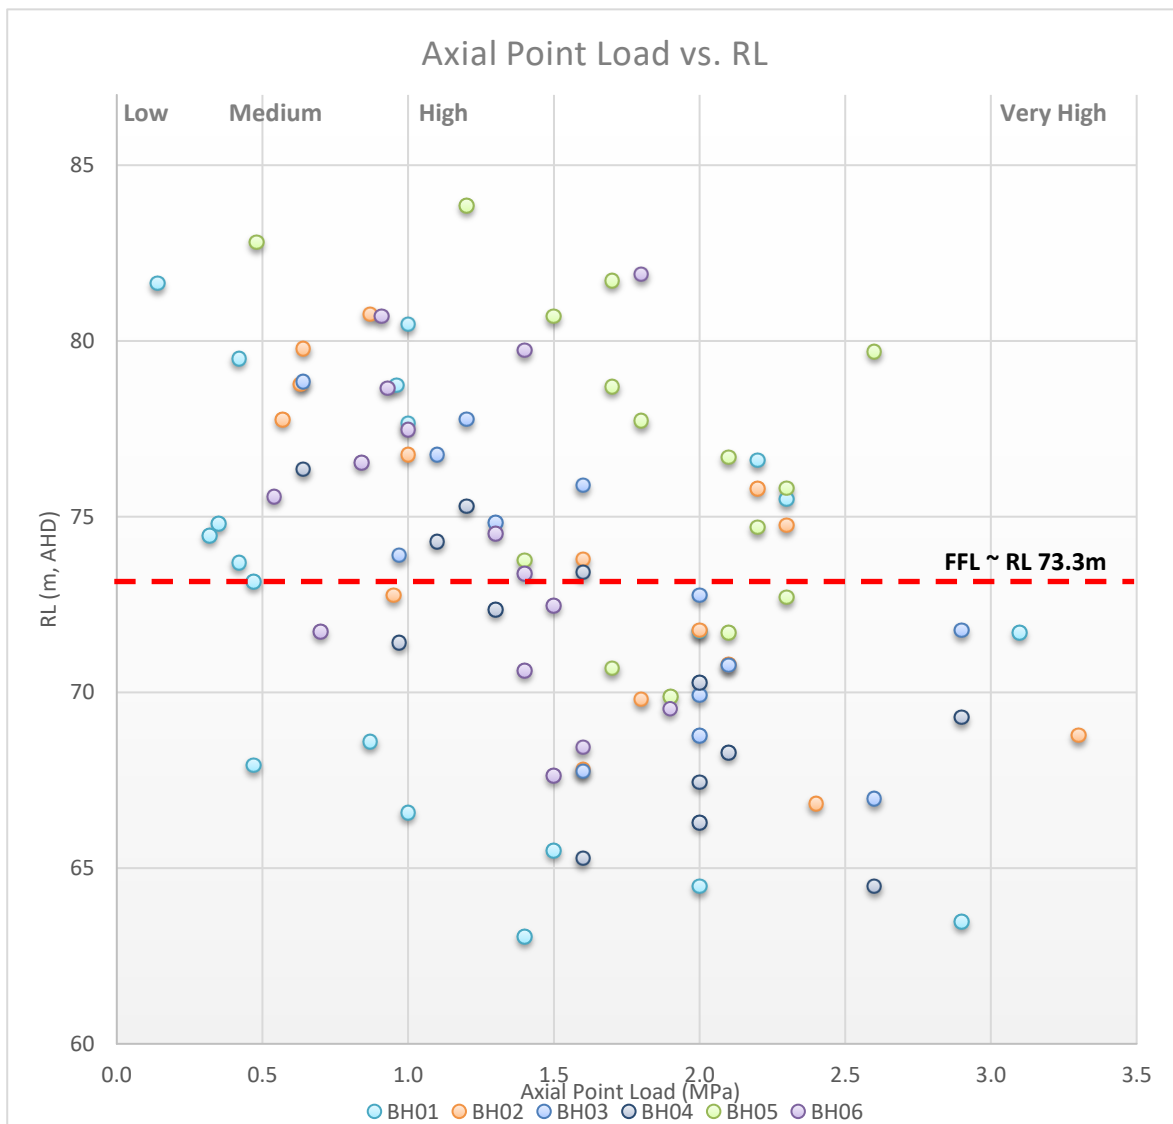
Figure 4: Point Load Results with RL

Axial point load strength index testing ($I_{s(50)}$) was carried out on selected rock core samples. The results are shown on the respective borehole logs and summarised in Figure 4 below. The $I_{s(50)}$ values from axial tests were used to provide an estimate of the Uniaxial Compressive Strength (UCS) of the sandstone, based on a UCS: $I_{s(50)}$ ratio of 20:1 (as per AS1726). Results ranged from 0.14 MPa to 3.30 MPa which correspond to low strength and high strength rock, respectively. The $I_{s(50)}$ results suggest Uniaxial Compressive Strengths of between about 3 MPa and 66 MPa based on the conversion factor of 20. The $I_{s(50)}$ results are shown on the borehole logs as PL(A) at the respective depths.

Note that point load testing is not carried out in very low strength materials (i.e. below $I_{s(50)}$ values of 0.1 MPa) and that a Site-specific conversion factor would require further laboratory testing (if required).

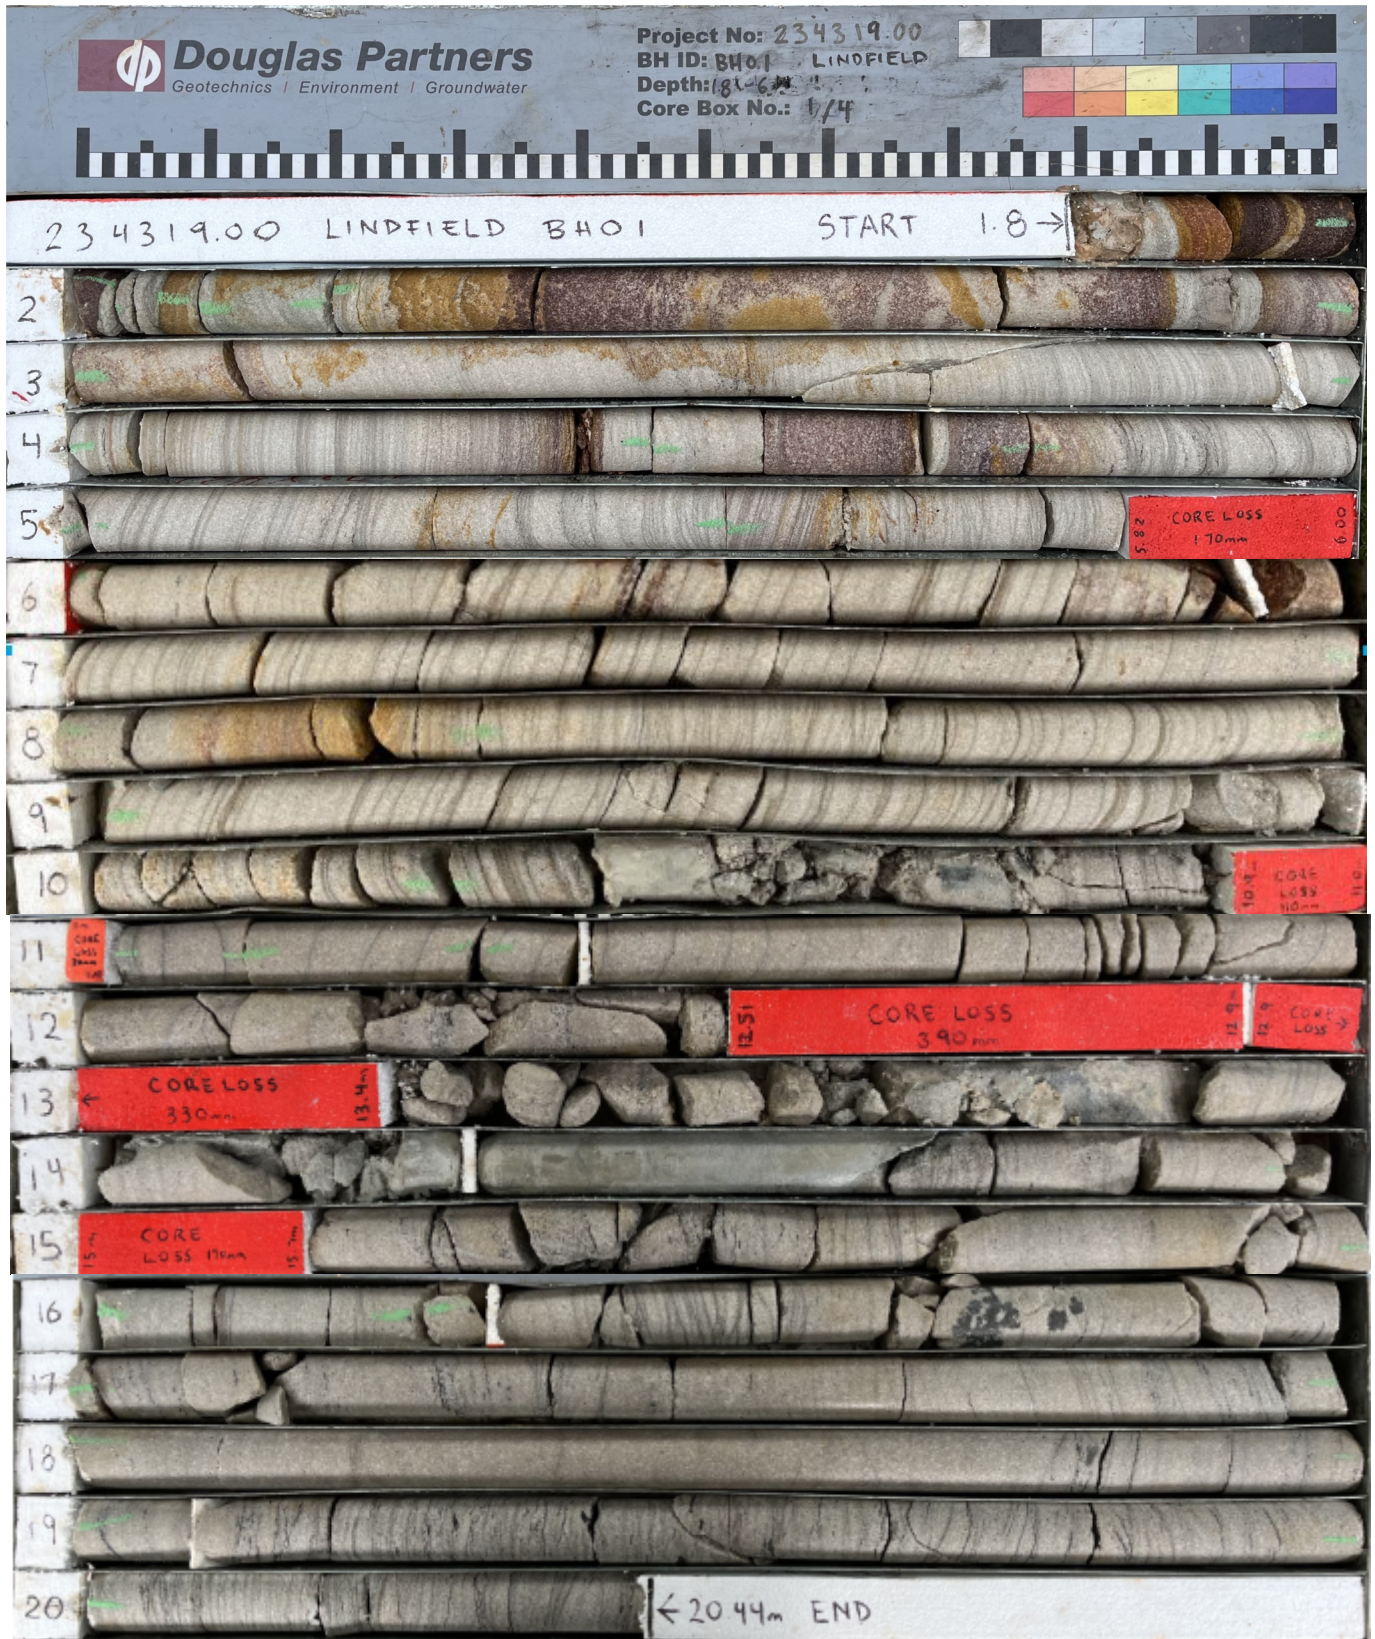
LOCATION ID: BH01
PROJECT No: 234319.00
DATE: 25/03/25
SHEET: 1 of 1

The boreholes drilled in 24 and 26 Middle Harbour Road (BH01 and BH02 respectively) encountered fill and residual soil to depths of between about 1.5 m – 2.0 m, overlying Hawkesbury Sandstone of medium to high strength. The sandstone in BH01 was highly fractured and jointed from 9.5 m – 17.5 m depth, with a clay layer between 14.35 m (RL 69.09) and 14.70 m (RL68.74) is possibly an extremely weathered dyke.

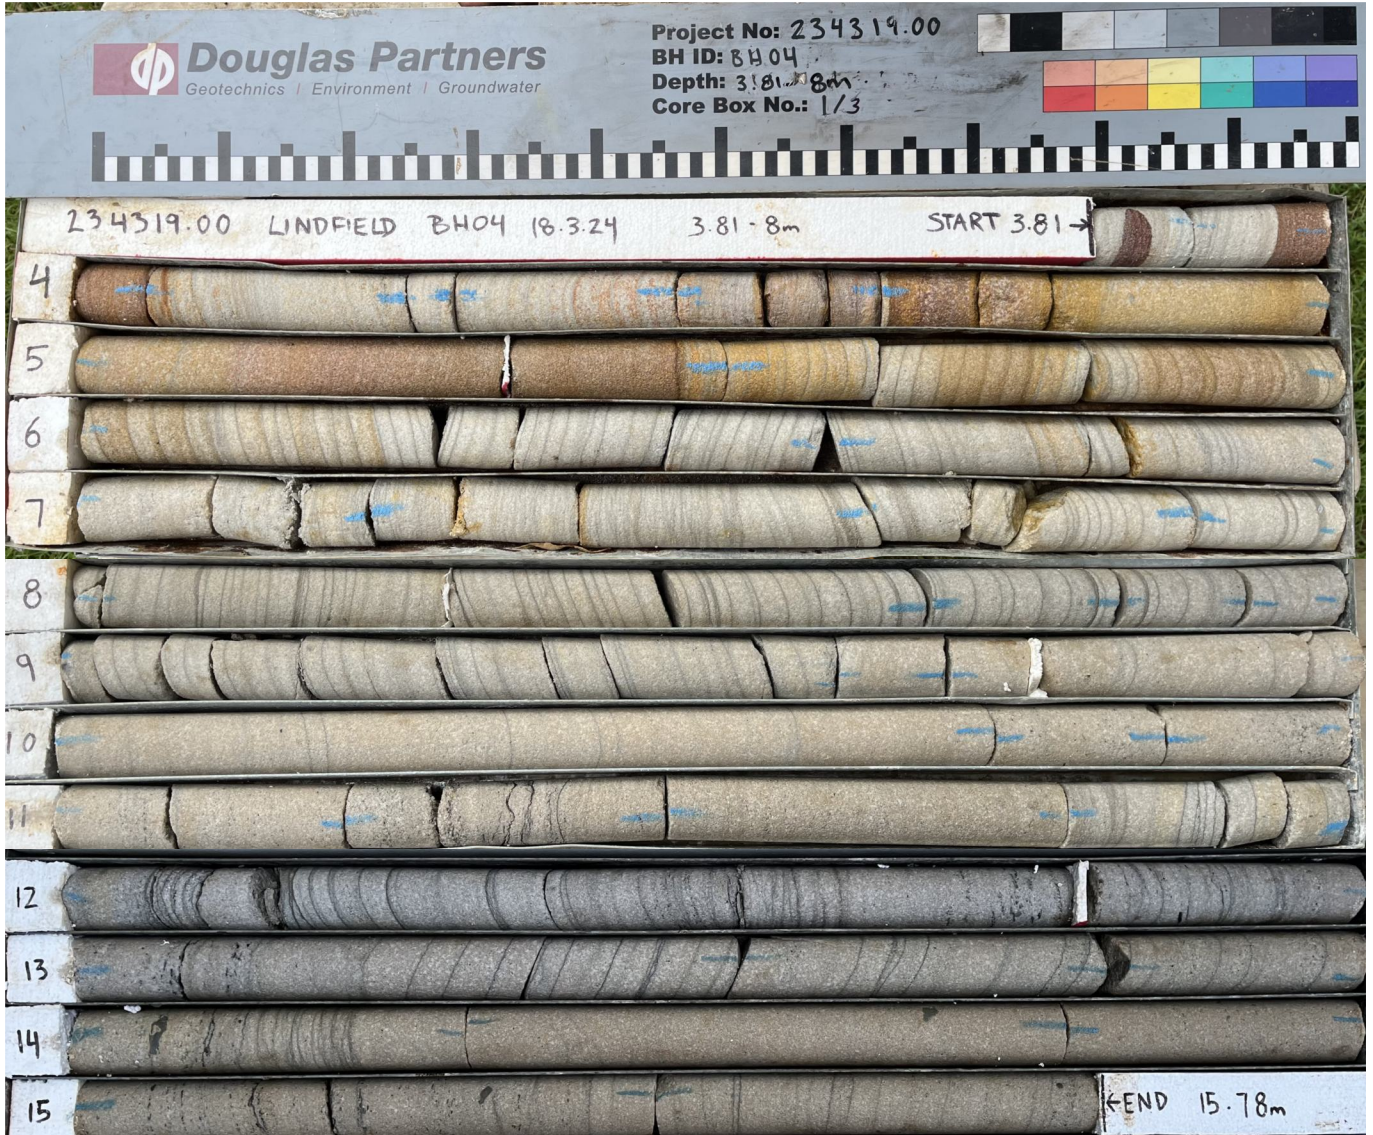
LOCATION ID: BH04
PROJECT No: 234319.00
DATE: 18/03/25 - 19/03/25
SHEET: 1 of 1

SURFACE LEVEL: 80.4 AHD
COORDINATE: E:330789.2, N:6261091.7
DATUM/GRID: MGA2020 Zone 56
DIP/AZIMUTH: 90°/---°

Generated with CORE-GS by Geoc - Split Soil-Rock Log

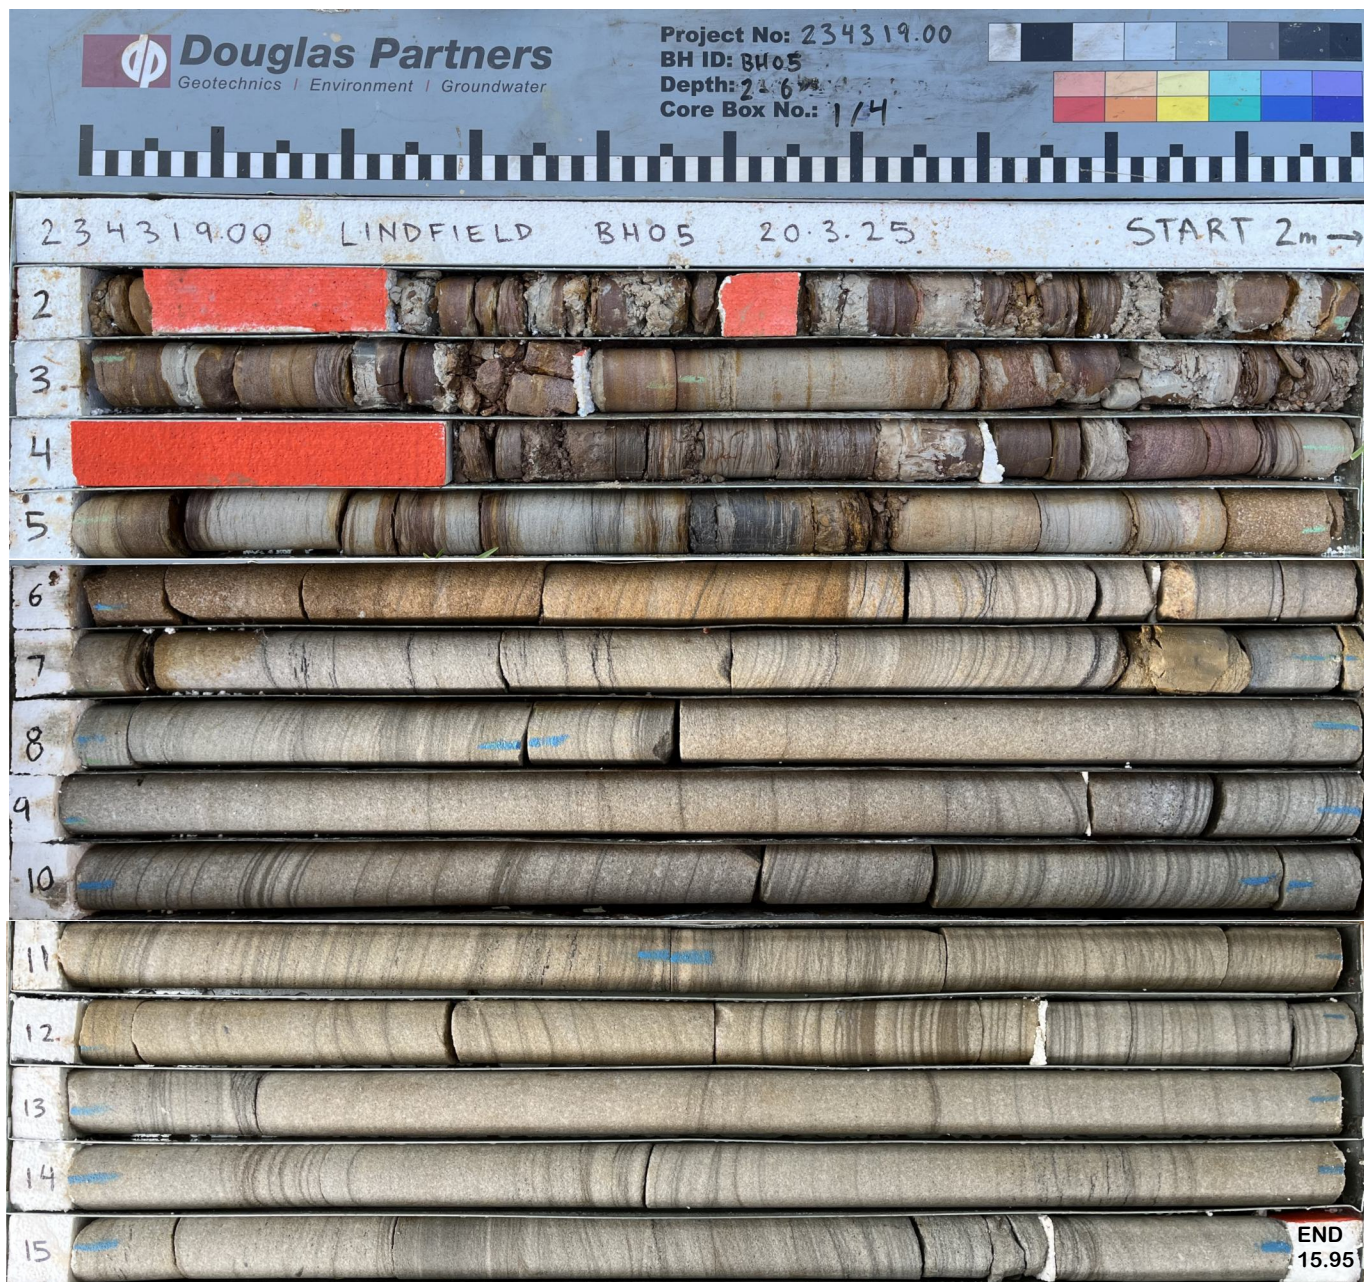
LOCATION ID: BH05
PROJECT No: 234319.00
DATE: 20/03/25 - 21/03/25
SHEET: 1 of 1

Bedding planes recorded in the rock cores dip 0-30° from horizontal, which is typical for Mittagong Formation/Hawkesbury Sandstone. Defect spacing (which includes bedding planes and joints) in the Mittagong Formation (BH05 and BH06) indicates the rock has fragmented bands and clay seams/decomposed beds with relatively low (very poor to poor rock mass quality) Rock Quality Designation (RQD) values. RQD in the Hawkesbury Sandstone is higher, generally 80 to 100% (good to excellent rock mass quality), barring BH01, which was highly jointed from 9.5 to 17.5 m, possibly with an extremely weathered dyke encountered from 14.35 m to 14.70 m, and had a relatively low RQD value. Defect dip angles recorded in the core generally range from 20° to 90°, with numerous joints in the 70° to 90° ranges. Fragmented bands and clay seams/decomposed beds, some up to 100 mm thick, were also encountered.
