SEPTEMBER 23, 2025

ROOT MAPPING INVESTIGATION

PREPARED FOR MHR LINDFIELD INVESTMENTS PTY LTD
ATF MHR LINDFIELD TRUST
24,26, & 28 MIDDLE HARBOUR ROAD, LIND FIELD

PREPARED BY LEE HANCOCK CONSULTING ARBORIST AQF LEVEL 5

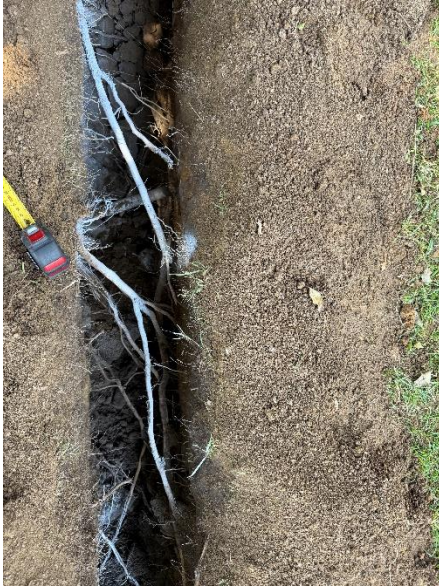
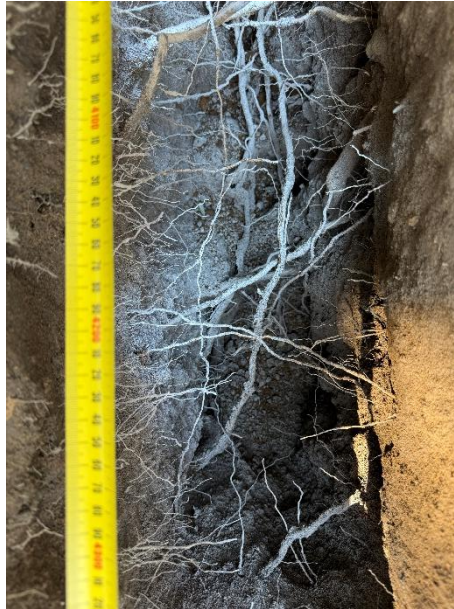
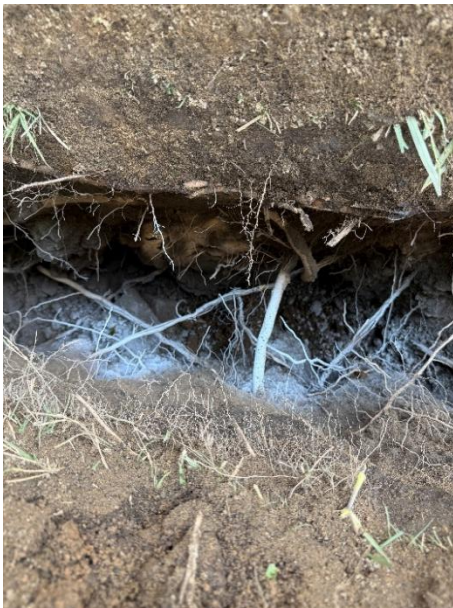
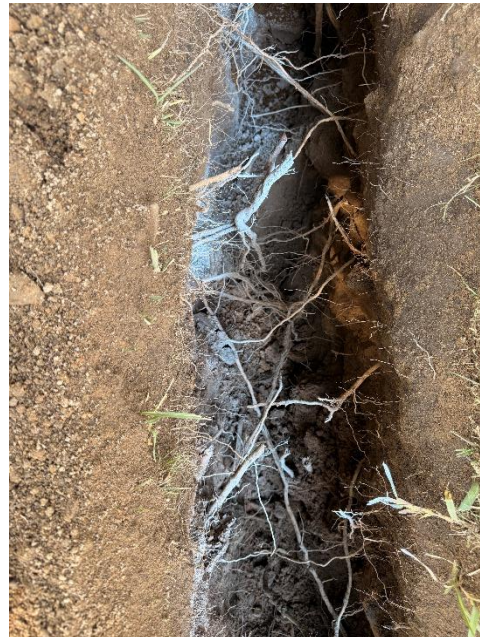
Tree 11. *Syncarpia glomulifera* (Turpentine)

Root Number	Distance to the Top of root in a trench depth of 600mm Offset 4.5m from front boundary 6.7m Length	Root Diameter	Measurement from Tree 11 metres linear distance from centre of trunk.
Root 1.	250mm	20mm	4.5m
Root 2.	150	15m	4.85m
Root 3.	300mm	10m	5.18m
Root 4	500mm	3mm Feeder roots	6.1m
Root 5	400mm	15mm	6.3m
Root 6	300mm	10mm feeder roots	6.4m
Root 7	500 – 600mm	5mm Feeder roots	6.7m

6.3 Retain the subject trees 11,15,16 &18A, root mapping investigations has found that trees will not be adversely affected by the proposed development and will be protected throughout all stages of the development in accordance with AS 4970–2025 *Protection of Trees on Development Sites*.

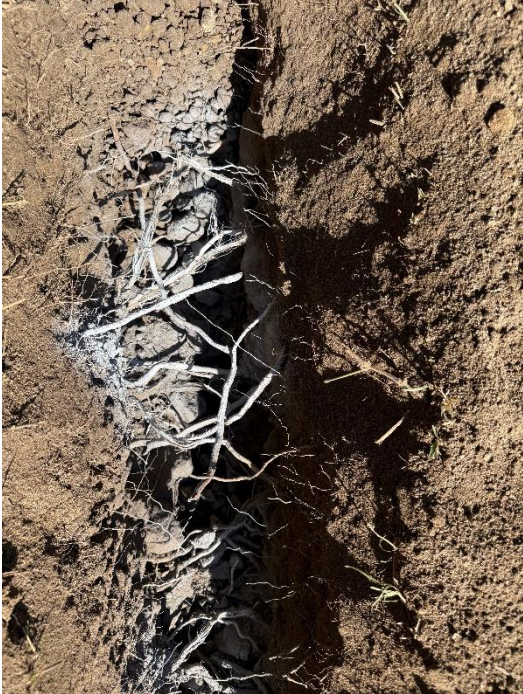
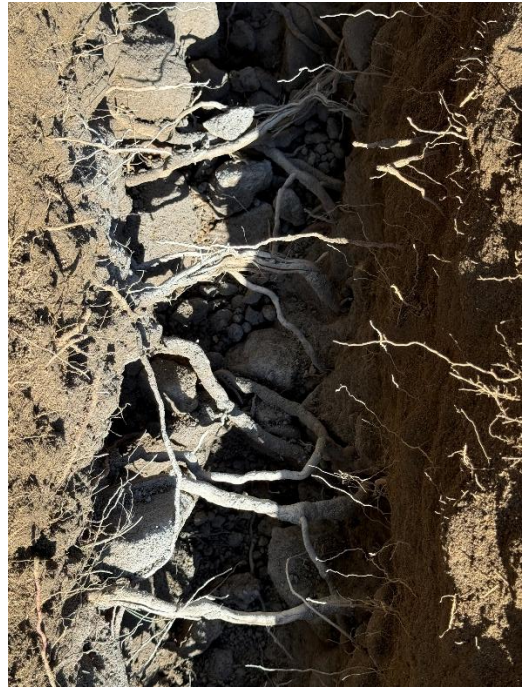
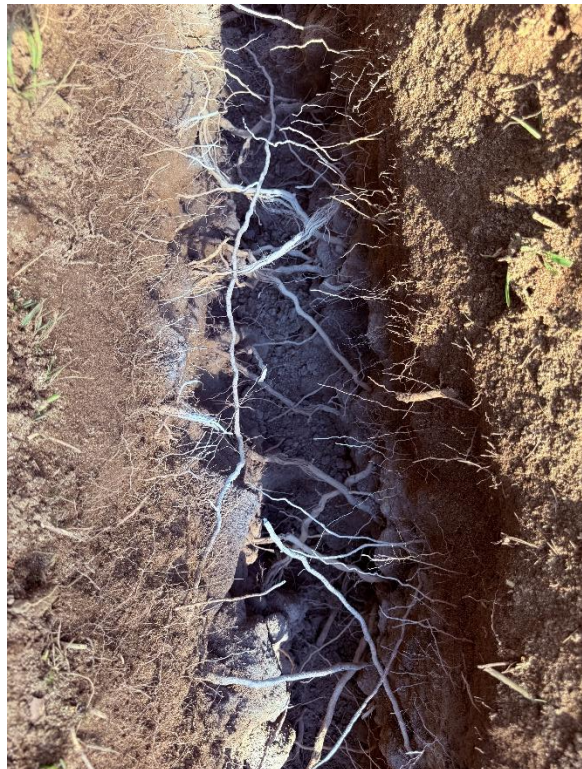
Tree 15. *Syncarpia glomulifera* (Turpentine)

Root Number	Distance to the Top of root in a trench depth of 600mm Trench length 6.7m	Root Diameter	Measurement from Tree 15 metres linear distance from centre of trunk
Root 1.	200-300mm	Feeder roots	4.4m
Root 2.	400mm	Feeder roots	4.1m
Root 3.	410mm	25mm	3.6m
Root 4	4500mm	Feeder roots	3.7m
Root 5	500mm	Feeder roots	3.8m
Root 6	500mm	Feeder Roots	3.9m
Root 7	500-600mm	Feeder Roots	4.0m

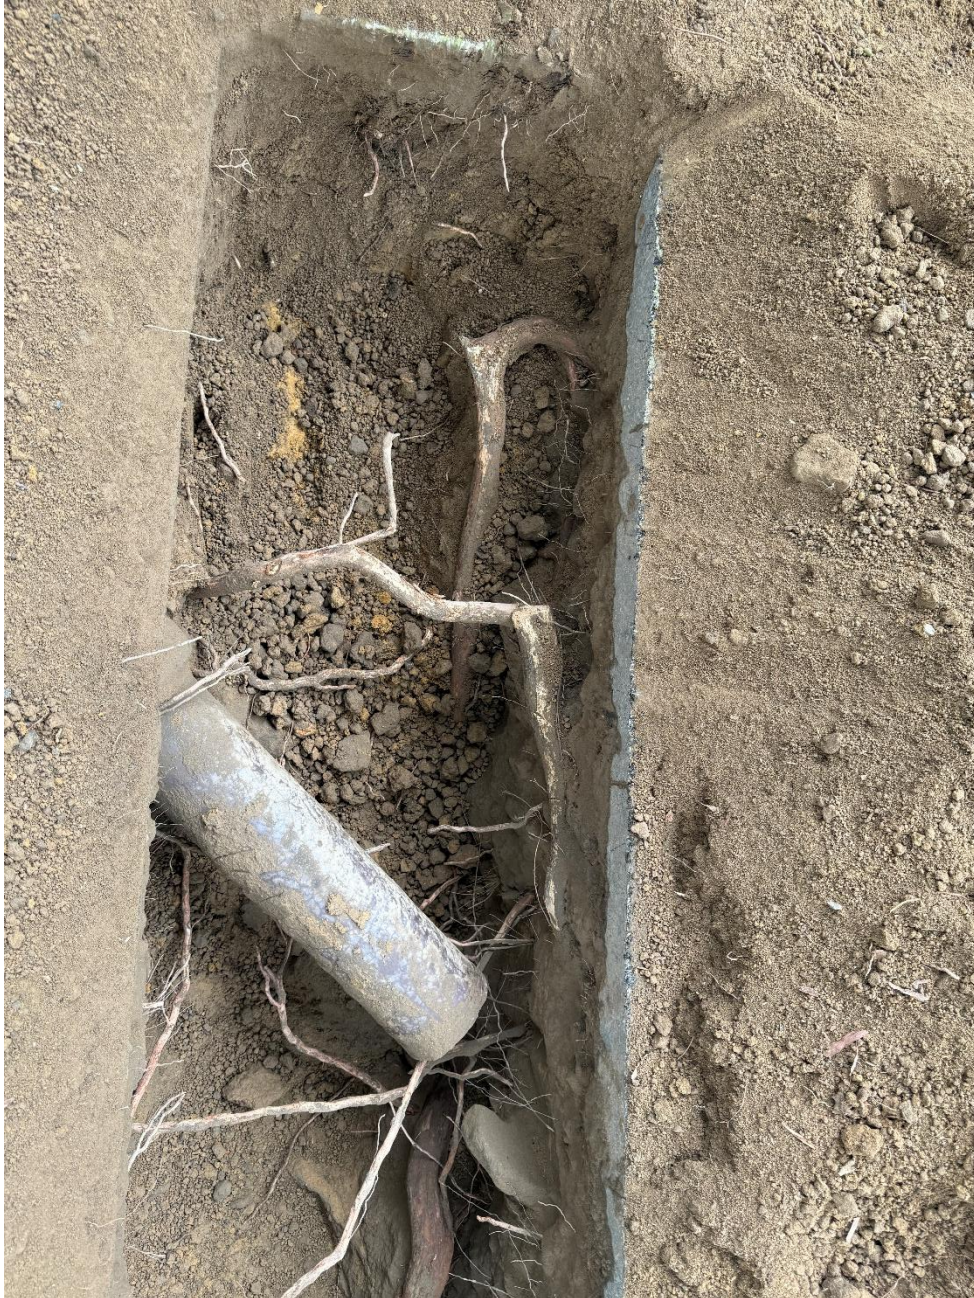
Tree 16

Disconnected pipe where dead root was enclosed in.

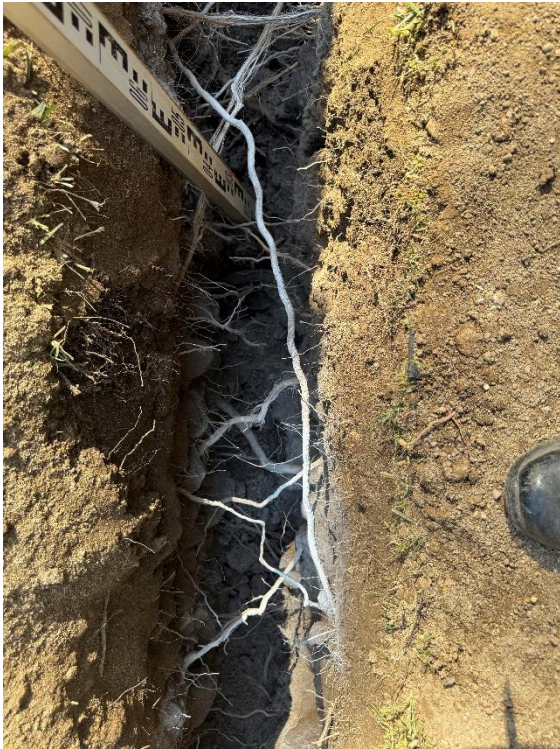
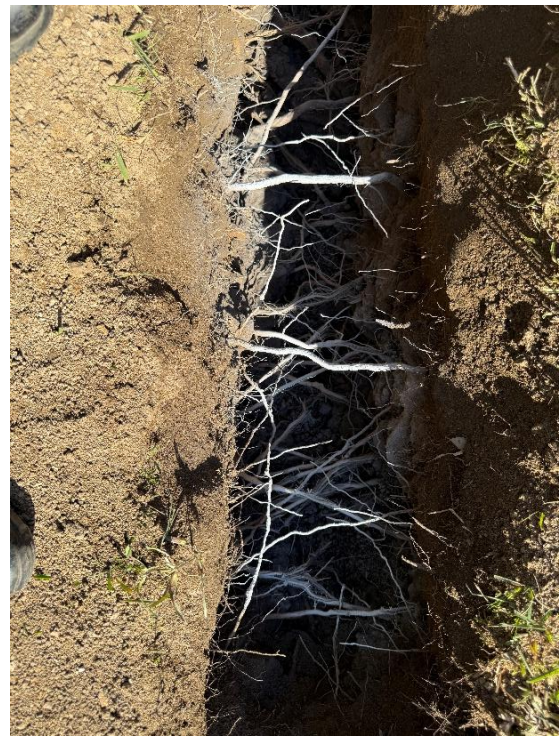
Tree 16

Feeder roots

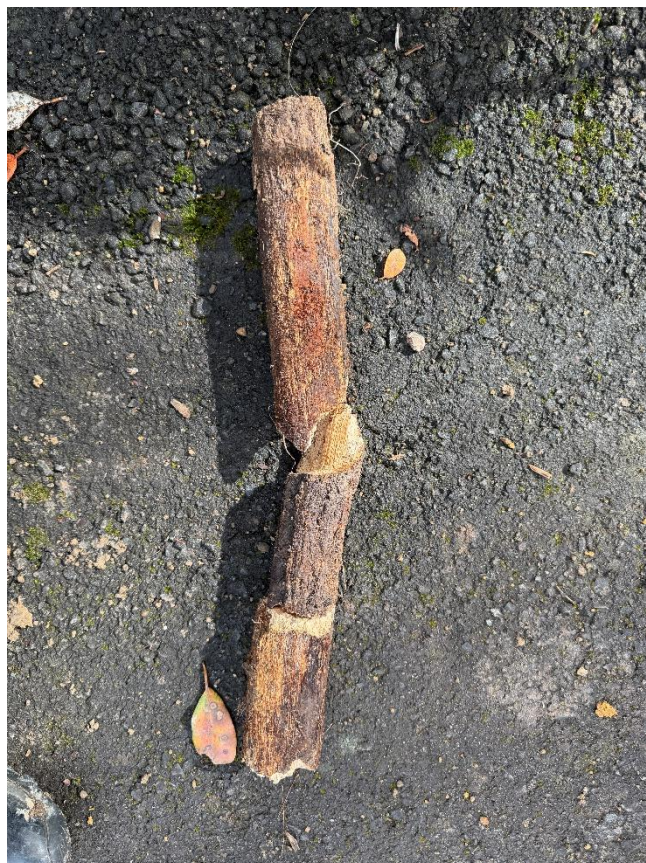
Figure 1. Dead Root 30mm

Root Number	Distance to the Top of root in a trench depth of 600mm 7m	Root Diameter	Measurement from Tree 16 metres linear distance from centre of trunk
Root 1.	150mm	20mm	4.3m
Root 2.	200mm	30mm	3.5m
Root 3.	100mm	25mm	Historically Cut and Dead Refer Figure 1.
Root 4	5mm	Feeder roots	4m

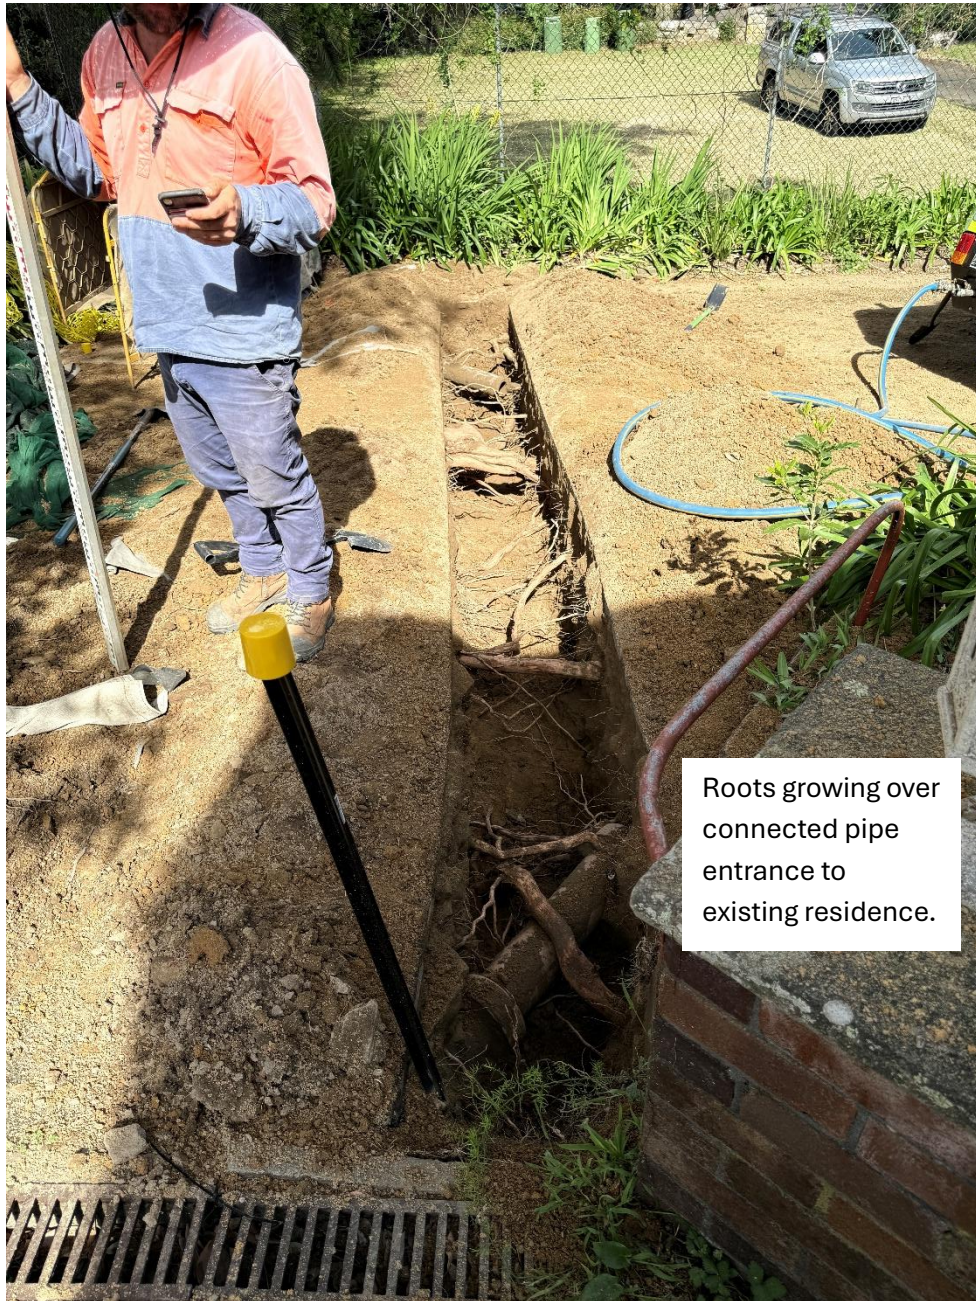
Tree 16 & Tree 18 are within 3m of each other the root mapping findings, it was assumed that roots 1 – 4 belonged to Tree 16. Roots 5 – 8 belonged to Tree 18.

Root Number	Distance to the Top of root in a trench depth of 600mm 7m	Root Diameter	Measurement from Tree 18 metres linear distance from centre of trunk
Root 5	100mm	Outside SRZ structural root 200mm	4m
Root 6	600mm	20mm	3.9m
Root 7	400mm	20mm	3.9m
Root 8	350mm	15mm 30mm	Existing connected pipe 4m

Tree 16 &18 7m trench 600mm depth

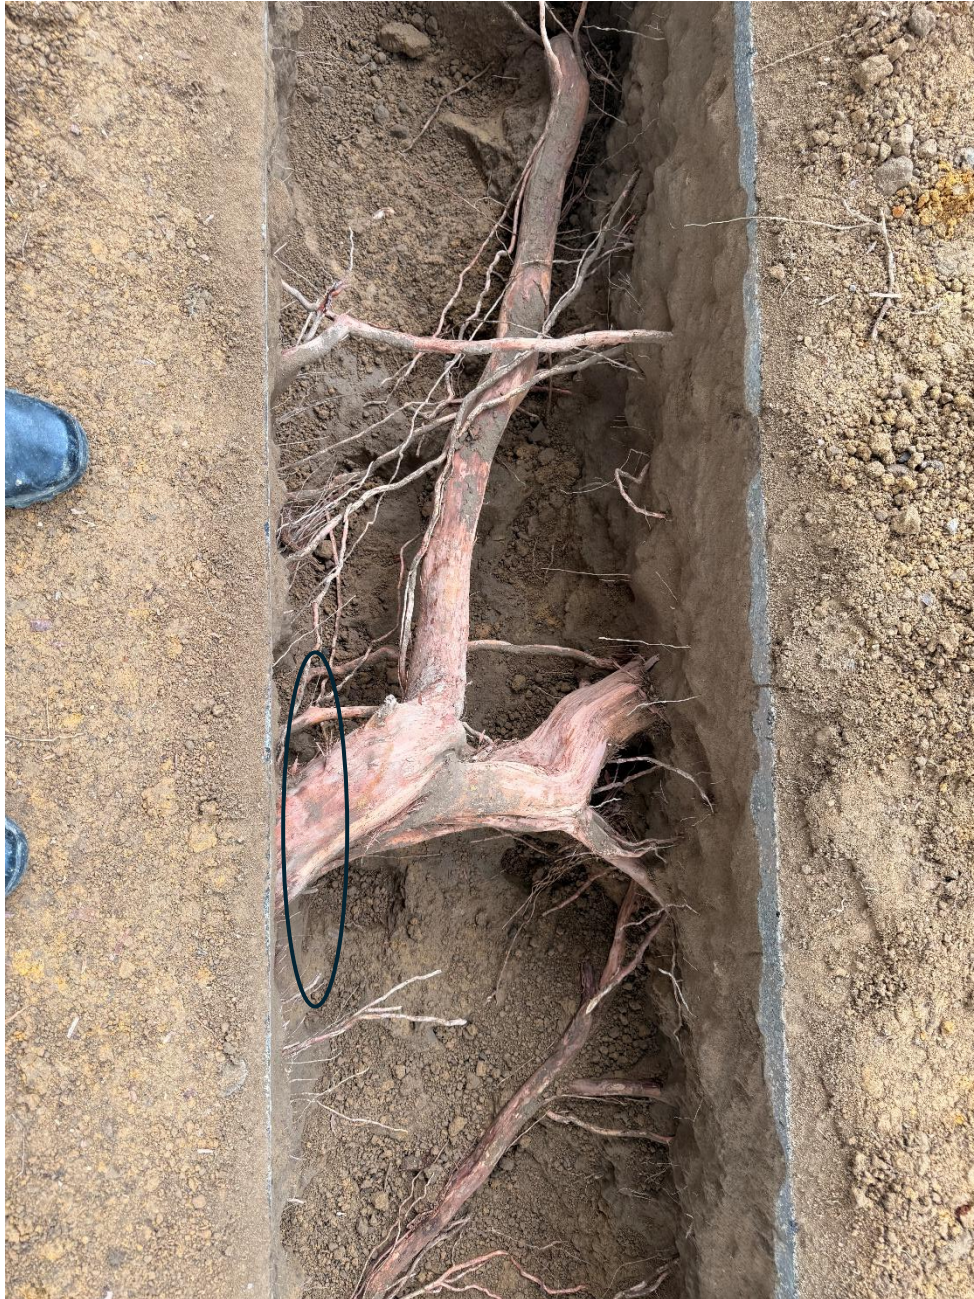
Tree 18 Root 5.

4.1 Roots varied in diameter from fine feeder roots (<5 mm) to structural roots (>200 mm) Tree 18 . One large structural root was observed extending in the direction of the proposed building, confirming that the tree relies on these roots for anchorage and stability.

200mm in diameter

The root mapping investigation at 28 Middle Harbour Road, confirmed the presence of minor roots less than 30mm were found associated with Trees 11,15,16,&18 *Syncarpia glomulifera* (Turpentine) within the study area. Tree 18 *Syncarpia glomulifera* (Turpentine) roots were observed at varying depths and orientations, with one structural root 200mm in diameter extending towards basement area of proposed works.

6.1 The findings highlight that the subject tree 18 is physiologically and structurally dependent on the roots within the investigated zones. Any disturbance, removal, or severance of these roots would likely have adverse impacts on tree health, stability, and long-term viability. Refer Images Tree18 Root No 5. 200mm in diameter.

6.4 It is recommended that Tree 18 is removed, the presence of significant roots within the Tree Protection Zone (TPZ) Tree 18 indicates that construction or excavation in these areas may adversely impact the health, stability, or longevity of the subject tree. Where roots were located beneath existing structures, there is potential for future structural conflict. Tree will endure an unsustainable impact from the proposed building.

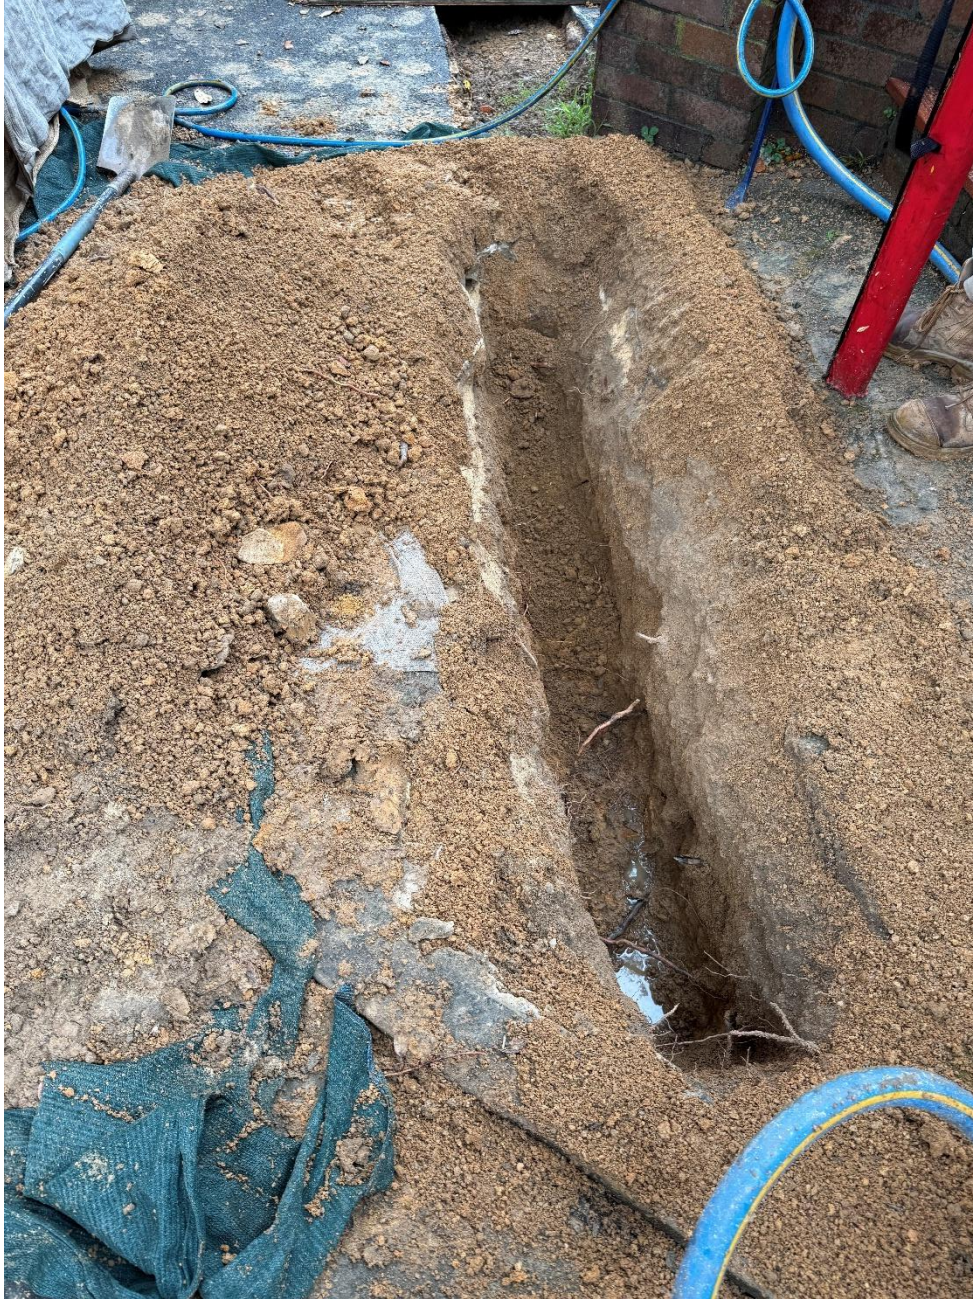
Root Number	Distance to the Top of root in a trench depth of 600mm 2m length	Root Diameter	Measurement from Tree 18 metres linear distance from centre of trunk
Root 1.	Nil roots	Nil	4.3 m
Root 2.	Nil roots	Nil	3.5m
Root 3.	Nil roots	Nil	3.9mm
Root 4	Feeder roots	Feeder Roots	3.9mm
Root 5	500mm	Feeder roots	3.9mm

Tree 18 A. Trench to 2m length 600mm depth

6.2 Tree 18A *Syncarpia glomulifera* (Turpentine) Trench was dug to 600mm 2m wide, the trench was located at the bottom step front entrance of site, it was only feasible to this distance as the building envelope prevented further investigations. No roots of any significance were encountered.
