**Specialist Advice
Report on Geotechnical Investigation**

Proposed Mixed-Use Hotel Development

153 - 157 Walker Street, North Sydney NSW

Project 233796.00

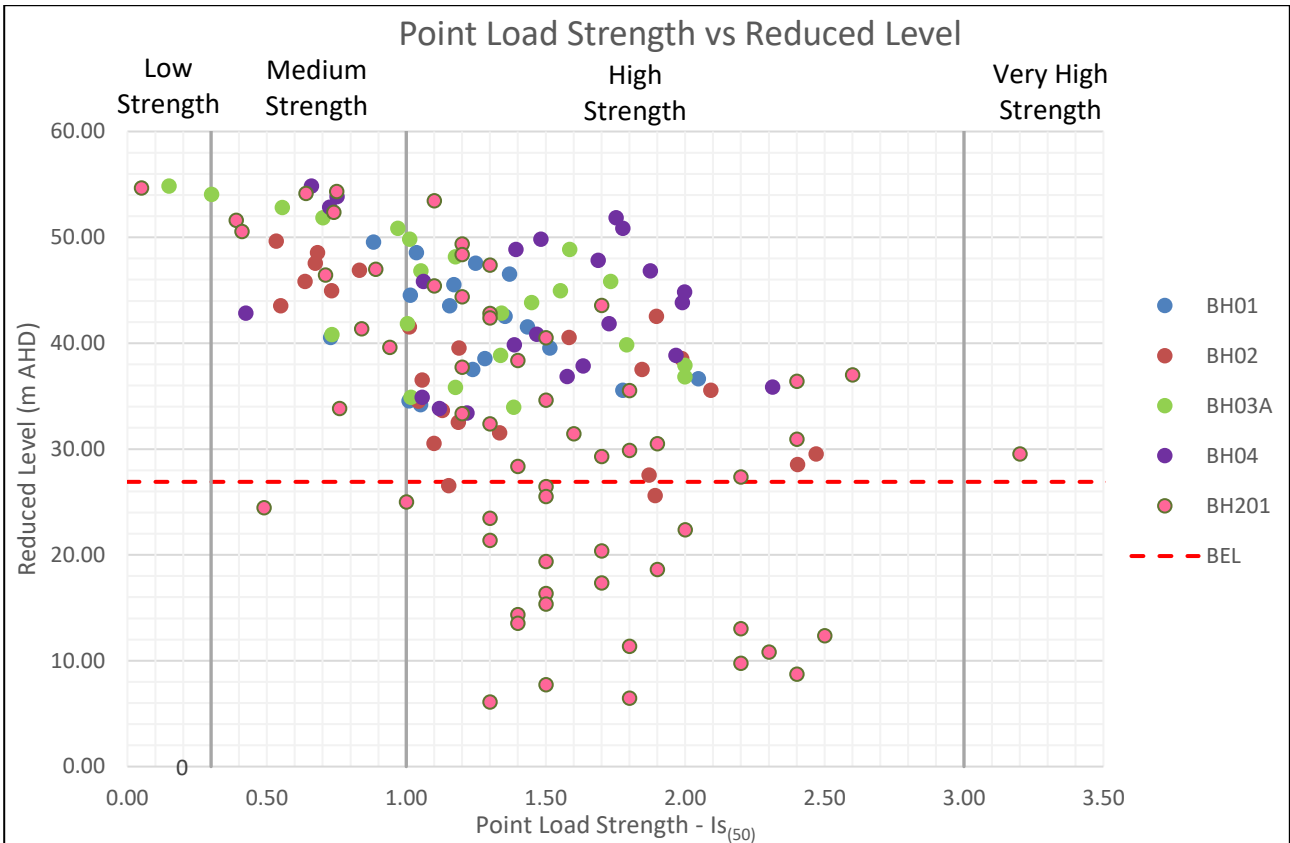
Figure 2- Axial Point Load Values vs RL

The results of point load strength index testing ($I_{s(50)}$), carried out at regular intervals on rock cores, are shown on the borehole logs in Appendix C. The $I_{s(50)}$ results range from 0.1 MPa to 3.2 MPa in the underlying bedrock. The results of point load strength index testing against depth are shown in Figure 2 below.

The $I_{s(50)}$ values were used to provide an estimate of the Uniaxial Compressive Strength (UCS) of the rock, based on a UCS: $I_{s(50)}$ ratio of 20:1. The estimated UCS values for the sandstone typically ranged from 1 MPa to 64 MPa, indicating that the rock tested ranged from very low to very high strength.

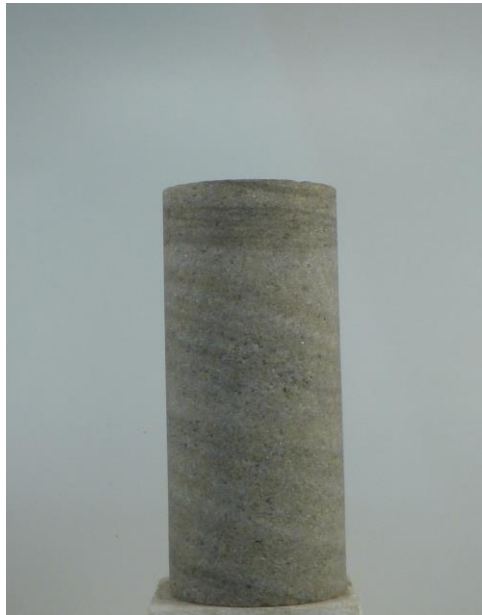
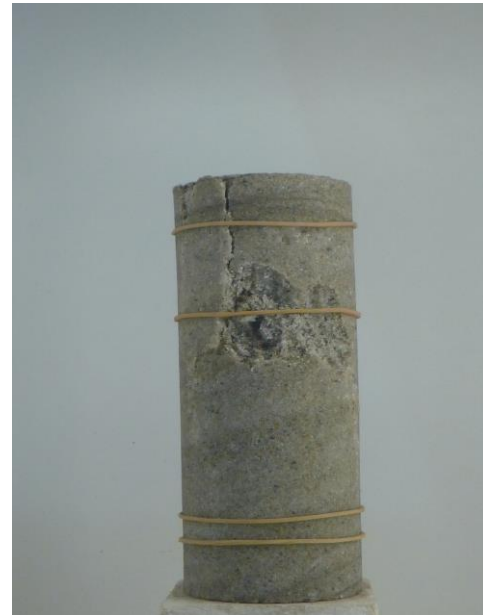
Average Specimen Diameter (mm)	51.7	Moisture Content (%)	6.6
Average Specimen Height (mm)	147.2	Wet Density (t/m³)	2.38
Length to Diameter Ratio	2.8	Dry Density (t/m³)	2.24
Duration of Test (min)	15.88	Rate of Displacement (mm/min):	< 0.1
Date of Test:	25/11/22	Specimen Curing	-
Mode of Failure	Mixed mode	Test Apparatus	Matest Compression Machine with Axial and Circumferential Extensometers.

Before Test

After Test

Uniaxial Compressive Strength		38	MPa
	<u>Young's Modulus</u>	<u>Poisson's Ratio</u>	
Tangent	16 GPa	0.12	from 42 % to 58 % of Max UCS
Secant	9.1 GPa	0.11	from 0 % to 50 % of Max UCS

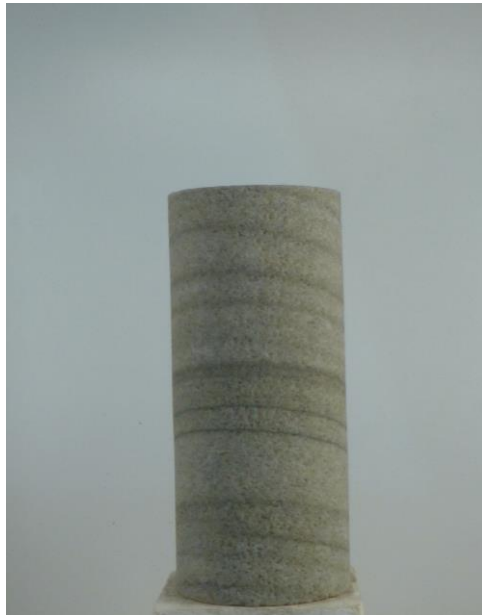
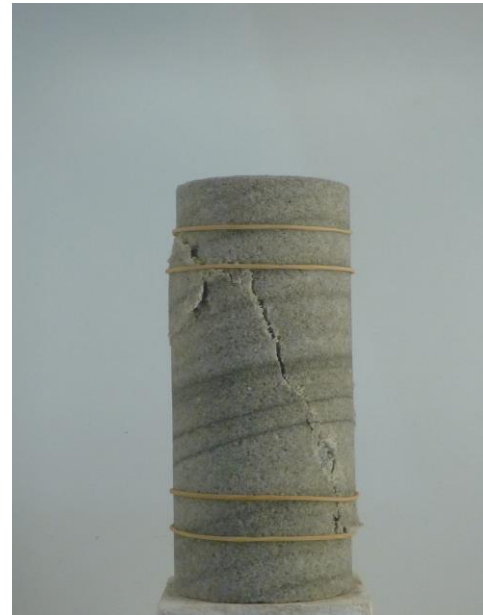
Average Specimen Diameter (mm)	51.8	Moisture Content (%)	7.5
Average Specimen Height (mm)	148.2	Wet Density (t/m³)	2.35
Length to Diameter Ratio	2.9	Dry Density (t/m³)	2.19
Duration of Test (min)	12.58	Rate of Displacement (mm/min):	< 0.1
Date of Test:	25/11/22	Specimen Curing	-
Mode of Failure	Single shear plane	Test Apparatus	Matest Compression Machine with Axial and Circumferential Extensometers.

Before Test

After Test

Uniaxial Compressive Strength		30	MPa
	<u>Young's Modulus</u>	<u>Poisson's Ratio</u>	
Tangent	8.9 GPa	0.20	from 42 % to 58 % of Max UCS
Secant	5.0 GPa	0.17	from 0 % to 50 % of Max UCS
