19-25 Balfour Street, Lindfield

Aboriginal Heritage Due Diligence

Prepared for Balfour Group Pty Ltd

May 2025

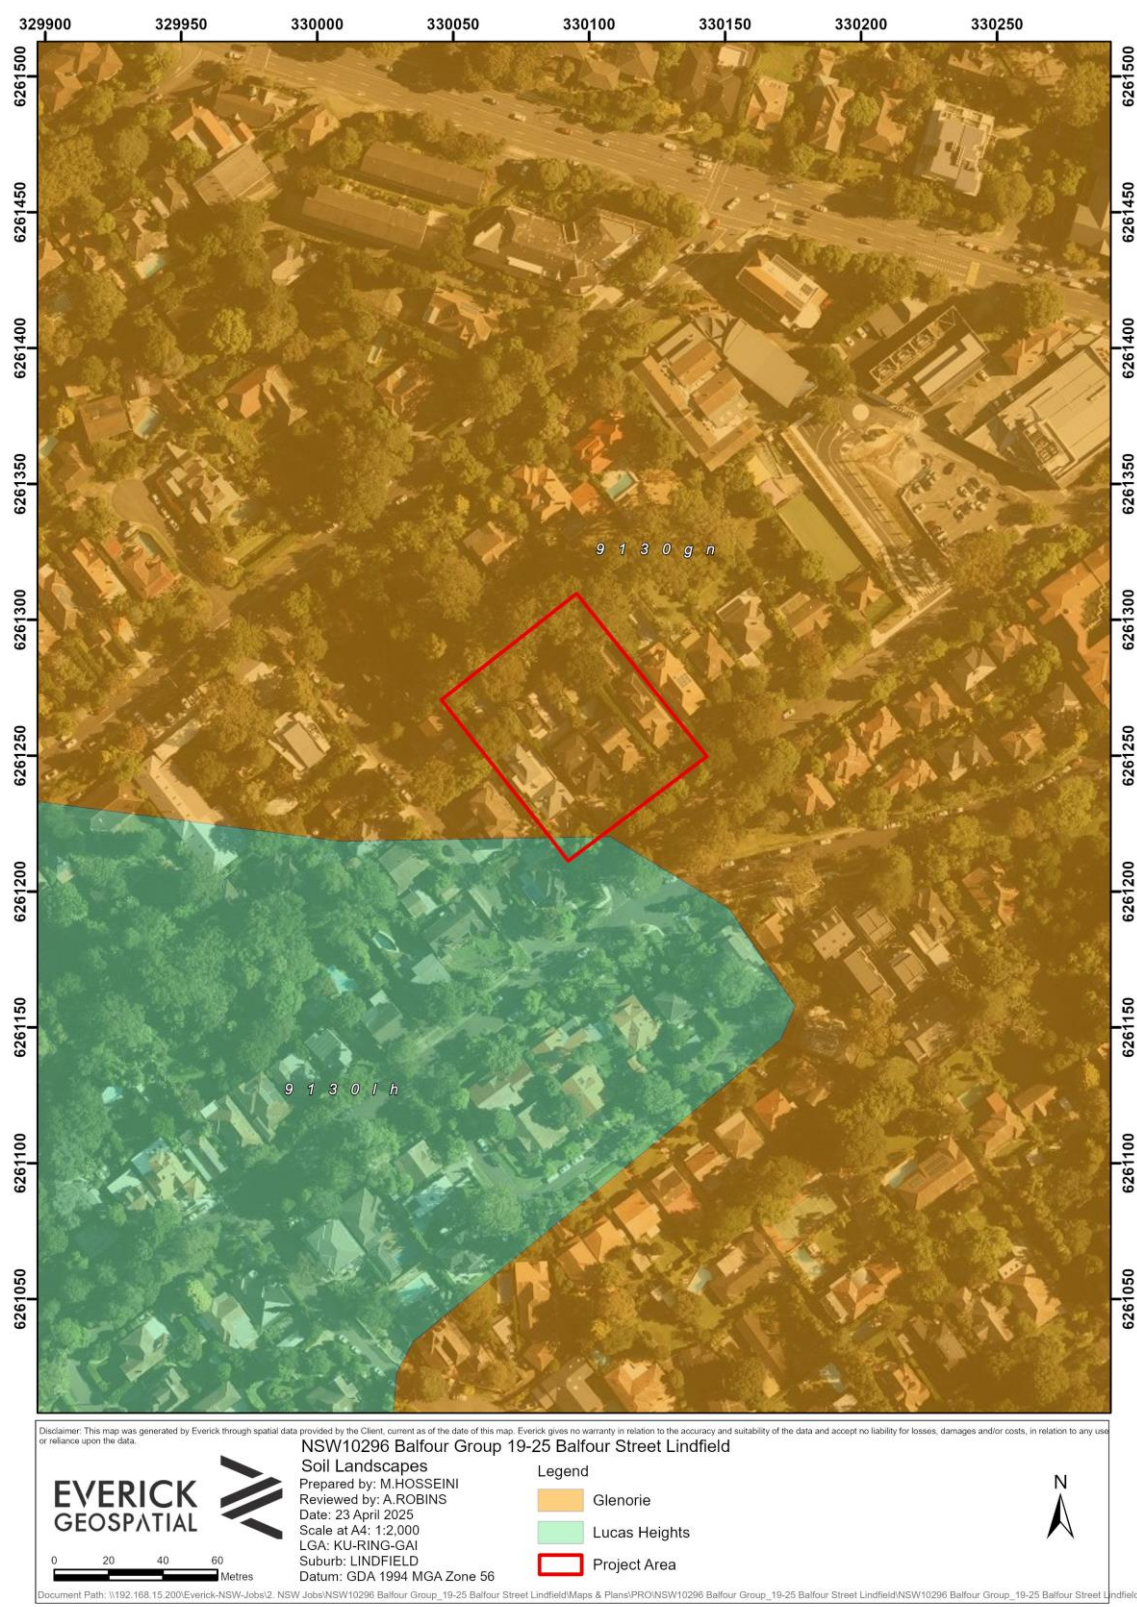
Figure 6-1: Soil Landscapes of the Project Area

This is a topographic map of the Balfour Group, showing the area around 19-25 Balfour Street in Lindfield. The map features yellow contour lines indicating elevation, with labels ranging from 66 to 112. A red rectangle highlights the project area, which is situated on a slope. The map also shows residential buildings, trees, and a road. The map is overlaid with a grid of coordinates, with Easting values from 329900 to 330250 and Northing values from 6261050 to 6261500. A scale bar at the bottom left indicates distances up to 60 metres. A north arrow is located at the bottom right. The map is titled 'NSW10296 Balfour Group 19-25 Balfour Street Lindfield' and includes a legend for 'Contours' and 'Project Area'.

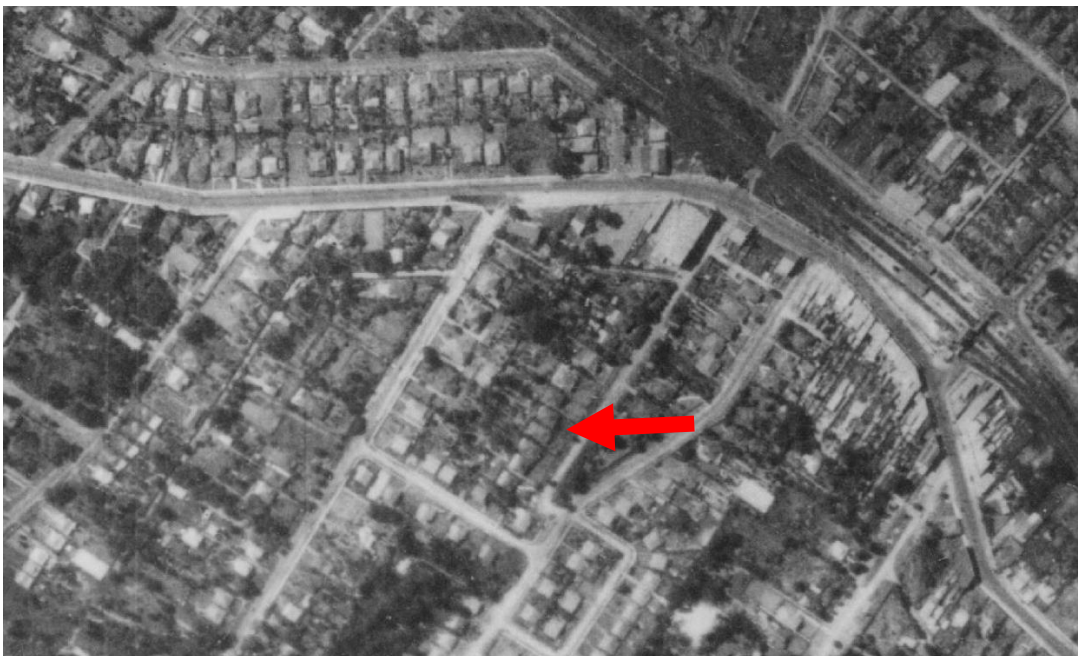
Figure 6-4: Historical Aerial from 1930 shows the Project Area largely cleared of mature vegetation and occupied by low density housing.

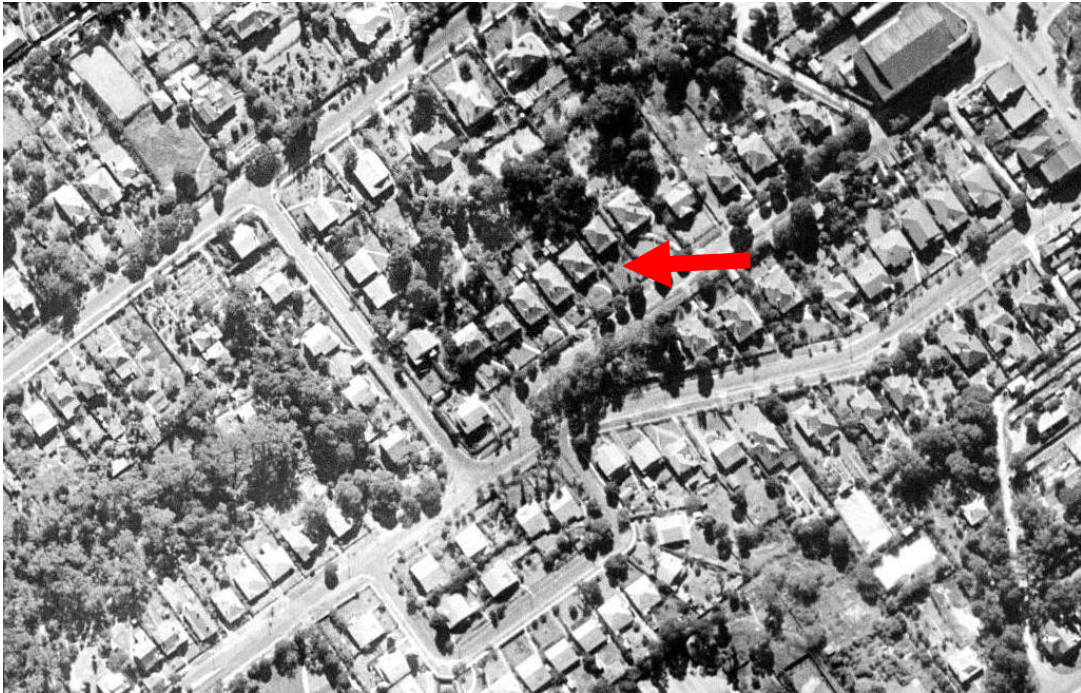
Figure 6-5: 1943 Historical Aerial shows the area has regrown several large trees and is occupied by with the same low-density housing present today. Note the smaller footprint of the rightmost house at 19 Balfour Street.

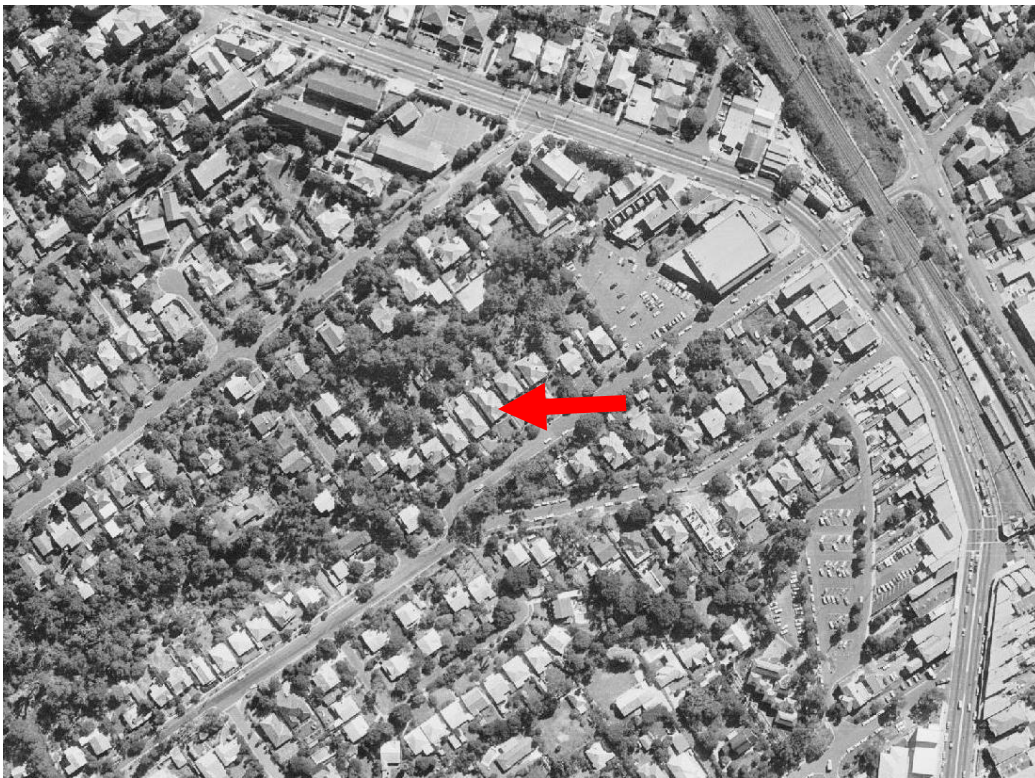
Figure 6-6: 1978 Aerial, showing continual development of the local area, same residential structures seen previously remain.

By the 1930s the lots have been cleared of vegetation, and residential properties had been constructed within the Project Area (Figure 6-4). These appear consistent with the Federation Queen Anne style housing with a frontage of large trees and hedges present today (Ku-ring-gai Council 2015). Construction and renovation of the residential properties has resulted in significant disturbance. Each of the four properties within the Project Area have landscaped front gardens with the addition of driveways and stone walls. Though the impacts of concrete slabs and laid pavers are relatively moderate, each of the front gardens appears to have undergone some form of landscaping or the deposition of soils from other areas. Aerial imagery from 1940s and 1970s shows progressive increases in tree cover within and surrounding the Project Area (Figure 6-5 and Figure 6-6). Imagery from 2025 shows the Project Area substantially similar with that seen previously, additional tree cover is present, however all four residential properties are retained (Figure 6-7).

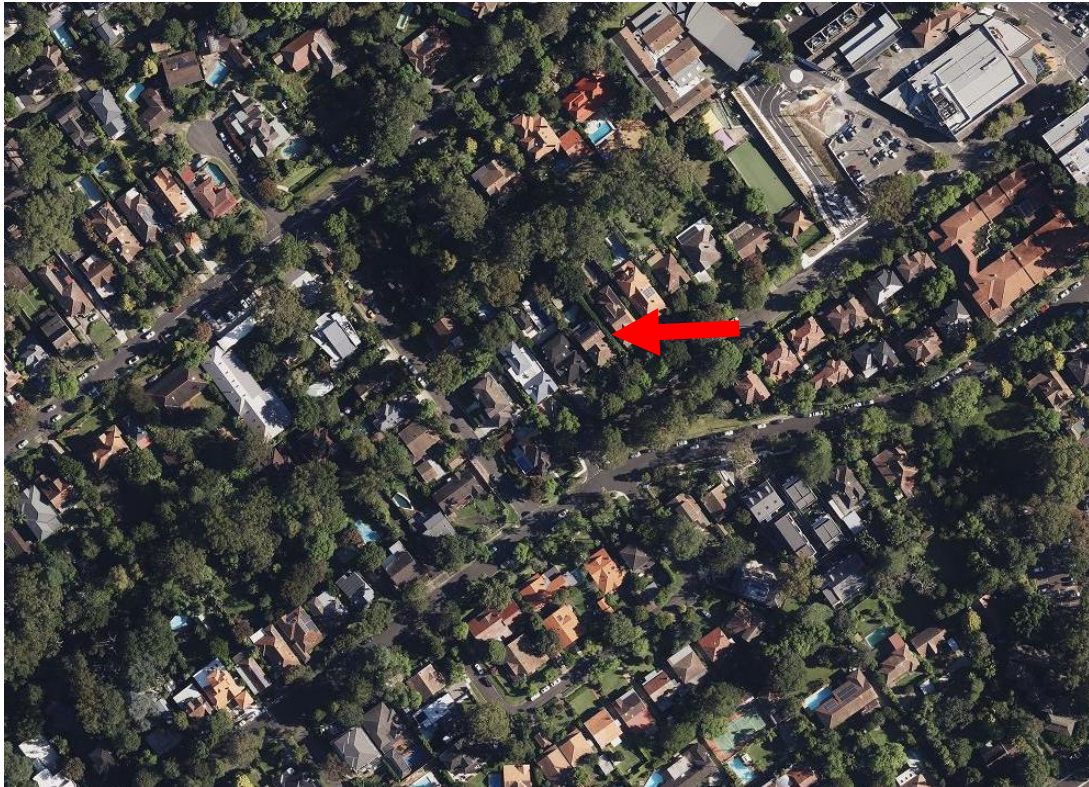
Figure 6-7: 2025 satellite imagery shows the installation of several pools in the back gardens of each of the properties.

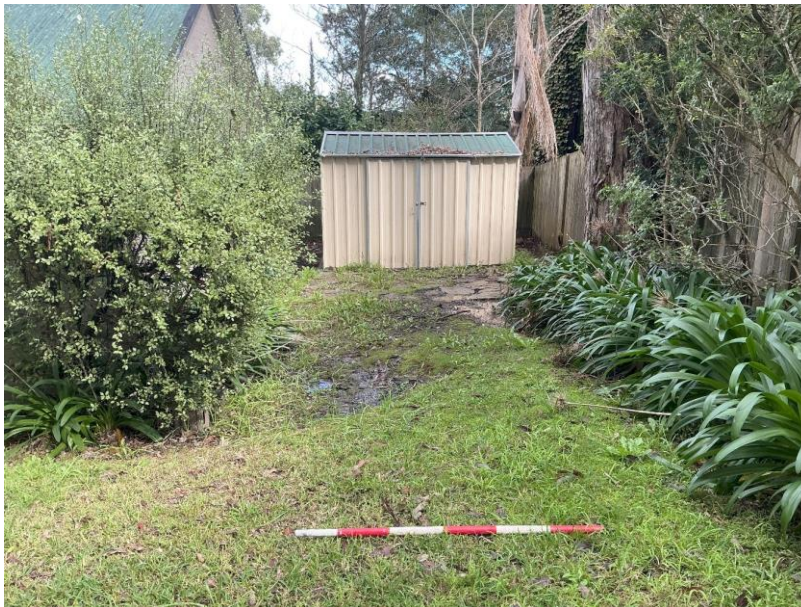
**Figure 6-9: Terracing and ancillary structure, 19 Balfour**

The visual inspection found that the Project Area had been heavily terraced with large retaining walls visible, little natural slope remains (Figure 6-9 – Figure 6-11). Imported fill was present throughout although material displaced during the terracing was also present. Four residential properties with exterior landscaping, ancillary building, pools and associated services were seen (Figure 6-12 – Figure 6-15), which would have had a significant impact on subsurface potential.
