Re: Aboriginal Heritage Impact Assessment Report – 1-5 Nelson Road, Lindfield NSW 2070

Artefact Heritage and Environment Pty Ltd (Artefact Heritage) have been engaged by Castle Hill No. 3 Pty Ltd to prepare an Aboriginal Heritage Impact Assessment Report for the proposed works at **1-5 Nelson Road, Lindfield NSW 2070**.

1.0 PROJECT INFORMATION

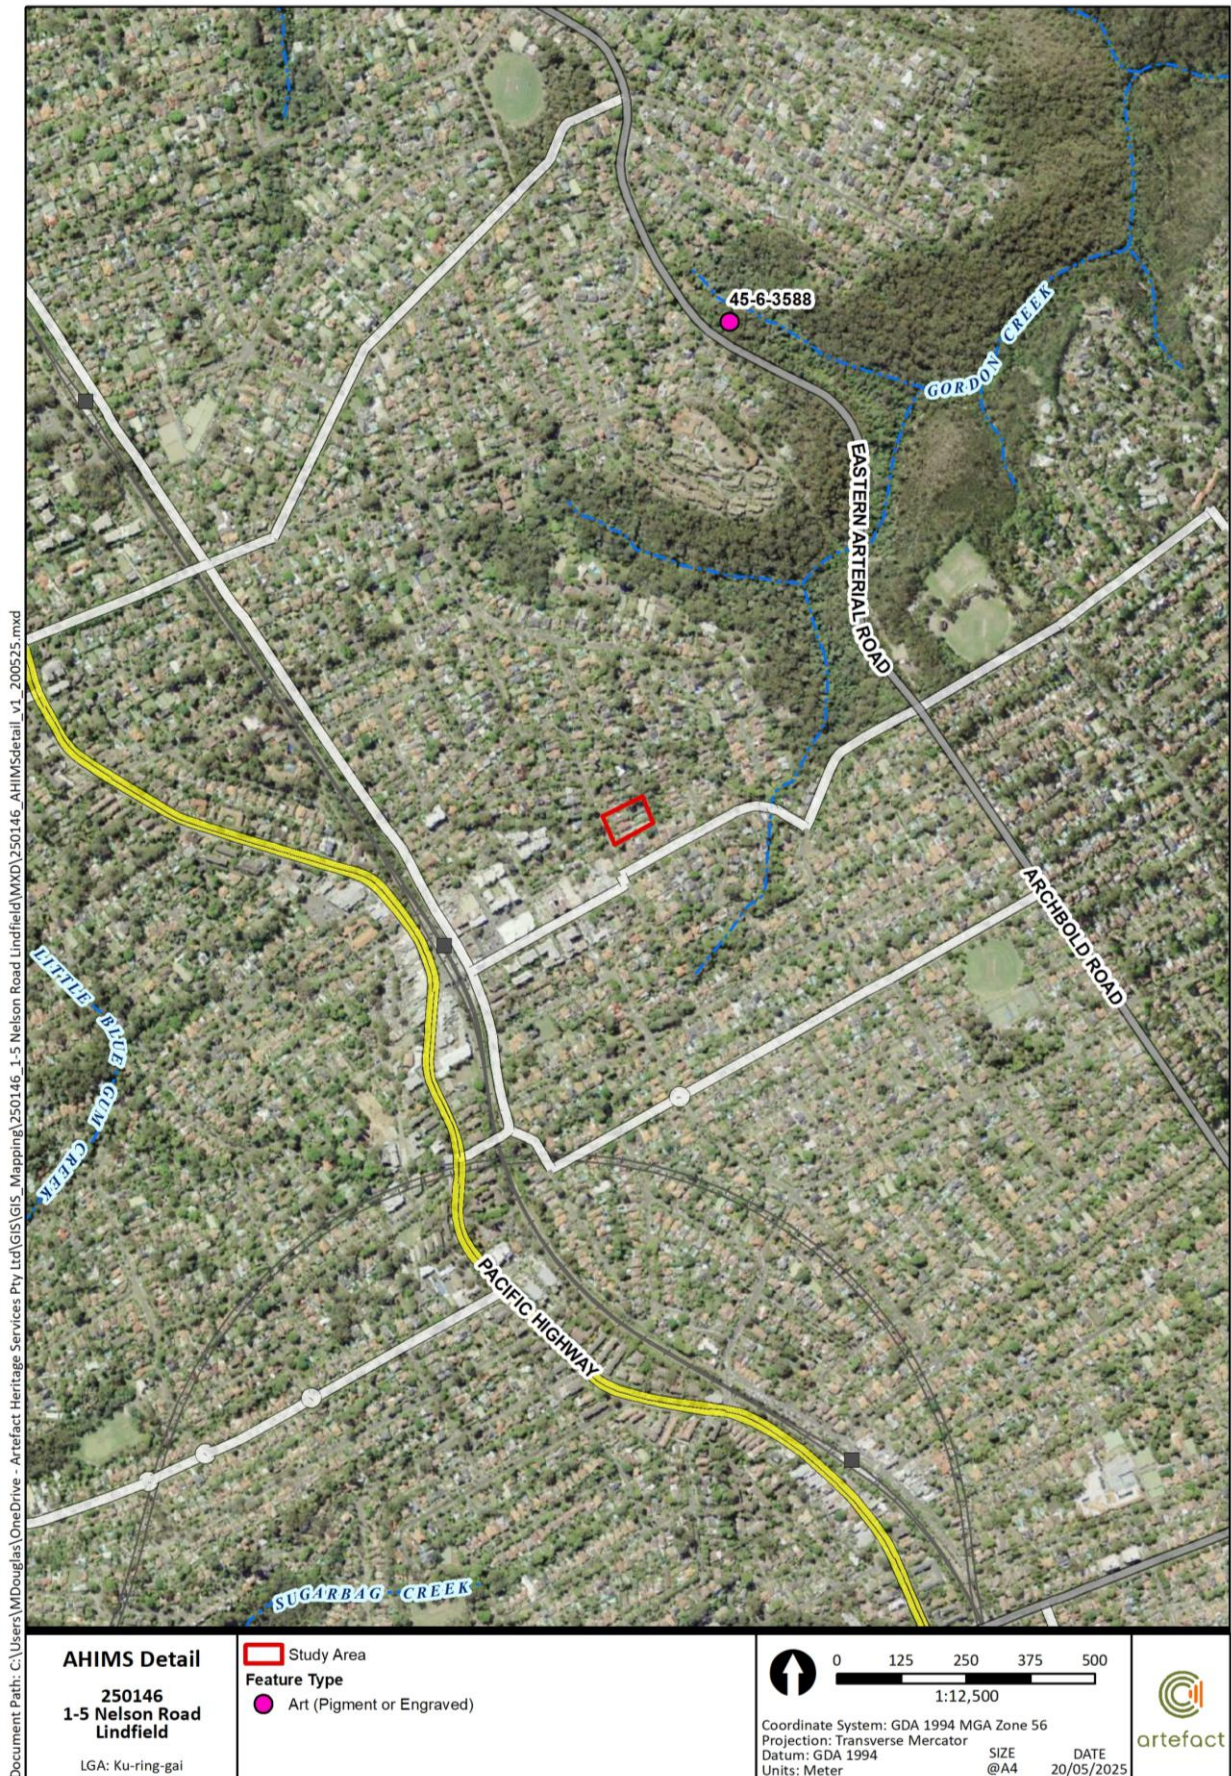
Figure 7: AHIMS detailed search results

A total of 43 registered Aboriginal sites were identified within the search area (Figure 6). There are no registered Aboriginal sites within the study area. The closest AHIMS site identified in the search area is a closed art site (AHIMS ID 45-6-3588), which is located approximately 935m northeast of the study area (Figure 7).

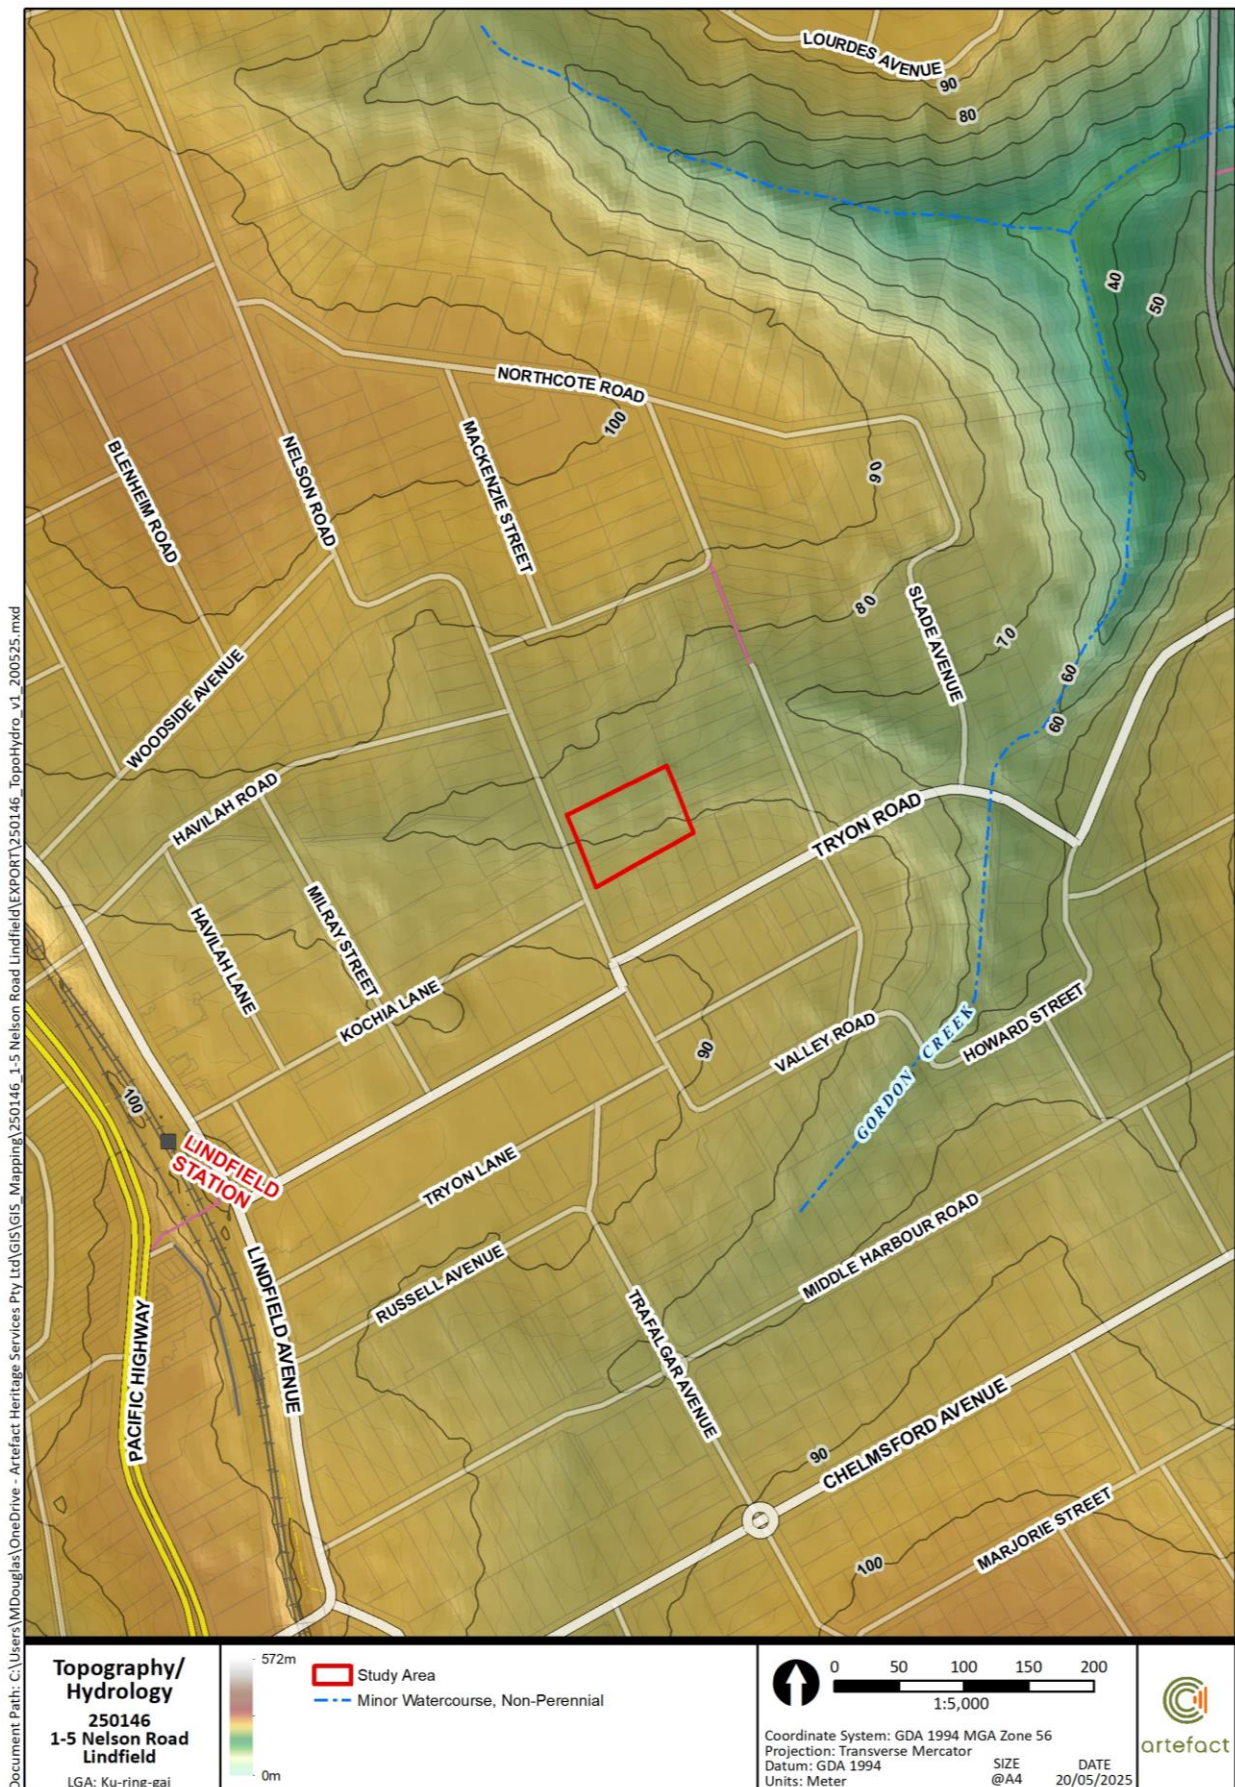
Figure 10: Topography and Hydrology in relation to the study area

The natural topography of the study area and the region surrounding it consists of ridgelines, precipitous and steep slopes descending to the numerous creeks in the region, including Gordon Creek, Middle Harbour Creek and Lane Cover River (Figure 10). However, much of the land surrounding the study area has been subject to modification by residential and infrastructural developments.

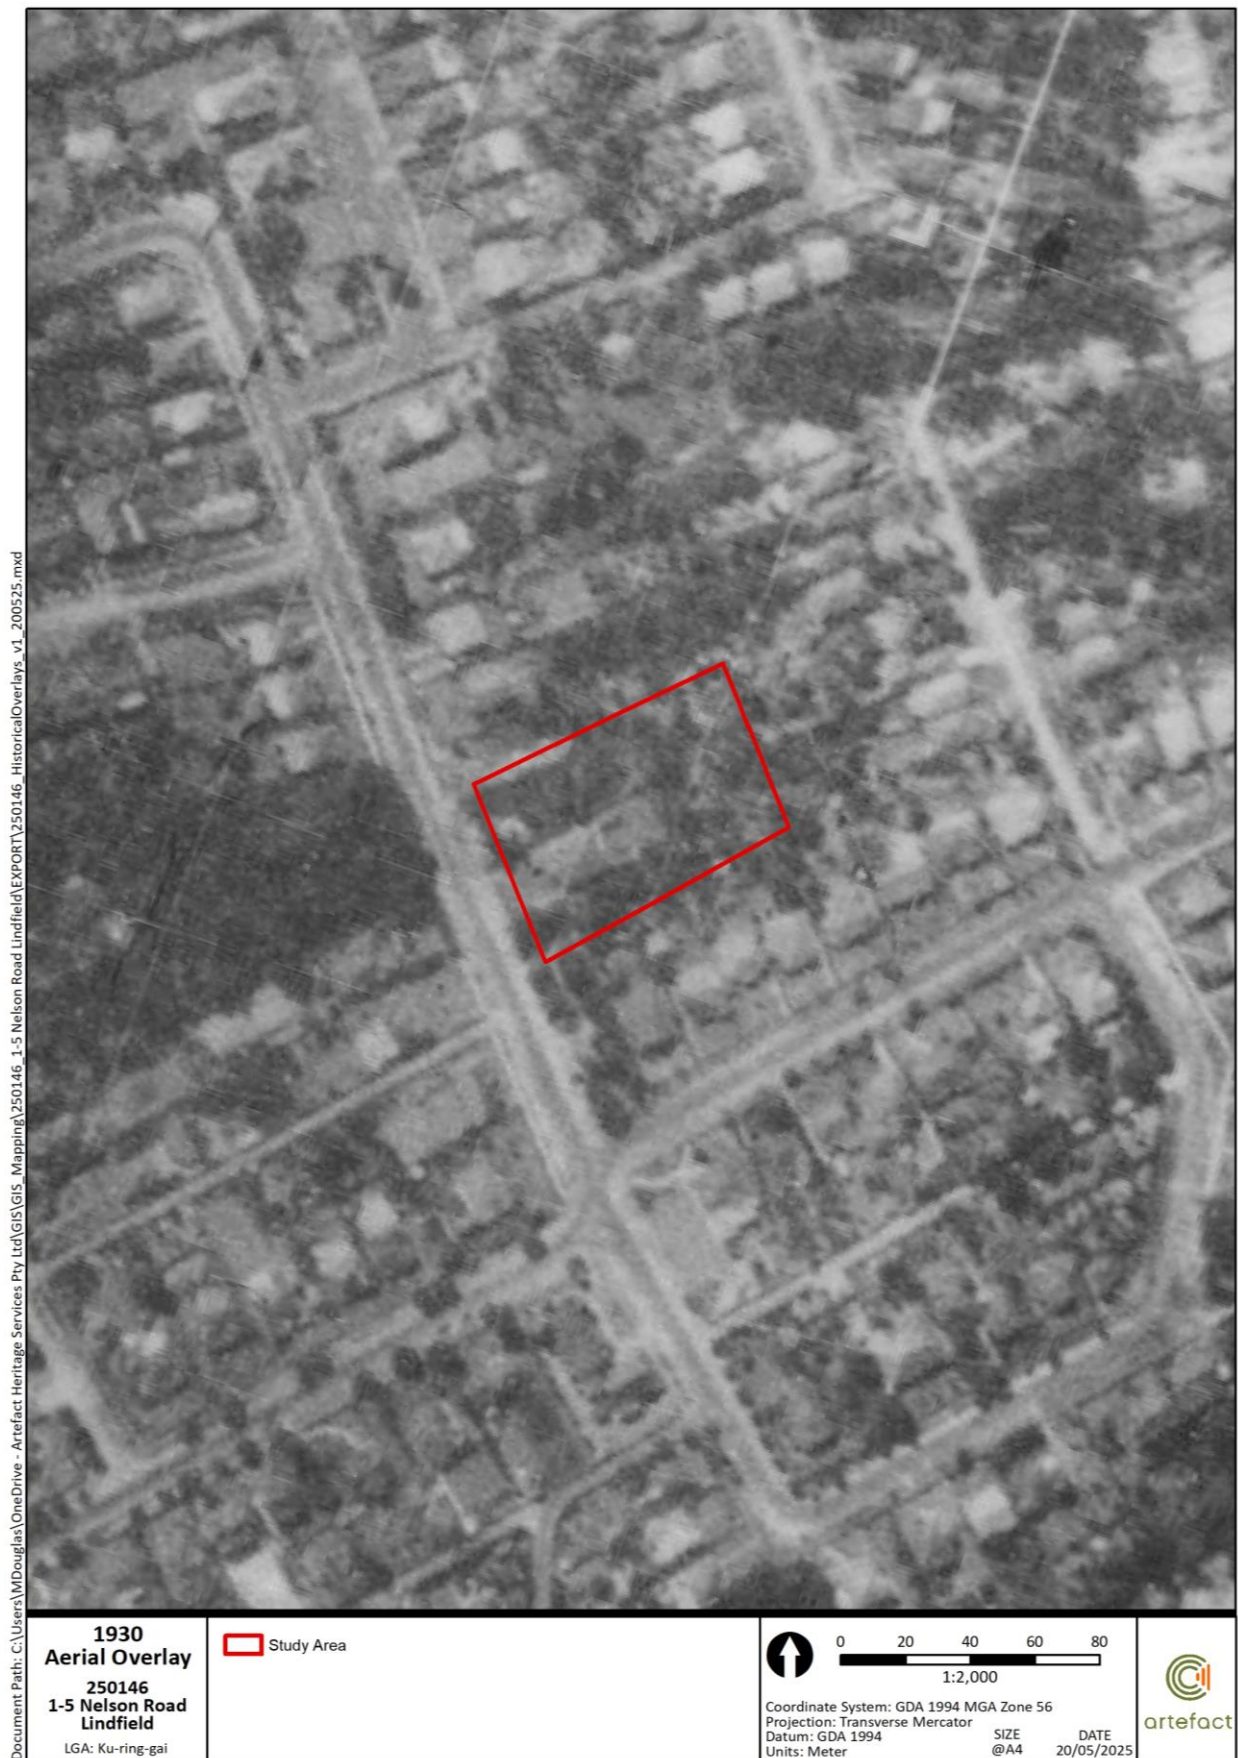
A review of historical aerials from the 1930s to the 2010s demonstrate that the study area has been subject to residential development from sometime prior to 1930. In 1930, a residential development was present in the centre of the study area, however it is unclear whether there were also houses in Lots 6 and 8 of DP9789 due to the aerial quality and dense tree cover across the site (Figure 11).

Figure 11: 1930 historical aerial showing a residential property in the centre of the study area

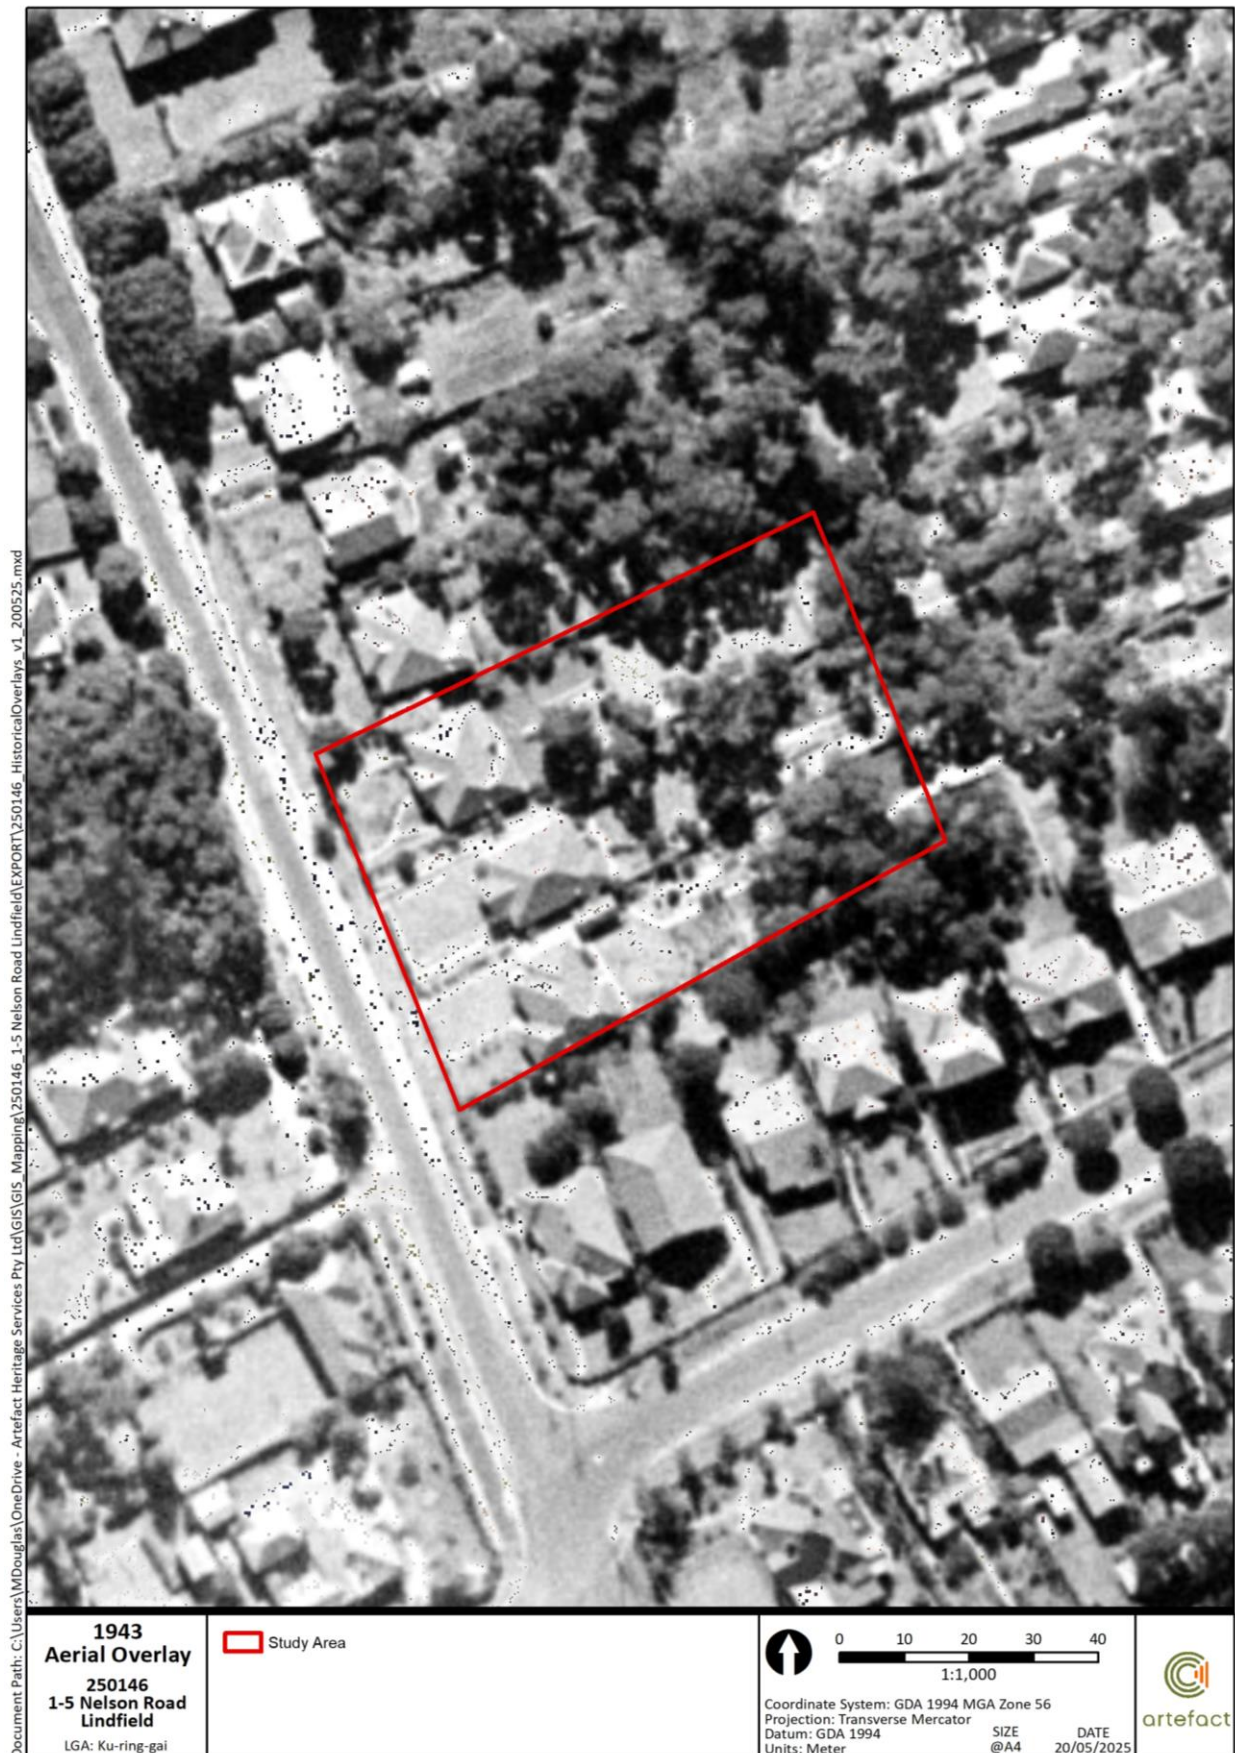
By 1943, the majority of the study area was cleared of trees and the ground landscaped. Aerial photos from this time demonstrate that there were three residential properties plus additional structures also present within the study area (Figure 12). However, some of these additional structures may have been temporary as they are not present in the 1960s aerial (Figure 13).

Figure 12: 1943 historical aerial showing the clearance of trees and three residential properties with additional structures within the study area

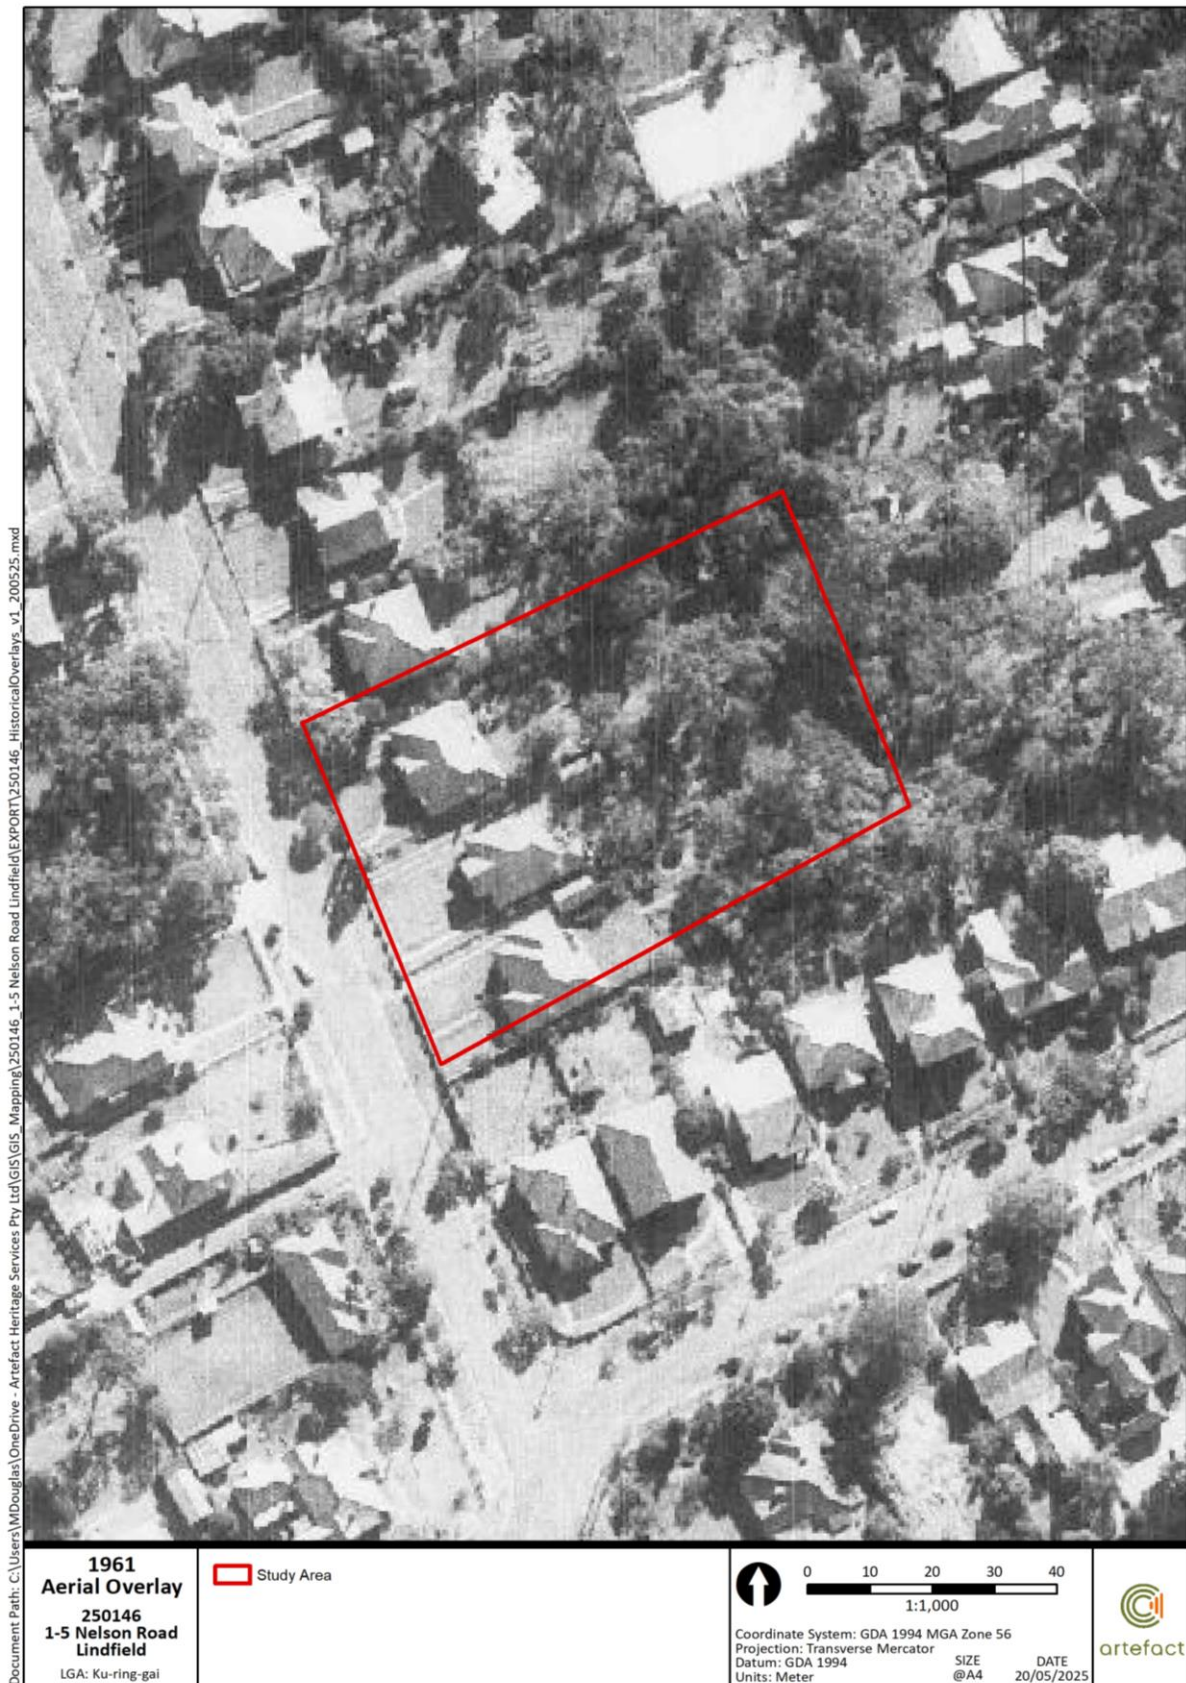
Figure 13: 1961 historical aerial showing additional structures are no longer present within the study area

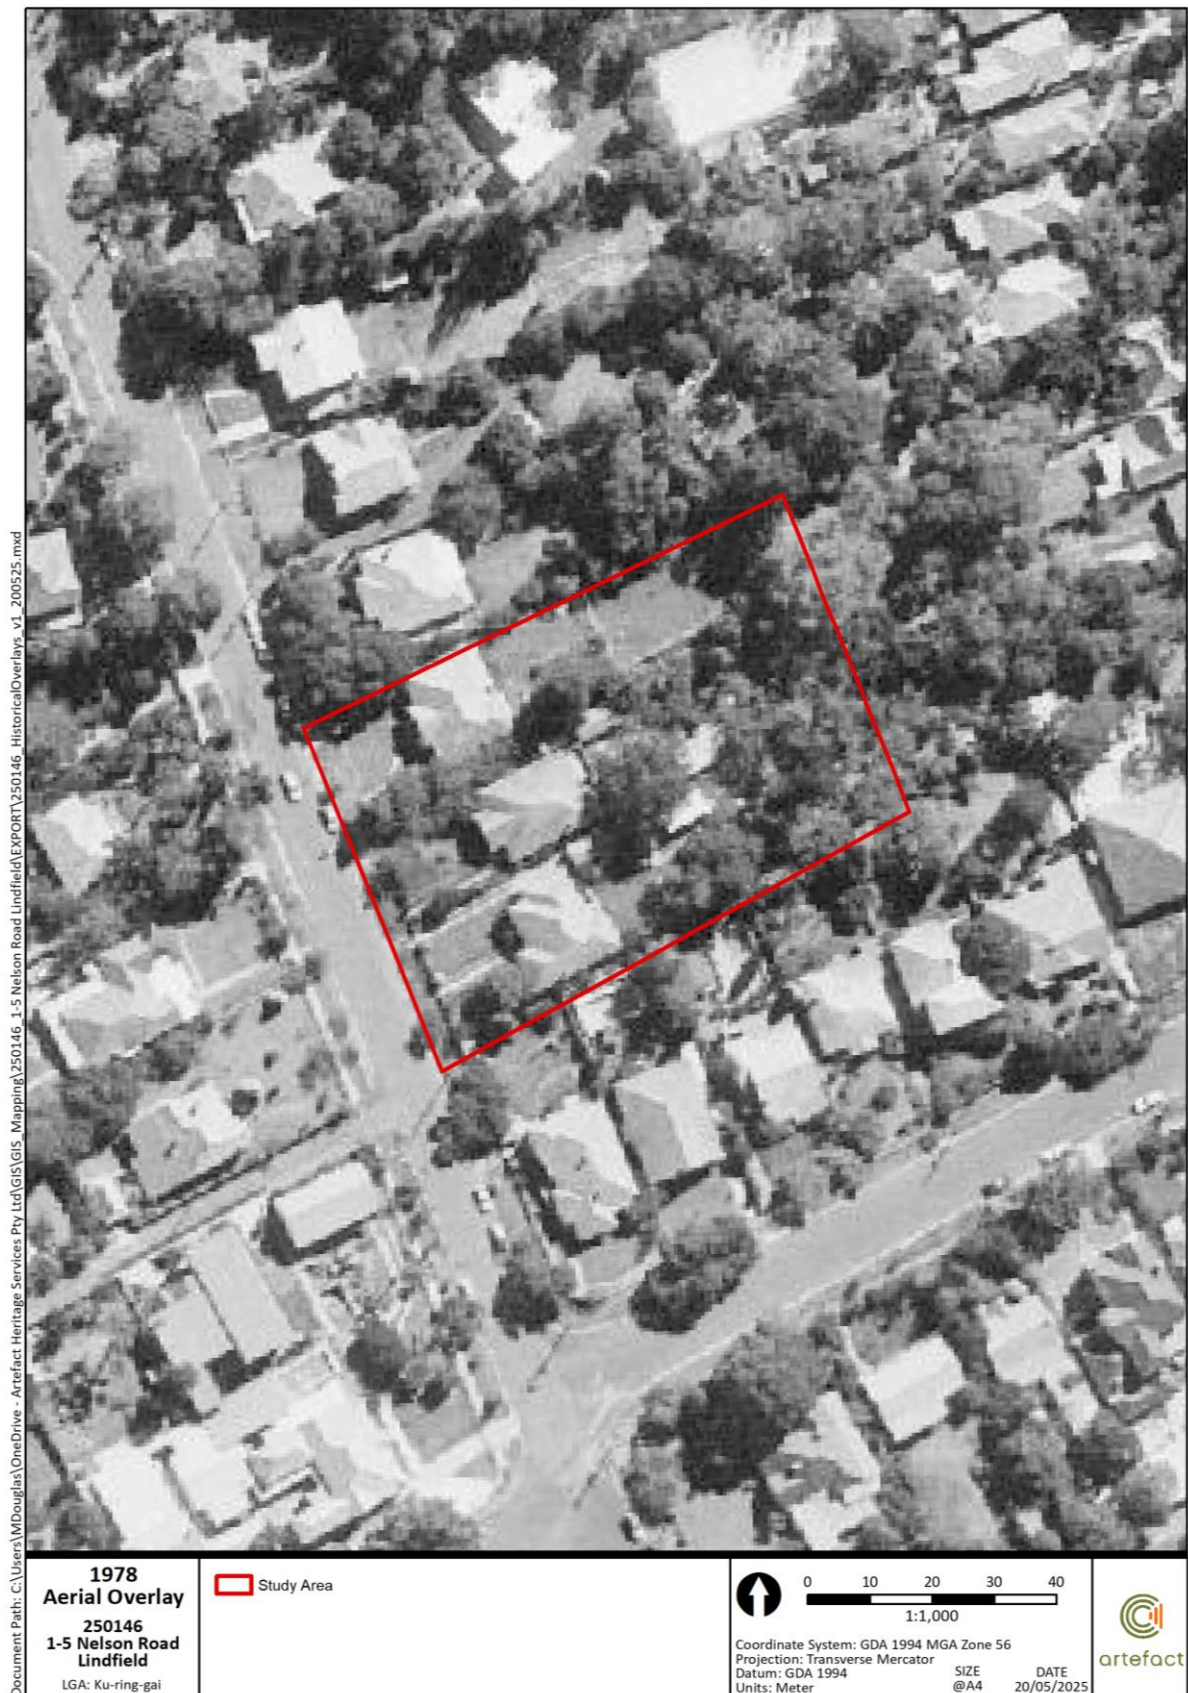
In 1978, a tennis court was present on Lot 8 DP9789 and further clearing of trees had occurred (Figure 14). Within Lots 6 and 7, new structures were observed within the study area as well as a new concrete driveway on the northern side of Lot 7 (Figure 15); although, some of these structures had been removed by the mid-1990s. Trees had also been cleared from the backyard of Lot 6 by the 1990s (Figure 16).

Figure 14: 1978 historical aerial showing a tennis court in Lot 8

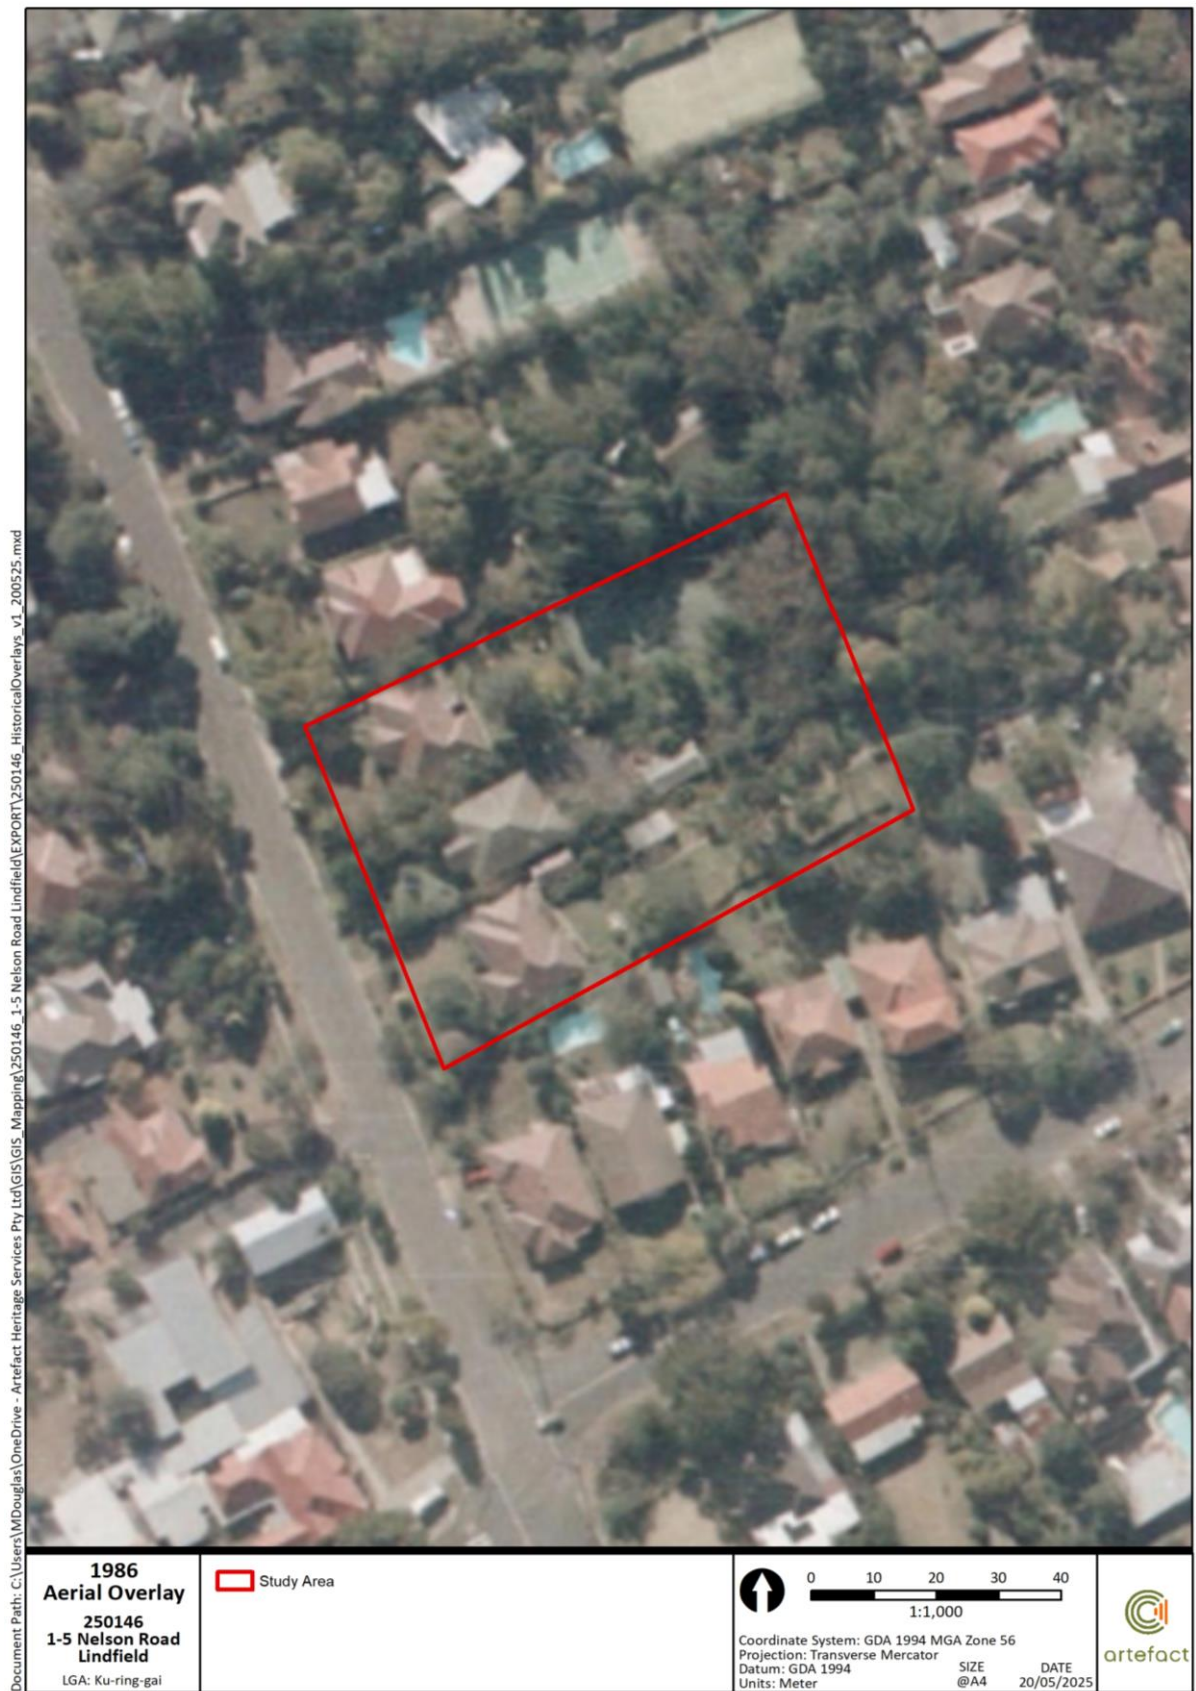
Figure 15: 1986 historical aerial showing new structures within the study area

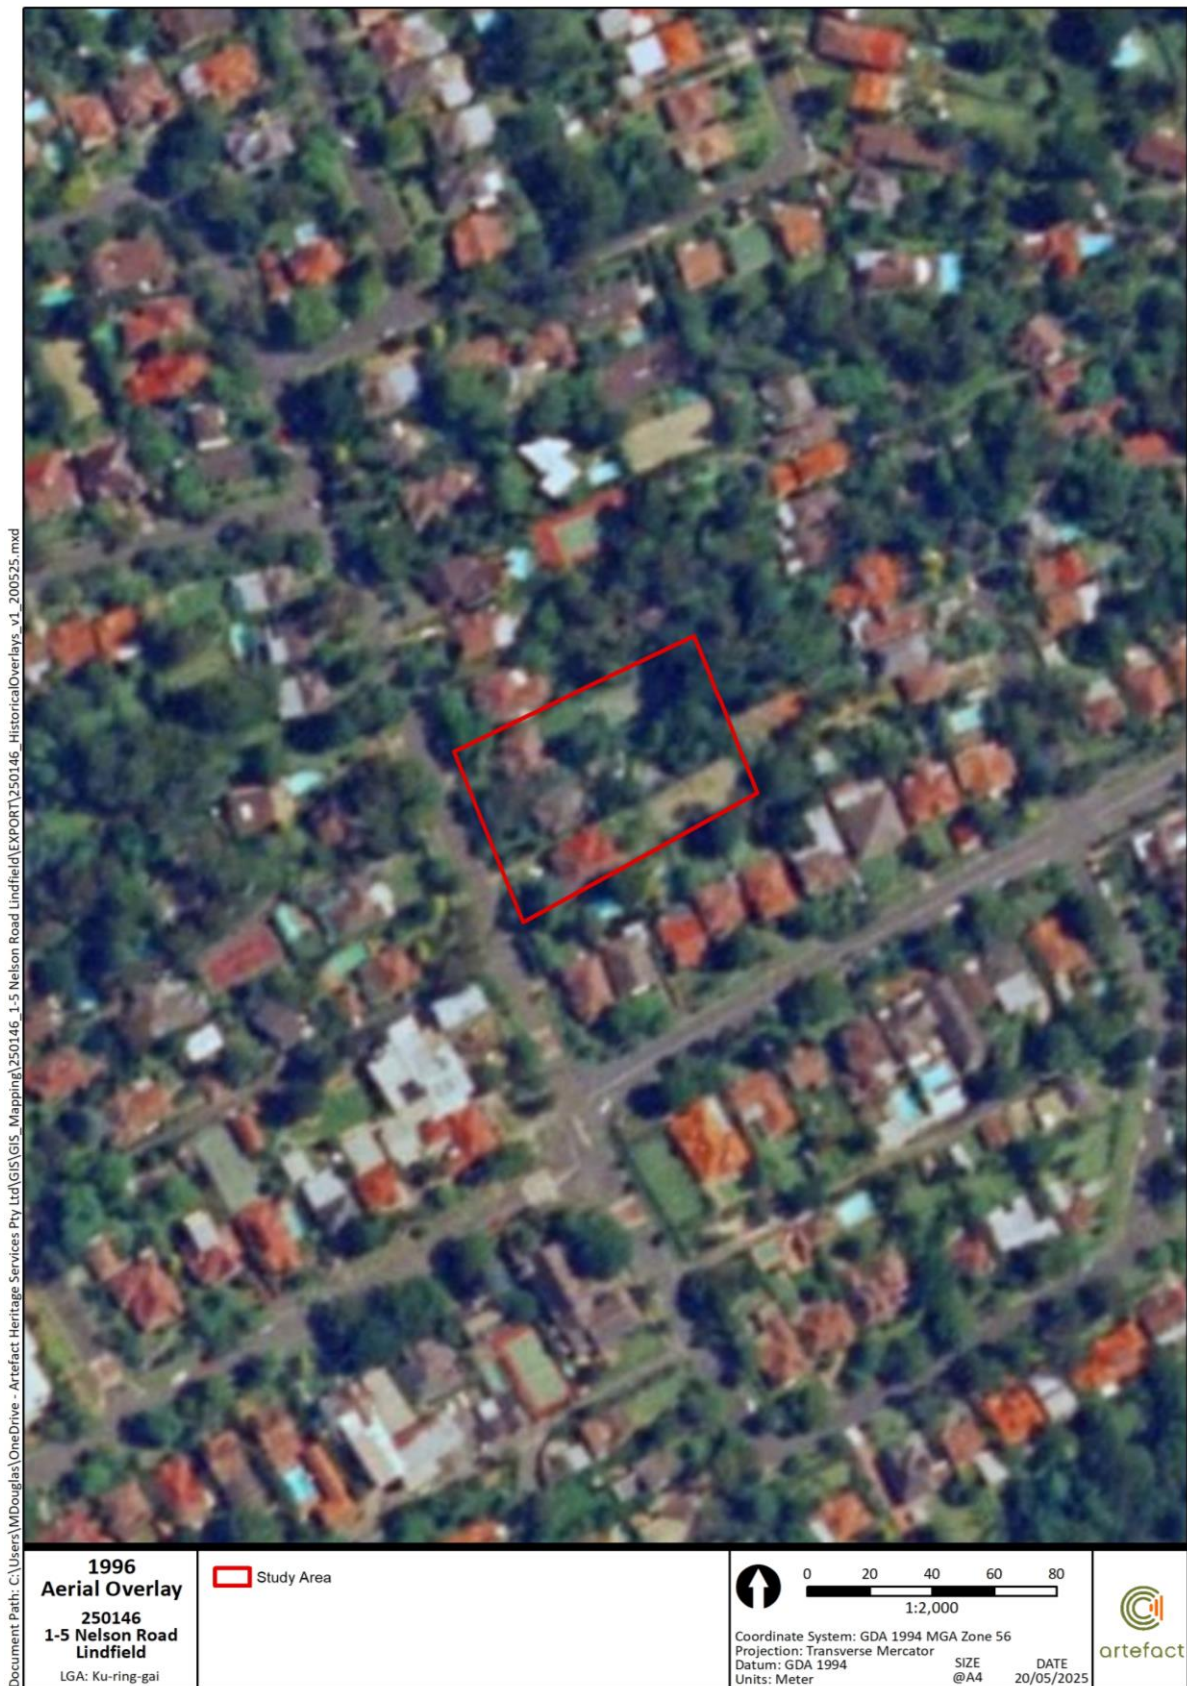
Figure 16: 1996 historical aerial showing new structures are longer present and trees have been cleared from the backyard of Lot 6

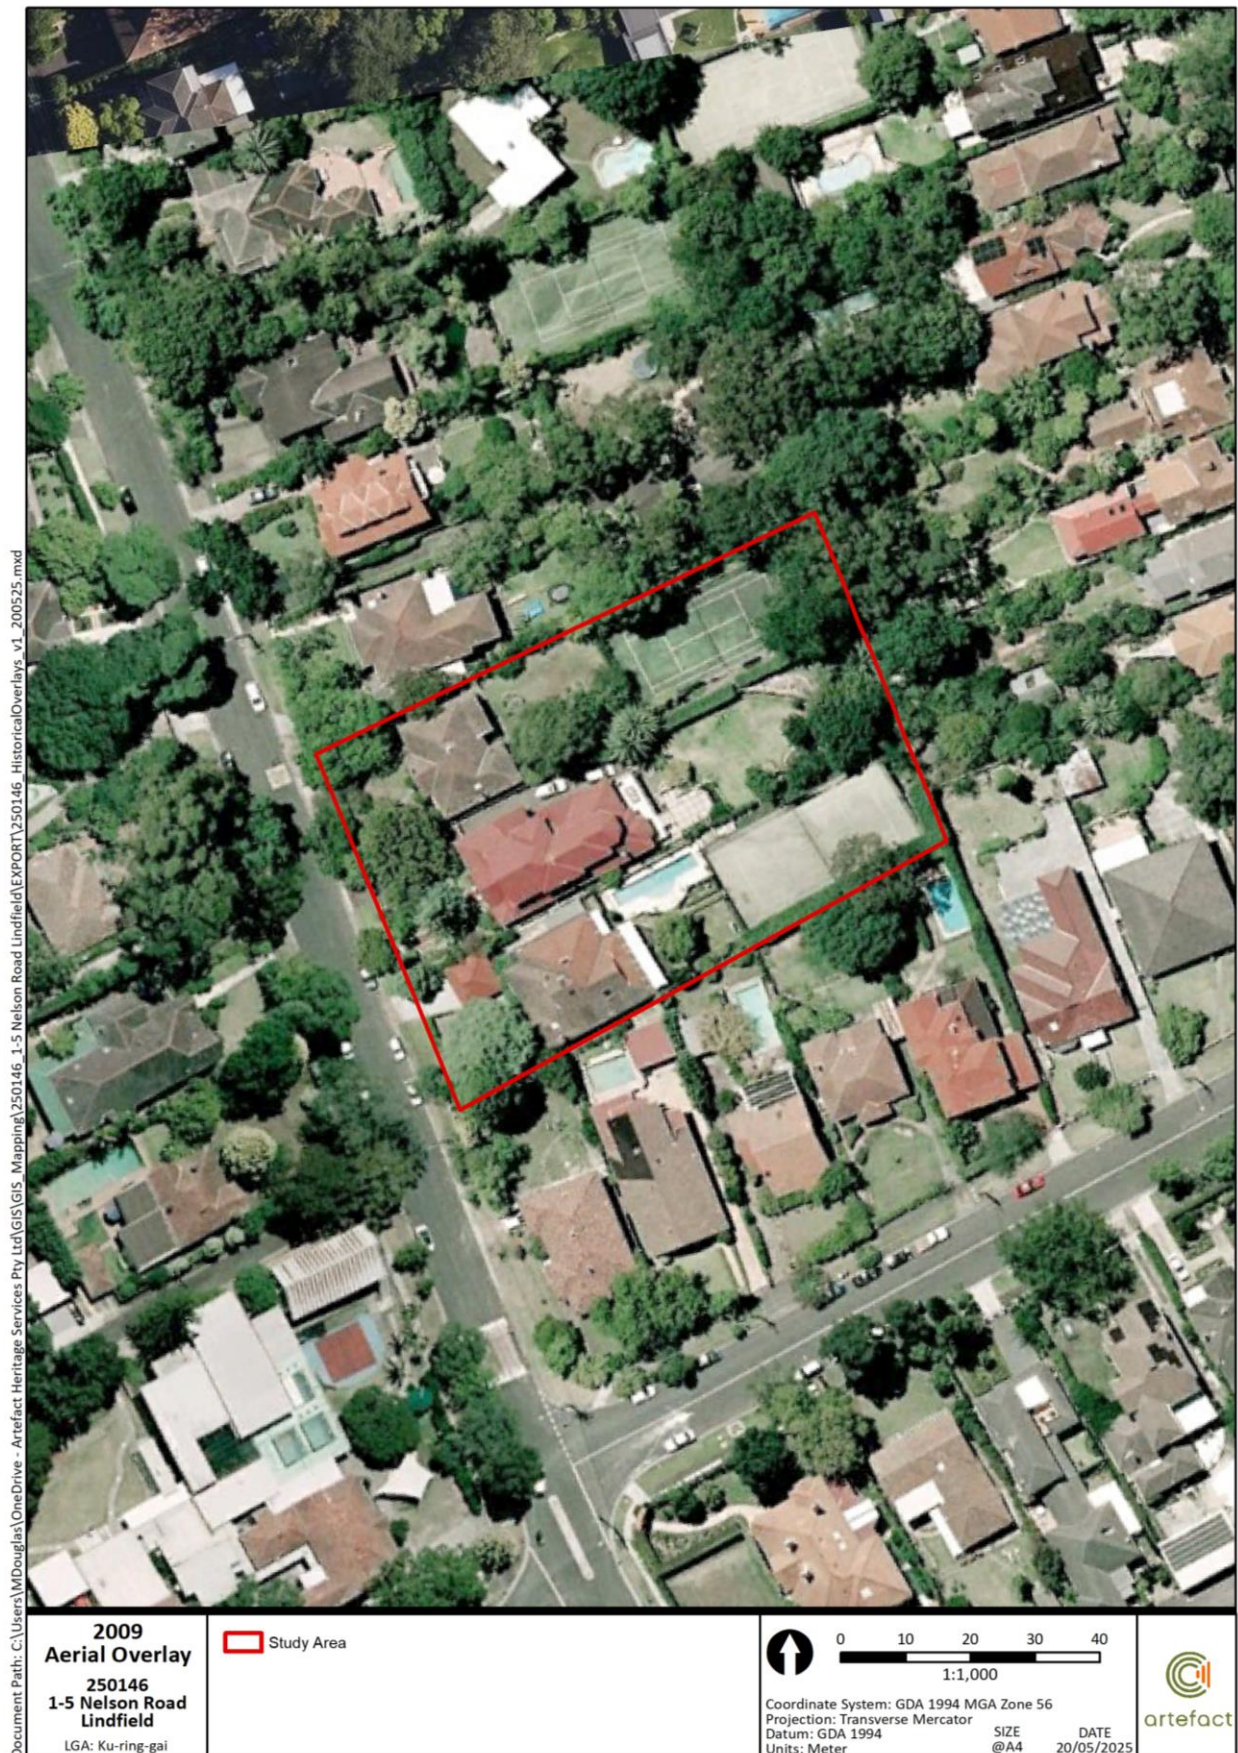
By 2009, there is evidence of further ground disturbance as the residential property within Lot 6 had been extended to the western side. A pool and additional structures on the eastern side of the lot were also constructed (Figure 17). Furthermore, the residential property within Lot 7 had been extended to the east and the garden landscaped.

Figure 17: 2009 historical aerial including new pool and structure within Lot 6 and extensions to eastern side of Lot 7

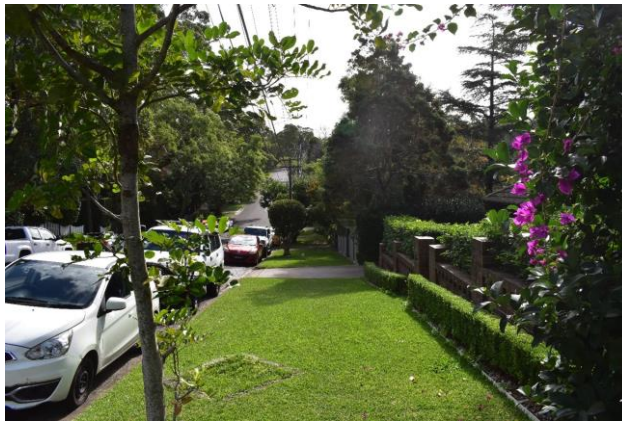
The study area was observed to extend across a mid to lower slope decreasing in elevation from south to north (Figure 18 and Figure 19). Extensive terracing and landscape modification was observed across all lots, particularly nearer to their frontage to Nelson Road. These earthworks are likely to have disturbed natural soil profiles and impacted any Aboriginal objects which may have previously been present within the study area.

Figure 18: Street frontage of 1 Nelson Road showing downward slope (north view),

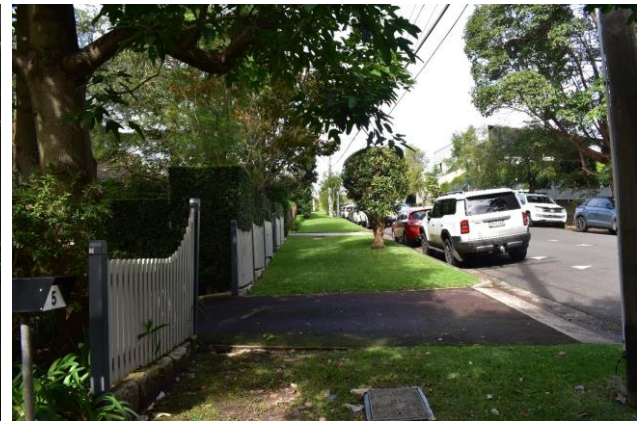
Figure 19: Street frontage of 5 Nelson Road showing upward slope (south view)

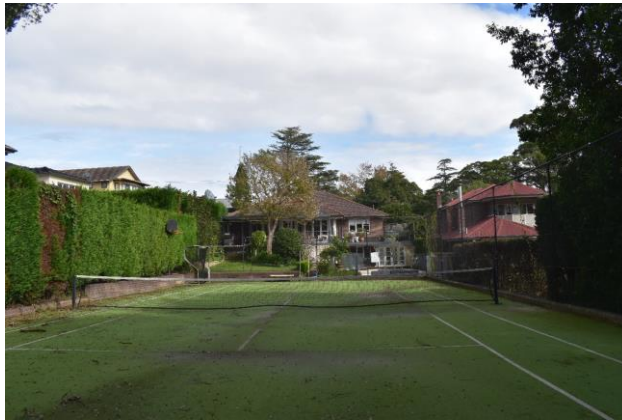
Significant landscape modification was observed at the location of the residential structure in the western portion of the lot (Figure 20). Elements of landscape modification included the installation of stairs against the slope of the landform, the construction of a swimming pool and terracing (Figure 21). A tennis court was observed in the eastern portion of the lot. This was identified as being constructed on a raised platform (Figure 22). Construction rubble, fill comprised of silt and sand, and exposed sandstone were observed underneath the tennis court platform. Remnants of tree stumps were identified on top of the sandstone, suggesting that the original soil of this area was at a higher level and concealed underlying bedrock (Figure 23). The exposed sandstone observed during the visual inspection showed evidence of modern cut marks, indicating damage to any rock surfaces which may have been originally exposed or contained Aboriginal objects (Figure 24). Drainage channels and underground services were observed throughout this lot, indicative of land disturbance.

Figure 20: 1 Nelson Road from eastern end of lot. Terracing visible towards the house and left of photo (southwest view)

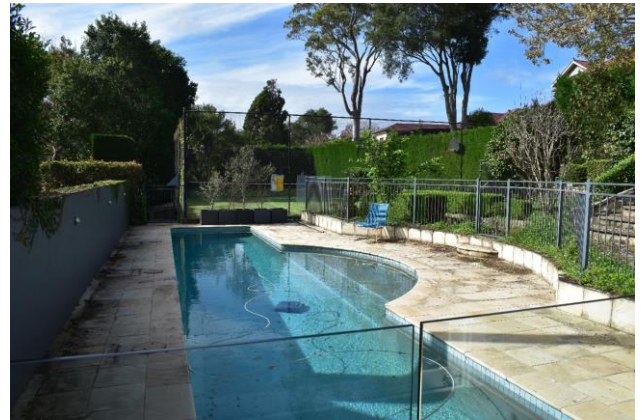
Figure 21: 1 Nelson Road, swimming pool view (northeast view)

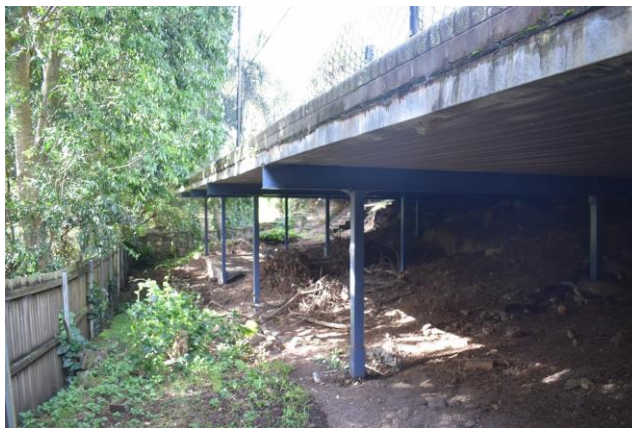
Figure 22: 1 Nelson Road, tennis court platform (east view)

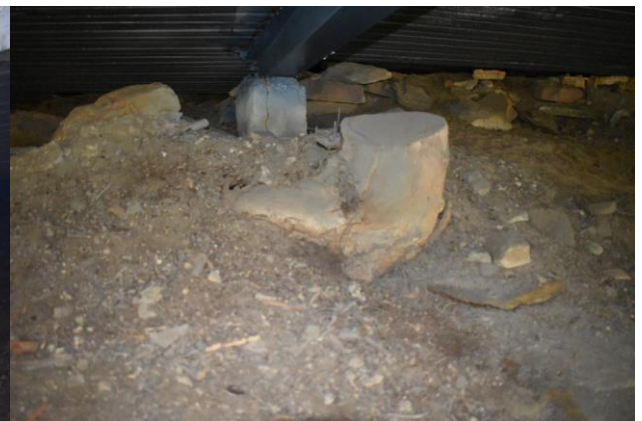
Figure 23: 1 Nelson Road, tree stump on fill beneath tennis court platform

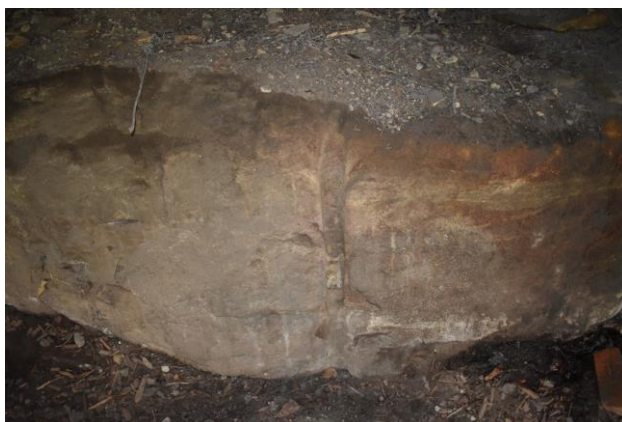
Figure 24: 1 Nelson Road, cut mark in sandstone beneath tennis court platform

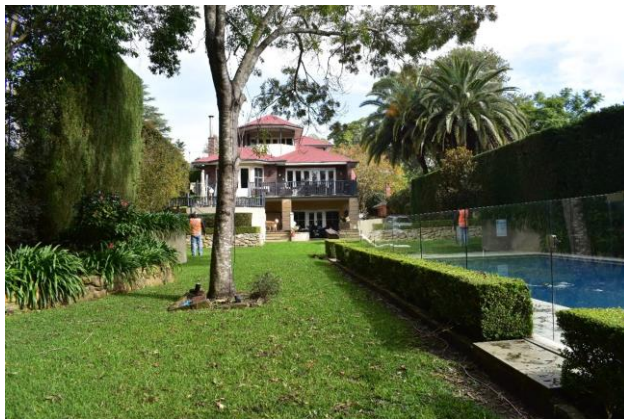
Figure 25: 3 Nelson Road (southwest view)

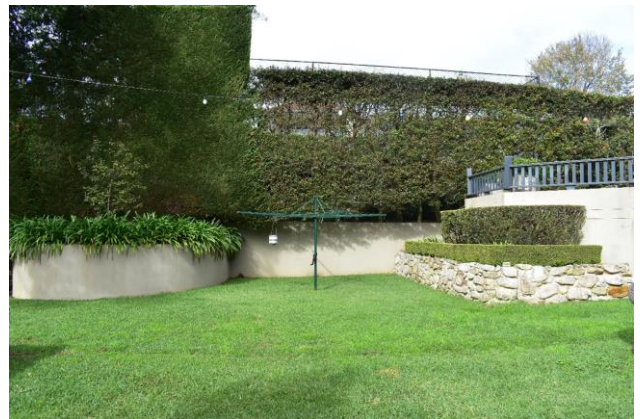
Figure 26: 3 Nelson Road terracing (southeast view)
