Re: Aboriginal Heritage Impact Assessment Report – 1-5 Nelson Road, Lindfield NSW 2070

Artefact Heritage and Environment Pty Ltd (Artefact Heritage) have been engaged by Castle Hill No. 3 Pty Ltd to prepare an Aboriginal Heritage Impact Assessment Report for the proposed works at **1-5 Nelson Road, Lindfield NSW 2070**.

1.0 PROJECT INFORMATION

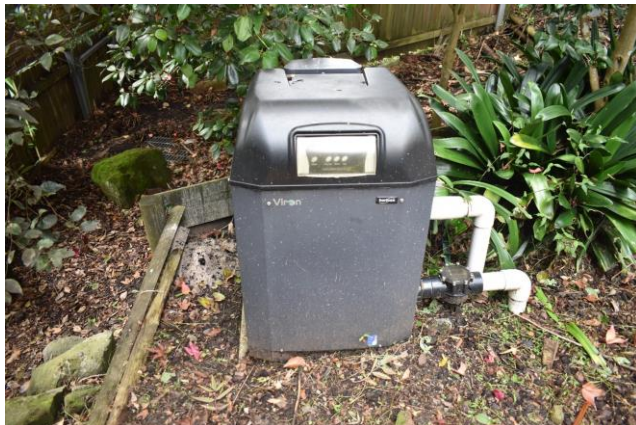
Significant landscape modification was observed at the location of the residential structure in the western and central portions of the lot. The grassed area in this lot was observed to be extensively flattened using cut and fill earthworks, disturbing any Aboriginal objects which may have previously been present in the study area (Figure 25 and Figure 26). Additional ground disturbance was identified in association with a swimming pool installed in this lot. The area at the eastern end of the lot was observed to contain the least modified landscape within this lot, retaining slope and survey markers which denote this area as a drainage line. Drainage and underground piping associated with the swimming pool were identified in the eastern end of the lot, indicating the presence of ground disturbance (Figure 27). Soft soil was identified underfoot in this area.

Figure 27: 3 Nelson Road pool services in eastern portion of lot. Note the steep slope of the fence line in the background

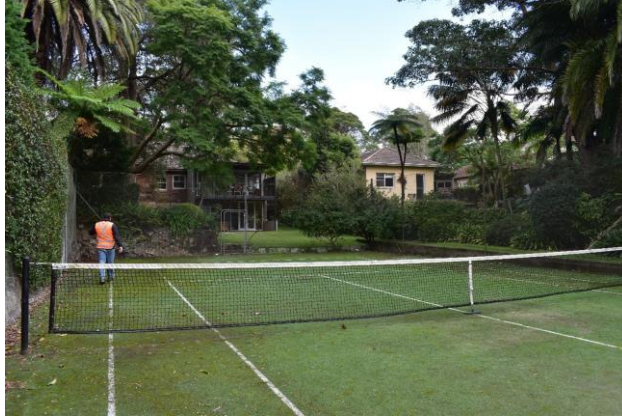
Significant landscape modification was observed across this lot. The backyard and tennis court areas were observed to be extensively flattened and terraced in comparison to the natural slope observed surrounding the study area (Figure 28 and Figure 29). It was observed that a channelised watercourse was present in the northeastern most portion of the lot. This was not thought to represent a natural watercourse due to cut marks observed in the sandstone forming the channel.

Figure 28: 5 Nelson Road terracing and landscape modification in backyard of property (west view)

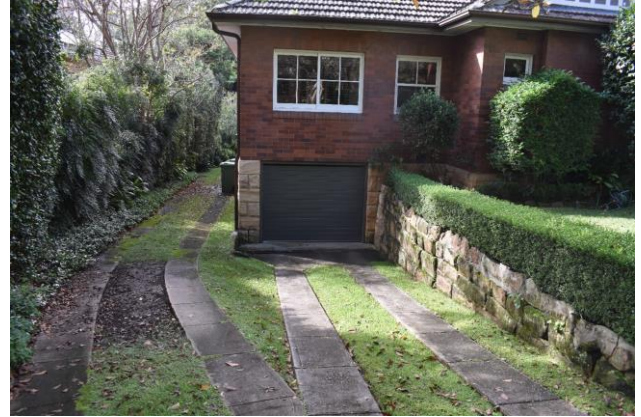
Figure 29: 5 Nelson Road terracing in front yard of property (east view)

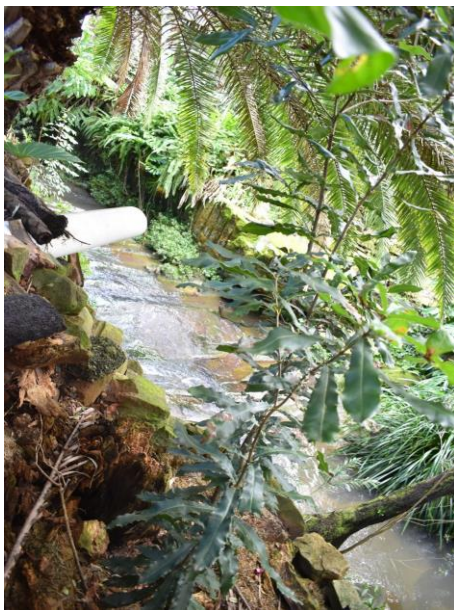
Drainage channels including plastic drainage pipes were observed to empty into the channel (Figure 30).

Figure 30: 5 Nelson Road channelised watercourse along eastern boundary of lot. Plastic drainage pipe and cut mark on stone visible
