Geotechnical Desktop Study 1-5 Nelson Road, Lindfield NSW

Prepared for: Castle Hill No.3 Pty Ltd

Reference: P3531_01

Date: 29 May 2025

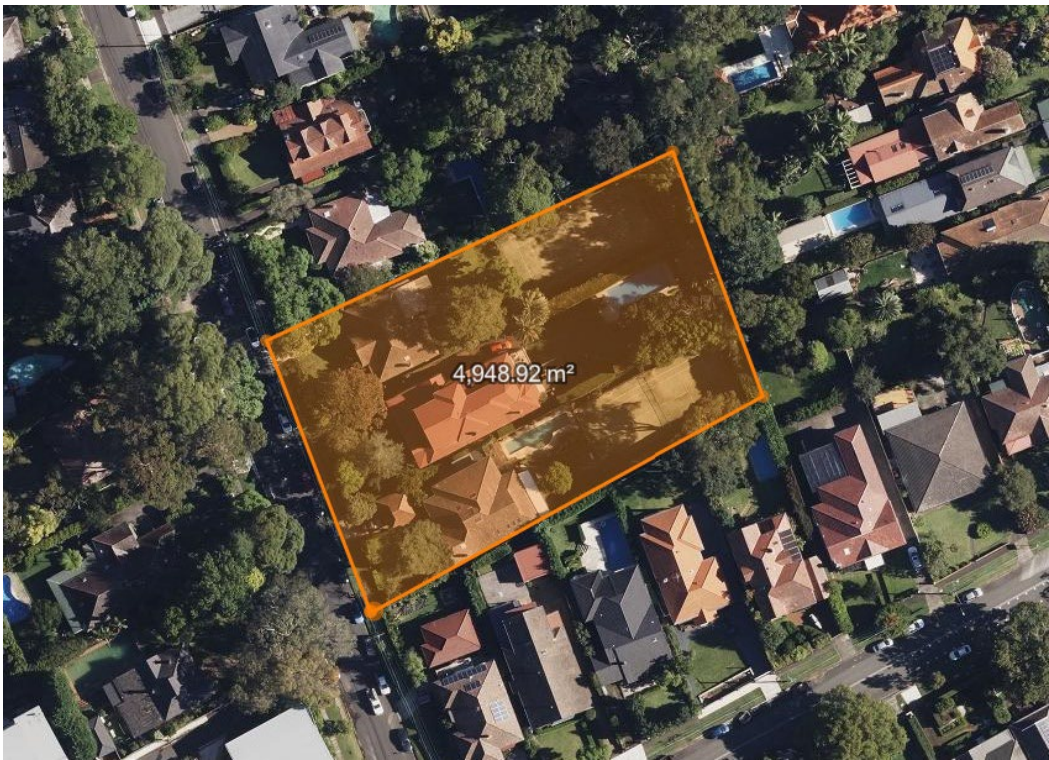
Figure 1 Site Plan (source: <https://portal.spatial.nsw.gov.au/explorer>; 13 May 2025)

Information	Detail
Local Government Authority	Ku-ring-gai Council Local Government Area
Site Description	The site comprises three lots and is rectangular in shape. See Figure 1 . At the time of the study the site is occupied by three single storey residential properties with a swimming pool at the north-eastern boundary of 3 Nelson Road, Lindfield NSW
Current Zoning	R2 – Low Density Residential, Ku-ring-gai Local Environmental Plan 2015. See Figure 2
Site Area	Approximately 4950 m ² (from NSW Spatial Explorer, https://portal.spatial.nsw.gov.au/explorer)

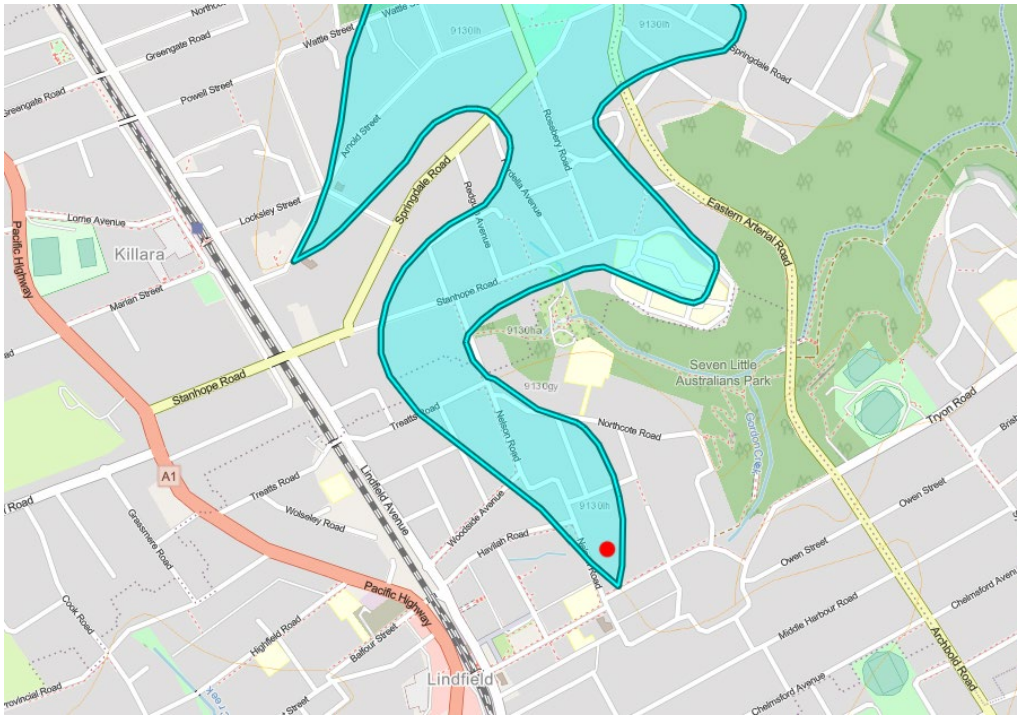
Figure 3 Lucas Heights Soil Landscape (source: geo.seed.nsw.gov.au; accessed 16 May 2025)

Attribute	Description
Topography	The regional geology grades downwards to the North at approximately 15° along Nelson Road.
Soil Landscapes	The Soil Conservation Service of NSW Sydney 1:100,000 Soil Landscapes Series Sheet 9130 (1st Edition) indicates that the soil landscape at the site likely comprises the Lucas Heights Landscape. The Lucas Heights Landscape comprises gently undulating crests and ridges on plateau surfaces of the Mittagong formation with slopes up to 10 %. Soils are generally moderately deep (0.5 to 1.5 m) hardsetting Yellow Podzolic Soils and Yellow Soloths. These soils are noted to present stony soil, and low available water capacity. See the Figure 3 .
Regional Geology	Information on regional sub-surface conditions, referenced from the Department of Mineral Resources Geological Map Sydney 1:100,000 (Geological Series Sheet 9130) indicates that the site is sits on the boundary of the (Rwa) Ashfield Shale of the Wianamatta Group, which is typically comprised of black to dark-grey shale and laminate and (Rh) Hawkesbury Sandstone, which is typically comprised of medium to coarse-grained quartz sandstone, with very minor shale and laminite lenses. See Figure 4

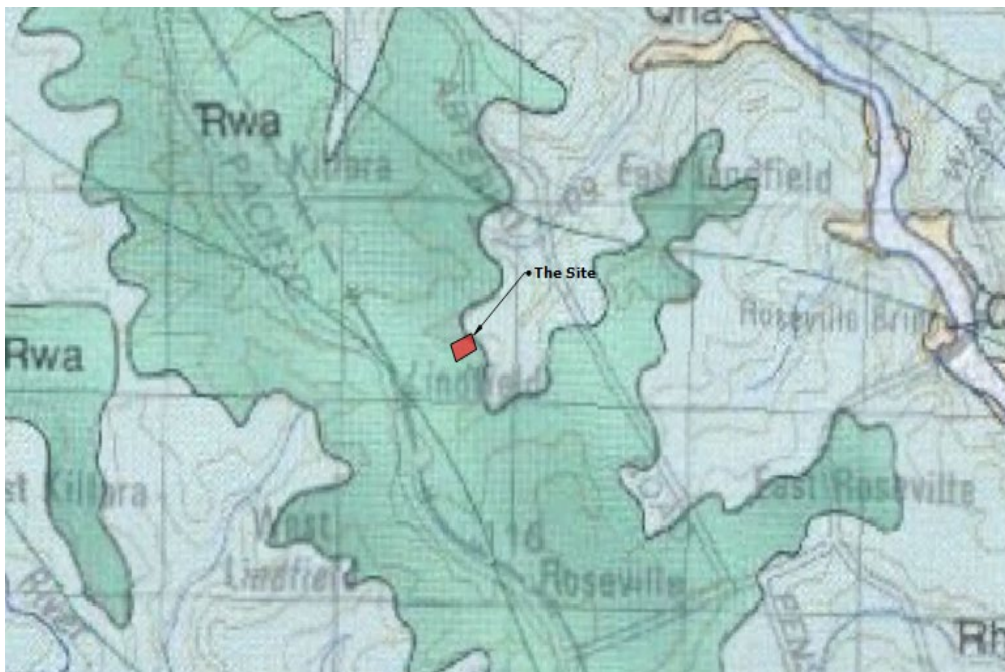
Figure 4 Regional geology for the Site - Department of Mineral Resources Geological Map Sydney 1:100,000 (Geological Series Sheet 9130)

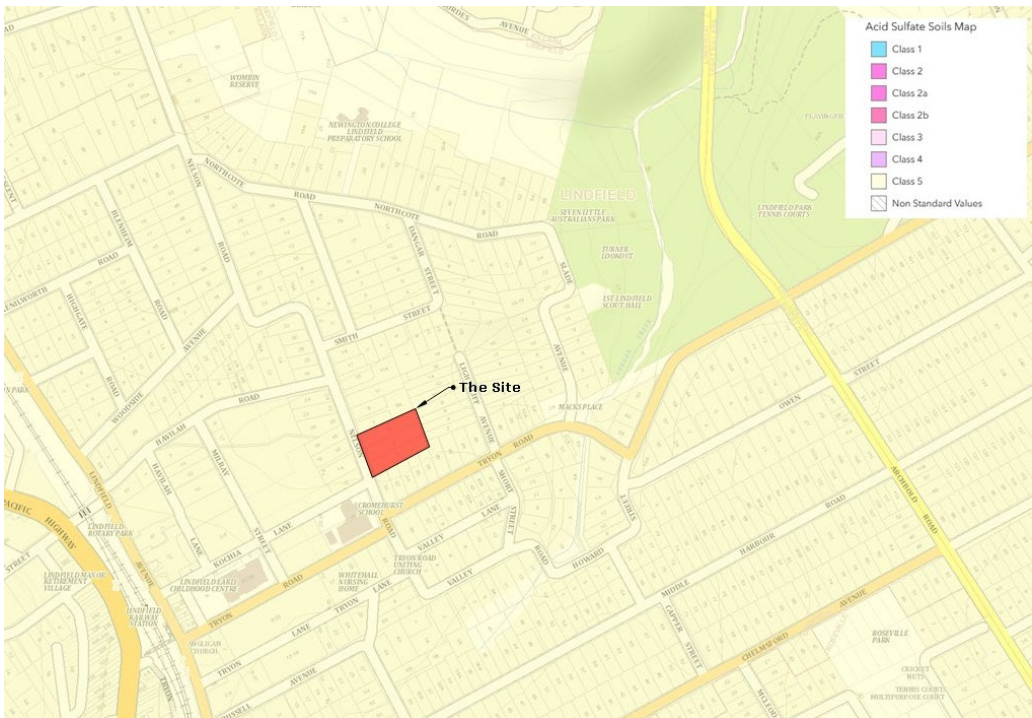
Figure 5 An excerpt from ASS Map (source: planningportal.nsw.gov.au; accessed 16 May 2025)

According to the Ku-ring-gai Council Local Environmental Plan 2015, the Acid Sulfate Soils Map in **Figure 5** in **Section 2.3** identifies the proposed development site as being within an area classified as Class 5. For sites in this category, development consent is required if works are carried out within 500 metres of Class 1, 2, 3, or 4 land and are likely to lower the water table below 1 metre AHD.
