# 68-80 Banks Avenue, Pagewood NSW

## Results of Geotechnical Investigation

PSM5745-009R REV2      07 November 2025

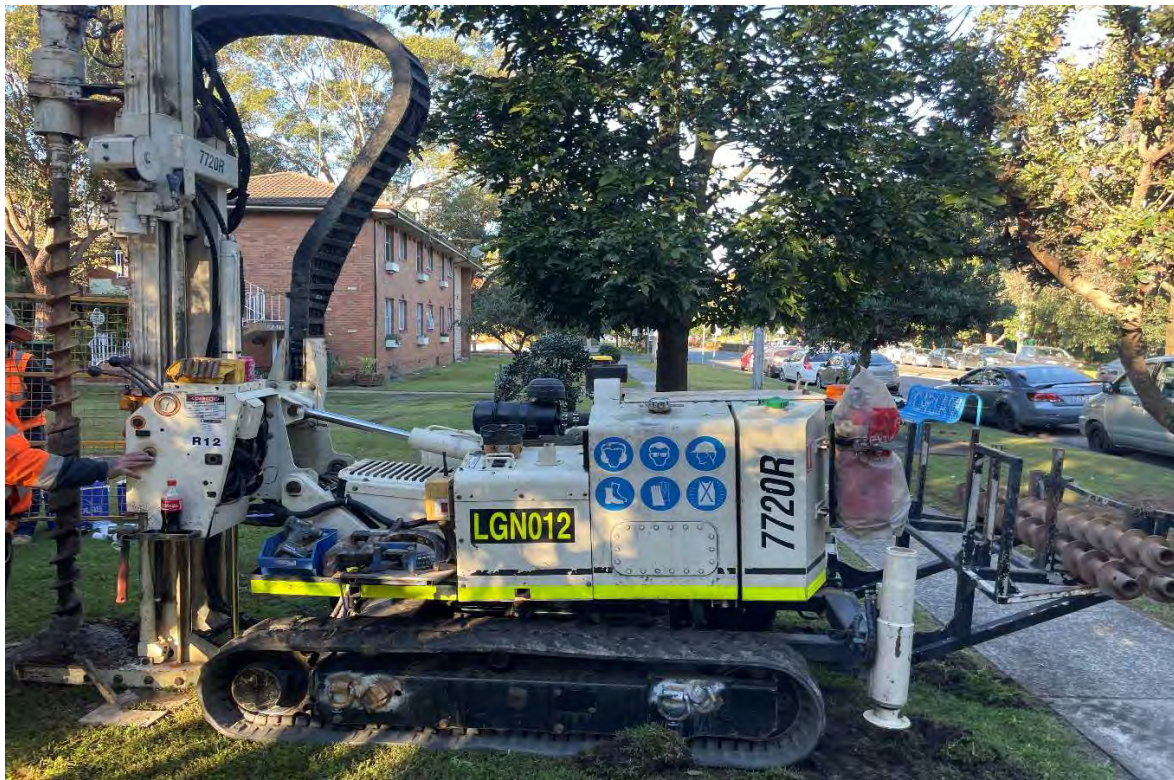
Photo 3 - Typical Setup of a Geoprobe 7720R Track-Mounted Drill Rig

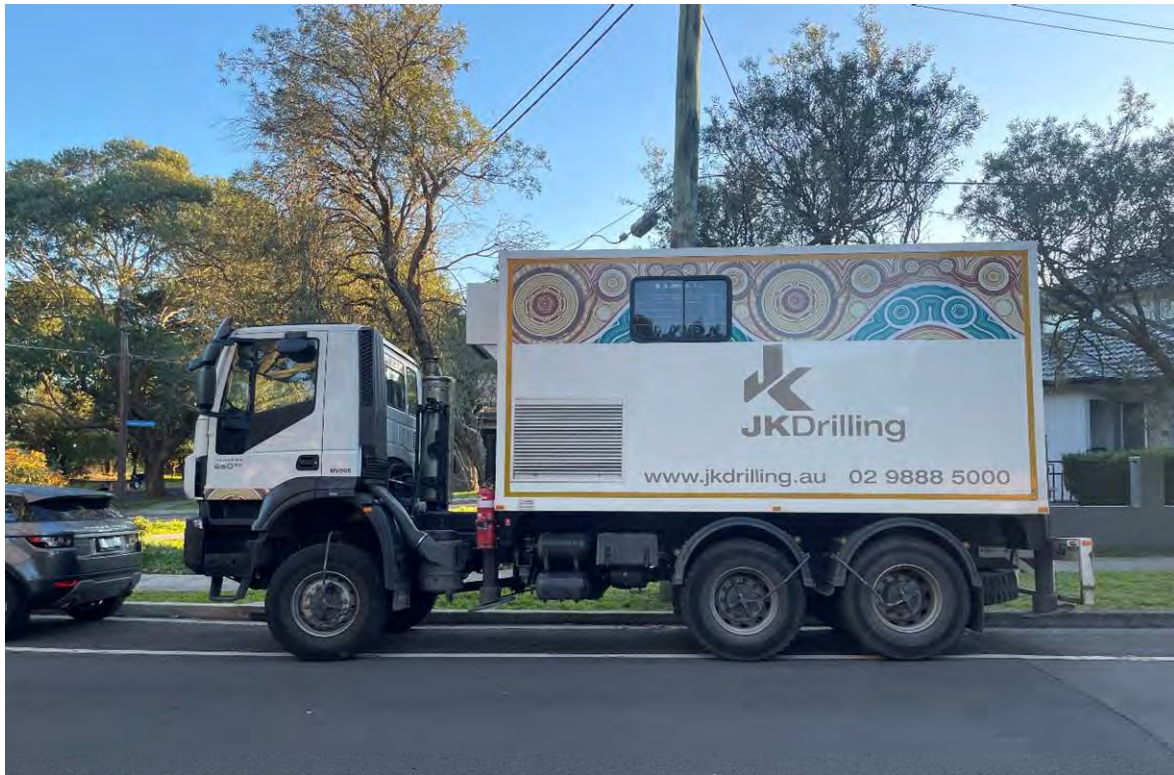
Photo 4 - JK Cone Penetration Testing Rig

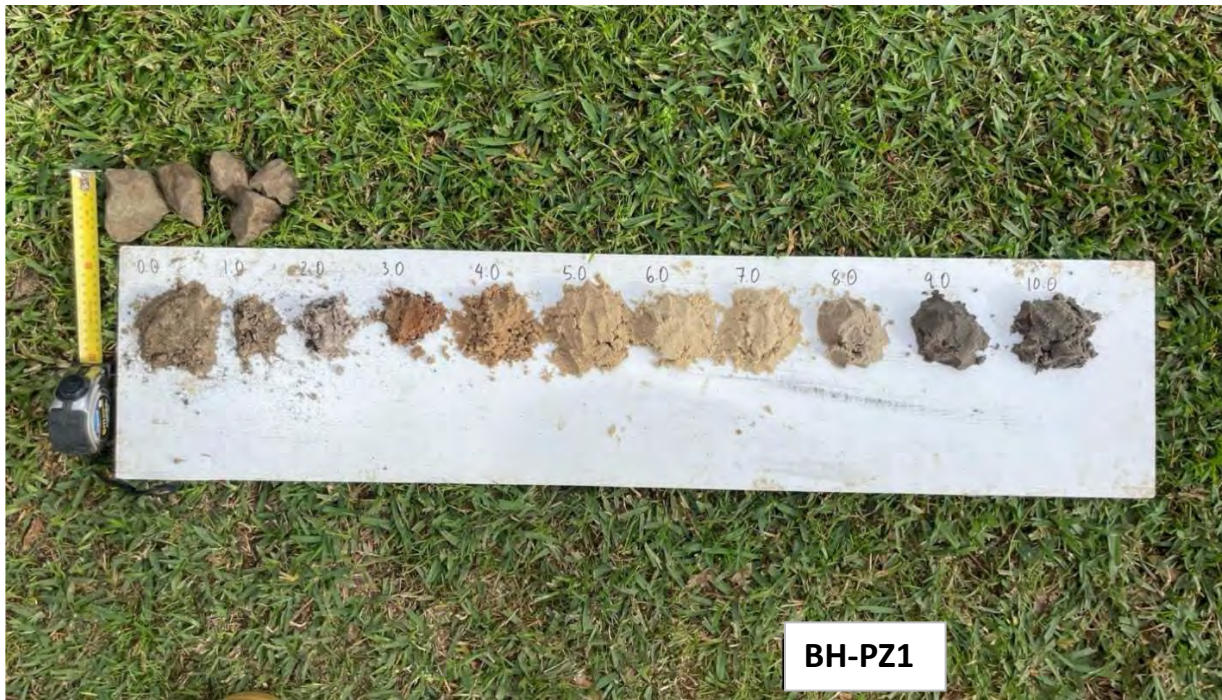
**BH-PZ1**

Photo 5 - Soil Profile in BH-PZ1

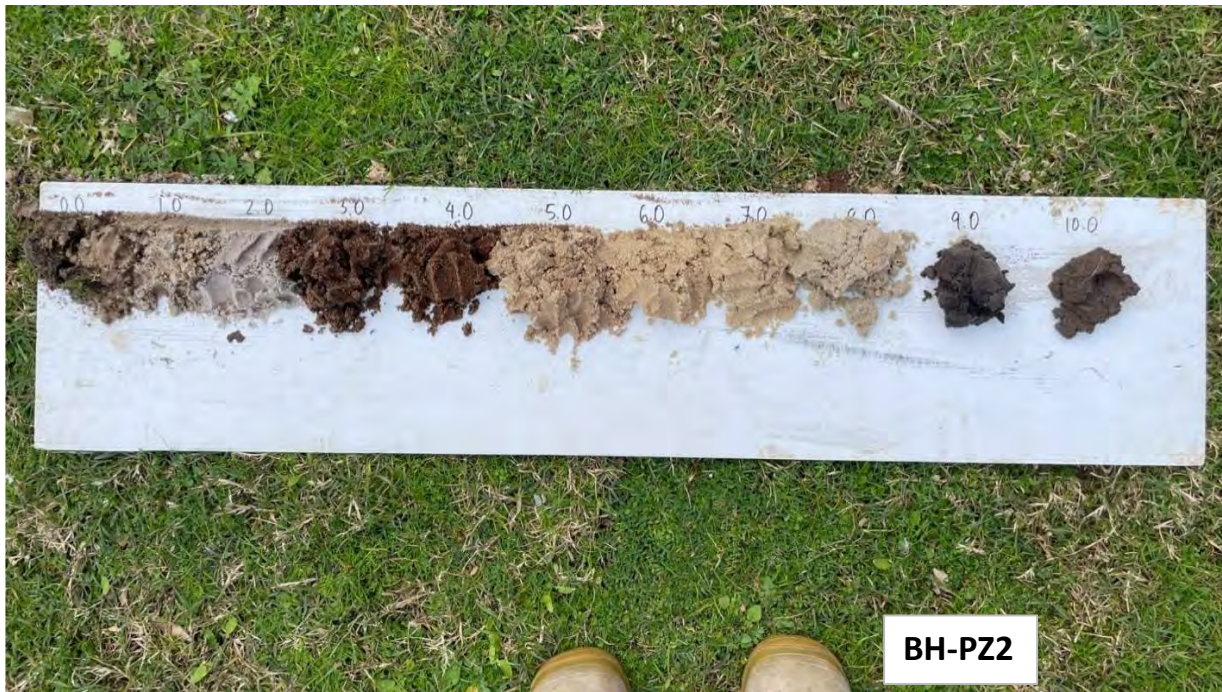
**BH-PZ2**

Photo 6 - Soil Profile in BH-PZ2

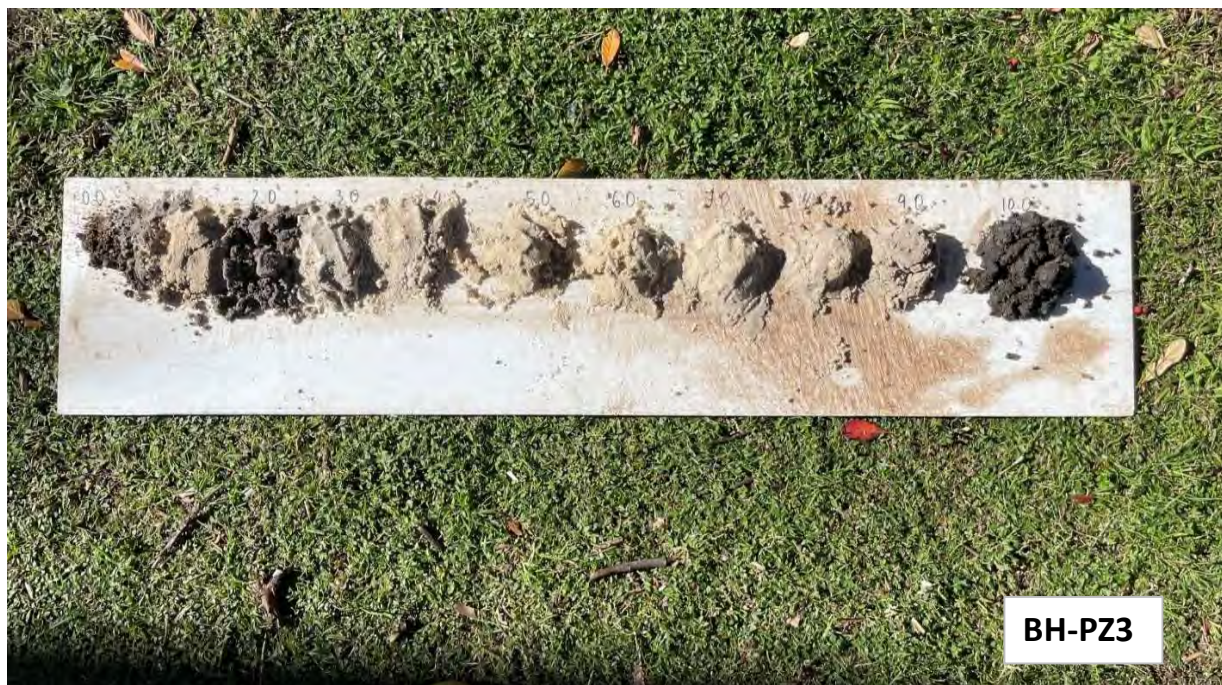
Photo 7 - Soil profile in BH-PZ3

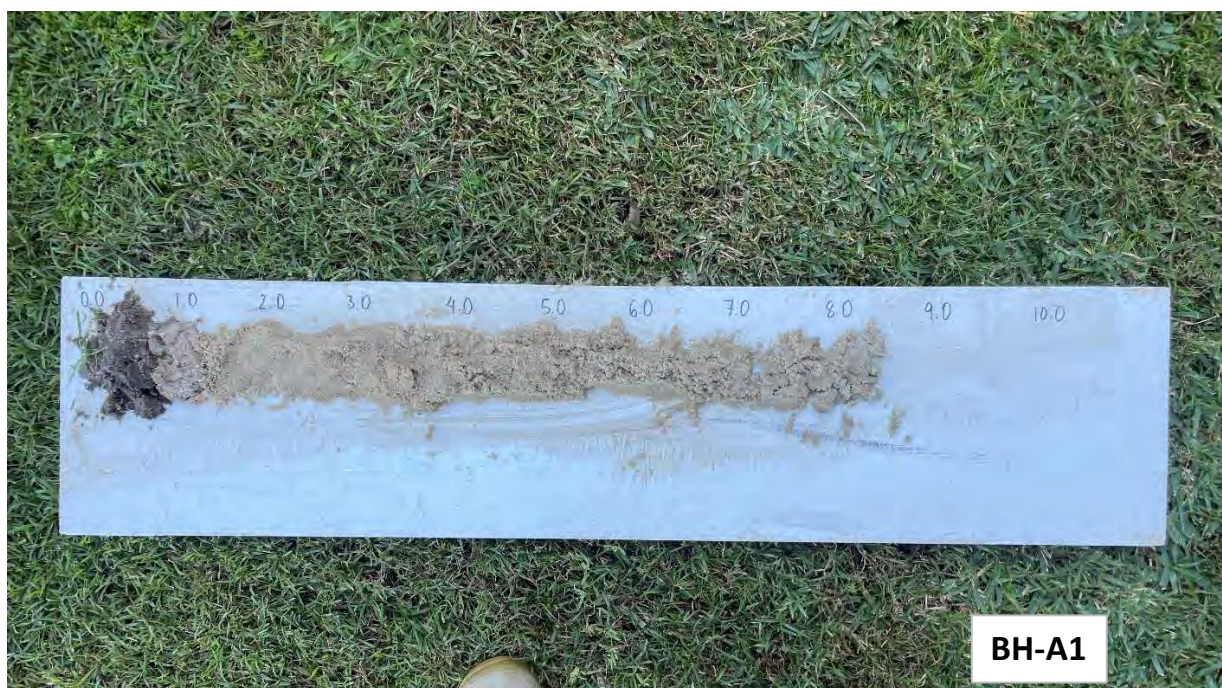
Photo 8 - Soil Profile in BH-A1

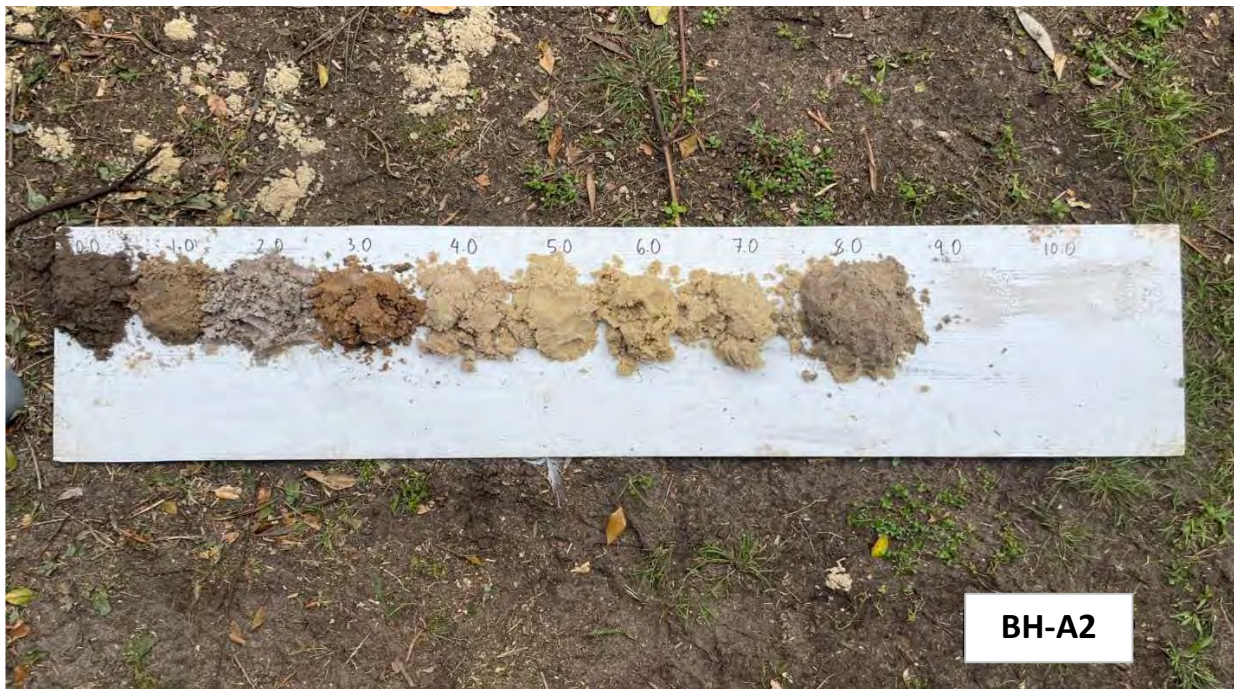
Photo 9 - Soil Profile in BH-A2

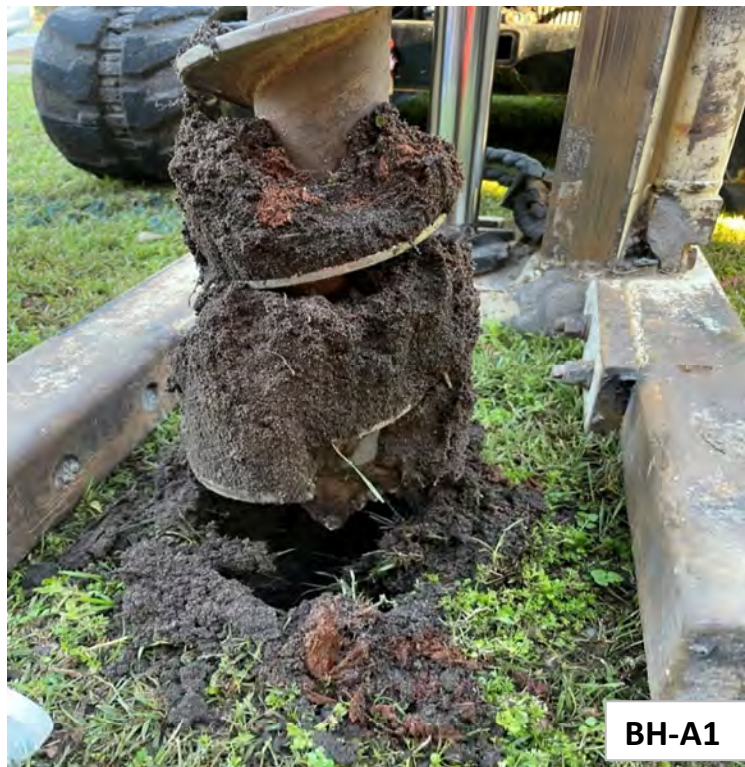
Photo 10 - Top Soil from BH-A1

| Inferred Unit | Depth to top of inferred unit (m) | Material Description |
|---|---|---|
| TOPSOIL | 0.0 | TOPSOIL: Silty SAND; fine to medium grained, grey-brown; silt low to medium plasticity; moist, loose, vegetation and rootlets present. |

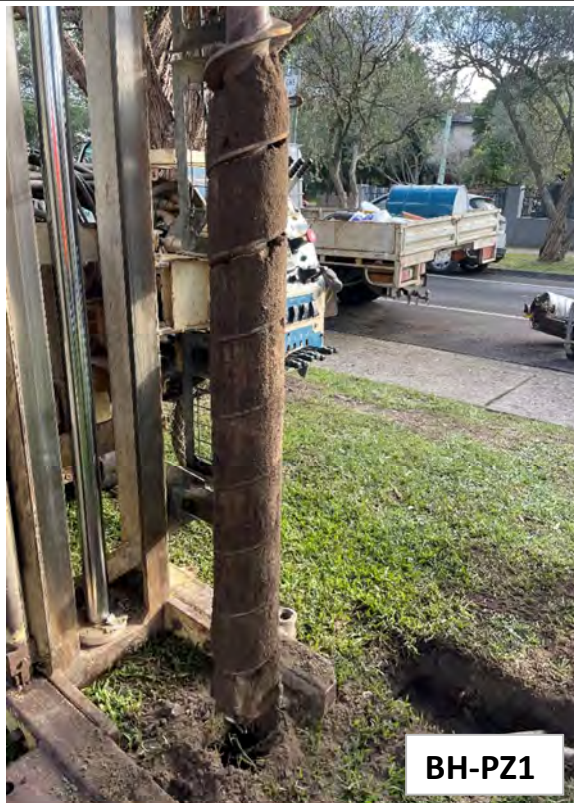
Photo 11 - Soil Profile up to 1.5m in BH-PZ1

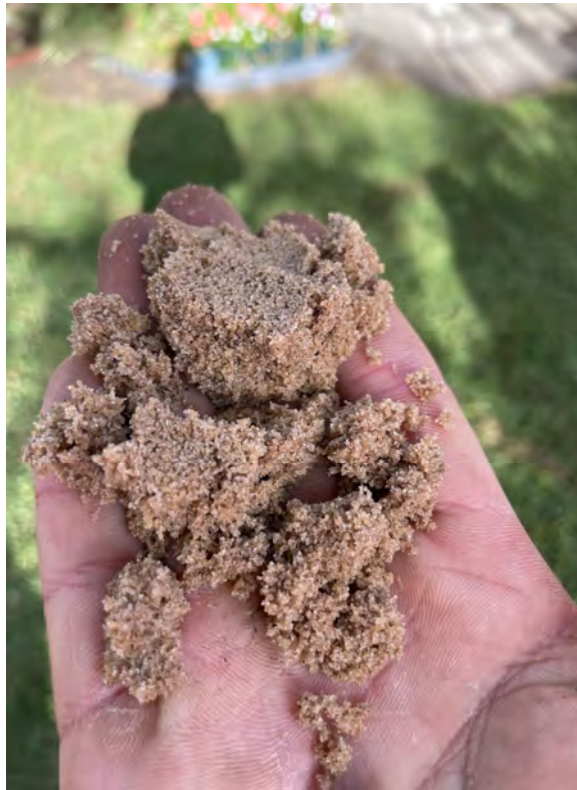
Photo 12 - Typical medium to coarse grained SAND (NATURAL SOIL)

| Inferred Unit | Depth to top of inferred unit (m) | Material Description |
|---|---|---|
| SAND A<br>(NATURAL) | 0.2 – 0.5 | SAND/ SILTY SAND/ SANDY SILT; medium to coarse grained, pale grey, grey-brown-orange, medium to coarse grained; moist, Medium dense. |

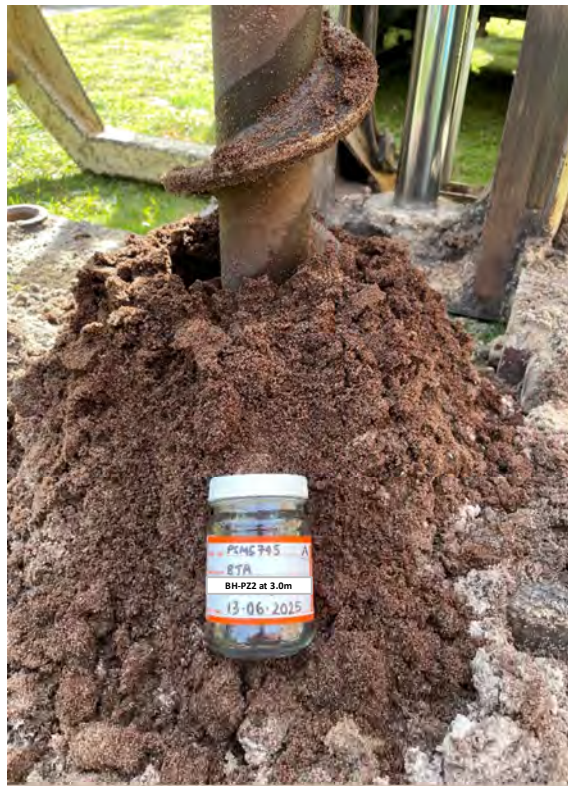
Photo 13 - NATURAL SOIL sampling from BH-PZ2

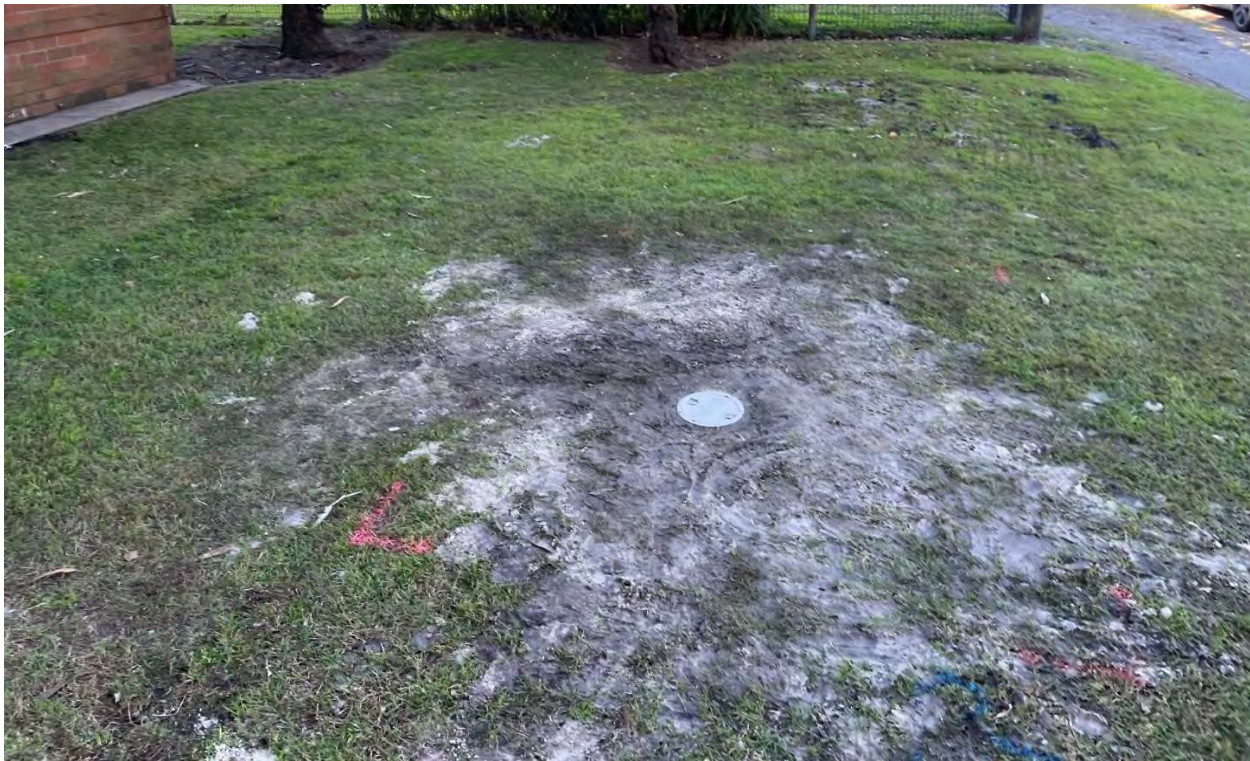
Photo 14 - Groundwater monitoring well (BH-PZ3)

Drilling fluids were used to facilitate the installation of the standpipes, i.e., to prevent collapse. Therefore, the groundwater level recorded on 18 June 2025 may be impacted by drilling fluids. It is noted that JBS&G has pumped out the water following the well installation when they “developed” the well.
