## **68-80 Banks Avenue, Pagewood**

### Aboriginal Archaeological Due Diligence Report

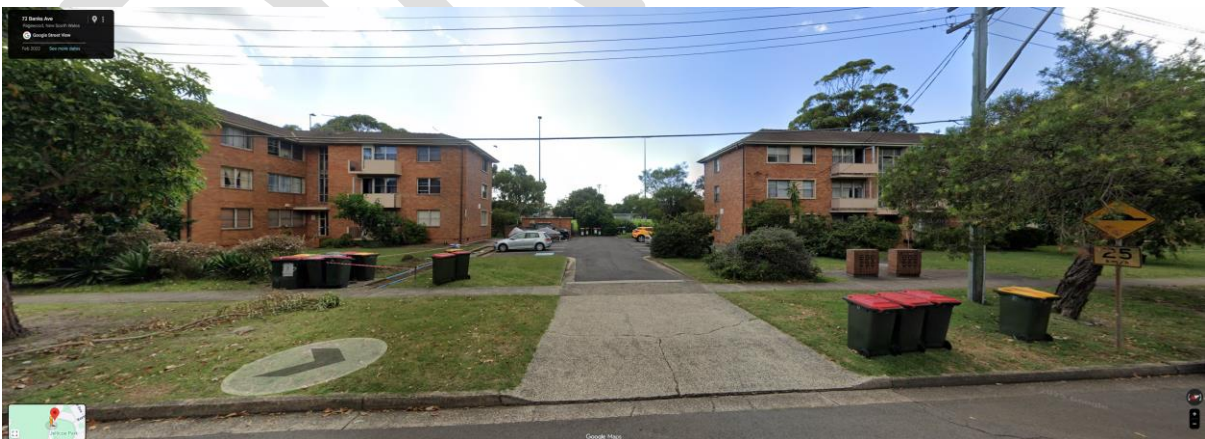
Figure 3-35 70-72 Banks Avenue section of study area as viewed from Banks Avenue, looking east. Jellicoe Park can be observed past the carpark. Source: Google Streetview, accessed September 2025.

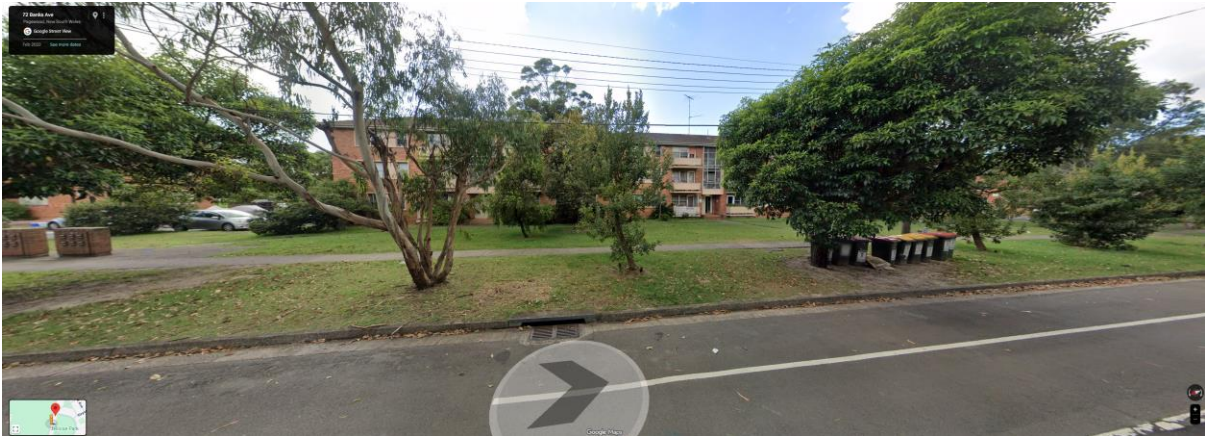
Figure 3-36 72-74 Banks Avenue section of study area as viewed from Banks Avenue, looking east. Source: Google Streetview, accessed September 2025.
