68-80 Banks Avenue, Pagewood NSW

Remediation Action Plan

69149 | 169981 (Rev 0)

23 October 2025

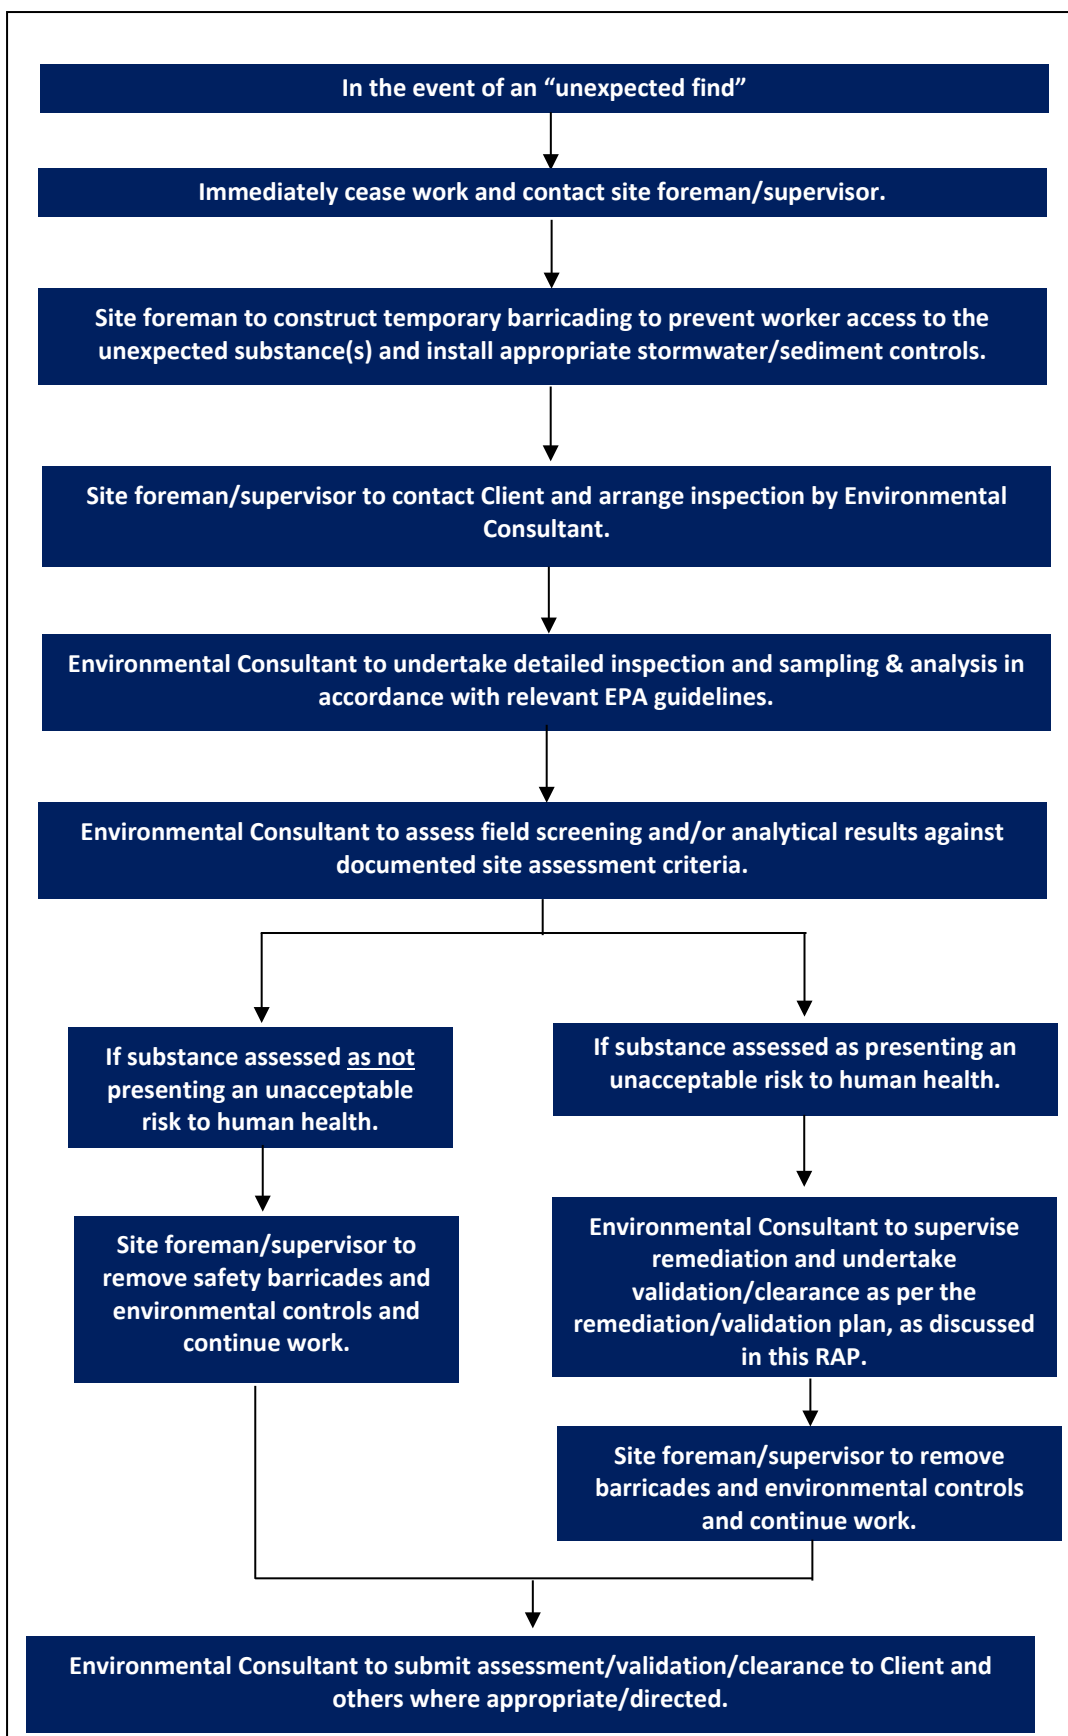
Figure 8.1 – Unexpected Finds Protocol

Where the preferred or contingent remedial strategies presented in this RAP may not be feasible based on assessment of an unexpected find, an alternate remedial strategy will require documentation, including any additional/alternate site management controls and validation requirements.

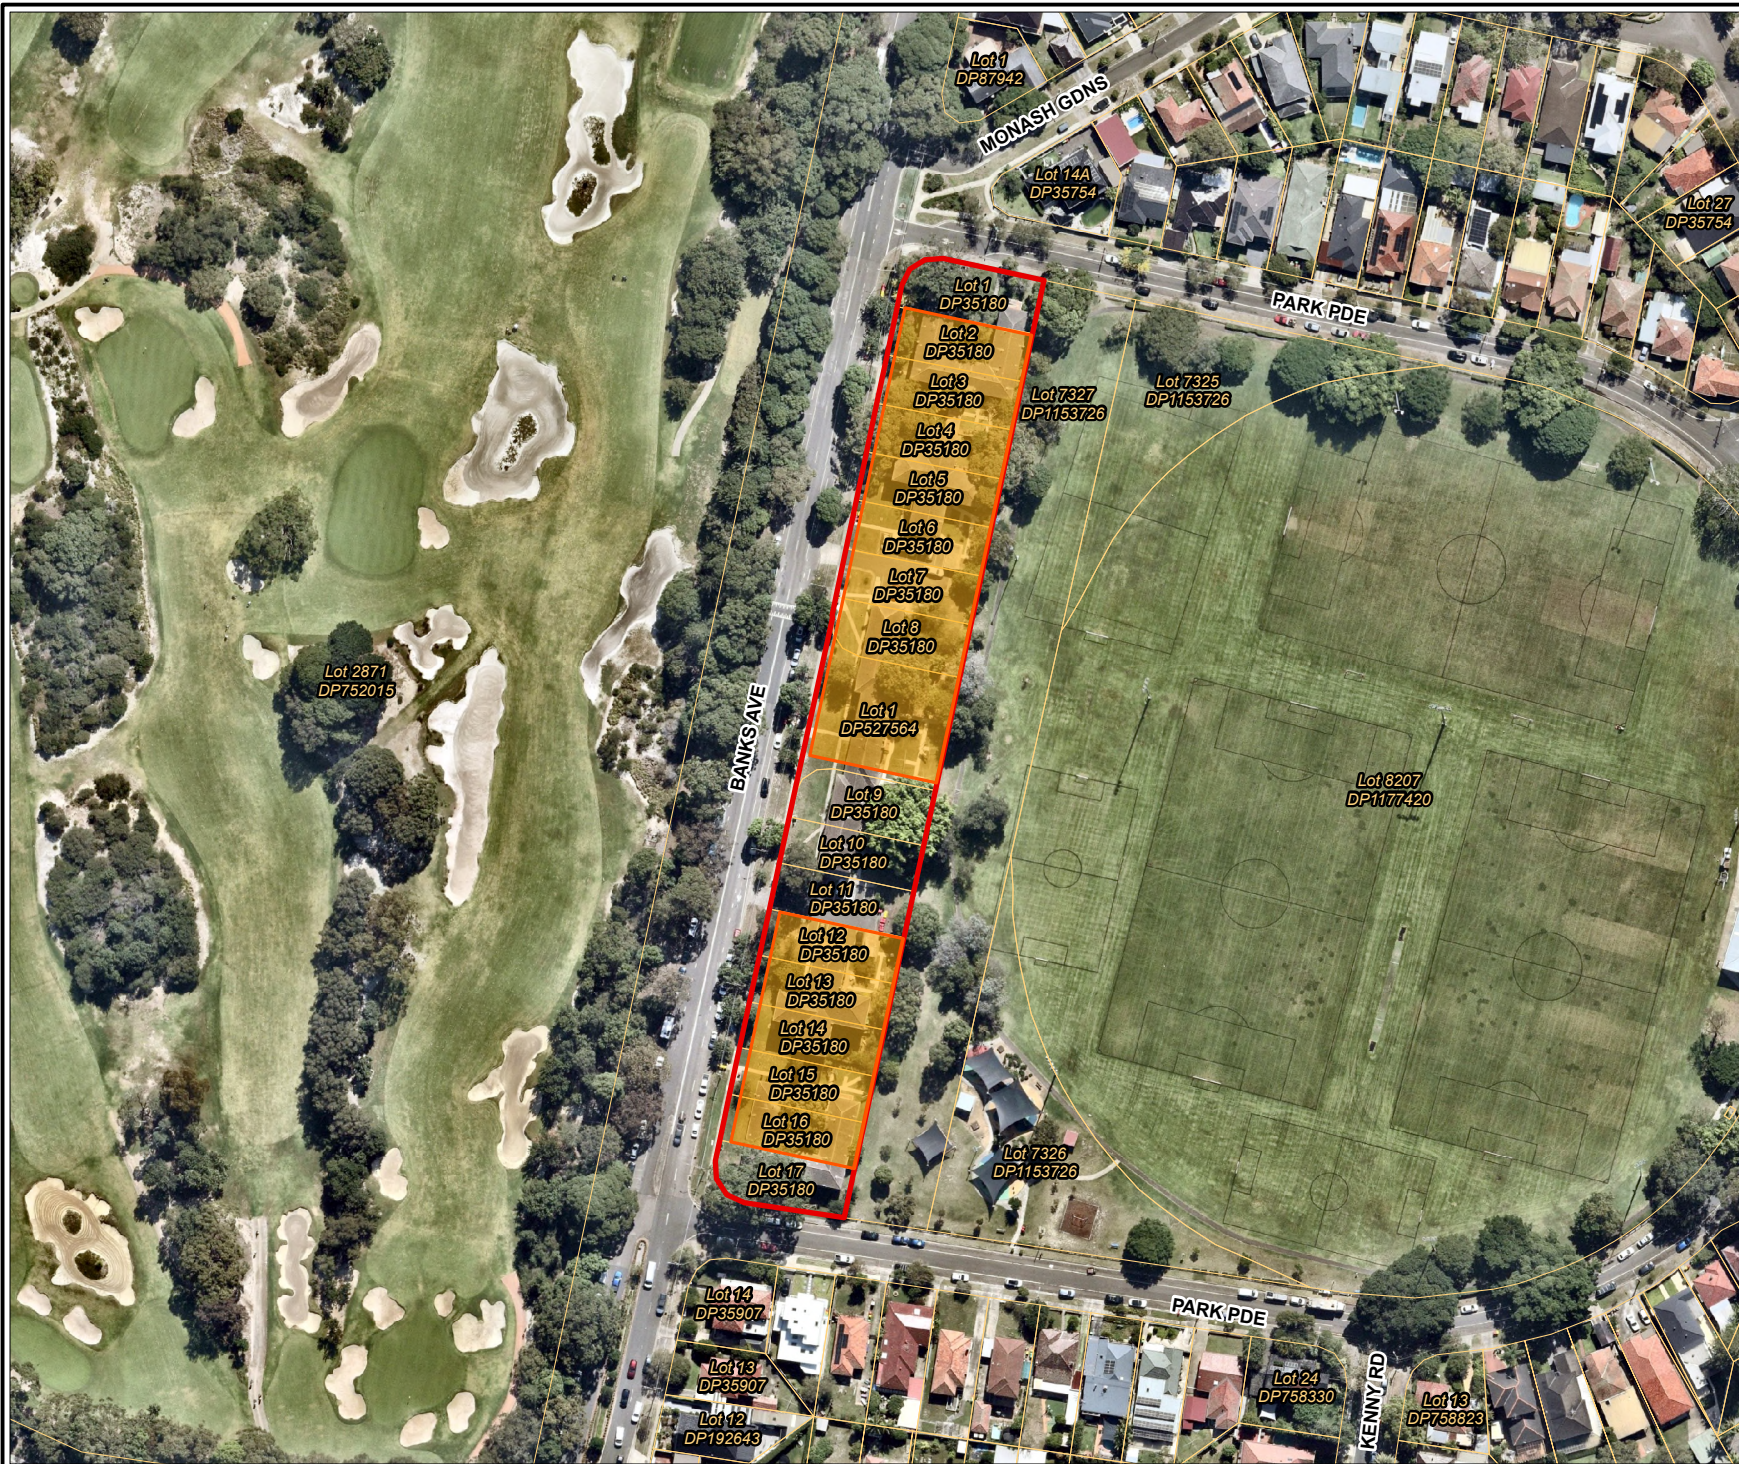
FIGURE 2

SITE LAYOUT

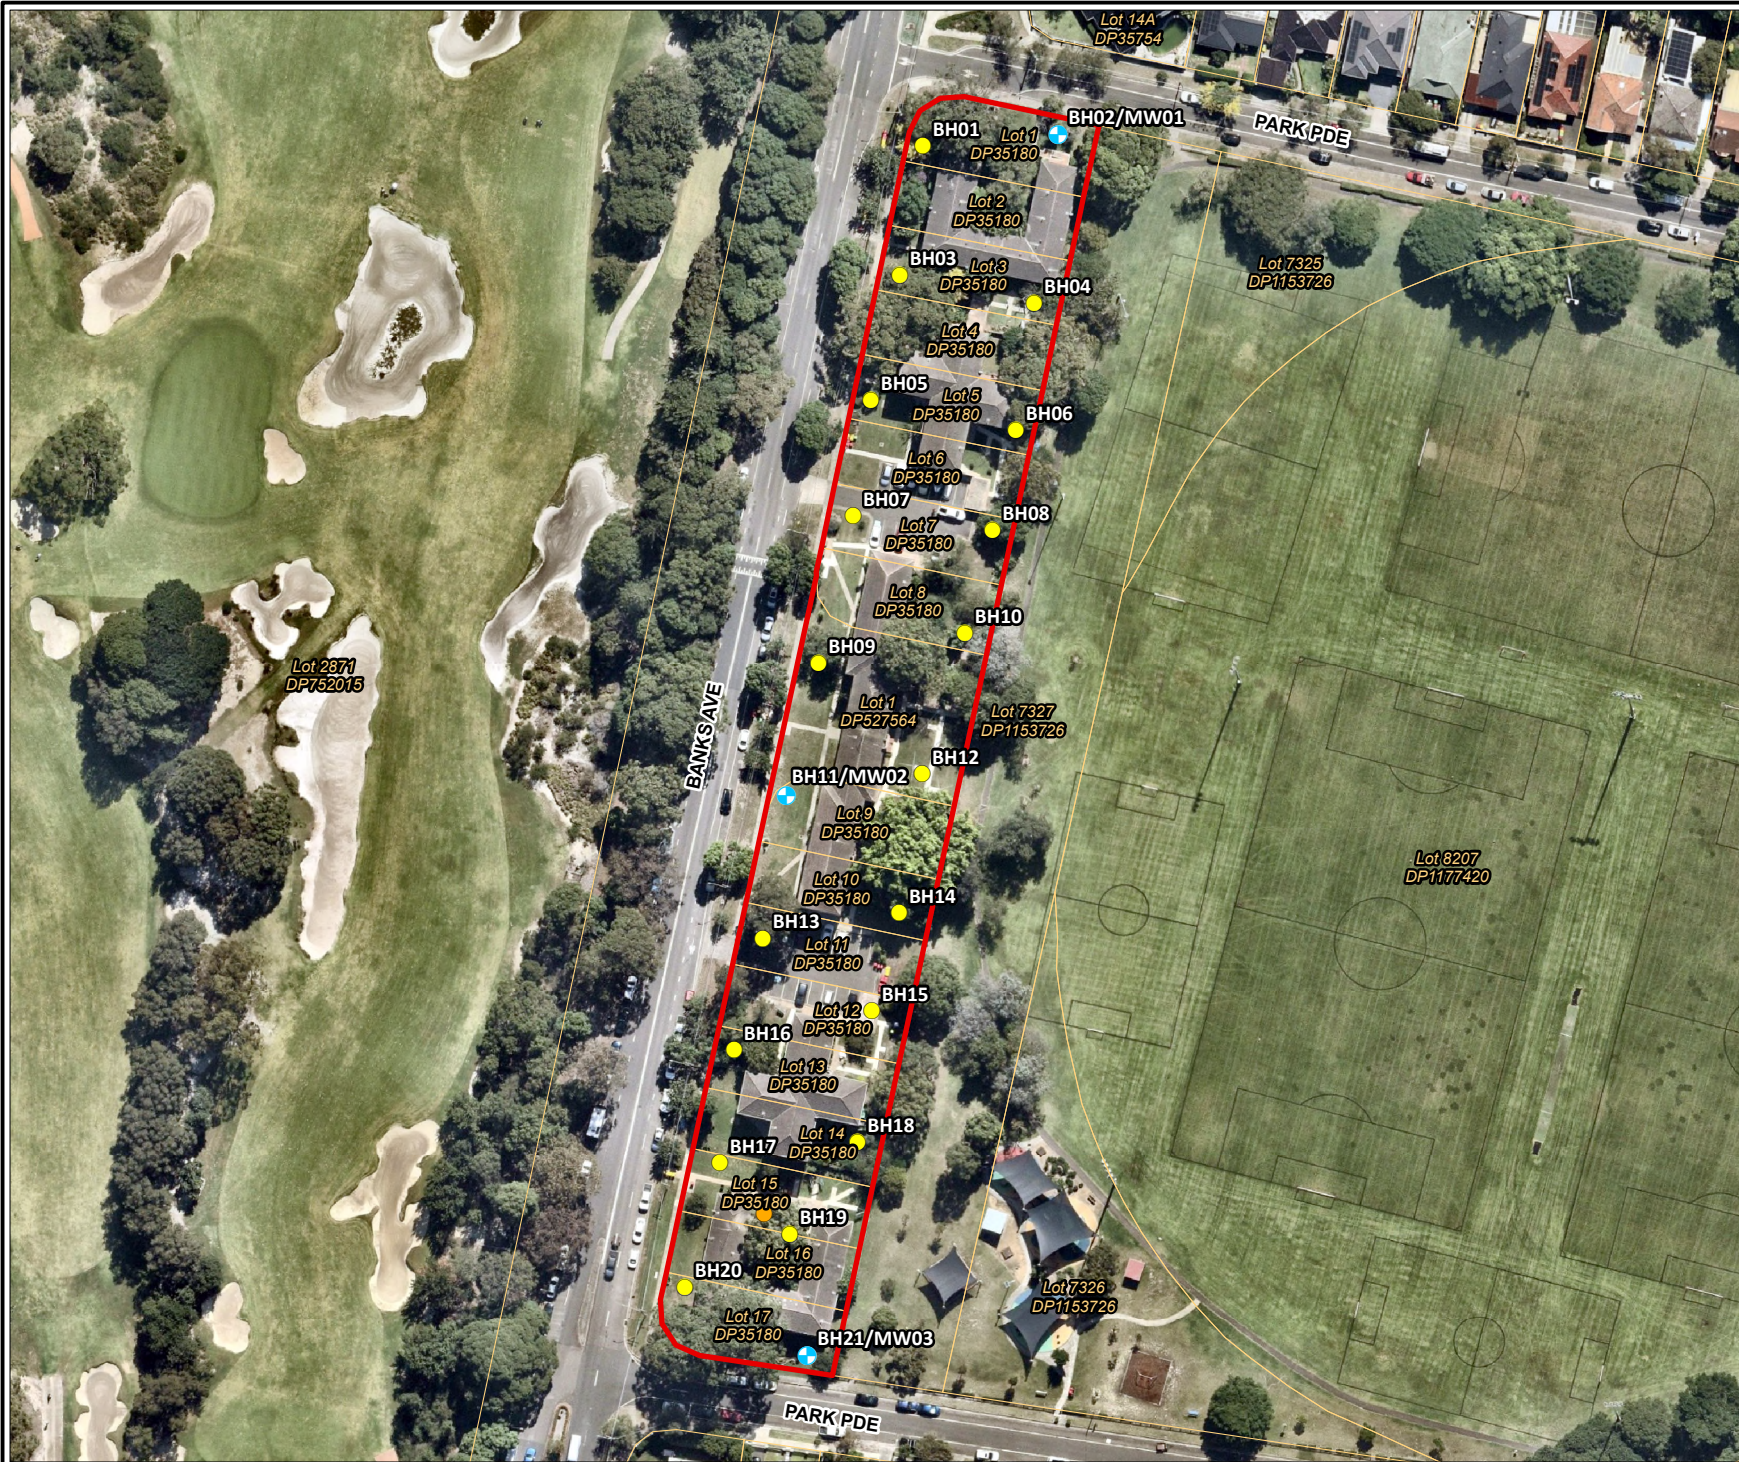
FIGURE 3

SAMPLE LOCATIONS

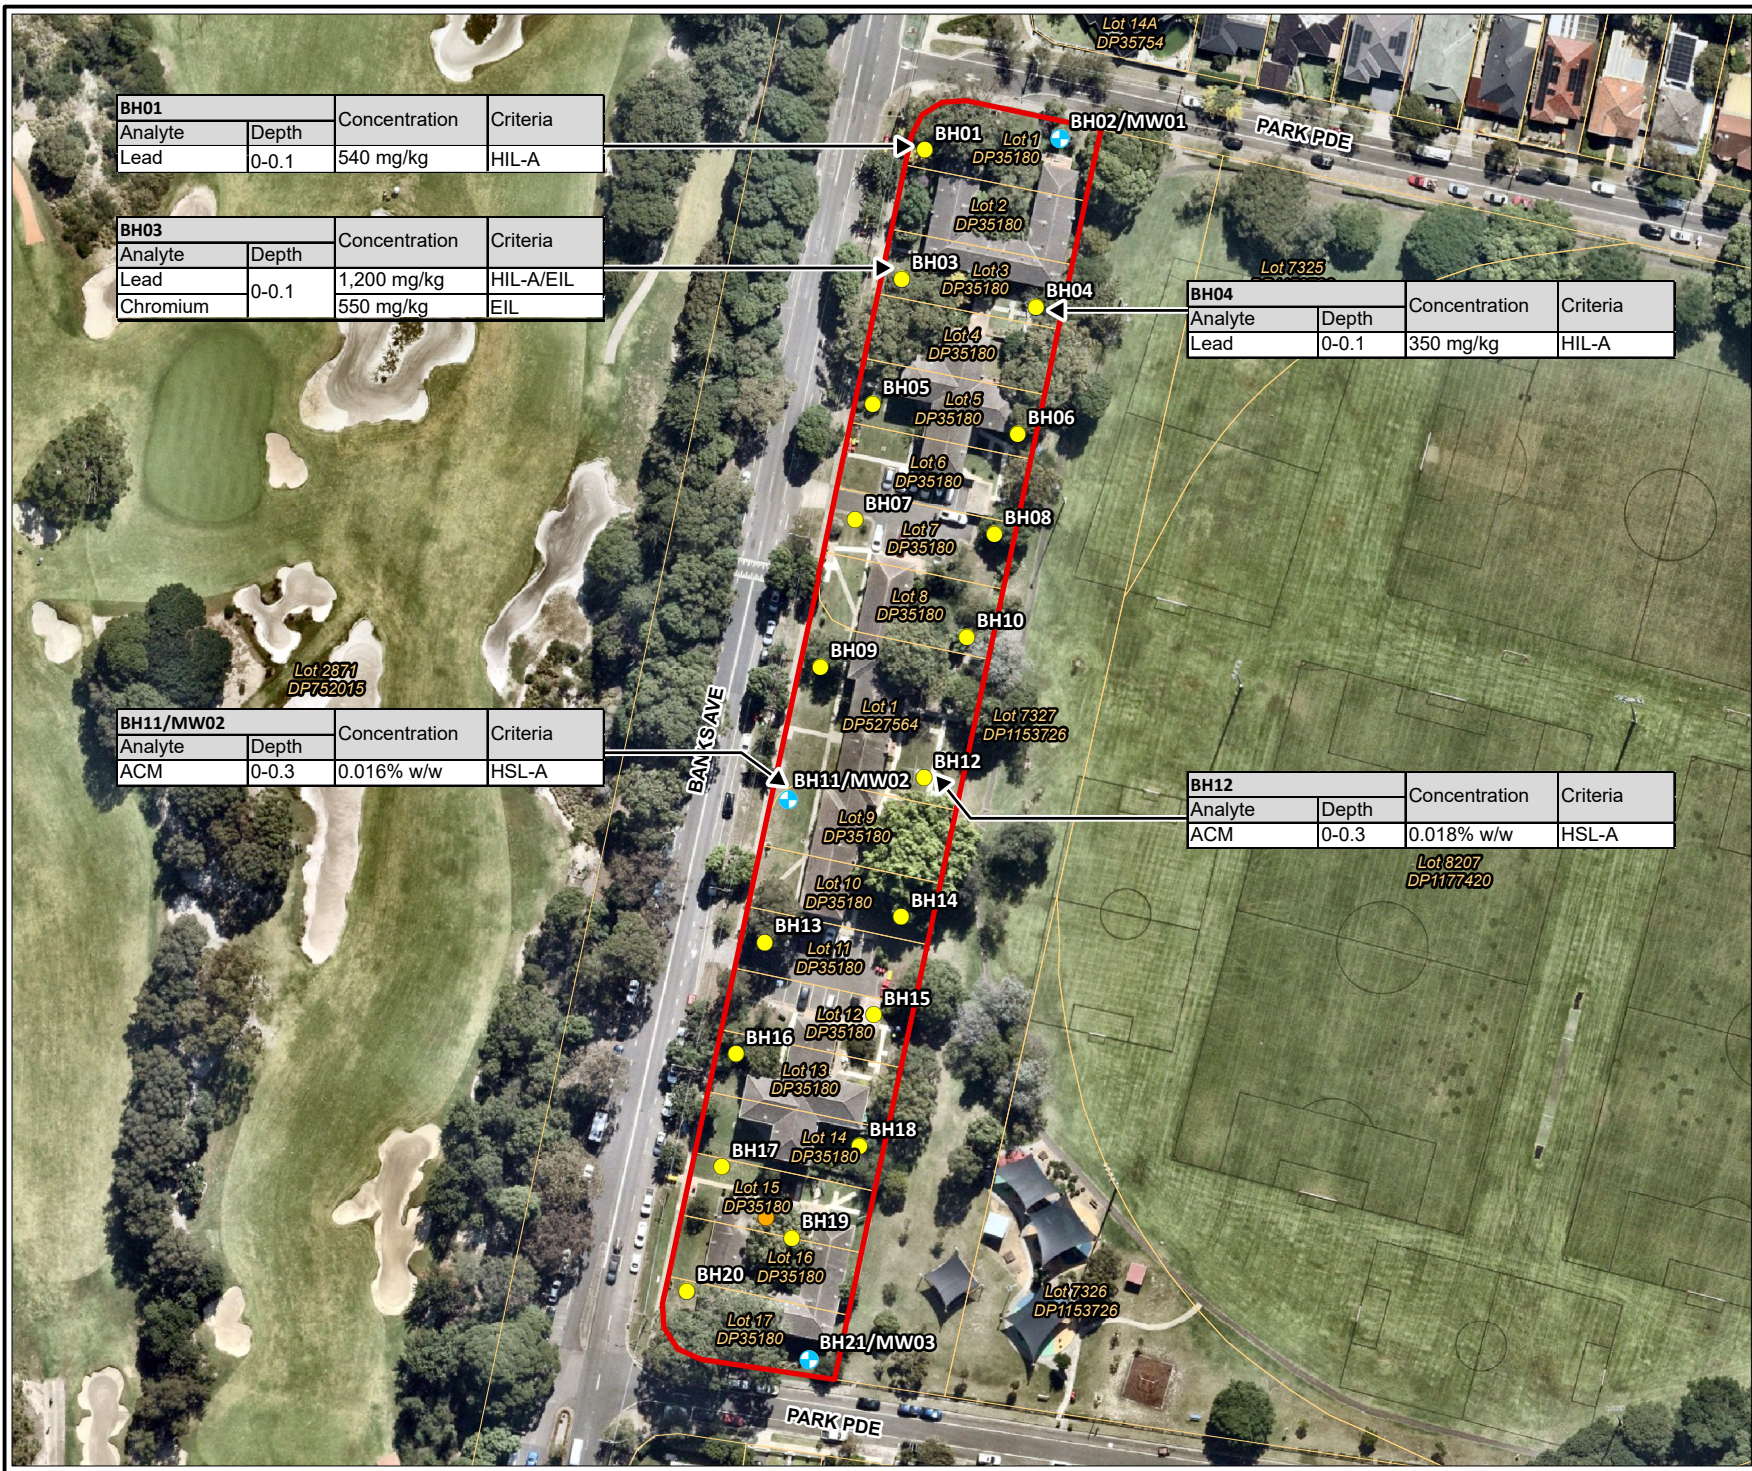
FIGURE 4A

Coord. Sys. GDA2020 MGA Zone 56
**68-80 Banks Avenue,
 Pagewood, NSW**
SOIL EXCEEDANCES

Asbestos in the form of non-friable ACM was observed on the ground surface and in fill materials on the site. ACM in soil was reported above the health-based assessment criteria at two locations (BH11/MW02_0-0.3 and BH12_0-0.3, see **Figure 4A**) and below the criterion at one location (BH19_0-0.8). It was noted that soils represented by sample BH19_0-0.8 located in surface soil would exceed health-based criterion of “no visible asbestos in the top 100mm”. The presence of non-friable ACM fragments may pose an unacceptable health risk to future site users should the fragments be disturbed/abraded and asbestos fibres be released and become airborne and respirable.

Asbestos as ACM fragments was identified on the ground surface at one location in the south and in fill materials at two locations (see **Figure 4A**) at concentrations above the adopted site assessment criteria. A fragment was also observed within fill material at BH19 (near the surface fragment), below the adopted site assessment criteria. The potential for further asbestos impacts in soil across the site was noted by JBS&G (2025).
