**Report on Geotechnical Investigation**

**Belmore Road, Belmore, Affordable  
Housing**

**270-278 Burwood Road and 54 Lakemba  
Street, Belmore NSW**

**Project 233414.01**

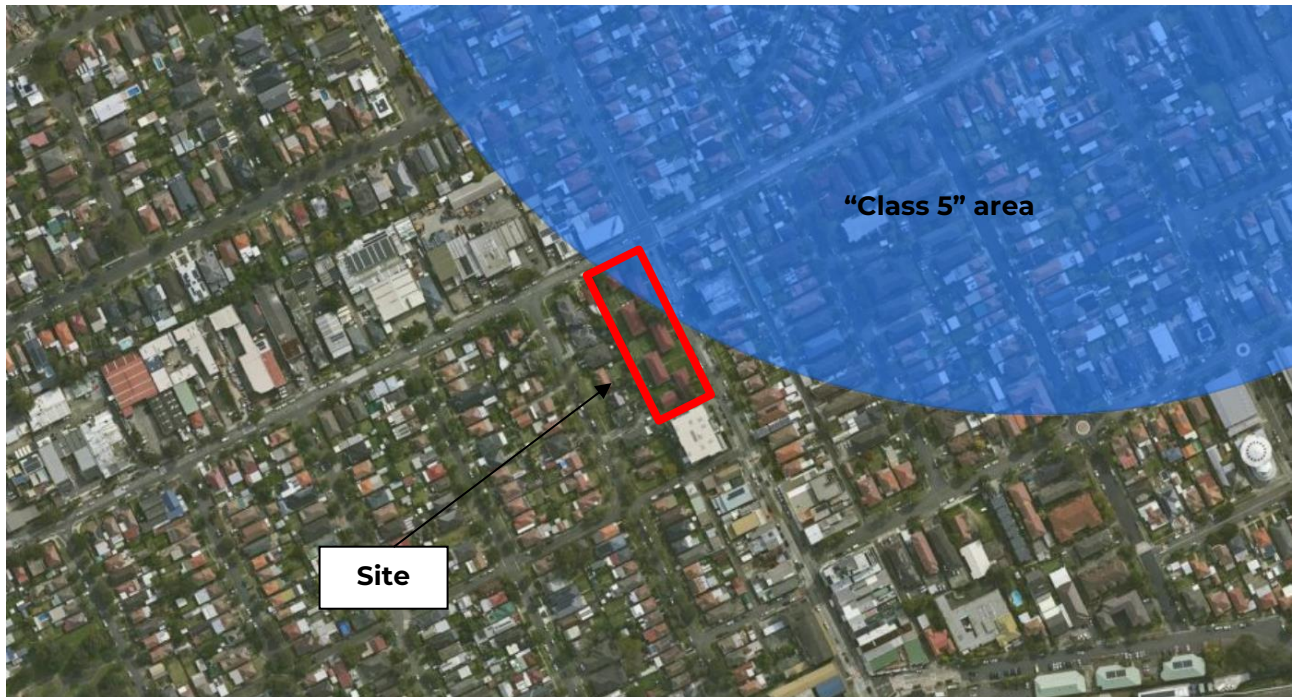
**Figure 4: Acid sulfate soil planning map with approximate site location**

The site is located outside of areas of known acid sulfate soil risk mapping (NSWDECC, 1994-1998). While partly within the “Class 5” area of the acid sulfate soil planning maps – Environmental Planning Instrument – Acid Sulfate Soils (NSW DPHI, 2025), it is noted that this Class refers to a 500 m buffer area around areas at risk of acid sulfate soils and does not indicate a specific risk within the site. An extract of the acid sulfate soil planning map is shown in Figure 4.

No signs of acid sulfate soils were observed during the investigation, hence an ASSMP is not considered necessary for the site.

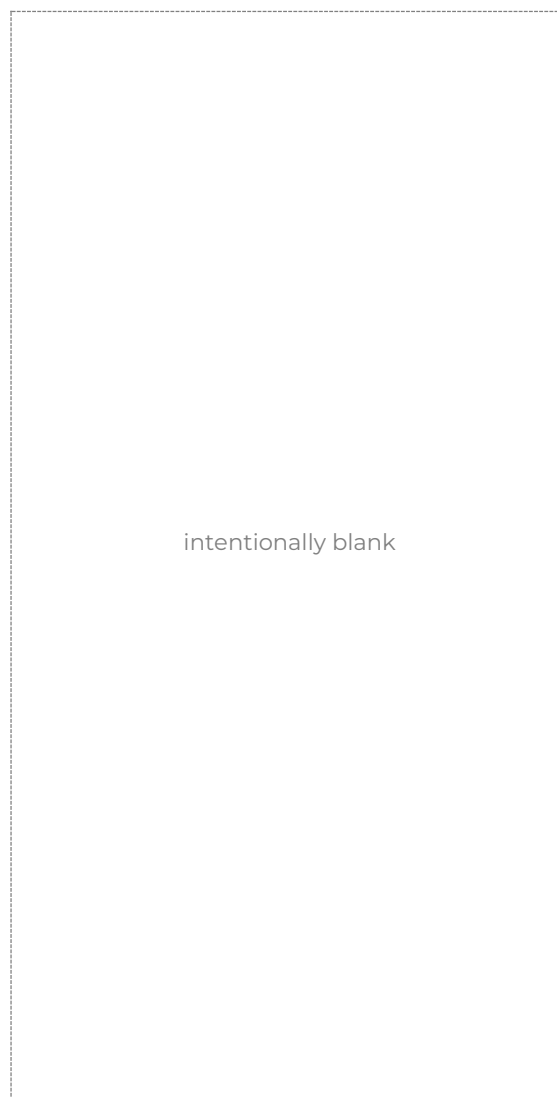
The inclination of defects is always measured from the perpendicular to the core axis.

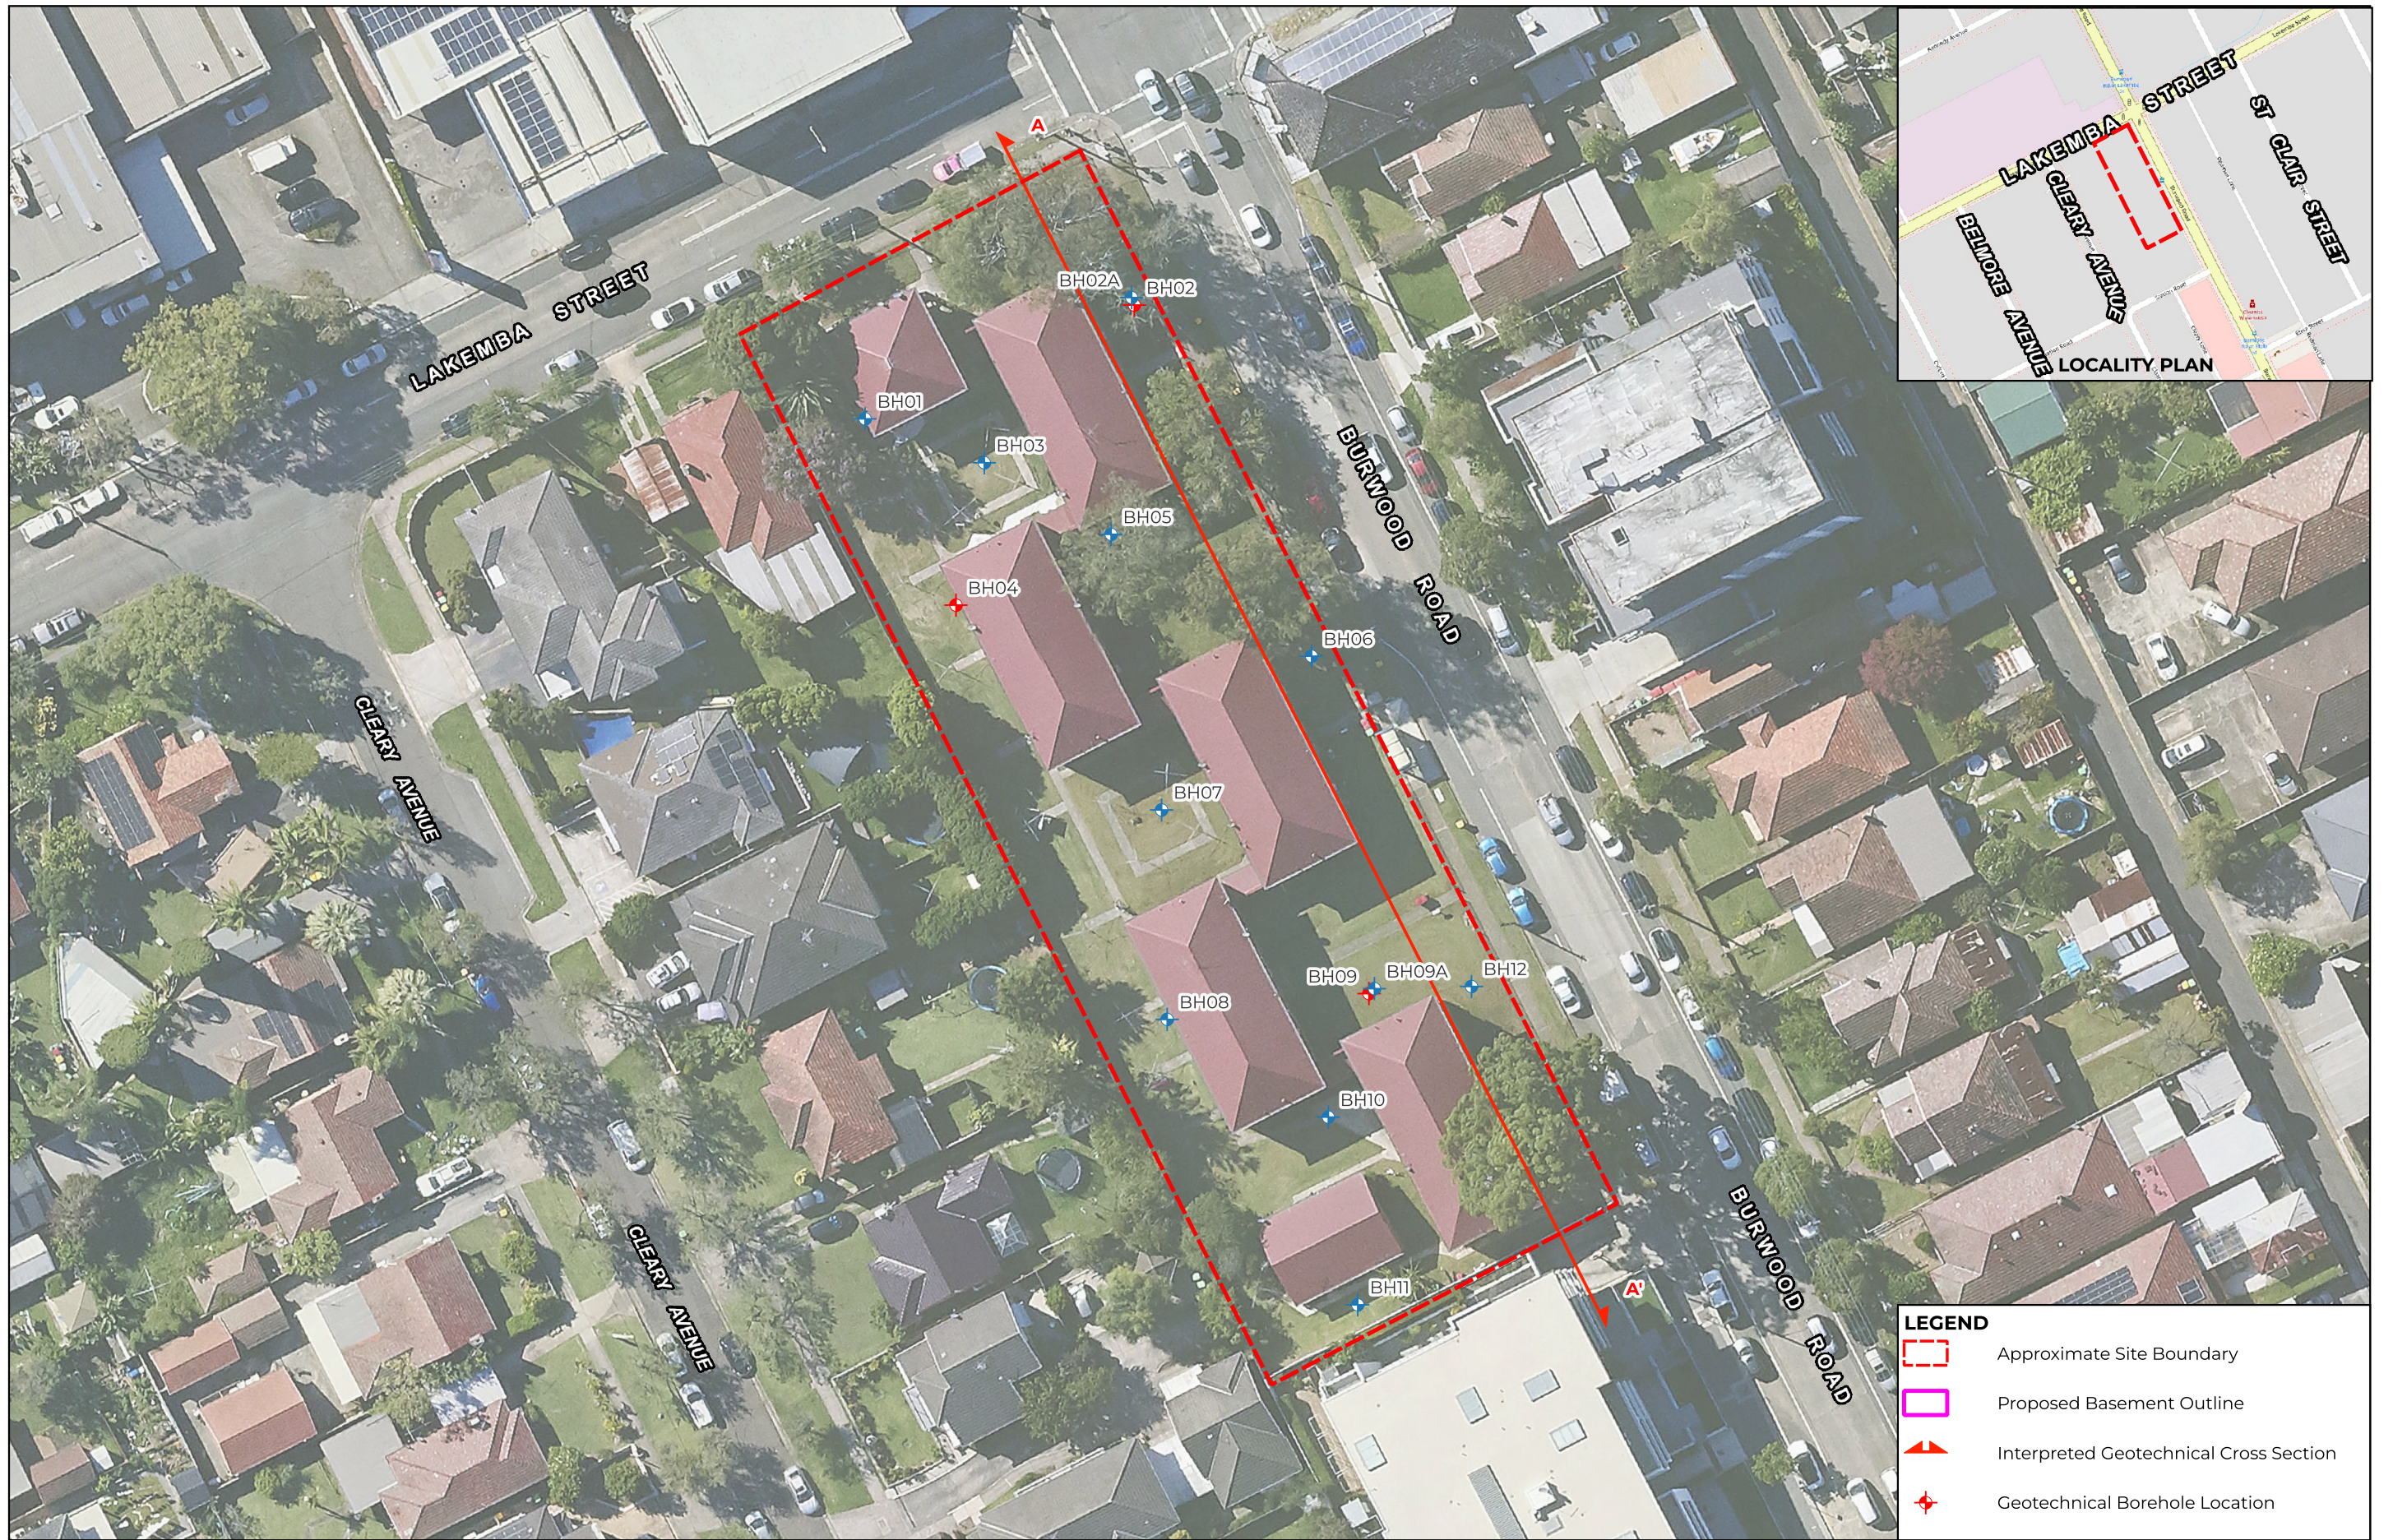
DRAWING NO:  
**1**

- Approximate Site Boundary
- Proposed Basement Outline
- A Interpreted Geotechnical Cross Section
- + Geotechnical Borehole Location

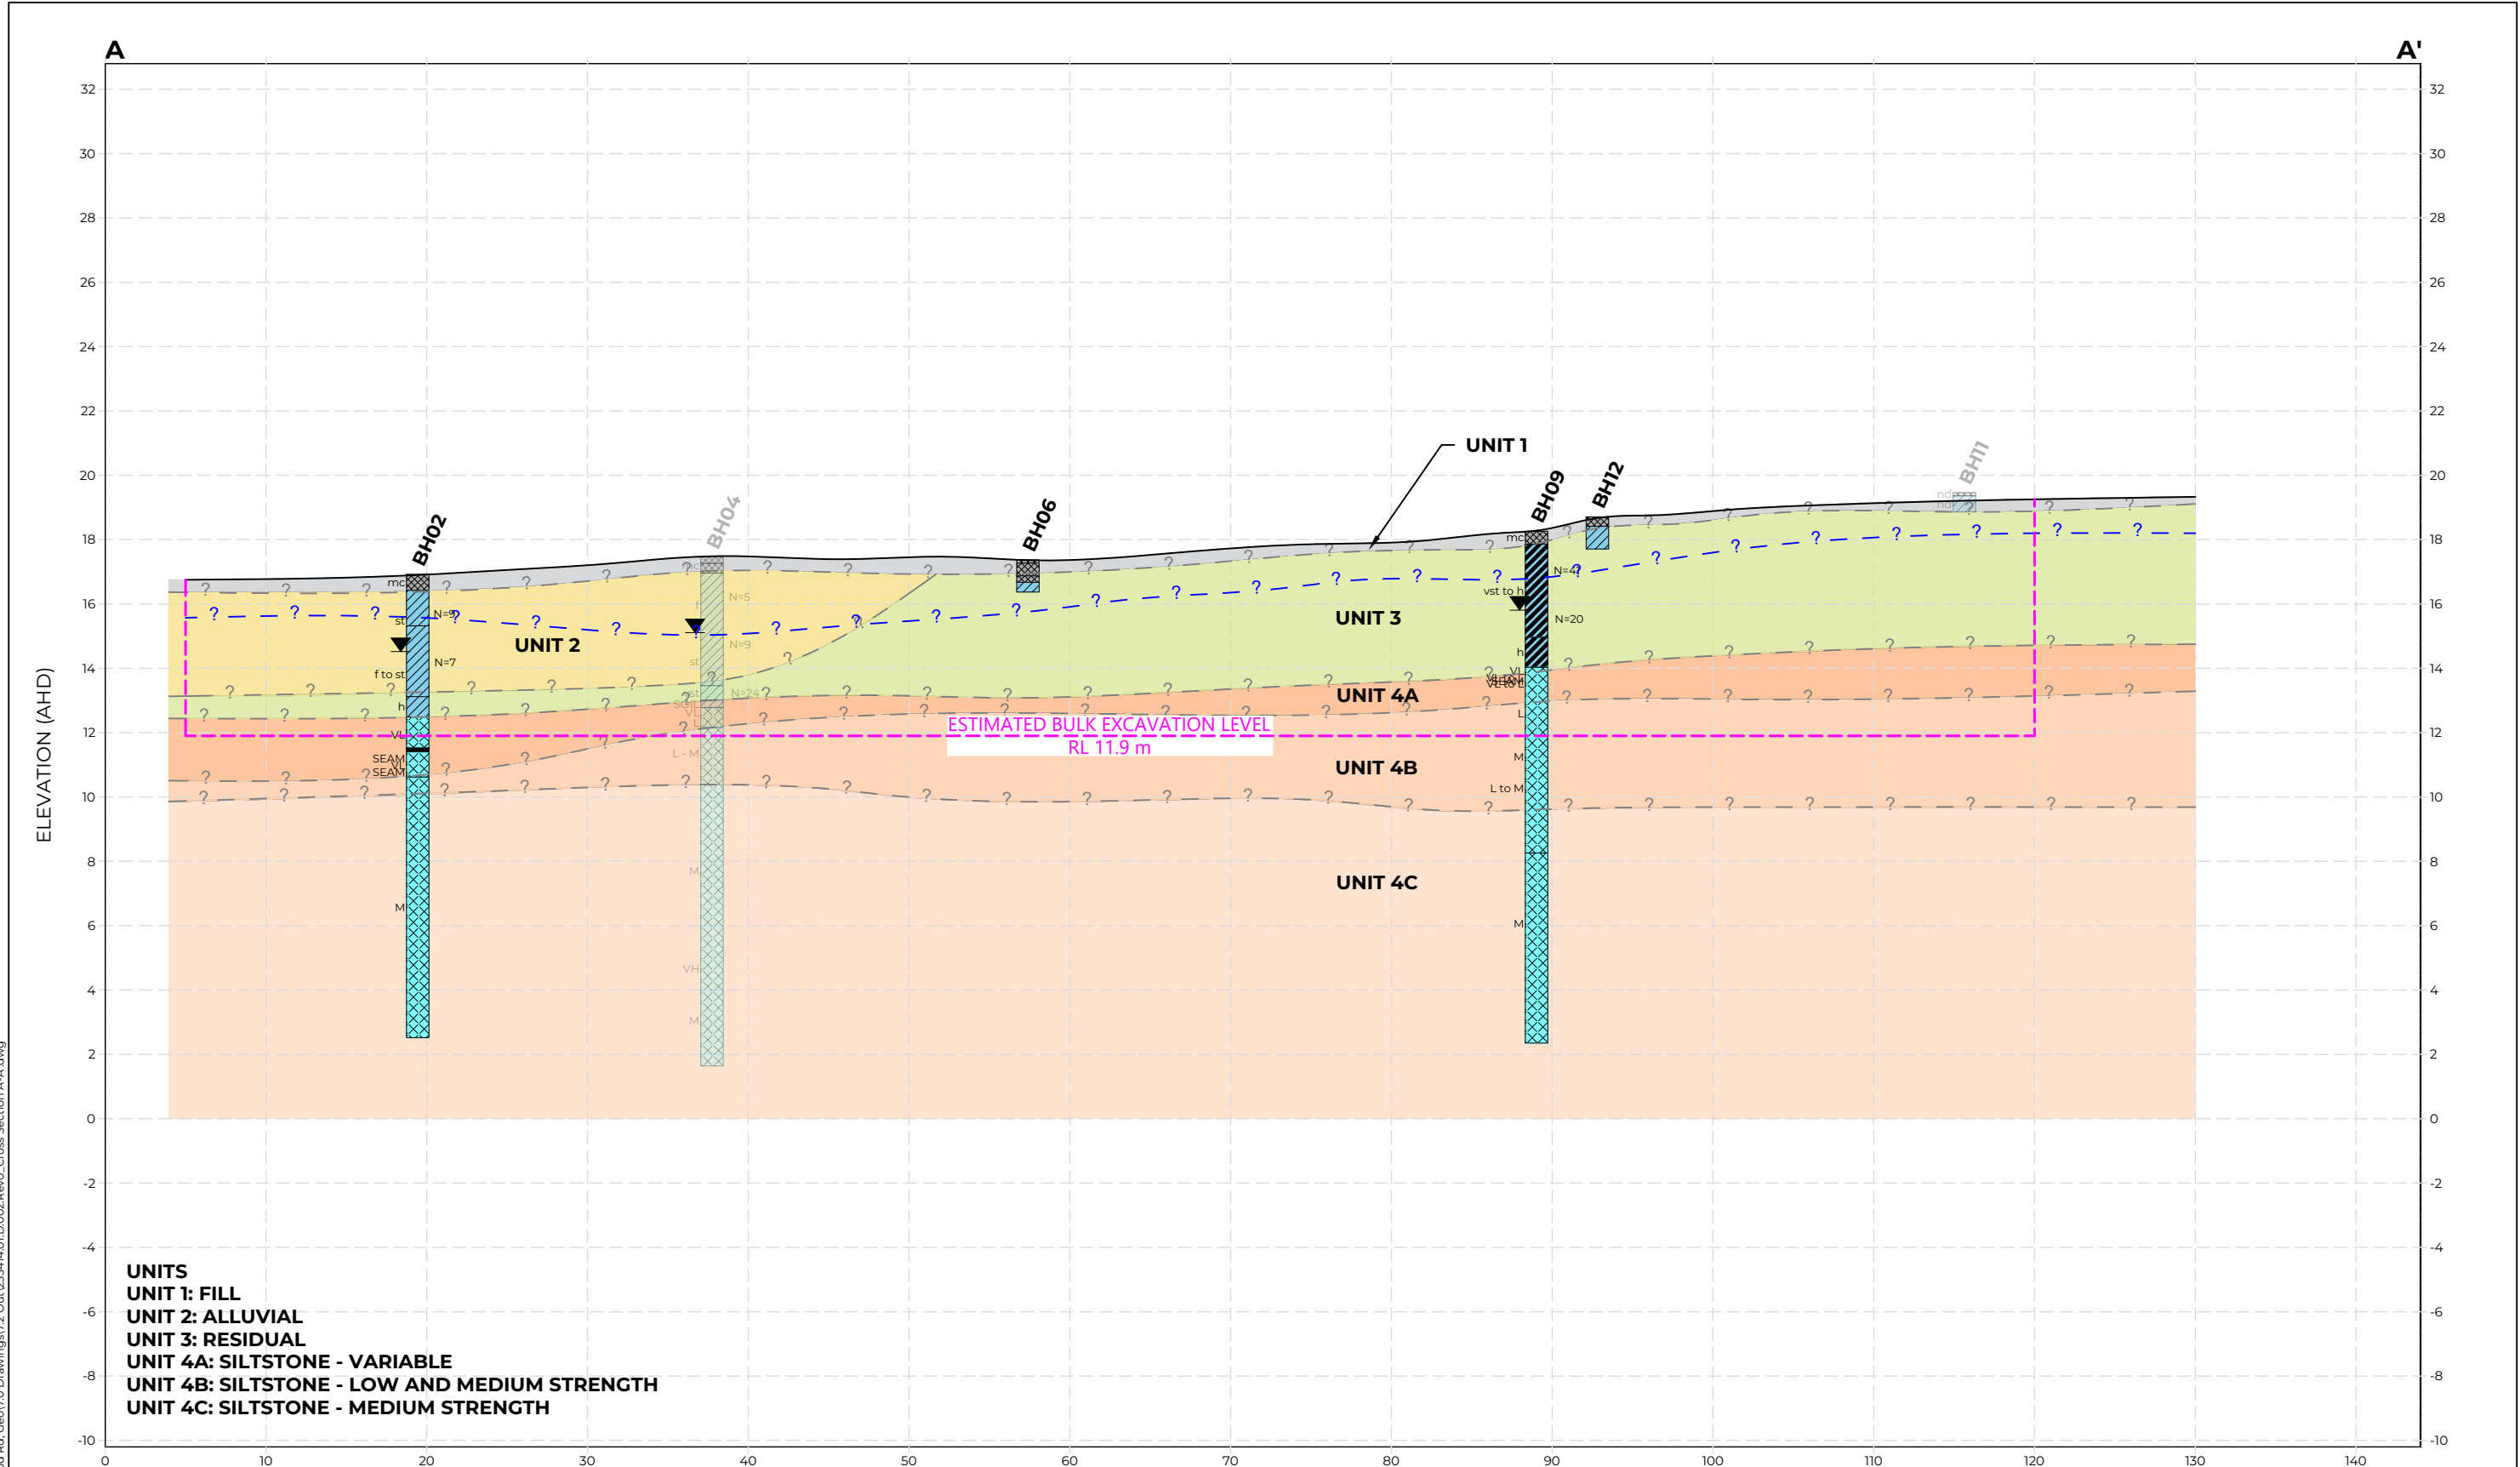
**UNITS**  
**UNIT 1: FILL**  
**UNIT 2: ALLUVIAL**  
**UNIT 3: RESIDUAL**  
**UNIT 4A: SILTSTONE - VARIABLE**  
**UNIT 4B: SILTSTONE - LOW AND MEDIUM STRENGTH**  
**UNIT 4C: SILTSTONE - MEDIUM STRENGTH**

The above units are shown in relation to the boreholes and site levels on the interpreted geotechnical cross-section, presented on Drawing 2, in Appendix B. It should be noted that the subsurface profile is accurate only at the borehole locations and that substantial variation can occur in between and away from the boreholes. The interpreted geotechnical boundaries are for illustrative purposes only and should not be relied upon, and it should be noted that BH04 is offset from the subject section. The approximate groundwater level, based on initial readings at standpipes only, is shown for illustrative purposes.
