**Re: Aboriginal Heritage Due Diligence Report – 211A- 215 Harbour Drive, Coffs Harbour**

Artefact Heritage and Environment Pty Ltd (Artefact Heritage) have been engaged by Homes NSW (the proponent) to prepare an Aboriginal Due Diligence Report to accompany a State Significant Development Application (SSD-83294209) for the construction of affordable housing at 211A -215 Harbour Drive. Secretary's Environmental Assessment Requirements (SEARs) for the project were issued on 2 May 2025.

## 1.0 INTRODUCTION

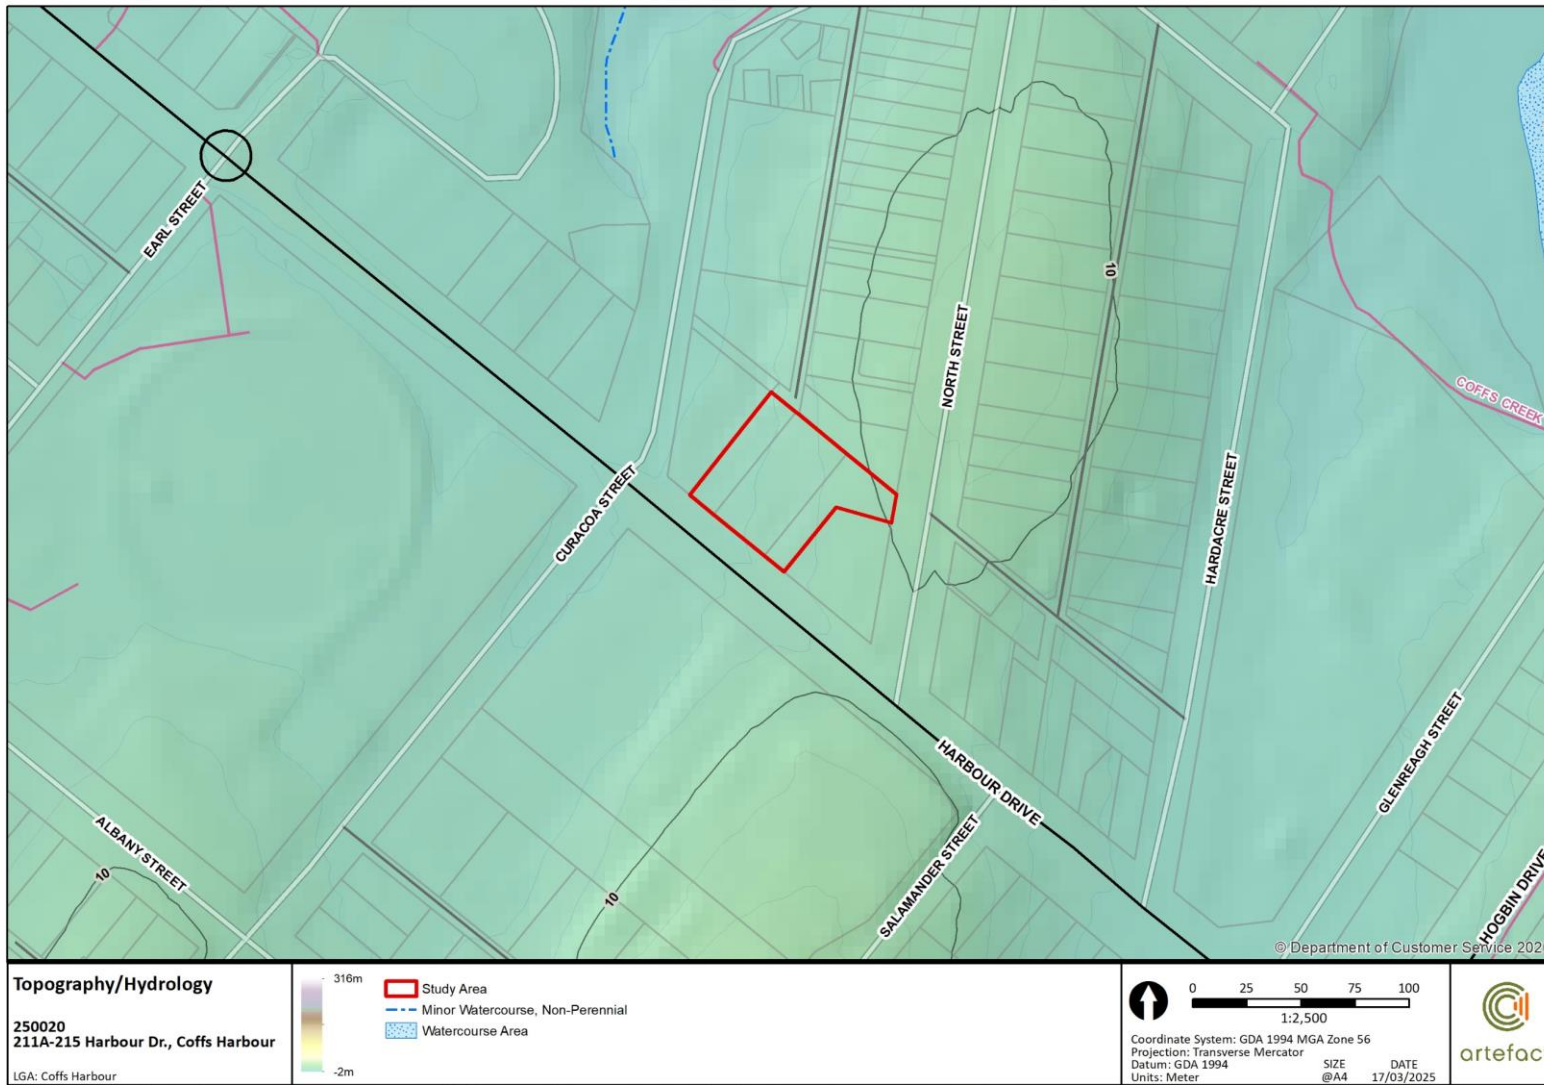
Figure 4: Topography and Hydrology of the study area

The study area is situated on the mid-portion of a gentle slope that grades upwards towards the southeast (Figure 4). The landform appears to have been subjected to regarding and modification in some areas, potentially as a result of previous development on the site (Figure 5 to Figure 9). The study area is approximately 130 metres southeast of a minor non-perennial watercourse Carralls Gully. Coffs Creek, a major watercourse in the area that drains out into the Pacific Ocean, is approximately 320m east of the study area. Due to modification of the landform the potential for Aboriginal objects to be present in the study area is limited.

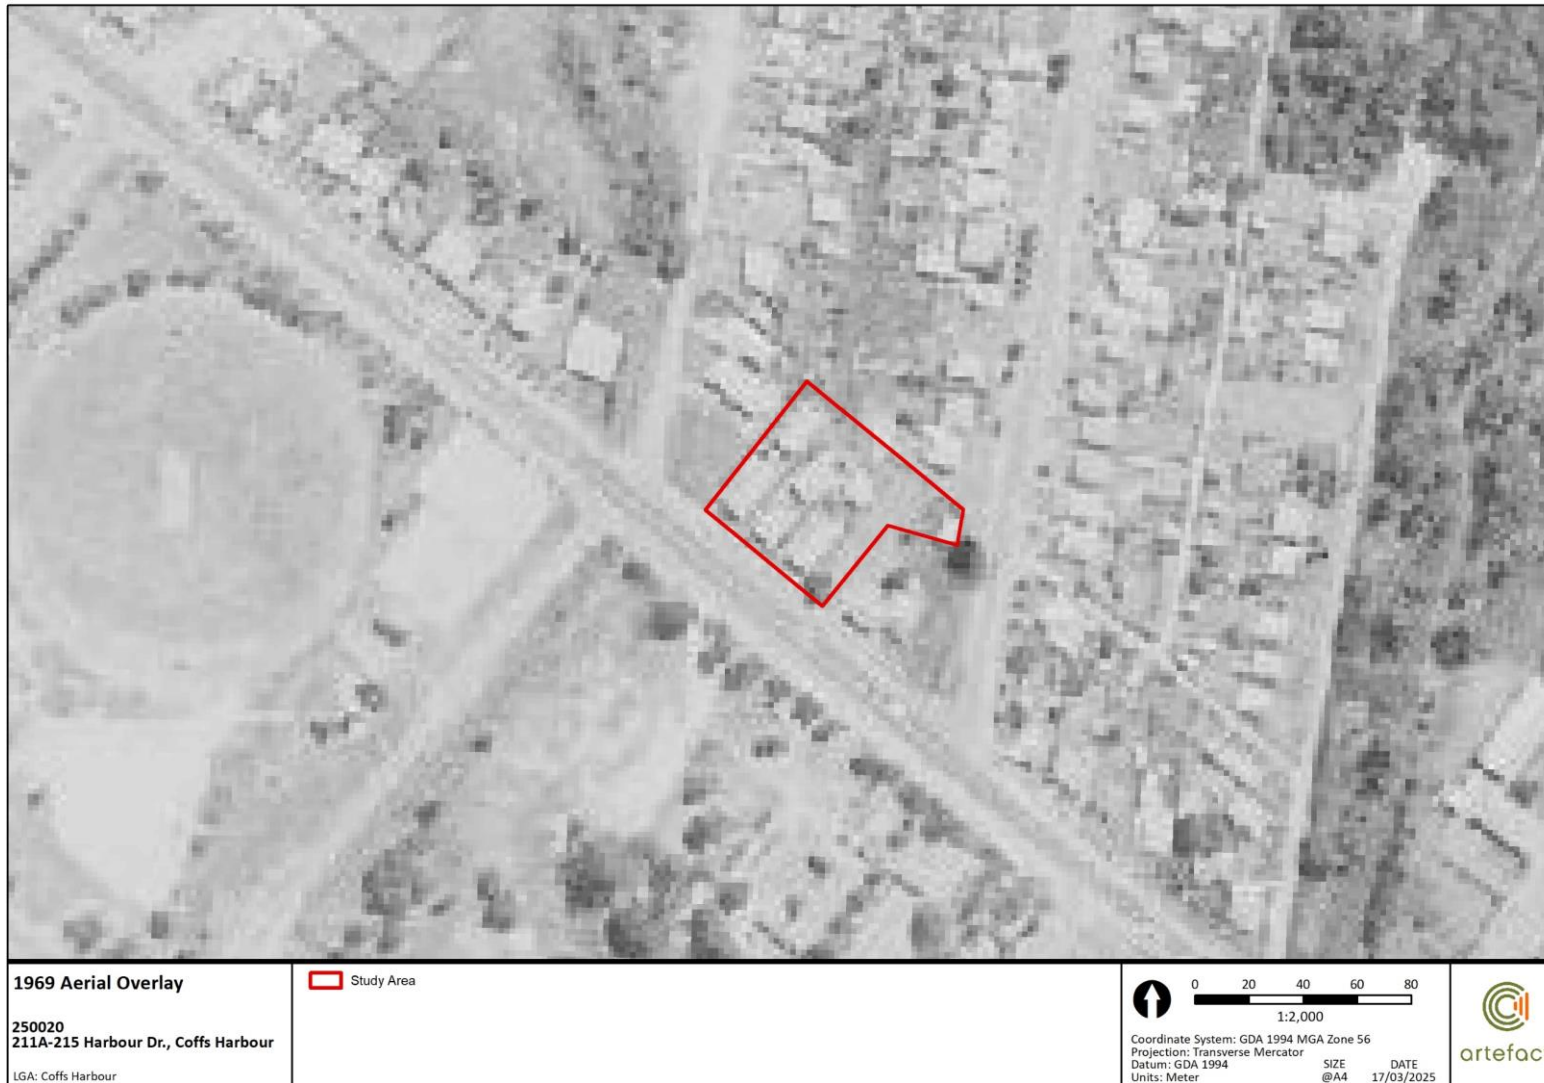
Figure 5: 1969 aerial photograph

There are limited available historic aerial images for the Coffs Harbour region, with the majority of available images coming from the latter half of the twentieth century. The earliest available aerial photograph of the study area comes from 1969 (Figure 5) and demonstrates that structures were present within the lots known as 211A and 213 Harbour Drive by this time and these structures appear to take up significant portions of their respective lots. A smaller structure appears in the northeast corner of 215 Harbour Drive, but much of the remaining portion of the property appears undeveloped at this time. The study area appeared to have remained generally unaltered between 1969 and 1974 (Figure 6); however, by 1989 (Figure 7), the structure that was formerly extant in the northeast corner of 215 Harbour Drive appears to have been demolished. Following this, the study area remained until some point between 2004 and 2010 (Figure 8 and Figure 9) when the remain structures present on the site were demolished. Due to this previous disturbance across the site, the potential for Aboriginal objects to be present in the study area is limited.

The study area is significantly disturbed and showed evidence of removal of potential artefact bearing residual soils. Varying levels of ground disturbance have taken place within the study area. This includes the construction of residential buildings (Figure 5) which are no longer extant on the property and the installation of associated services. Some cement was partially visible on the property (Figure 21), mostly obscured by grass cover indicating that additional foundational remains may still be present on the site further impacting the natural soil profile. Cuts into the landscape and the extant vegetation coincide with the location of the previous buildings and landscaping on the property.

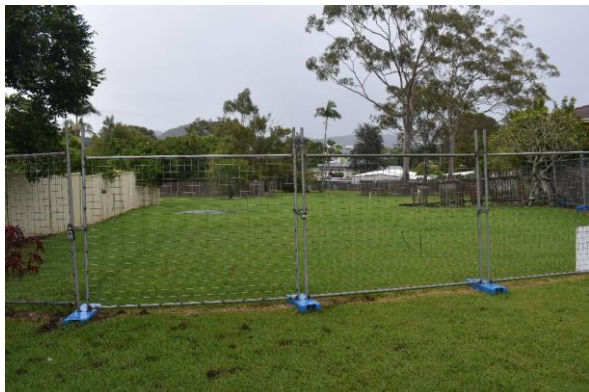
**Figure 10: View west of property access from North Street**

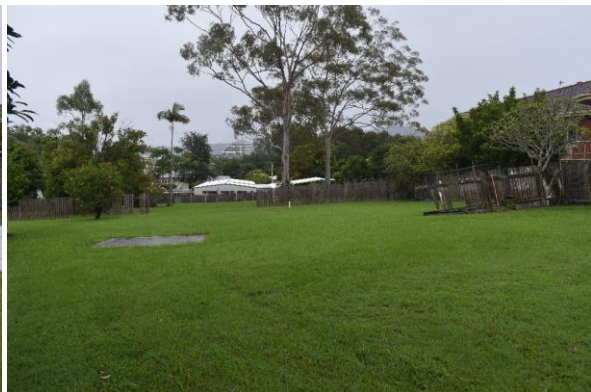
**Figure 11: View west of property, extant fences and building foundation visible.**

Existing fence lines visible on the Lot 100 boundary of the study area and the concrete foundation to the north of the curtilage of the current heritage listed site 'former courthouse and police station' are evidence of continued occupation and disturbance to the northeast portion of the study area. This disturbance is separate to the visible buildings works in 1969 onwards towards the west of the property.

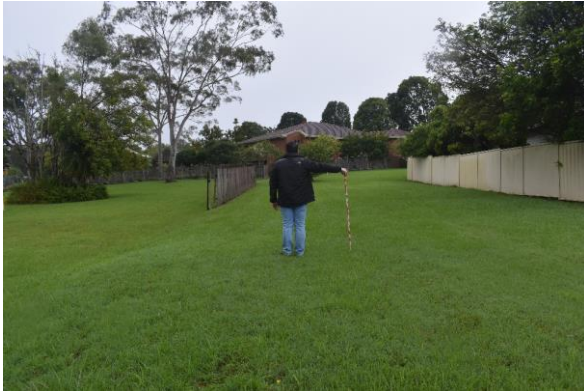
**Figure 12: view northeast from Harbour Drive Road. Ranging pole to indicate gentle downward slope of the property**

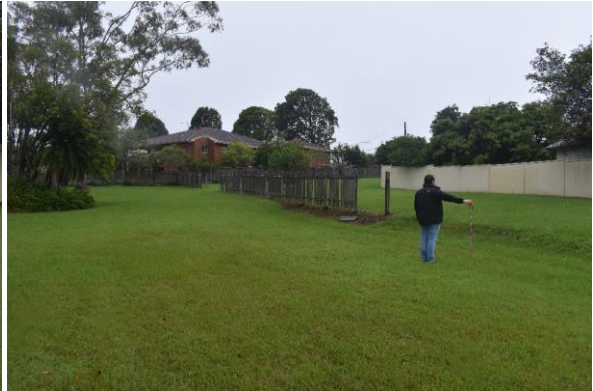
**Figure 13: View east of cut and fill of the slope between Lot 15 and 100 indicating landscape modification and levelling**

The study area is located on a slope that shows signs of modification from the structures that previously existed on the site. This modification, which involved cuts and fill into the slope in some areas, indicates ground disturbance across the site. In addition, visual inspection noted markers of subsurface works across the study area. As a result of this disturbance, it is unlikely that Aboriginal objects will be present in the study area.

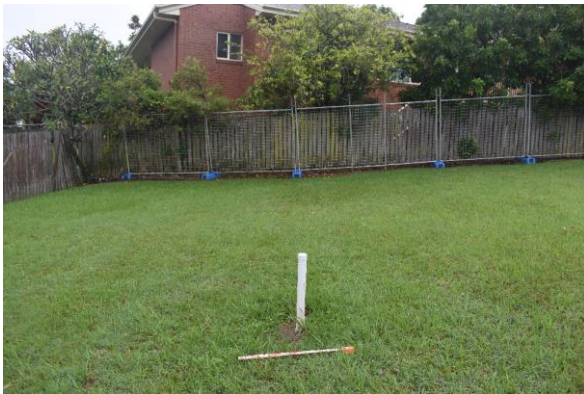
**Figure 14: Indication of subsurface works at the north of the study area**

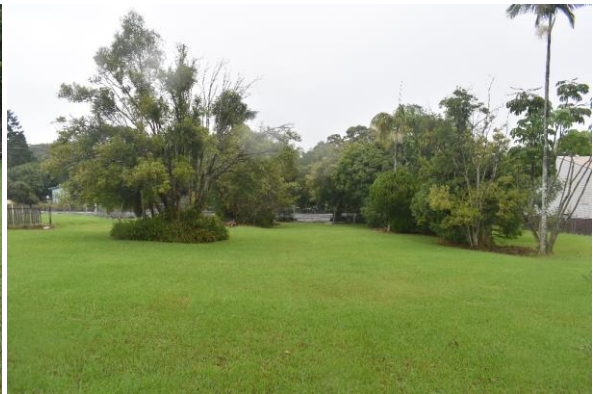
**Figure 15: View south of introduced vegetation on the property (view towards Harbour Drive Road)**

Three mature trees were located to the north of the property revealed no evidence of cultural modification or scarring (Figure 16). Additional vegetation to the southeast of the study area was identified as recent landscaping and introduced trees.

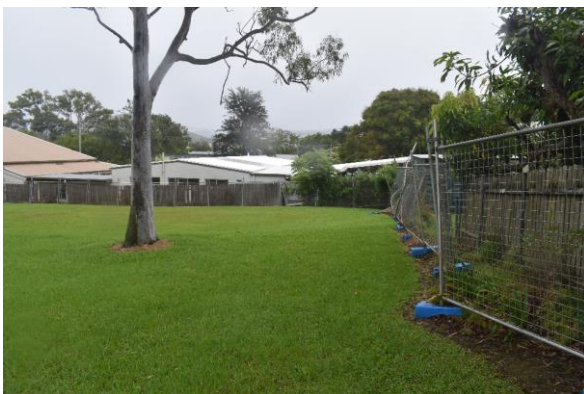
**Figure 16: View northwest of mature tree and visible soil profile along the study area boundary**

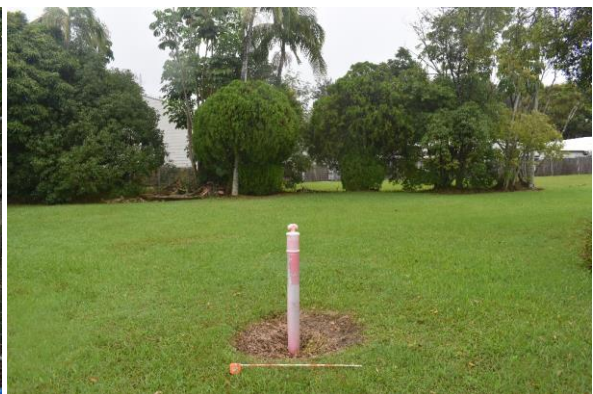
**Figure 17: View northwest of hole indicating subsurface works**

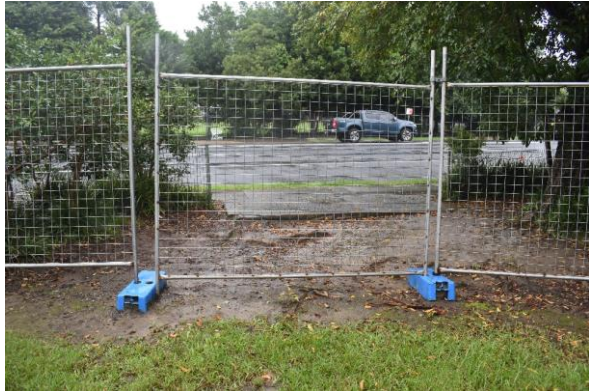
**Figure 18: View to Harbour Drive Road indicating exposed clay and introduced gravels**

Patches of ground visibility were identified within grassed areas, where clay (Figure 18) and imported gravels was observed. Disturbance to the site will have removed the natural soil profiles, therefore, the soils present within the study area are unlikely to contain subsurface Aboriginal artefacts.

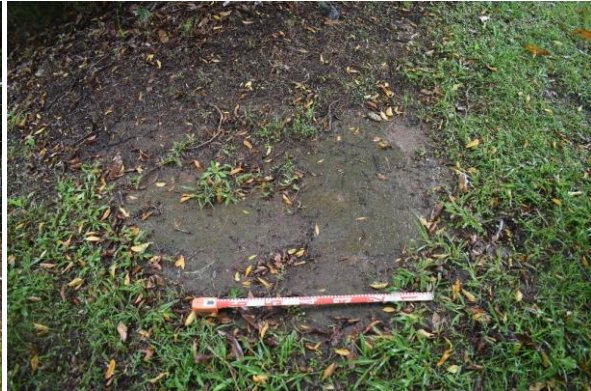
**Figure 19: Exposed clay towards the Harbour Drive lot 15 entrance of the property**

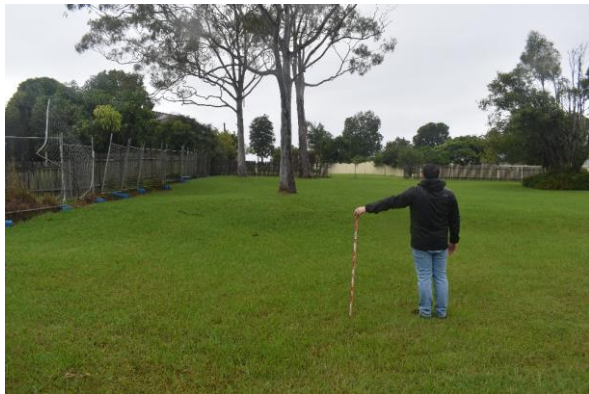
**Figure 20: View of additional cuts and modifications to the landscape slope from the northwest corner of the property**

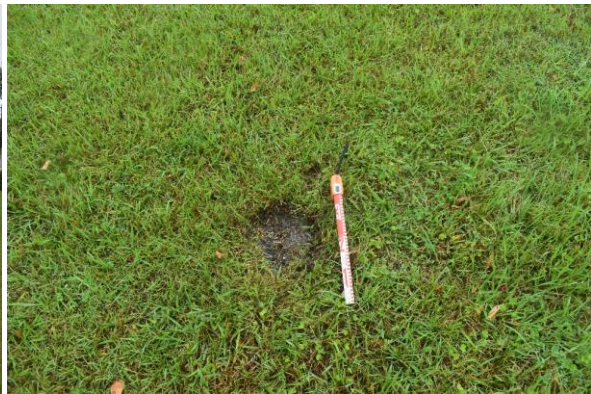
**Figure 21: View of subsurface remnant potential building foundations**
